From: Hannah Houraira <hourairahannah@gmail.com>
Sent: Monday, January 12, 2026 3:08 PM
To: Clerkoftheboard; Angel Barajas
Subject: County Road 41 - #35 on the agenda for January 13, 2026
Attachments: Landslide progression July 2023 - Jan 2026v2 (1).pdf

Landslide Progression and Ongoing Slope Instability
(July 2023 – January 2026)

Ongoing Landslide Progression and Infrastructure Risk (July 2023 – January 2026)

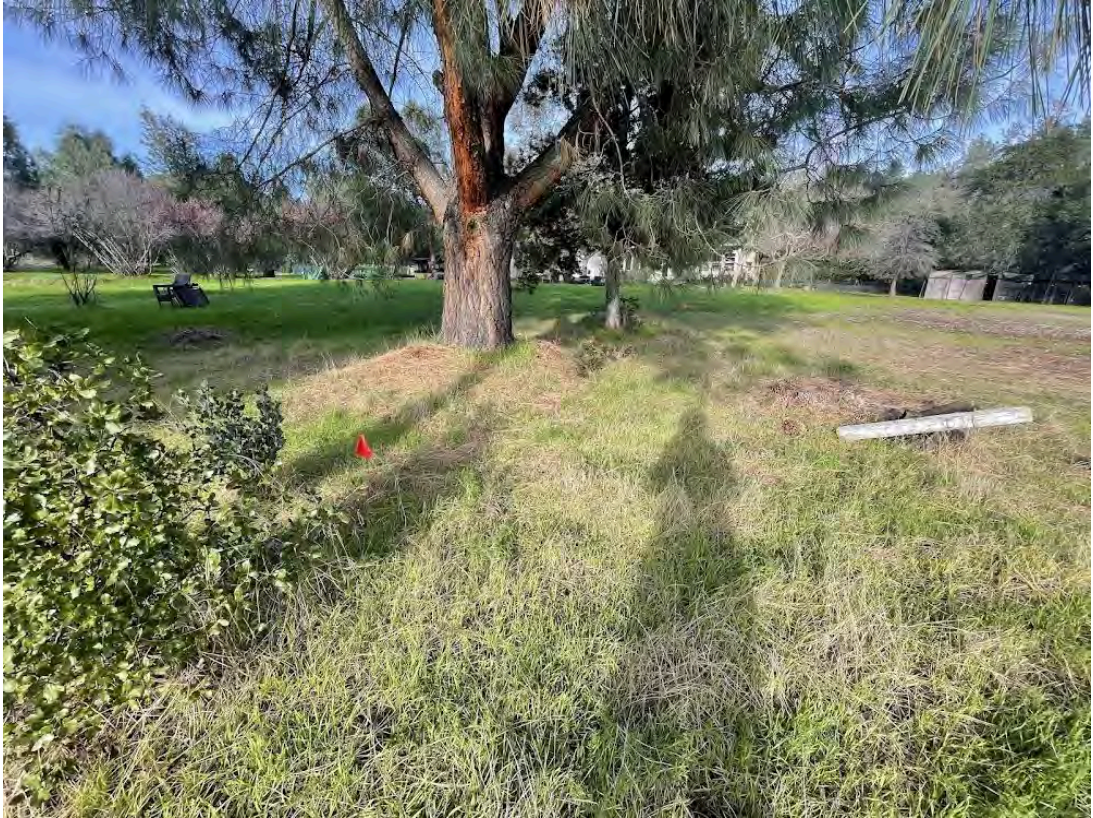
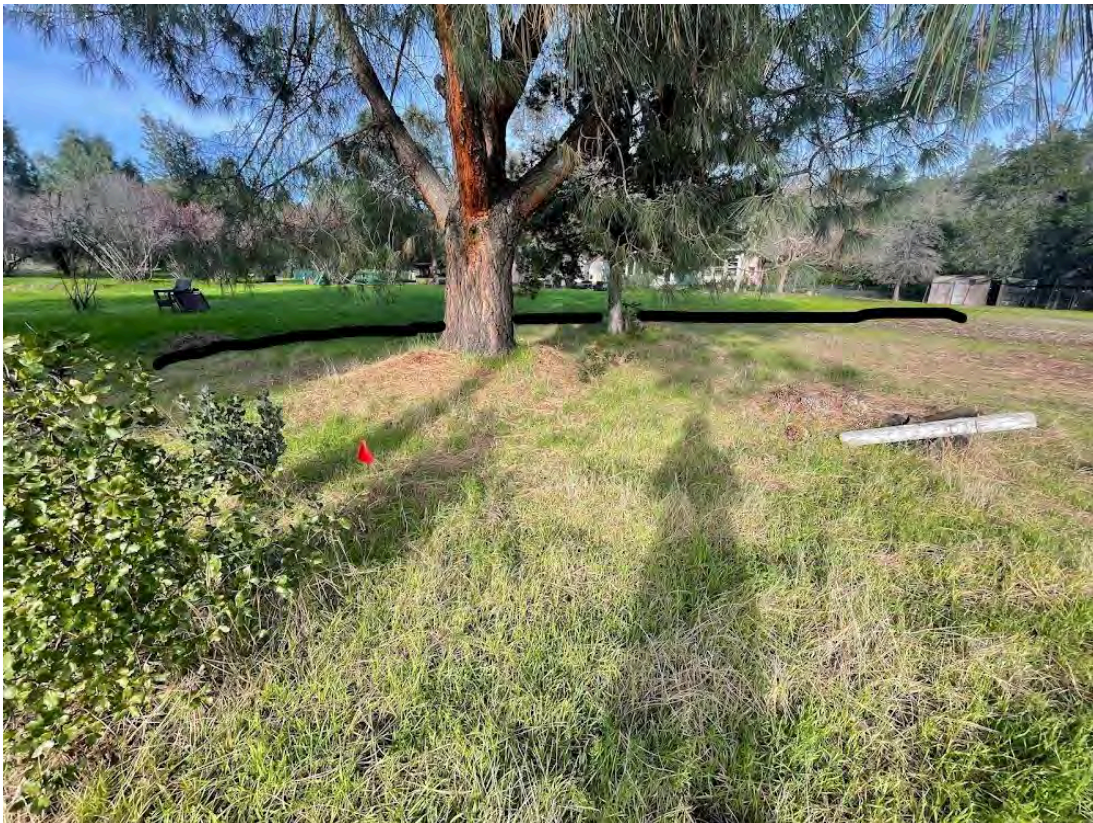
This picture is taken from the most recent shelf crack looking toward the house and you can see, much farther inland from the crack the entire yard is already sinking, where I draw the black line, all of that land has already sunk several inches
