# Stillwater Building Inspection Summary

Prepared by the City of Billings – Facilities Division

8/11/2021

# **Structural Condition Assessment Report**

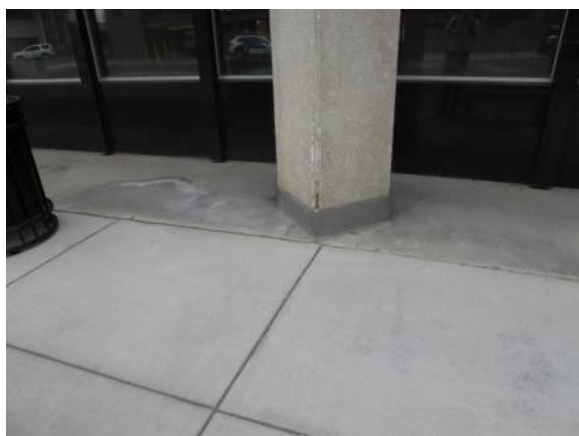
P5: weathered façade

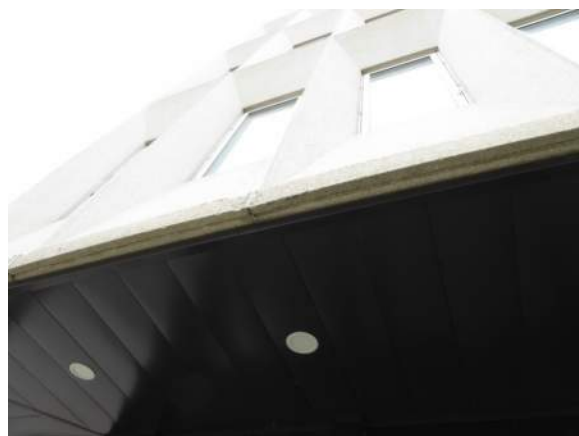
P6: weathered façade

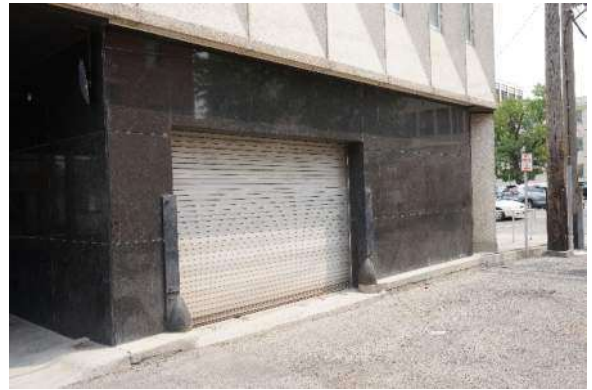
entry and ramp to the basement level parking garage are located on the west elevation. Two additional, overhead doors are located at grade, near the west end of the south elevation and the south end of the west elevation. **(Photos #3 and #4)** A pedestrian bridge was constructed across North 26th Street to a neighboring parking garage. Two precast wall panels were removed during the bridge construction and were available for our examination. **(Photo #5)** The removed window units were also stored but were wrapped and not readily accessible for our examination.

**Photo #4** West elevation overhead door.

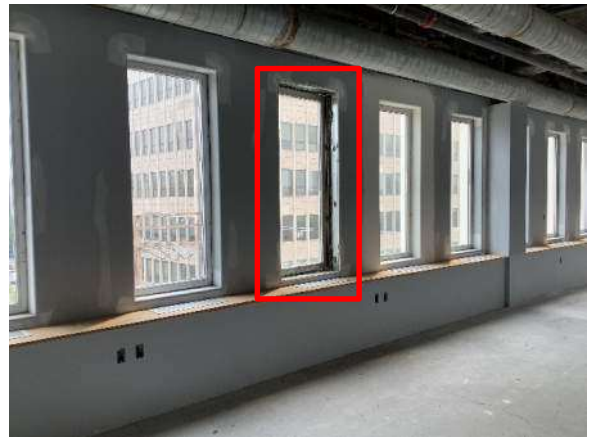
**Photo #10** Gypsum board had not been installed at one window on the fourth and fifth floors indicated by the red rectangle.

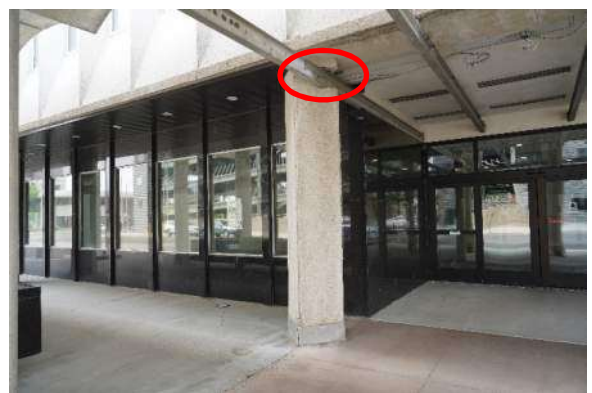
The precast column cover located at the south side of the east pedestrian entrance appears to have moved slightly based on separations within the joint sealants. **(Photos #18 and #19)** The column cover was

**Photo #18** Column cover at the east entrance. Note the cover was modified to accommodate a beam indicated by red oval.

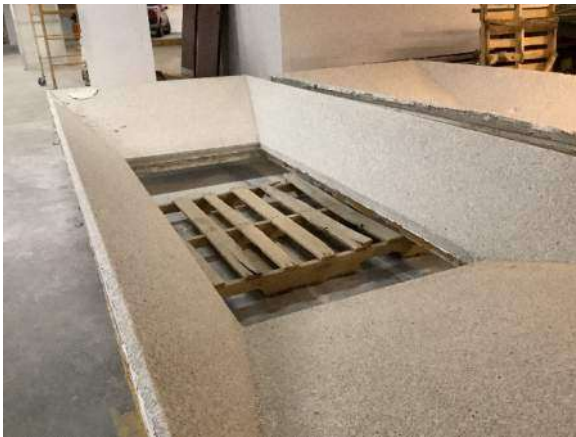
The two wall panels that were removed during the pedestrian bridge construction were stored in the basement and examined as part of our assessment. **(Photos #20 and #21)** The panels have overall dimensions of approximately 13 feet by five (5) feet. The average panel thickness is approximately five (5) inches, and the overall panel depth is approximately 16 inches.

**Photo #21** Wall panels removed from the façade and stored in the basement.

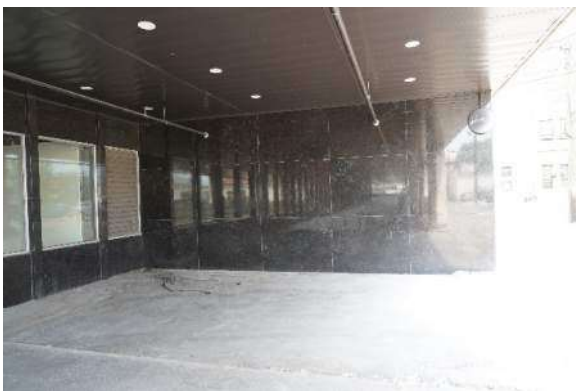
The granite cladding at the first floor was observed to be in generally good and serviceable condition. **(Photos #22 and #23)** Evidence of deterioration or distress was not observed within the areas of granite cladding during our assessment. Other than the wall areas adjacent to the overhead doors, the exterior walls at the first floor are protected from the weather by the overhanging the upper floors. Granite is an extremely durable material and unlikely to require maintenance over the life of the building.

**Photo #23** View showing the granite cladding at the top of the vehicular ramp.

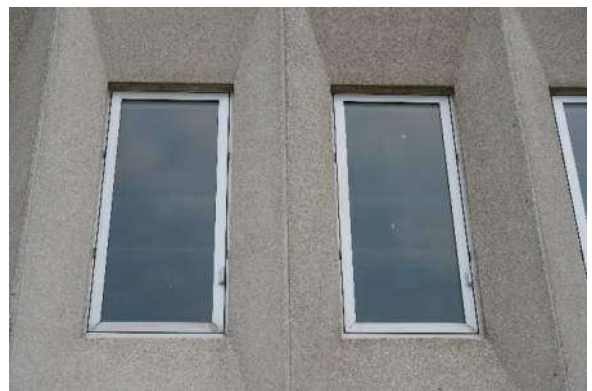
The windows at floors two thru five are aluminum frame, vertical pivot windows with insulating glass (IG) units. **(Photos #24 and #25)** The approximately overall dimensions of the operable windows are 31 inches by 75 inches. The sashes are glazed from the building interior. At the building interior, the handles have been removed and the sash latch key holes have been filled with sealant. **(Photos #26 and #27)** The handles remain at the exterior and the latch strike plates are visible at approximately the third points of each jamb. **(Photo #28)** The joint between the operable sash and the frame is typically located behind the new interior finishes and therefore we were not able to observe its condition. **(refer to Photos #24 and #25)**

**Photo #24** Typical exterior view of the operable window units installed at floors two thru five.

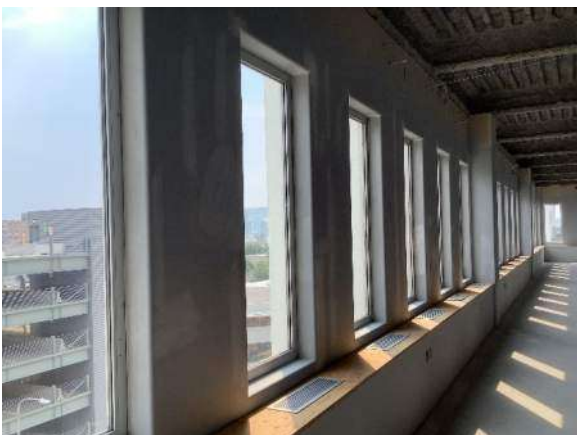
**Photo #25** Typical interior view of the operable window units installed at floors two thru five.

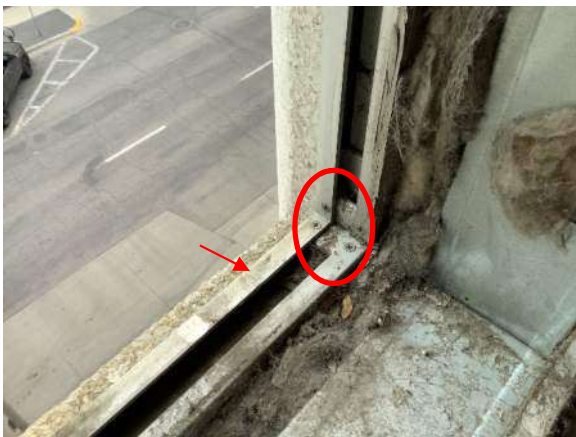
At the location where the sash could be pivoted, we examined concealed portions of the frame and sash as well as the joint sealants and precast wall panels in the area. The frame section appeared to have been assembled from two pieces of aluminum, connected at the corners with small plates. **(Photo #35)** The frames are not thermally broken, and weep holes are located at the underside of the sills near the jambs. **(Photo #36)** The corners of the frames and sashes are mitered. One strip of fin-type weather stripping was provided at the sash crack, the joint between the operable sash and the frame. The exterior glazing materials were in very poor condition.

**Photo #35** Exterior window frame piece indicated by red arrow attached to main frame by plate at the corner indicated by red oval.

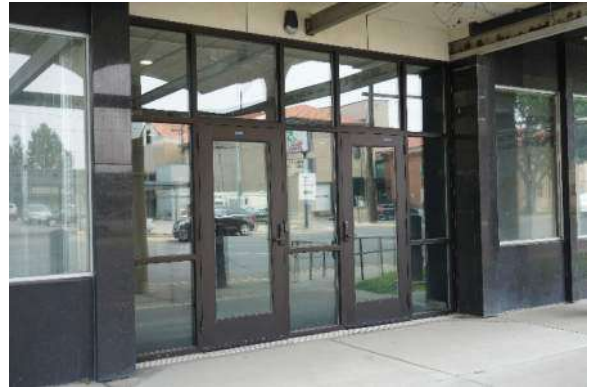
The original fenestration at each of the three pedestrian entrances was replaced with Kawneer storefront systems. **(Photos #44 and #45)** The storefronts and related components were observed to be in serviceable condition.

**Photo #44** North elevation entry storefront. The south elevation entry storefront is similar.

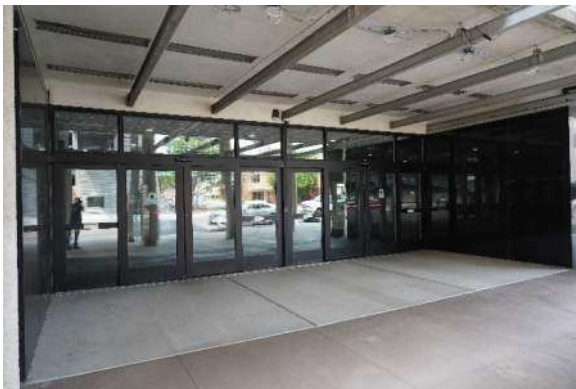
**Photo #45** East elevation entry storefront.

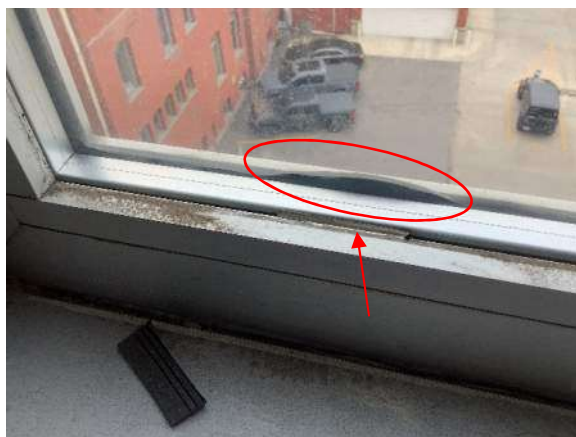
The first replacement program is believed to have occurred around 1991 as the Insulating Glass Certification Council (IGCC) spacer stamp is dated from 1991. **(refer to Photo #31)** The 1991 replacement IG units were "wet" glazed at the exterior, and the original interior gaskets were typically reinstalled but were often damaged. **(refer to Photo #31)** It was reported that as many as 80 additional IG units were recently replaced, and stickers were present on the interior of a few recently replaced units. **(Photo #50)** These recent replacements do not have IGCC spacer stamps, and the spacer is cut at the corners. **(Photo #51)** The recent replacements used butyl tape as the exterior glazing material, but rubber shims were used in lieu of continuous gaskets at the interior of the units. The shims were typically installed at two locations along the head and sill and at three locations along each jamb. At many locations, the head shims had fallen out. At the sill, we observed the butyl glazing materials pushing out of the glazing joint at the shim locations indicating a high level of IG unit edge pressure at the shim locations. **(Photos #52 and #53)**

**Photo #53** Butyl glazing tape bulging from the exterior glazing joint (red oval) at the shim (red arrow).

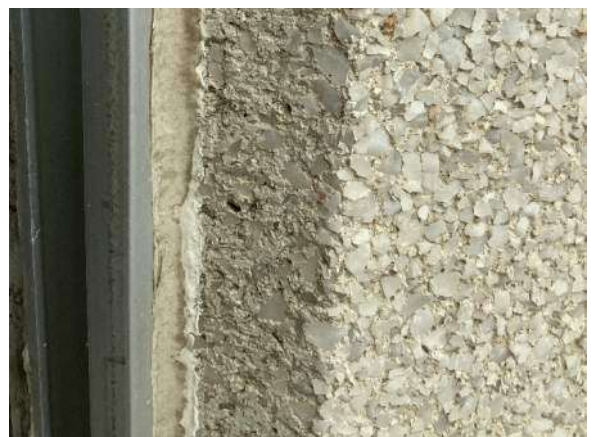
**Photo #54** Window perimeter sealant at the fourth floor. Two colors of sealant indicate that the sealant has been overcaulked.

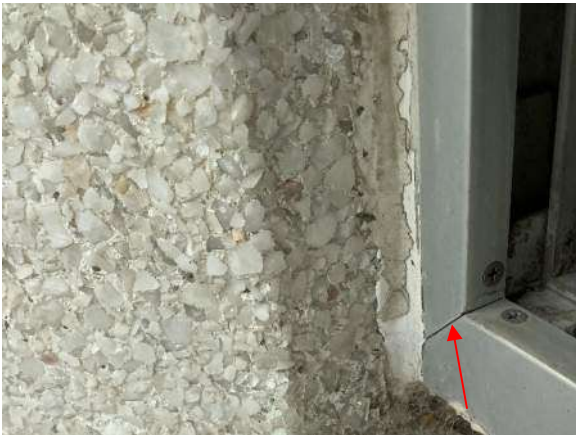
**Photo #55** Overcaulked window perimeter sealant at the fourth floor. Note that the frame corner joint is open (red arrow).
