## WORK SESSION AGENDA

August 16, 2021

# **Structural Condition Assessment Report**

Subject: Stillwater Building Preliminary Condition Assessment

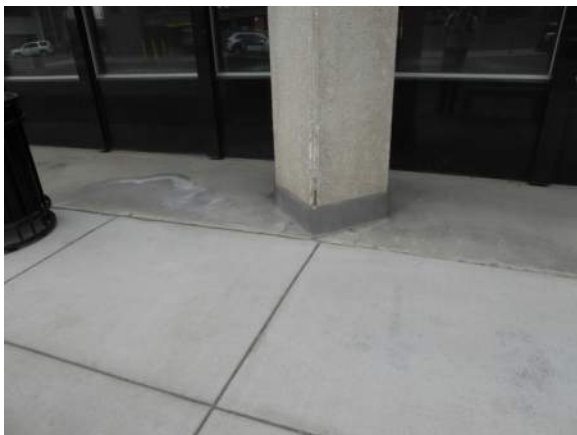
P5: weathered façade

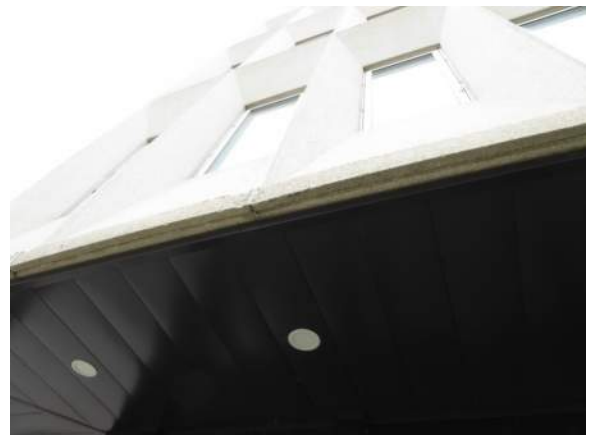
P6: weathered façade

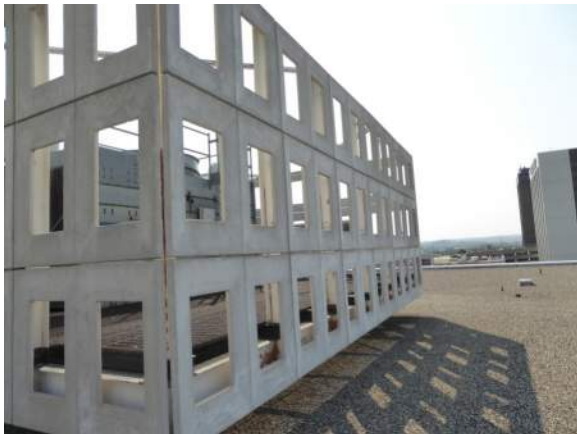
P41: Roof top mech equipment enclosure; precast concrete panels and steel frame

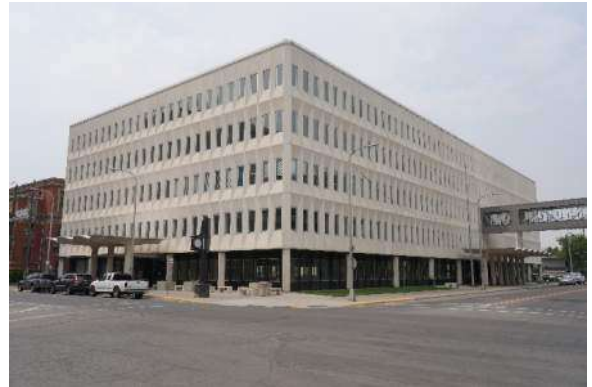
**Photo #2** Overall view of the Stillwater Building looking northwest.

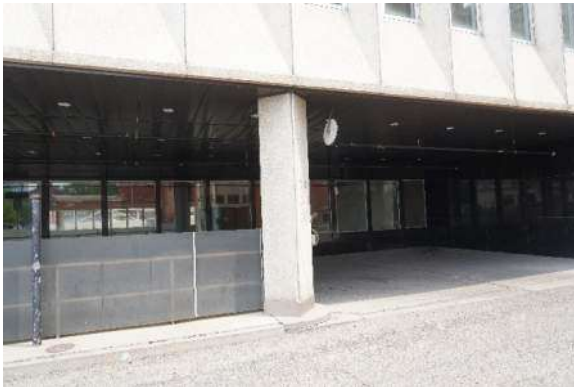
entry and ramp to the basement level parking garage are located on the west elevation. Two additional, overhead doors are located at grade, near the west end of the south elevation and the south end of the west elevation. **(Photos #3 and #4)** A pedestrian bridge was constructed across North 26th Street to a neighboring parking garage. Two precast wall panels were removed during the bridge construction and were available for our examination. **(Photo #5)** The removed window units were also stored but were wrapped and not readily accessible for our examination.

**Photo #3** West elevation entry to the vehicular ramp to the basement garage.

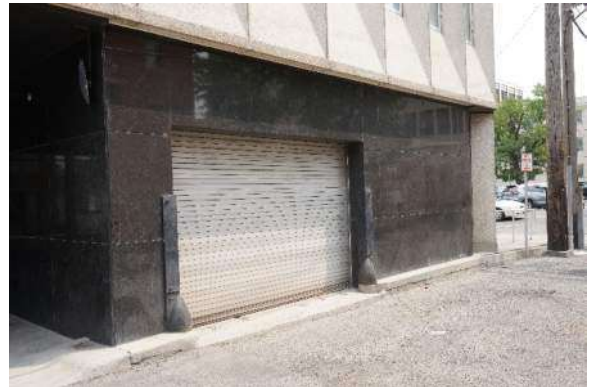
**Photo #4** West elevation overhead door.

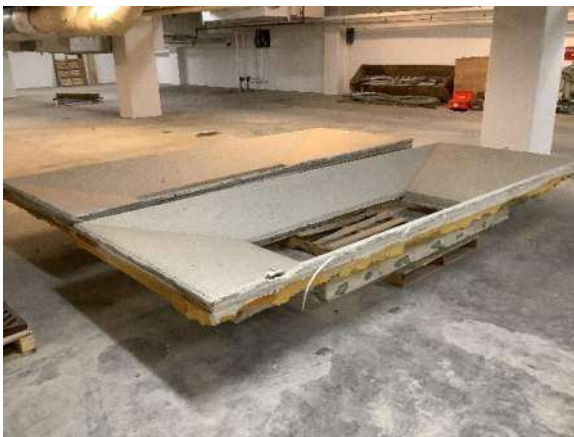
**Photo #5** Precast panels removed as part of the pedestrian bridge construction.

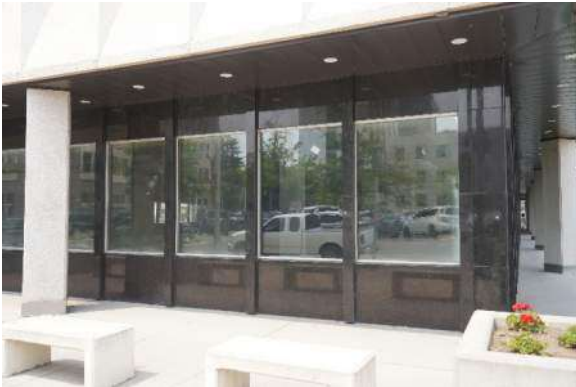
**Photo #7** Polished black granite cladding at the first floor.

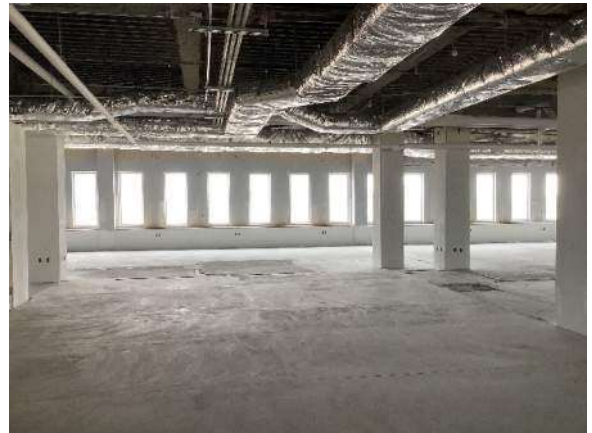
**Photo #8** Overall view of the fifth floor at the time of our assessment.

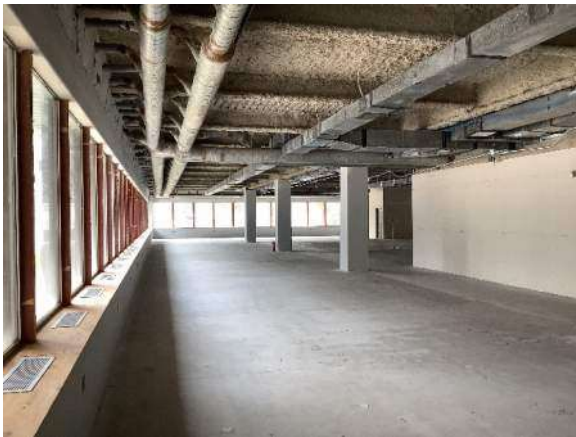
**Photo #9** Overall view of the first floor at the time of our assessment.

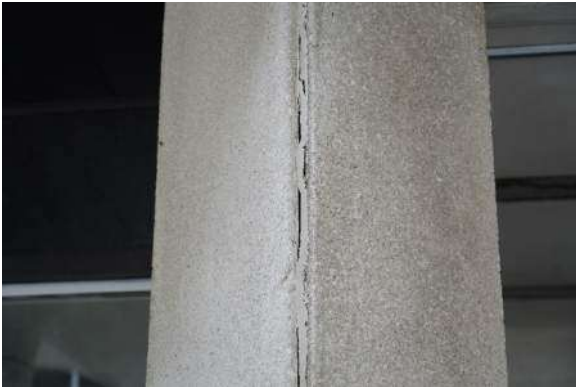
The precast column cover located at the south side of the east pedestrian entrance appears to have moved slightly based on separations within the joint sealants. **(Photos #18 and #19)** The column cover was

**Photo #19** Separations within the joint sealant suggest that the column cover has moved.

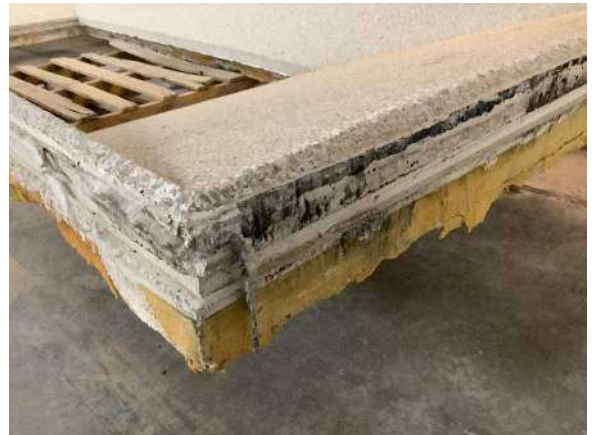
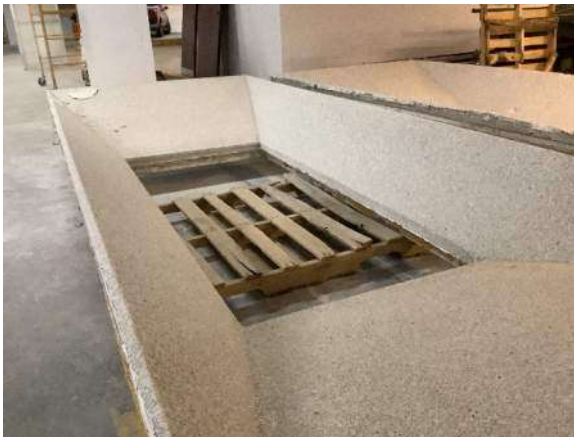
The two wall panels that were removed during the pedestrian bridge construction were stored in the basement and examined as part of our assessment. **(Photos #20 and #21)** The panels have overall dimensions of approximately 13 feet by five (5) feet. The average panel thickness is approximately five (5) inches, and the overall panel depth is approximately 16 inches.

**Photo #20** Wall panels removed from the façade and stored in the basement.

**Photo #21** Wall panels removed from the façade and stored in the basement.

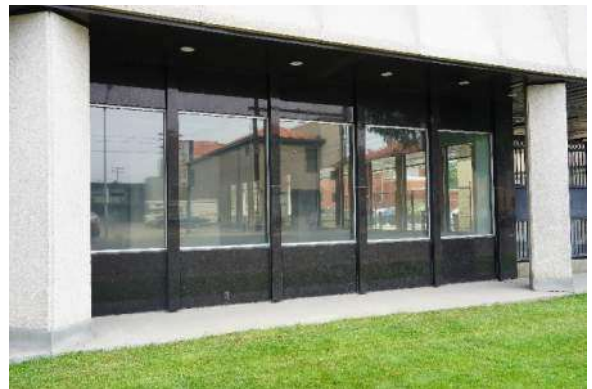
The granite cladding at the first floor was observed to be in generally good and serviceable condition. **(Photos #22 and #23)** Evidence of deterioration or distress was not observed within the areas of granite cladding during our assessment. Other than the wall areas adjacent to the overhead doors, the exterior walls at the first floor are protected from the weather by the overhanging the upper floors. Granite is an extremely durable material and unlikely to require maintenance over the life of the building.

**Photo #22** Typical view of the granite cladding installed at the first floor.

**Photo #23** View showing the granite cladding at the top of the vehicular ramp.

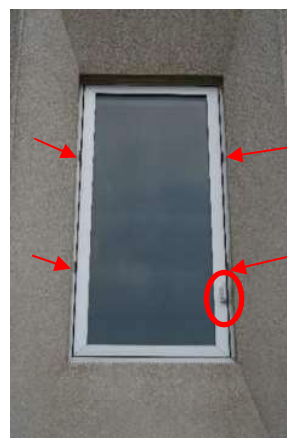
**Photo #28** Exterior handle indicated by red oval and latch strike plates indicated by red arrows.

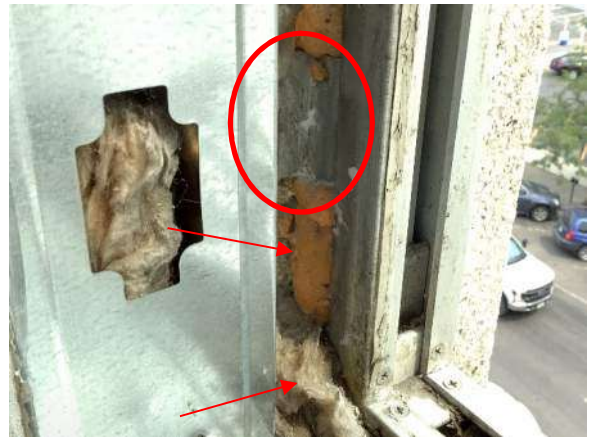
**Photo #34** Batt & SPF insulation indicated by red arrows. Window anchor indicated by red oval.

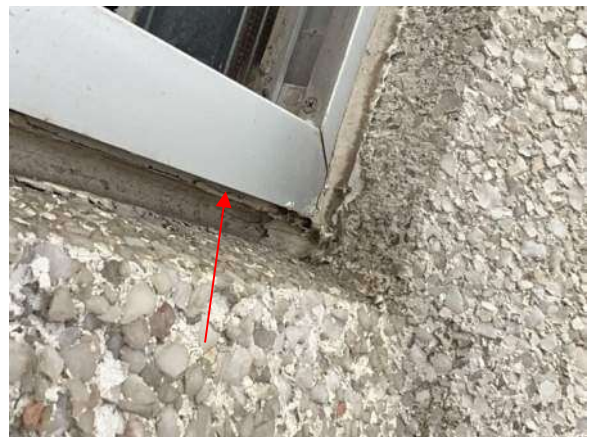
**Photo #36** Approximate location of the weep hole is indicated by red arrow.

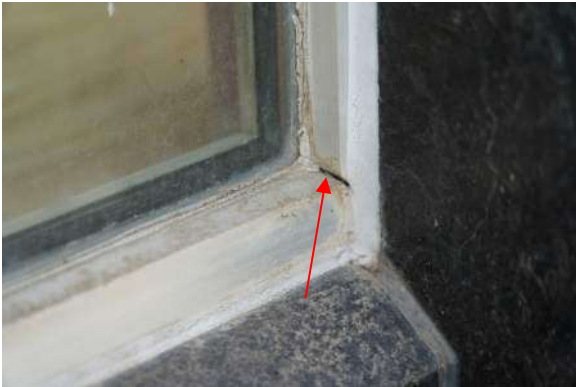
In addition to the glazing joints, metal-to-metal joints are located at the corners of the frames. These joints were typically appeared to be tight; however, some locations were open and susceptible to water penetration. **(Photo #43)** As we did not observe weeps for the glazing pocket or frame, it is important that the exterior face of the units be maintained in a watertight condition.

**Photo #43** Open metal-to-metal joint at first floor window frame corner indicated by red arrow.

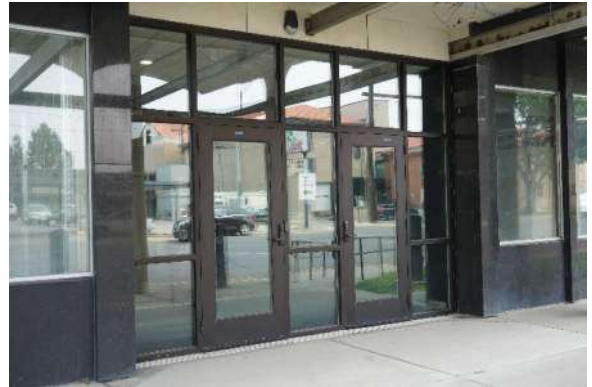
The original fenestration at each of the three pedestrian entrances was replaced with Kawneer storefront systems. **(Photos #44 and #45)** The storefronts and related components were observed to be in serviceable condition.

**Photo #44** North elevation entry storefront. The south elevation entry storefront is similar.

**Photo #45** East elevation entry storefront.

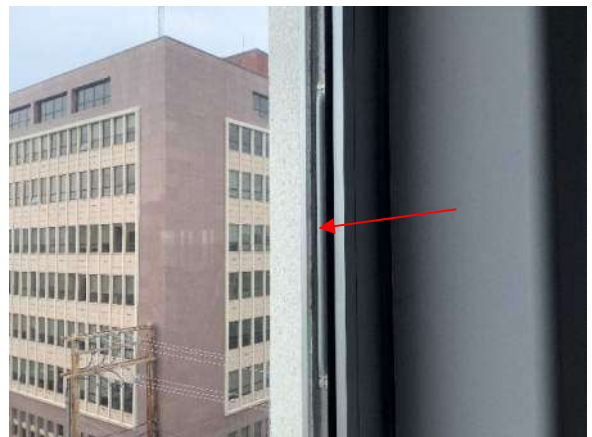
as three distinct types of IG units were observed. The original IG units have an aluminum channel spacer with a desiccant-filled tube mounted to the jamb spacer. **(Photo #48)** The original exterior glazing material appeared to be compound glazing and, as noted above, was observed to typically be in very poor condition. The original interior glazing material was a continuous gasket, and the original IG units have "Thermopane" etched in the lower right corner. **(Photo #49)**

**Photo #48** Desiccant-filled tube (red arrow) typical of original IG units.

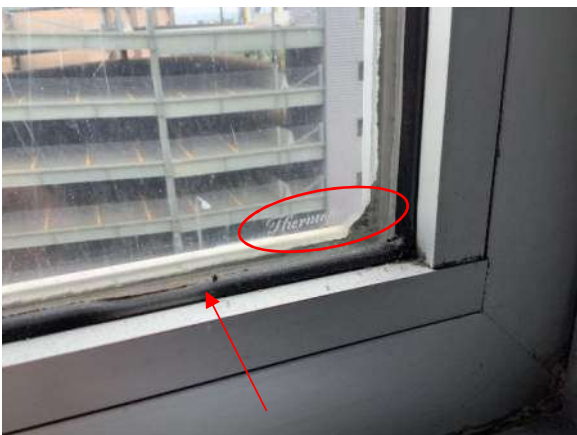
**Photo #49** Original IG units have “Thermopane” etched in the lower right corner (red oval) and interior glazing gaskets (red arrow).

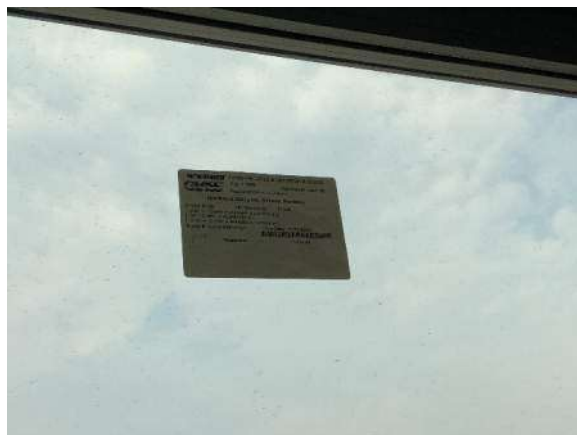
**Photo #50** Fabricator sticker found on a number of recently replaced IG units.

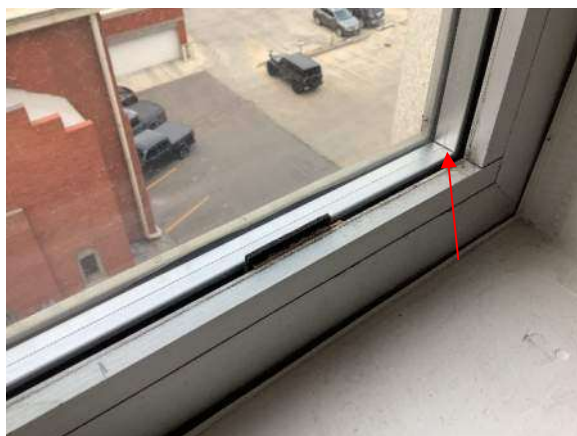
**Photo #51** Recently replaced IG units typically have no spacer stamp and the spacers have cut corners (red arrow).
