Cushing
Terrell®

BABCOCK THEATRE BUILDING

Building Assessment Report

Babcock Theatre Site Survey and Audio System Recommendations

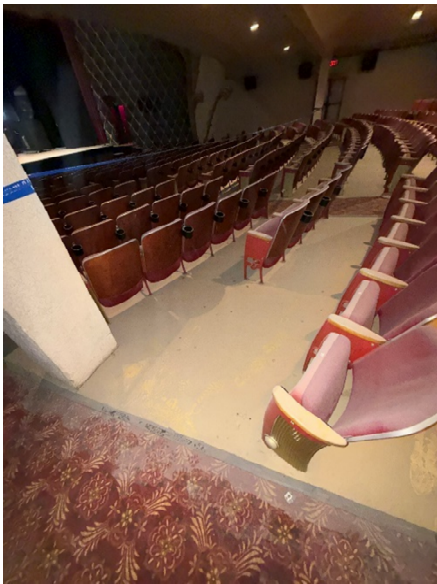
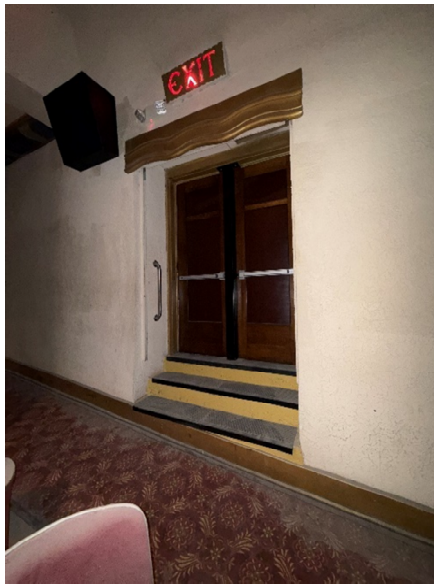
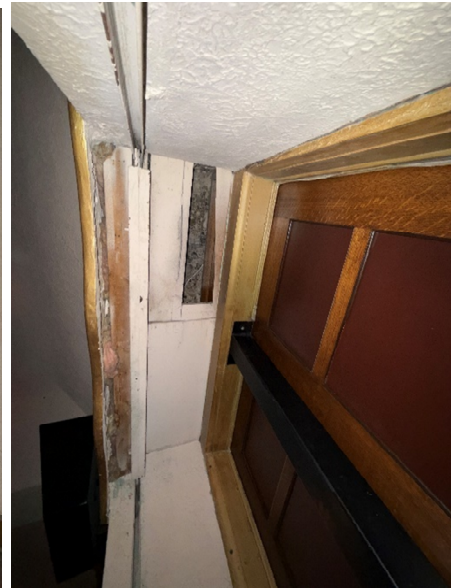
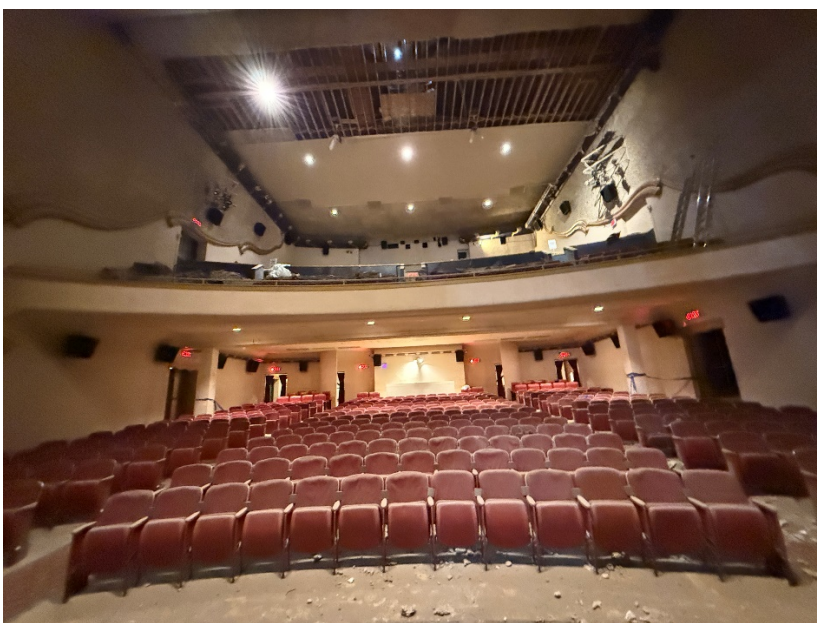
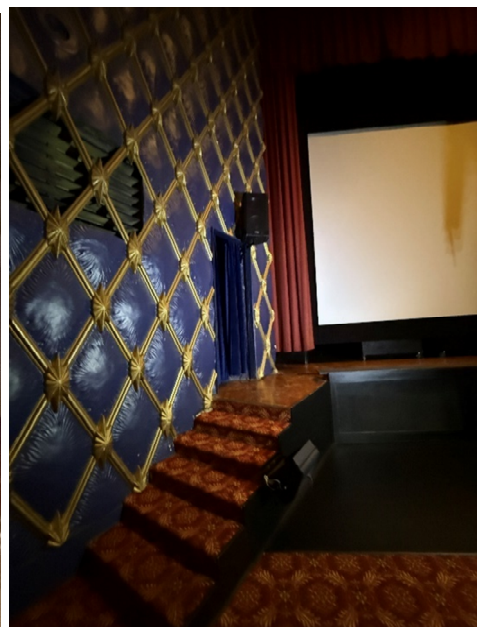
- **DM:** The ceiling collapse also damaged some of the plaster cove along the walls. We recommend having these restored to the original condition.
 - o Plaster cove repair \$50,000 - \$75,000
- **DM:** There is water damage around an air diffuser/return at the back of the theater above the sound platform. The source of the damage should be investigated further and the plaster damage repaired and painted.
 - o Plaster repair at diffuser - \$1,000

- **CODE:** There are no handrails in the balcony rows. These should be added for safety/code.
 - o Balcony Railings: \$6,000 - \$10,000
- **DM:** The floor deck / seat platform of the upper balcony has some damage throughout. This should be replaced or repaired.

- o Balcony Wall Plaster Patching \$1,000 - \$5,000
- **DM:** There are general minor wall chips throughout. These could be patched and repainted.
 - o Part of overall plaster patch cost

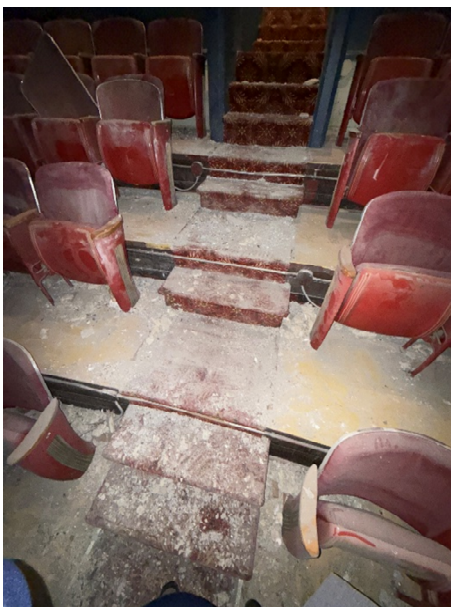
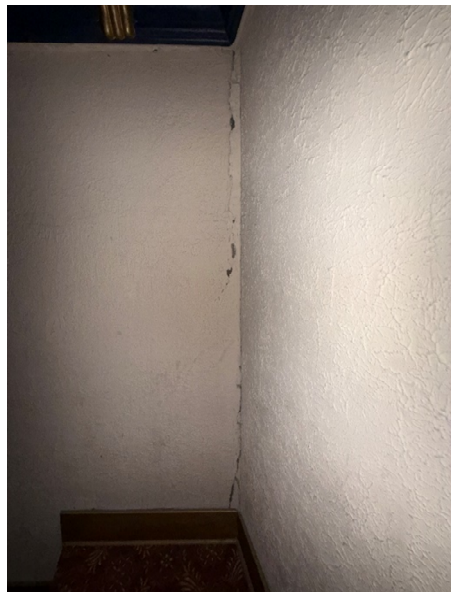
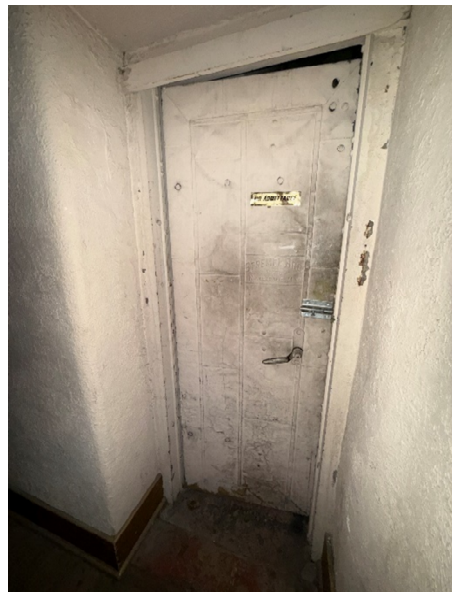
Projection Booth Mezzanine

- **CODE:** The door to the Projection Booth is difficult to operate. This door should be replaced with properly functioning hardware.
 - o Booth Mezzanine entry door: \$2,000 - \$2,500

- **CODE:** The threshold at the door is abrupt and uneven this should be leveled to reduce the trip hazard.
 - o Booth Mezzanine Threshold: \$500 - \$1,000
- **DM:** The landing inside the door is bare sheathing. A durable wear surface should be installed.
 - o Booth Mezzanine Landing: \$500 - \$1,000

- **DM:** There are several areas of plaster walls that need patching and painting.
 - o Booth Mezzanine Plaster patch: \$1,000 - \$1,500
- **DM:** The plaster ceiling at the roof appears to have had water damage and fallen away. The source for the damage should be investigated and patched. The plaster should be patched and all repainted.
 - o Booth Mezzanine Ceiling: \$1,000 - \$1,500

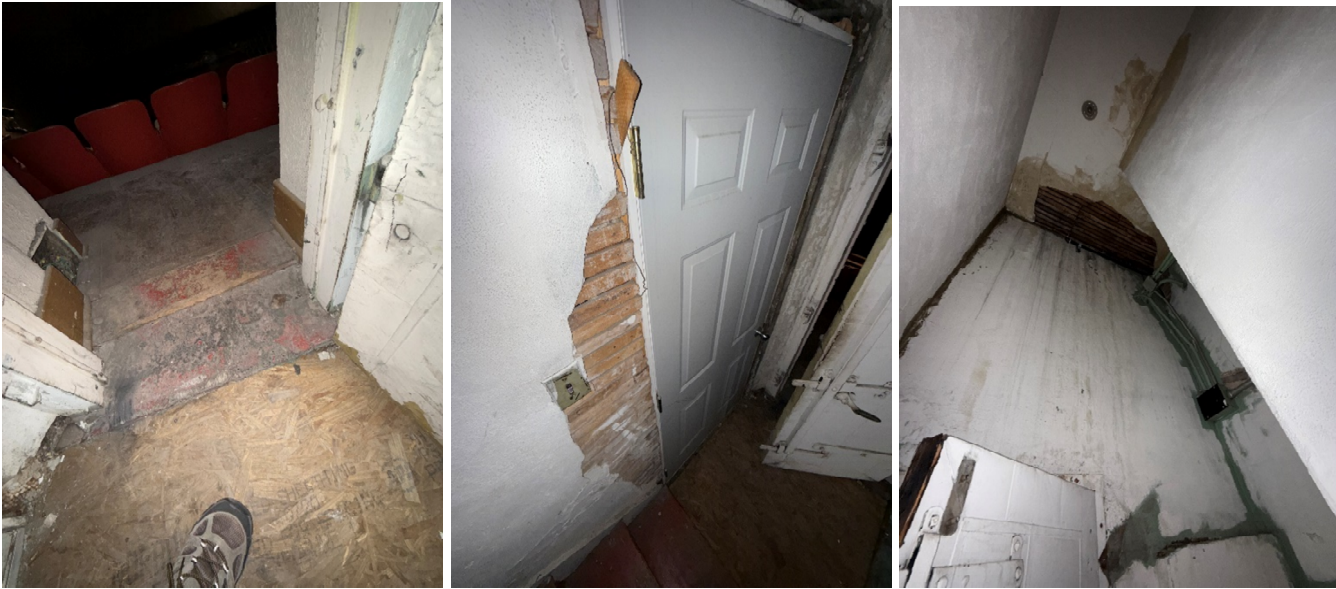
Lower Projection/Storage

- **DM:** The floor has patches of missing floorboards. The floorboards are also cupped to give an uneven surface. These should be replaced with a durable wear finish.
 - o Projection Storage Floor Repair: \$1,500 - \$2,000
- **DM:** There are several areas of plaster walls that need patching and painting.
 - o Projection Storage Plaster Patch: \$1,000 - \$1,500
- **CODE:** The windows are single-pane steel framed, which are very inefficient. These should be filled in or replaced with more efficient windows
 - o Projection Storage Windows: \$1,500 - \$2,000

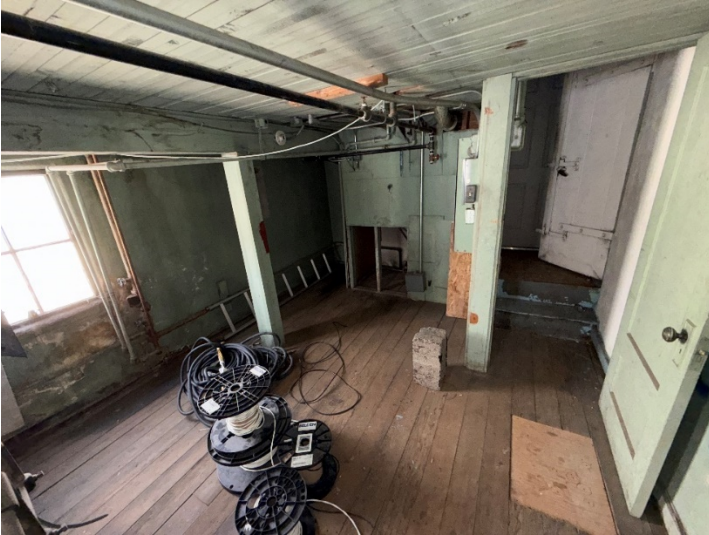
**Upper Projection Booth**

- **DM:** The restroom is very dated and appears to be dysfunctional. A full update is recommended if this is intended to be usable.
 - o Projection Restroom Update: \$2,500 – \$3,500

- **CODE:** The windows are single-pane steel framed, which are very inefficient. These should be filled in or replaced with more efficient windows
 - o Projection Booth Windows: \$1,500 - \$2,000

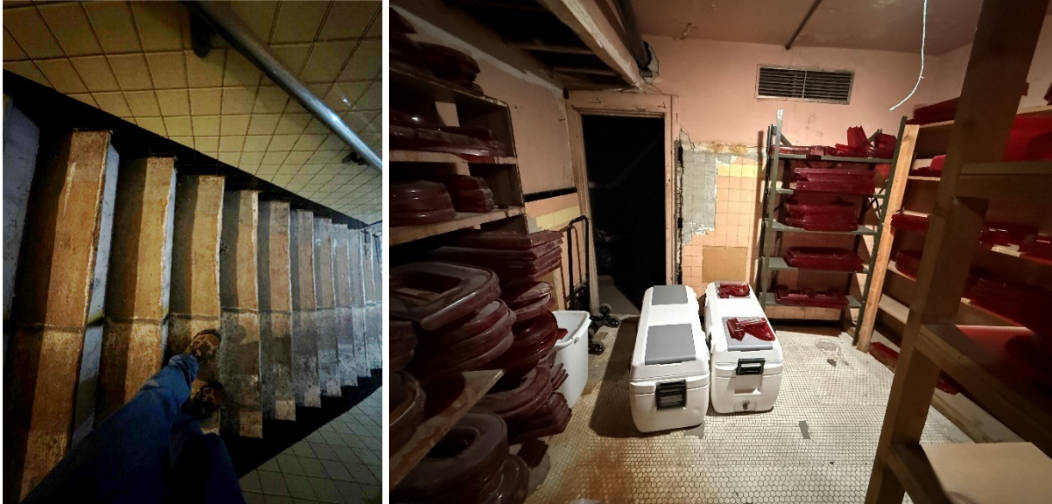
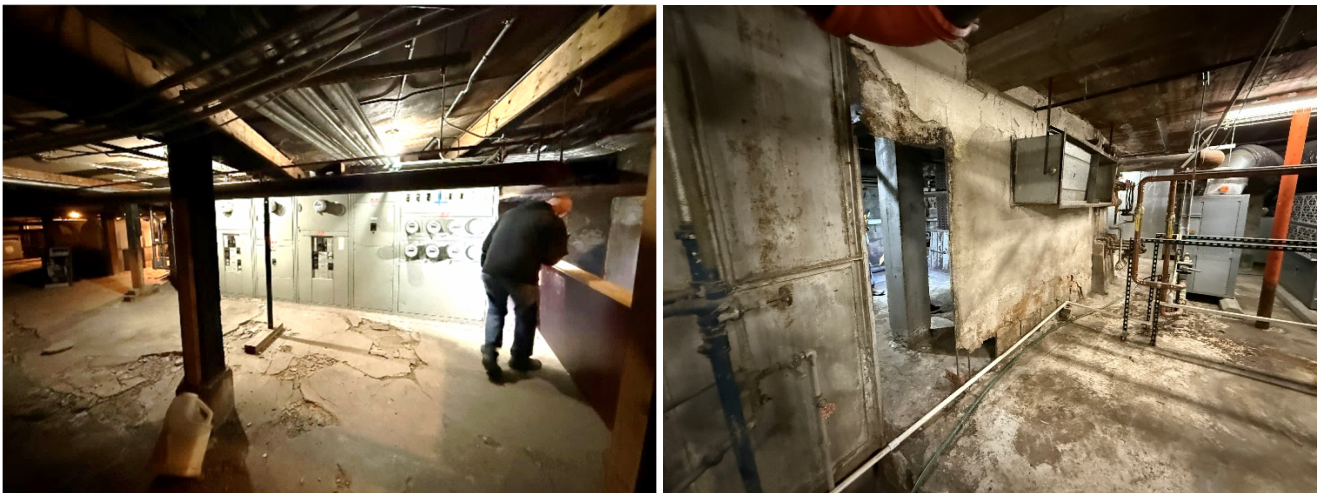
GREEN ROOM

- **CODE:** The basement is not fully accessible
 - An accessible lift could possibly be installed to provide full accessibility depending on building space availability.
 - Wheelchair lift or Stair climber: \$15,000 - \$25,000
- **DM:** The terrazzo floor is heaved in the west room. This should be ground down and filled to reduce the trip hazard.
 - Terrazzo grinding: \$500 - \$1,000

- **CODE:** Threshold at north bathroom could be modified to reduce trip hazard. Possibly the hallway floor could be sloped to the door and a sloped threshold installed.
 - o \$1,000 - \$1,500
- **DM:** General finishes could be updated – stained floors, paint, chipped walls
 - o Covered in finishes Costs

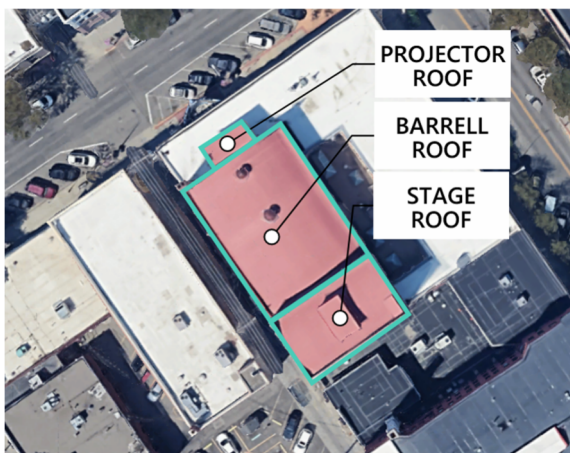
The main theatre roof areas over the theatre portion of the building, stage and projector room were installed using a mechanically fastened, Hypalon, single ply membrane. The roof areas are insulated between the Hypalon membrane and the roof deck using flat stock insulation. The membrane roof in all three of these areas was found in poor condition with visible open membrane laps and tears at the membrane seams. Several other membrane detail areas at drains and roof edges appear to have been poorly installed to begin with and most likely currently allow water infiltration into the building. The single ply roofing assemblies above the theatre portions of the building are all in need of replacement.

- Roofing Membrane Replacement (Red Single Ply): Total = \$313,750 (mid range)*
 - Stage Roof: 2,200 SF @ \$45/sf = \$99,000
 - Barrell: 5,150 SF @ \$40/sf = \$206,000
 - Projector Roof: 350 SF @ \$25/sf = \$8,750
- (*Low range total = \$275,000, High range total = \$350,000)

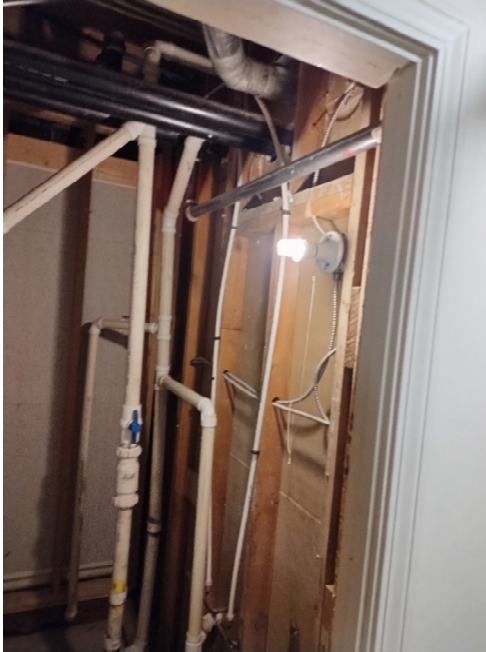
- The Plumbing equipment closet off basement hallway near kitchen and restrooms does not have sprinkler protection. If room remains without a ceiling, upright sprinklers will need to be added to this room in accordance with NFPA 13. If a ceiling is installed, a pendent sprinkler will need to be added in accordance with NFPA 13. (Photo #3)
 - o \$4,200 addition sprinklers, piping & fittings.

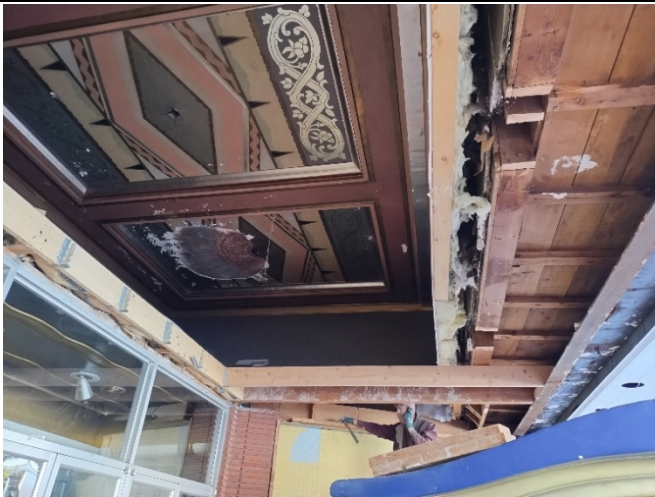
- At the exterior entry to the main floor lobby, sprinklers are not installed in the combustible concealed space above exterior entry. The concealed space either needs to be protected by a dry-pipe fire sprinkler system, or the concealed space shall be filled entirely with insulation in accordance with NFPA 13. (Photo #6)

- The dry sidewall sprinklers are missing under the exterior entry canopy. The dry sidewall sprinkler will need to be installed for proper coverage in accordance with NFPA 13. (Photo #6)

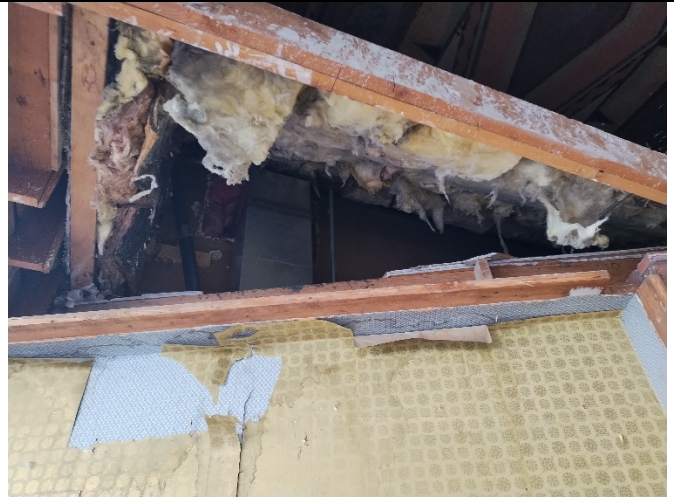
- o \$1,800 dry sidewall sprinklers, piping & escutcheons
- All wet-pipe sprinkler piping, feeding the dry sidewall sprinklers under exterior entry canopy need to be protected from freezing conditions. The wet-pipe sprinkler system shall be maintained above 40 degrees F. Heat and Insulation will need to be provided to maintain the temperature requirement to prevent sprinkler piping from freezing. (Photo #7)

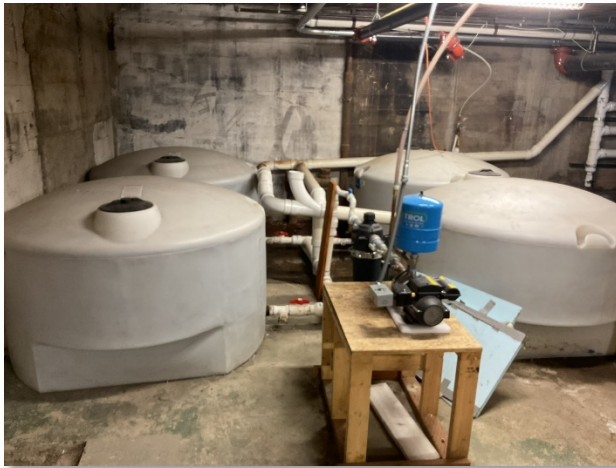
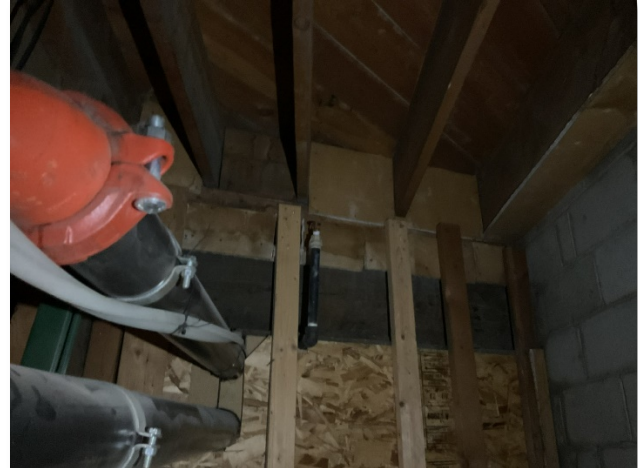
reason, it is recommended that the water-source heat pumps and return air path in the basement be separated by a wall from the rainwater catchment basins and the majority of PVC piping in the basement air handling room. The remainder of the PVC piping within this new room will need to be insulated for plenum installation.

- The return air path from the theater will need to be ducted or lined with gyp. As part of this effort, the quantity and pathway of the return air path should be verified to ensure adequate return air back to the air handler. Previous drawings indicate approximately three return air paths, at least one of which does not exist currently.

- Insulate heating water piping and domestic hot water in boiler room and elsewhere as is feasible: ROM \$12/linear foot of piping insulation. Boiler room approximately 200 ft of pipe = \$2400 for insulating exposed piping in boiler room. As additional pipe is uncovered or can be accessed, it should be insulated.
 - The heating water piping in the boiler room is not insulated. It is assumed that much of the existing heating water piping throughout the building is uninsulated. For energy efficiency, all piping conveying liquids above 105 deg F should be insulated which includes the heating water piping.
 - Similarly, all domestic hot water piping should be insulated.

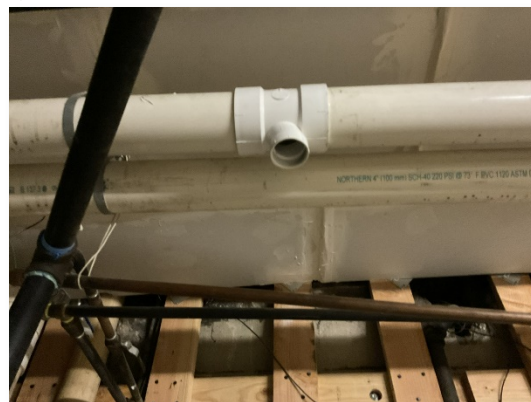
- A portion of the intake combustion air pipe on the boilers is open to the boiler room. ROM \$5000 if booster fan is needed.
 - o Verify that adequate transfer air is provided for boilers to utilize the volume of the space for combustion air. If not, verify adequate sizing and routing of the intake combustion air from the outdoors and design a booster fan if needed.

- Ventilation air is not provided for much of the green room occupied space. ROM \$30,000 excluding architectural ceiling replacement or soffits for new ductwork routing

- o It is recommended that an energy recover ventilator (ERV) be installed to bring in outside air as well as exhaust air from the bathroom spaces. This type of system will transfer heat between the incoming outside air and exhaust air to temper the incoming ventilation air in all seasons.

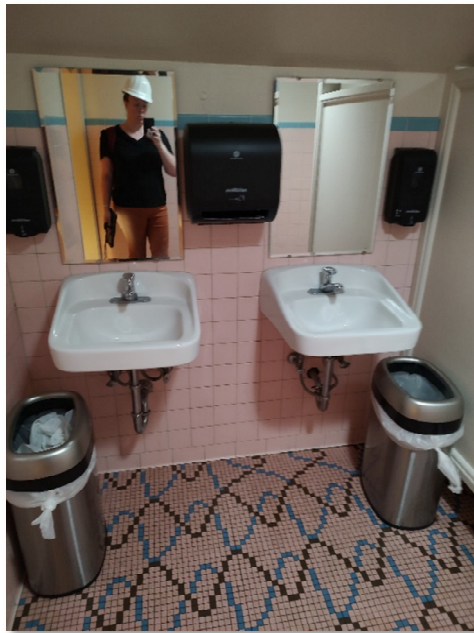
- The mezzanine p-traps and hot water connections on the public lavatories should be insulated with True-bro insulation kits or equal if these are considered accessible restrooms. ROM \$200 each, 4 lavatories, total \$800

- It was mentioned that the plumbing system utilizes a stormwater catchment tank for toilet flushing in the building. This application should be verified and proper signage should be installed at locations of fixtures that utilize reclaimed water.

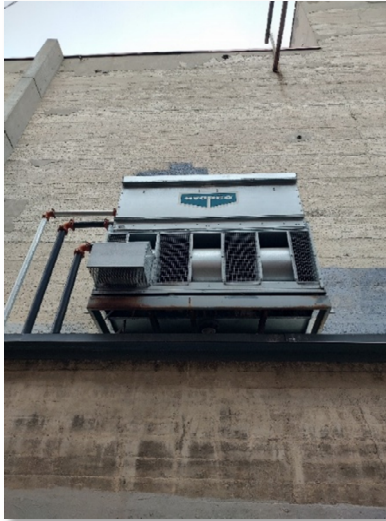
- Fluid coolers are notorious for buildup even in a closed-loop system using stormwater. This equipment is outside, exposed to the elements, and in this case is difficult to access.
- We recommend that the fluid cooler be inspected and general maintenance performed from an approved Evapco service technician to ensure optimal performance.

- Continue scheduled maintenance of filter changes, strainer cleanouts, rainwater dust trap cleanouts, glycol feeder fills, sump pump maintenance, equipment maintenance, sensor calibration, etc.
 - ROM \$50,000/year

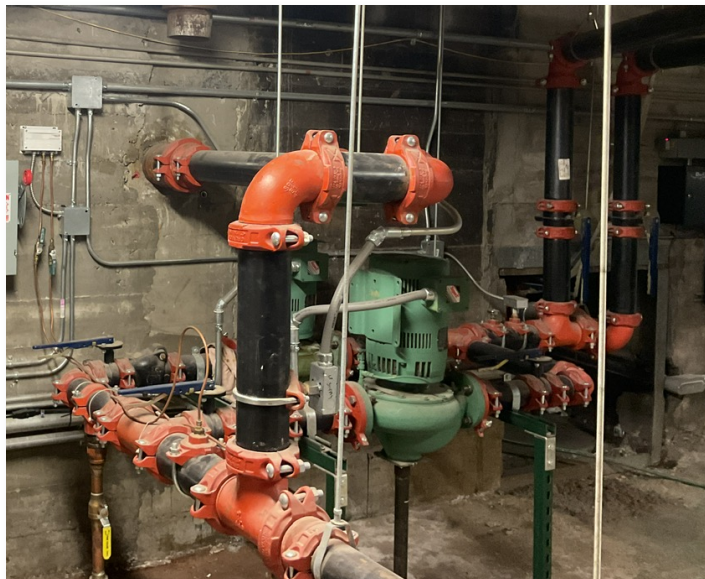
- Monitor heat pump loop system pumps PU-HP-1&2 for replacement: ROM \$15,000
 - The two heat pump loop system pumps are past their estimated useful life and should be monitored for future replacement.

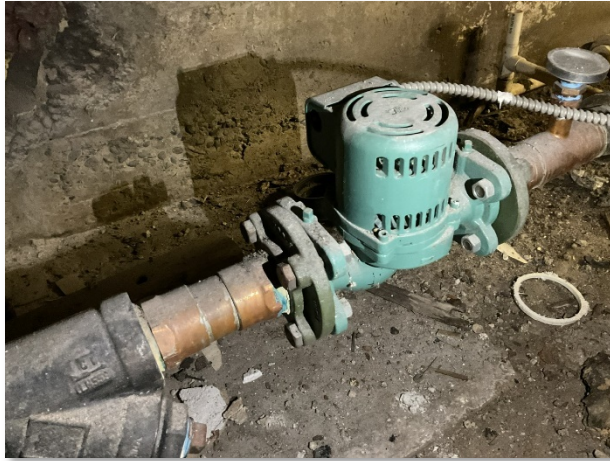
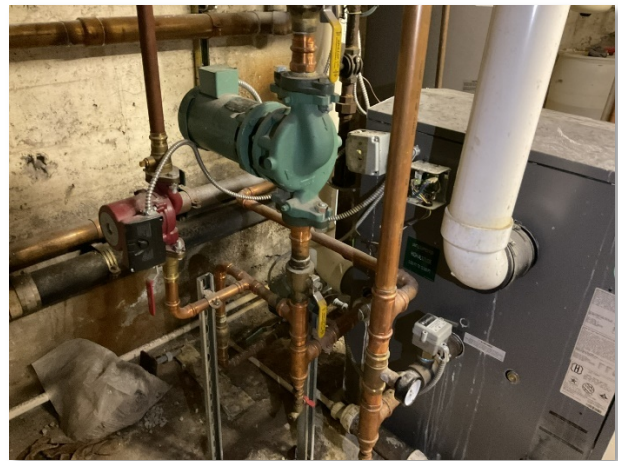
- Monitor boiler circulation pumps for future replacement
 - o ROM \$3000 each, \$6000 for both

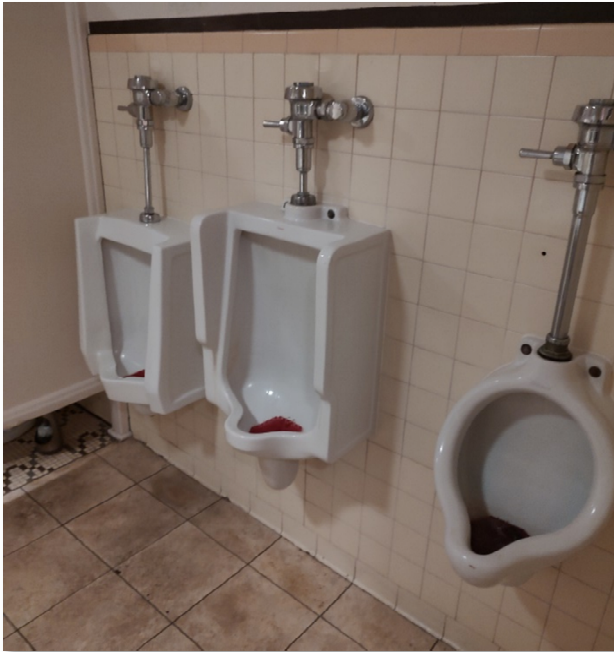
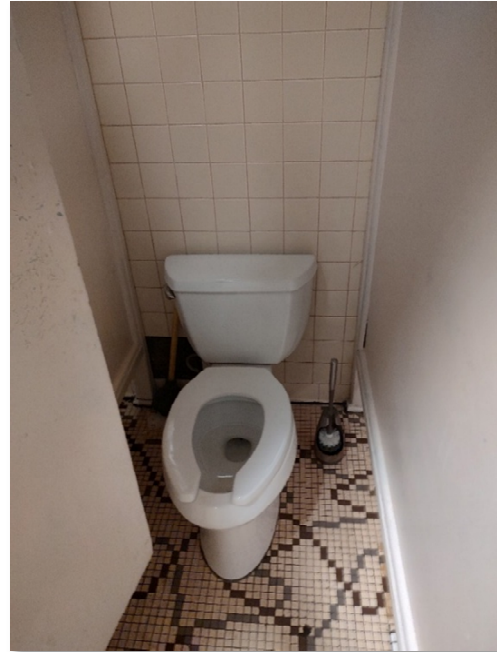
- Replace mezzanine restroom fixtures for upgrade. Current mezzanine fixture count is 4 toilets, 3 urinals, and 4 lavatories for a total ROM of \$11,000

- o ROM \$600 for each tank style toilet
 - o ROM \$1500 each including flush valve
 - o ROM \$1000 for each wall-hung lavatory

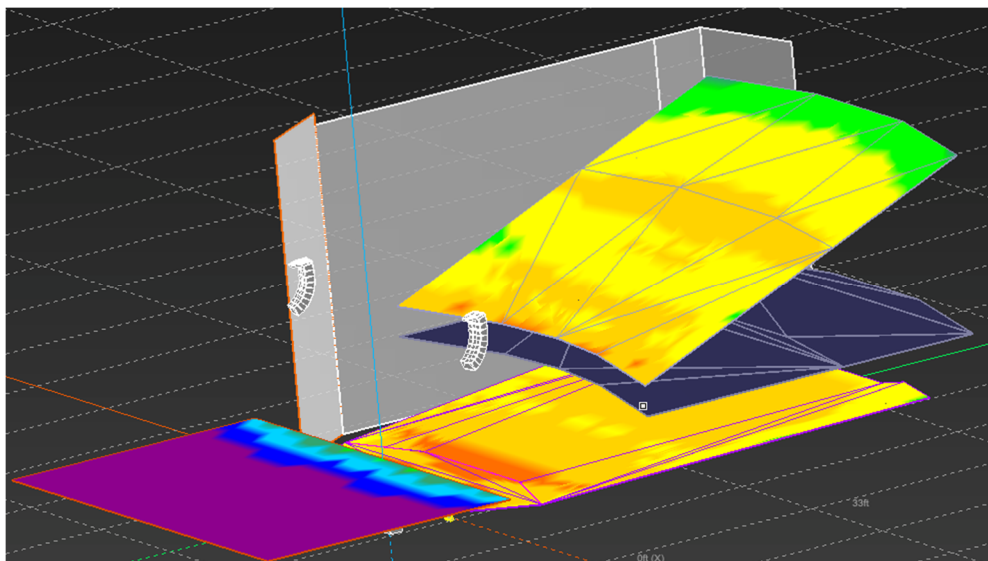
Figure 2: Babcock Theatre SPL Coverage Map showing Basis of Design D&B Y System

Based on the intended program and inherent flexibility required, K2 recommends a high-quality medium-format line array system be purchased for the Babcock Theatre. The intent would be to create a highly flexible system that would be appropriate for a variety of events including “rock and roll”. K2 recommends the basis of design be a d&b Audiotechnik “Y” series loudspeakers for audio quality and for greatest compliance with artist performance contract technical riders. As currently designed the system should be capable of reaching concert levels with peak levels at or above 112+ dB throughout the lower orchestra seating and balcony areas. The system would include the following:

- Two 9-element line arrays flown from overhead near the edge of the stage. Basis of design to be D&B Yi8 and Yi12 loudspeakers.
- Two 21” ground-stacked subwoofers. Basis of design to be D&B 21S-SUB.
- Five 10” two-way under balcony fills. Basis of design to be D&B 10S with horizontal U-bracket.
- Five dual 4” stage front fills. Basis of design to be D&B 44S.
- Amplification/Processing. Basis of design D&B 40D, 10D, and 5D amplifiers.
- Includes required rigging components, hardware, and wire and cable.
- Includes estimated labor.
- **Estimated Cost: \$245,000 to \$260,000.**

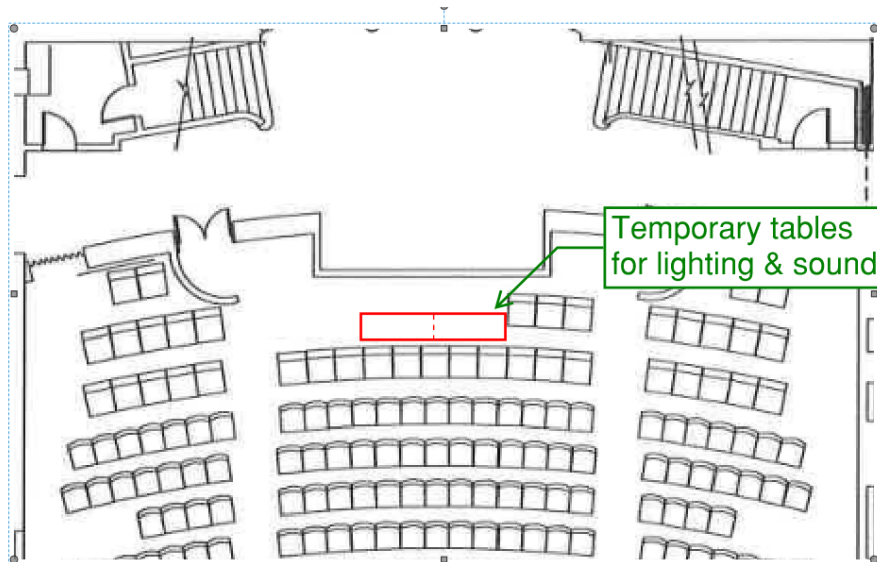
Figure 3: Sketch of Temporary Sound and Lighting Location

K2 recommends that a new rear center technical operation location be constructed in the rear of the center orchestra seating section (see Figure 3). This approach would create an open space that could be used for temporary sound and lighting equipment. A minimum of eight seats would need to be removed, however for access and aesthetic reasons, the entire rear row may also be removed as well. Temporary velvet rope or retractable belt barriers could be used to implement some basic access control to this area too.

- Work to include removal of seats, general costs to bring additional electrical circuits to this location (on the back wall, temporary tables, crowd barriers, etc.
 - **Estimated Cost: TBD.**

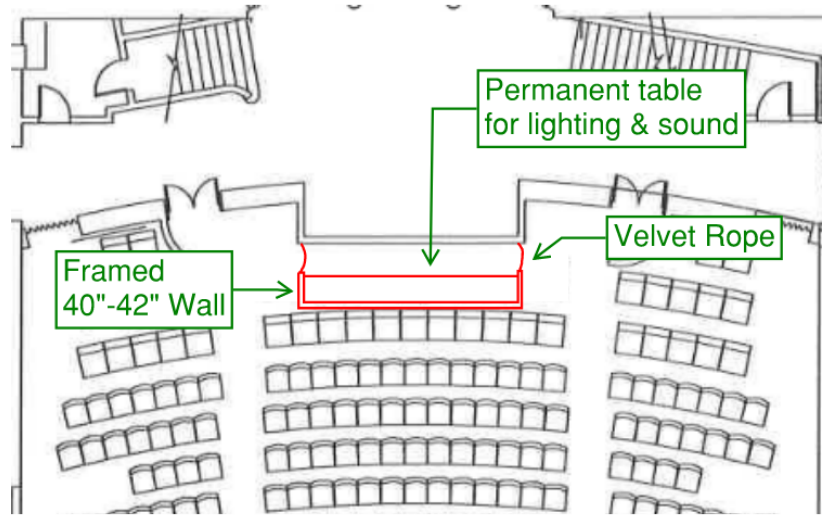
Figure 4: Sketch of Permanent Sound and Lighting Location

For a more permanent (future) aesthetically pleasing option, a new rear center technical operation location should be considered. This would be constructed in the rear of the center orchestra seating section (see Figure 4) and would remove the entire last row of seats and create a ½ height (40"-42") pony could be used for lighting and sound consoles during events. To allow for a little more space in the tech area, the 2nd to last row of reclining seats might also be replaced with non-reclining seats and perhaps the entire row shifted forward slightly. The floor for this new area would need to be leveled as well. Like above, velvet rope or retractable belt barriers could be used to create some basic access control to this area.

- Work to include removal of seats, general construction costs (framing, finishing, work surfaces, electrical, etc).
 - **Estimated Cost: TBD.**
