**APPENDIX D**

**Interior Photographs of the David Babbitt House  
(319 North Beaver Street)**

**Section 3 of 6**

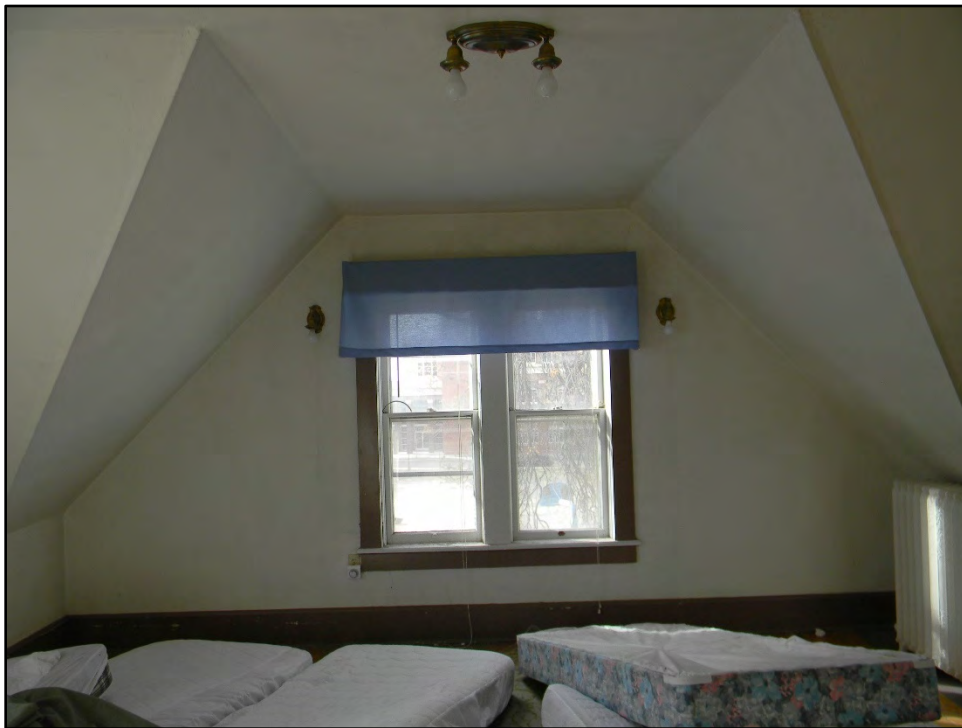
**Figure D-347. The edge of the gable cuts into the room (note the cracked wall at right).**

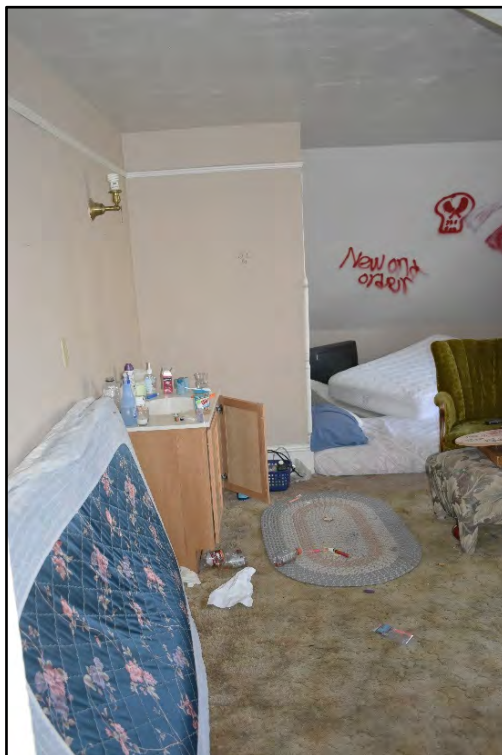
**Figure D-366. Walking into the second bedroom reveals extensive graffiti due to squatters that broke into the residence.**

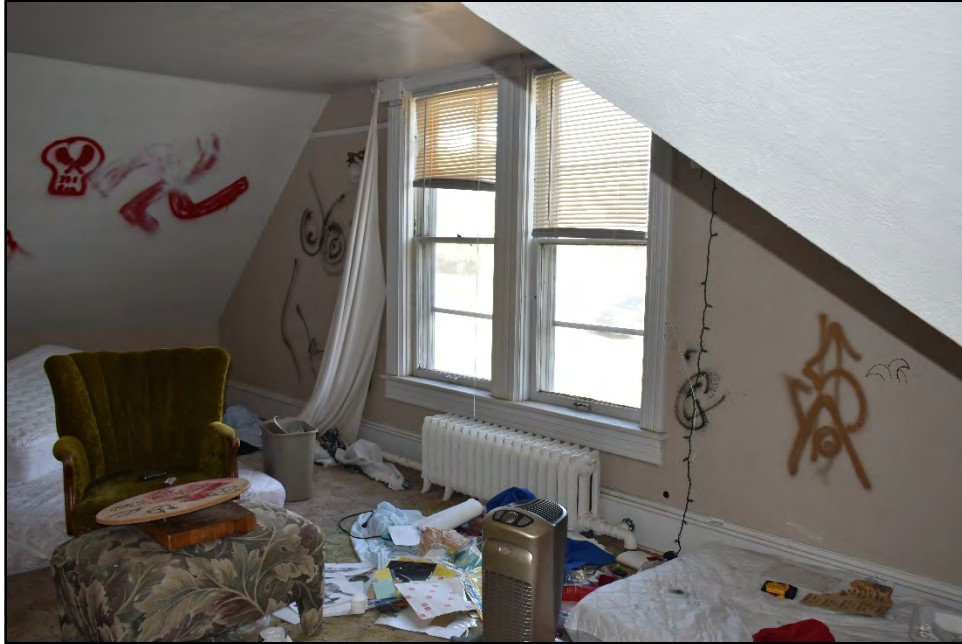
**Figure D-367. The vandalism of the second bedroom attempts to distract from the original elements still present in this room (please excuse the inappropriateness of the graffiti in this image).**
