APPENDIX D

**Interior Photographs of the David Babbitt House
(319 North Beaver Street)**

Section 4 of 6

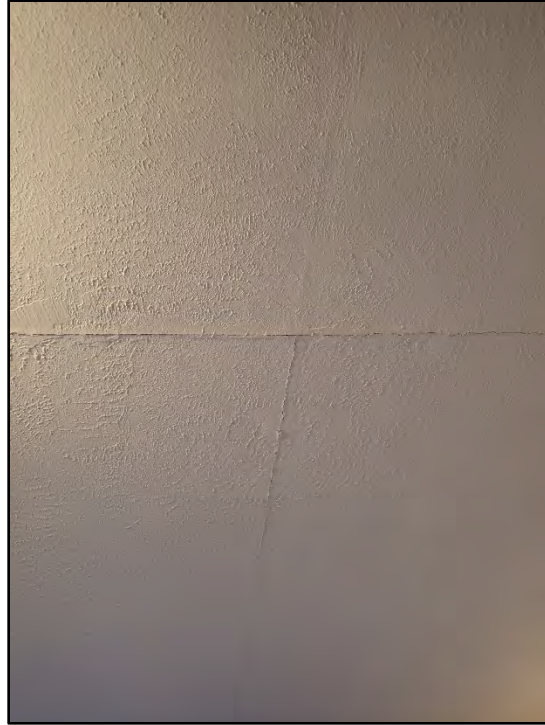
Figure D-409. The ceiling panels of the third bedroom are evident as it is suspected the ceiling is separating from the walls in this and other rooms throughout the house.

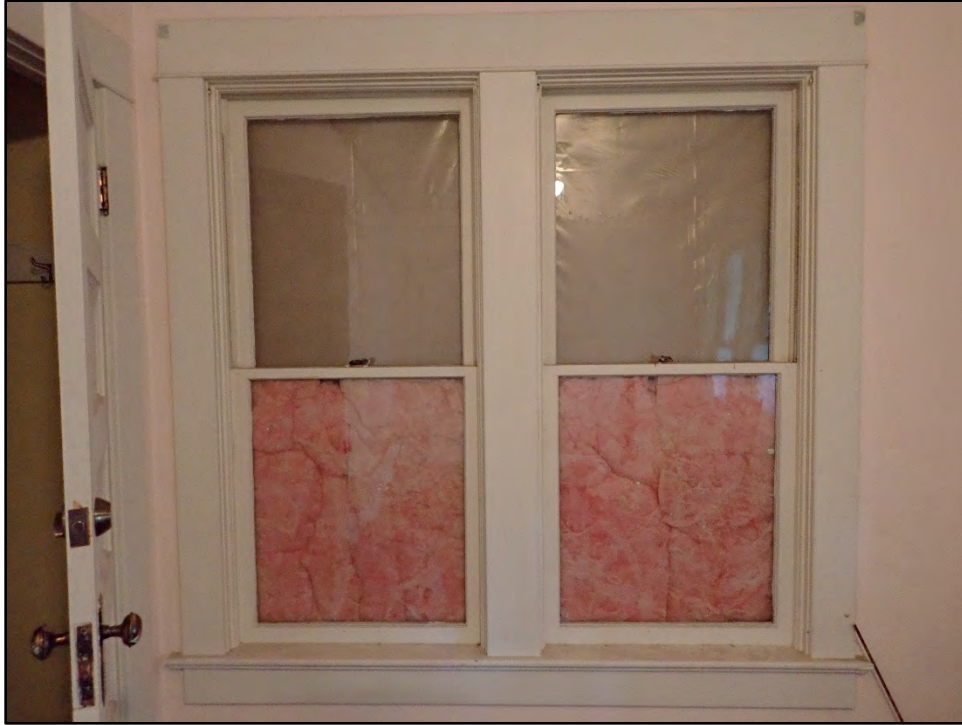
Figure D-433. A detailed view of the once-exterior windows that have been filled in with insulation and covered over with drywall.

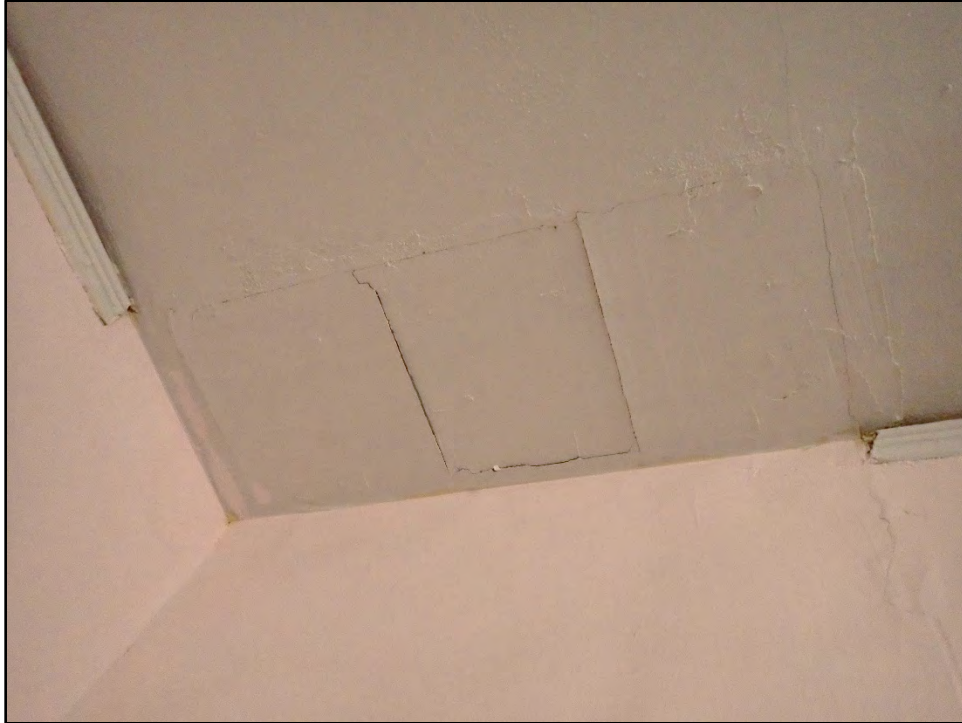
Figure D-435. A view of the ceiling above the corner sink, which reveals portions of the ceiling and walls have been filled in with sheetrock/drywall.

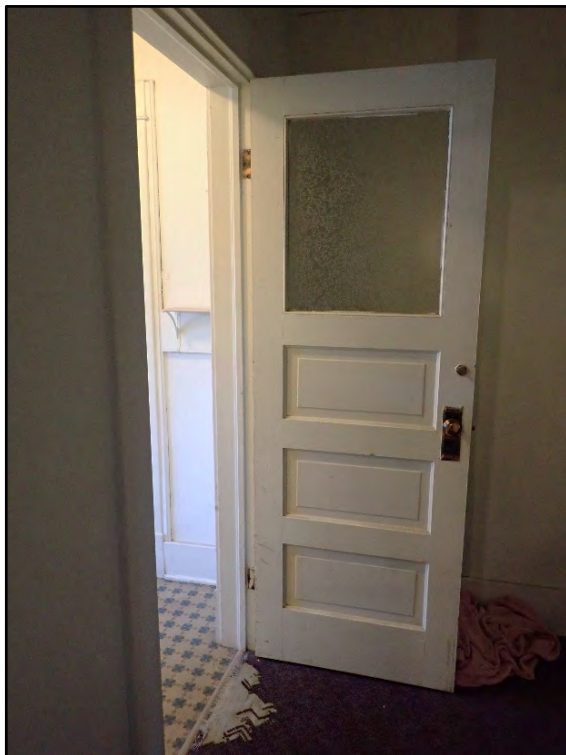
Figure D-440. The original wood panel door with privacy glass, suggesting this small space was once a bathroom.

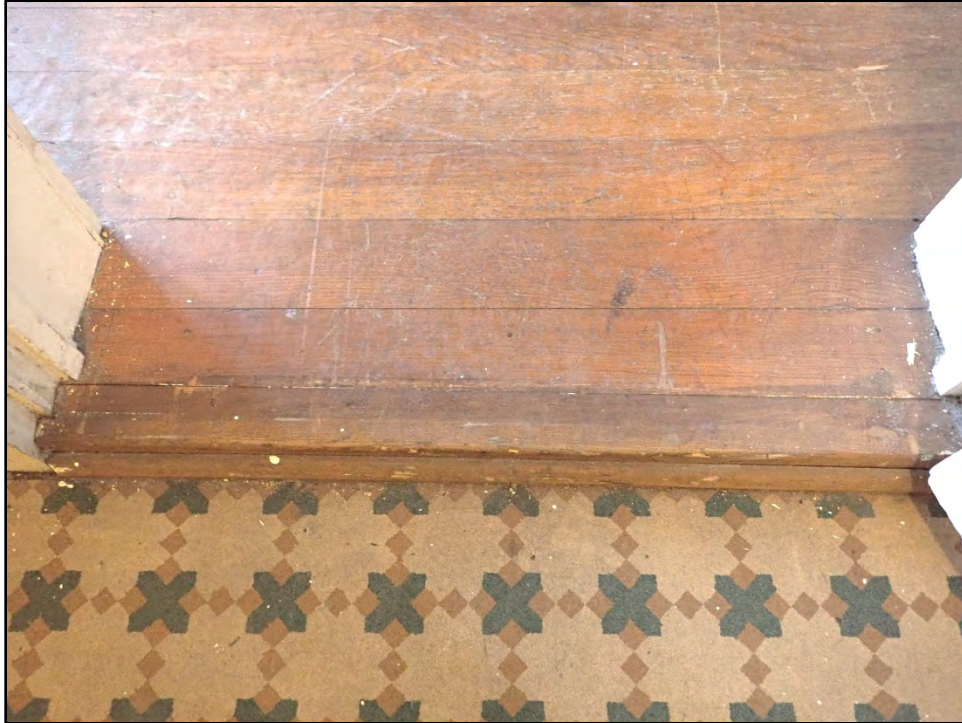
Figure D-453. A close-up view of the historic-era linoleum and original hardwood floors between the third bedroom and laundry room on the second floor.

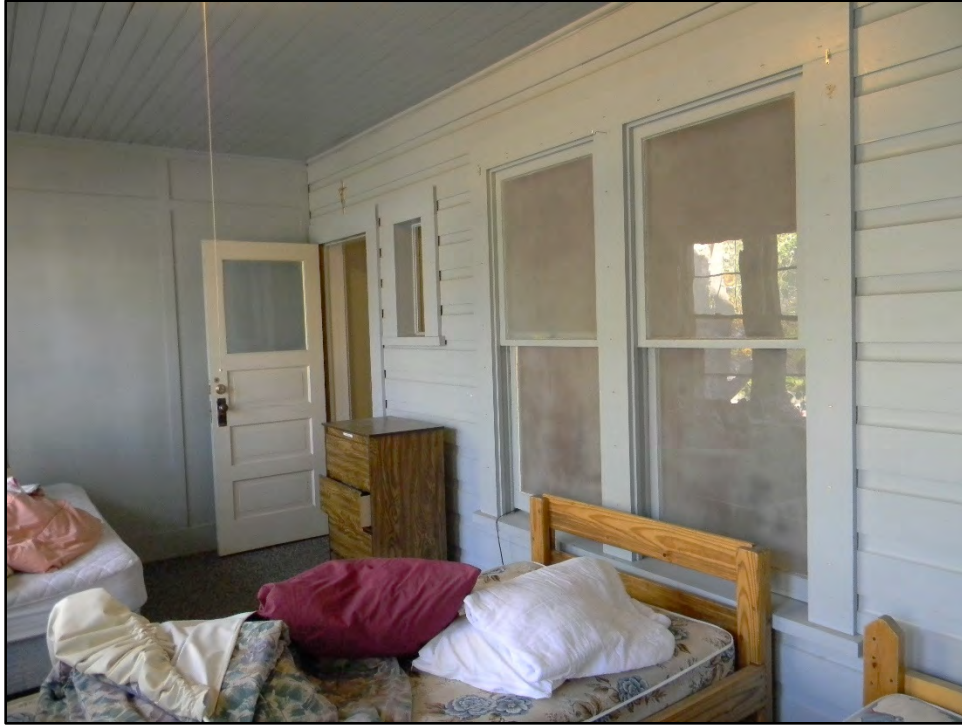
Figure D-461. Overview of the interior of the sleeping porch looking back toward the laundry room door, showing the original drop siding of the expansion completed between 1910 and 1916 by David Babbitt.

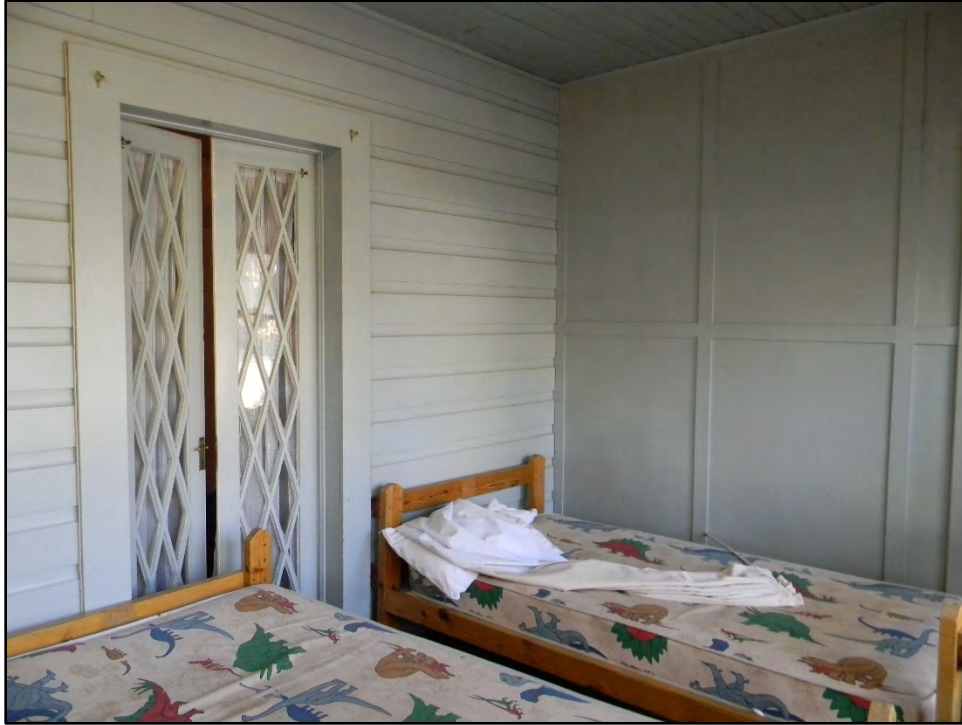
Figure D-465. View of the corner of the sleeping porch, revealing the wood construction as built between 1910 and 1916.

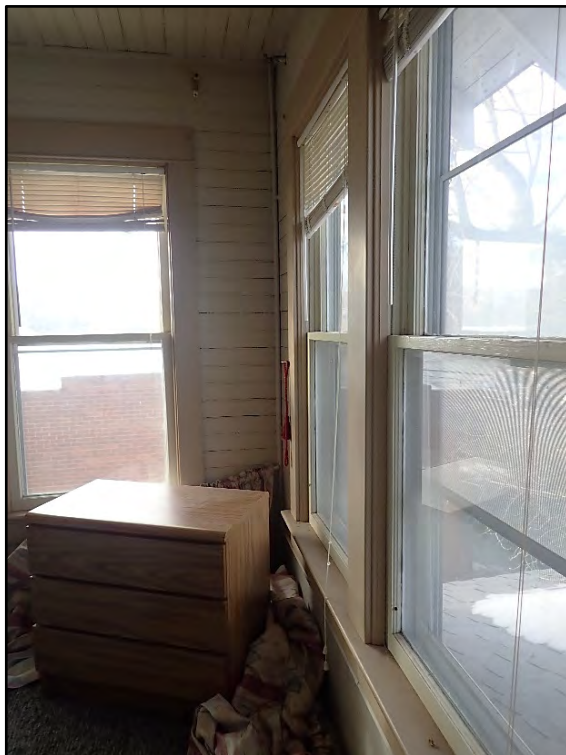
Figure D-470. View of the corner of the first small room on the second floor, created when this sleeping porch was divided into smaller spaces.

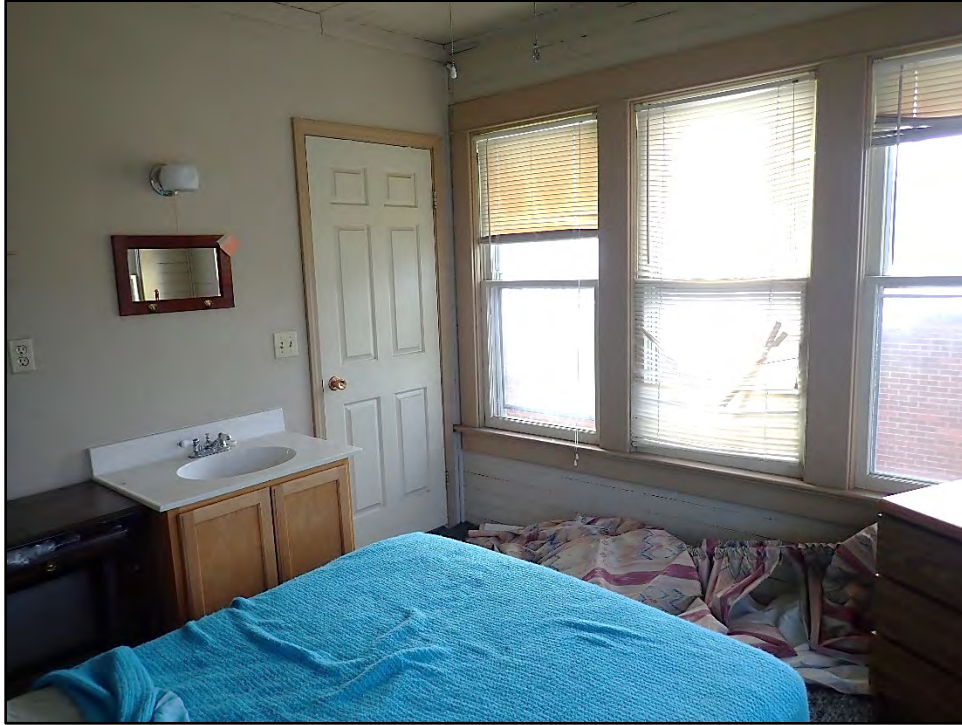
Figure D-471. Overview of the first small room, with the modern sheetrock/drywall on the left installed to divide up the sleeping porch on this side of the house.

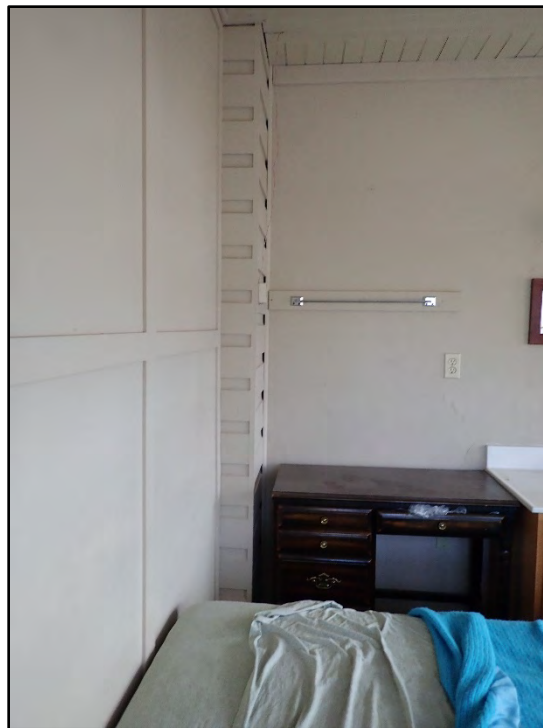
Figure D-472. View of the corner of this small room, showing the comparison of the original wood construction on the left and modern sheetrock/drywall on the right.

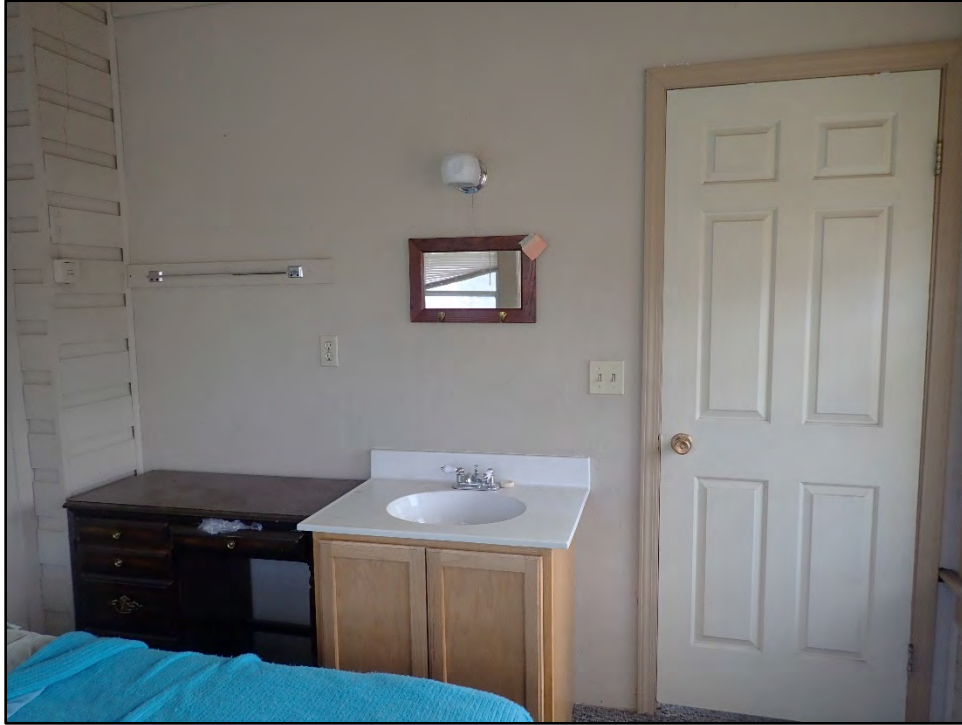
Figure D-473. View of the south wall of the first small room, showing the modern dividing wall, hollow-core door, and other upgraded amenities.

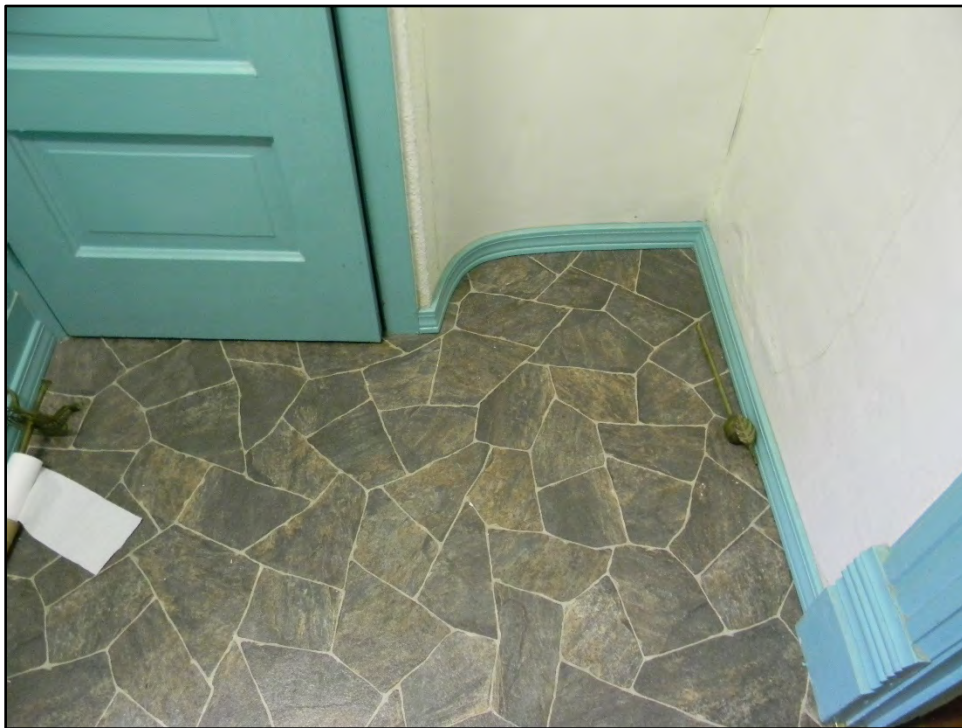
Figure D-516. A detailed view of the floor-wall junction of the same wall, also showing its curved design (the linoleum likely covers original hardwood floors).

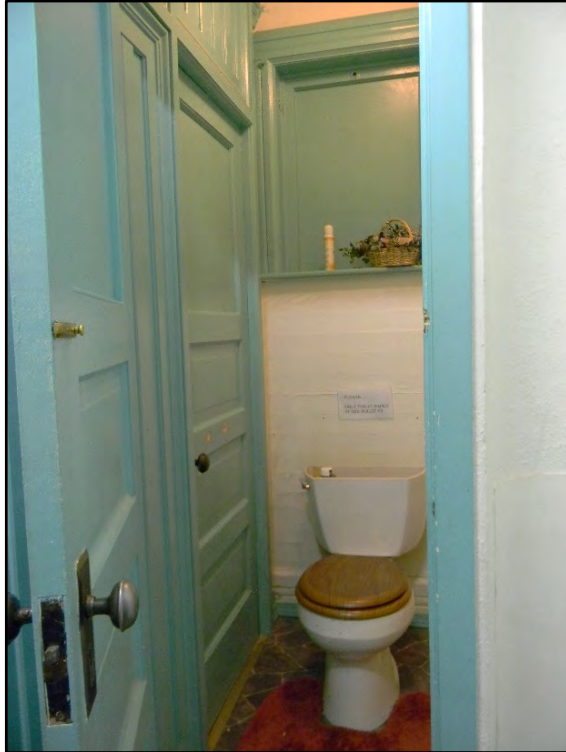
Figure D-517. A view of the interior of the small toilet area.

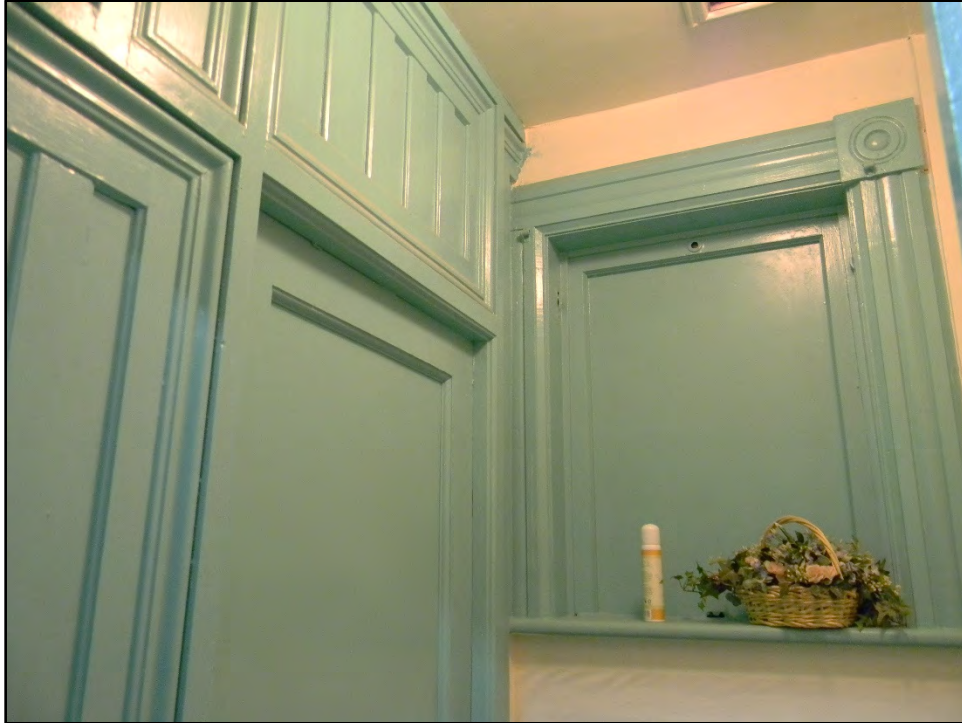
Figure D-519. Detail of the original window and door to the small toilet area that are now closed off (the shower room is on the other side of the door on the left and the modern bath is behind the small upper window).

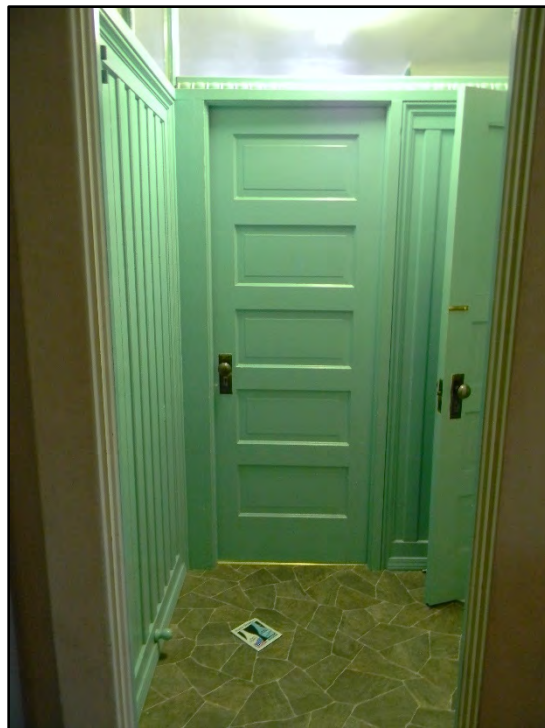
Figure D-520. View of the interior door of the large bath, framed by decorative wood panels on either side (door to the small toilet area is open to the right).

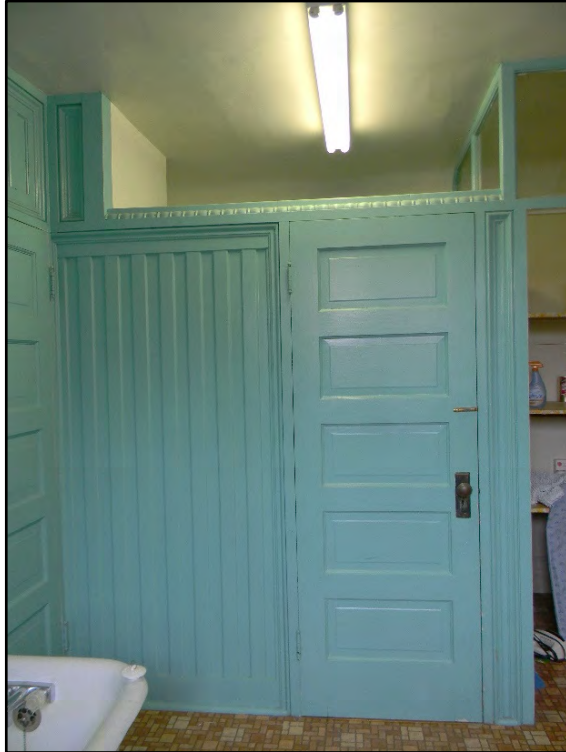
Figure D-521. View of the other side of the same door, showing the decorative wood construction and creative detailing in the large bath.

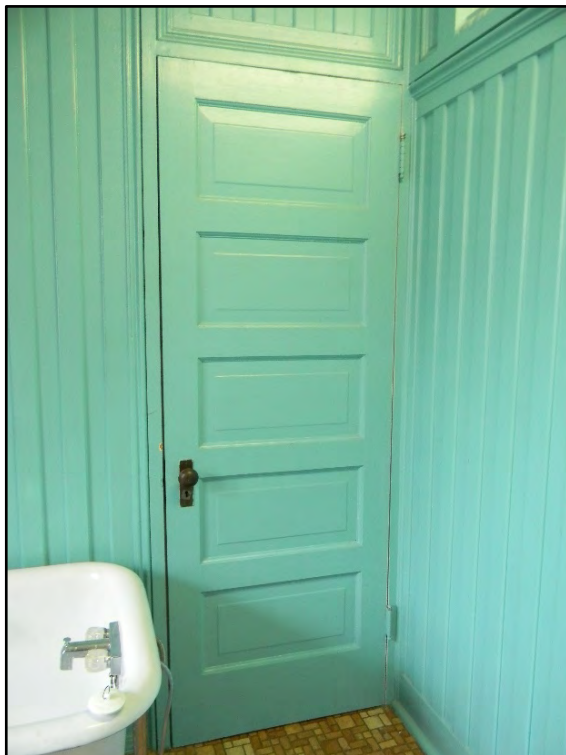
Figure D-522. View of the original door to what is now a separate shower.

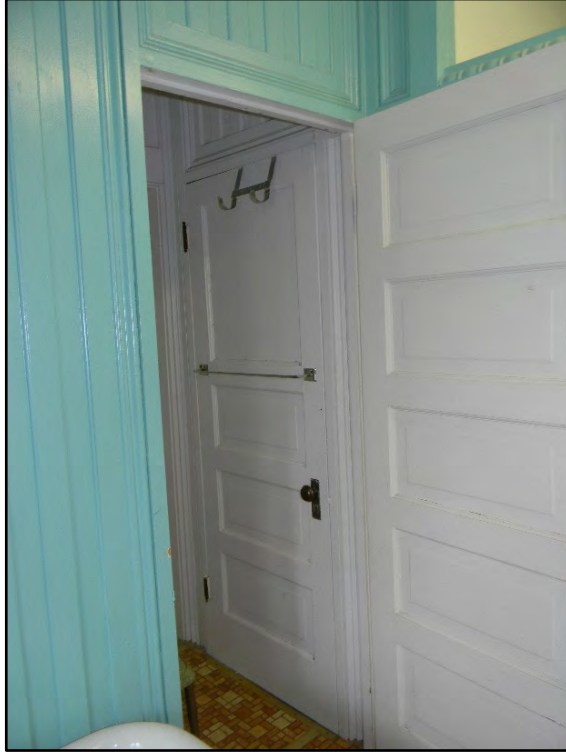
Figure D-523. A peek into the shower room reveals the back of the now closed-off door in the small area of the separate toilet.

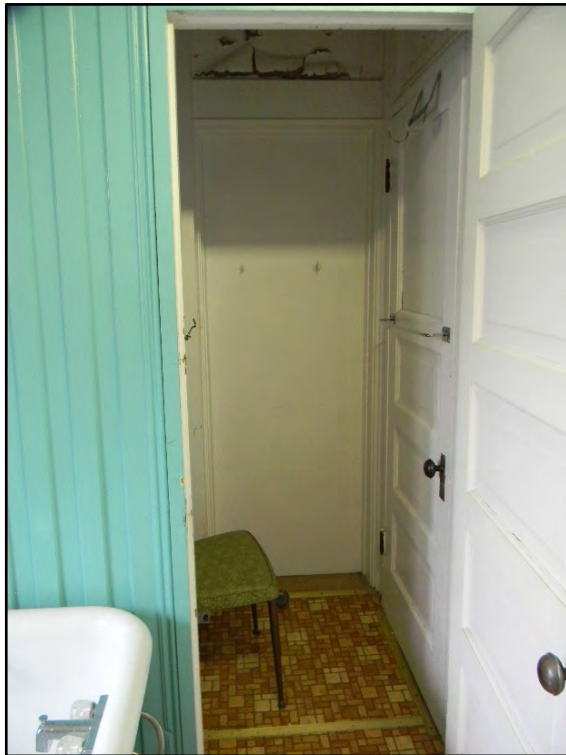
Figure D-524. The interior of the separate shower, showing yet another doorway that has since been closed off (also into the modern bath).

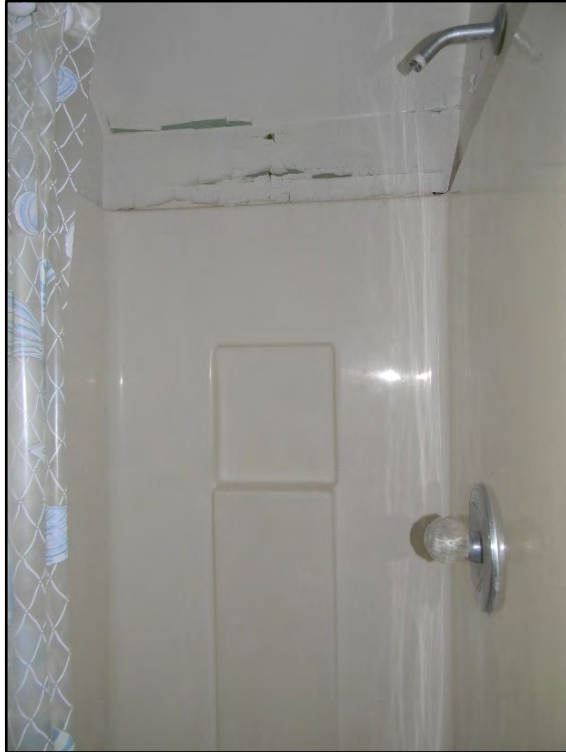
Figure D-525. Detail view of the separate shower that now fills in the space between the modern bath and large bath.

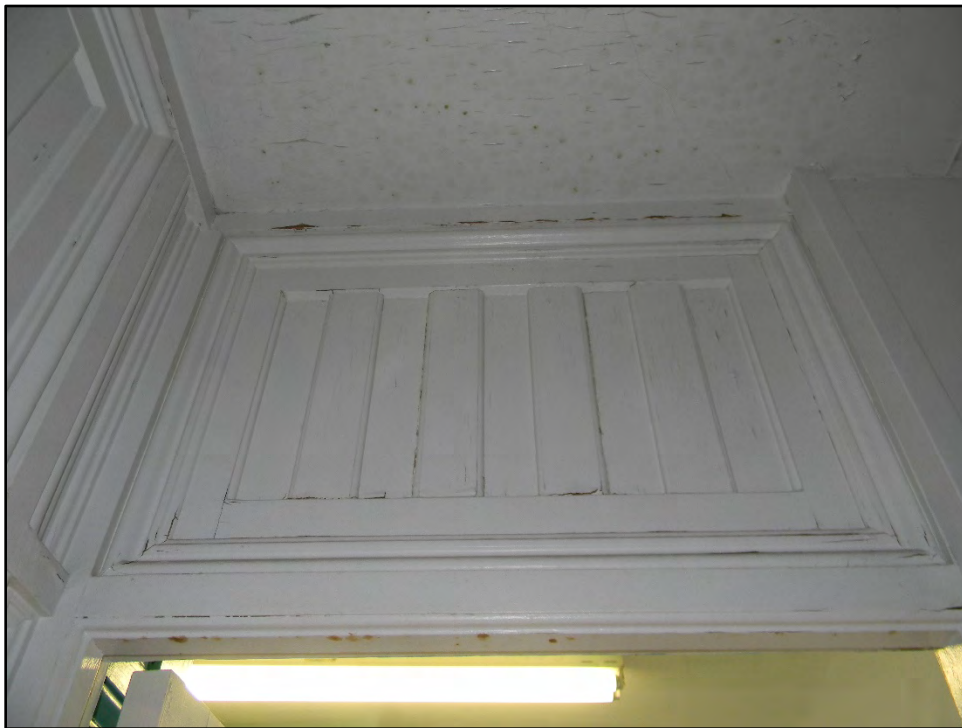
Figure D-526. The original decorative panel above the door to the separate shower.

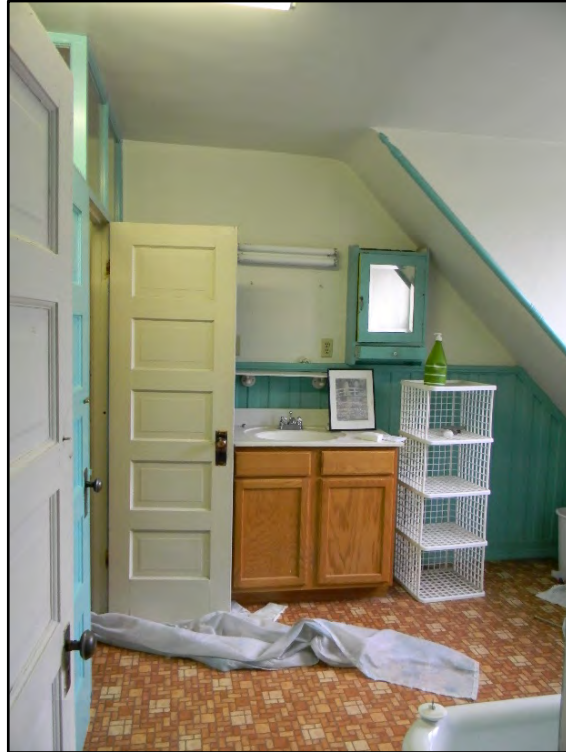
Figure D-527. Overview of the interior of the large bath as seen from the doorway to the separate shower.

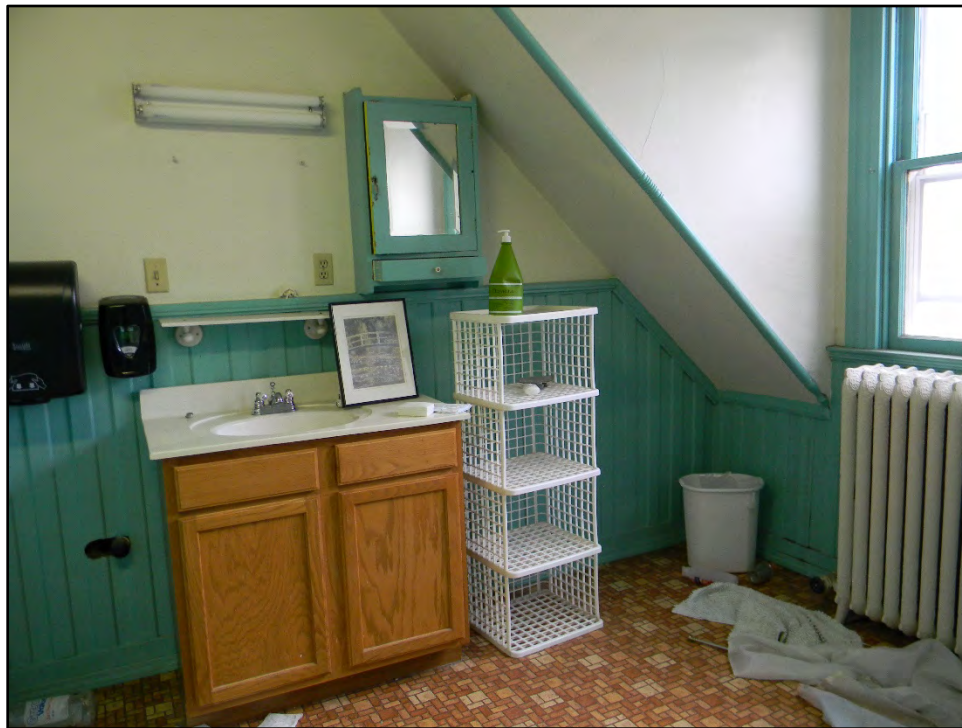
Figure D-528. View of the large bath (east wall), showing the wood wainscoting and other decorative details original to the bathroom when constructed by 1901.

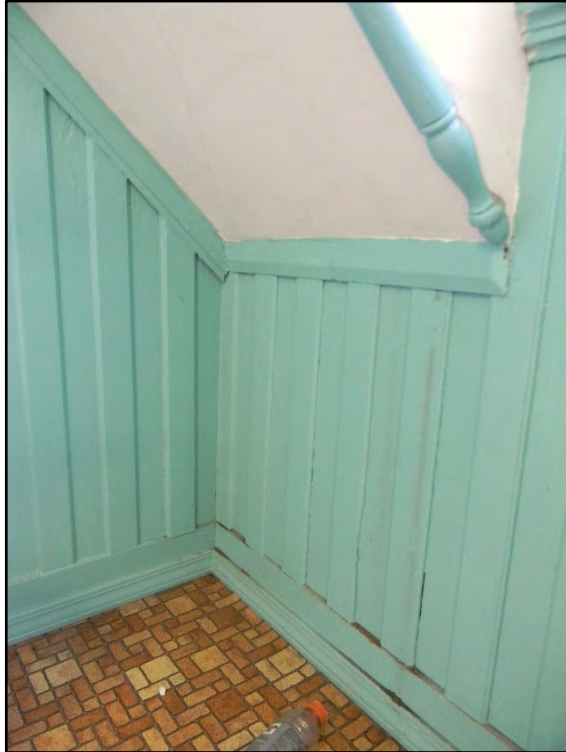
Figure D-529. Detail view of the decorative wainscot panels and corner accents.

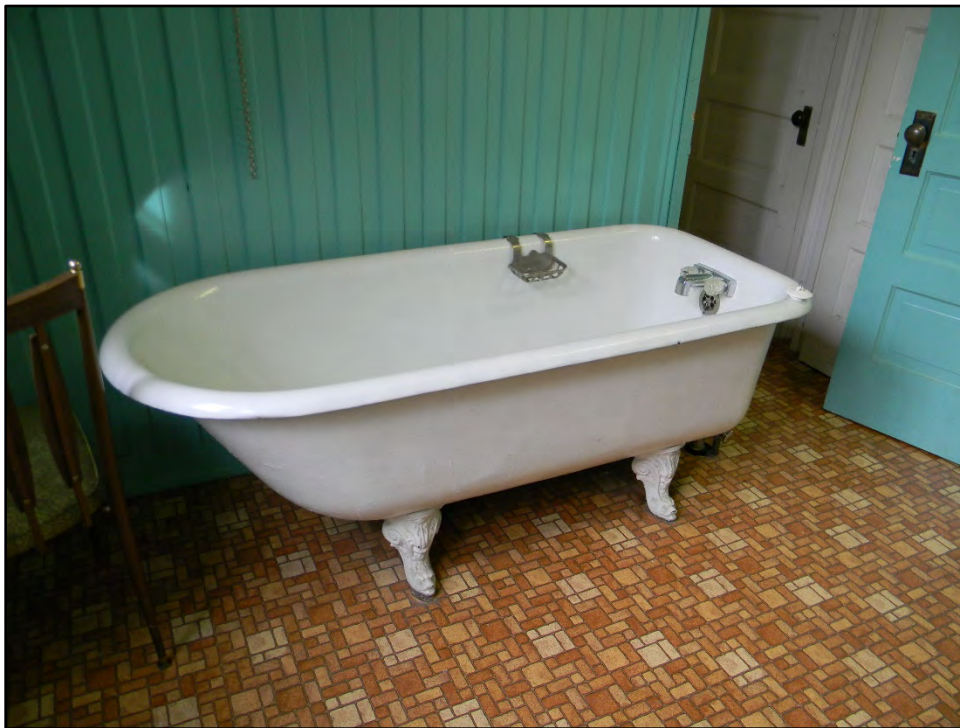
Figure D-530. The opulent clawfoot tub that may be original to the home.

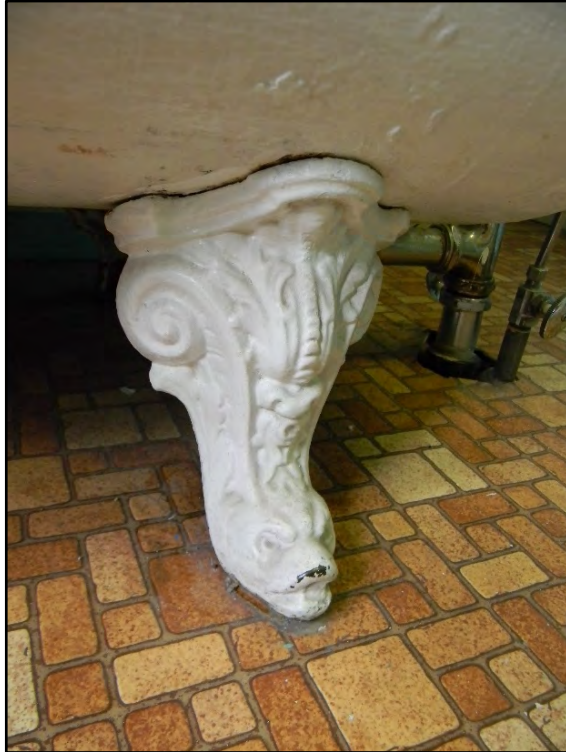
Figure D-531. Close-up view of the fish-shaped foot of the clawfoot tub.

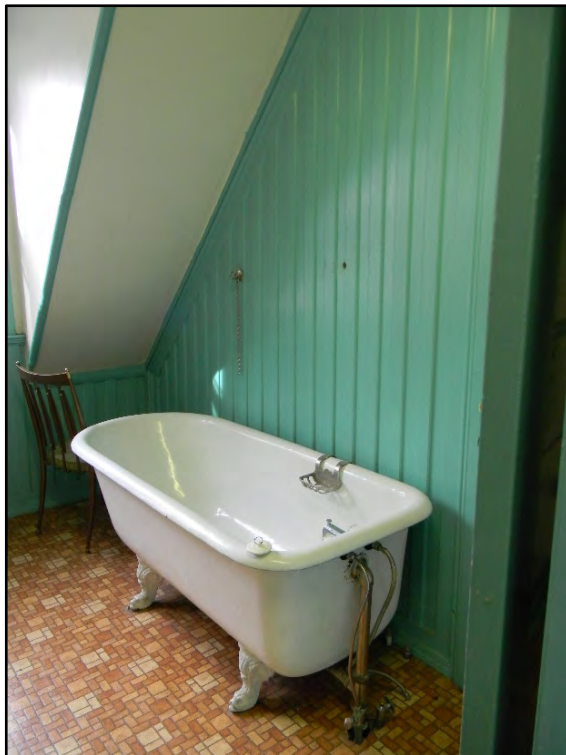
Figure D-532. View of the clawfoot tub and wood-paneled wall.

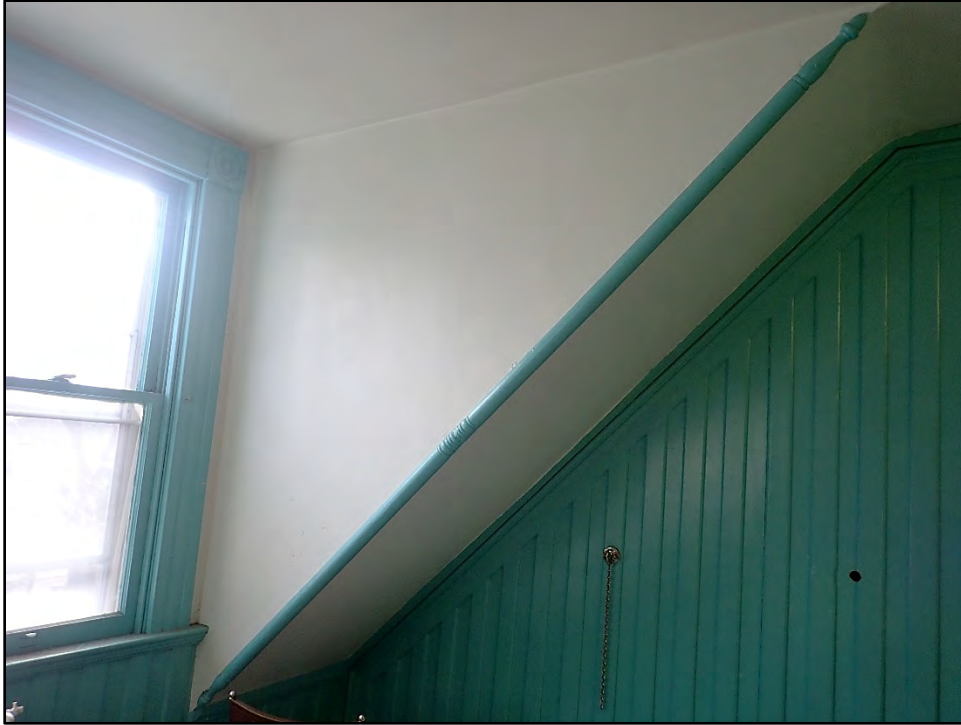
Figure D-533. Detail of the wood accent on the corner of the cut in of the ceiling formed by the framing of the dormer (which was constructed by 1901 and is seen in the 1906 photographs in Appendix B).

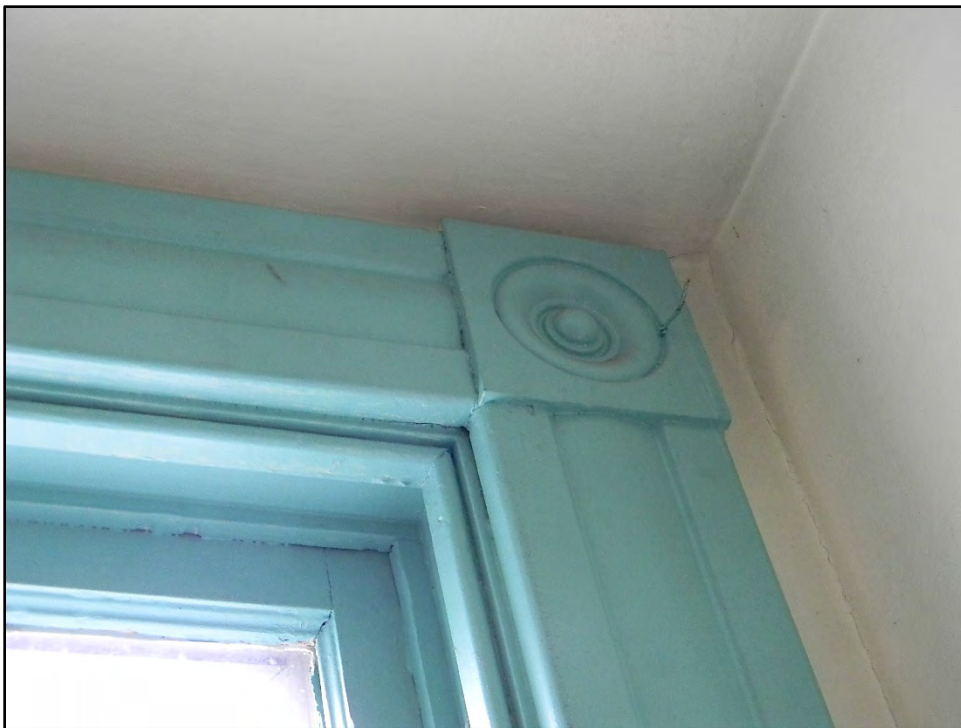
Figure D-534. Close-up view of the window casings and corner block in the large bath.

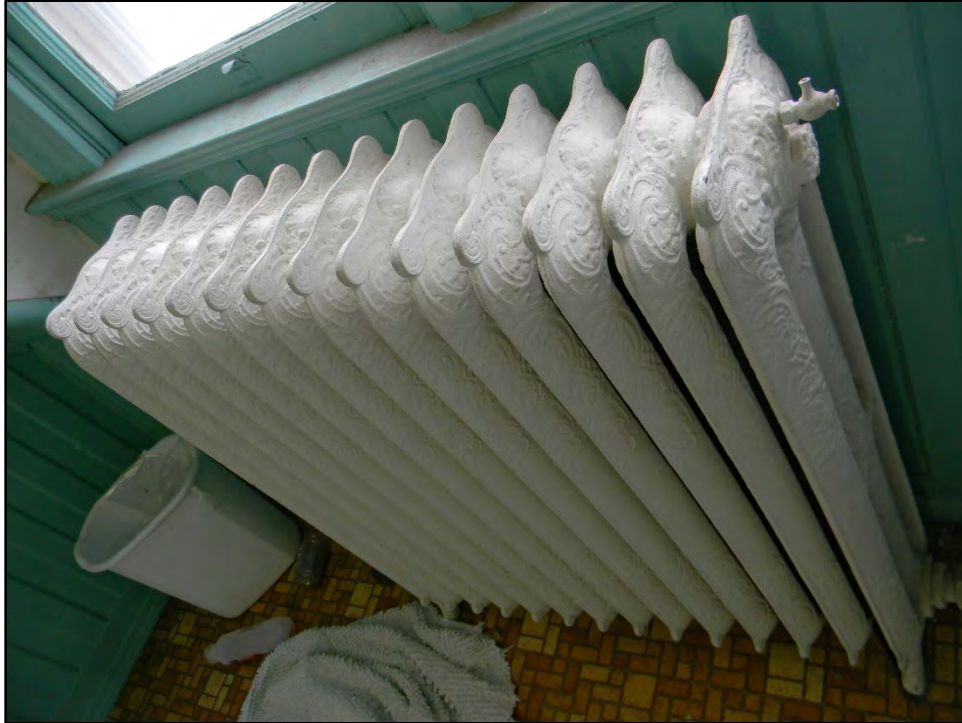
Figure D-535. The large radiator under the paired windows of the large bath.

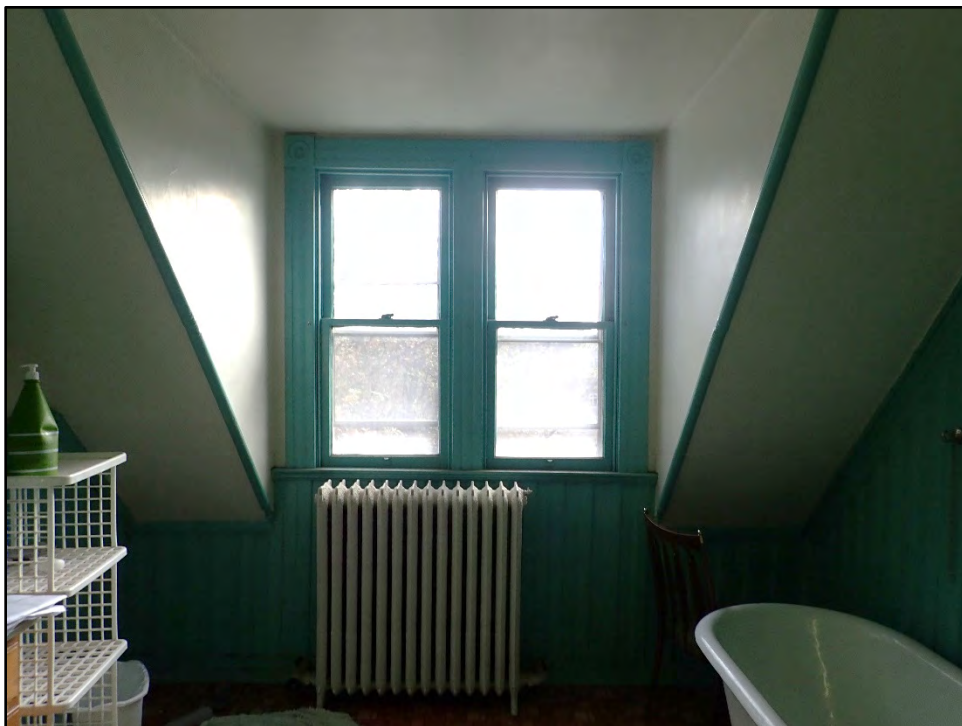
Figure D-536. View of the paired windows in the gable end framed by the shape of the ceilings and walls of the hipped-roof dormer.
