Façade Grant, Completion Report – 112 E Elm Ave

112 E. ELM ST.

122 E ELM St Façade Grant Rehabilitation

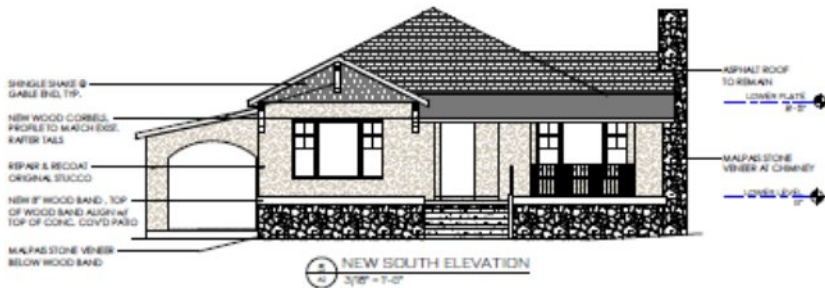
Stripped added stucco layer

Therefore, we were wondering if it would be possible to get approval to do stucco all the way up to the roof line and maintain the clay pipes. We would no longer be doing the original gable detail that was shown on the plans. We would still do the rounded stucco wraps on the windows and the stone on the stemwall. Is this something you think you could approve without going back to the HPC? Please see the attached photo of the house after we removed the siding. Let us know what you think.

HPO Reavis: This is absolutely what you should do when you discover something that is historically accurate with the Spanish Colonial style. It was a very good assumption of what the gable looked like but with the siding removed and the reality uncovered this is what is required to maintain the grant. It is a historic preservation Façade restoration project and the original history should be maintained. Now looking at it uncovered makes more sense. The HPC did have some questions regarding the gable shingles. At this point I am also not sure about the eve support brackets that are more bungalow craftsman. What are your thoughts about them?

The stucco on the gable end is now a requirement in maintaining the grant.

To All; So clues were being taken from the adjacent houses to the east and looking at some craftsmen detailing such as the eve support brackets (Wood Corbels). Now looking at the lower-slope roof and the now uncovered Spanish details the installation of eave support brackets (plan set call them out as Wood Corbels) should not be installed – so that the style shifts to the now apparent Spanish Colonial Style.
