Re: 23 E Fine Avenue / Cultural Resource Study & Proposed Project Narrative

1. REPAIR SCOPE AREA #1 - SOUTH FOUNDATION WALL

2. REPAIR SCOPE AREA #2 - LEVEL 1 BAY WINDOW PROJECTION

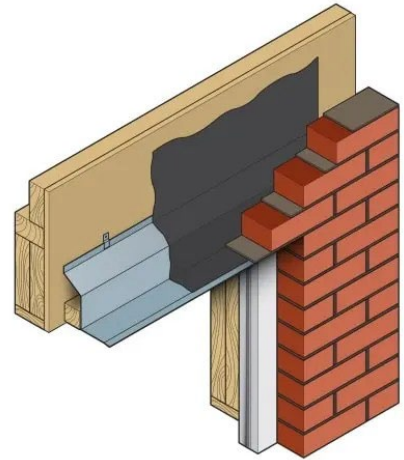
*Figure 1 - Diagrammatic Lintel Detail
(Note - masonry to be installed in vertical Soldier Course orientation at new lintel to provide visual consistency with existing / adjacent brickwork to remain.)*

- **The proposed re-construction would utilize contemporary steel angles as lintels/headers to carry the weight of the proposed brick masonry veneer over window openings. All steel lintels are to be painted to match adjacent brick construction. To maintain visual consistency with adjacent brick masonry openings, non-structural brickwork at new openings is proposed to be installed in vertical "Soldier Course" orientation to remain visually consistent with adjacent masonry flat arch. Similarly to the modular brick sizing, this minor variation is expected to be visually indiscernible after new construction is painted to match existing portions to remain. (See Figures 1 & 2 on following sheet).**

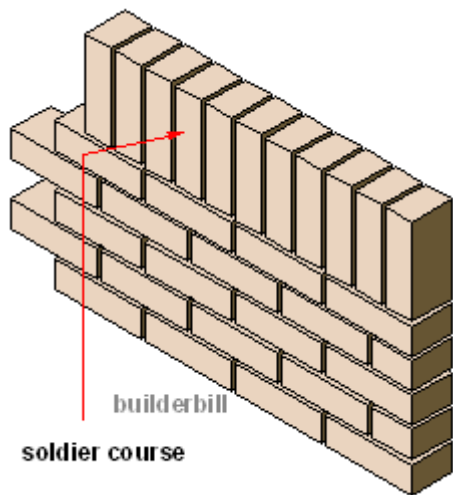
Figure 2 - Soldier Course over 50/50 Running Bond
