## Inspection Report

### Women's Care Center

**Property Address:**  
1009 Delaware Ave  
Ft. Pierce Fl.

**Date:** 4/26/2019

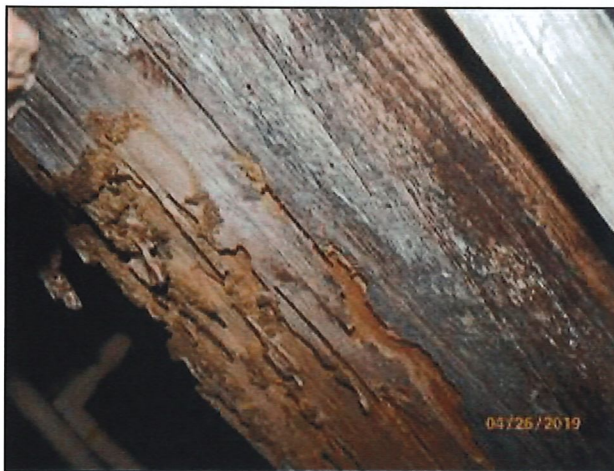
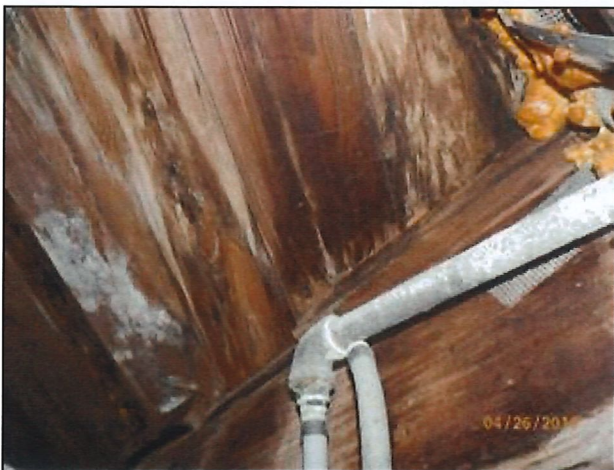
There were areas at the crawlspace bricks that need repair. There was no access to get under the house.

There were damaged floor beams in the crawlspace.

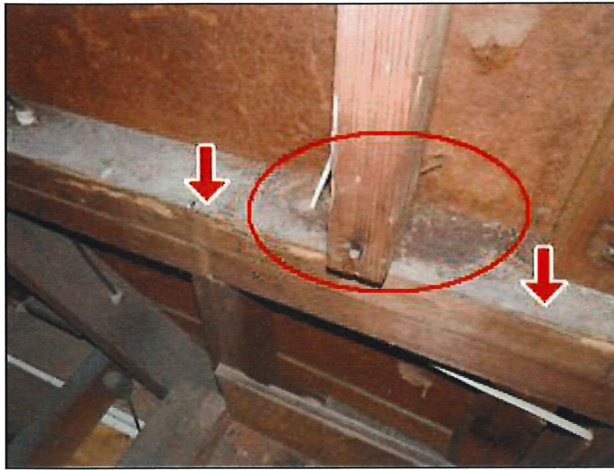
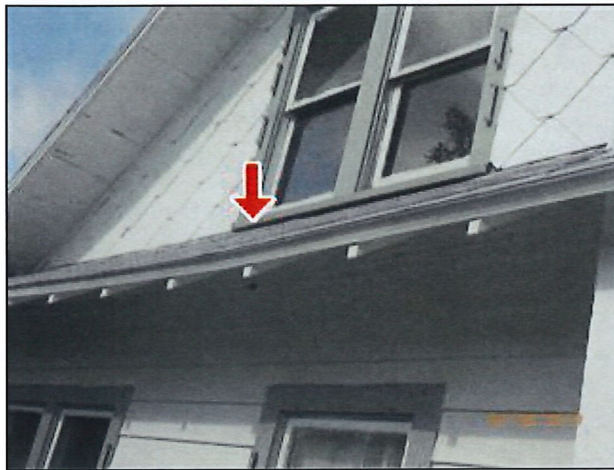
There is damage to the roof sheathing in numerous places.

There are signs of insect related damage to structural members in the attic space. It is recommended to have a licensed GC inspect and provide a repair estimate.

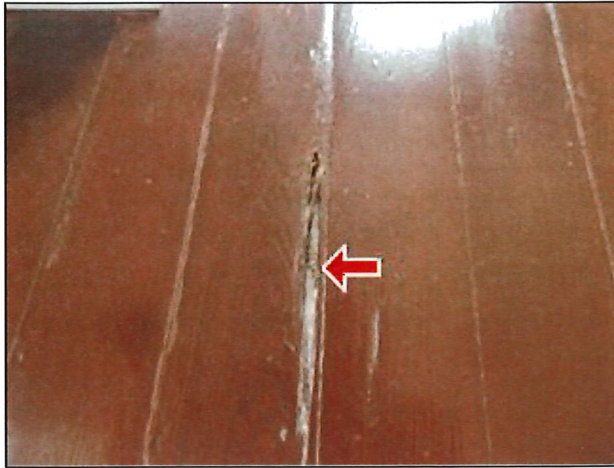
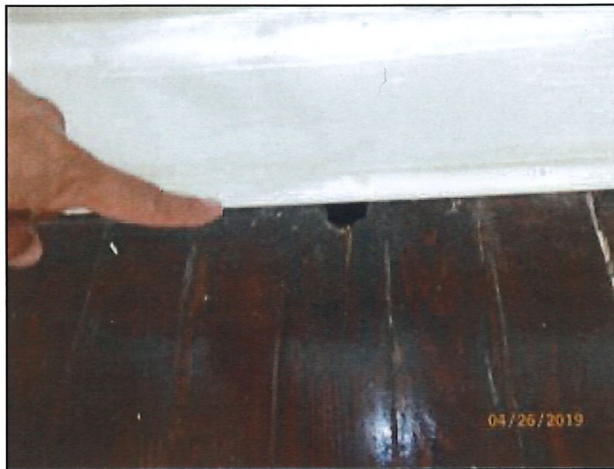
There was a hole in the flooring in the sun room.

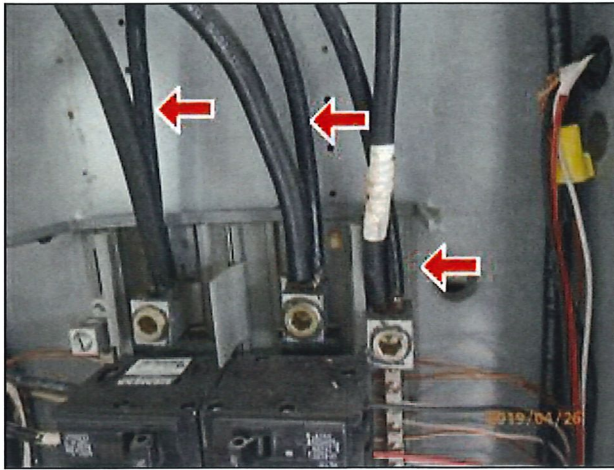
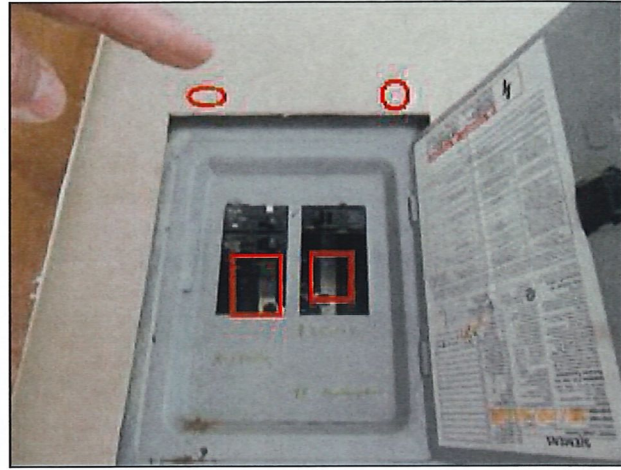
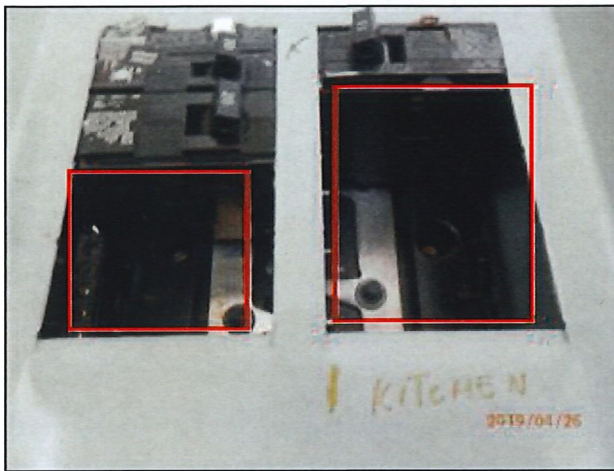
The main feed coming from the meter is double tapped to the main panel lugs. This wrong and should be corrected by a licensed electrician. The double taps are going to a sub panel above the main panel.

The sub panel above has been covered with paneling and the top 2 screws on the panel cover are not accessible. This needs to be corrected. There are open slots that need to be covered with the proper blanks.
