Housing Rehab Program

ENTITY: Countywide Area
PROJECT: Approval for Assistance under the Colonia Self-Help Program.
FUNDING YEAR: HOME 2018

Property Address: 1003 Dove Street, Alamo TX.

A home inspection was conducted on December 17, 2019 by Roberto Cavazos (Program Specialist) with Hidalgo County Urban County Program and the following items were noted.

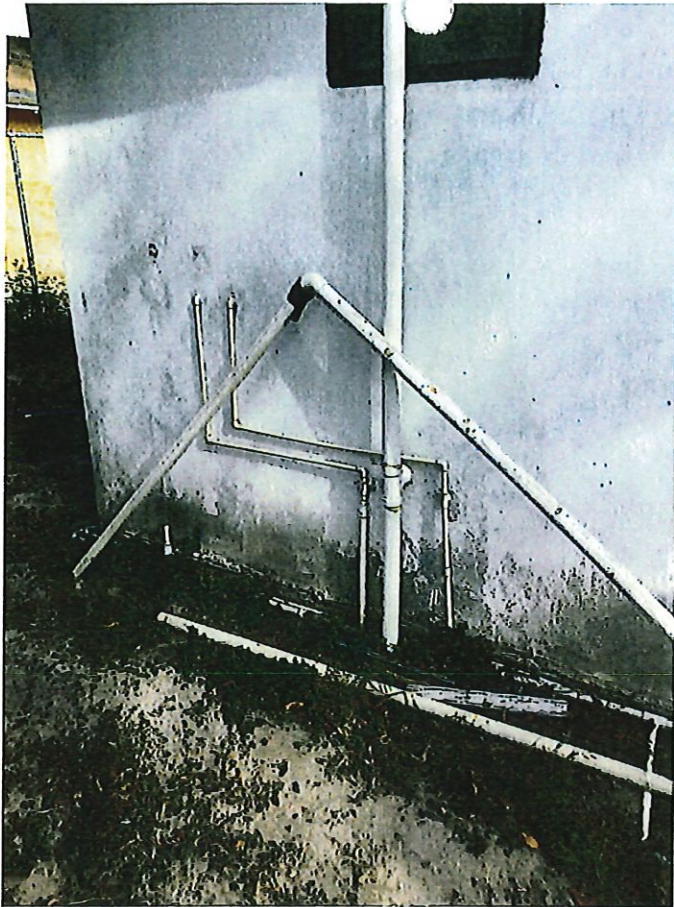
Exposed plumbing Located
At rear of House

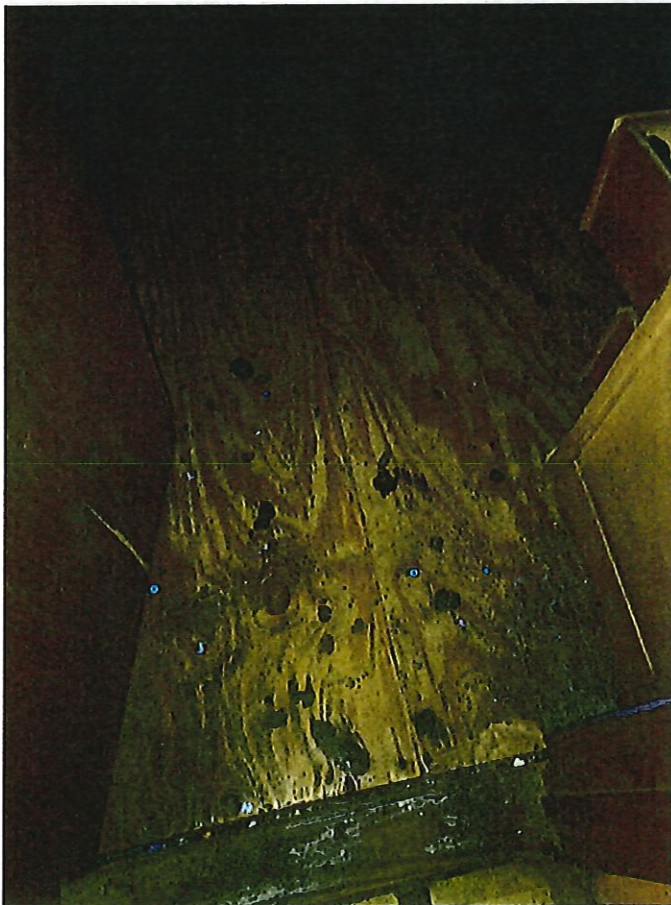
Entry to bedroom #2. Exposed Plywood decking.

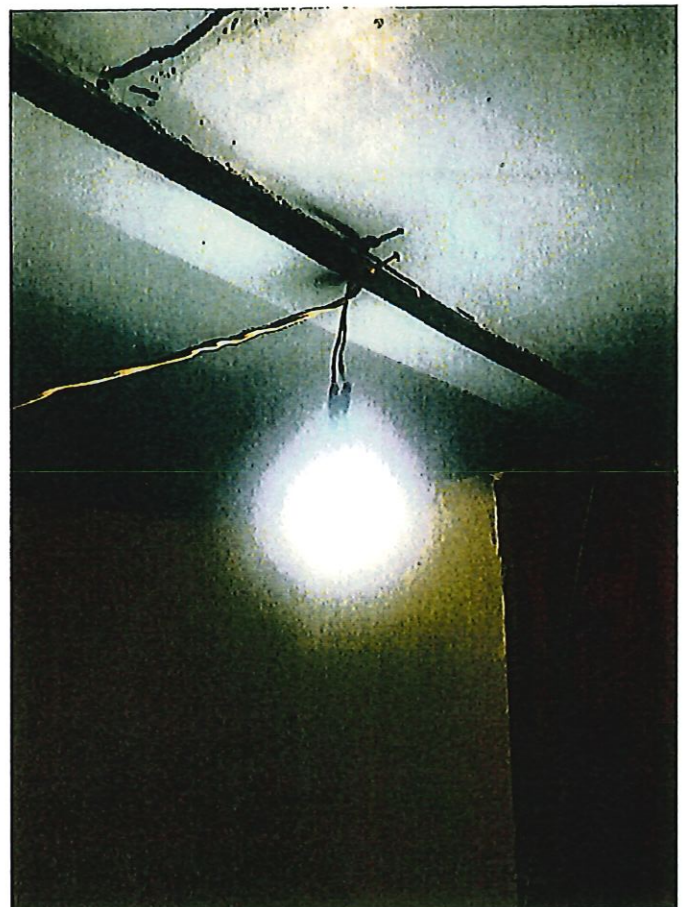
Hanging light with extension cord.
