## Disaster Recovery Program

**PROJECT:** Approval for Assistance under the Disaster Recovery Program Housing Project.

# INITIAL INSPECTION

Address: 4711 Raven Circle Edinburg Tx.

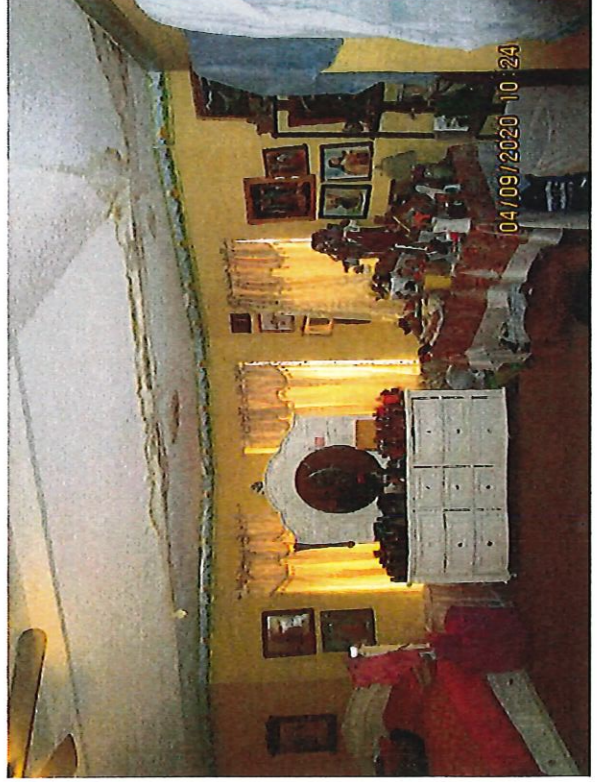
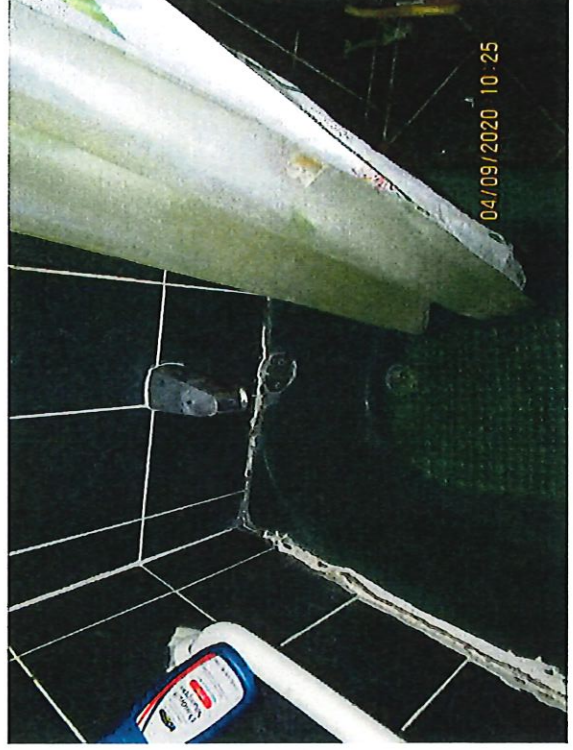
The ceiling coverings have mold and several areas where water damage has stained the ceiling..

Ceiling Deficiencies
