Housing Rehab Program

PROJECT: Reconstruction of a single family housing unit located at: 1000 Dove St., Alamo, Texas

PROJECT: Reconstruction of a single family housing unit located at: 8015 Buckles Blvd., Edinburg, Texas

INITIAL INSPECTION

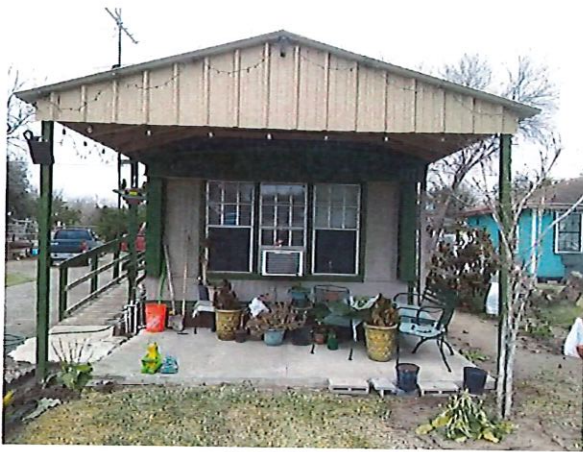
Front of the house facing south

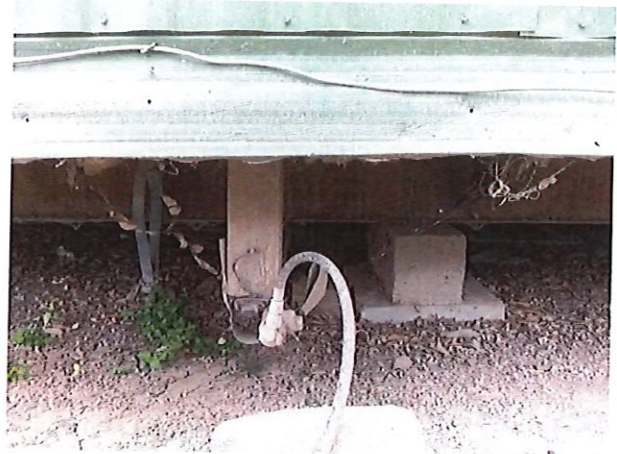
propane tank connection and footing
