Disaster Recovery Program

PROJECT: Approval for Assistance under the Disaster Recovery Program Housing Project.

INITIAL INSPECTION

Address: 5414 Leigh Ann Dr. Edinburg Tx.

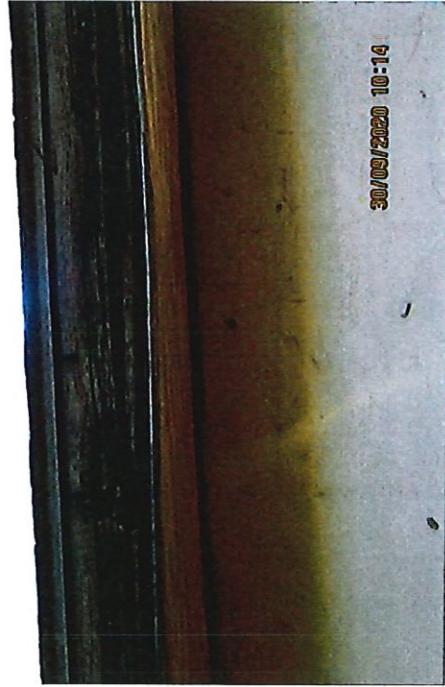
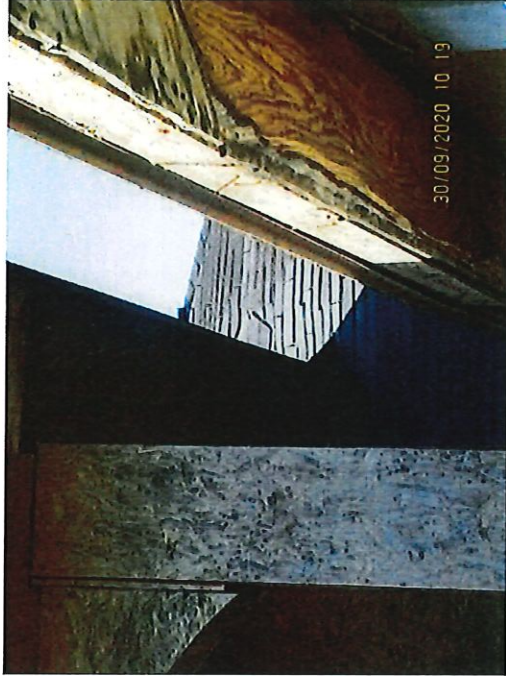
Soffit and Fascia & Roof

The roofing shingles and paper felt need to be replaced. The plywood decking needs to be replaced due to severe deterioration. Water stains mold and fallen ceilings through the house.

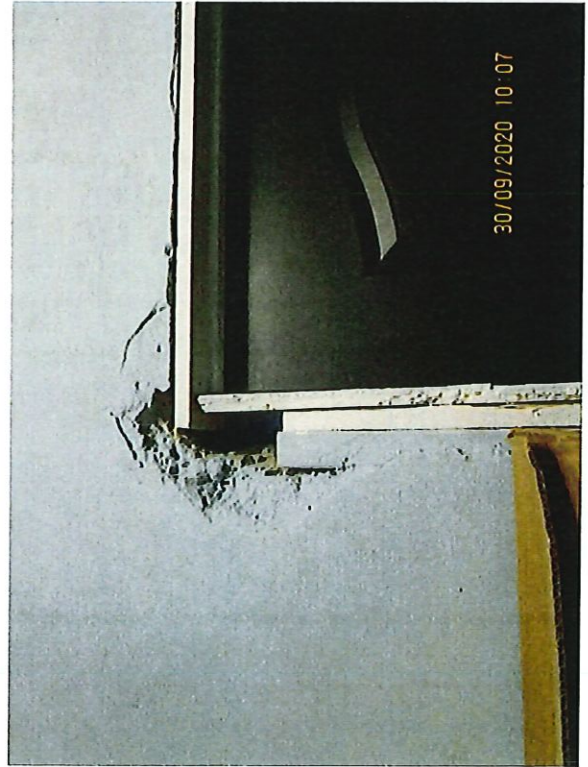
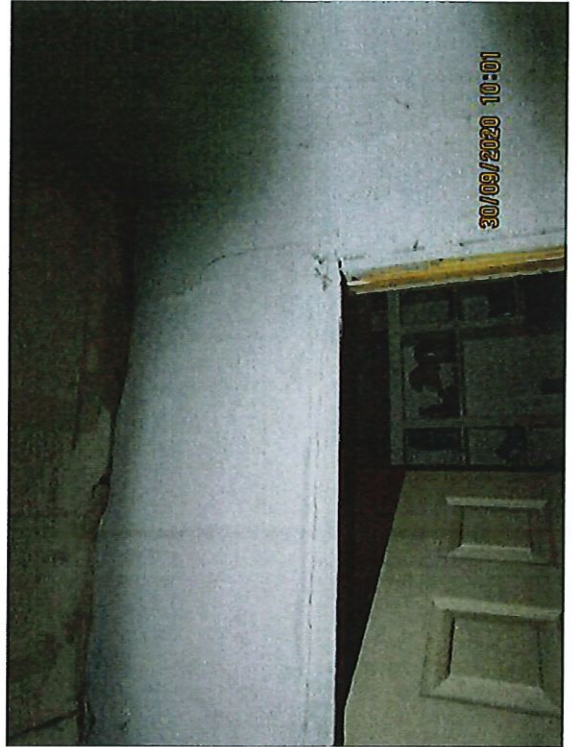
The house has no wall coverings only painted cmu. There are holes and cracks in the cmu walls due to foundation movement. Door frames and trims are broken and do not close properly.

Cracks in walls/Ceilings

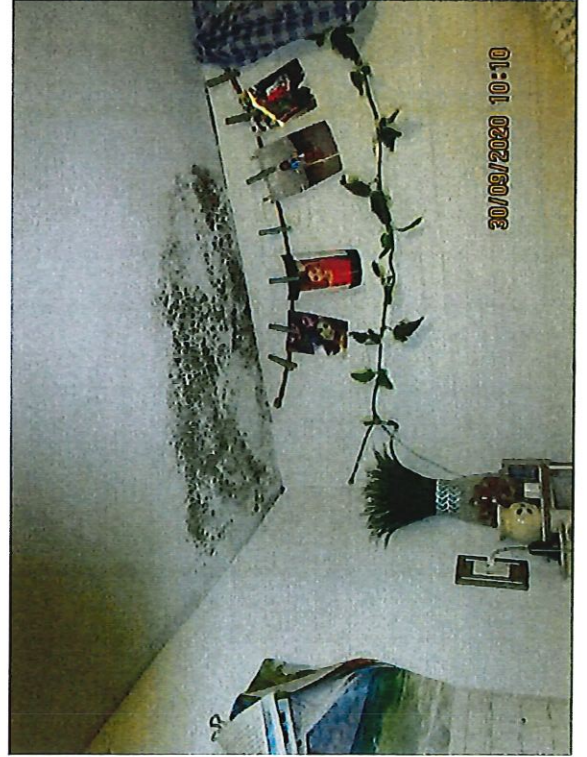
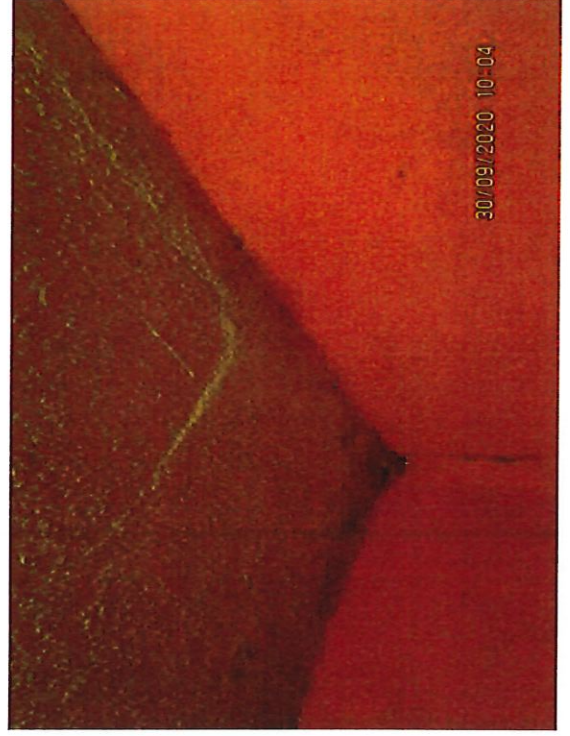
The ceiling coverings have mold and several areas where water damage has stained the ceiling..

Ceiling Deficiencies

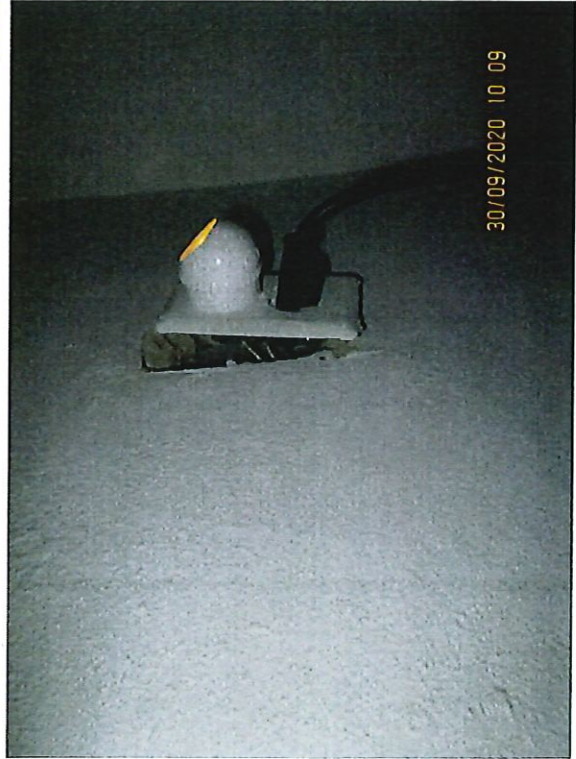
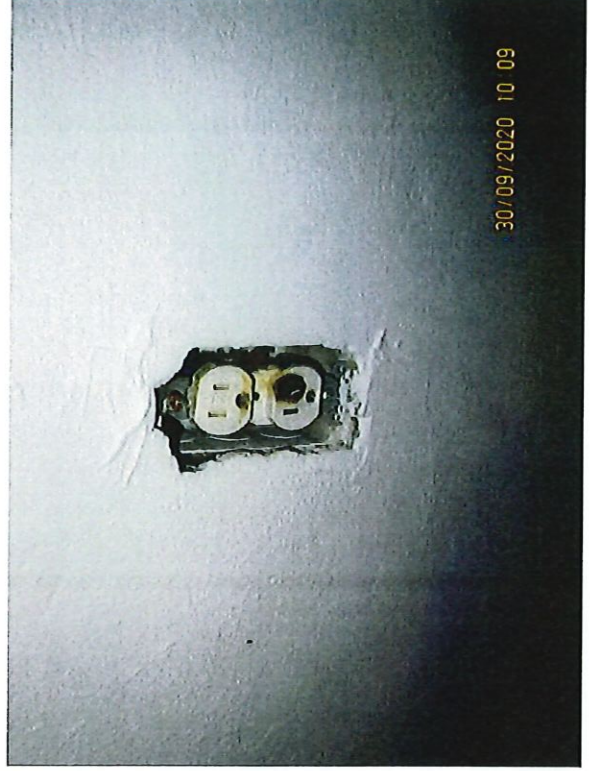
There were several plugs throughout the house that were not working. Several ceiling light fixtures in the house were also not working. Electrical needs to be inspected for electrical shorts. Many switch and electrical outlet covers were missing leaving wires exposed.

Electrical Deficiencies

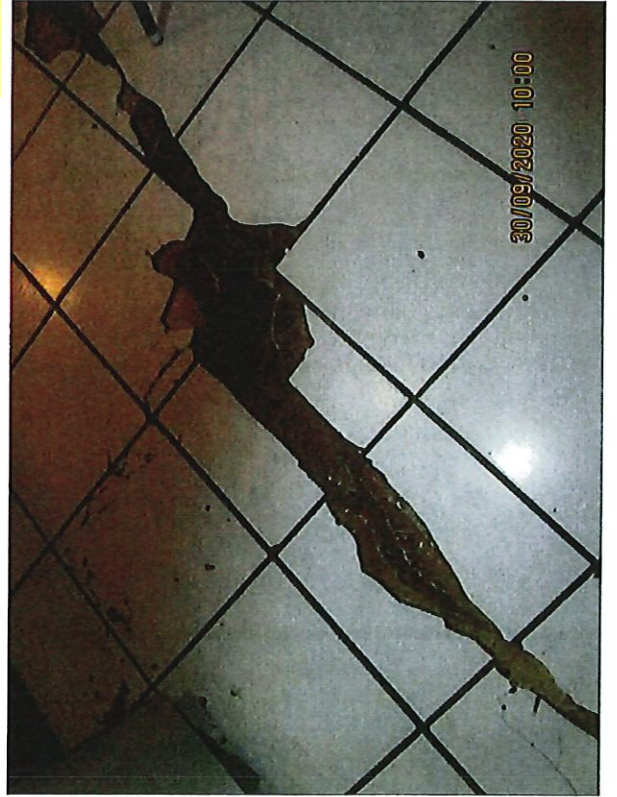
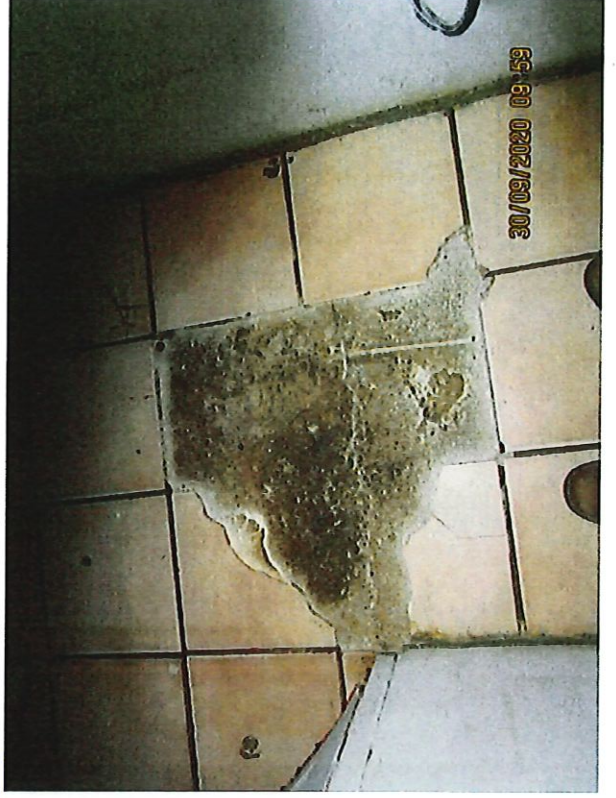
The entire house needs flooring most areas have tile and its cracked with sharp edges other areas bare conc.

Flooring Deficiencies
