**RE: Professional Engineering Services for Construction Materials Testing
(C-20-184-01-12) Work Authorization No. 2 ~ Construction Materials Testing
Hidalgo County Health Dept. Testing/Bio-Safety Laboratory
PO #847843**

Hidalgo County Bio-Safety Lab Geo & CMT
Contract # C-20-184-01-12
Work Authorization #2
PO# 847843
B2Z JOB: 4124

4124
Hidalgo County Health Dept Testing/Bio-Safety
Laboratory
Various
Edinburg, TX

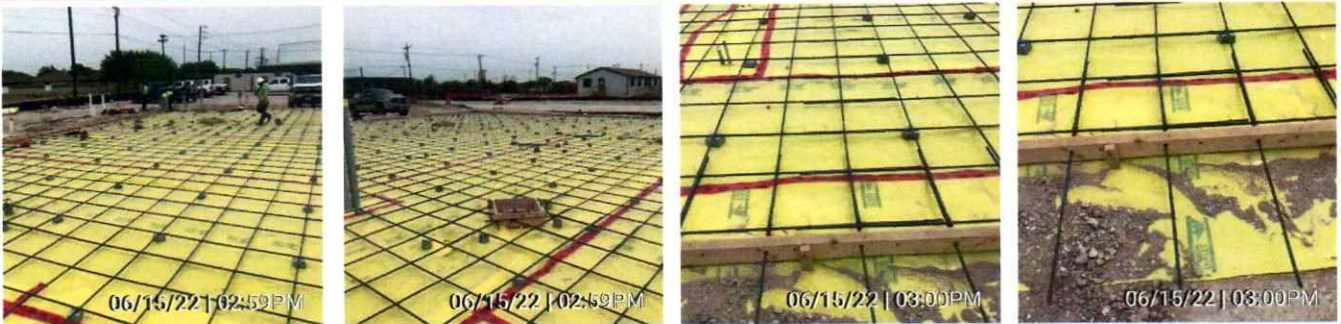
Attachments

8. Epoxy coating specified.	<input checked="" type="checkbox"/>	<input type="checkbox"/>	<input type="checkbox"/>	
9. Bars are properly laid and positioned.	<input type="checkbox"/>	<input type="checkbox"/>	<input checked="" type="checkbox"/>	All rebar properly positioned as for spec's <small>OBJ</small> Gio Mares 06/15/22 03:05PM
