## Certificate of Substantial Completion

**PROJECT:** *(name and address)*  
Hidalgo County El Paraiso Health Clinic & Community Resource Center

**CERTIFICATE INFORMATION:**  
Certificate Number: 001  
Date: June 15, 2026

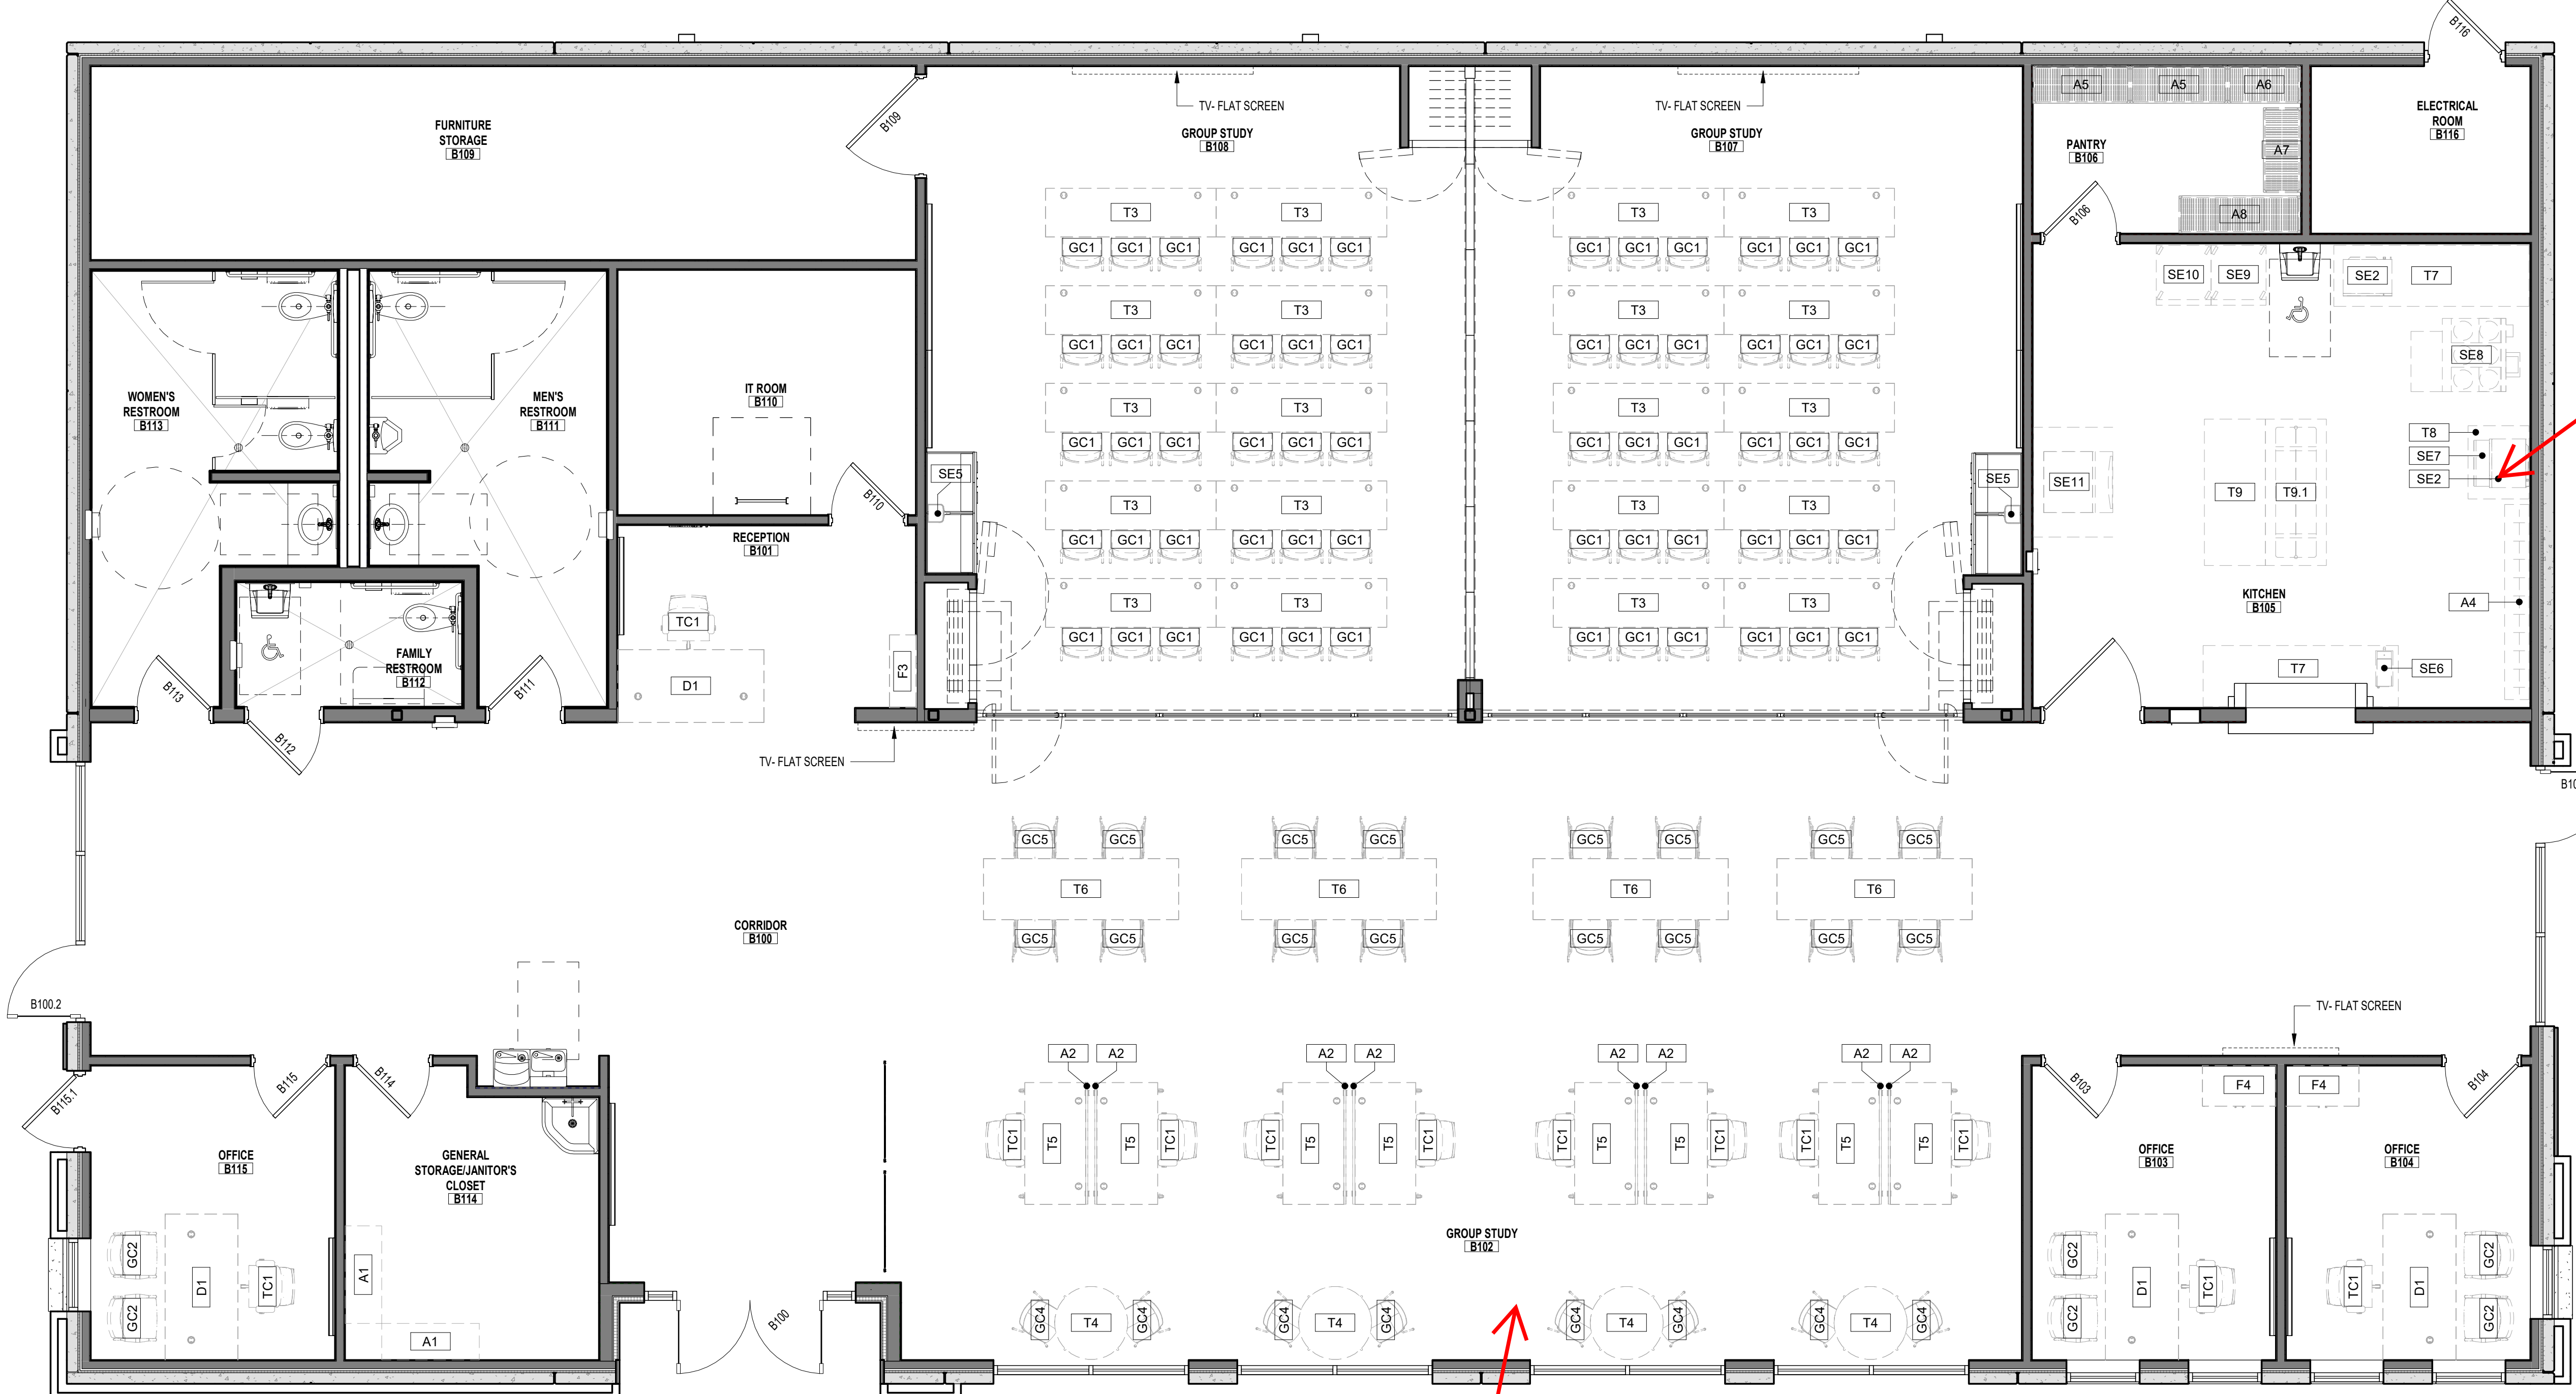
PROJECT NO.: 21087  
 ISSUE DATE: 08.02.2023  
 DRAWN BY: Author  
 CHECKED BY: Checker  
 SHEET NAME: FURNITURE PLANS - BLDG A  
 SHEET NUMBER: A1103  
 PROJECT STATUS: 100% CONSTRUCTION DOCUMENTS

ALL KITCHEN EQUIPMENT IS IN THE ROOM, BUT NOT IN PLACE.

FURNITURE THAT WAS ORDERED IS IN BUILDING, BUT NOT IN PLACE. STILL PENDING ADDITIONAL FURNITURE FROM OWNER LATEST CHANGE.

PLEASE MOVE ALL FURNITURE TO ITS DELEGATED SPACE IN ORDER TO PROVIDE A FULL FINALIZED PUNCH LIST.

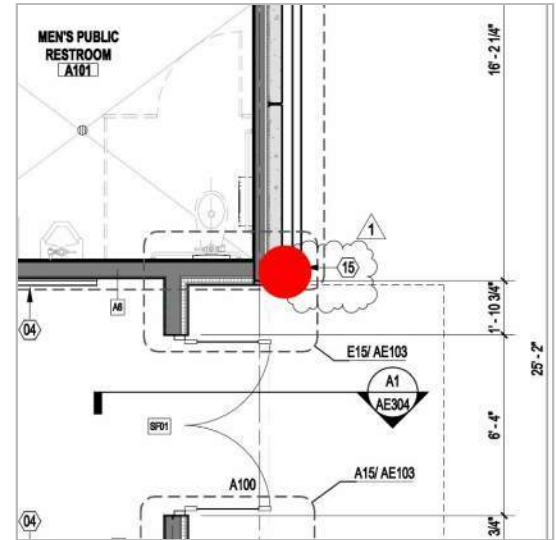
<b>Description</b>	smooth and clean excess concrete	Completed
<b>Assigned to</b>	—	
<b>Created by</b>	<b>Yesenia Tijerina</b> (ERO Architects)	
<b>Created on</b>	Aug 28, 2025	
<b>Issue owner</b>	<b>Yesenia Tijerina</b> (ERO Architects)	
<b>Location</b>	—	
<b>Location details</b>	—	
<b>Due date</b>	Sep 30, 2025	
<b>Root cause</b>	—	
<b>Reference drawing</b>	<a href="#">AE101 [V1]</a>

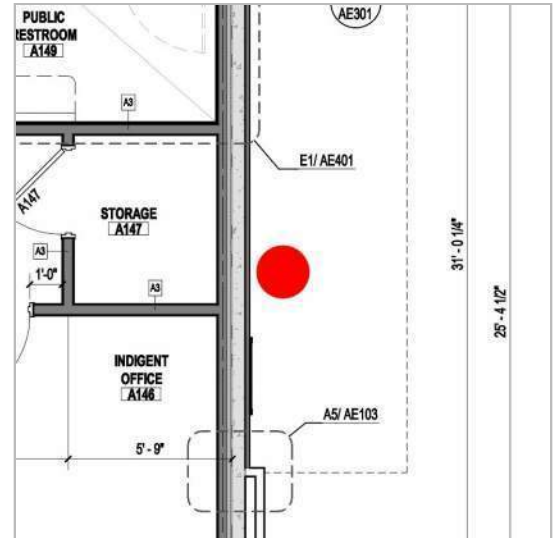
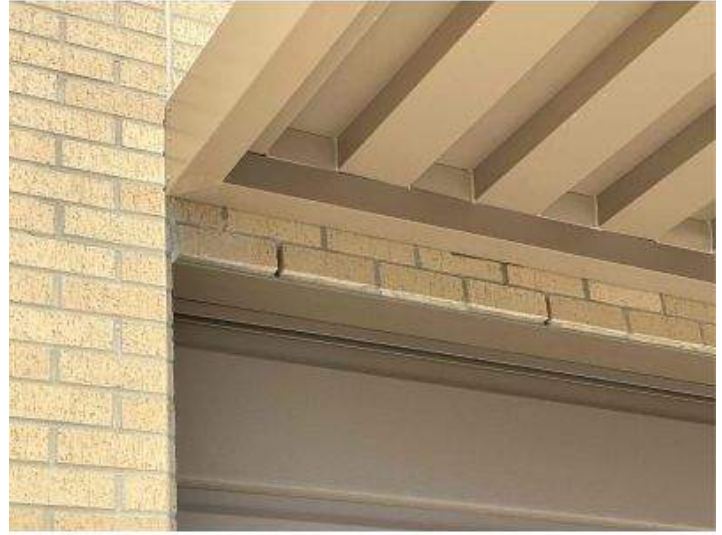
<b>Description</b>	weep vent missing	Pending
<b>Assigned to</b>	—	
<b>Created by</b>	Yesenia Tijerina (ERO Architects)	
<b>Created on</b>	Aug 28, 2025	
<b>Issue owner</b>	Yesenia Tijerina (ERO Architects)	
<b>Location</b>	—	
<b>Location details</b>	—	
<b>Due date</b>	Sep 30, 2025	
<b>Root cause</b>	—	
<b>Reference drawing</b>	<a href="#">AE101 [V1]</a>

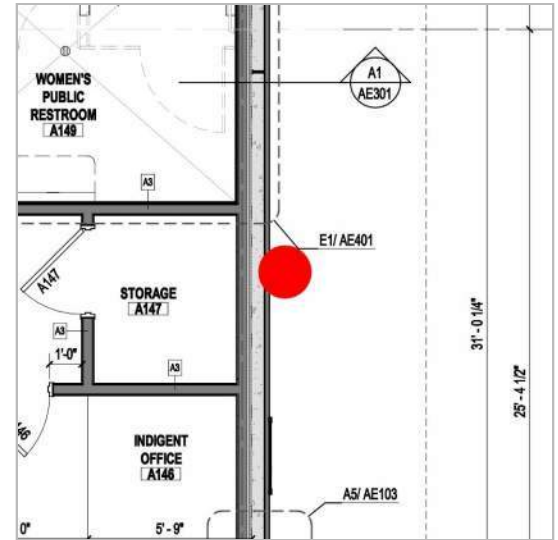
<b>Description</b>	needs to be recessed	Completed
<b>Assigned to</b>	—	
<b>Created by</b>	Yesenia Tijerina (ERO Architects)	
<b>Created on</b>	Aug 28, 2025	
<b>Issue owner</b>	Yesenia Tijerina (ERO Architects)	
<b>Location</b>	—	
<b>Location details</b>	—	
<b>Due date</b>	Sep 30, 2025	
<b>Root cause</b>	—	
<b>Reference drawing</b>	<a href="#">AE101 [V1]</a>

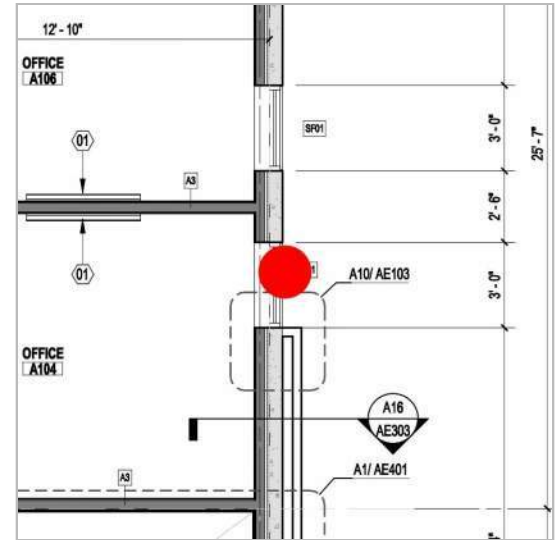
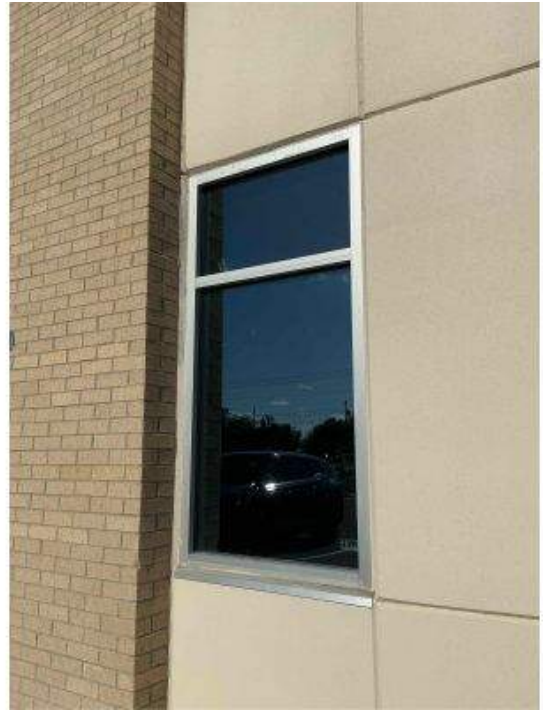
<b>Description</b>	Fill-in and smooth out all window edges at all concrete tilt-wall locations for both buildings. Paint and texture as needed.	Completed
<b>Assigned to</b>	—	
<b>Created by</b>	<b>Yesenia Tijerina</b> (ERO Architects)	
<b>Created on</b>	Aug 28, 2025	
<b>Issue owner</b>	<b>Yesenia Tijerina</b> (ERO Architects)	
<b>Location</b>	—	
<b>Location details</b>	—	
<b>Due date</b>	Sep 30, 2025	
<b>Root cause</b>	—	
<b>Reference drawing</b>	<a href="#">AE101 [V1]</a>

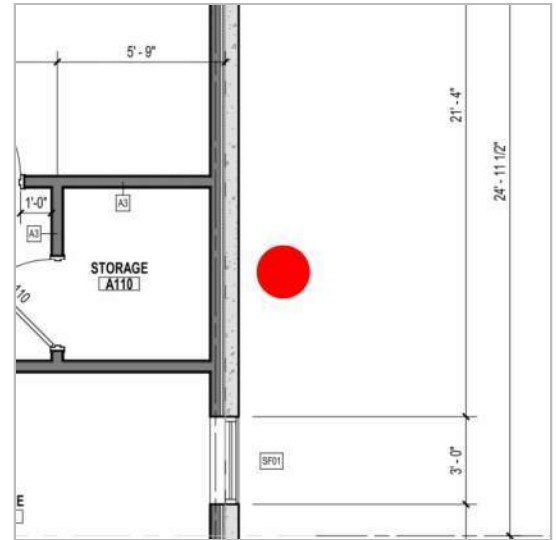
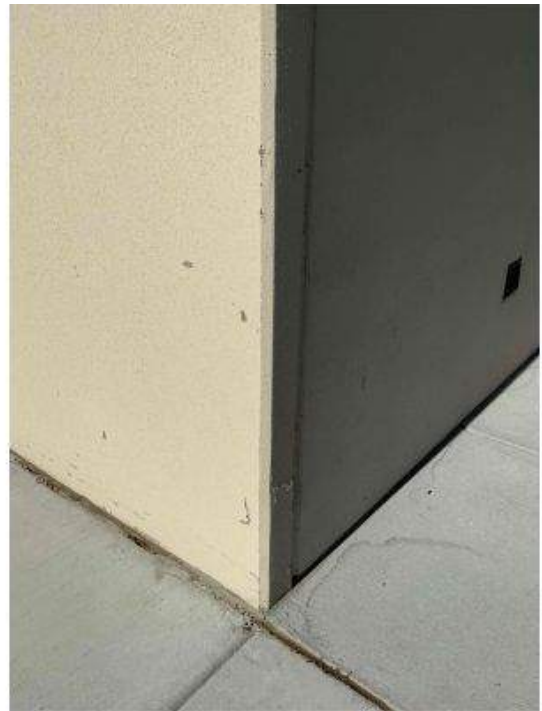
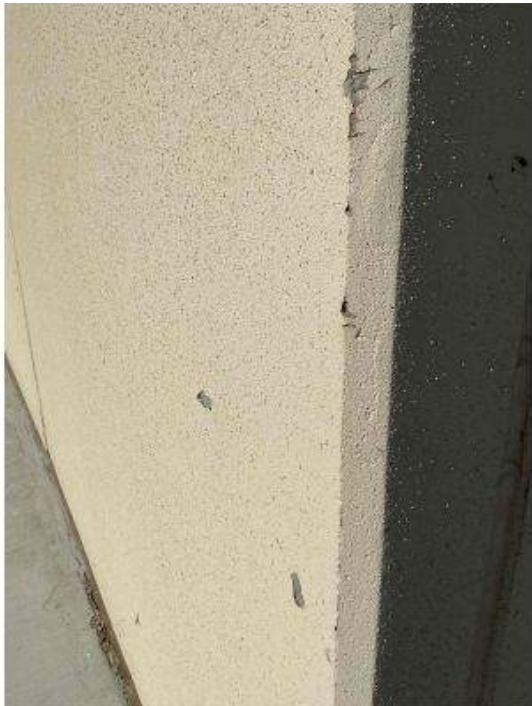
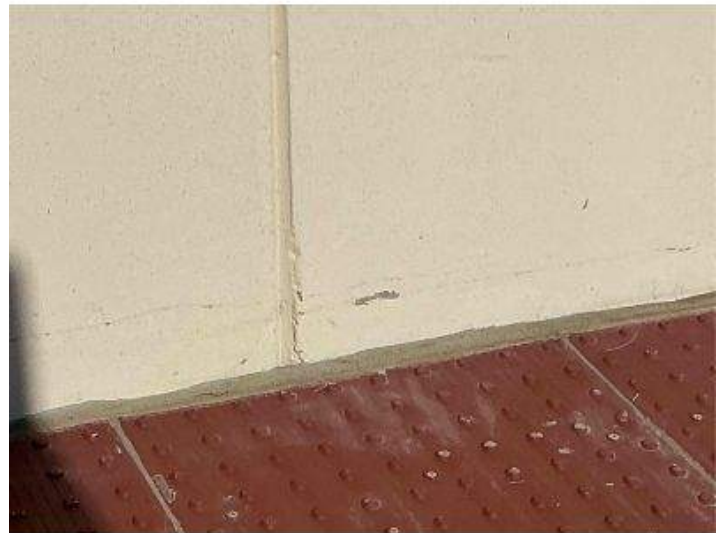
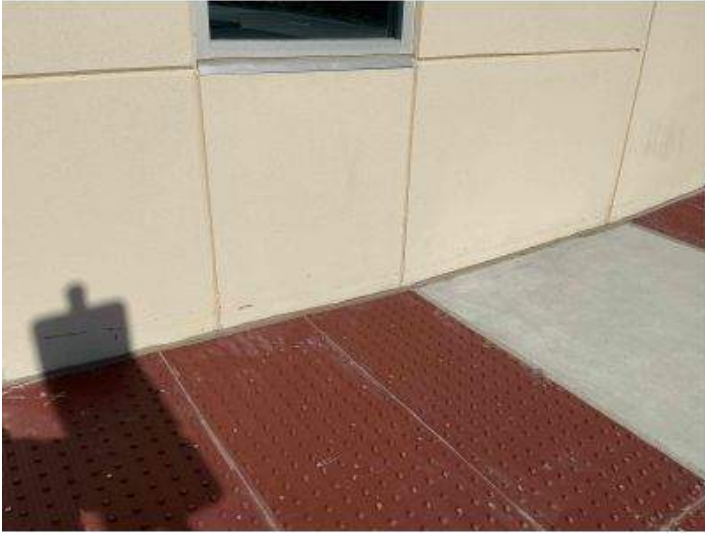
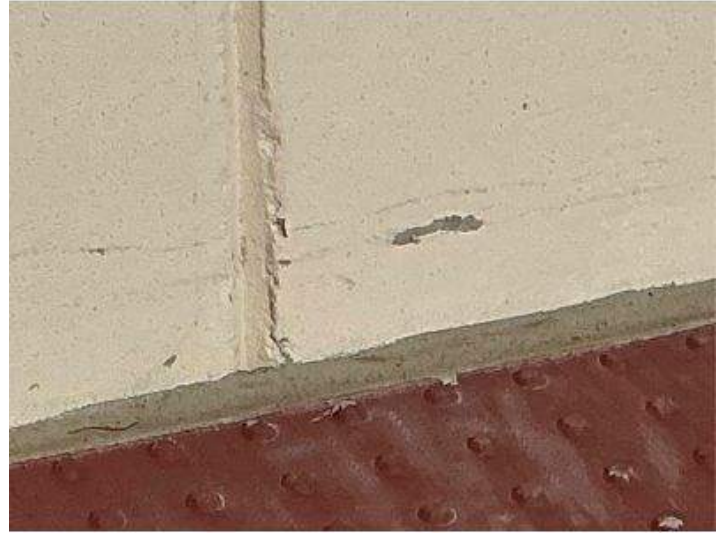
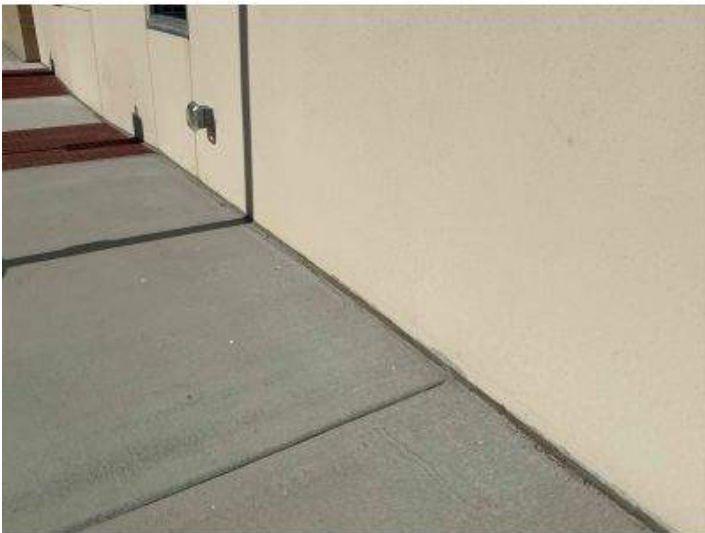
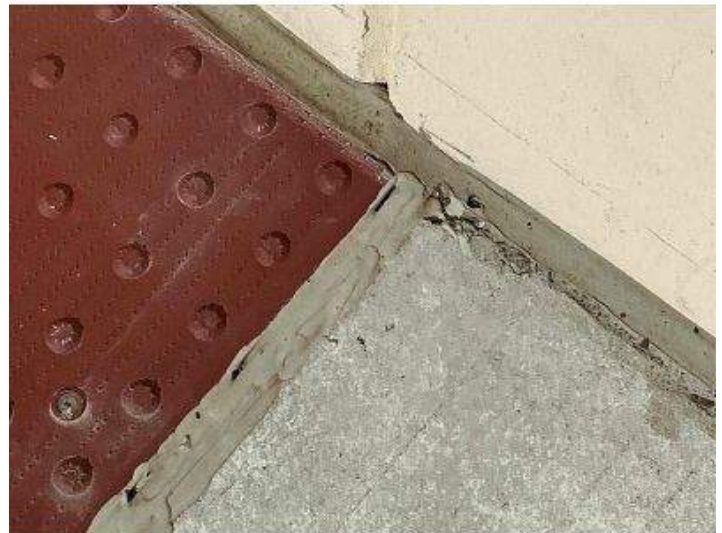
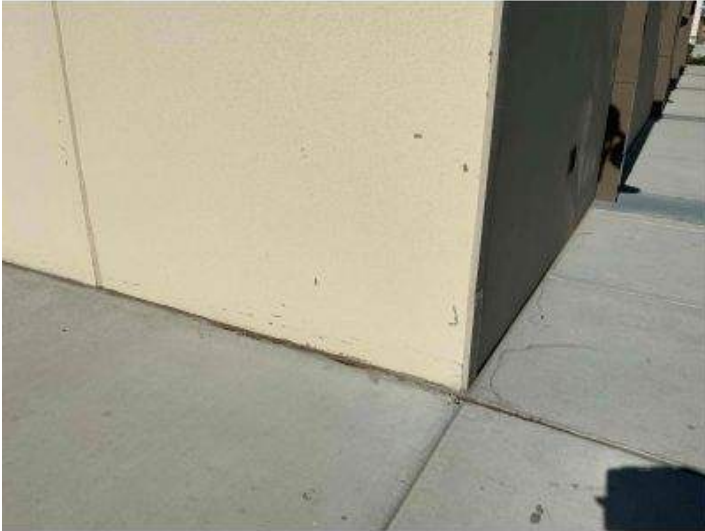
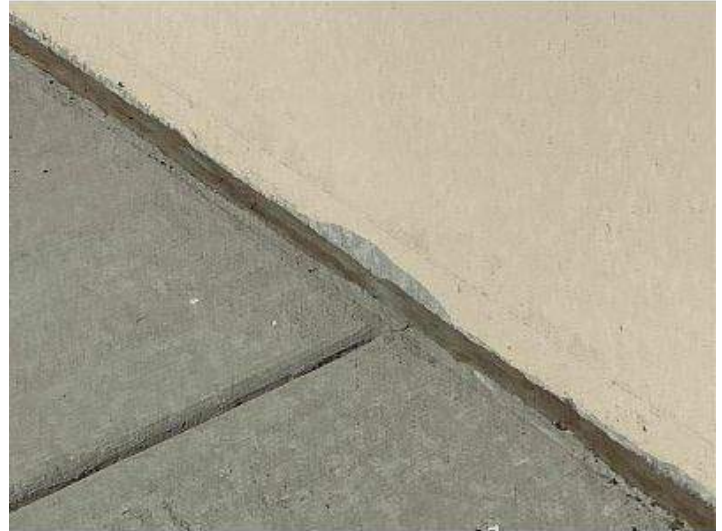
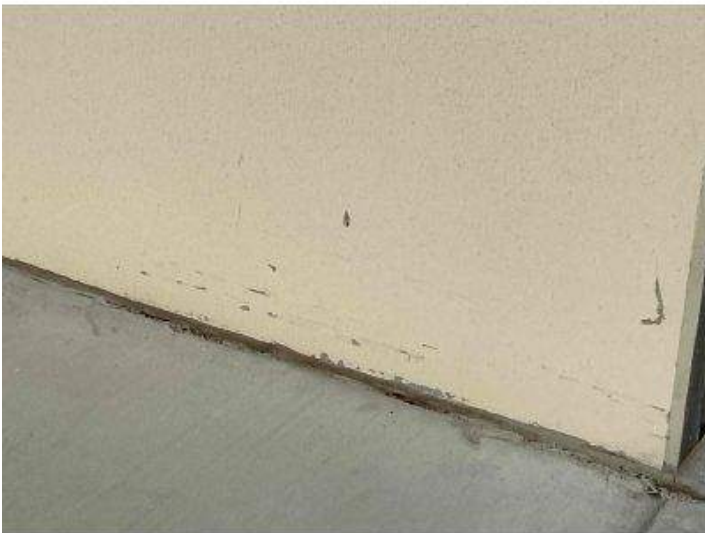
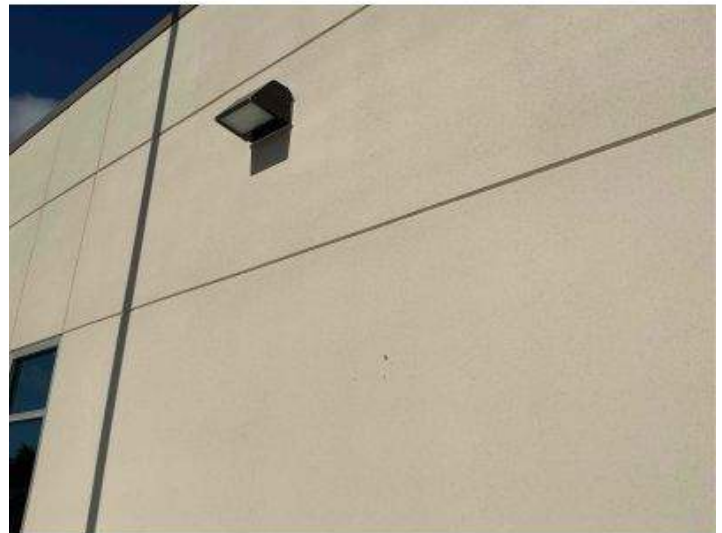
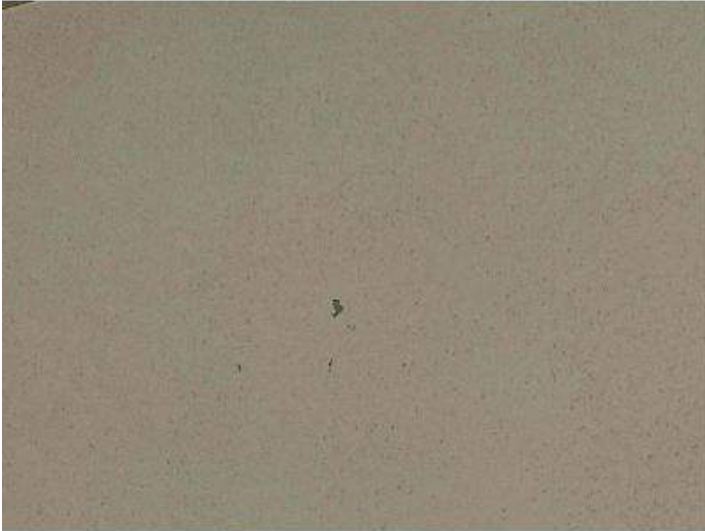
<b>Description</b>	Clean wall surface, paint touch-up, and re-texture. Prepare the concrete surface to reapply primer where paint has detached from it. <span style="background-color: yellow;">Completed</span>
<b>Assigned to</b>	—
<b>Created by</b>	<b>Yesenia Tijerina</b> (ERO Architects)
<b>Created on</b>	Aug 28, 2025
<b>Issue owner</b>	<b>Yesenia Tijerina</b> (ERO Architects)
<b>Location</b>	—
<b>Location details</b>	—
<b>Due date</b>	Sep 30, 2025
<b>Root cause</b>	—
<b>Reference drawing</b>	<a href="#">AE101 [V1]</a>

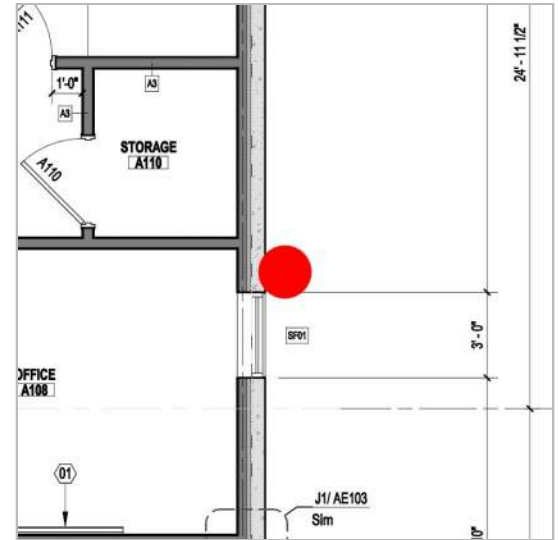
<b>Description</b>	all power boxes need to be recessed	Completed
<b>Assigned to</b>	—	
<b>Created by</b>	<b>Yesenia Tijerina</b> (ERO Architects)	
<b>Created on</b>	Aug 28, 2025	
<b>Issue owner</b>	<b>Yesenia Tijerina</b> (ERO Architects)	
<b>Location</b>	—	
<b>Location details</b>	—	
<b>Due date</b>	Sep 30, 2025	
<b>Root cause</b>	—	
<b>Reference drawing</b>	<a href="#">AE101 [V1]</a>

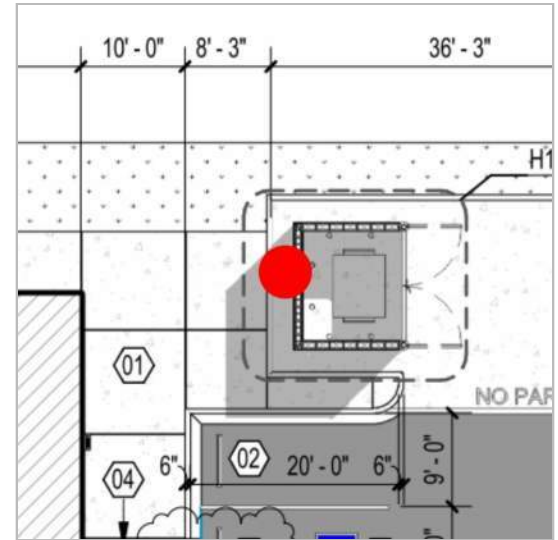
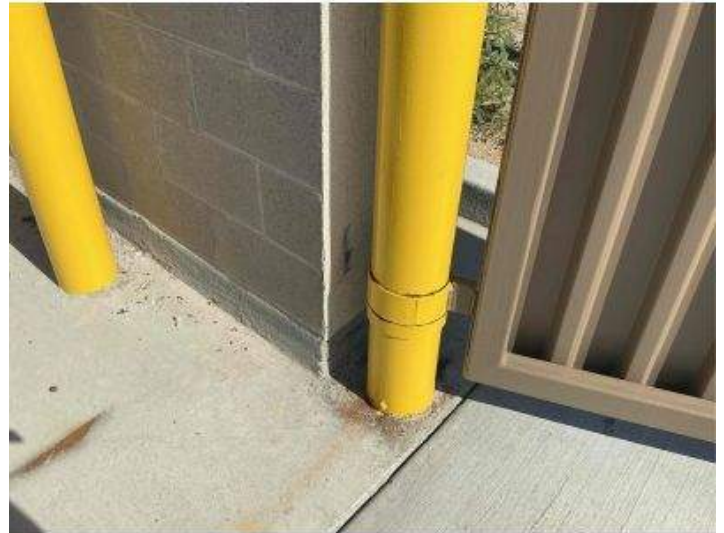
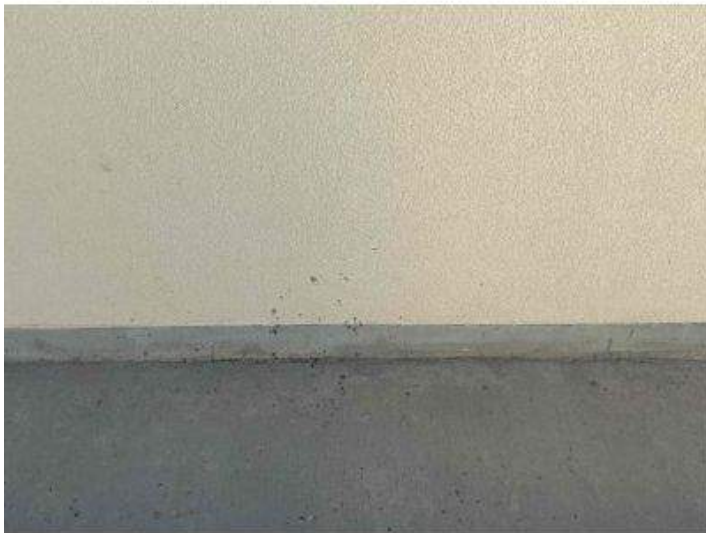
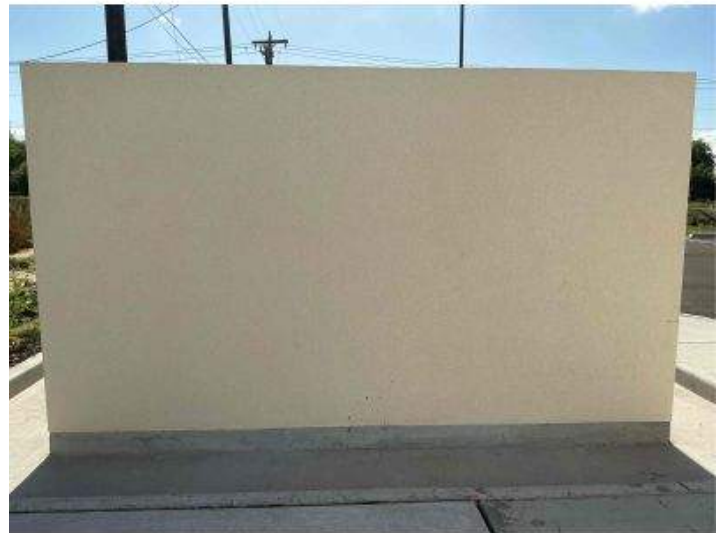
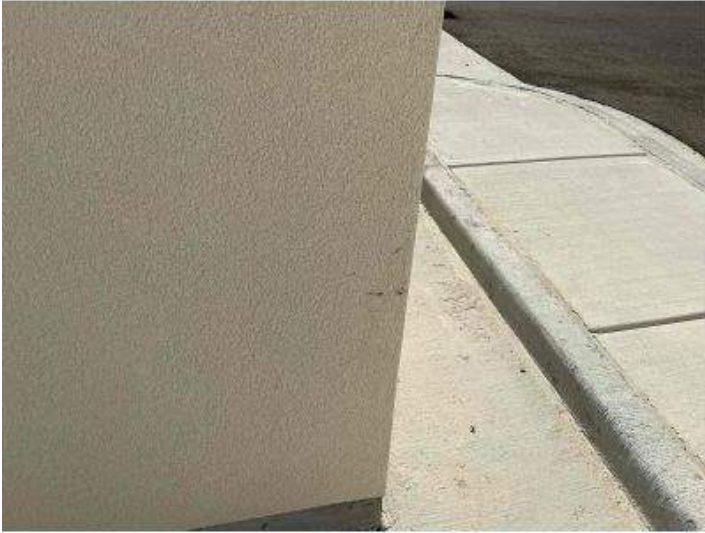
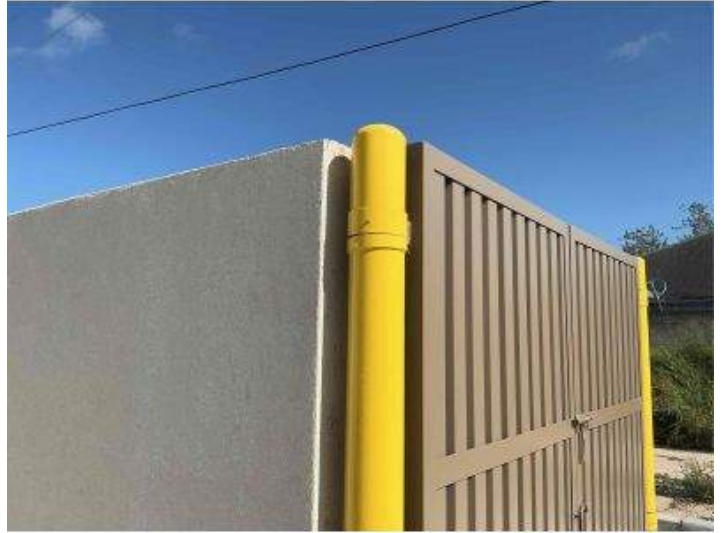
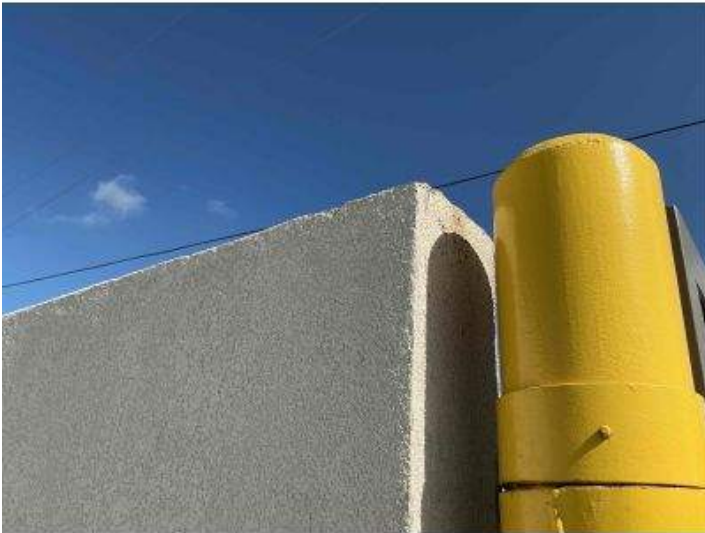
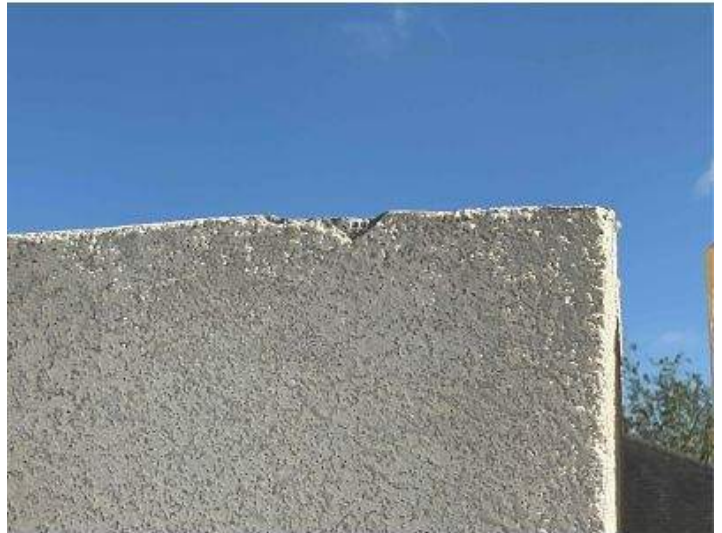
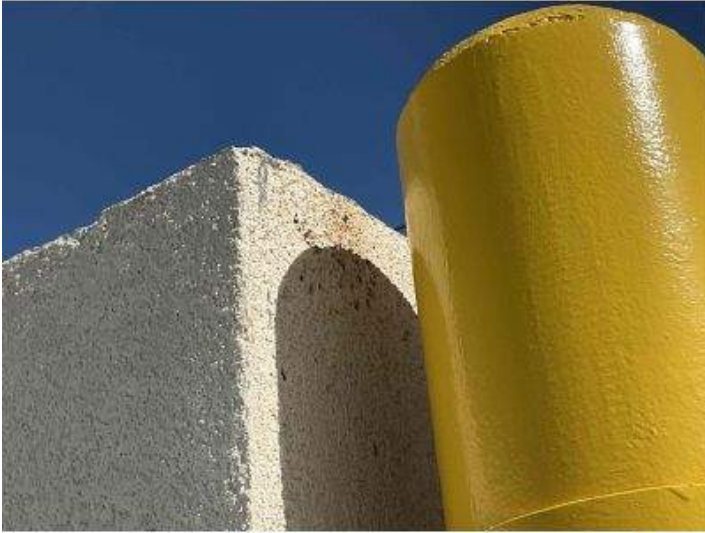
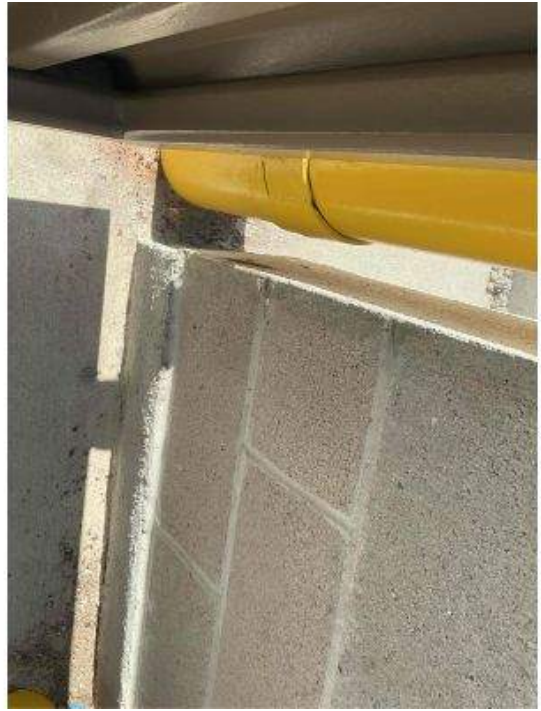
<b>Description</b>	Repair, touch up and clean stucco	<b>Completed</b>
<b>Assigned to</b>	—	
<b>Created by</b>	<b>Yesenia Tijerina</b> (ERO Architects)	
<b>Created on</b>	Aug 28, 2025	
<b>Issue owner</b>	<b>Yesenia Tijerina</b> (ERO Architects)	
<b>Location</b>	—	
<b>Location details</b>	—	
<b>Due date</b>	Sep 30, 2025	
<b>Root cause</b>	—	
<b>Reference drawing</b>	<a href="#">AS101 [V1]</a>

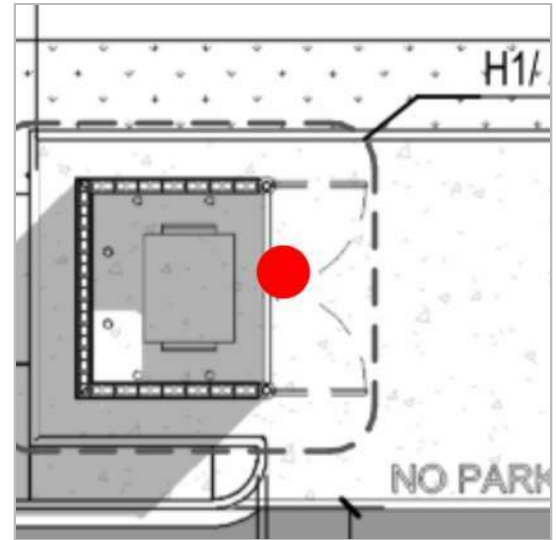
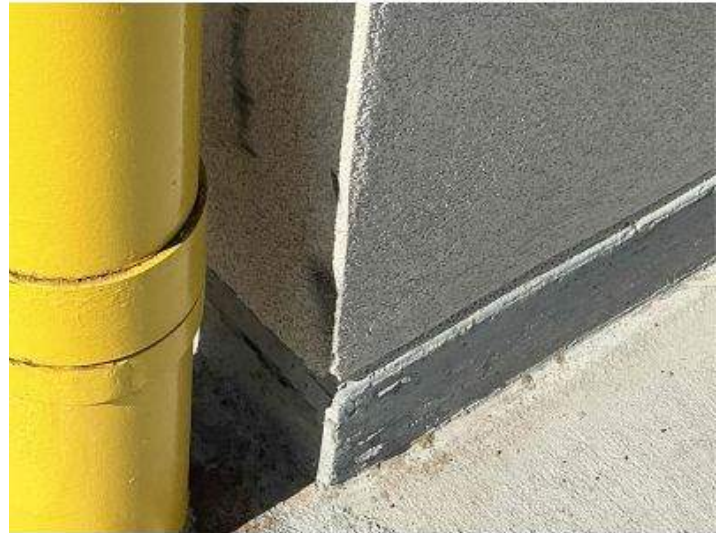
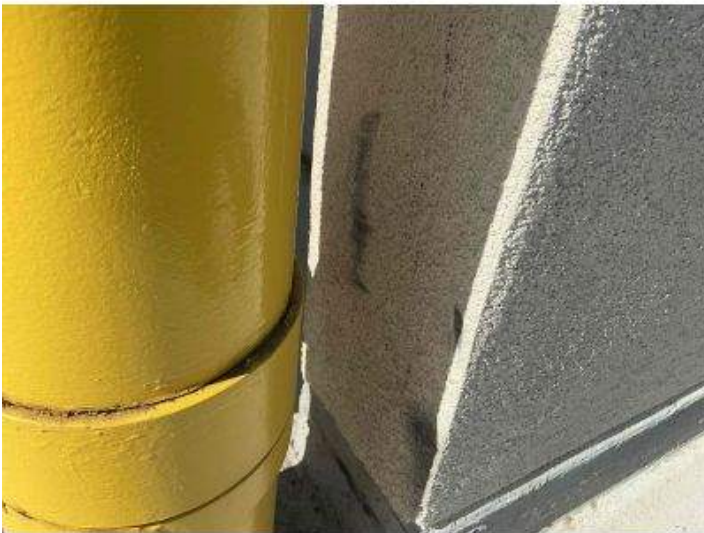
<b>Description</b>	Repair and touch up stucco as needed	<b>Completed</b>
<b>Assigned to</b>	—	
<b>Created by</b>	<b>Yesenia Tijerina</b> (ERO Architects)	
<b>Created on</b>	Aug 28, 2025	
<b>Issue owner</b>	<b>Yesenia Tijerina</b> (ERO Architects)	
<b>Location</b>	—	
<b>Location details</b>	—	
<b>Due date</b>	Sep 30, 2025	
<b>Root cause</b>	—	
<b>Reference drawing</b>	<a href="#">AS101 [V1]</a>

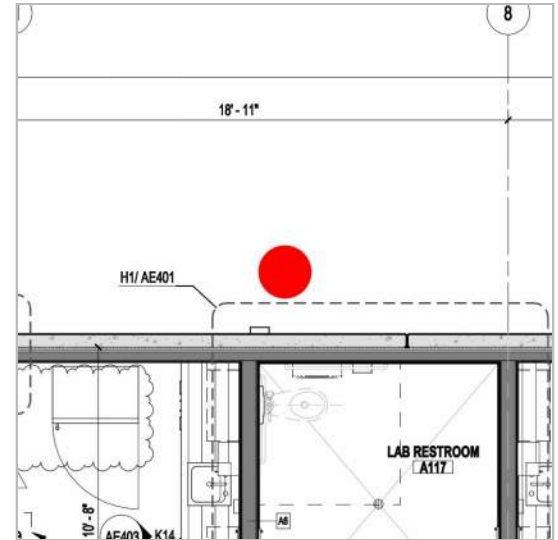
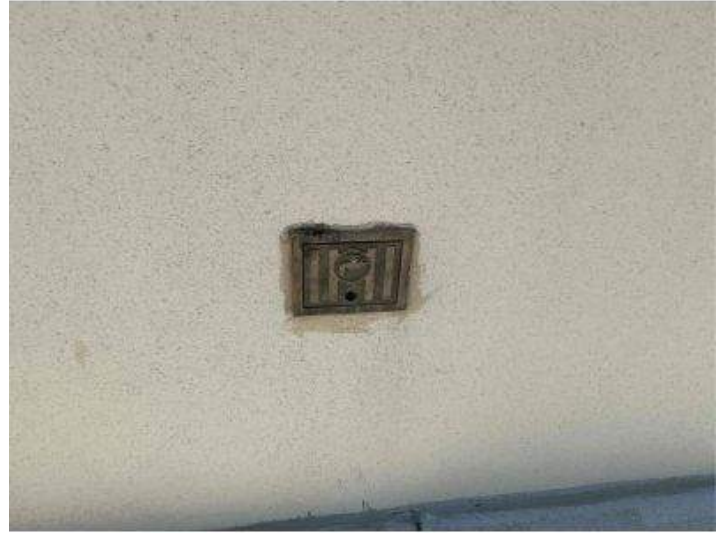
<b>Description</b>	clean exess caulk	Completed
<b>Assigned to</b>	—	
<b>Created by</b>	Yesenia Tijerina (ERO Architects)	
<b>Created on</b>	Aug 28, 2025	
<b>Issue owner</b>	Yesenia Tijerina (ERO Architects)	
<b>Location</b>	—	
<b>Location details</b>	—	
<b>Due date</b>	Sep 30, 2025	
<b>Root cause</b>	—	
<b>Reference drawing</b>	<a href="#">AE101 [V1]</a>

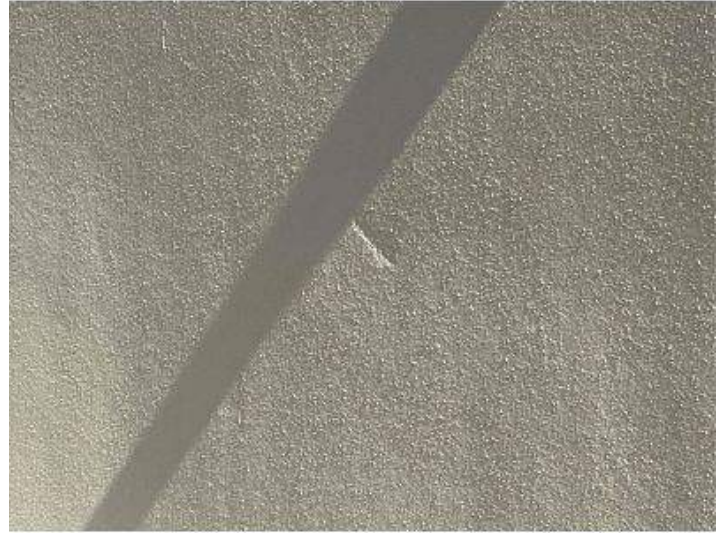
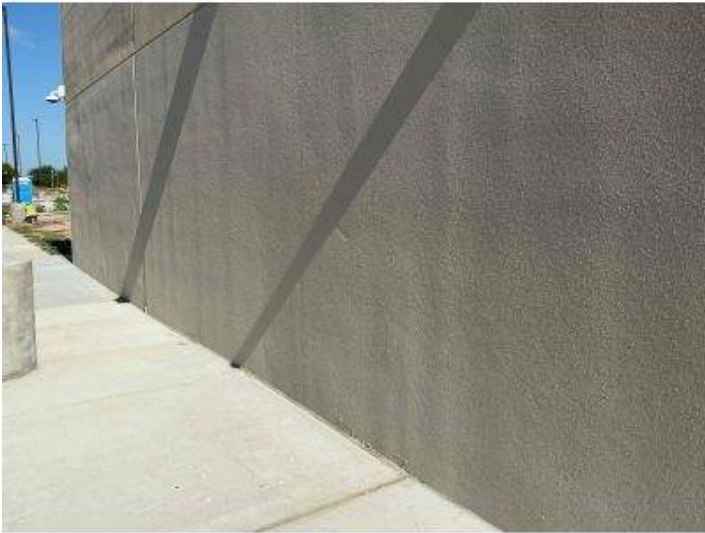
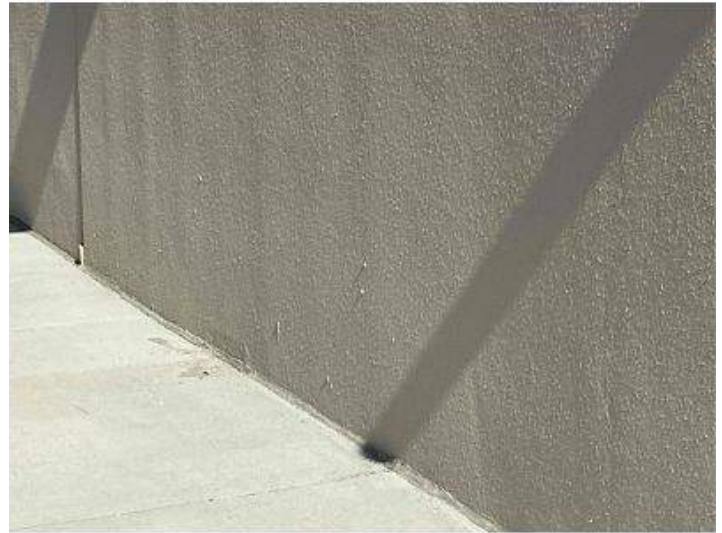
<b>Description</b>	Fill in to even out the tilt-wall surface. Smooth out excess paint/texture. Paint and texture as needed. <span style="background-color: yellow; color: red; padding: 2px;">Pending</span>
<b>Assigned to</b>	—
<b>Created by</b>	<b>Yesenia Tijerina</b> (ERO Architects)
<b>Created on</b>	Aug 28, 2025
<b>Issue owner</b>	<b>Yesenia Tijerina</b> (ERO Architects)
<b>Location</b>	—
<b>Location details</b>	—
<b>Due date</b>	Sep 30, 2025
<b>Root cause</b>	—
<b>Reference drawing</b>	<a href="#">AE101 [V1]</a>

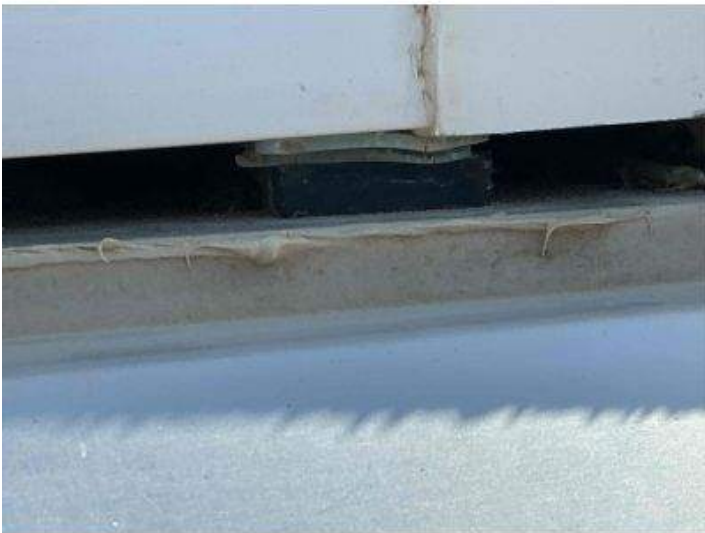
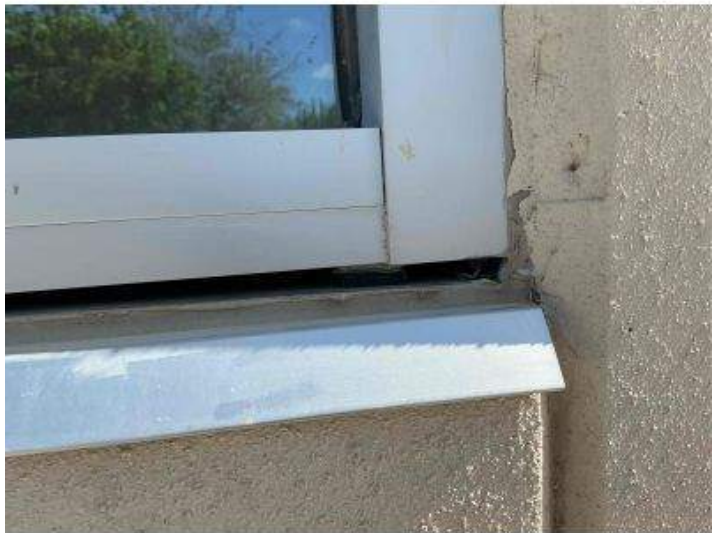
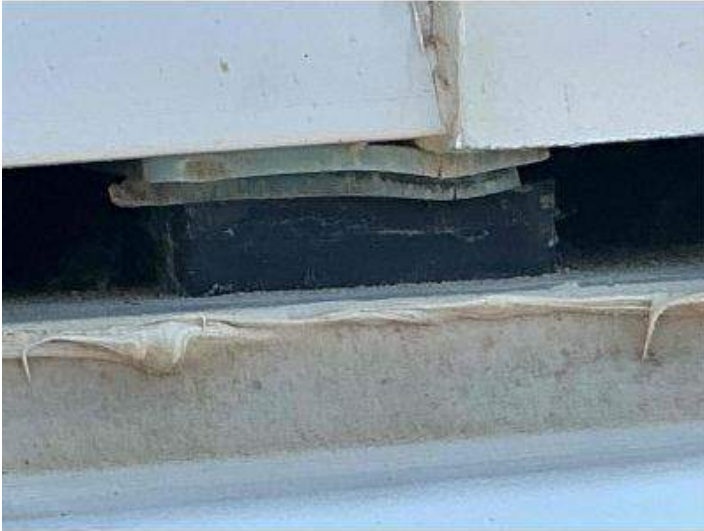
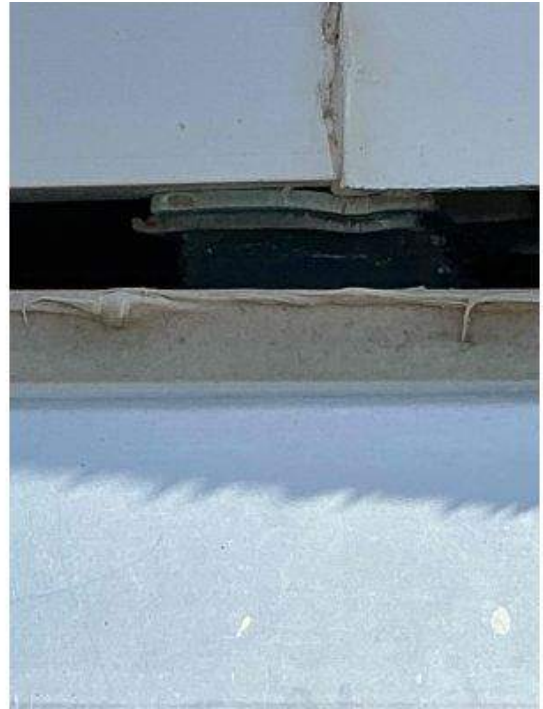
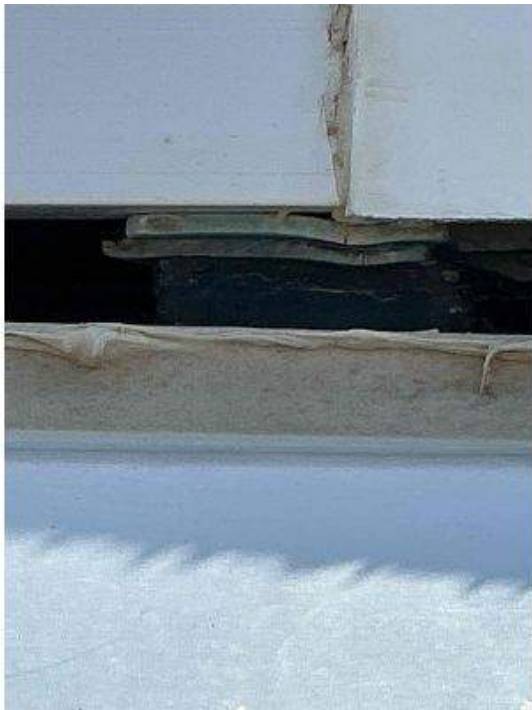
<b>Description</b>	close gap, aligned and level window metal flashing	Completed
<b>Assigned to</b>	—	
<b>Created by</b>	Yesenia Tijerina (ERO Architects)	
<b>Created on</b>	Aug 28, 2025	
<b>Issue owner</b>	Yesenia Tijerina (ERO Architects)	
<b>Location</b>	—	
<b>Location details</b>	—	
<b>Due date</b>	Sep 30, 2025	
<b>Root cause</b>	—	
<b>Reference drawing</b>	<a href="#">AE101 [V1]</a>

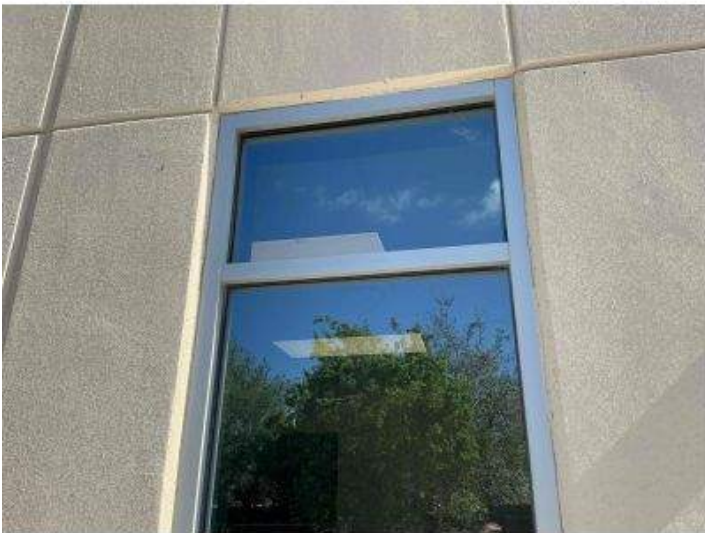
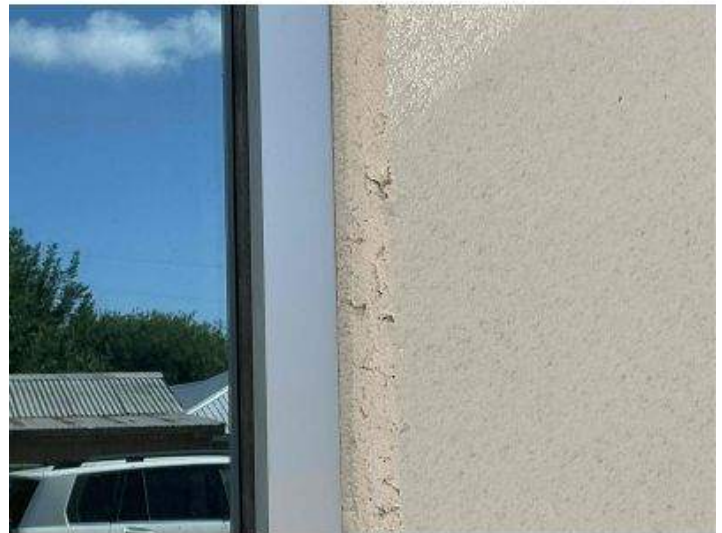
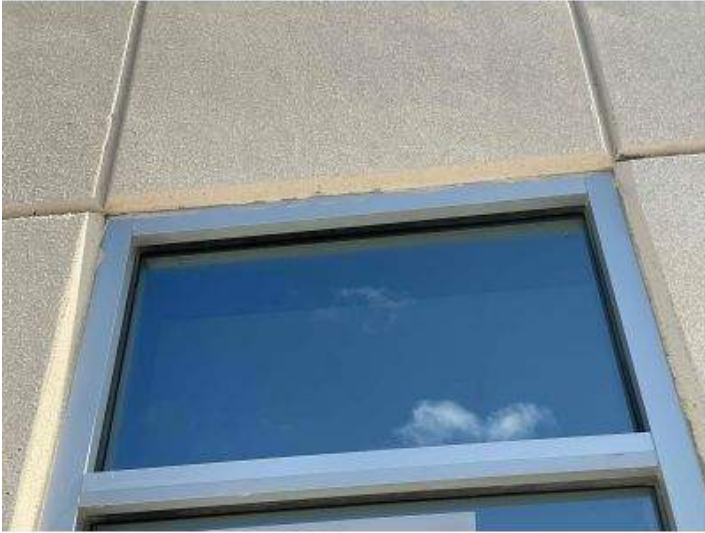
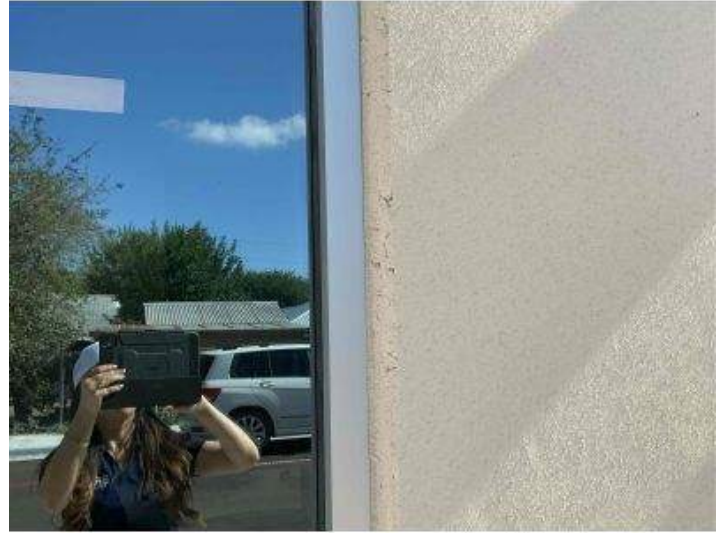
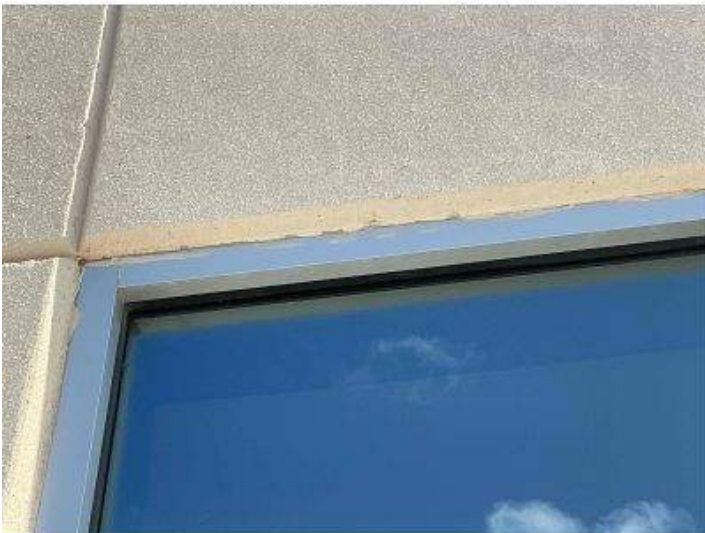
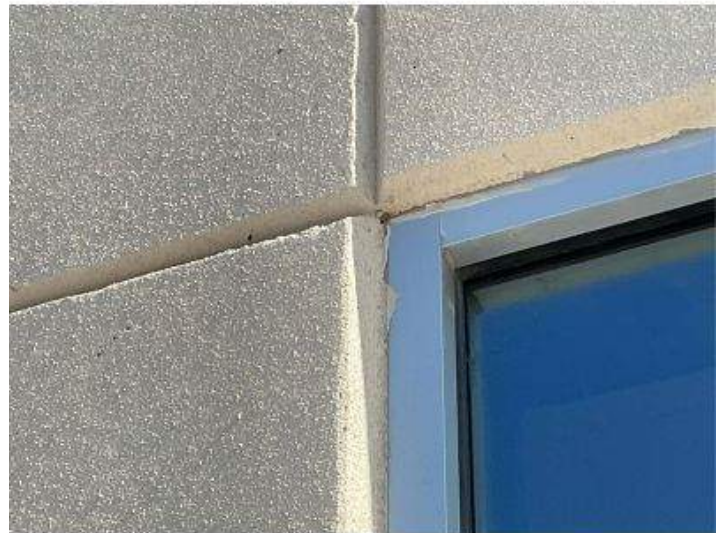
<b>Description</b>	Fill-in and smooth out all window edges at all concrete tilt-wall locations for both buildings. Paint and texture as needed. <span style="background-color: yellow; color: red; padding: 2px;">Pending</span>
<b>Assigned to</b>	—
<b>Created by</b>	<b>Yesenia Tijerina</b> (ERO Architects)
<b>Created on</b>	Aug 28, 2025
<b>Issue owner</b>	<b>Yesenia Tijerina</b> (ERO Architects)
<b>Location</b>	—
<b>Location details</b>	—
<b>Due date</b>	Sep 30, 2025
<b>Root cause</b>	—
<b>Reference drawing</b>	<a href="#">AE101 [V1]</a>
