## Certificate of Substantial Completion

**PROJECT:** *(name and address)*  
Hidalgo County El Paraiso Health Clinic & Community Resource Center

**CERTIFICATE INFORMATION:**  
Certificate Number: 001  
Date: June 15, 2026

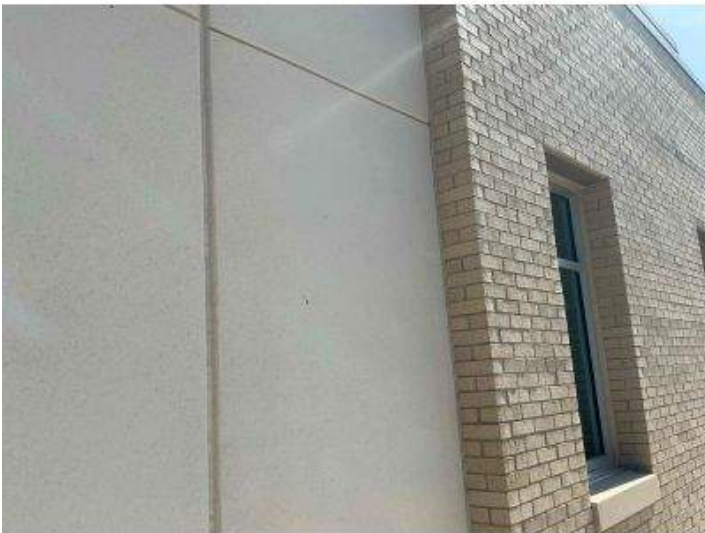
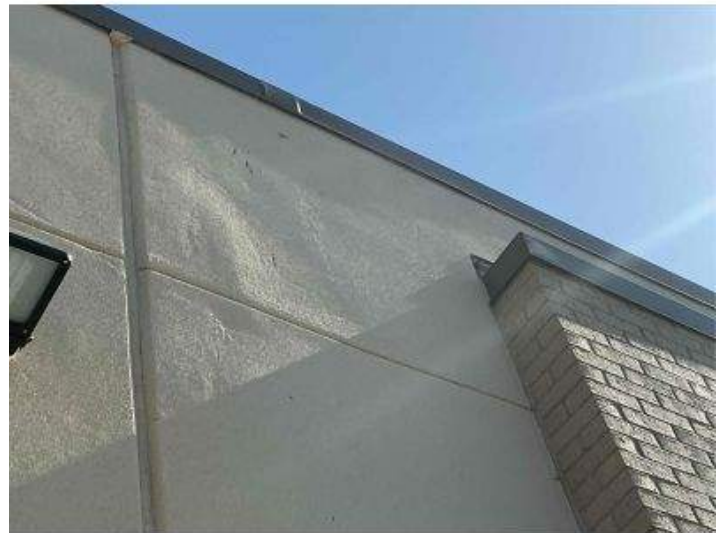
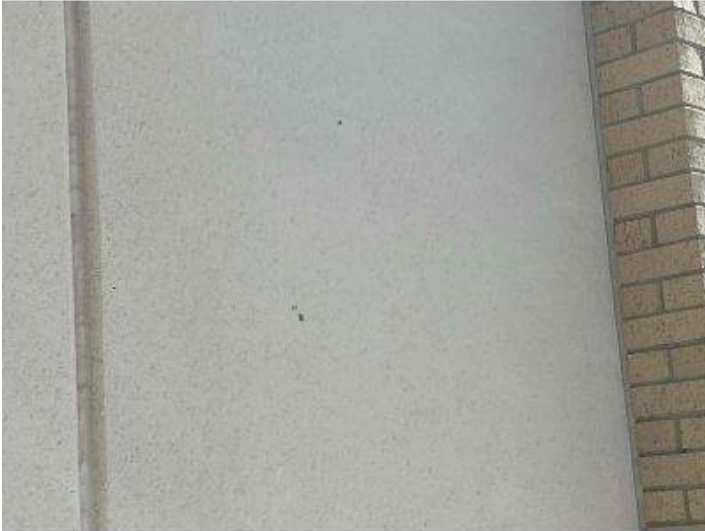
<b>Description</b>	Clean wall surface, paint touch-up, and re-texture. Prepare the concrete surface to reapply primer where paint has detached from it. <span style="background-color: yellow; color: red; padding: 2px;">Pending</span>
<b>Assigned to</b>	—
<b>Created by</b>	<b>Yesenia Tijerina</b> (ERO Architects)
<b>Created on</b>	Aug 28, 2025
<b>Issue owner</b>	<b>Yesenia Tijerina</b> (ERO Architects)
<b>Location</b>	—
<b>Location details</b>	—
<b>Due date</b>	Sep 30, 2025
<b>Root cause</b>	—
<b>Reference drawing</b>	<a href="#">AE101 [V1]</a>

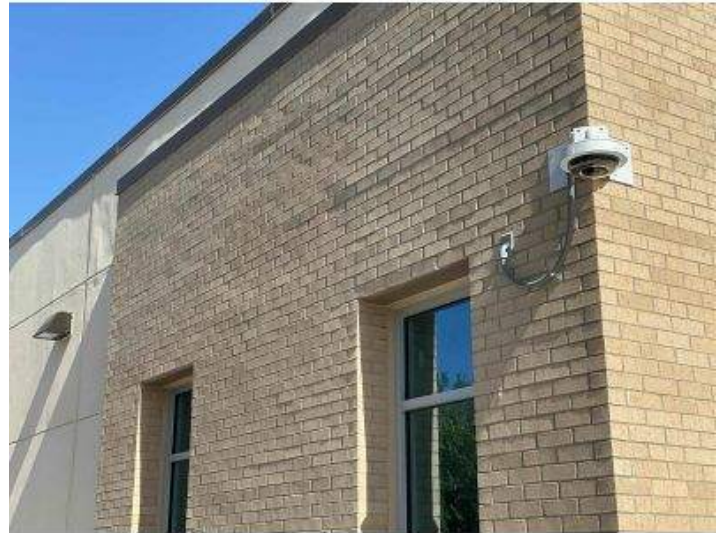
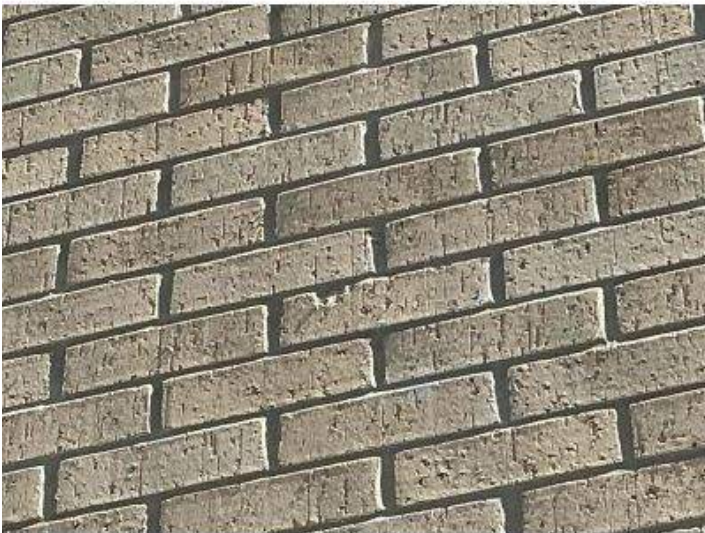
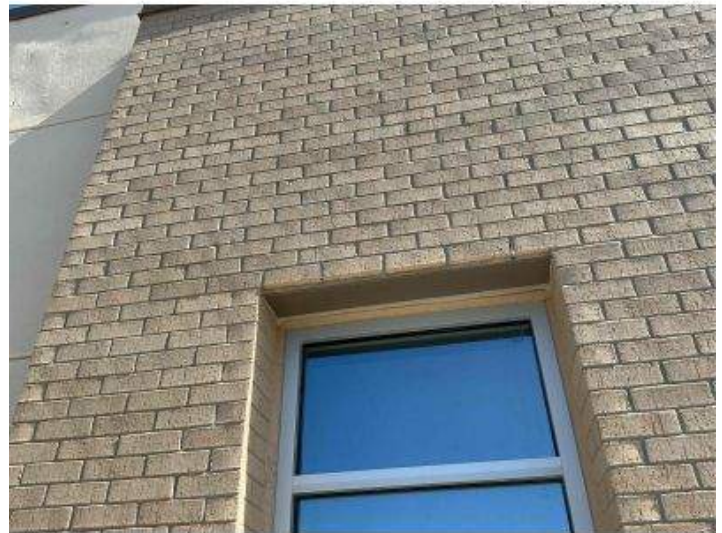
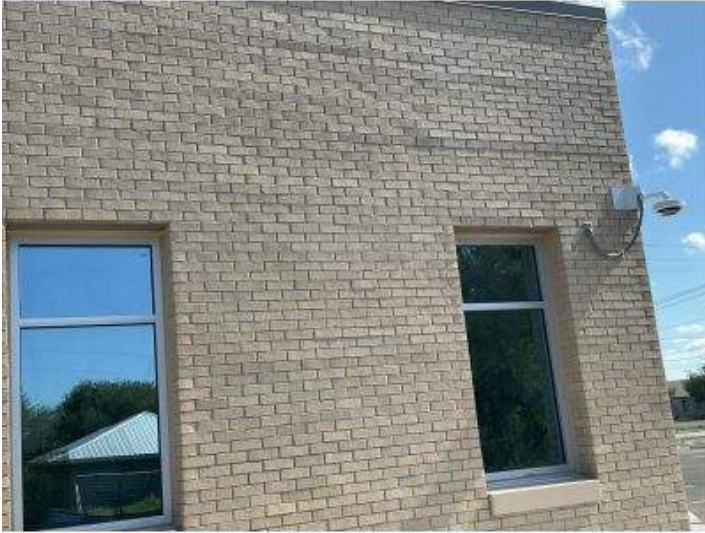
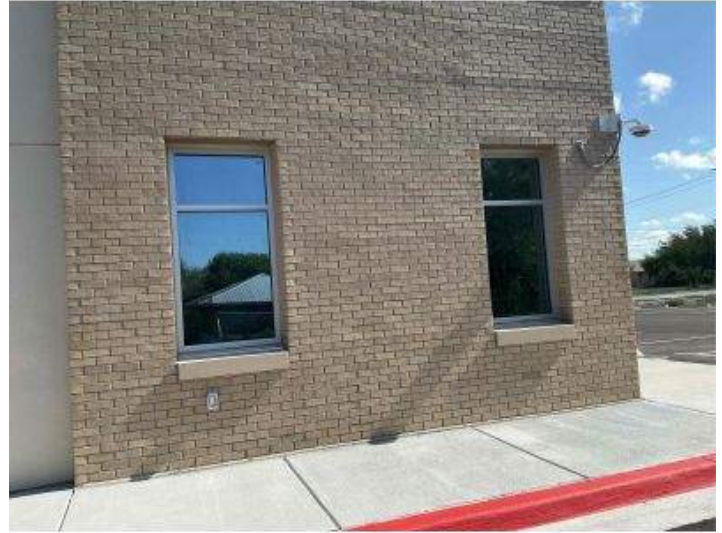
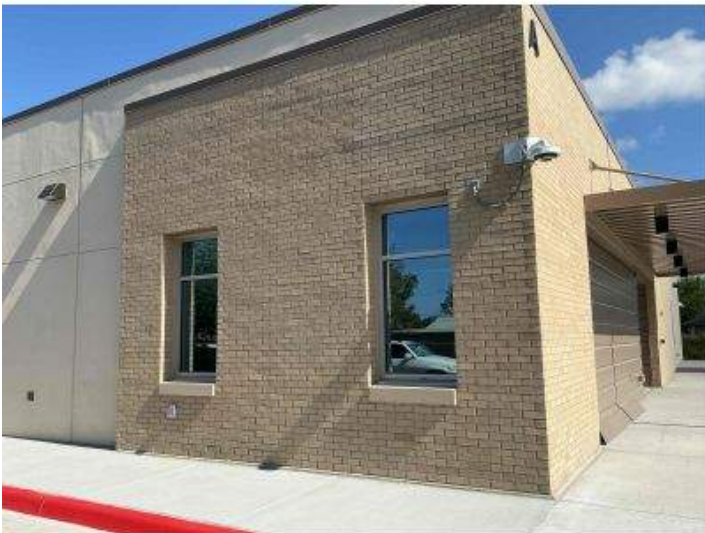
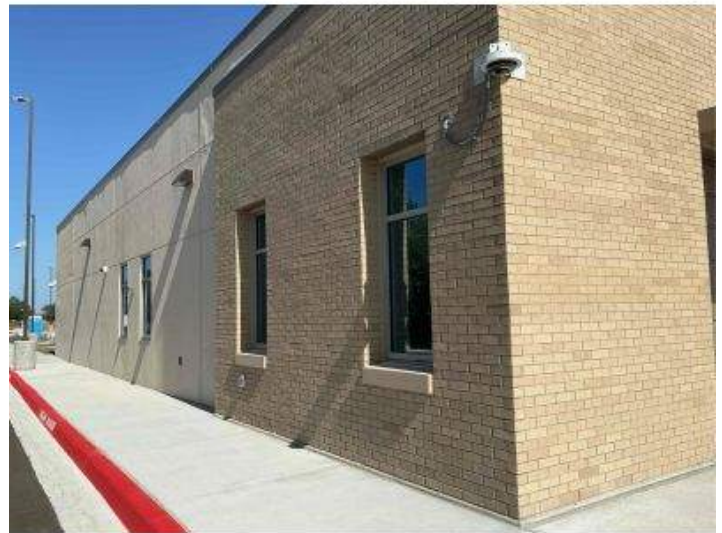
# #146: Brick damaged and installation

<b>Description</b>	Remove and replace damaged brick and uneven lines and levels not conforming to specification 04 26 13 3.03 TOLERANCES. <span style="background-color: yellow;">Completed</span>
<b>Assigned to</b>	—
<b>Created by</b>	<b>Yesenia Tijerina</b> (ERO Architects)
<b>Created on</b>	Aug 28, 2025
<b>Issue owner</b>	<b>Yesenia Tijerina</b> (ERO Architects)
<b>Location</b>	—
<b>Location details</b>	—
<b>Due date</b>	Sep 30, 2025
<b>Root cause</b>	—
<b>Reference drawing</b>	<a href="#">AE101 [V1]</a>

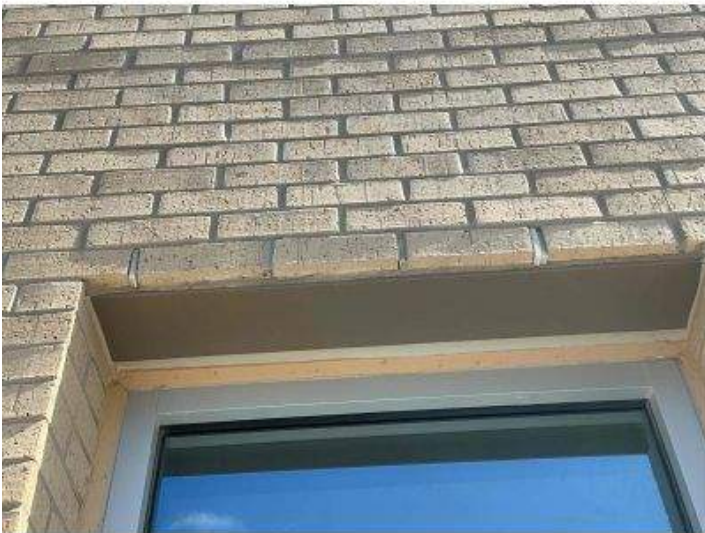
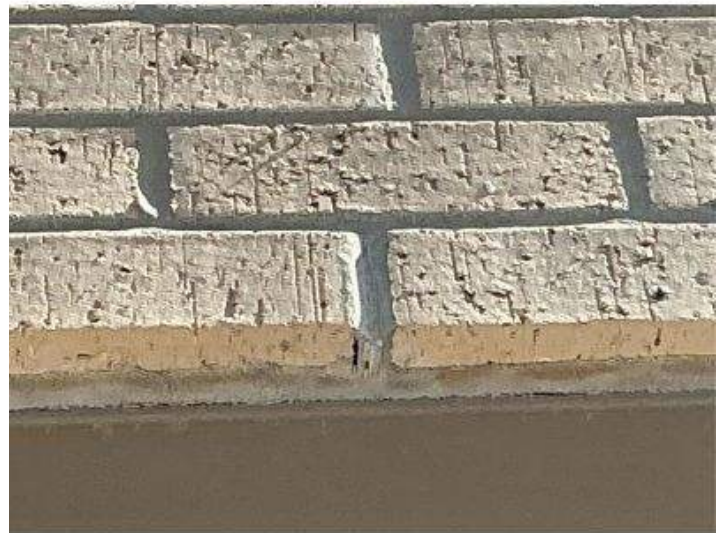
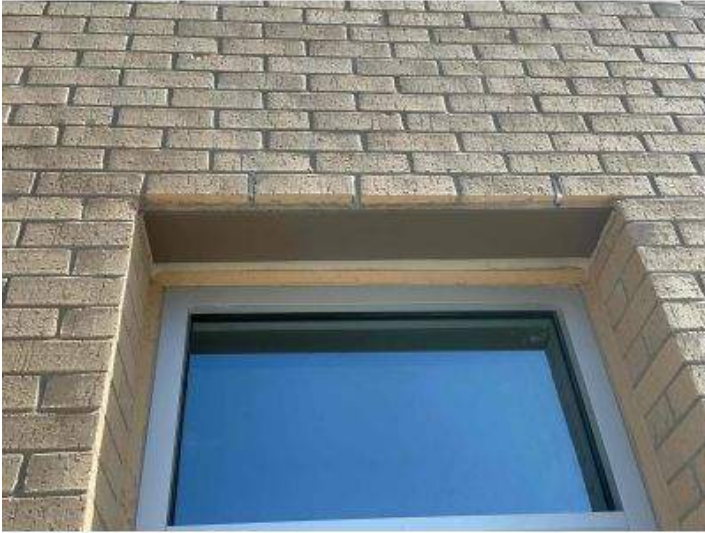
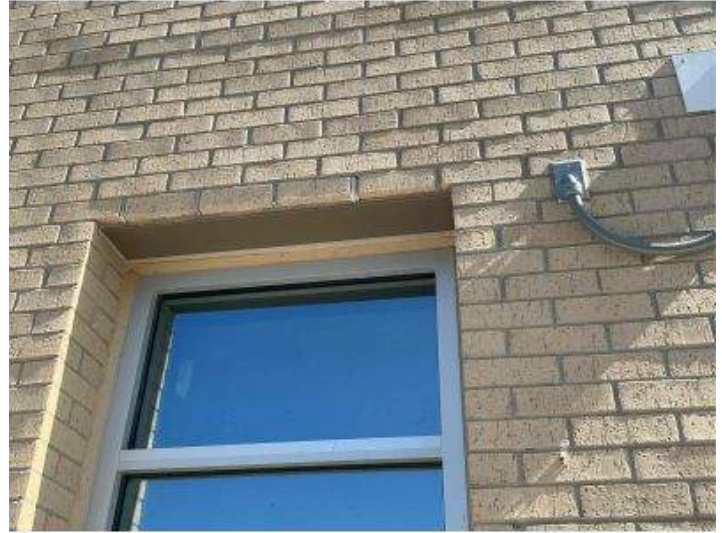
<b>Description</b>	remove grout from all weep vents. Weep holes at 24 inches o.c. unless otherwise specified. <span style="background-color: yellow;">Pending</span>
<b>Assigned to</b>	—
<b>Created by</b>	<b>Yesenia Tijerina</b> (ERO Architects)
<b>Created on</b>	Aug 28, 2025
<b>Issue owner</b>	<b>Yesenia Tijerina</b> (ERO Architects)
<b>Location</b>	—
<b>Location details</b>	—
<b>Due date</b>	Sep 30, 2025
<b>Root cause</b>	—
<b>Reference drawing</b>	<a href="#">AE101 [V1]</a>

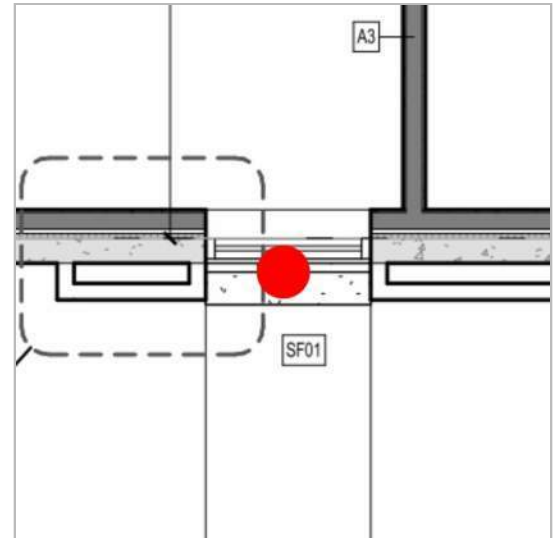
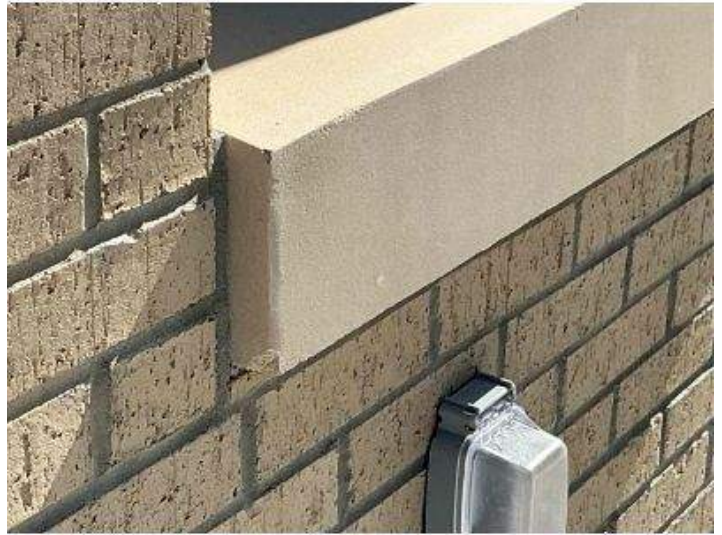
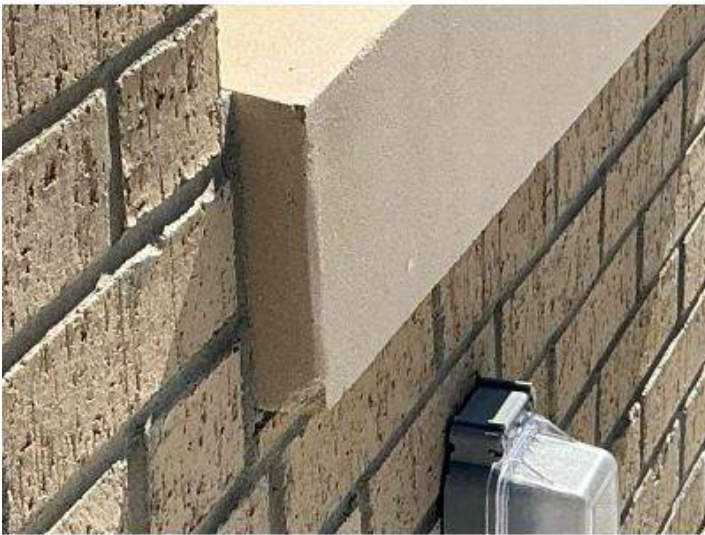
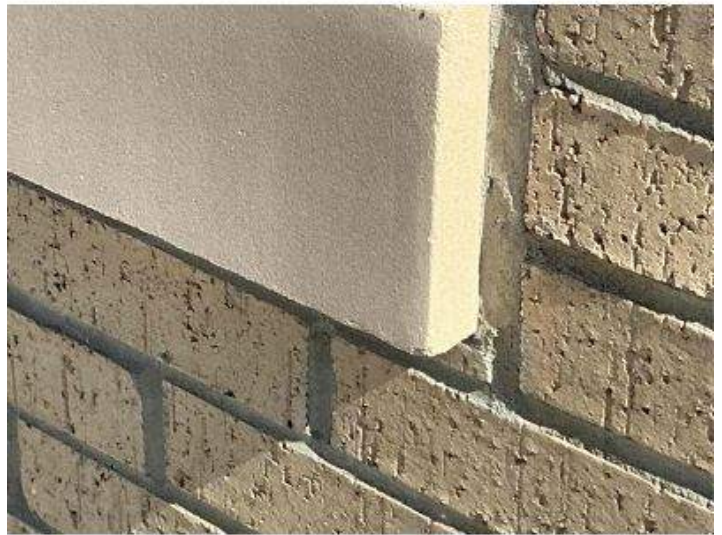
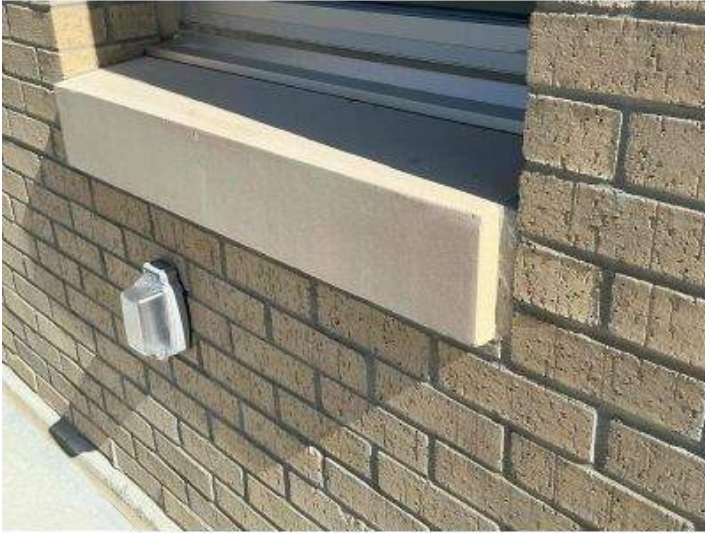
# #148: Cast Stone Damaged

<b>Description</b>	repair and or replace as needed all damaged cast stones for both buildings.
<b>Assigned to</b>	— <span style="background-color: yellow; padding: 2px;">Pending</span>
<b>Created by</b>	<b>Yesenia Tijerina</b> (ERO Architects)
<b>Created on</b>	Aug 28, 2025
<b>Issue owner</b>	<b>Yesenia Tijerina</b> (ERO Architects)
<b>Location</b>	—
<b>Location details</b>	—
<b>Due date</b>	Sep 30, 2025
<b>Root cause</b>	—
<b>Reference drawing</b>	<a href="#">AE101 [V1]</a>

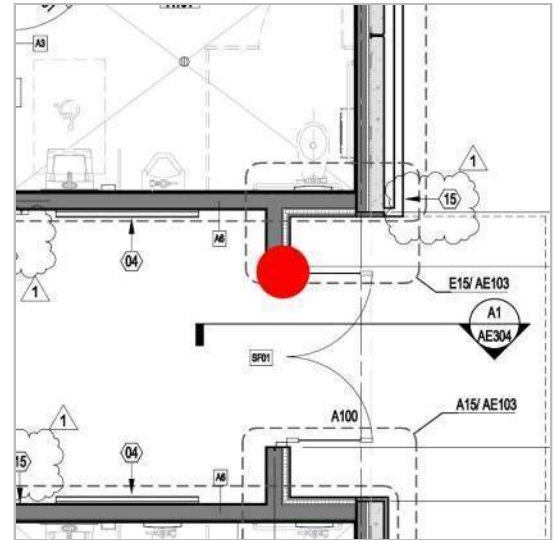
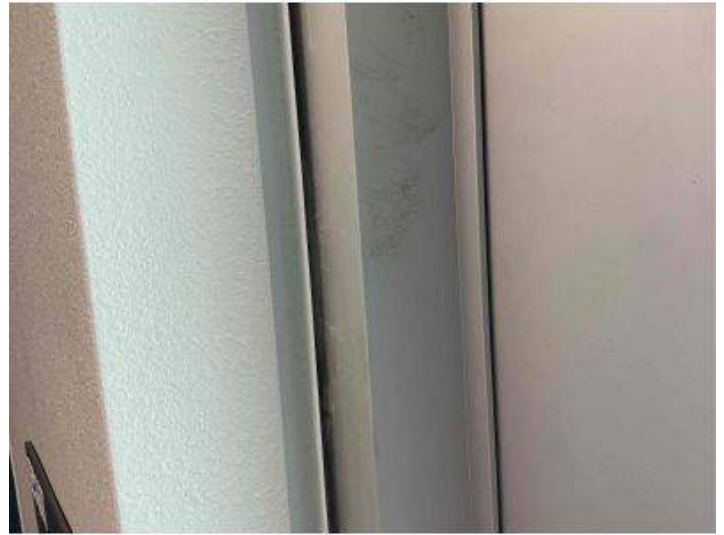
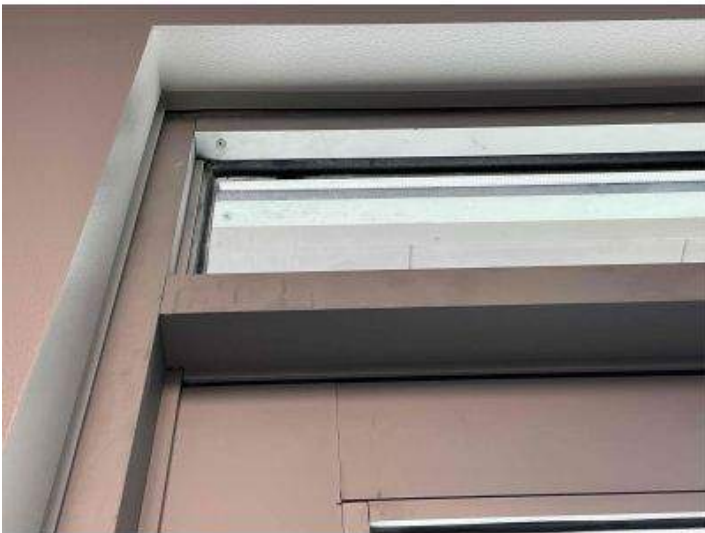
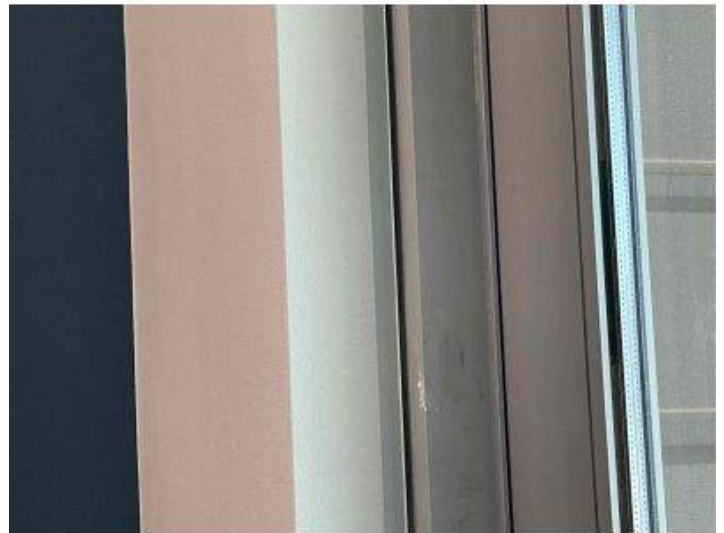
<b>Description</b>	fill in gaps around door trim	Completed
<b>Assigned to</b>	—	
<b>Created by</b>	<b>Yesenia Tijerina</b> (ERO Architects)	
<b>Created on</b>	Aug 28, 2025	
<b>Issue owner</b>	<b>Yesenia Tijerina</b> (ERO Architects)	
<b>Location</b>	—	
<b>Location details</b>	—	
<b>Due date</b>	Sep 30, 2025	
<b>Root cause</b>	—	
<b>Reference drawing</b>	<a href="#">AE101 [V1]</a>

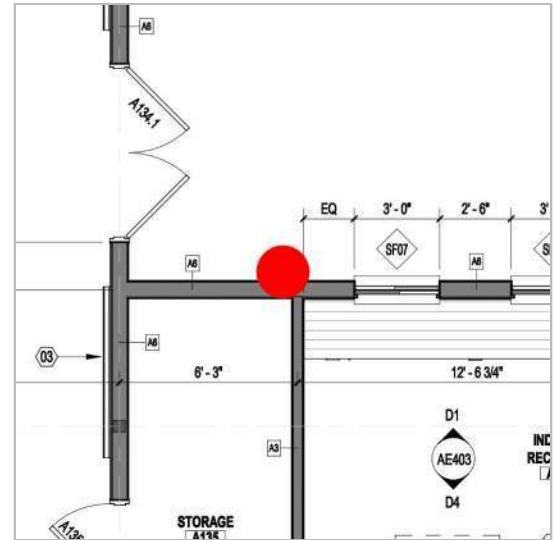
<b>Description</b>	uneven wall base	<b>Pending</b>
<b>Assigned to</b>	—	
<b>Created by</b>	<b>Yesenia Tijerina</b> (ERO Architects)	
<b>Created on</b>	Aug 28, 2025	
<b>Issue owner</b>	<b>Yesenia Tijerina</b> (ERO Architects)	
<b>Location</b>	—	
<b>Location details</b>	—	
<b>Due date</b>	Sep 30, 2025	
<b>Root cause</b>	—	
<b>Reference drawing</b>	<a href="#">AE101 [V1]</a>

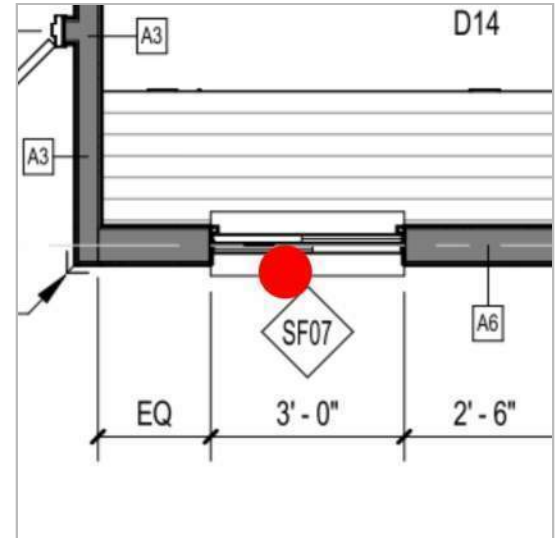
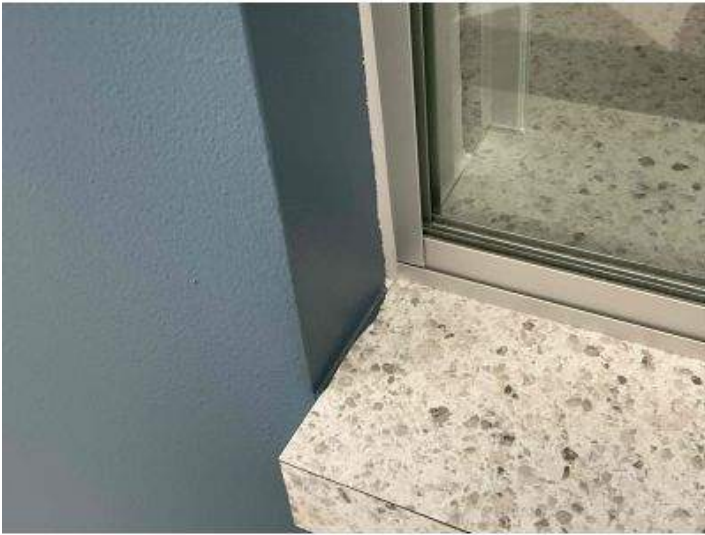
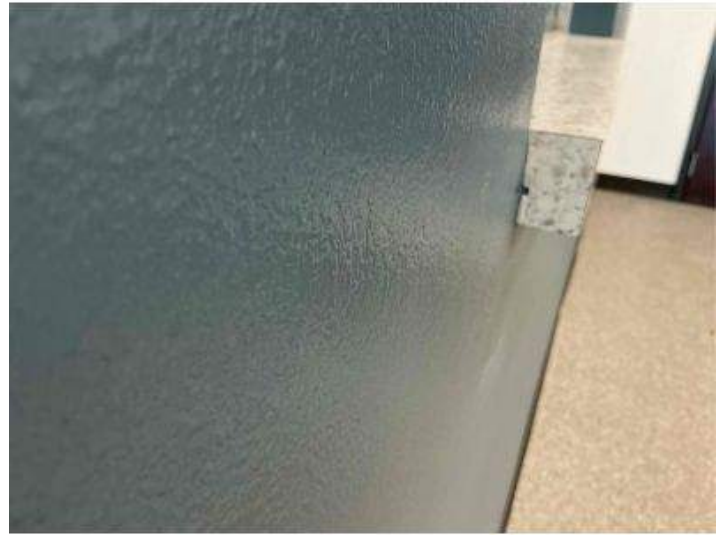
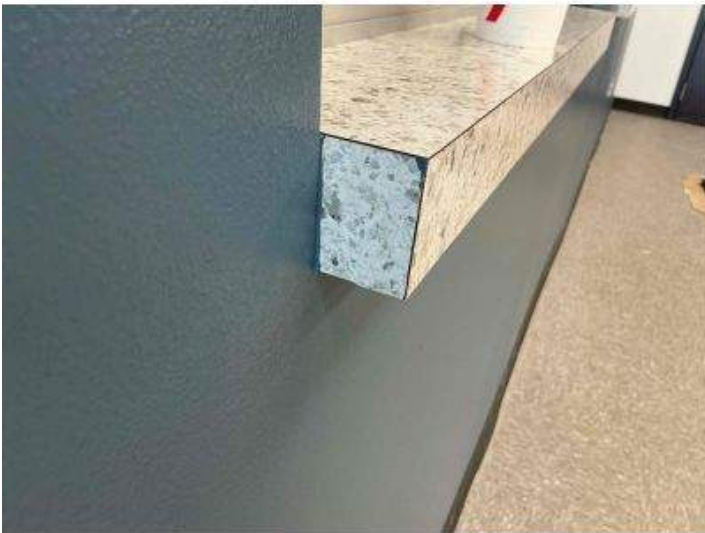
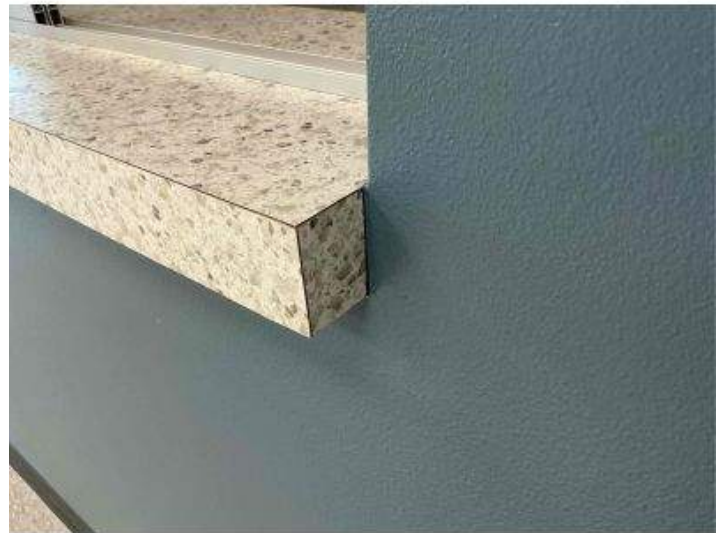
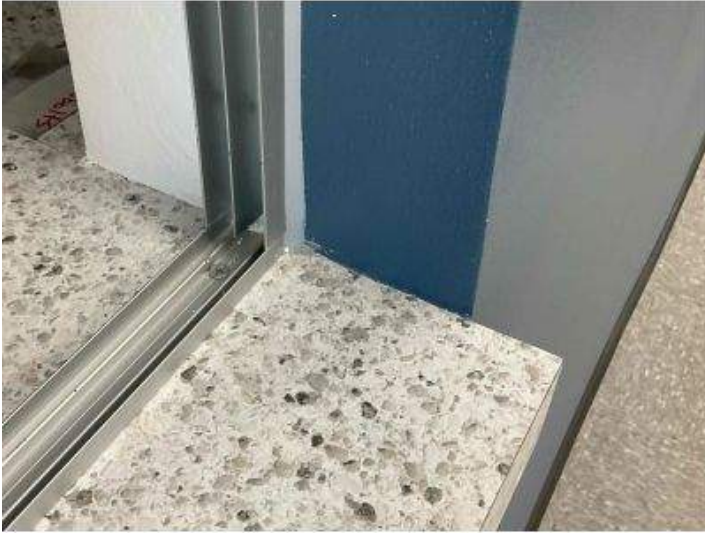
<b>Description</b>	Clean wall from plastic laminate, touch up paint as needed.	<b>Pending</b>
<b>Assigned to</b>	—	
<b>Created by</b>	<b>Yesenia Tijerina</b> (ERO Architects)	
<b>Created on</b>	Aug 28, 2025	
<b>Issue owner</b>	<b>Yesenia Tijerina</b> (ERO Architects)	
<b>Location</b>	—	
<b>Location details</b>	—	
<b>Due date</b>	Sep 30, 2025	
<b>Root cause</b>	—	
<b>Reference drawing</b>	<a href="#">AE101 [V1]</a>

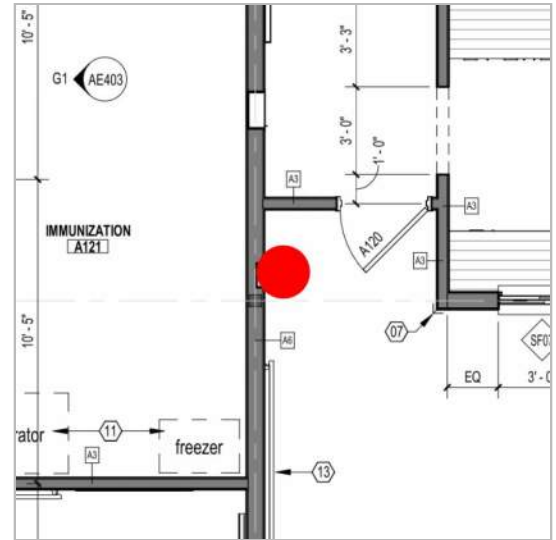
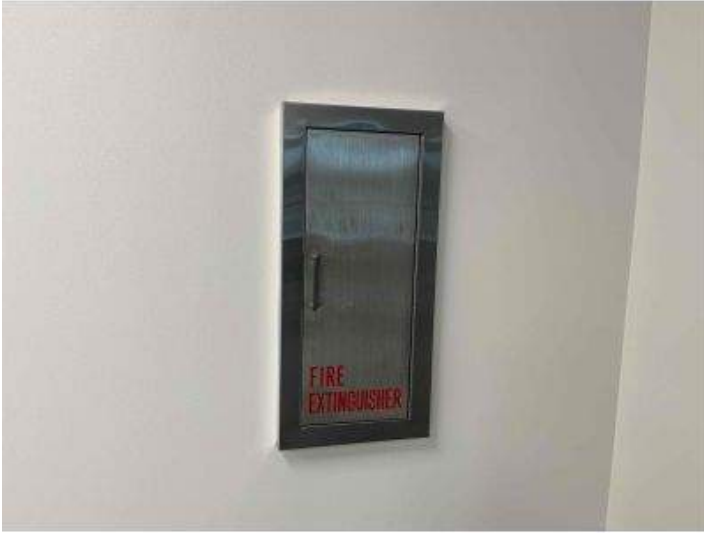
<b>Description</b>	FE cabinet does not march round corner type. Replace all FEC to match the round corner type. <span style="background-color: yellow; color: red;">Pending</span>
<b>Assigned to</b>	—
<b>Created by</b>	<b>Yesenia Tijerina</b> (ERO Architects)
<b>Created on</b>	Aug 28, 2025
<b>Issue owner</b>	<b>Yesenia Tijerina</b> (ERO Architects)
<b>Location</b>	—
<b>Location details</b>	—
<b>Due date</b>	Sep 30, 2025
<b>Root cause</b>	—
<b>Reference drawing</b>	<a href="#">AE101 [V1]</a>

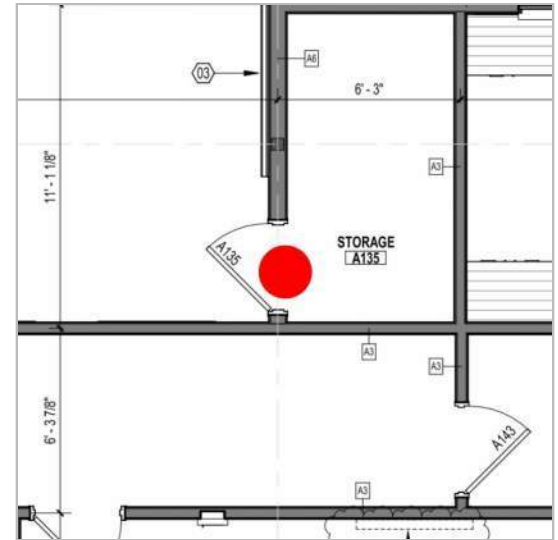
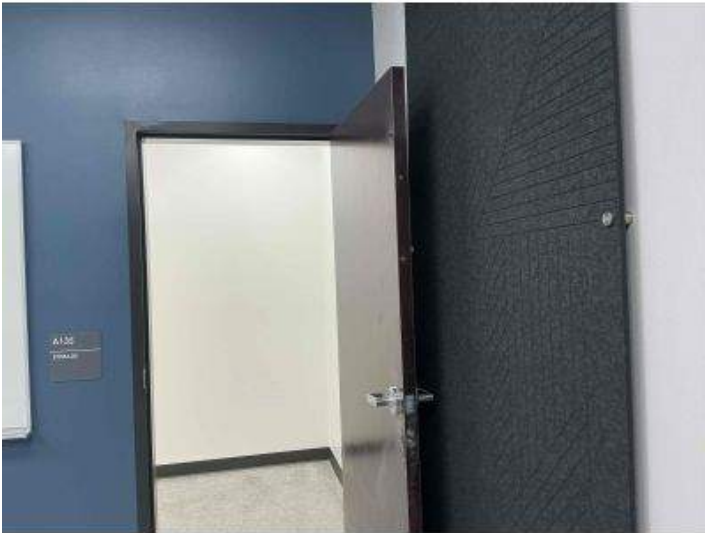
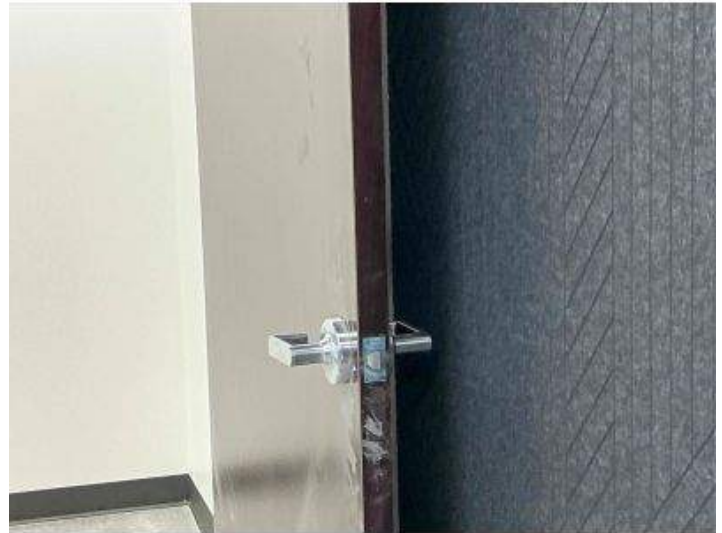
<b>Description</b>	install floor door stop	Completed
<b>Assigned to</b>	—	
<b>Created by</b>	Yesenia Tijerina (ERO Architects)	
<b>Created on</b>	Aug 28, 2025	
<b>Issue owner</b>	Yesenia Tijerina (ERO Architects)	
<b>Location</b>	—	
<b>Location details</b>	—	
<b>Due date</b>	Sep 30, 2025	
<b>Root cause</b>	—	
<b>Reference drawing</b>	<a href="#">AE101 [V1]</a>

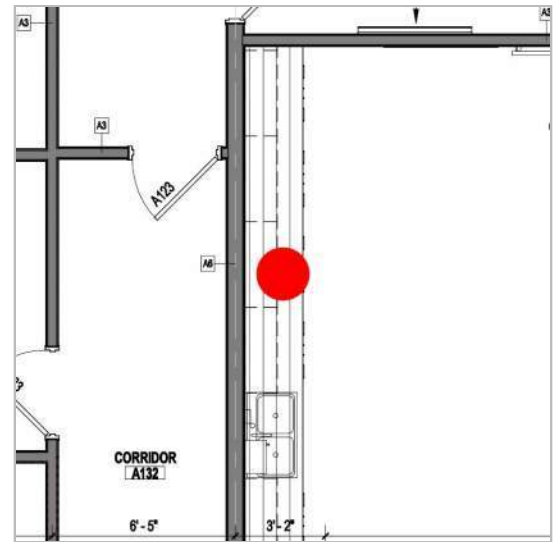
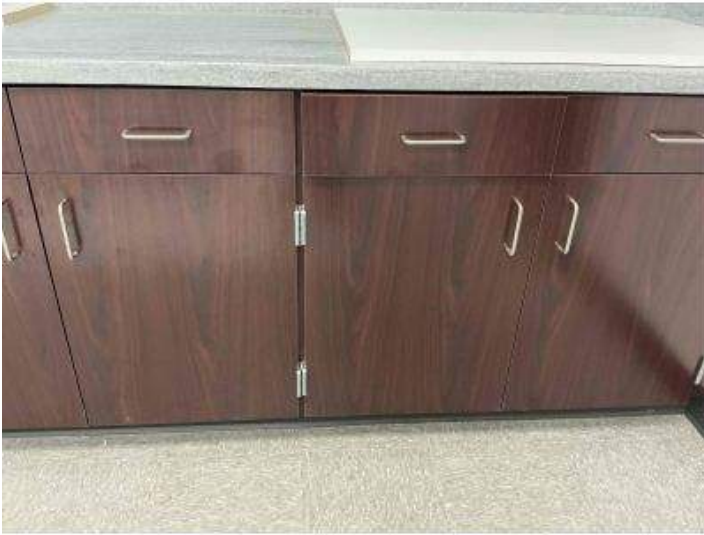
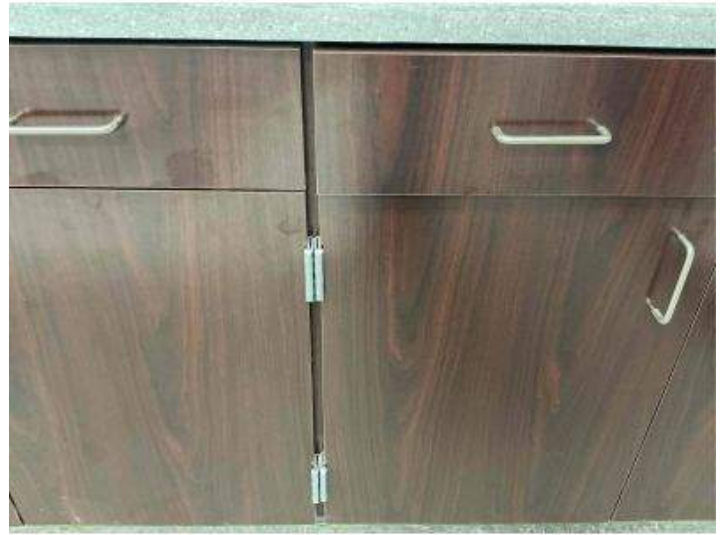
<b>Description</b>	Cabinet hardware shall be consistent with the same finish	Completed
<b>Assigned to</b>	—	
<b>Created by</b>	<b>Yesenia Tijerina</b> (ERO Architects)	
<b>Created on</b>	Aug 28, 2025	
<b>Issue owner</b>	<b>Yesenia Tijerina</b> (ERO Architects)	
<b>Location</b>	—	
<b>Location details</b>	—	
<b>Due date</b>	Sep 30, 2025	
<b>Root cause</b>	—	
<b>Reference drawing</b>	<a href="#">AE101 [V1]</a>

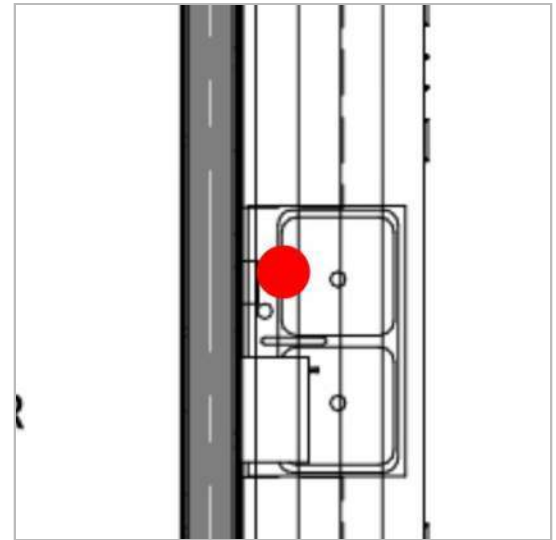
#155: Missing Soap Dispenser NM / CFS

<b>Description</b>	Missing Soap Dispenser <span style="background-color: yellow; color: red;">Pending</span>
<b>Assigned to</b>	—
<b>Created by</b>	<b>Yesenia Tijerina</b> (ERO Architects)
<b>Created on</b>	Aug 28, 2025
<b>Issue owner</b>	<b>Yesenia Tijerina</b> (ERO Architects)
<b>Location</b>	—
<b>Location details</b>	—
<b>Due date</b>	Sep 30, 2025
<b>Root cause</b>	—
<b>Reference drawing</b>	<a href="#">AE101 [V1]</a>

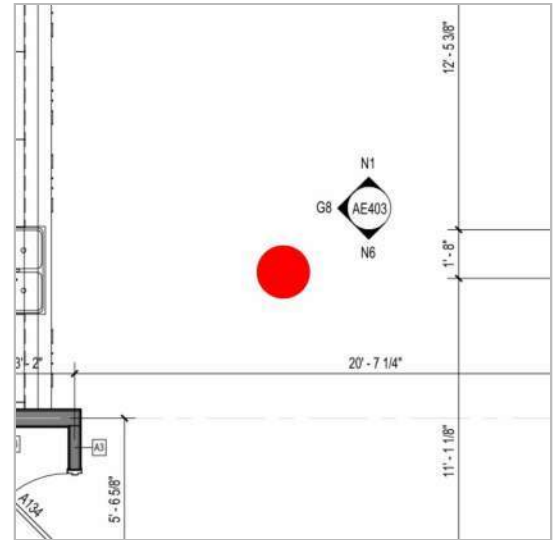
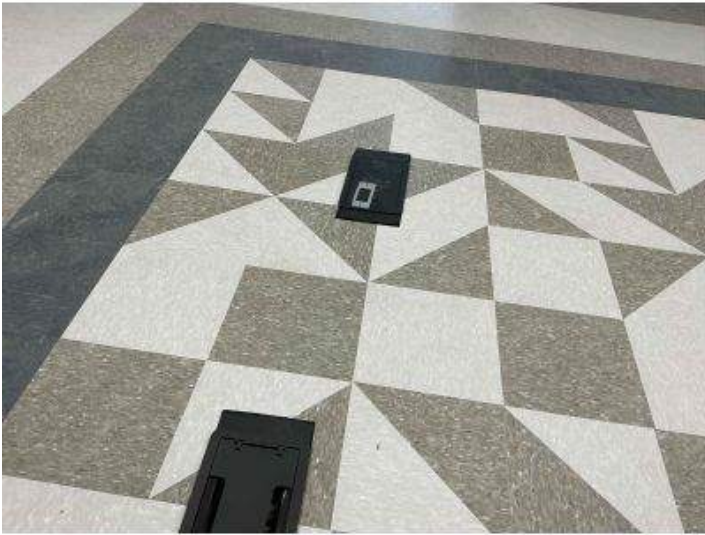
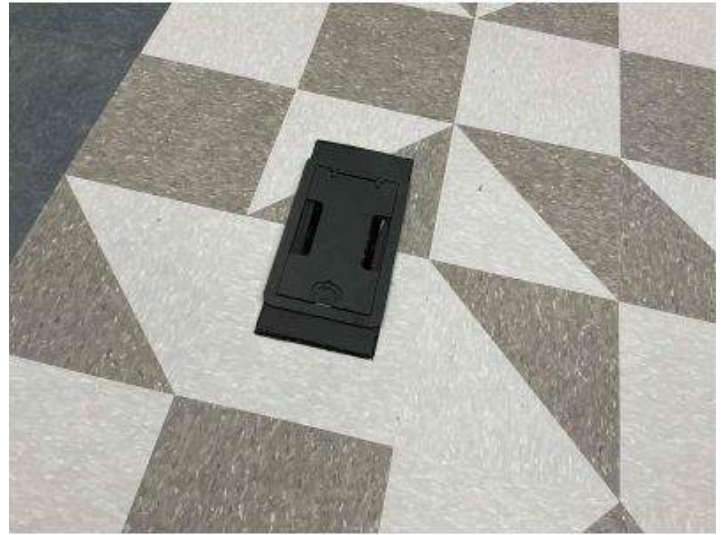
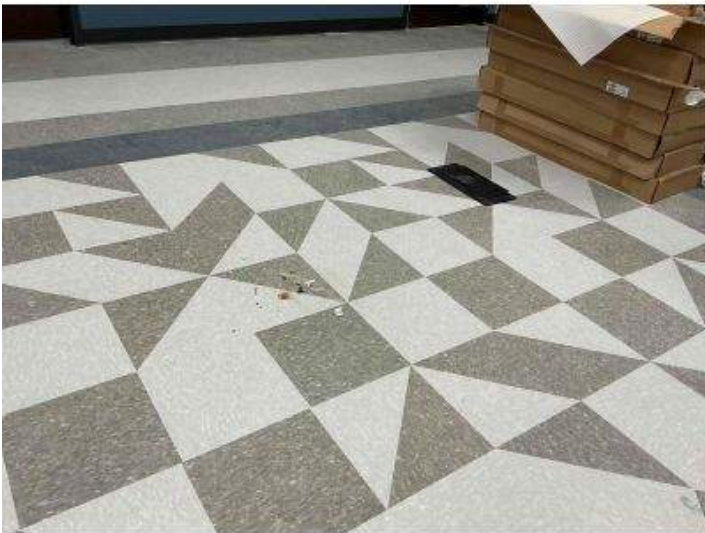
<b>Description</b>	non-conforming with the scope of work.	Completed
<b>Assigned to</b>	—	
<b>Created by</b>	<b>Yesenia Tijerina</b> (ERO Architects)	
<b>Created on</b>	Aug 28, 2025	
<b>Issue owner</b>	<b>Yesenia Tijerina</b> (ERO Architects)	
<b>Location</b>	—	
<b>Location details</b>	—	
<b>Due date</b>	Sep 30, 2025	
<b>Root cause</b>	—	
<b>Reference drawing</b>	<a href="#">AE101 [V1]</a>

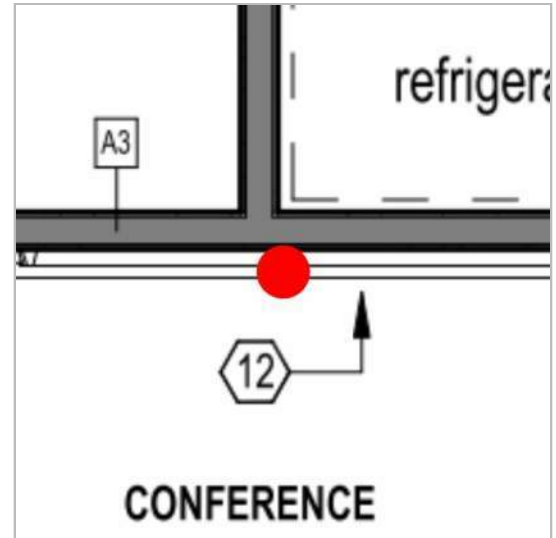
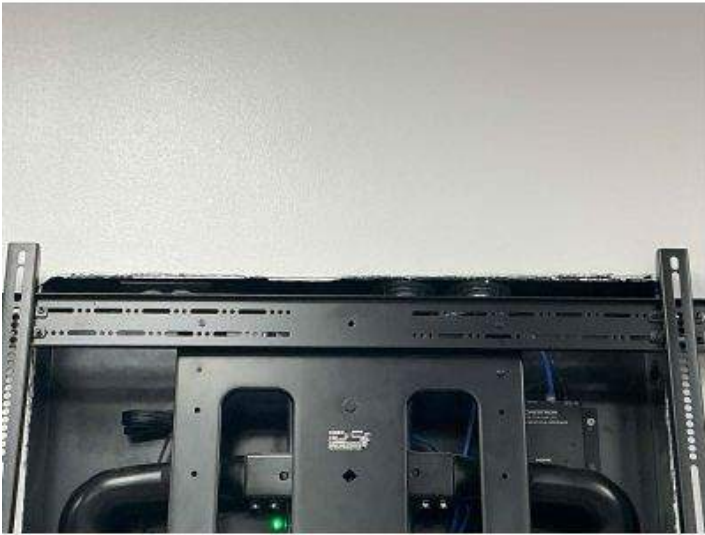
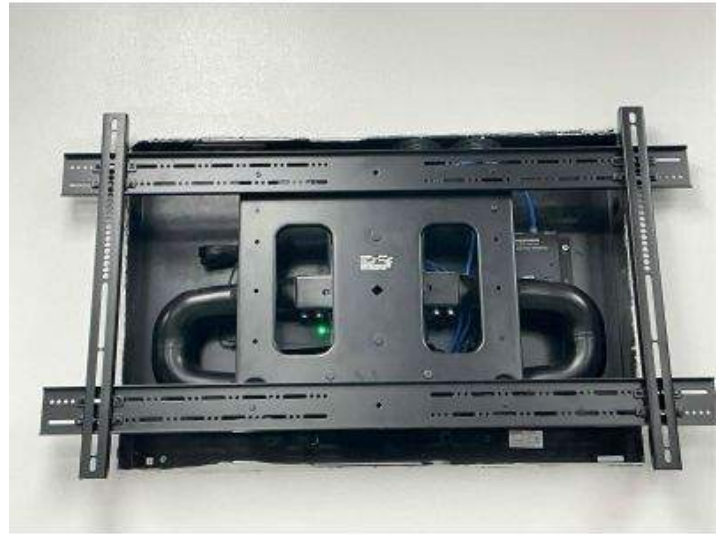
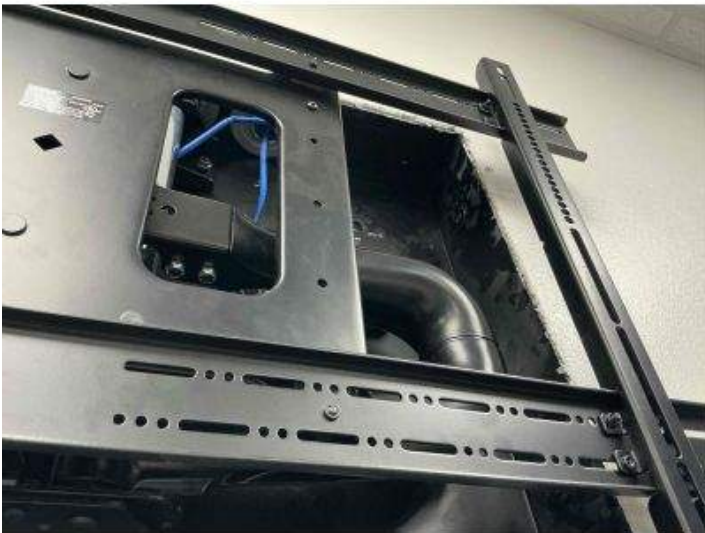
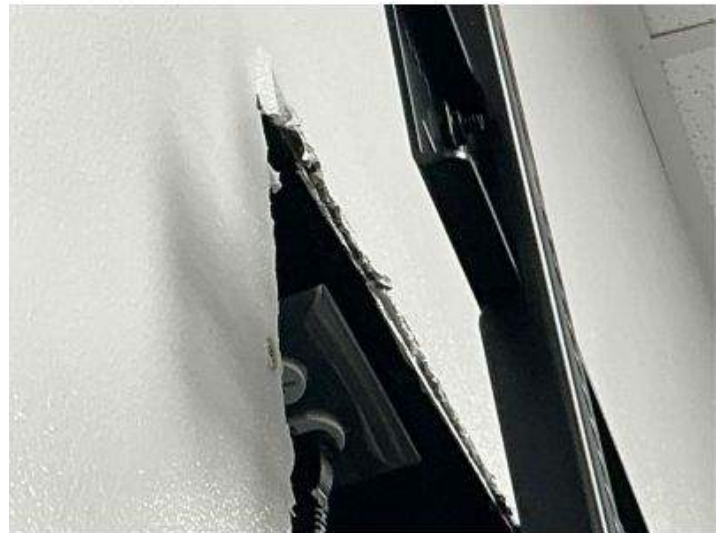
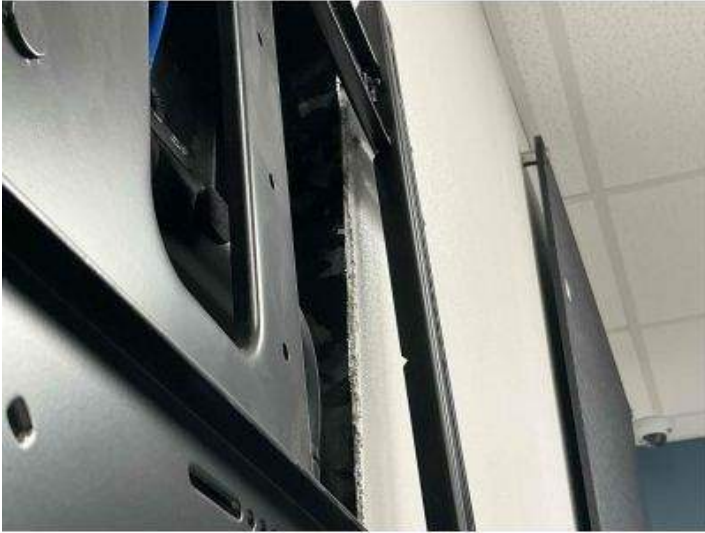
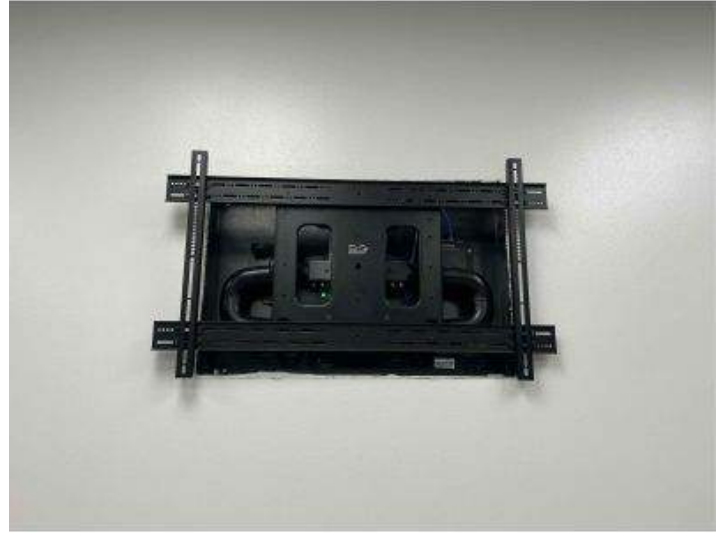
Description	TV Box edge needs to be even, smooth, and caulked as needed. Applies to both buildings. <span style="background-color: yellow;">Pending</span>
Assigned to	—
Created by	Yesenia Tijerina (ERO Architects)
Created on	Aug 28, 2025
Issue owner	Yesenia Tijerina (ERO Architects)
Location	—
Location details	—
Due date	Sep 30, 2025
Root cause	—
Reference drawing	<a href="#">AE101 [V1]</a>

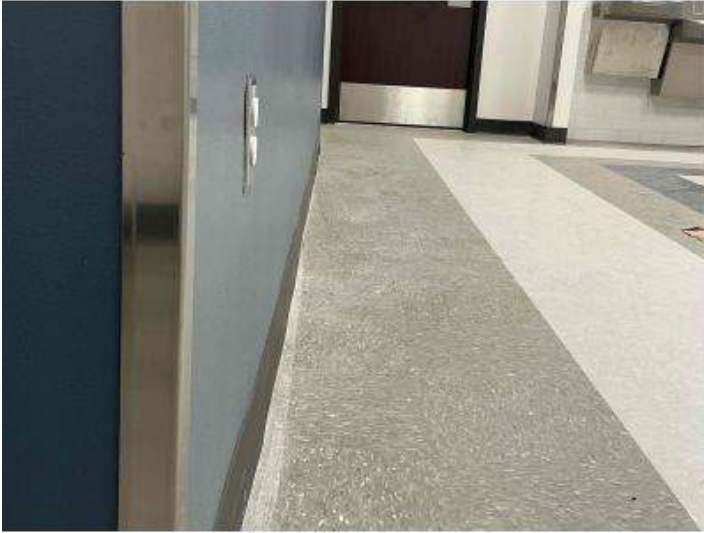
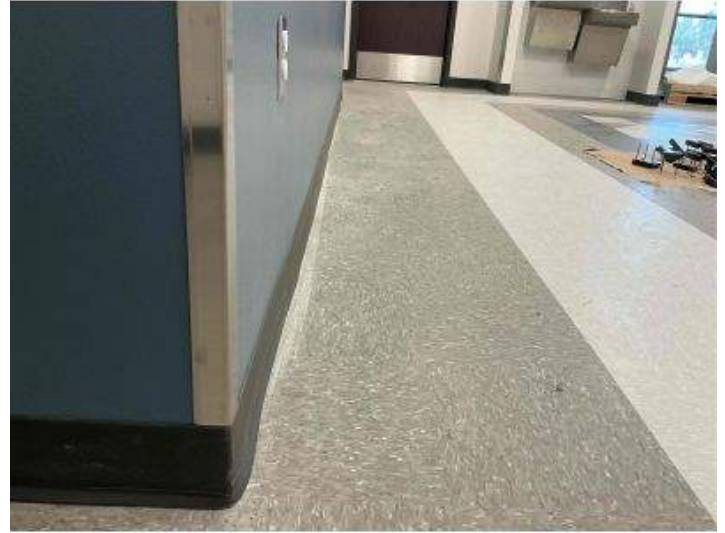
<b>Description</b>	Fix uneven wall base. Applies to both buildings	Pending
<b>Assigned to</b>	—	
<b>Created by</b>	<b>Yesenia Tijerina</b> (ERO Architects)	
<b>Created on</b>	Aug 28, 2025	
<b>Issue owner</b>	<b>Yesenia Tijerina</b> (ERO Architects)	
<b>Location</b>	—	
<b>Location details</b>	—	
<b>Due date</b>	Sep 30, 2025	
<b>Root cause</b>	—	
<b>Reference drawing</b>	<a href="#">AE101 [V1]</a>

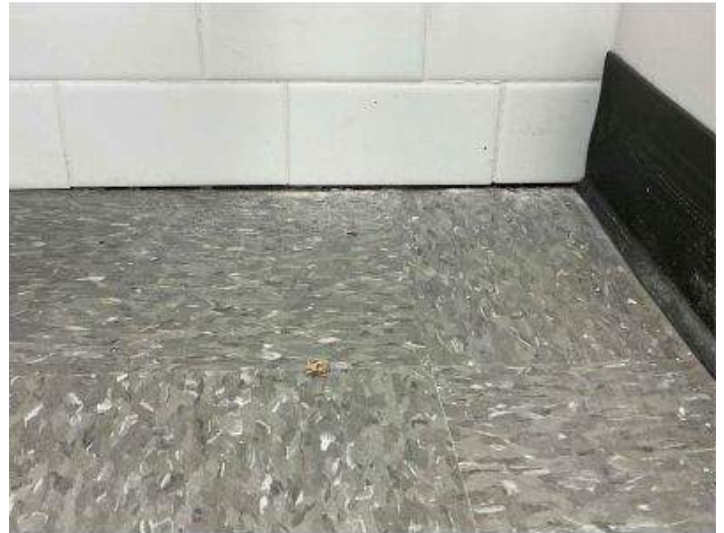
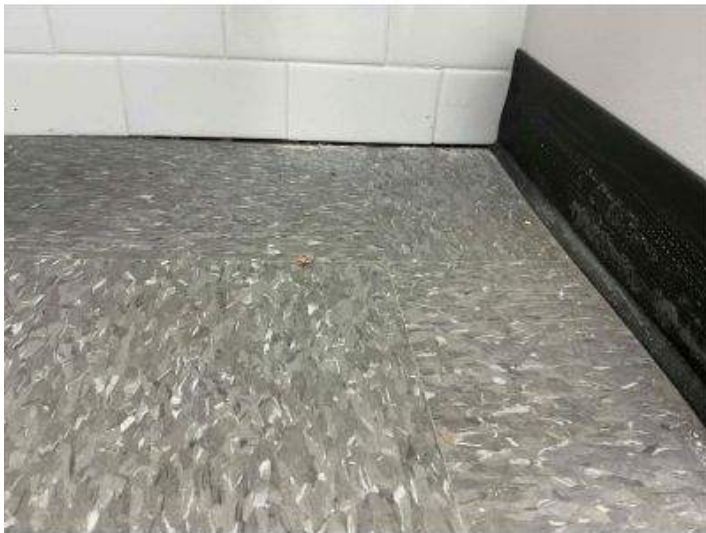
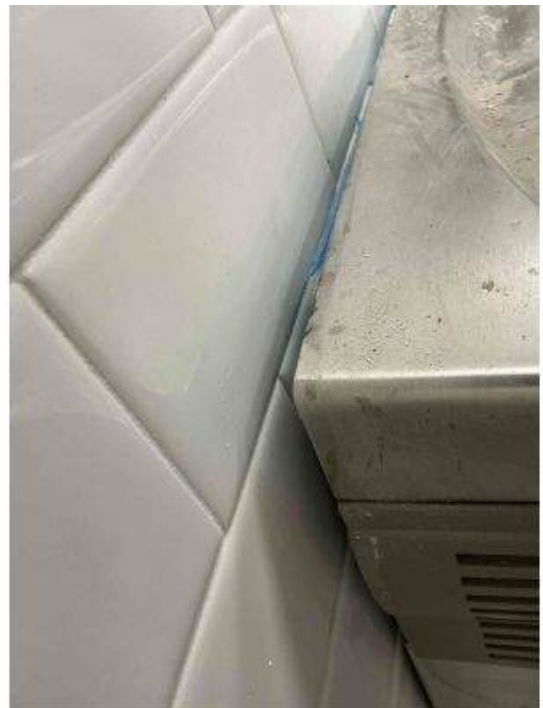
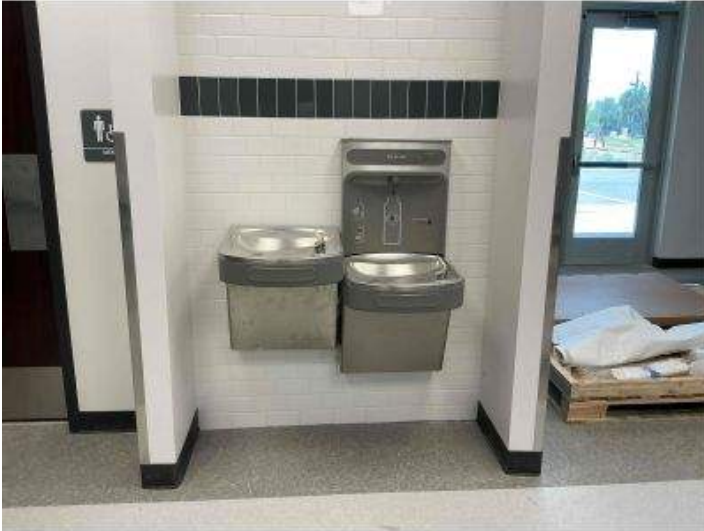
# #160: Missing Schluter trim

<b>Description</b>	Install Schluter trim between tile and VCT. Applies to all water fountain areas.	Completed
<b>Assigned to</b>	—	
<b>Created by</b>	<b>Yesenia Tijerina</b> (ERO Architects)	
<b>Created on</b>	Aug 28, 2025	
<b>Issue owner</b>	<b>Yesenia Tijerina</b> (ERO Architects)	
<b>Location</b>	—	
<b>Location details</b>	—	
<b>Due date</b>	Sep 30, 2025	
<b>Root cause</b>	—	
<b>Reference drawing</b>	<a href="#">AE101 [V1]</a>
