## Certificate of Substantial Completion

**PROJECT:** *(name and address)*  
Hidalgo County El Paraiso Health Clinic & Community Resource Center

**CERTIFICATE INFORMATION:**  
Certificate Number: 001  
Date: June 15, 2026

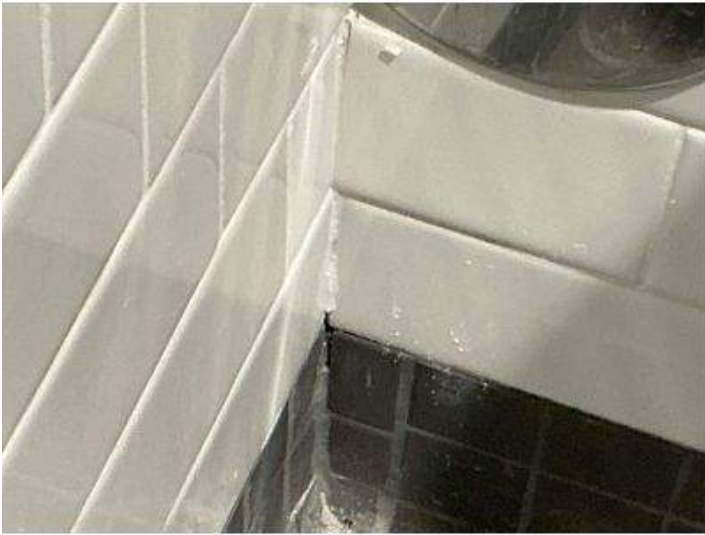
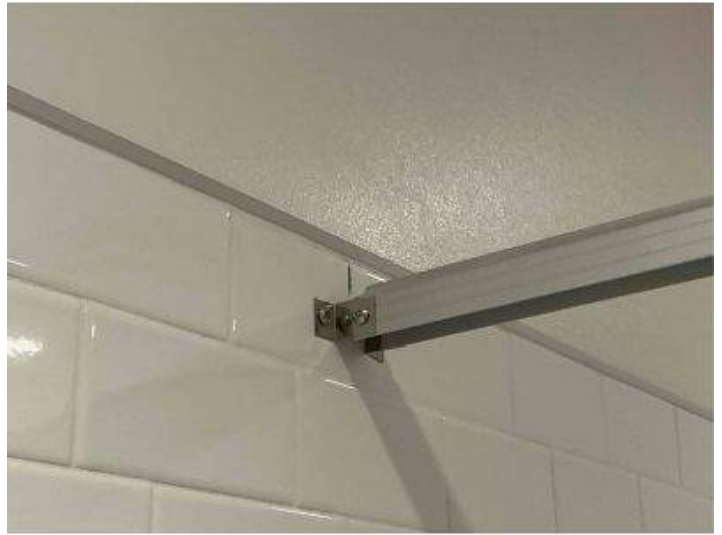
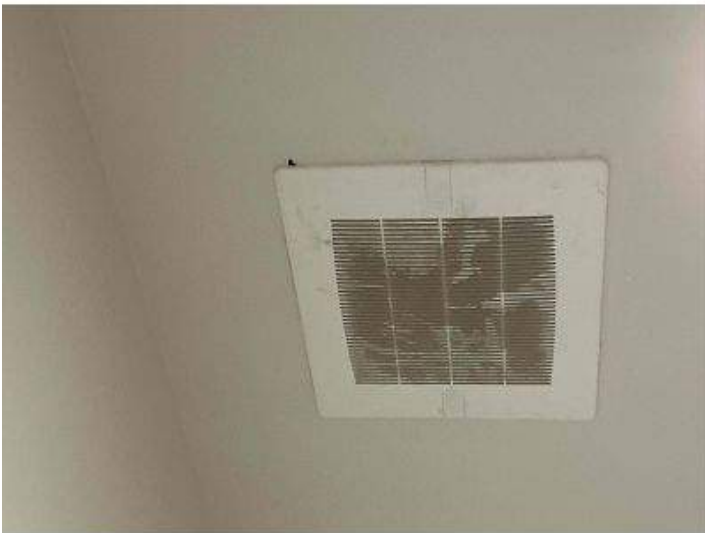
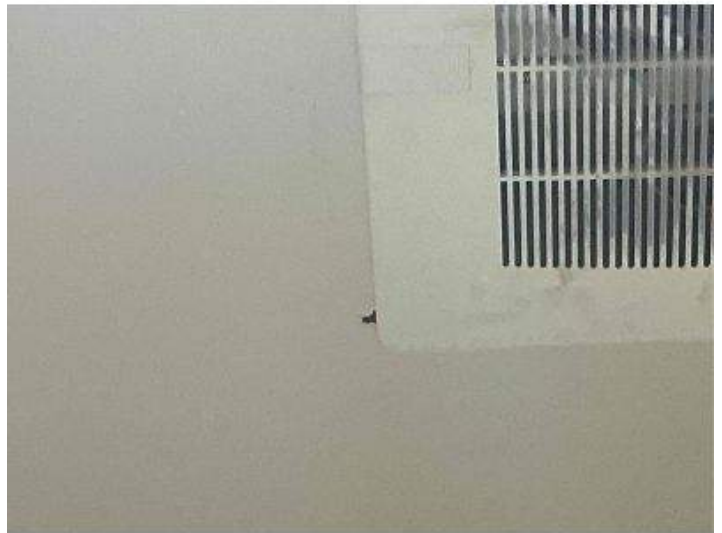
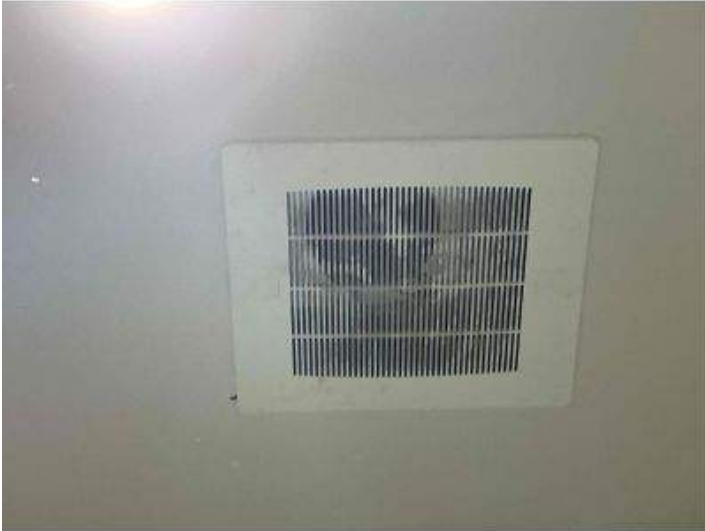
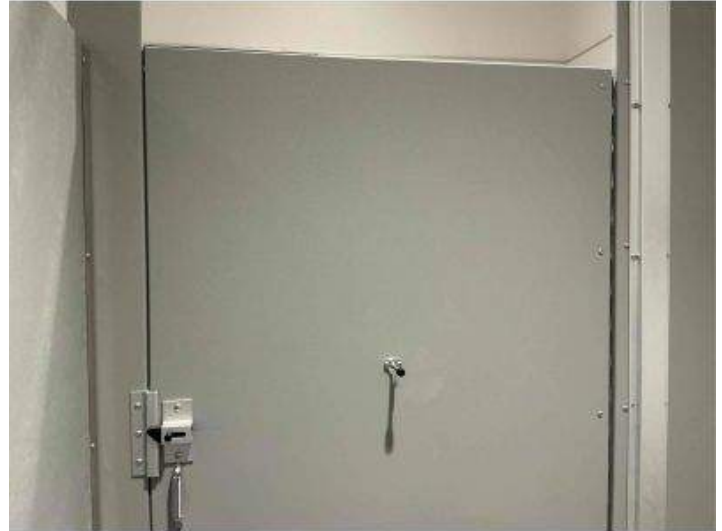
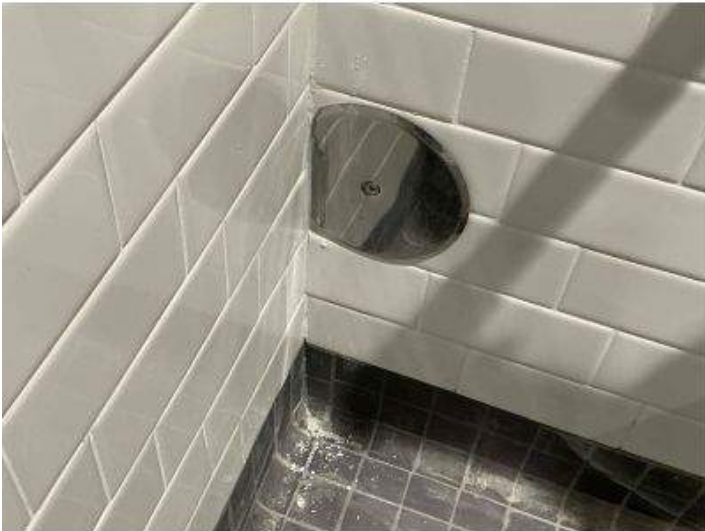
<b>Description</b>	Clean excess grout, remove pencil marks, clean fan, fill in and seal gaps around fixtures. Applies to all restrooms. <span style="background-color: yellow; color: red; padding: 2px;">Pending</span>
<b>Assigned to</b>	—
<b>Created by</b>	<b>Yesenia Tijerina</b> (ERO Architects)
<b>Created on</b>	Aug 28, 2025
<b>Issue owner</b>	<b>Yesenia Tijerina</b> (ERO Architects)
<b>Location</b>	—
<b>Location details</b>	—
<b>Due date</b>	Sep 30, 2025
<b>Root cause</b>	—
<b>Reference drawing</b>	<a href="#">AE101 [V1]</a>

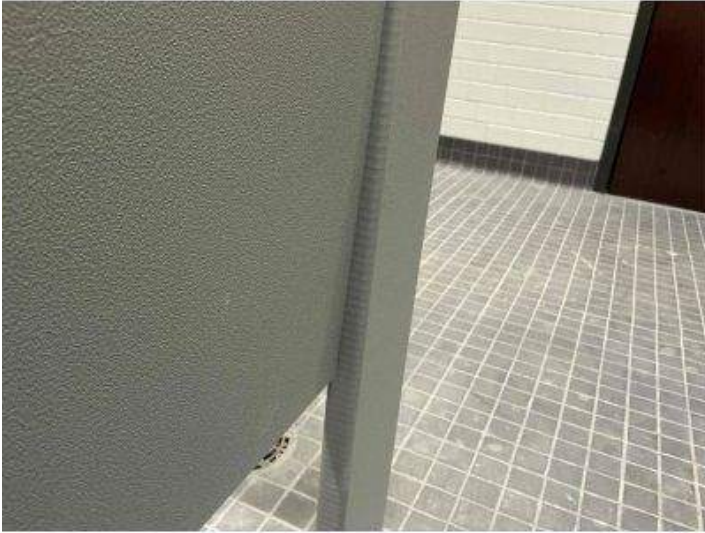
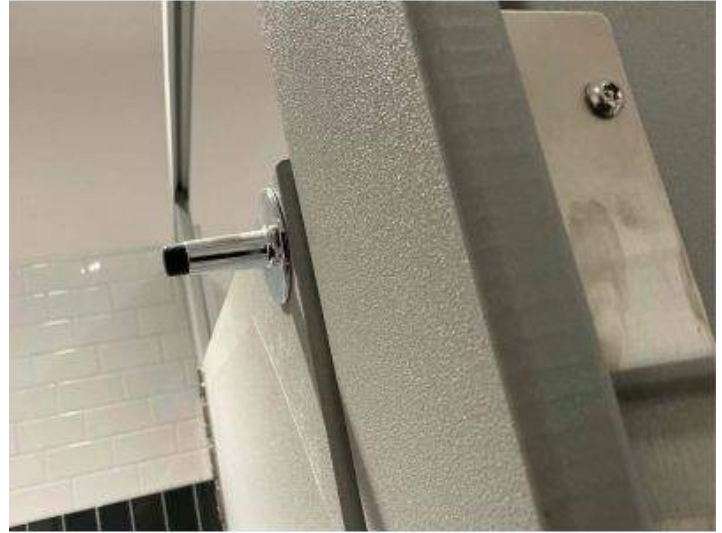
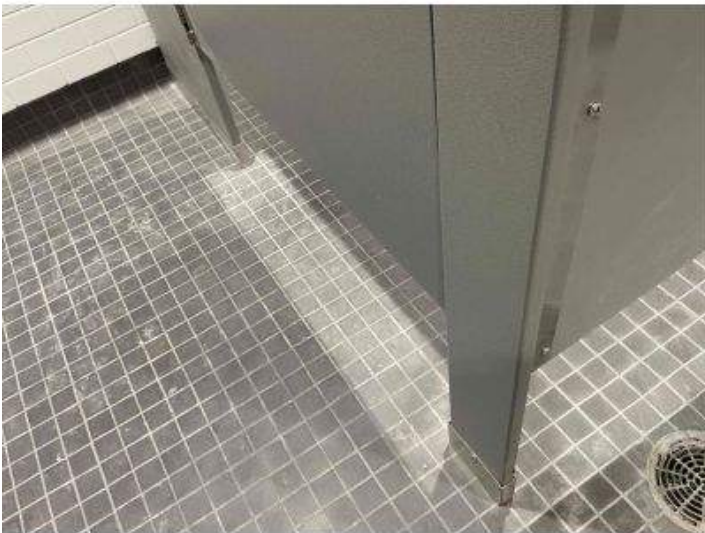
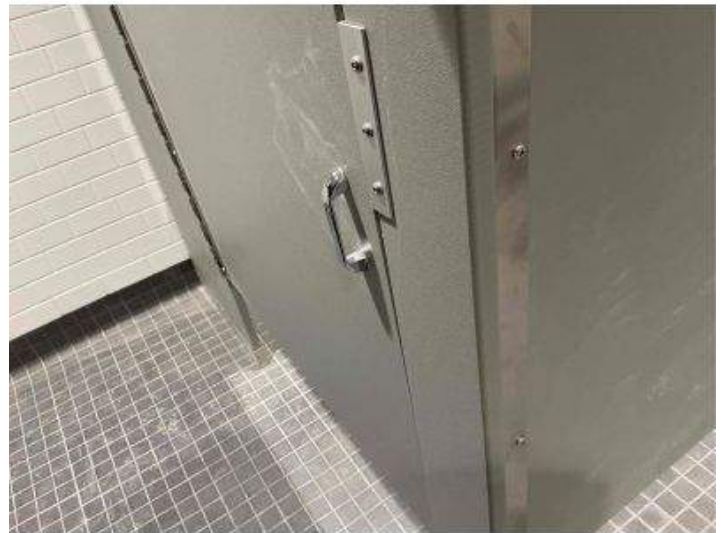
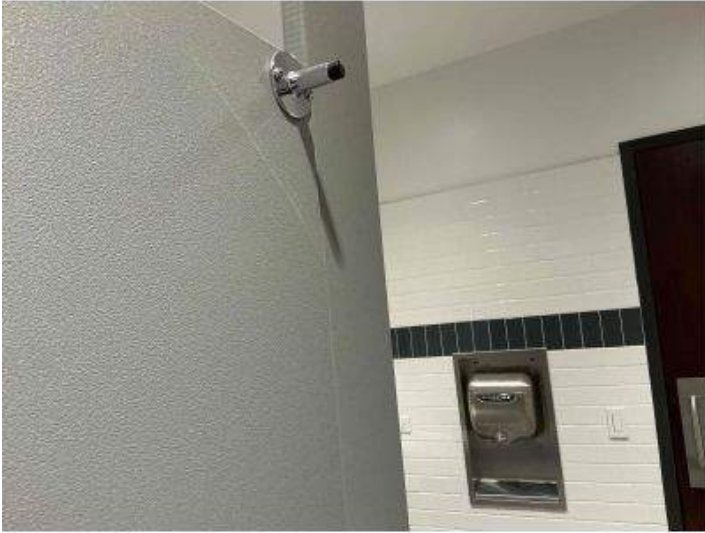
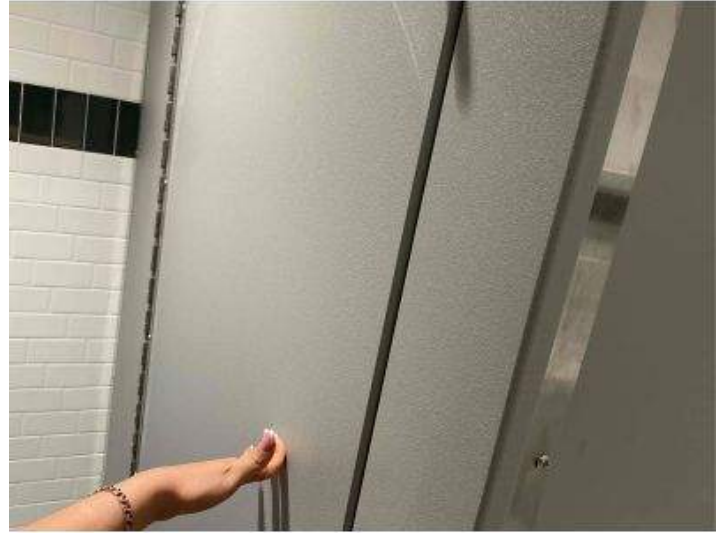
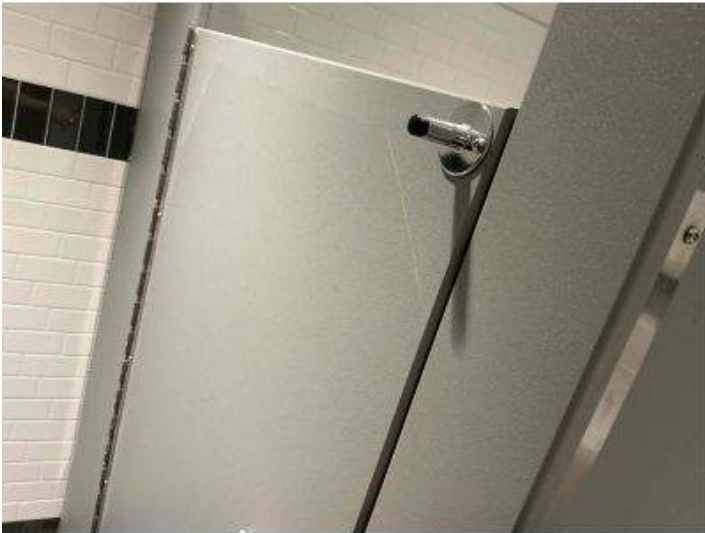
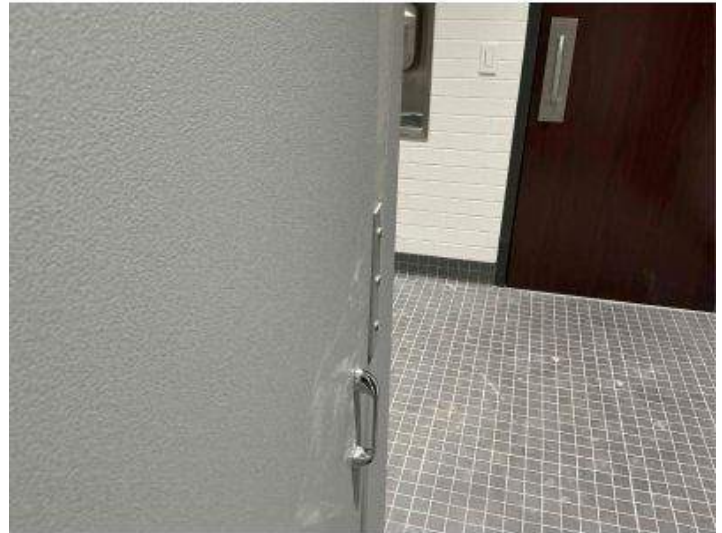
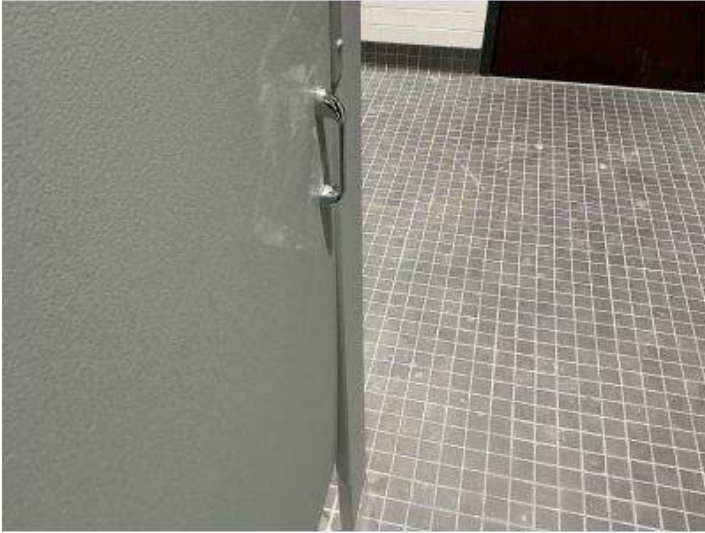
<b>Description</b>	stall door is uneven, adjust and level	Pending
<b>Assigned to</b>	—	
<b>Created by</b>	Yesenia Tijerina (ERO Architects)	
<b>Created on</b>	Aug 28, 2025	
<b>Issue owner</b>	Yesenia Tijerina (ERO Architects)	
<b>Location</b>	—	
<b>Location details</b>	—	
<b>Due date</b>	Sep 30, 2025	
<b>Root cause</b>	—	
<b>Reference drawing</b>	<a href="#">AE101 [V1]</a>

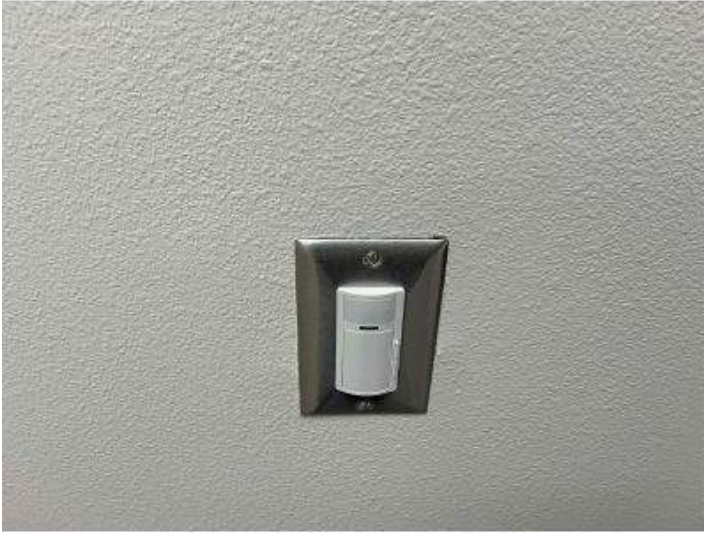
<b>Description</b>	Fill in any gaps around wall plates. Applies to both buildings.	<b>Pending</b>
<b>Assigned to</b>	—	
<b>Created by</b>	<b>Yesenia Tijerina</b> (ERO Architects)	
<b>Created on</b>	Aug 28, 2025	
<b>Issue owner</b>	<b>Yesenia Tijerina</b> (ERO Architects)	
<b>Location</b>	—	
<b>Location details</b>	—	
<b>Due date</b>	Sep 30, 2025	
<b>Root cause</b>	—	
<b>Reference drawing</b>	<a href="#">AE101 [V1]</a>

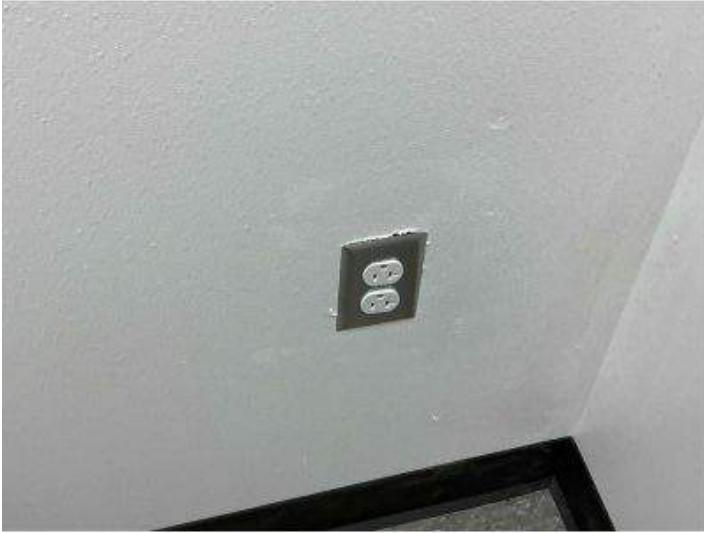
<b>Description</b>	seal and caulk gaps at all wall plates, applies to both buildings
<b>Assigned to</b>	—
<b>Created by</b>	<b>Yesenia Tijerina</b> (ERO Architects)
<b>Created on</b>	Aug 28, 2025
<b>Issue owner</b>	<b>Yesenia Tijerina</b> (ERO Architects)
<b>Location</b>	—
<b>Location details</b>	—
<b>Due date</b>	Sep 30, 2025
<b>Root cause</b>	—
<b>Reference drawing</b>	<a href="#">AE101 [V1]</a>

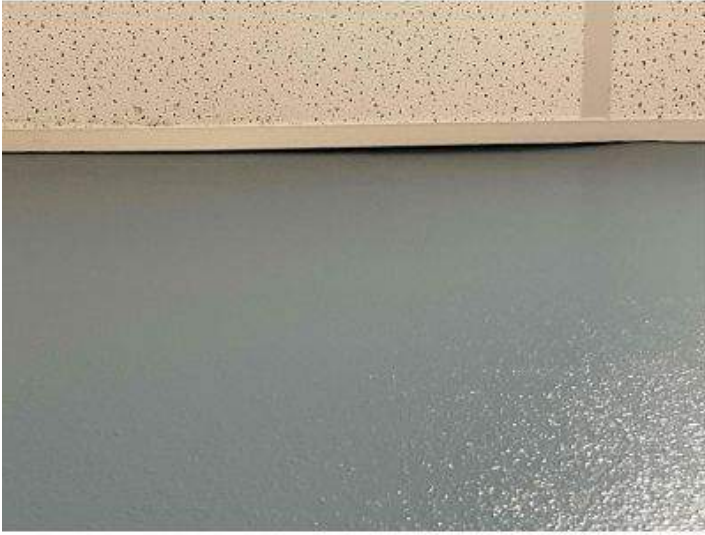
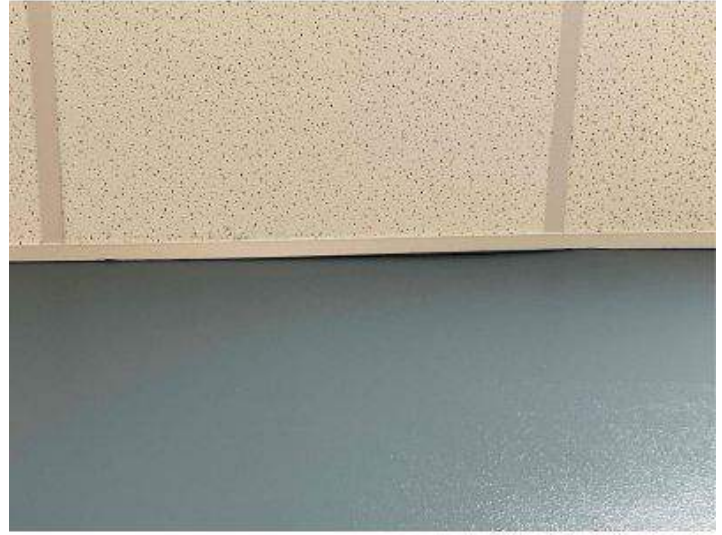
<b>Description</b>	repair gap at wall and ceiling grid	<b>Completed</b>
<b>Assigned to</b>	—	
<b>Created by</b>	<b>Yesenia Tijerina</b> (ERO Architects)	
<b>Created on</b>	Aug 28, 2025	
<b>Issue owner</b>	<b>Yesenia Tijerina</b> (ERO Architects)	
<b>Location</b>	—	
<b>Location details</b>	—	
<b>Due date</b>	Sep 30, 2025	
<b>Root cause</b>	—	
<b>Reference drawing</b>	<a href="#">AE101 [V1]</a>

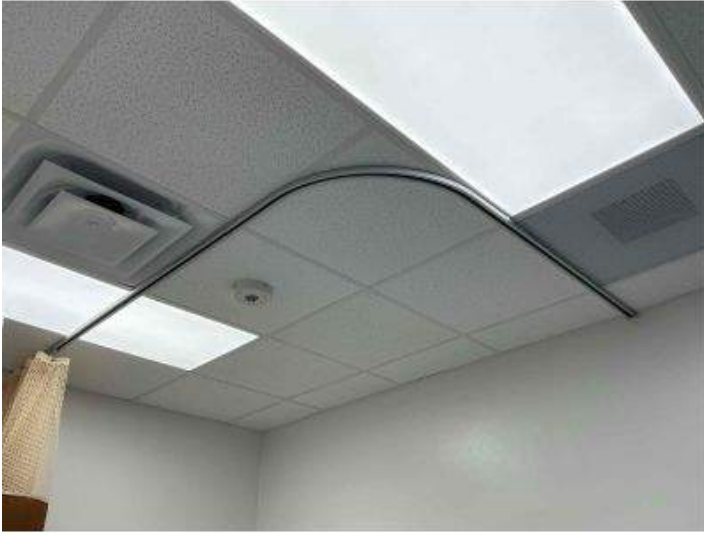
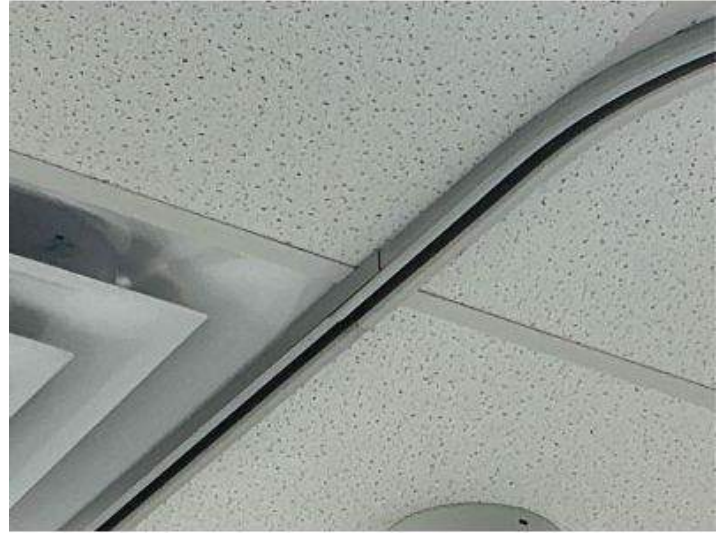
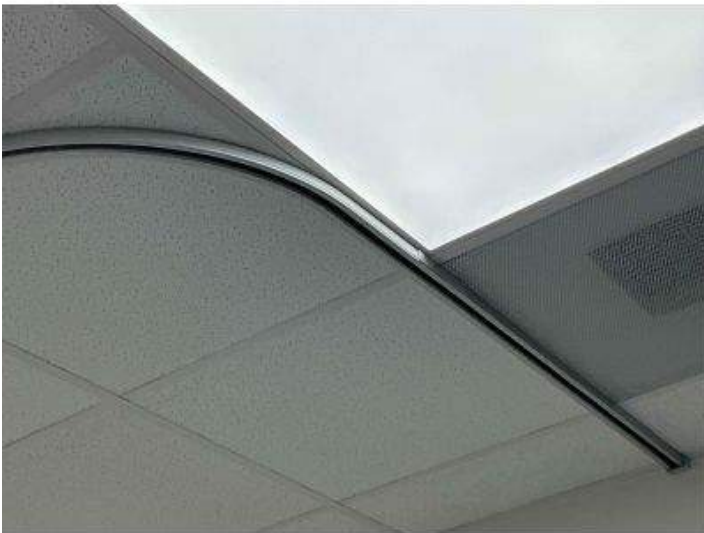
<b>Description</b>	Align the curtain track, the curtain gets stuck as it goes over the track joints.	Completed
<b>Assigned to</b>	—	
<b>Created by</b>	Yesenia Tijerina (ERO Architects)	
<b>Created on</b>	Aug 28, 2025	
<b>Issue owner</b>	Yesenia Tijerina (ERO Architects)	
<b>Location</b>	—	
<b>Location details</b>	—	
<b>Due date</b>	Sep 30, 2025	
<b>Root cause</b>	—	
<b>Reference drawing</b>	<a href="#">AE101 [V1]</a>

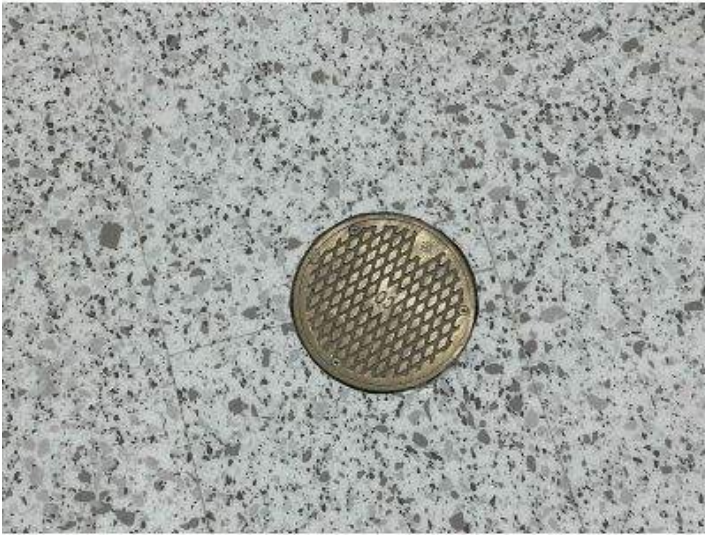
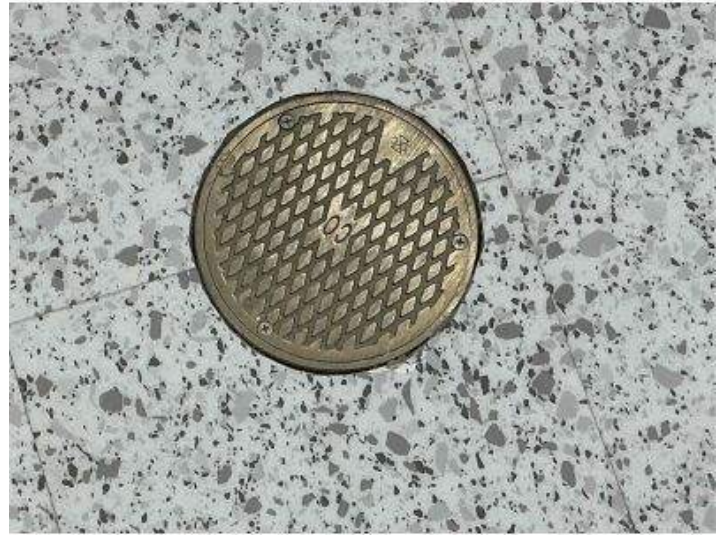
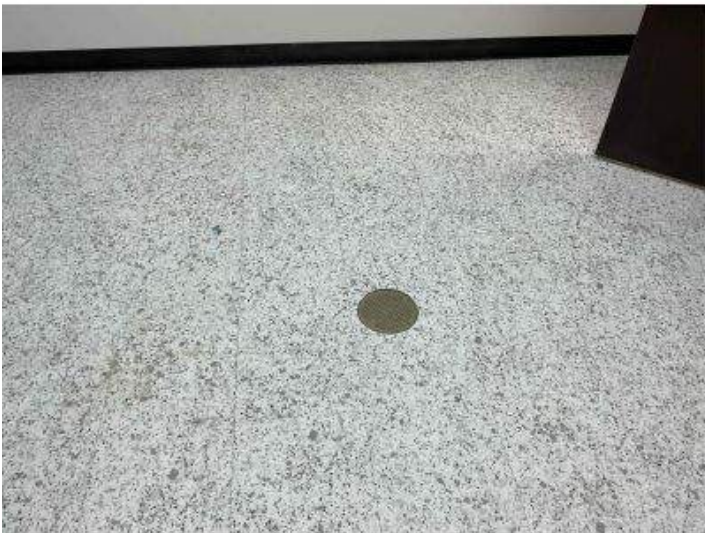
<b>Description</b>	Seal gaps at Clean Out edges	Completed
<b>Assigned to</b>	—	
<b>Created by</b>	Yesenia Tijerina (ERO Architects)	
<b>Created on</b>	Aug 28, 2025	
<b>Issue owner</b>	Yesenia Tijerina (ERO Architects)	
<b>Location</b>	—	
<b>Location details</b>	—	
<b>Due date</b>	Sep 30, 2025	
<b>Root cause</b>	—	
<b>Reference drawing</b>	<a href="#">AE101 [V1]</a>

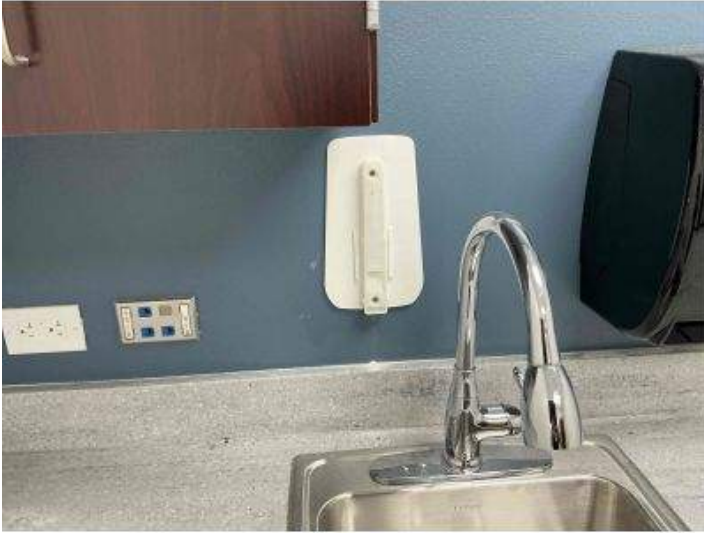
<b>Description</b>	missing soap dispenser <span style="background-color: yellow; color: red;">Pending</span>
<b>Assigned to</b>	—
<b>Created by</b>	<b>Yesenia Tijerina</b> (ERO Architects)
<b>Created on</b>	Aug 28, 2025
<b>Issue owner</b>	<b>Yesenia Tijerina</b> (ERO Architects)
<b>Location</b>	—
<b>Location details</b>	—
<b>Due date</b>	Sep 30, 2025
<b>Root cause</b>	—
<b>Reference drawing</b>	<a href="#">AE101 [V1]</a>

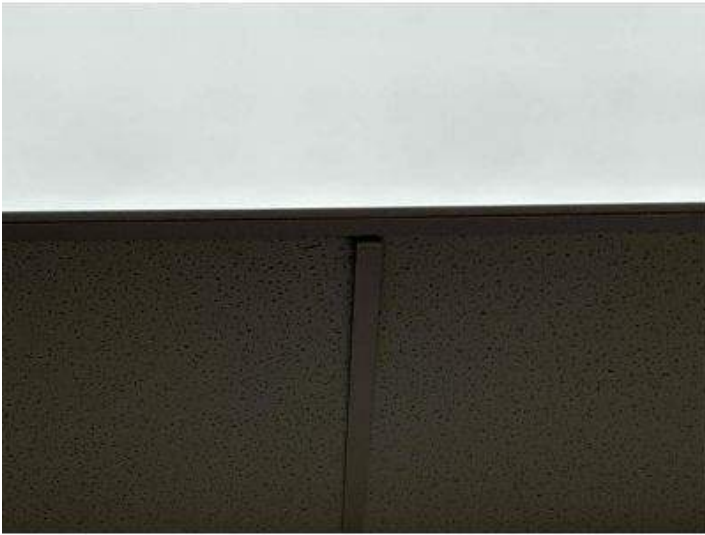
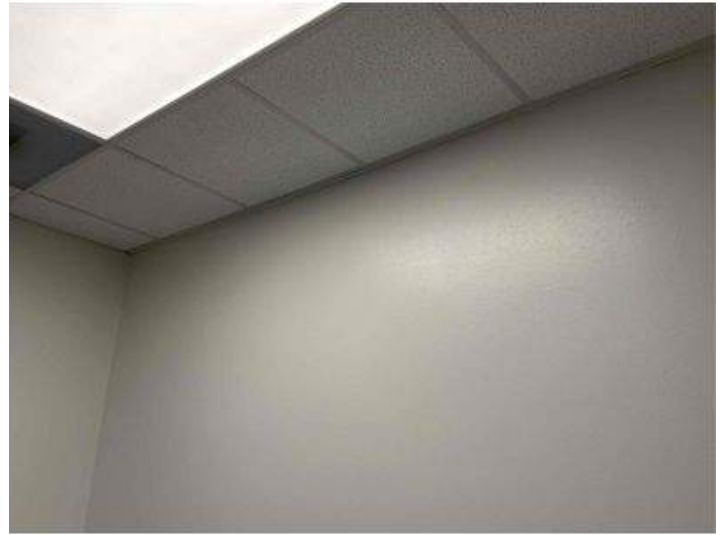
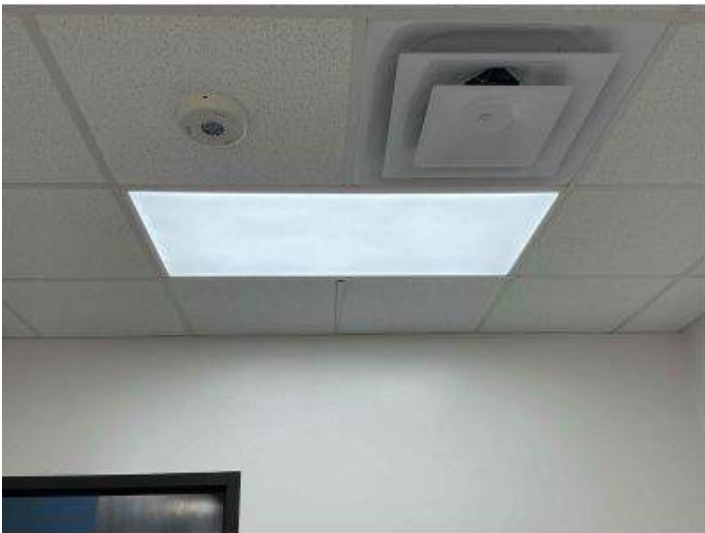
<b>Description</b>	Fix overlapping grid. Applies to both buildings. <span style="background-color: yellow;">Completed</span>
<b>Assigned to</b>	—
<b>Created by</b>	<b>Yesenia Tijerina</b> (ERO Architects)
<b>Created on</b>	Aug 28, 2025
<b>Issue owner</b>	<b>Yesenia Tijerina</b> (ERO Architects)
<b>Location</b>	—
<b>Location details</b>	—
<b>Due date</b>	Sep 30, 2025
<b>Root cause</b>	—
<b>Reference drawing</b>	<a href="#">AE101 [V1]</a>

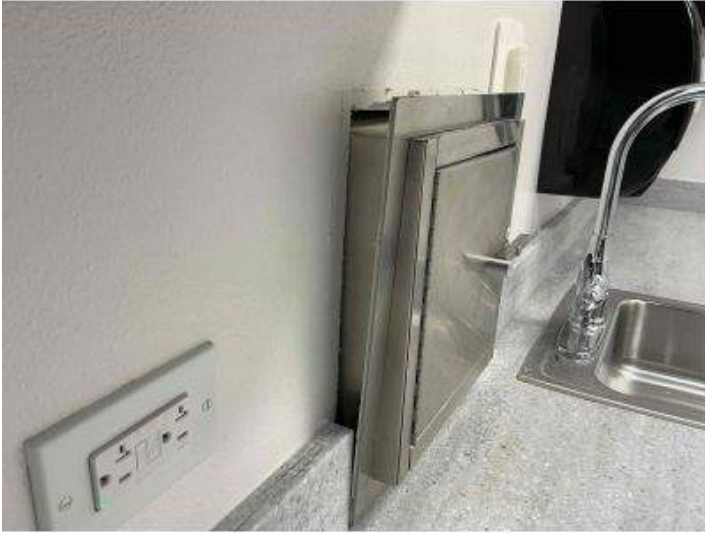
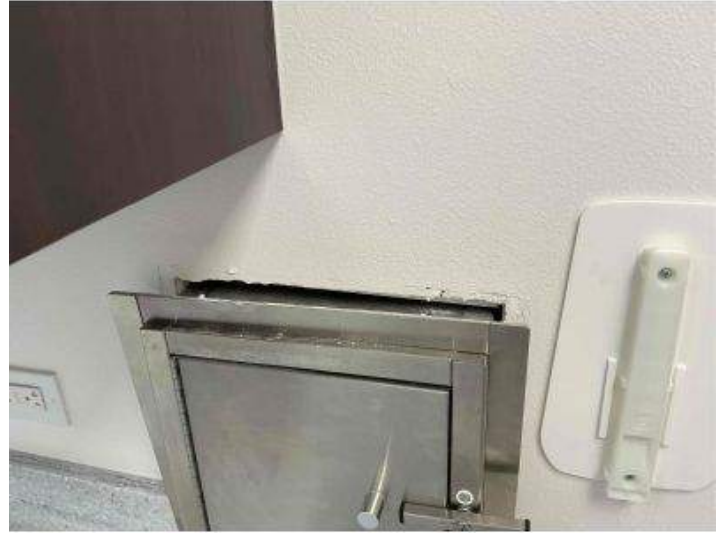
<b>Description</b>	cabinet frame is not anchored to wall	Completed
<b>Assigned to</b>	—	
<b>Created by</b>	Yesenia Tijerina (ERO Architects)	
<b>Created on</b>	Aug 28, 2025	
<b>Issue owner</b>	Yesenia Tijerina (ERO Architects)	
<b>Location</b>	—	
<b>Location details</b>	—	
<b>Due date</b>	Sep 30, 2025	
<b>Root cause</b>	—	
<b>Reference drawing</b>	<a href="#">AE101 [V1]</a>

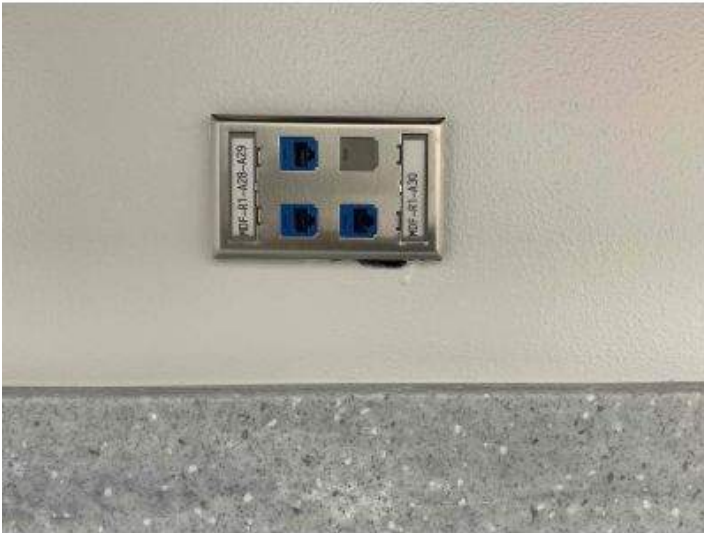
<b>Description</b>	Fill in any gaps around wall plates. Applies to both buildings.	Pending
<b>Assigned to</b>	—	
<b>Created by</b>	<b>Yesenia Tijerina</b> (ERO Architects)	
<b>Created on</b>	Aug 28, 2025	
<b>Issue owner</b>	<b>Yesenia Tijerina</b> (ERO Architects)	
<b>Location</b>	—	
<b>Location details</b>	—	
<b>Due date</b>	Sep 30, 2025	
<b>Root cause</b>	—	
<b>Reference drawing</b>	<a href="#">AE101 [V1]</a>

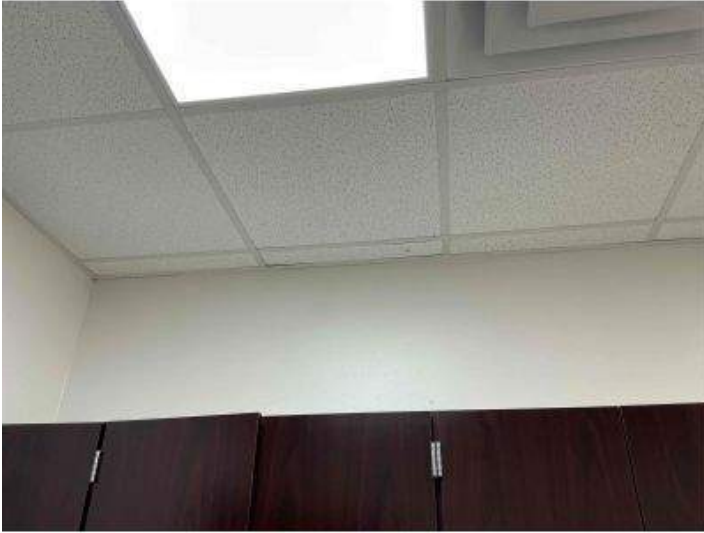
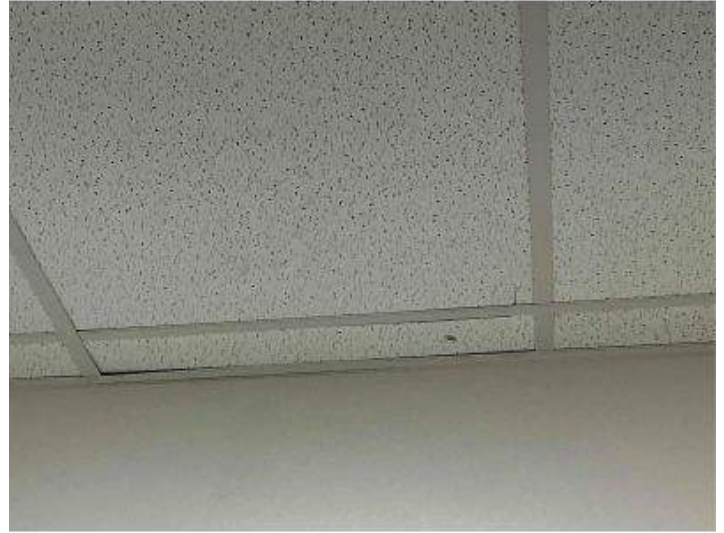
<b>Description</b>	replace any damaged ceiling tile at both buildings	Completed
<b>Assigned to</b>	—	
<b>Created by</b>	Yesenia Tijerina (ERO Architects)	
<b>Created on</b>	Aug 28, 2025	
<b>Issue owner</b>	Yesenia Tijerina (ERO Architects)	
<b>Location</b>	—	
<b>Location details</b>	—	
<b>Due date</b>	Sep 30, 2025	
<b>Root cause</b>	—	
<b>Reference drawing</b>	<a href="#">AE101 [V1]</a>

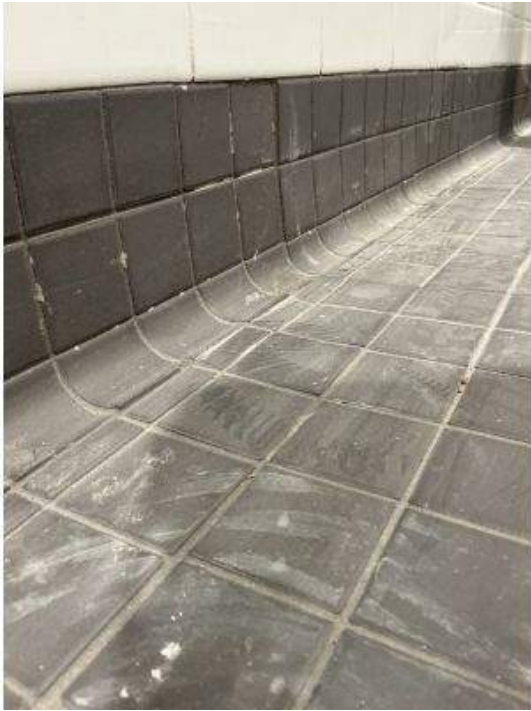
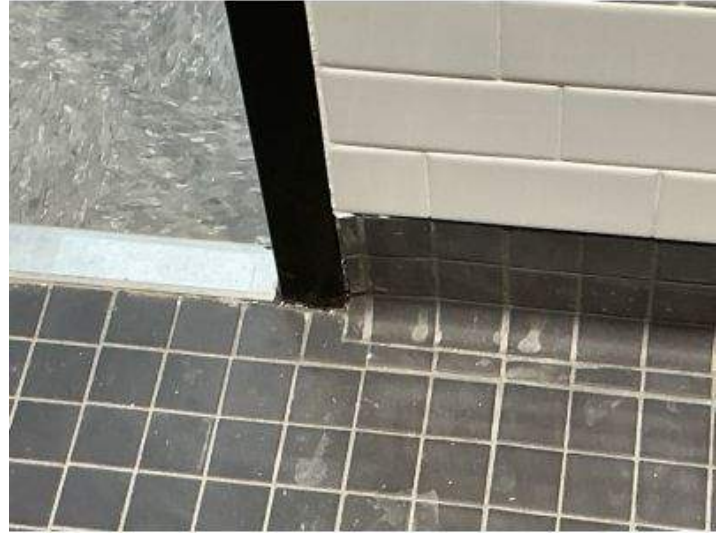
<b>Description</b>	Fill in the missing grout in the restroom tile. Even out the tiles set in or protruding. This applies to all tiles in both buildings. <span style="background-color: yellow;">Completed</span>
<b>Assigned to</b>	—
<b>Created by</b>	<b>Yesenia Tijerina</b> (ERO Architects)
<b>Created on</b>	Aug 28, 2025
<b>Issue owner</b>	<b>Yesenia Tijerina</b> (ERO Architects)
<b>Location</b>	—
<b>Location details</b>	—
<b>Due date</b>	Sep 30, 2025
<b>Root cause</b>	—
<b>Reference drawing</b>	<a href="#">AE101 [V1]</a>

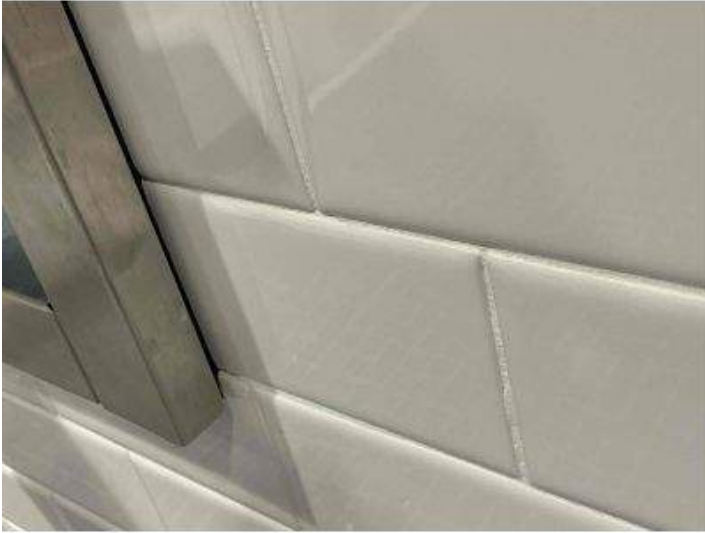
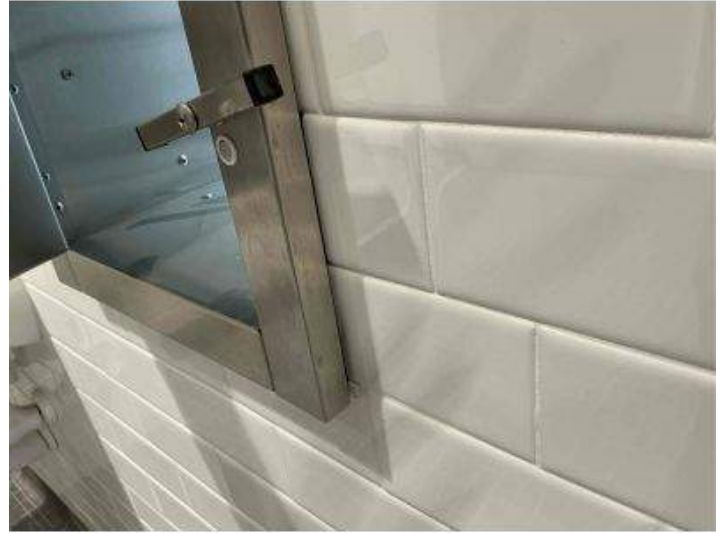
<b>Description</b>	cabinet frame is not anchored to the wall	<b>Pending</b>
<b>Assigned to</b>	—	
<b>Created by</b>	<b>Yesenia Tijerina</b> (ERO Architects)	
<b>Created on</b>	Aug 28, 2025	
<b>Issue owner</b>	<b>Yesenia Tijerina</b> (ERO Architects)	
<b>Location</b>	—	
<b>Location details</b>	—	
<b>Due date</b>	Sep 30, 2025	
<b>Root cause</b>	—	
<b>Reference drawing</b>	<a href="#">AE101 [V1]</a>

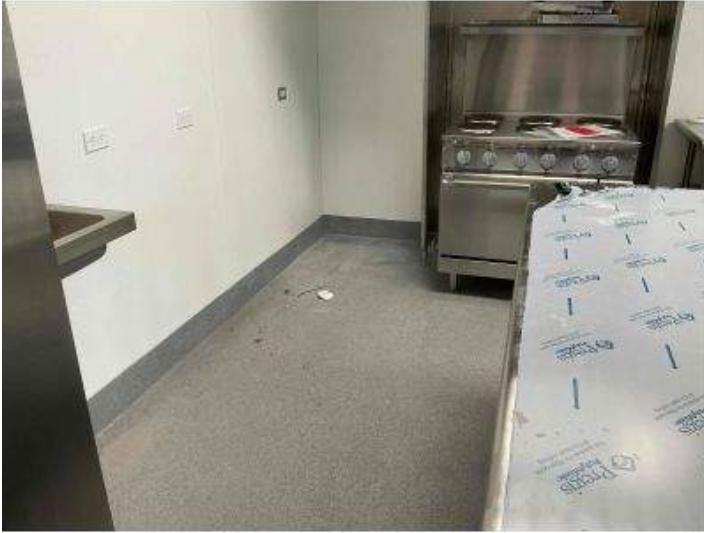
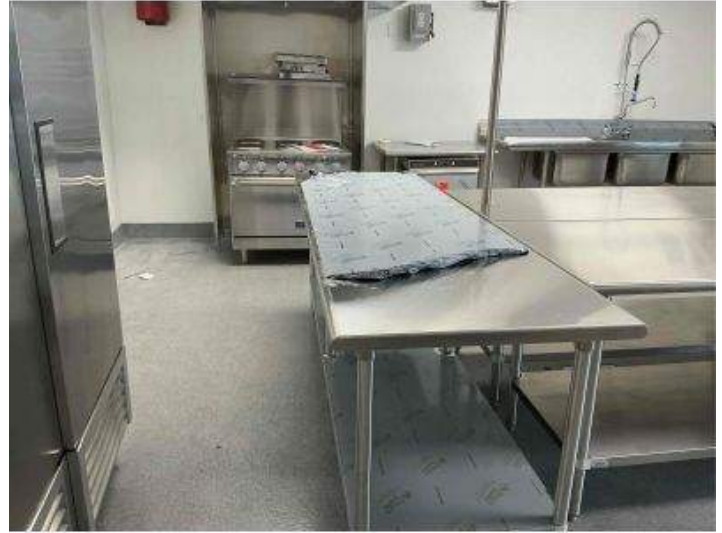
<b>Description</b>	General Note: Clean floor and move stainless steel counters to their respective locations. <span style="background-color: yellow; color: red; padding: 2px;">Pending</span>
<b>Assigned to</b>	—
<b>Created by</b>	<b>Joey Yzaguirre</b> (ERO Architects)
<b>Created on</b>	Sep 15, 2025
<b>Issue owner</b>	<b>Joey Yzaguirre</b> (ERO Architects)
<b>Location</b>	—
<b>Location details</b>	—
<b>Due date</b>	—
<b>Root cause</b>	—
<b>Reference drawing</b>	<a href="#">AE102 [V1]</a>

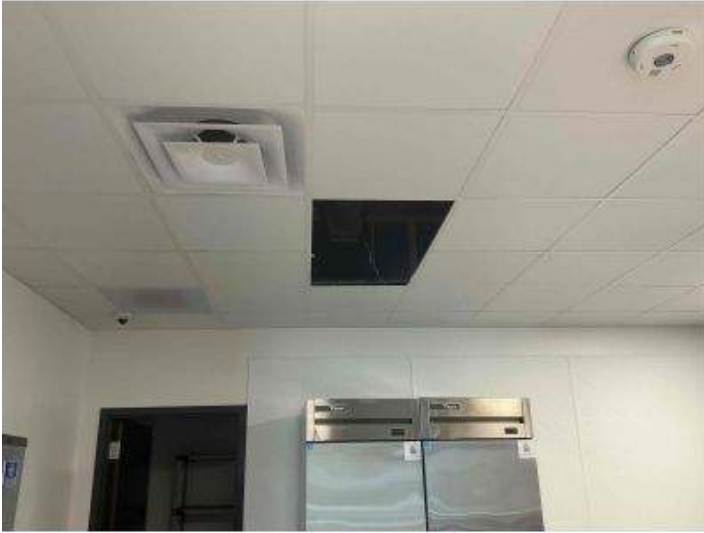
<b>Description</b>	Missing 2x4 ceiling tile. <span style="background-color: yellow;">Completed</span>
<b>Assigned to</b>	—
<b>Created by</b>	<b>Joey Yzaguirre</b> (ERO Architects)
<b>Created on</b>	Sep 15, 2025
<b>Issue owner</b>	<b>Joey Yzaguirre</b> (ERO Architects)
<b>Location</b>	—
<b>Location details</b>	—
<b>Due date</b>	—
<b>Root cause</b>	—
<b>Reference drawing</b>	<a href="#">AE102 [V1]</a>

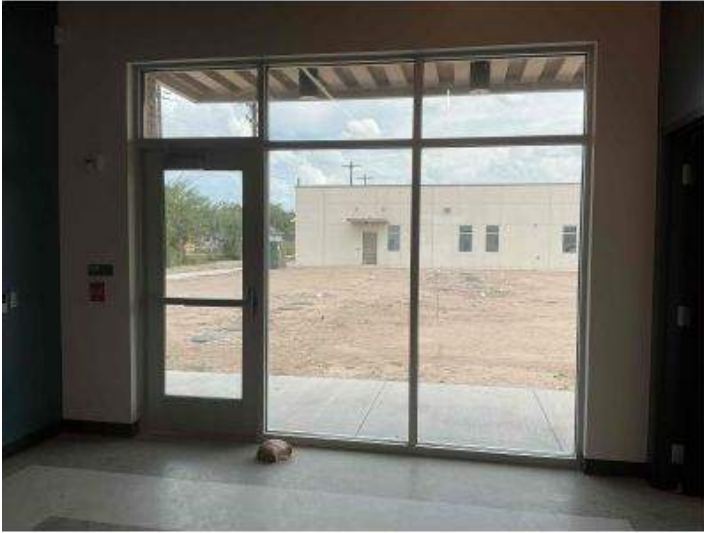
<b>Description</b>	General Note: Clean all storefronts.	<b>Completed</b>
<b>Assigned to</b>	—	
<b>Created by</b>	<b>Joey Yzaguirre</b> (ERO Architects)	
<b>Created on</b>	Sep 15, 2025	
<b>Issue owner</b>	<b>Joey Yzaguirre</b> (ERO Architects)	
<b>Location</b>	—	
<b>Location details</b>	—	
<b>Due date</b>	—	
<b>Root cause</b>	—	
<b>Reference drawing</b>	<a href="#">AE102 [V1]</a>

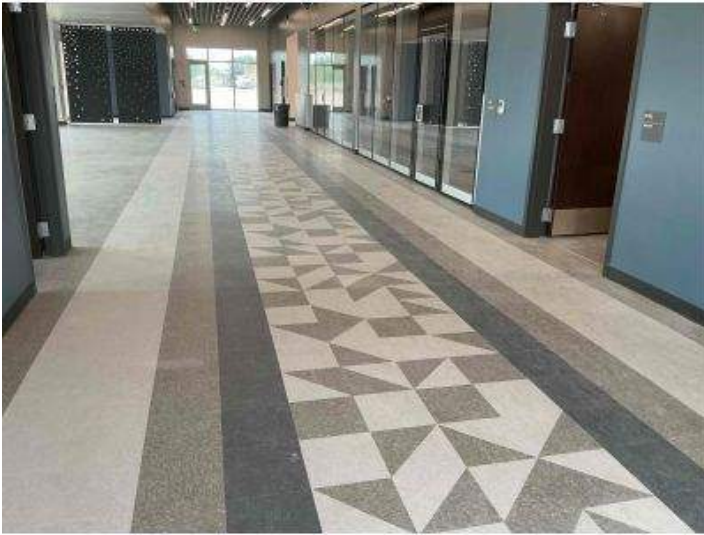
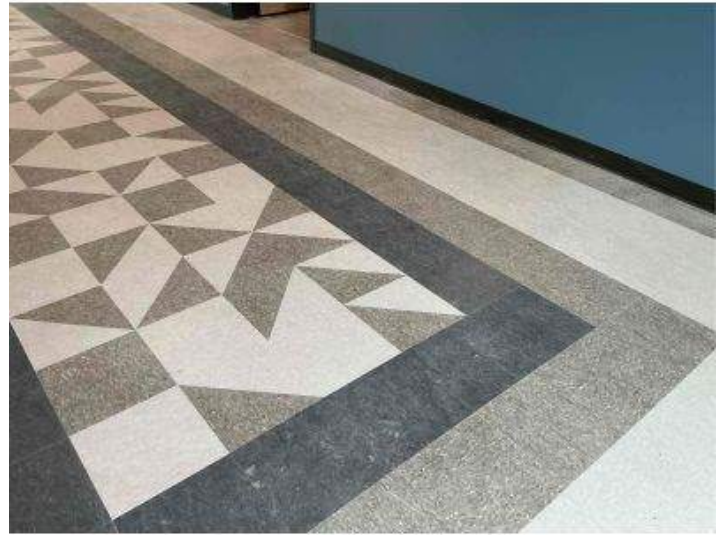
<b>Description</b>	General Note: Clean all VCT floors.	<b>Completed</b>
<b>Assigned to</b>	—	
<b>Created by</b>	<b>Joey Yzaguirre</b> (ERO Architects)	
<b>Created on</b>	Sep 15, 2025	
<b>Issue owner</b>	<b>Joey Yzaguirre</b> (ERO Architects)	
<b>Location</b>	—	
<b>Location details</b>	—	
<b>Due date</b>	—	
<b>Root cause</b>	—	
<b>Reference drawing</b>	<a href="#">AE102 [V1]</a>

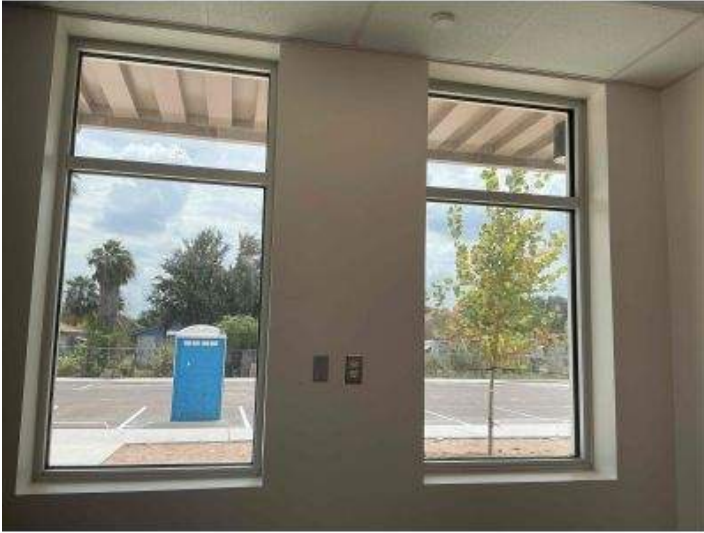
<b>Description</b>	General Note: Clean all storefront windows.	Completed
<b>Assigned to</b>	—	
<b>Created by</b>	Joey Yzaguirre (ERO Architects)	
<b>Created on</b>	Sep 15, 2025	
<b>Issue owner</b>	Joey Yzaguirre (ERO Architects)	
<b>Location</b>	—	
<b>Location details</b>	—	
<b>Due date</b>	—	
<b>Root cause</b>	—	
<b>Reference drawing</b>	AE102 [V1]

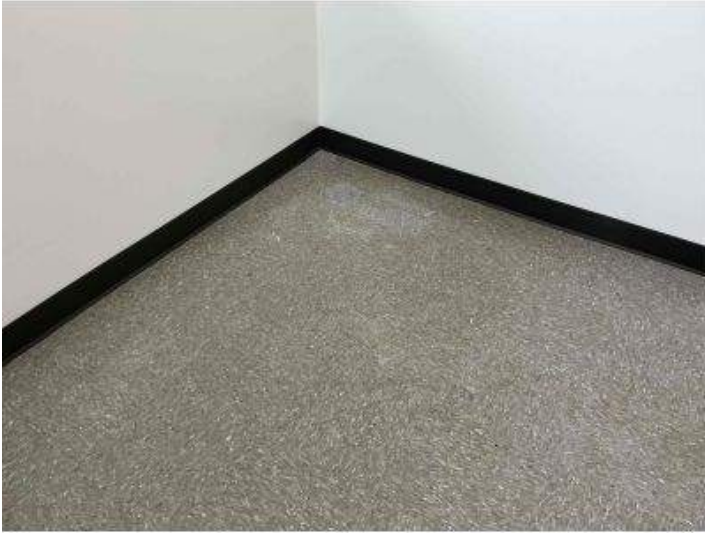
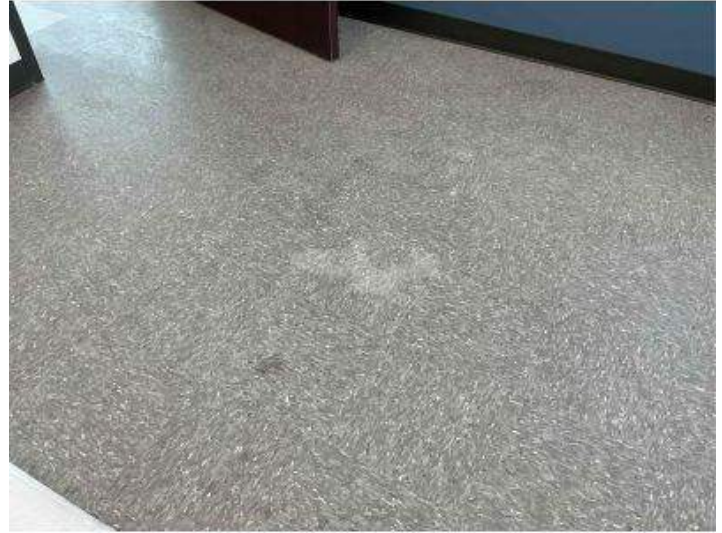
<b>Description</b>	Clean VCT floor.	Completed
<b>Assigned to</b>	—	
<b>Created by</b>	Joey Yzaguirre (ERO Architects)	
<b>Created on</b>	Sep 15, 2025	
<b>Issue owner</b>	Joey Yzaguirre (ERO Architects)	
<b>Location</b>	—	
<b>Location details</b>	—	
<b>Due date</b>	—	
<b>Root cause</b>	—	
<b>Reference drawing</b>	<a href="#">AE102 [V1]</a>

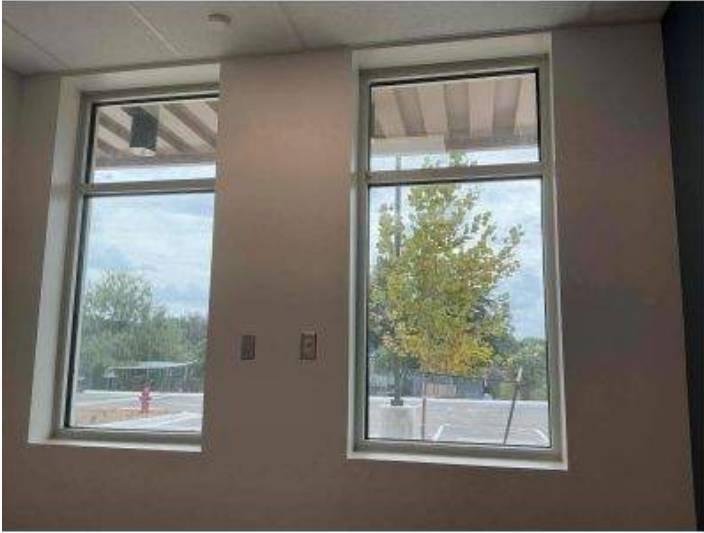
<b>Description</b>	Clean storefront windows. <span style="background-color: yellow;">Completed</span>
<b>Assigned to</b>	—
<b>Created by</b>	Joey Yzaguirre (ERO Architects)
<b>Created on</b>	Sep 15, 2025
<b>Issue owner</b>	Joey Yzaguirre (ERO Architects)
<b>Location</b>	—
<b>Location details</b>	—
<b>Due date</b>	—
<b>Root cause</b>	—
<b>Reference drawing</b>	<a href="#">AE102 [V1]</a>

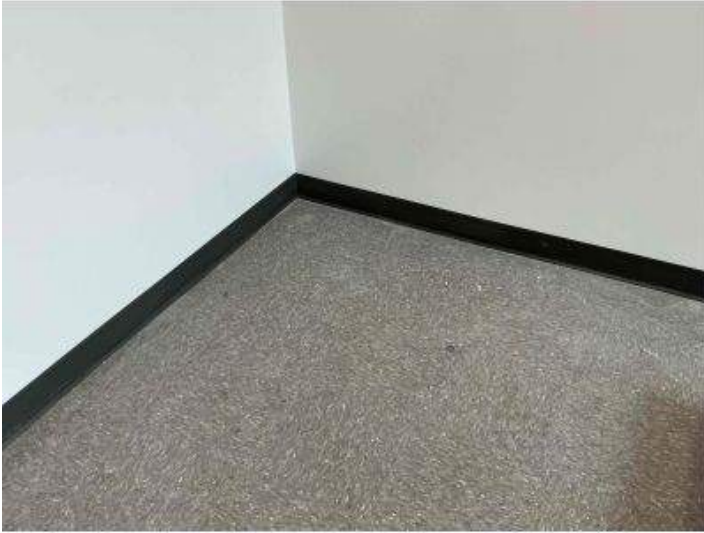
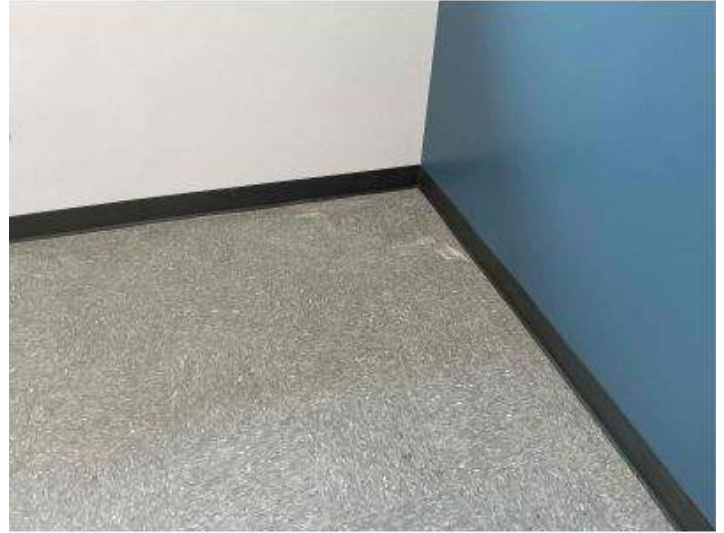
<b>Description</b>	Clean VCT floor.	Completed
<b>Assigned to</b>	—	
<b>Created by</b>	Joey Yzaguirre (ERO Architects)	
<b>Created on</b>	Sep 15, 2025	
<b>Issue owner</b>	Joey Yzaguirre (ERO Architects)	
<b>Location</b>	—	
<b>Location details</b>	—	
<b>Due date</b>	—	
<b>Root cause</b>	—	
<b>Reference drawing</b>	<a href="#">AE102 [V1]</a>

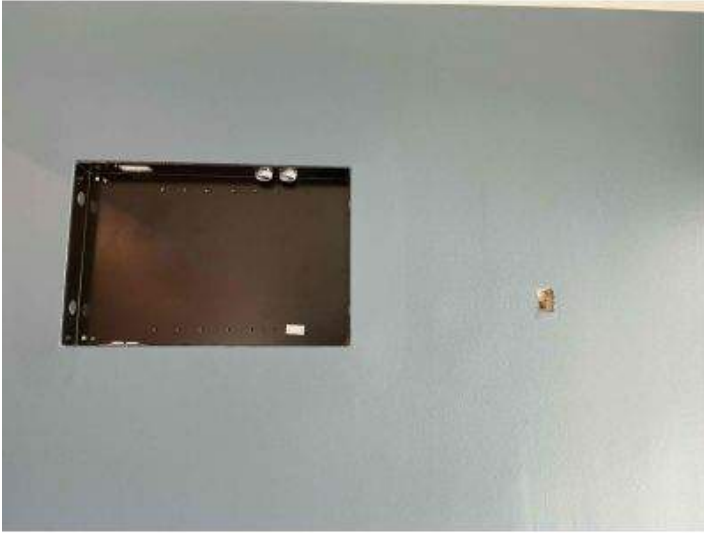
<b>Description</b>	Repair damaged wall & install monitor.	Completed
<b>Assigned to</b>	—	
<b>Created by</b>	Joey Yzaguirre (ERO Architects)	
<b>Created on</b>	Sep 15, 2025	
<b>Issue owner</b>	Joey Yzaguirre (ERO Architects)	
<b>Location</b>	—	
<b>Location details</b>	—	
<b>Due date</b>	—	
<b>Root cause</b>	—	
<b>Reference drawing</b>	<a href="#">AE102 [V1]</a>
