## Certificate of Substantial Completion

**PROJECT:** *(name and address)*  
Hidalgo County El Paraiso Health Clinic & Community Resource Center

**CERTIFICATE INFORMATION:**  
Certificate Number: 001  
Date: June 15, 2026

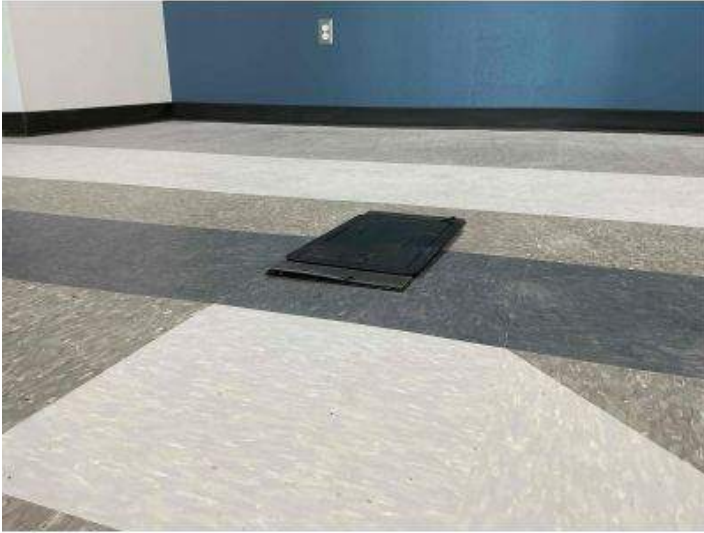
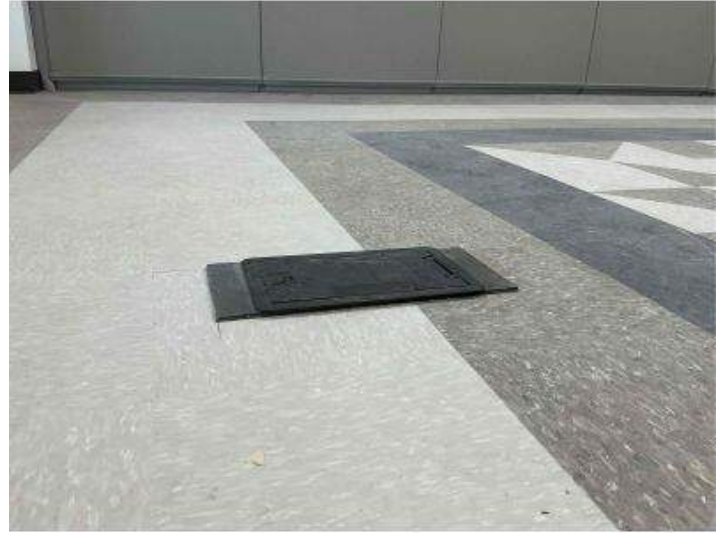
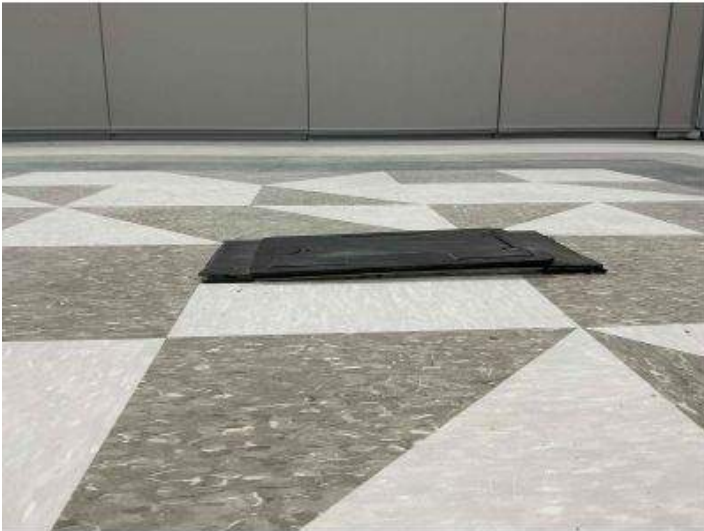
<b>Description</b>	All floor boxes must be flushed with floor. It's creating a tripping hazard.	<b>Completed</b>
<b>Assigned to</b>	—	
<b>Created by</b>	<b>Joey Yzaguirre</b> (ERO Architects)	
<b>Created on</b>	Sep 15, 2025	
<b>Issue owner</b>	<b>Joey Yzaguirre</b> (ERO Architects)	
<b>Location</b>	—	
<b>Location details</b>	—	
<b>Due date</b>	—	
<b>Root cause</b>	—	
<b>Reference drawing</b>	<a href="#">AE102 [V1]</a>

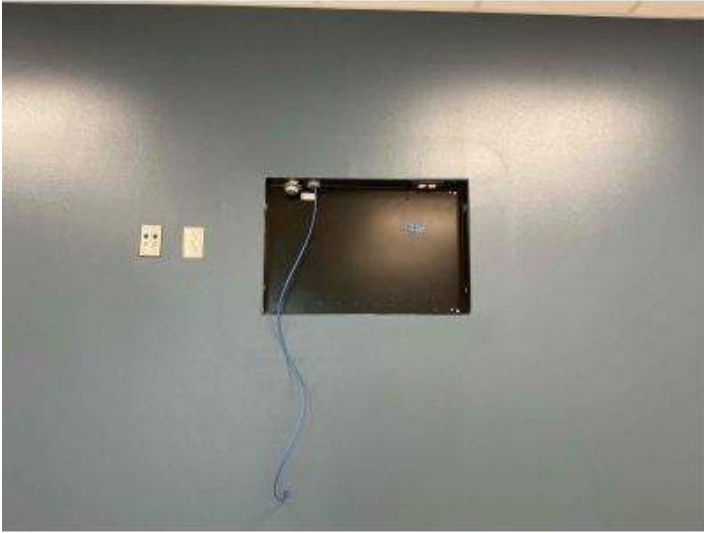
<b>Description</b>	Install monitor. <span style="background-color: yellow;">Completed</span>
<b>Assigned to</b>	—
<b>Created by</b>	<b>Joey Yzaguirre</b> (ERO Architects)
<b>Created on</b>	Sep 15, 2025
<b>Issue owner</b>	<b>Joey Yzaguirre</b> (ERO Architects)
<b>Location</b>	—
<b>Location details</b>	—
<b>Due date</b>	—
<b>Root cause</b>	—
<b>Reference drawing</b>	<a href="#">AE102 [V1]</a>

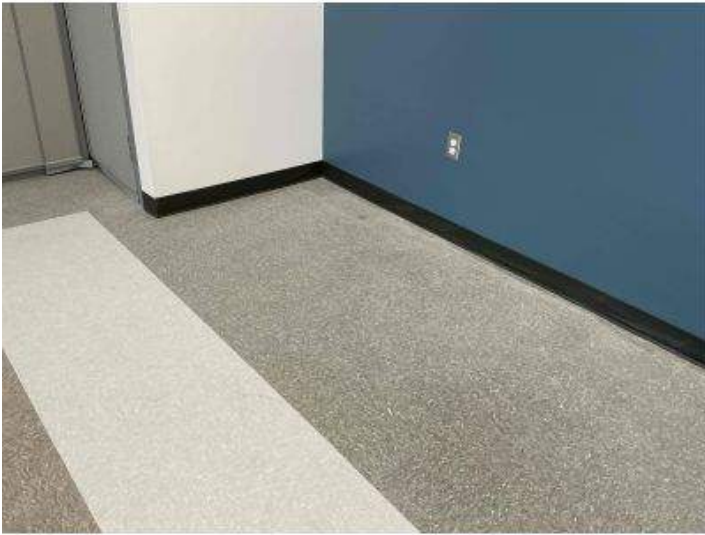
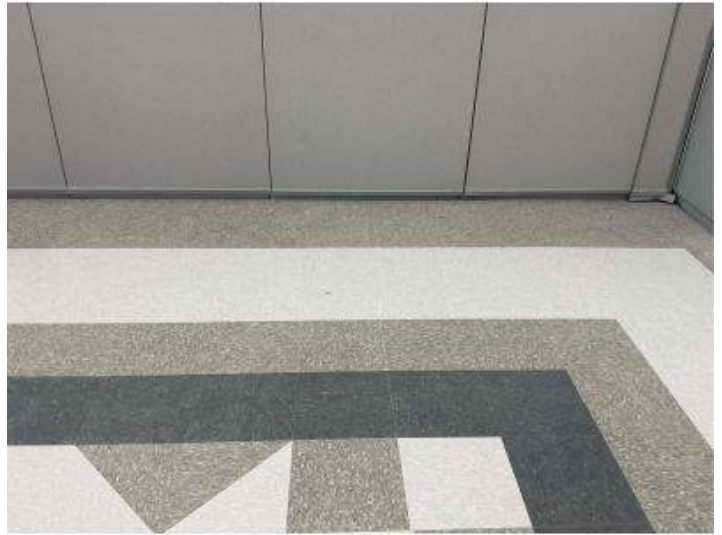
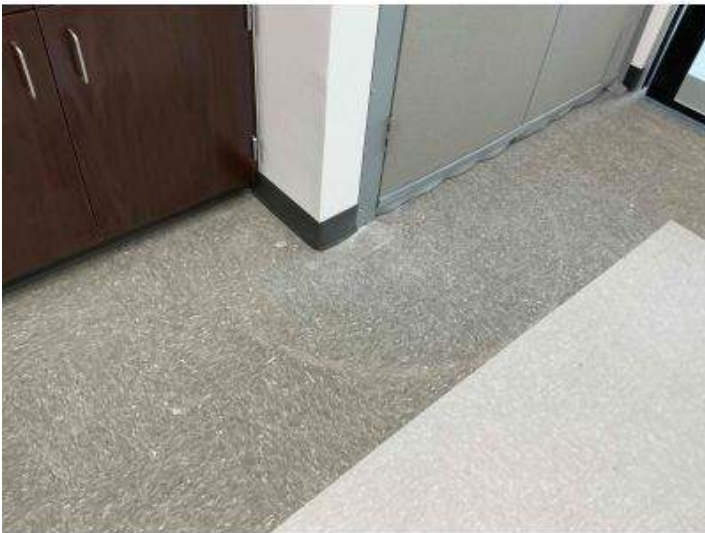
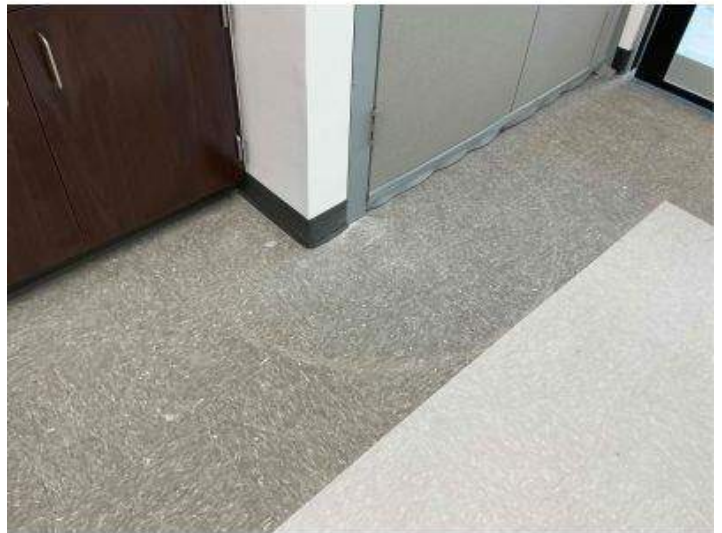
<b>Description</b>	Clean VCT floor. <span style="background-color: yellow;">Completed</span>
<b>Assigned to</b>	—
<b>Created by</b>	<b>Joey Yzaguirre</b> (ERO Architects)
<b>Created on</b>	Sep 15, 2025
<b>Issue owner</b>	<b>Joey Yzaguirre</b> (ERO Architects)
<b>Location</b>	—
<b>Location details</b>	—
<b>Due date</b>	—
<b>Root cause</b>	—
<b>Reference drawing</b>	<a href="#">AE102 [V1]</a>

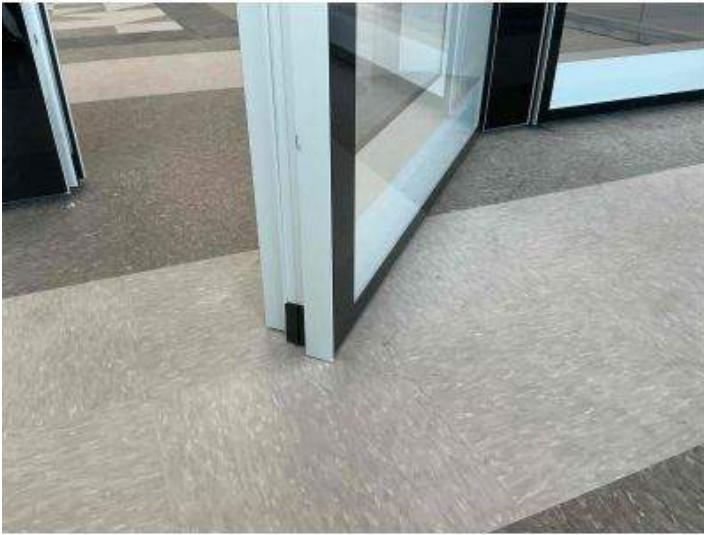
<b>Description</b>	Glass partition door not opening properly. Bottom of door is scratching VCT floor.
<b>Assigned to</b>	Completed
<b>Created by</b>	<b>Joey Yzaguirre</b> (ERO Architects)
<b>Created on</b>	Sep 15, 2025
<b>Issue owner</b>	<b>Joey Yzaguirre</b> (ERO Architects)
<b>Location</b>	—
<b>Location details</b>	—
<b>Due date</b>	—
<b>Root cause</b>	—
<b>Reference drawing</b>	<a href="#">AE102 [V1]</a>

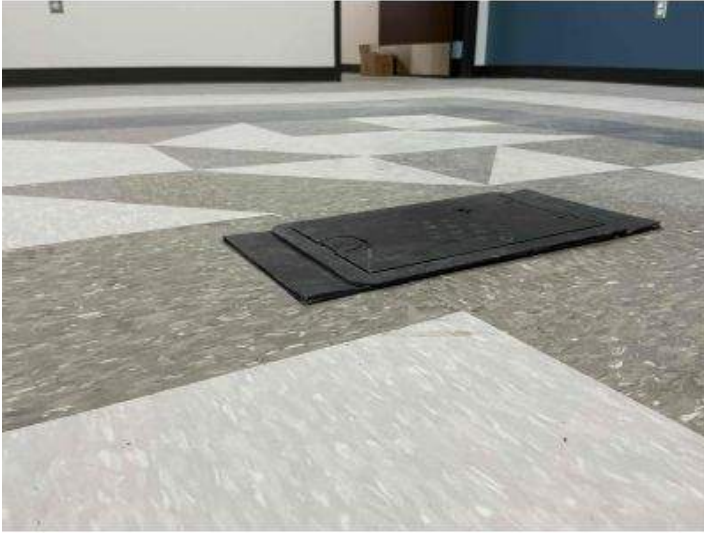
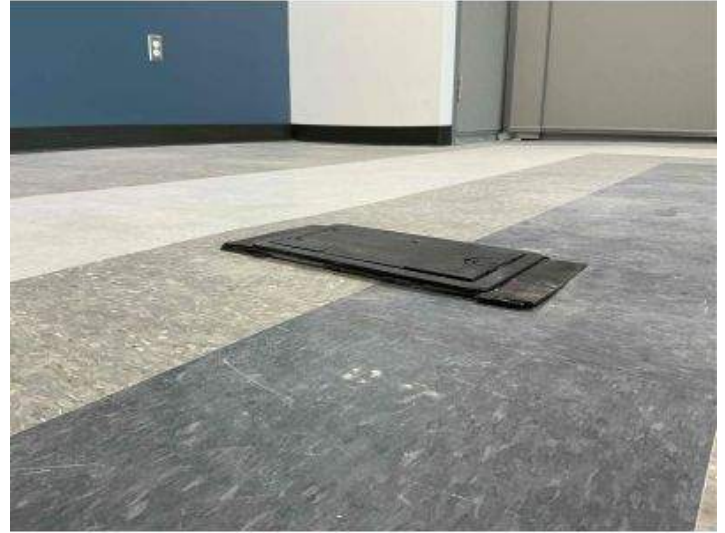
<b>Description</b>	All floor boxes must be flushed with floor. Its creating a tripping hazard.	Completed
<b>Assigned to</b>	—	
<b>Created by</b>	Joey Yzaguirre (ERO Architects)	
<b>Created on</b>	Sep 15, 2025	
<b>Issue owner</b>	Joey Yzaguirre (ERO Architects)	
<b>Location</b>	—	
<b>Location details</b>	—	
<b>Due date</b>	—	
<b>Root cause</b>	—	
<b>Reference drawing</b>	<a href="#">AE102 [V1]</a>

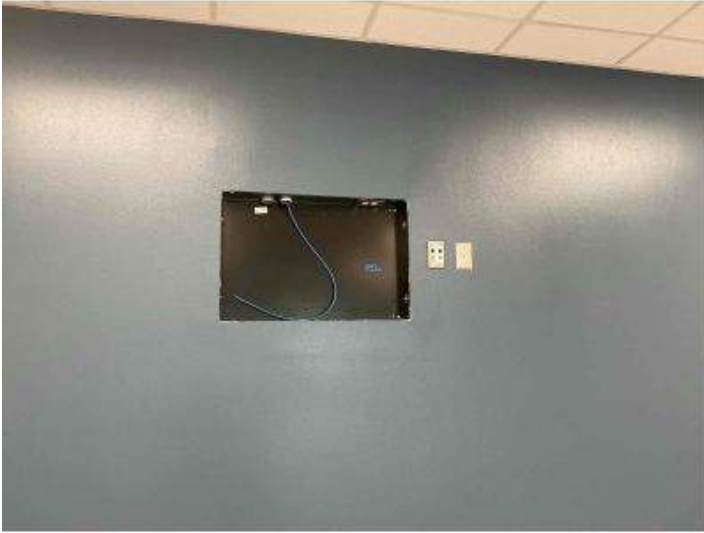
<b>Description</b>	Install monitor. <span style="background-color: yellow;">Completed</span>
<b>Assigned to</b>	—
<b>Created by</b>	Joey Yzaguirre (ERO Architects)
<b>Created on</b>	Sep 15, 2025
<b>Issue owner</b>	Joey Yzaguirre (ERO Architects)
<b>Location</b>	—
<b>Location details</b>	—
<b>Due date</b>	—
<b>Root cause</b>	—
<b>Reference drawing</b>	<a href="#">AE102 [V1]</a>

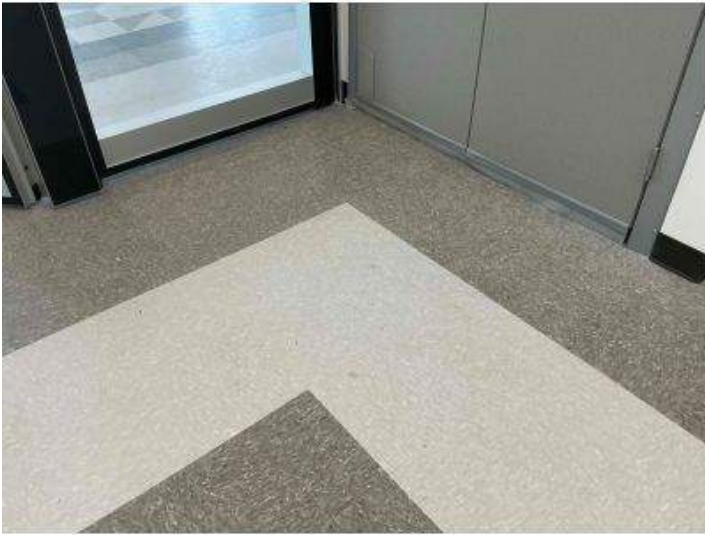
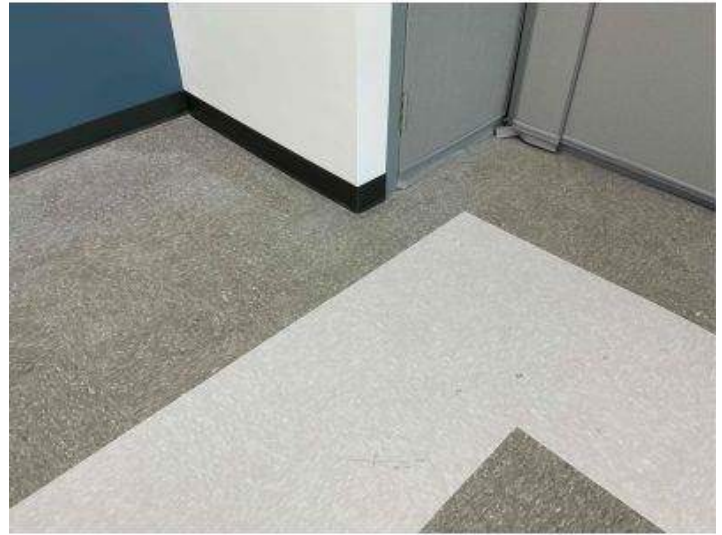
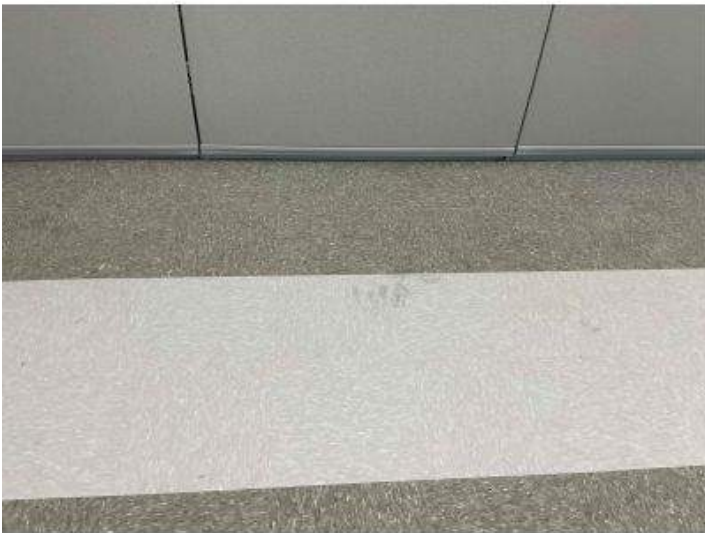
<b>Description</b>	Clean VCT floor. <span style="background-color: yellow;">Completed</span>
<b>Assigned to</b>	—
<b>Created by</b>	<b>Joey Yzaguirre</b> (ERO Architects)
<b>Created on</b>	Sep 15, 2025
<b>Issue owner</b>	<b>Joey Yzaguirre</b> (ERO Architects)
<b>Location</b>	—
<b>Location details</b>	—
<b>Due date</b>	—
<b>Root cause</b>	—
<b>Reference drawing</b>	<a href="#">AE102 [V1]</a>

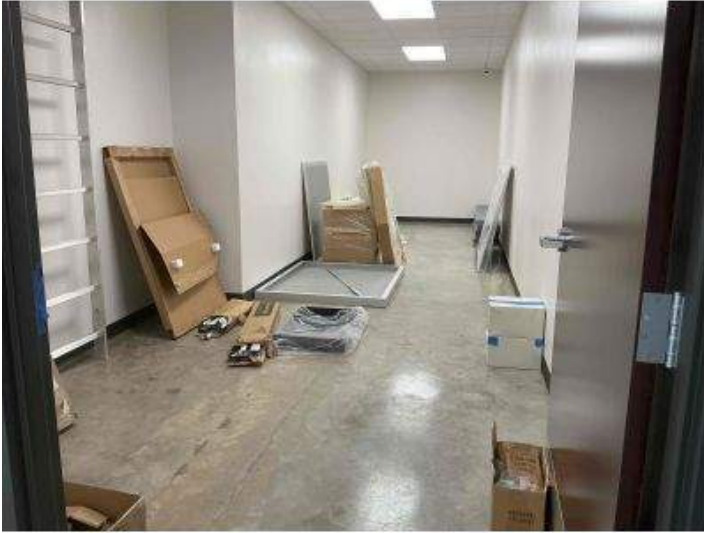
<b>Description</b>	Clean entire storage room.	<b>Pending</b>
<b>Assigned to</b>	—	
<b>Created by</b>	<b>Joey Yzaguirre</b> (ERO Architects)	
<b>Created on</b>	Sep 15, 2025	
<b>Issue owner</b>	<b>Joey Yzaguirre</b> (ERO Architects)	
<b>Location</b>	—	
<b>Location details</b>	—	
<b>Due date</b>	—	
<b>Root cause</b>	—	
<b>Reference drawing</b>	<a href="#">AE102 [V1]</a>

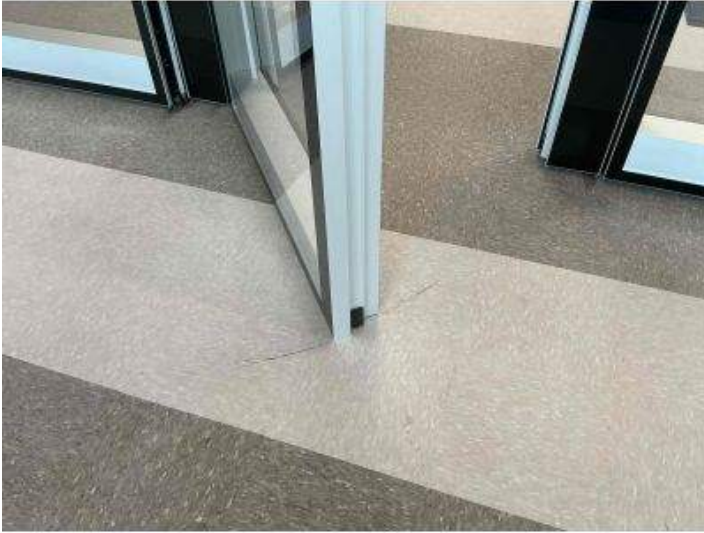
<b>Description</b>	Glass partition door not opening properly. Door is scratching VCT floor.	Completed
<b>Assigned to</b>	—	
<b>Created by</b>	Joey Yzaguirre (ERO Architects)	
<b>Created on</b>	Sep 15, 2025	
<b>Issue owner</b>	Joey Yzaguirre (ERO Architects)	
<b>Location</b>	—	
<b>Location details</b>	—	
<b>Due date</b>	—	
<b>Root cause</b>	—	
<b>Reference drawing</b>	<a href="#">AE102 [V1]</a>

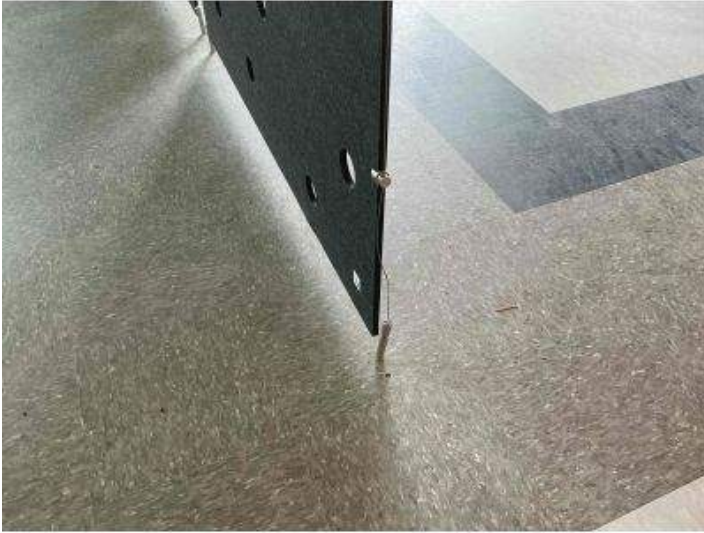
<b>Description</b>	Bottom of panel is loose. <span style="background-color: yellow;">Pending</span>
<b>Assigned to</b>	—
<b>Created by</b>	<b>Joey Yzaguirre</b> (ERO Architects)
<b>Created on</b>	Sep 15, 2025
<b>Issue owner</b>	<b>Joey Yzaguirre</b> (ERO Architects)
<b>Location</b>	—
<b>Location details</b>	—
<b>Due date</b>	—
<b>Root cause</b>	—
<b>Reference drawing</b>	<a href="#">AE102 [V1]</a>

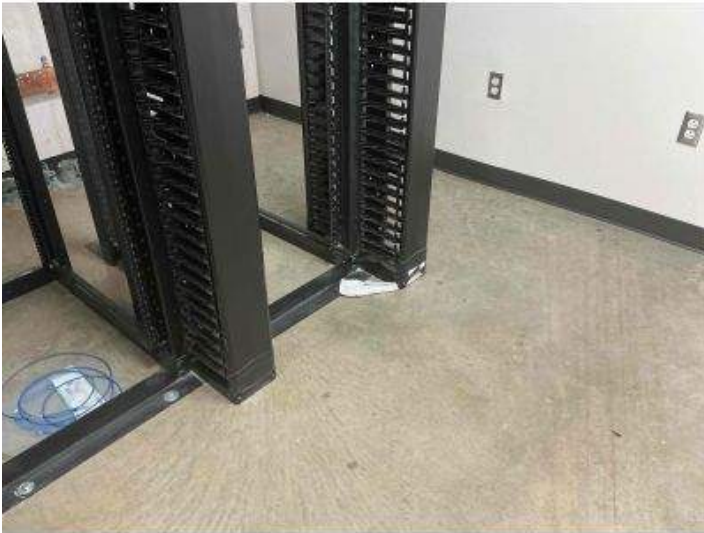
<b>Description</b>	Clean floor and remove trash. <span style="background-color: yellow;">Completed</span>
<b>Assigned to</b>	—
<b>Created by</b>	<b>Joey Yzaguirre</b> (ERO Architects)
<b>Created on</b>	Sep 15, 2025
<b>Issue owner</b>	<b>Joey Yzaguirre</b> (ERO Architects)
<b>Location</b>	—
<b>Location details</b>	—
<b>Due date</b>	—
<b>Root cause</b>	—
<b>Reference drawing</b>	<a href="#">AE102 [V1]</a>

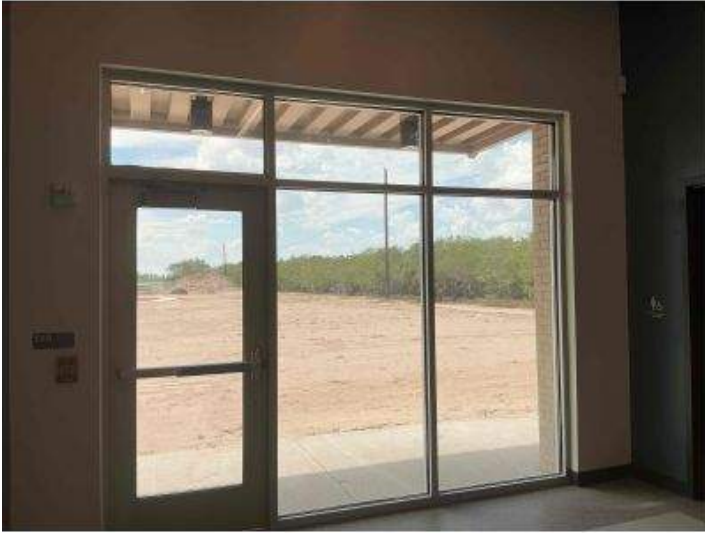
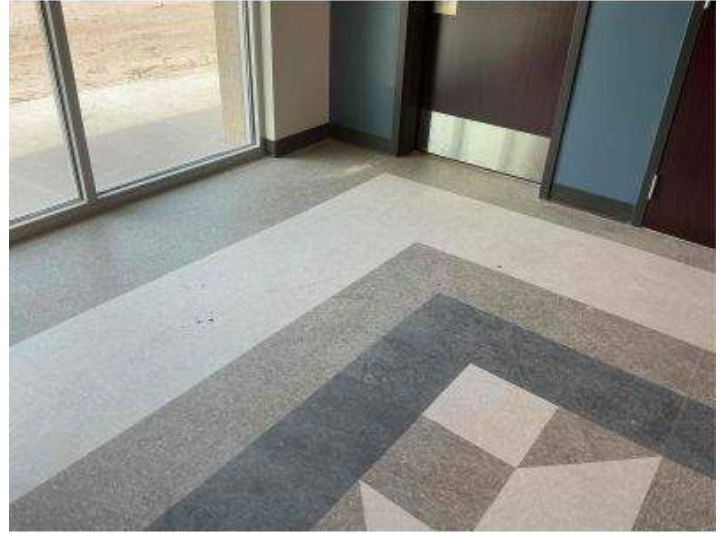
<b>Description</b>	Clean VCT floor and clean storefront windows.	<b>Completed</b>
<b>Assigned to</b>	—	
<b>Created by</b>	<b>Joey Yzaguirre</b> (ERO Architects)	
<b>Created on</b>	Sep 15, 2025	
<b>Issue owner</b>	<b>Joey Yzaguirre</b> (ERO Architects)	
<b>Location</b>	—	
<b>Location details</b>	—	
<b>Due date</b>	—	
<b>Root cause</b>	—	
<b>Reference drawing</b>	<a href="#">AE102 [V1]</a>

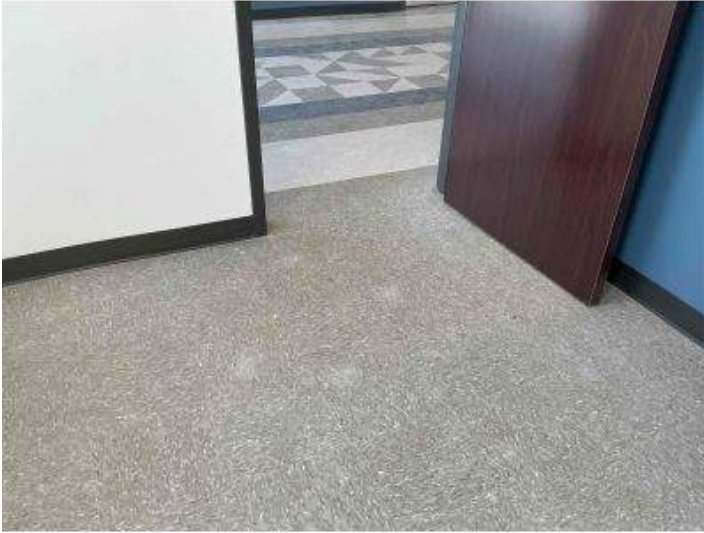
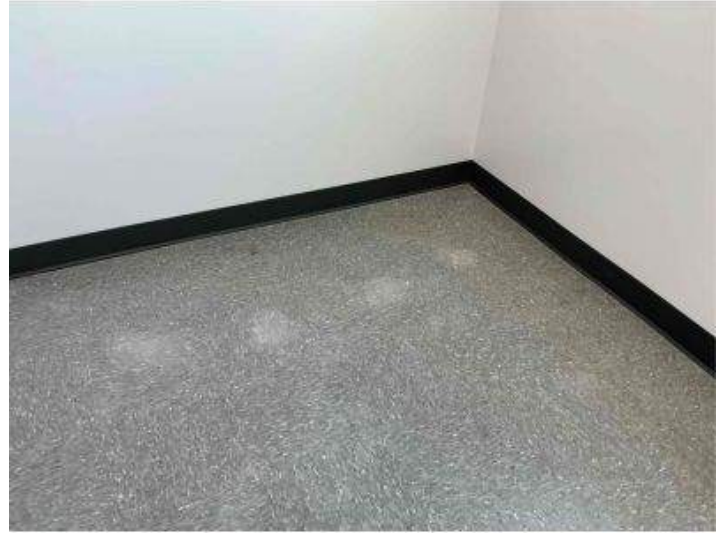
<b>Description</b>	Clean VCT floor. <span style="background-color: yellow;">Completed</span>
<b>Assigned to</b>	—
<b>Created by</b>	<b>Joey Yzaguirre</b> (ERO Architects)
<b>Created on</b>	Sep 15, 2025
<b>Issue owner</b>	<b>Joey Yzaguirre</b> (ERO Architects)
<b>Location</b>	—
<b>Location details</b>	—
<b>Due date</b>	—
<b>Root cause</b>	—
<b>Reference drawing</b>	<a href="#">AE102 [V1]</a>

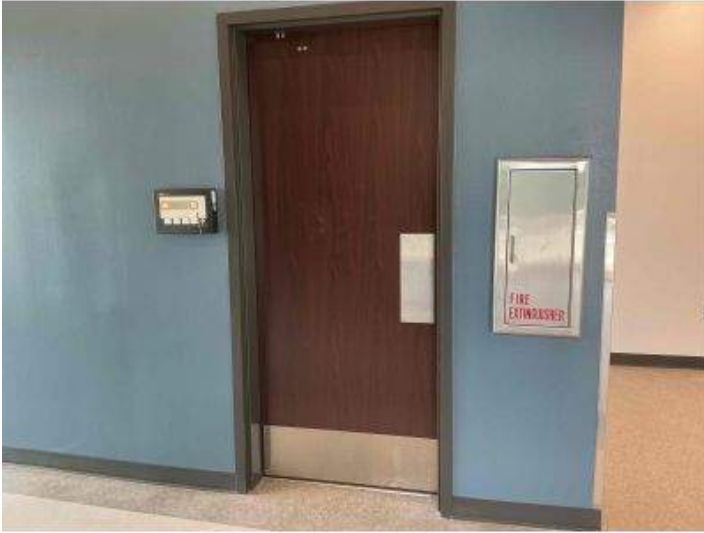
<b>Description</b>	Missing men's rr signage. <span style="background-color: yellow;">Pending</span>
<b>Assigned to</b>	—
<b>Created by</b>	Joey Yzaguirre (ERO Architects)
<b>Created on</b>	Sep 15, 2025
<b>Issue owner</b>	Joey Yzaguirre (ERO Architects)
<b>Location</b>	—
<b>Location details</b>	—
<b>Due date</b>	—
<b>Root cause</b>	—
<b>Reference drawing</b>	<a href="#">AE102 [V1]</a>

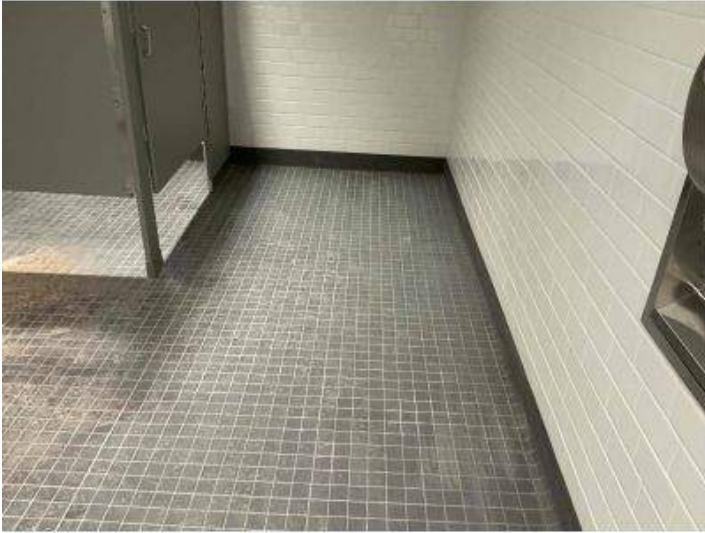
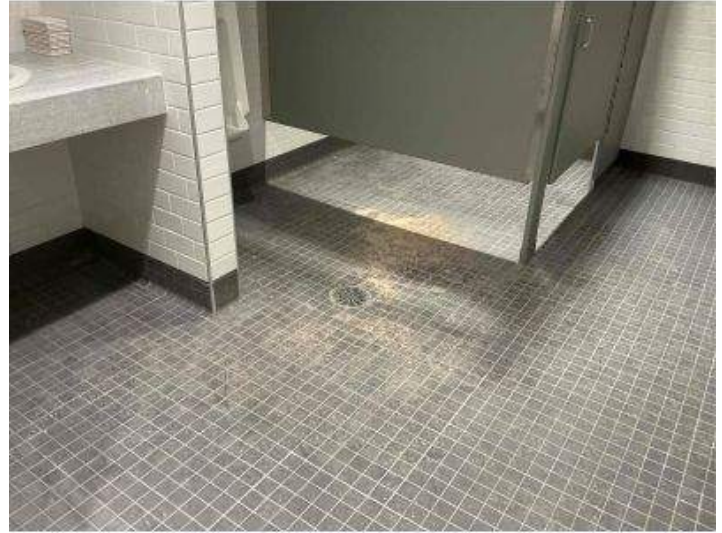
<b>Description</b>	Remove dirt from floor and clean floor.	Completed
<b>Assigned to</b>	—	
<b>Created by</b>	Joey Yzaguirre (ERO Architects)	
<b>Created on</b>	Sep 15, 2025	
<b>Issue owner</b>	Joey Yzaguirre (ERO Architects)	
<b>Location</b>	—	
<b>Location details</b>	—	
<b>Due date</b>	—	
<b>Root cause</b>	—	
<b>Reference drawing</b>	<a href="#">AE102 [V1]</a>

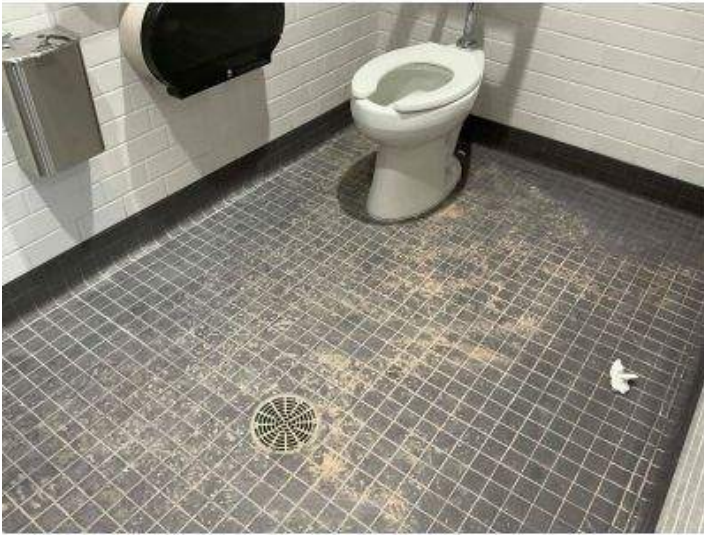
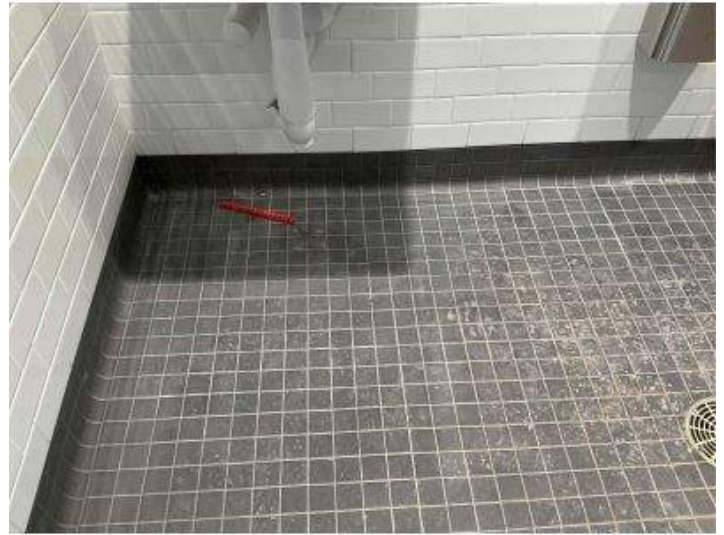
<b>Description</b>	Remove dirt from floor and clean floor.	Completed
<b>Assigned to</b>	—	
<b>Created by</b>	Joey Yzaguirre (ERO Architects)	
<b>Created on</b>	Sep 15, 2025	
<b>Issue owner</b>	Joey Yzaguirre (ERO Architects)	
<b>Location</b>	—	
<b>Location details</b>	—	
<b>Due date</b>	—	
<b>Root cause</b>	—	
<b>Reference drawing</b>	AE102 [V1]

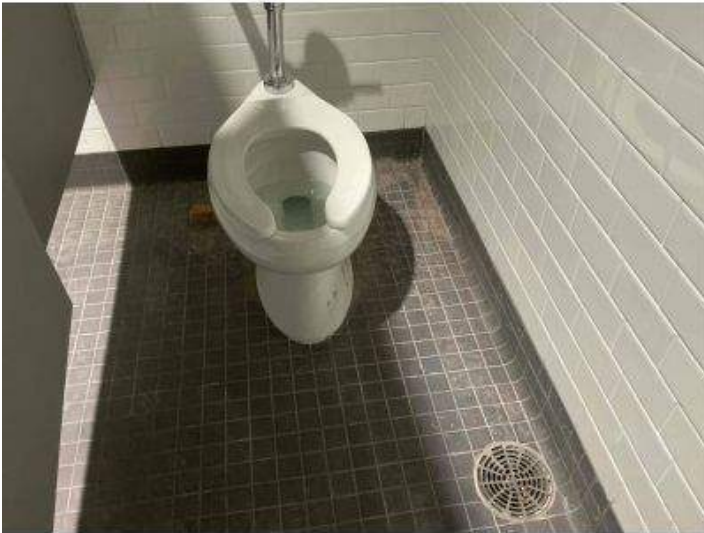
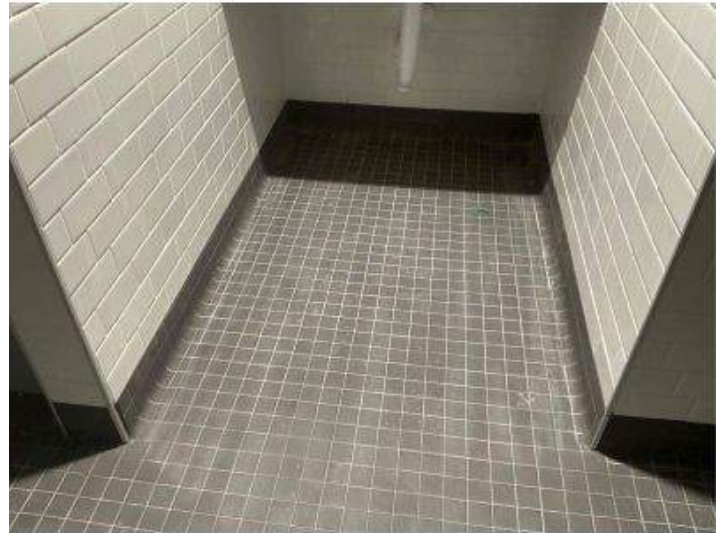
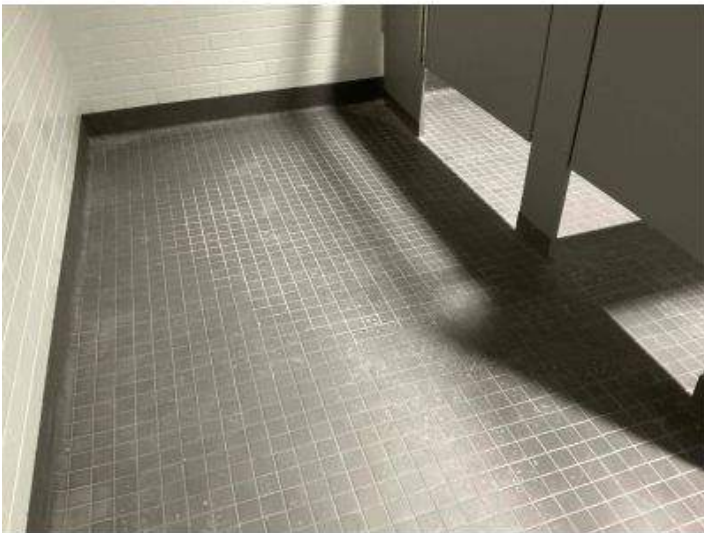
<b>Description</b>	Clean entire floor. <span style="background-color: yellow;">Completed</span>
<b>Assigned to</b>	—
<b>Created by</b>	Joey Yzaguirre (ERO Architects)
<b>Created on</b>	Sep 15, 2025
<b>Issue owner</b>	Joey Yzaguirre (ERO Architects)
<b>Location</b>	—
<b>Location details</b>	—
<b>Due date</b>	—
<b>Root cause</b>	—
<b>Reference drawing</b>	<a href="#">AE102 [V1]</a>

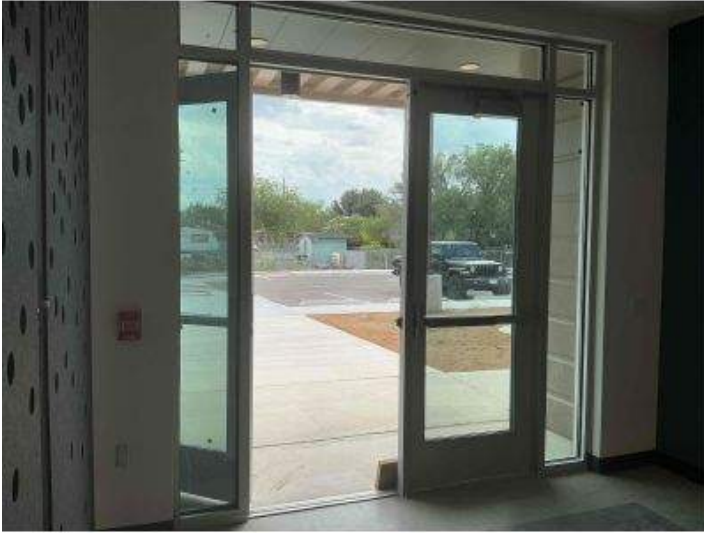
<b>Description</b>	Clean storefront windows. <span style="background-color: yellow;">Completed</span>
<b>Assigned to</b>	—
<b>Created by</b>	<b>Joey Yzaguirre</b> (ERO Architects)
<b>Created on</b>	Sep 15, 2025
<b>Issue owner</b>	<b>Joey Yzaguirre</b> (ERO Architects)
<b>Location</b>	—
<b>Location details</b>	—
<b>Due date</b>	—
<b>Root cause</b>	—
<b>Reference drawing</b>	<a href="#">AE102 [V1]</a>

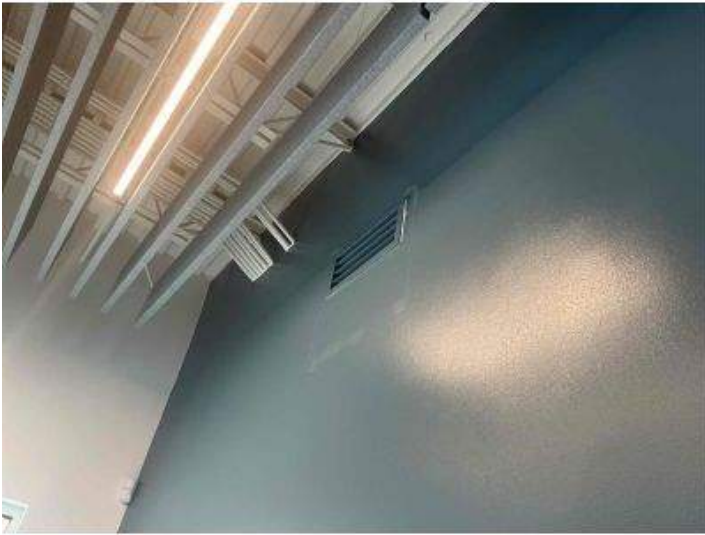
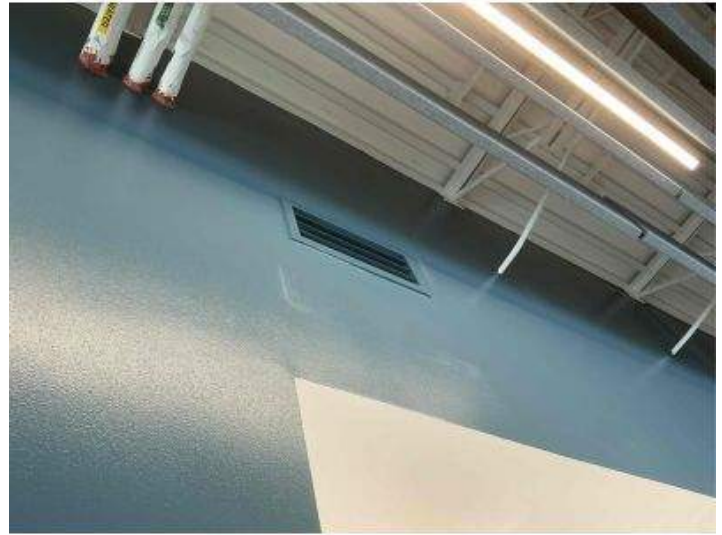
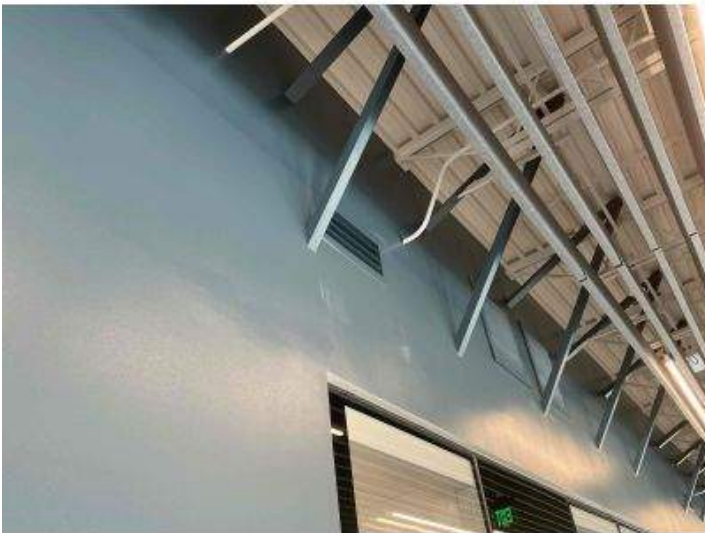
<b>Description</b>	Touch up paint at diffusers.	<b>Completed</b>
<b>Assigned to</b>	—	
<b>Created by</b>	<b>Joey Yzaguirre</b> (ERO Architects)	
<b>Created on</b>	Sep 15, 2025	
<b>Issue owner</b>	<b>Joey Yzaguirre</b> (ERO Architects)	
<b>Location</b>	—	
<b>Location details</b>	—	
<b>Due date</b>	—	
<b>Root cause</b>	—	
<b>Reference drawing</b>	<a href="#">AE102 [V1]</a>

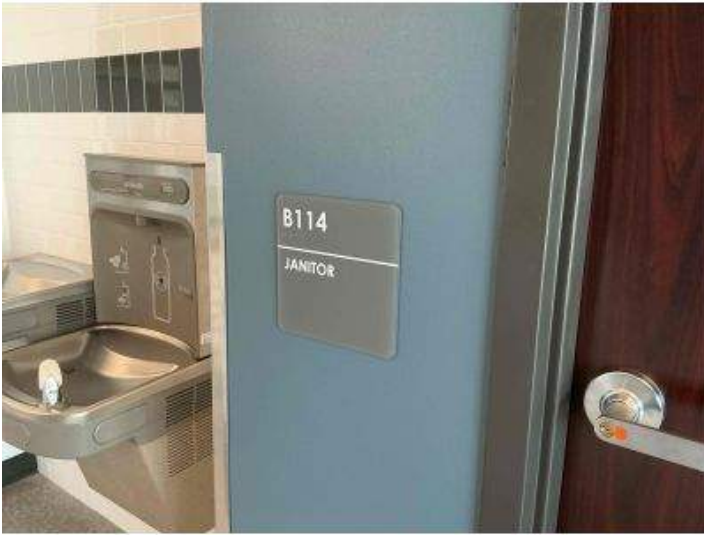
<b>Description</b>	I couldn't access janitor rm. room was locked.	Completed
<b>Assigned to</b>	—	
<b>Created by</b>	Joey Yzaguirre (ERO Architects)	
<b>Created on</b>	Sep 15, 2025	
<b>Issue owner</b>	Joey Yzaguirre (ERO Architects)	
<b>Location</b>	—	
<b>Location details</b>	—	
<b>Due date</b>	—	
<b>Root cause</b>	—	
<b>Reference drawing</b>	AE102 [V1]

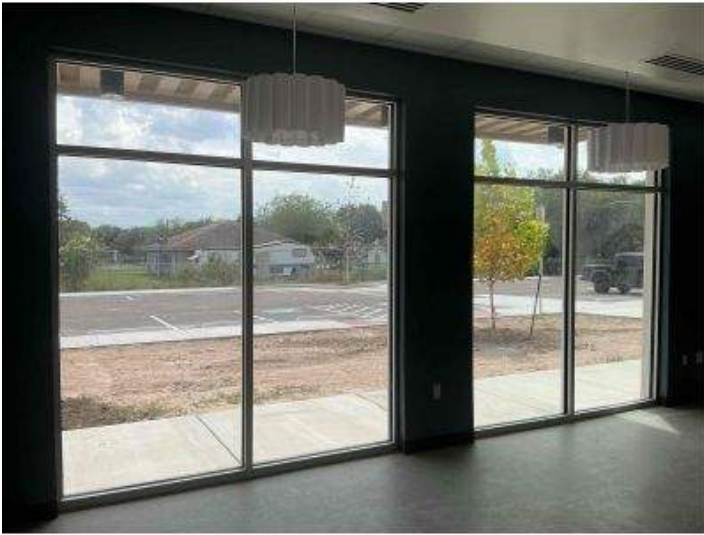
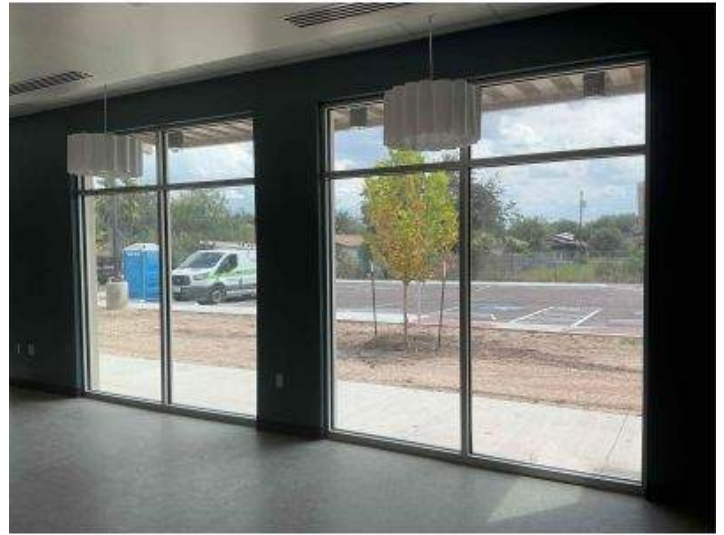
<b>Description</b>	Clean storefront windows.	<b>Completed</b>
<b>Assigned to</b>	—	
<b>Created by</b>	<b>Joey Yzaguirre</b> (ERO Architects)	
<b>Created on</b>	Sep 15, 2025	
<b>Issue owner</b>	<b>Joey Yzaguirre</b> (ERO Architects)	
<b>Location</b>	—	
<b>Location details</b>	—	
<b>Due date</b>	—	
<b>Root cause</b>	—	
<b>Reference drawing</b>	<a href="#">AE102 [V1]</a>

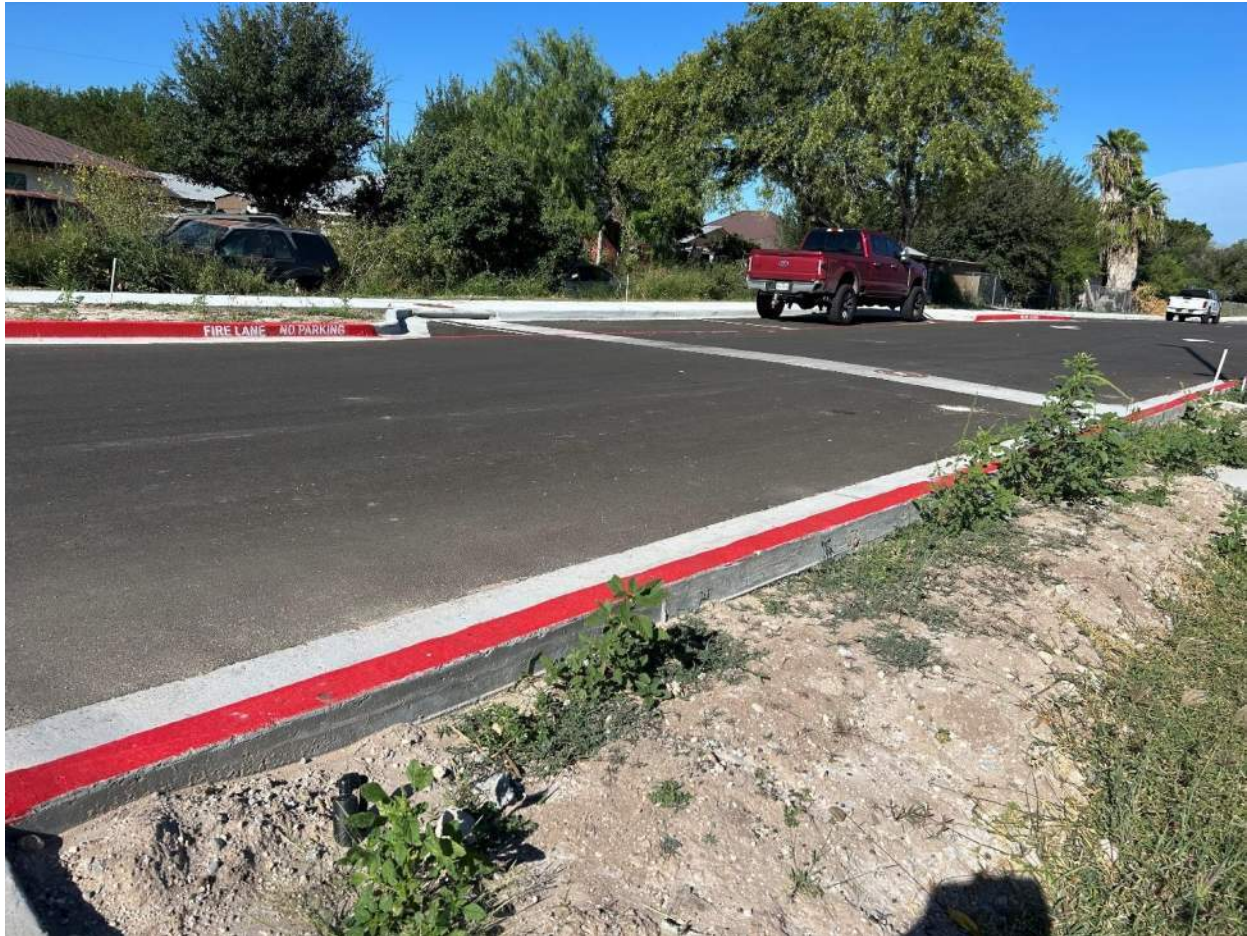
Photo 1

ITEM NO.	LOCATION (AREA)	DESCRIPTION	COMPLETION DATE (GC CHECK DATE)	A/E CHECK DATE	OWNER CHECK DATE
1.	South side of detention area	Contractor to backfill behind back of curb in detention area. See Photo 1.

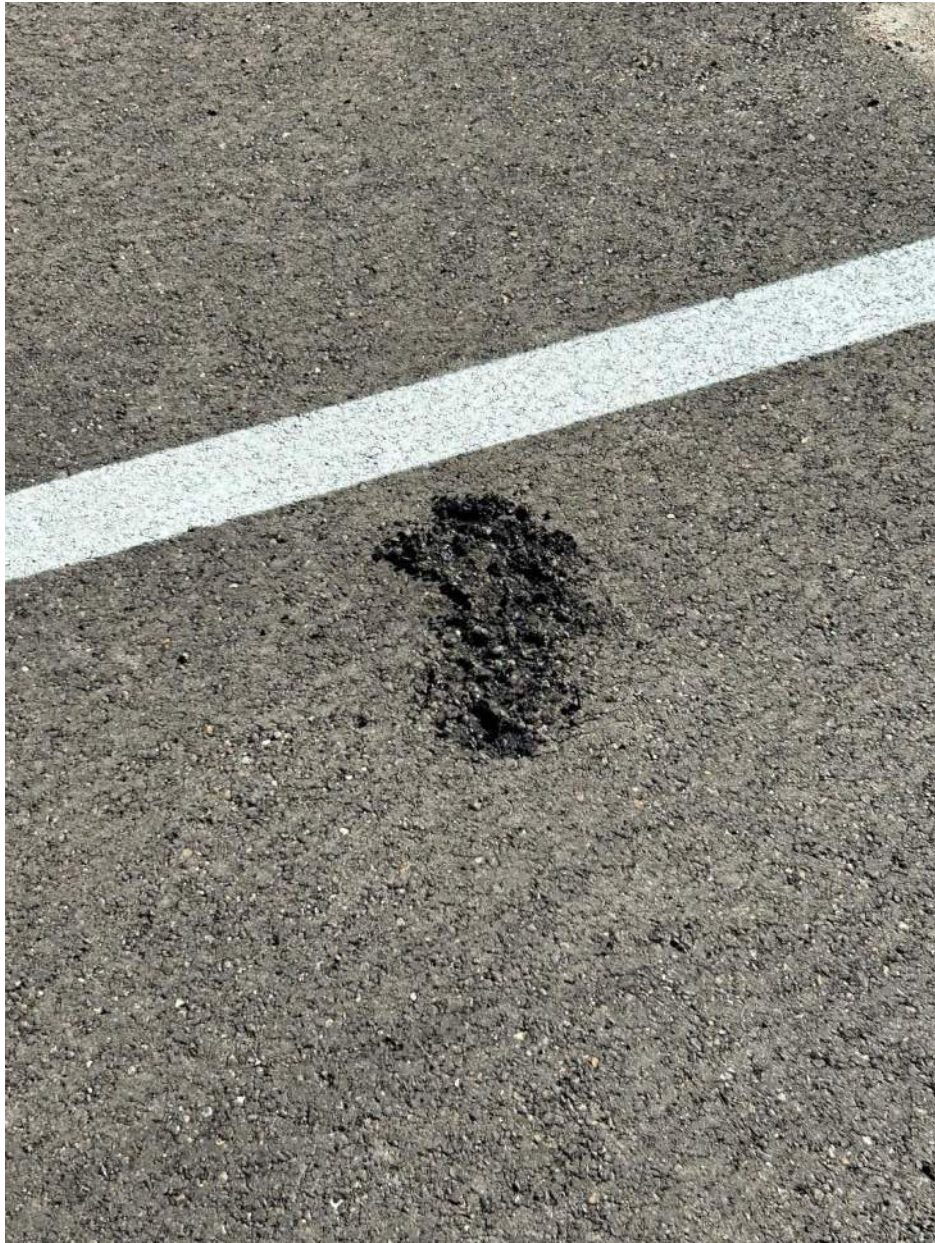
Photo 2

2.	Throughout site	Asphalt needs to be fixed in areas that are raveling throughout site. See Photo 2.			
3.	Northeast corner of East Building	Concrete patch needed. See Photo 3.

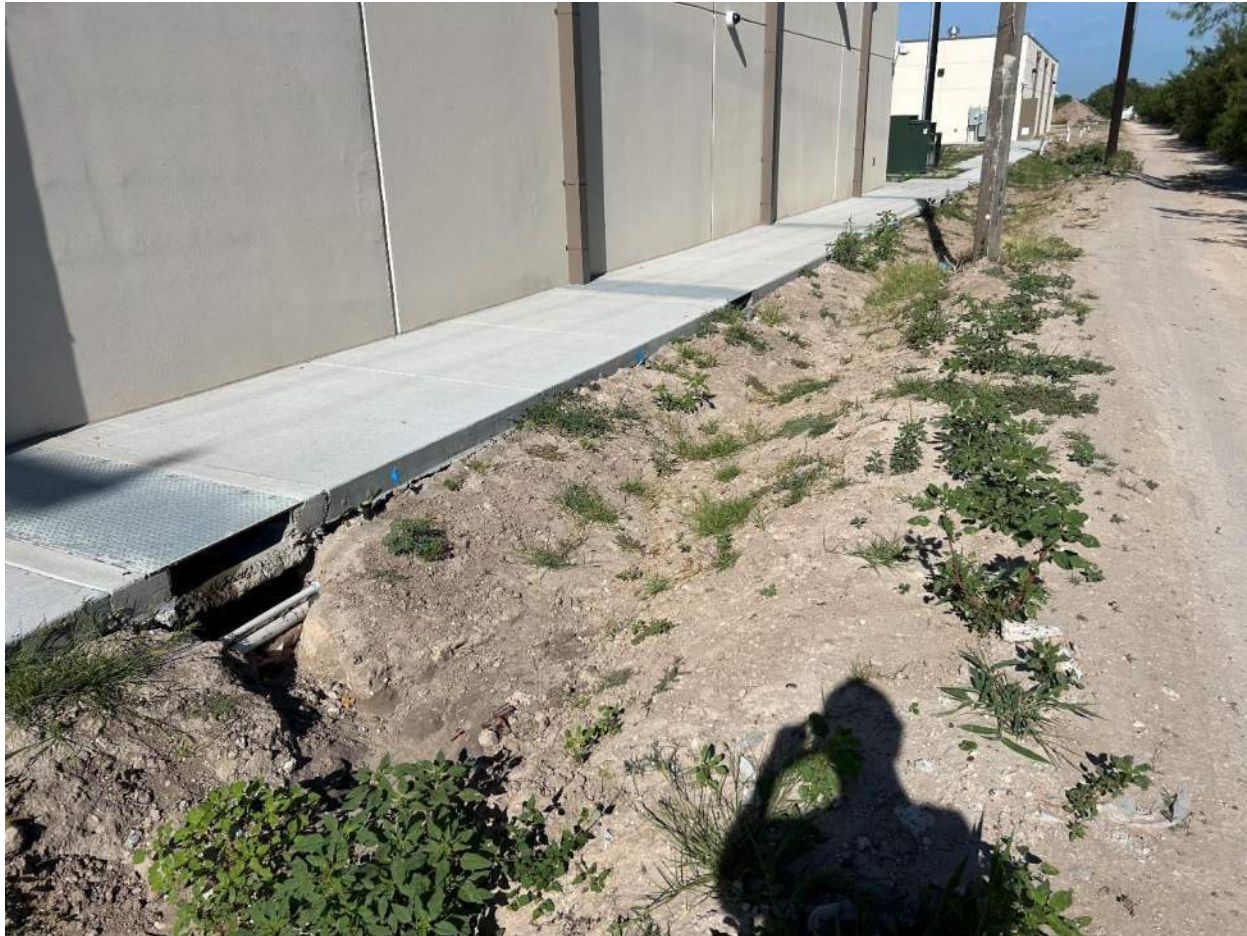
Photo 4

4.	North side of East Building	Swales need to be regraded to match existing grade. See Photo 4.			
5.	Northeast corner of East Building	RCP at grate inlet needs to be cleaned out. See Photo 5.

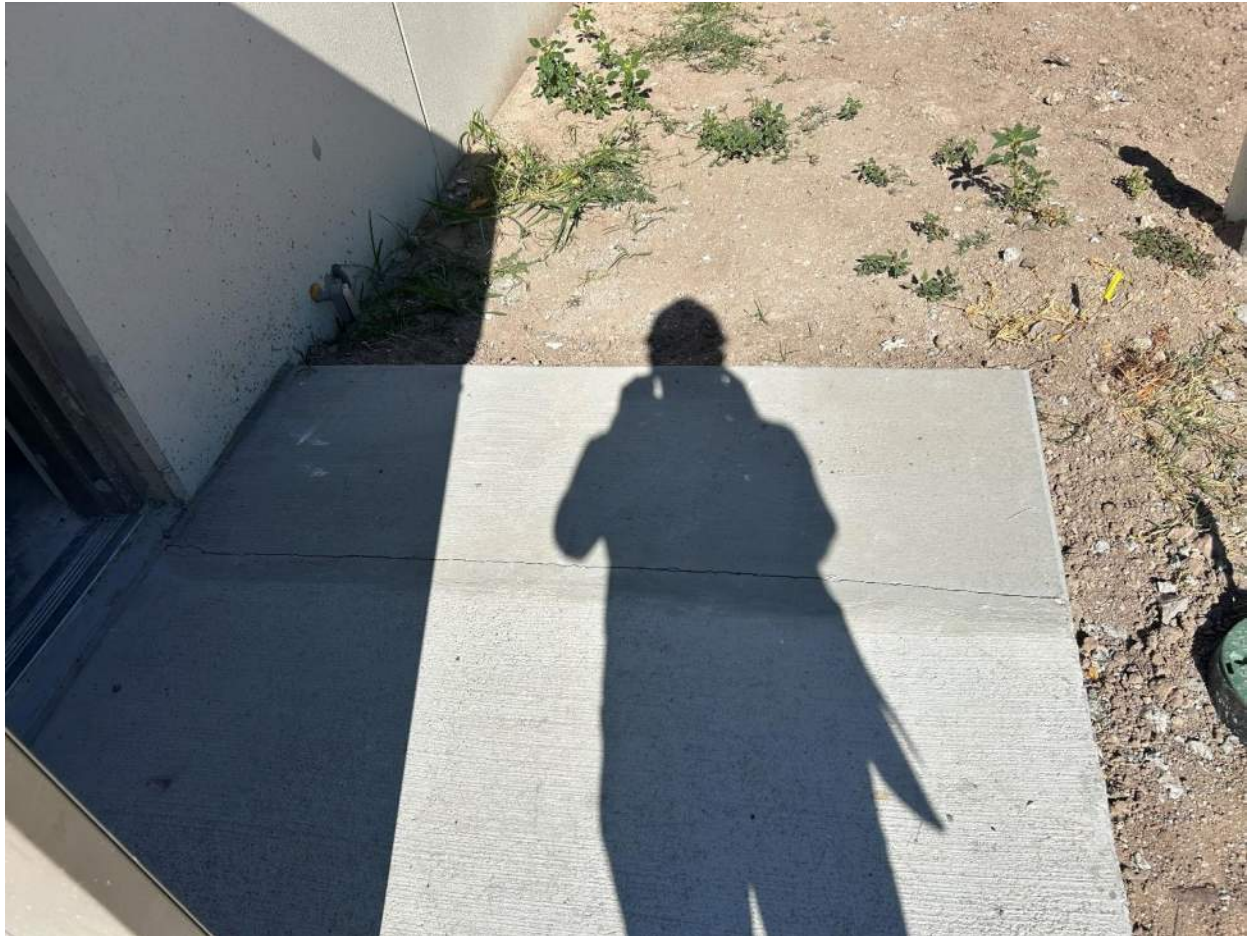
Photo 6

6.	Northeast corner of West Building	Section of concrete needs to be sawcut and replaced. See Photo 6.			
7.	Eastside of West Building	Cleanouts need to be flush with sidewalk. See Photo 7.

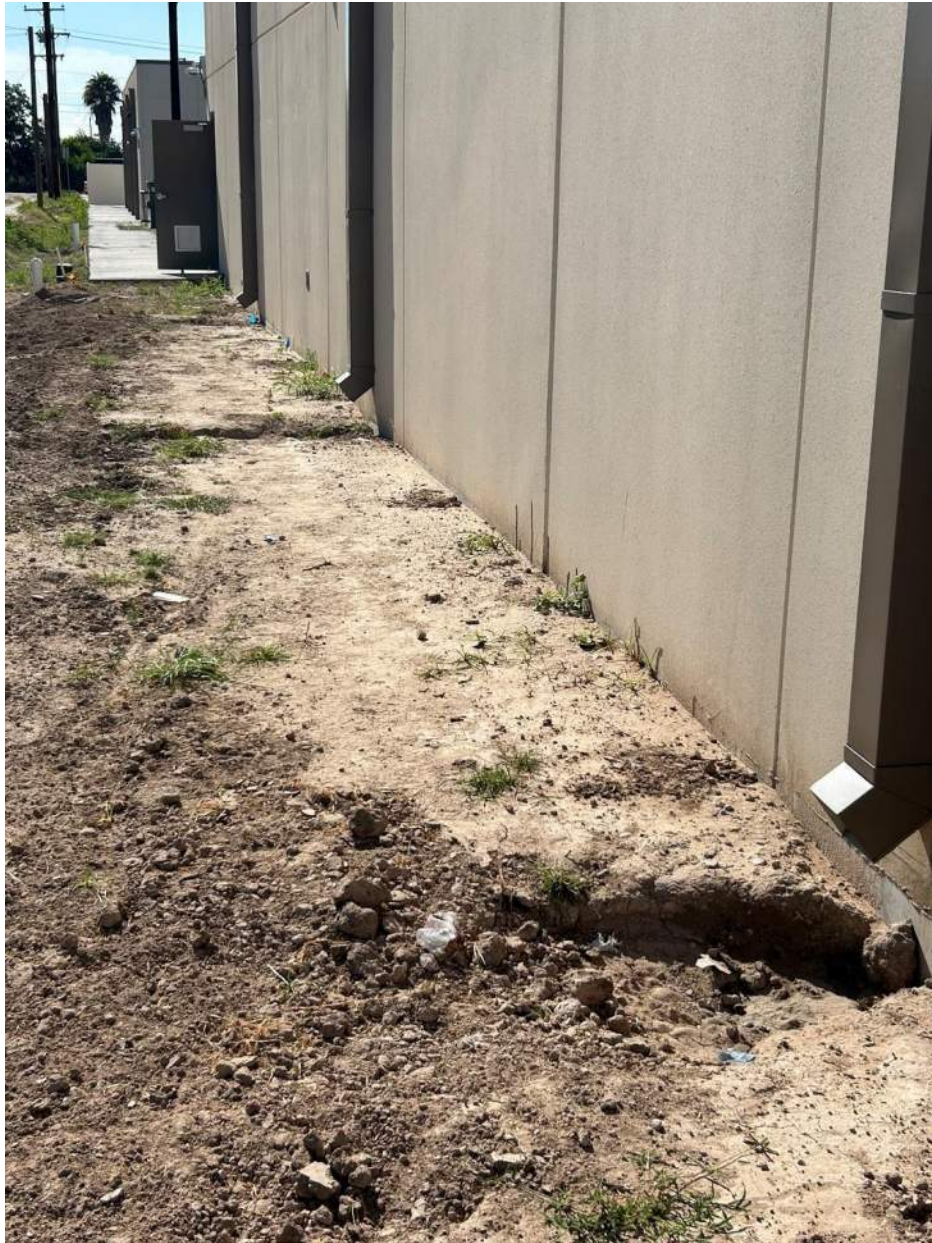
Photo 8

8.	North side of West Building	Add splash blocks as per plans. See Photo 8.			
9.	Throughout site	General sidewalk cleanup. See Photo 9.			
10.	Ramp on South side of West Building	Fix curb to match ramp edge. See Photo 10.
