## Certificate of Substantial Completion

**PROJECT:** *(name and address)*  
Hidalgo County El Paraiso Health Clinic & Community Resource Center

**CERTIFICATE INFORMATION:**  
Certificate Number: 001  
Date: June 15, 2026

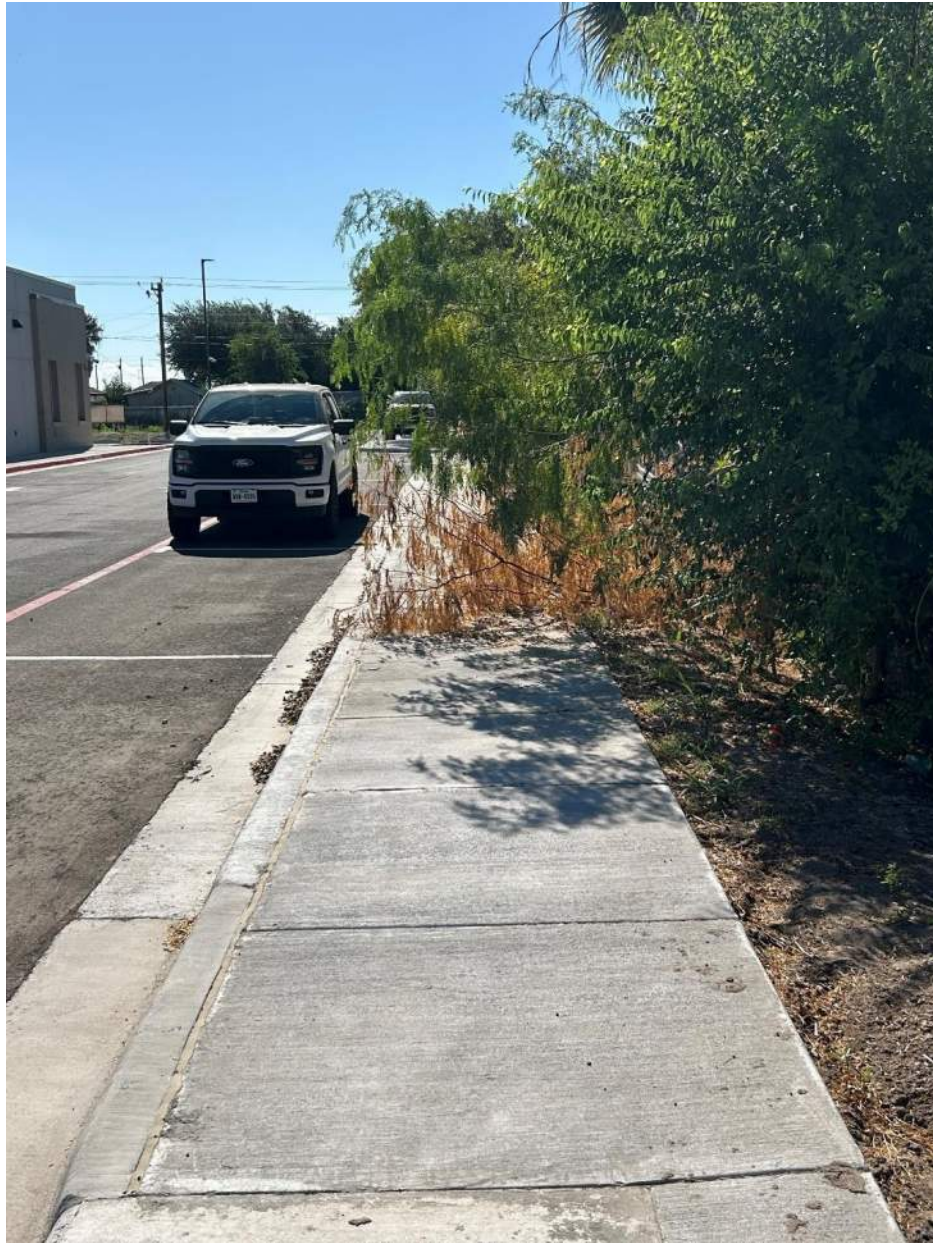
Photo 11

11.	Throughout sidewalk	General brush cleanup throughout site. See Photo 11.

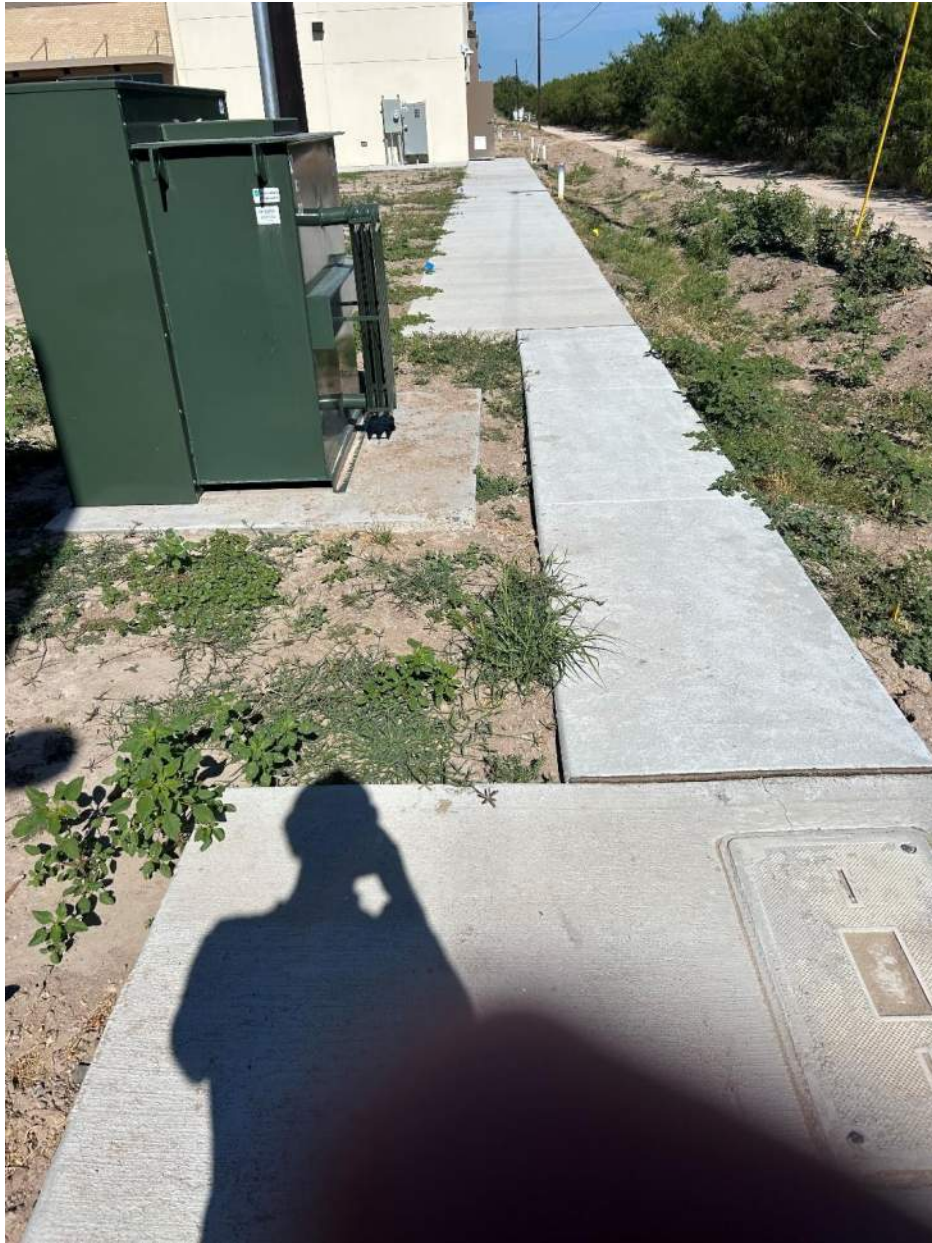
Photo 12

12.	Northwest side near East Building	Width of concrete sidewalk does not match plans. See Photo 12.			
13.	Throughout site	General debris cleanup throughout site. See Photo 13.

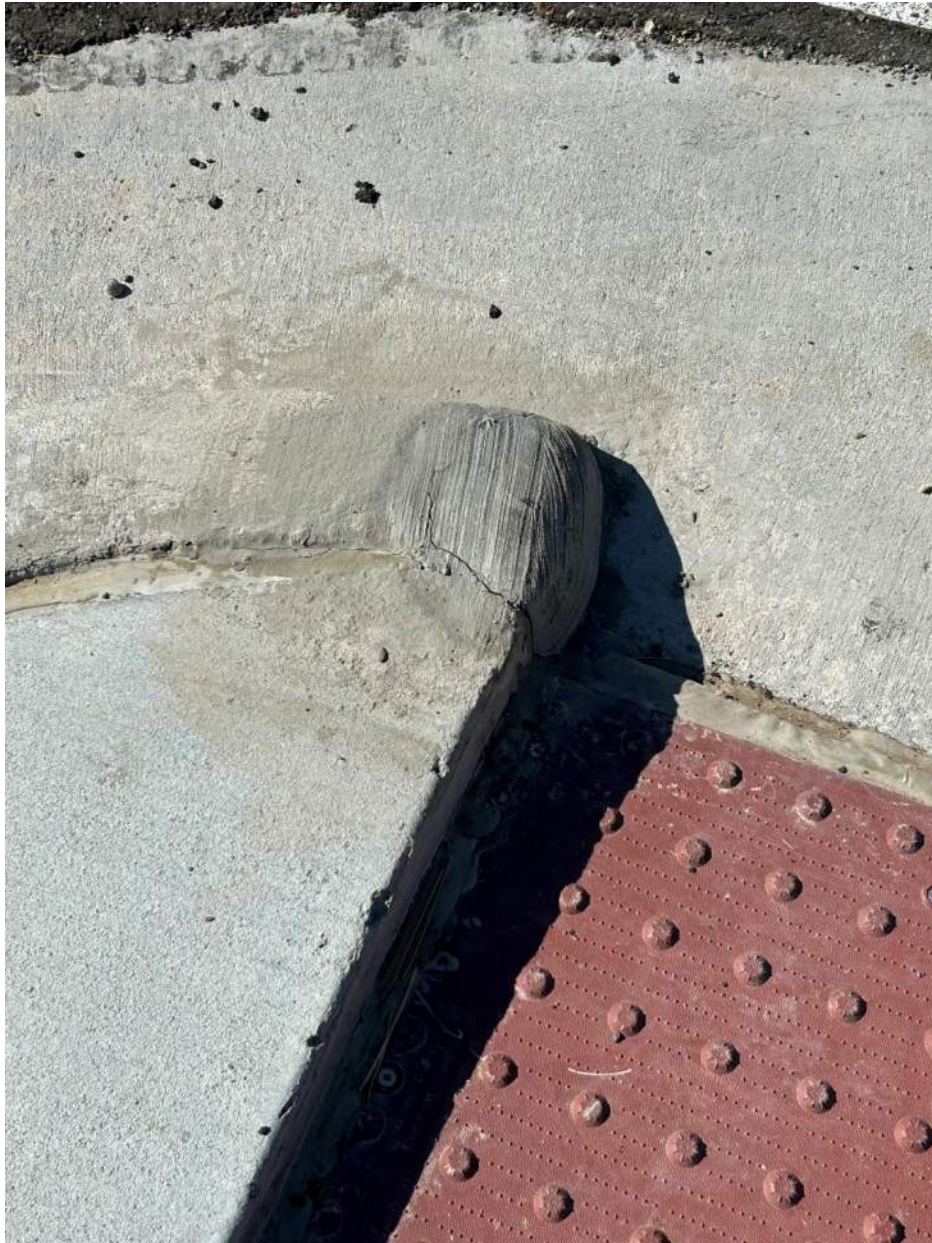
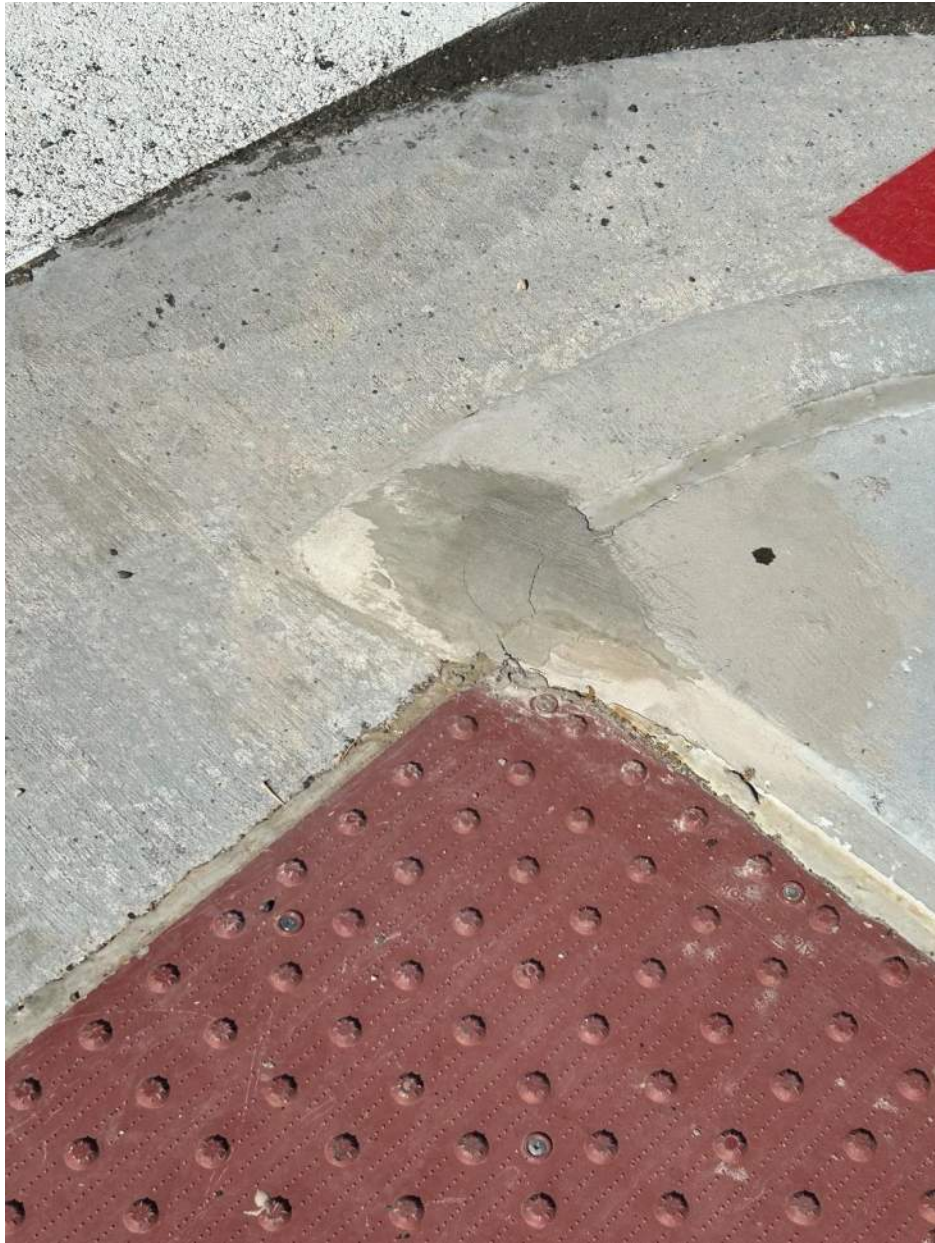
14.	Ramp on South side of West Building	Fix concrete on corner of curb. See Photo 14 and 15.			
15.	South side of West Building	Three concrete panels need to be replaced between West Building sidewalk and parking lot sidewalk. See Photo 16.

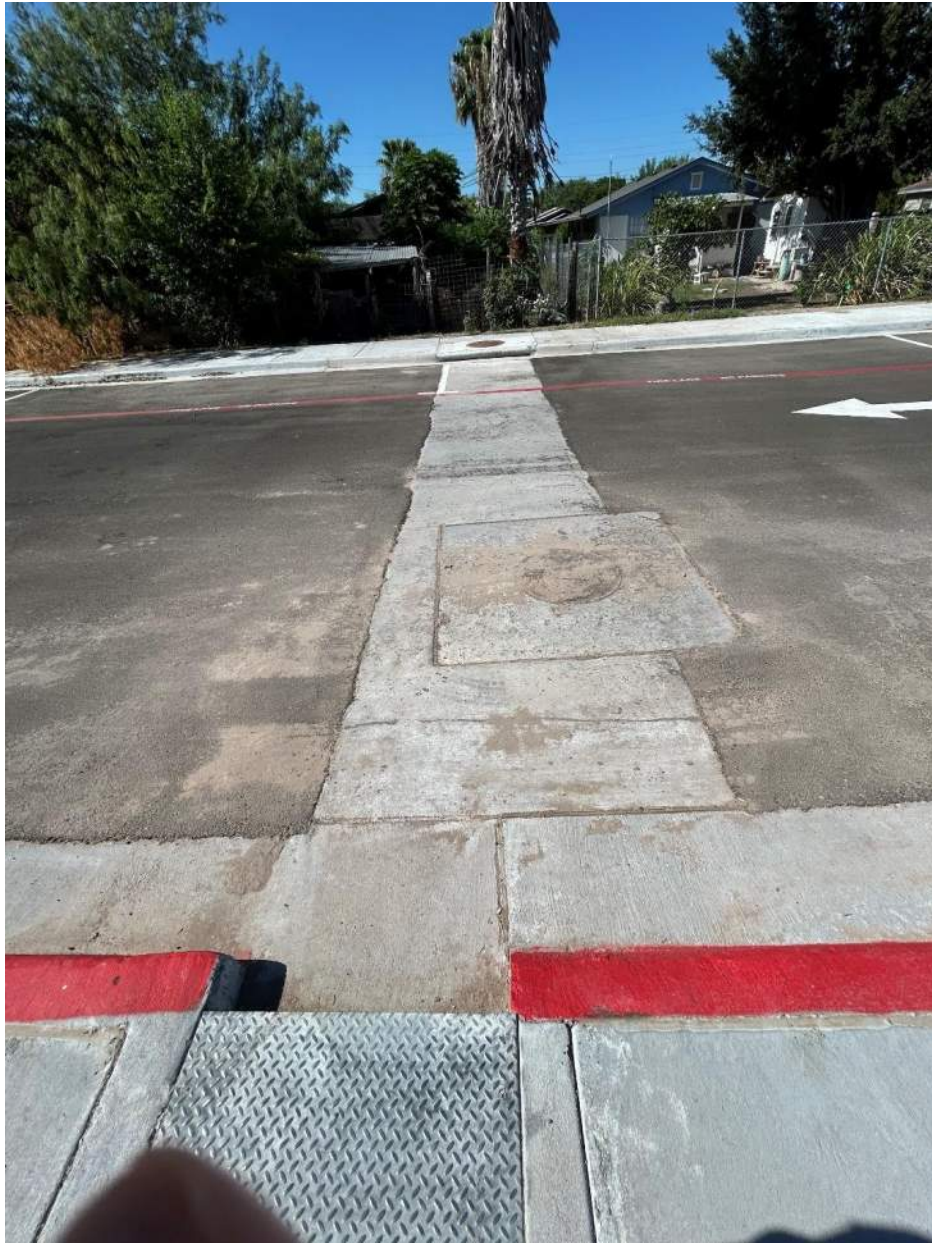
Photo 17

16.	South side of site on main drive	Concrete needs to be reworked for positive flow between sidewalk flume and inlet. See Photo 17.			
17.	Throughout site	Concrete needs to be patched throughout site. See Photo 18 and 22.

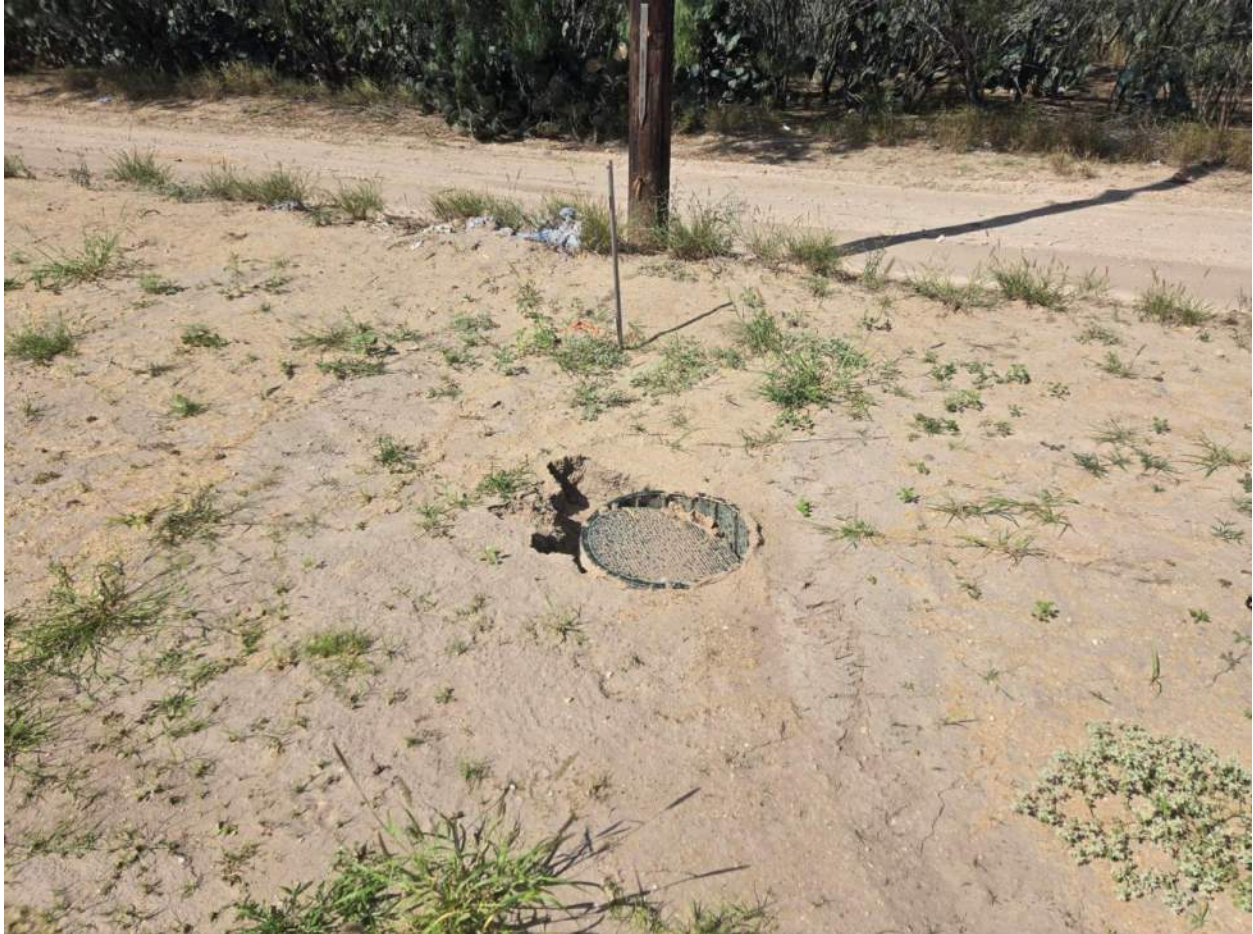
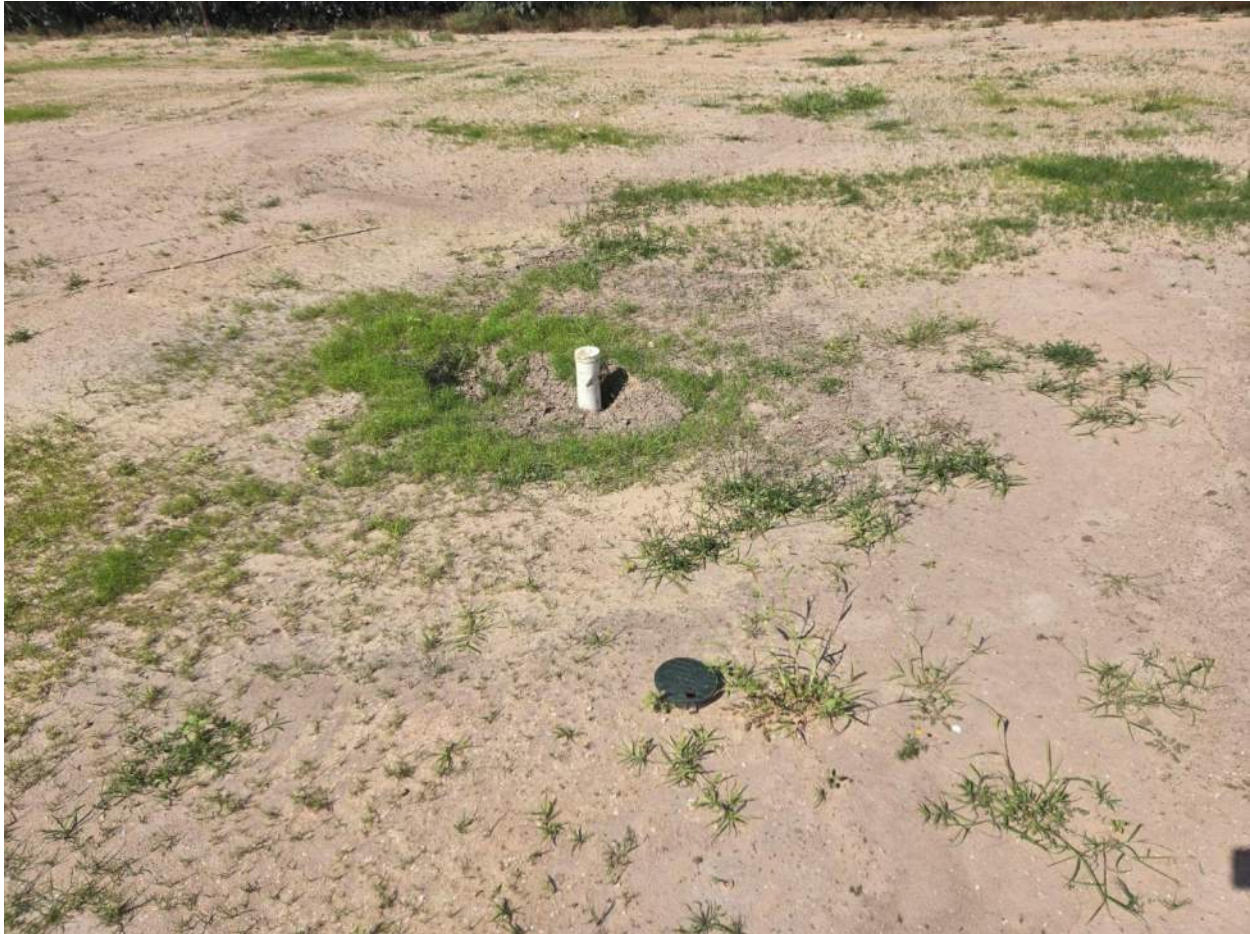
18.	Septic Leech Fields	Compaction is required at several locations to prevent sinking in. replace broken inspection ports, clean outs, and access points. Refer to Photos 19 and 20.

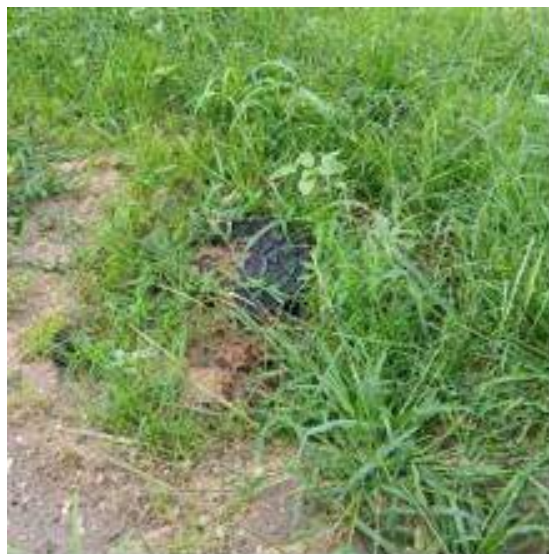
Photo 21

19.	Front of the Property	Cast Iron Cleanout to be adjusted to grade to prevent mowing hazard. See Photo 21.

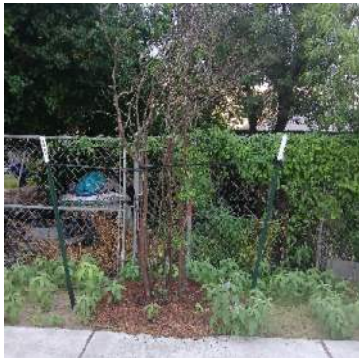
1. ½ dead Texas Persimmon. Replace with specified Texas Persimmon.

We can replace it with Rosemary and Butterfly Weed if appropriate for that area.

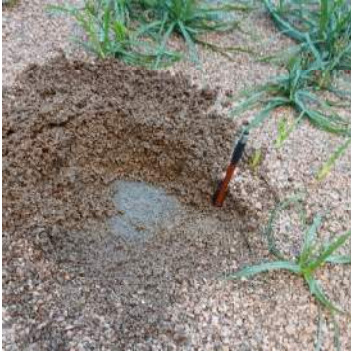
3. All areas of the decomposed aggregate are less than the 4 inches specified (typical).

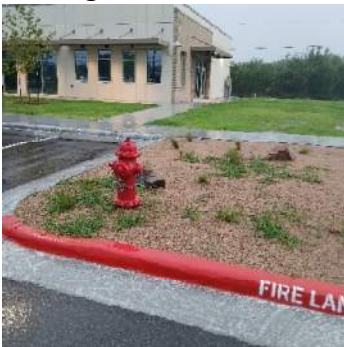
4. Remove all weeds in plant beds for the 90-day maintenance period. One (1) Powder Puff missing in this area. Earth & Irrigation

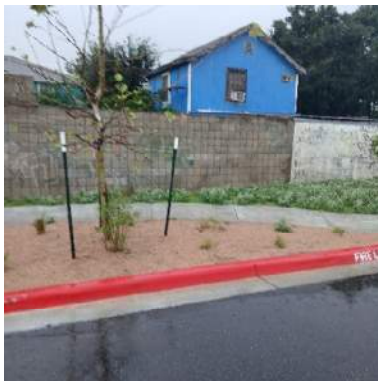
5. One Firecracker plant missing in this planter. Earth & Irrigation

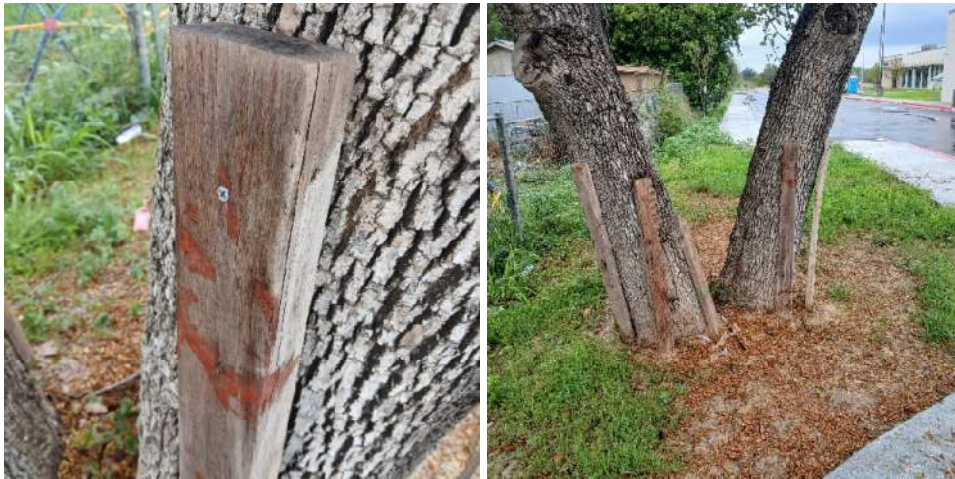
6. Remove all 2x4 wood from existing tree. **NM**

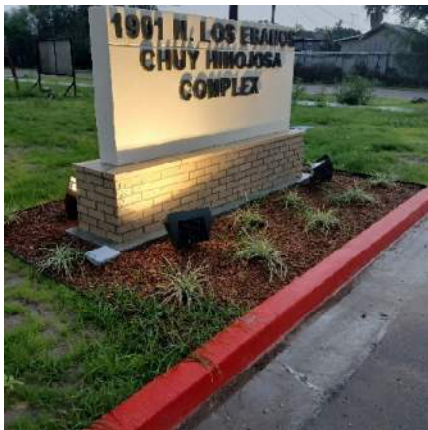
7. Adjust irrigation heads to not spray directly on the property main entry signage.

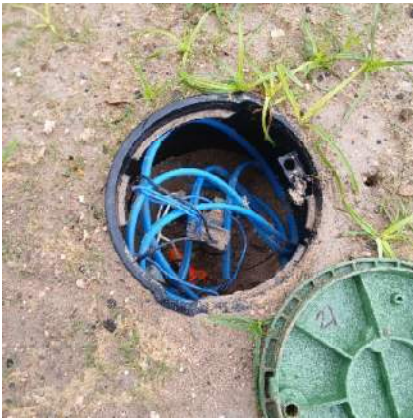
8. Add aggregate to base of all valve boxes as well as main water meter for the irrigation system (typical). **Earth & Irrigation**

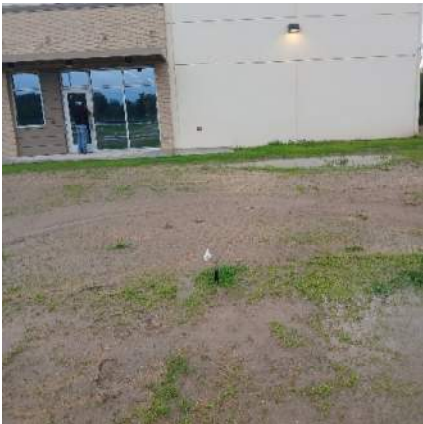
9. Repair and adjust all irrigation heads (typical). **Earth & Irrigation**

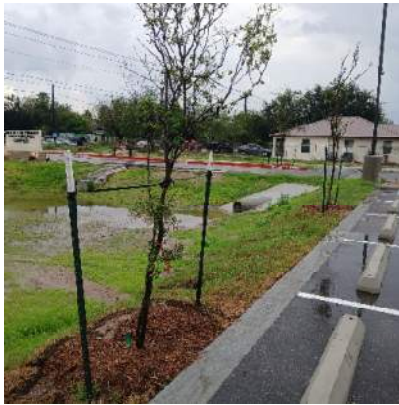
10. Provide T post caps for all T post. This is a hazard once the project is open to the public.

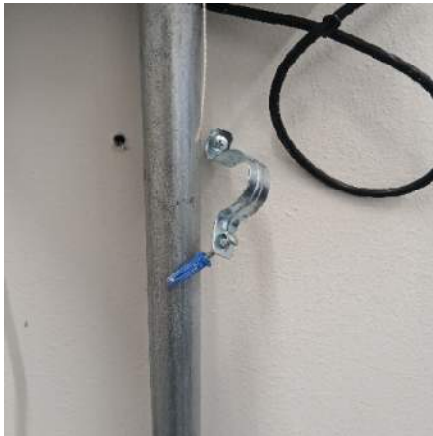
11. Repair mounting bracket.

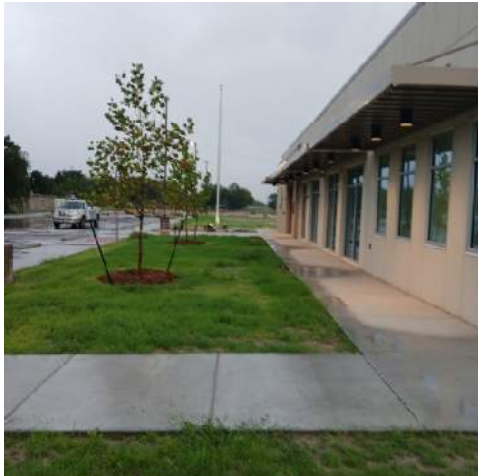
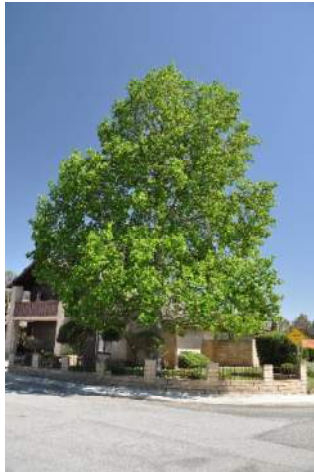
1. I do not recommend a large canopy tree next to the new building and area lights. In time the trees will grow well beyond the areas next to the open area and will deface the buildings with tree limbs craping the buildings as well as cover the pedestrian lighting as well as the parking lighting. I recommend they be removed and replaced with a small canopy native tree such as what was specified. Photo below shows a mature Mexican Sycamore. [HidalgoCounty](#)

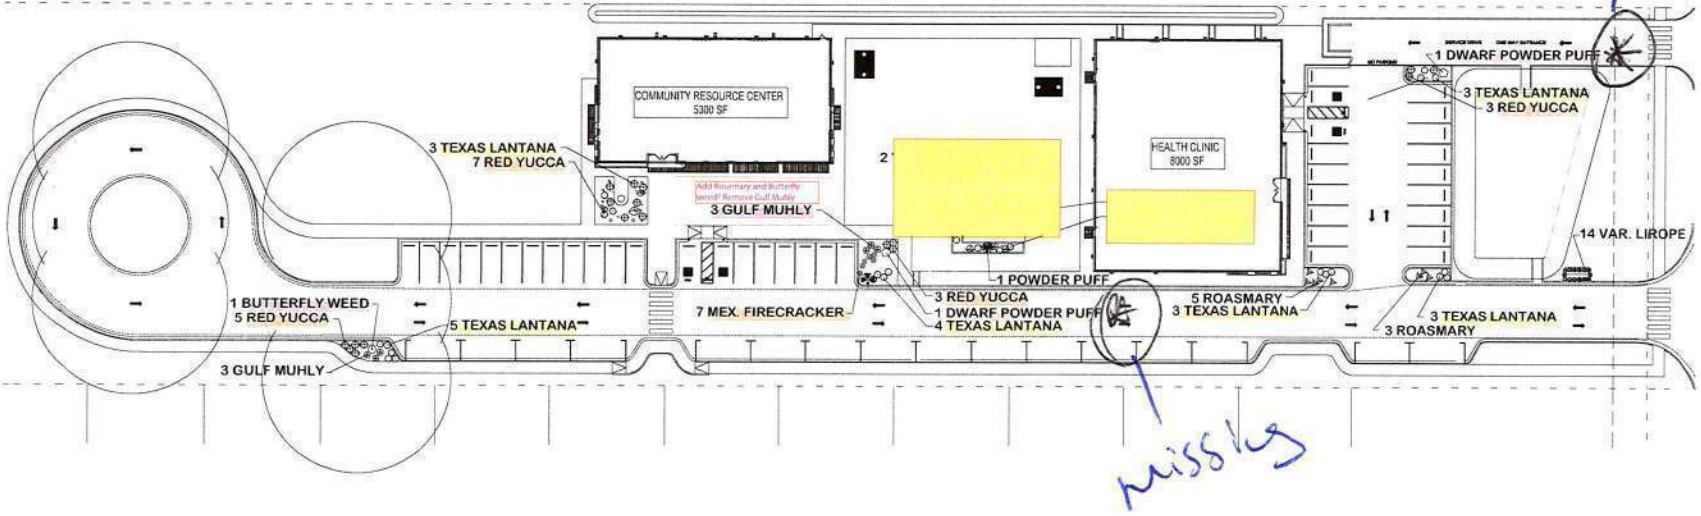
(powder puff)  
 missing
