# Coon Rapids Dam Pool Shoreline Inventory

*The Minnesota Department of Natural Resources*

December 2012

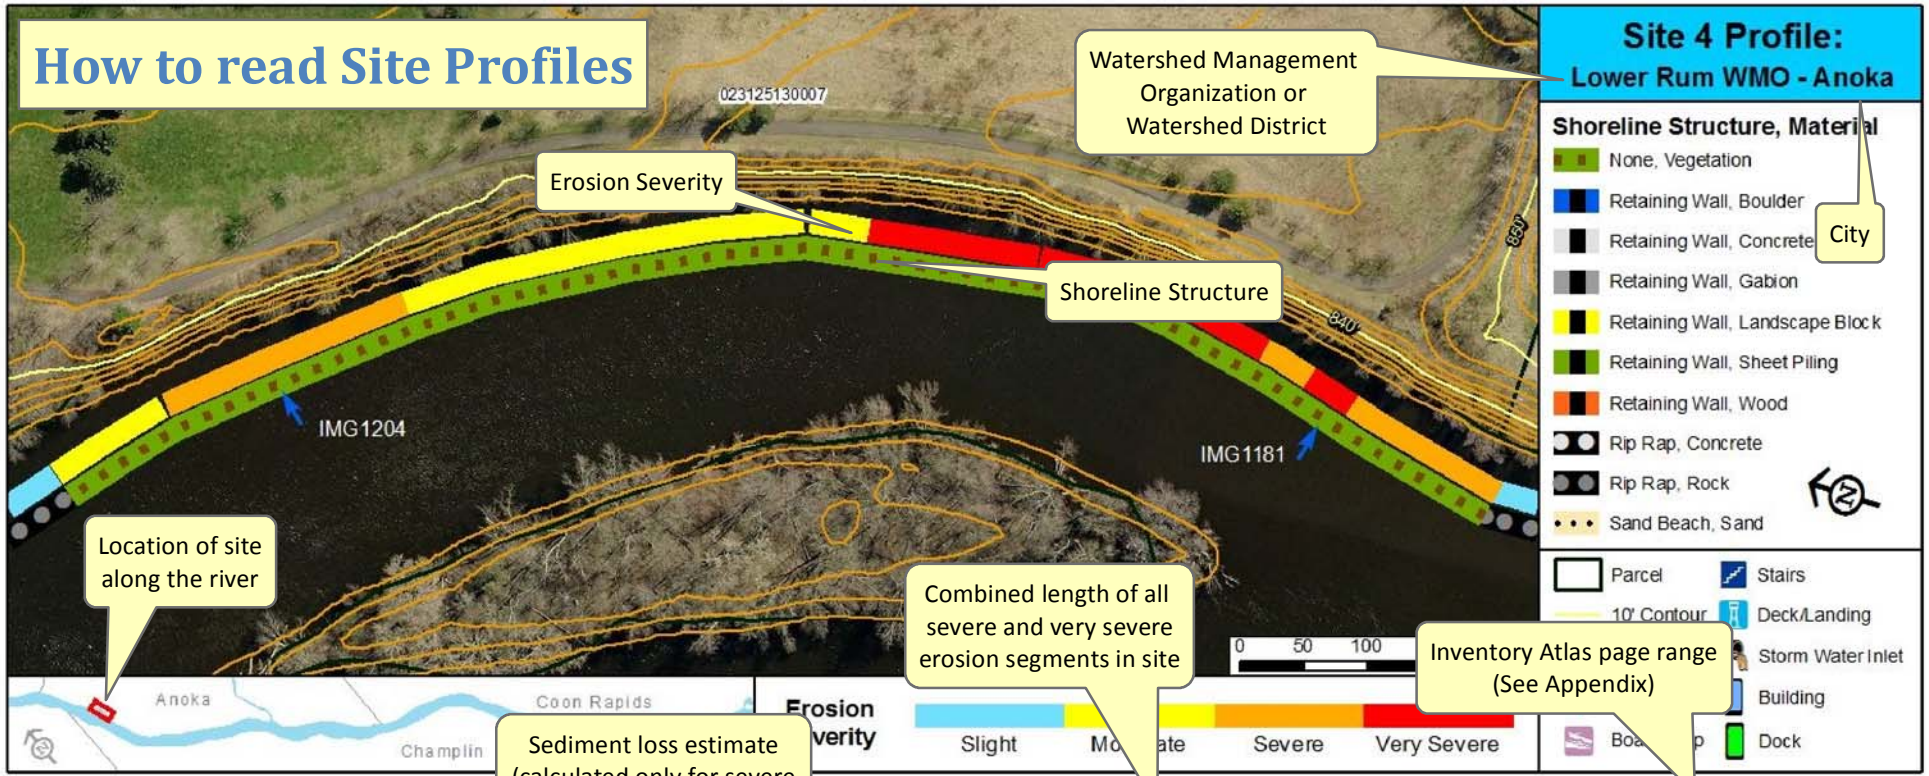
**Additional Info:** Located on a cut-bank, this area is likely to be hit by large sheets of ice in the spring. Many slumping and recently fallen trees show the fast pace of soil loss here. Root overhangs of several feet are widespread in the areas marked severe and very severe. A paved City of Anoka bike trail runs along the top of the bank, between 10 and 15 feet away from the steep bank. Within a few years erosion could threaten the integrity of the trail.

**Potential Solution:** Protect the toe of this bank from ice damage by armering it with large rip rap or boulders several feet above the waterline. Use native plants to cover and stabilize the upper slopes. A turf stabilization material may also be needed for the top of the bank.

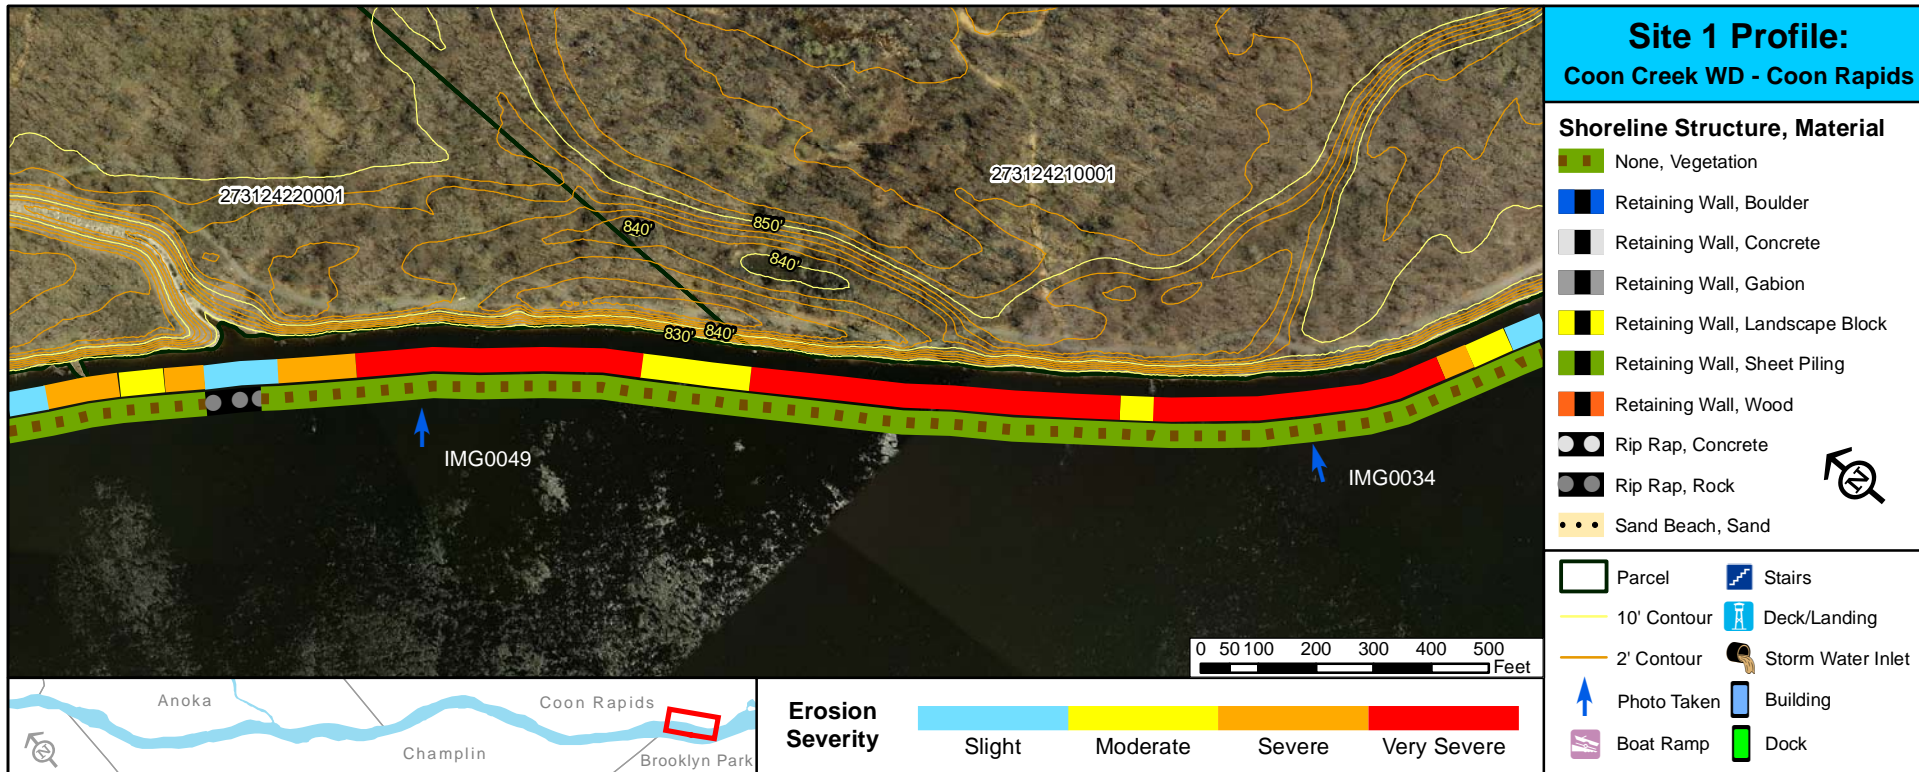
**Additional Info:** This site is located on the outside of a curve in the river, called a cut-bank. This makes it likely to be hit by large ice sheets and moving water during the spring melt. Many fallen trees and vegetative overhangs of several feet show the fast pace of erosion here. The bank varies in height between 12 and 20 feet. A paved bike trail runs along the top of the bank, often 5 feet or less from the edge of the bank. Within a few years the bank could threaten the stability of the trail.

**Potential Solution:** Protect the toe of this bank from ice damage by arming it with large rip rap or boulders. Use native planting on the slope to hold the soil in place. Turf reinforcement material may be necessary on the steepest slopes.

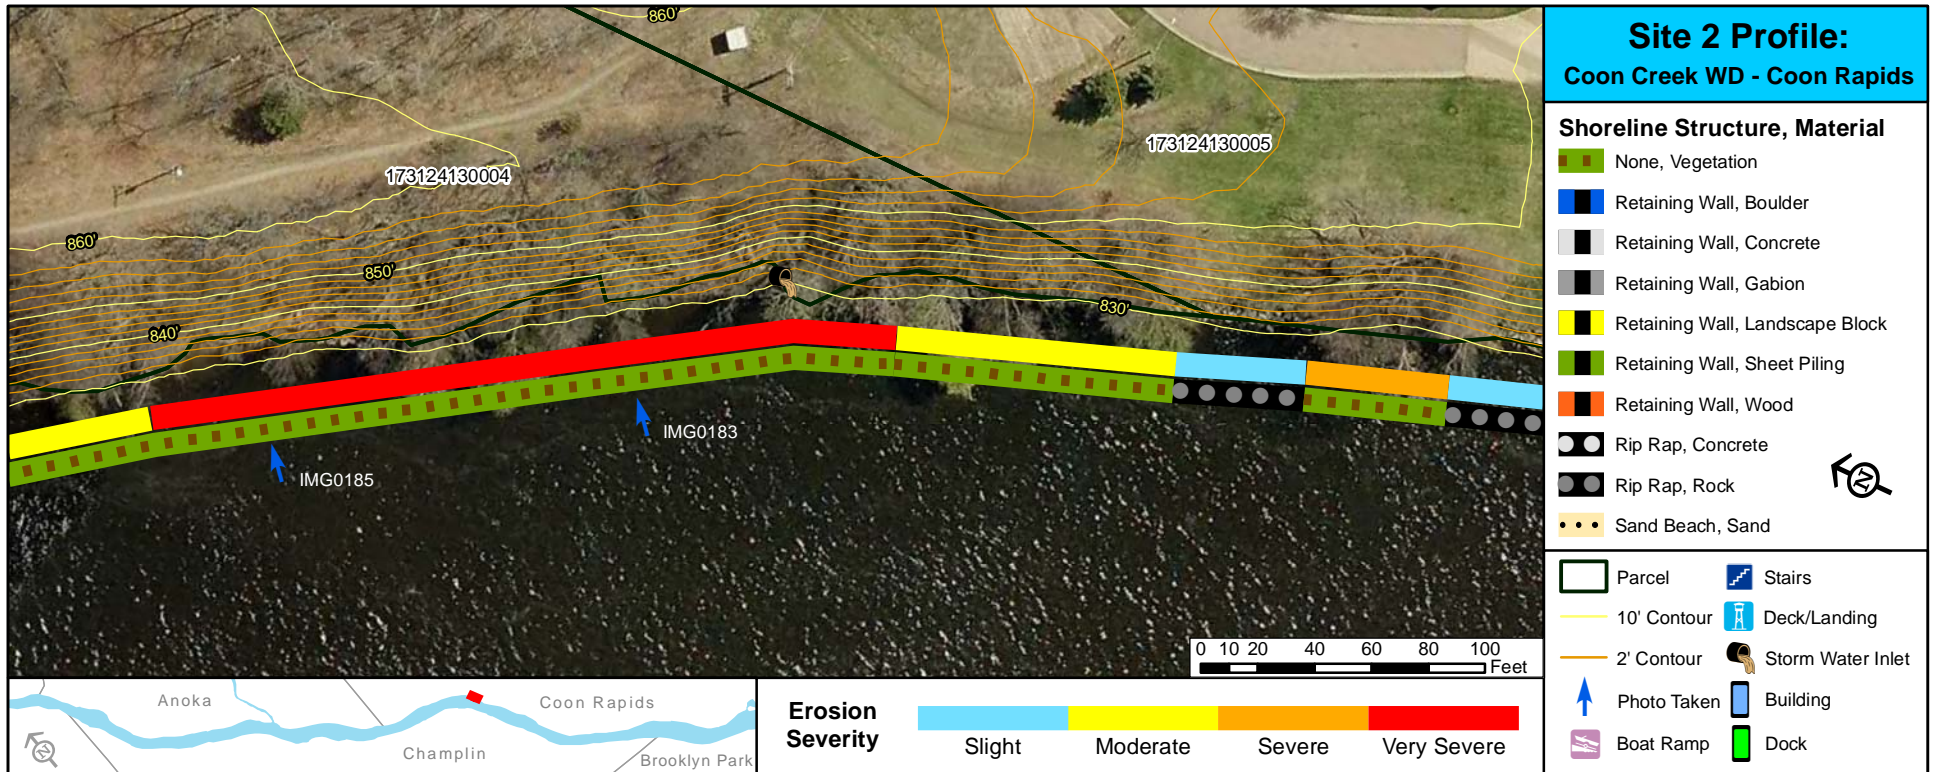
**Additional Info:** This site is located on the outside of a curve in the river, called a cut-bank. It is likely hit by large ice sheets and moving water during the spring melt. As shown in picture 183, a concrete storm water culvert is sticking 5 feet out from the sheer bank. This along with the many slumping trees at the site show the large amount of sediment lost.

**Potential Solution:** Protect the toe of this bank from ice damage by armoring it with large rip rap or boulders. Use native planting on the slope to hold the soil in place. Turf reinforcement material may be necessary on the steepest slopes. This site has the highest ratio of soil loss per linear foot of any site inventoried, which could potentially make it a more cost-effective project.

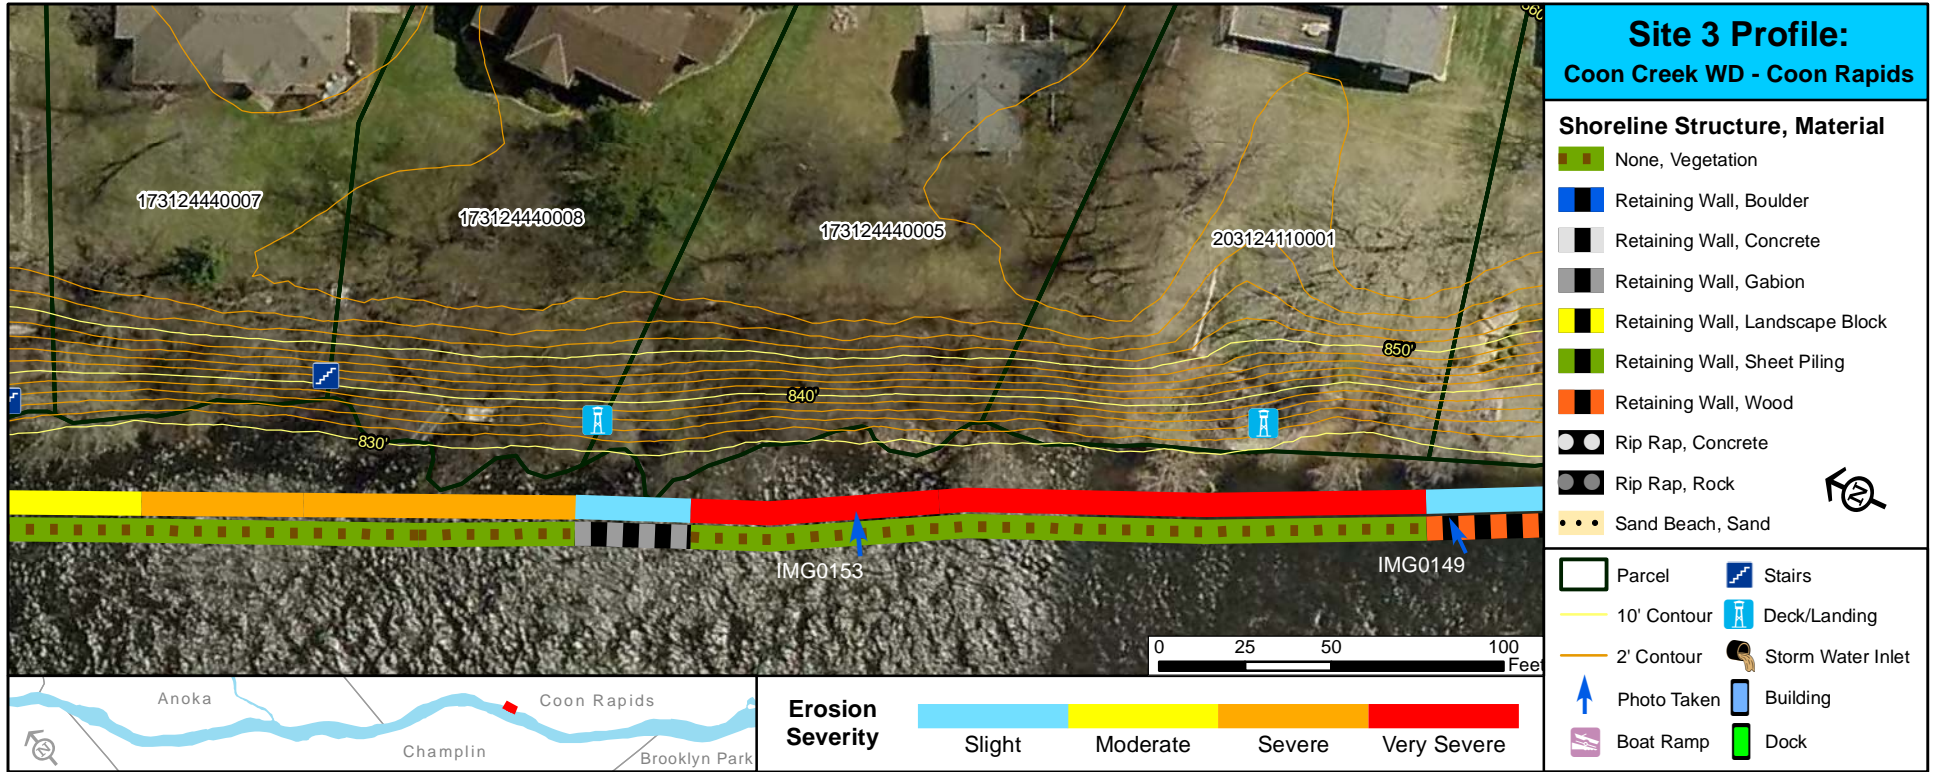
**Additional Info:** At least one large tree has been lost here since the last photo inventory in 2004. Several others are slumping and have their roots exposed. Vegetative overhangs of a few feet are common.

**Potential Solution:** Protect the toe of the bank from ice damage using large rip rap or boulders. The bank is so steep here that grading of the slope might be necessary to produce a stable bank. Native planting with a turf control material might also be an option for some of the slope. This site has a high ratio of soil loss per linear foot, which could make it more cost-effective than other potential projects.

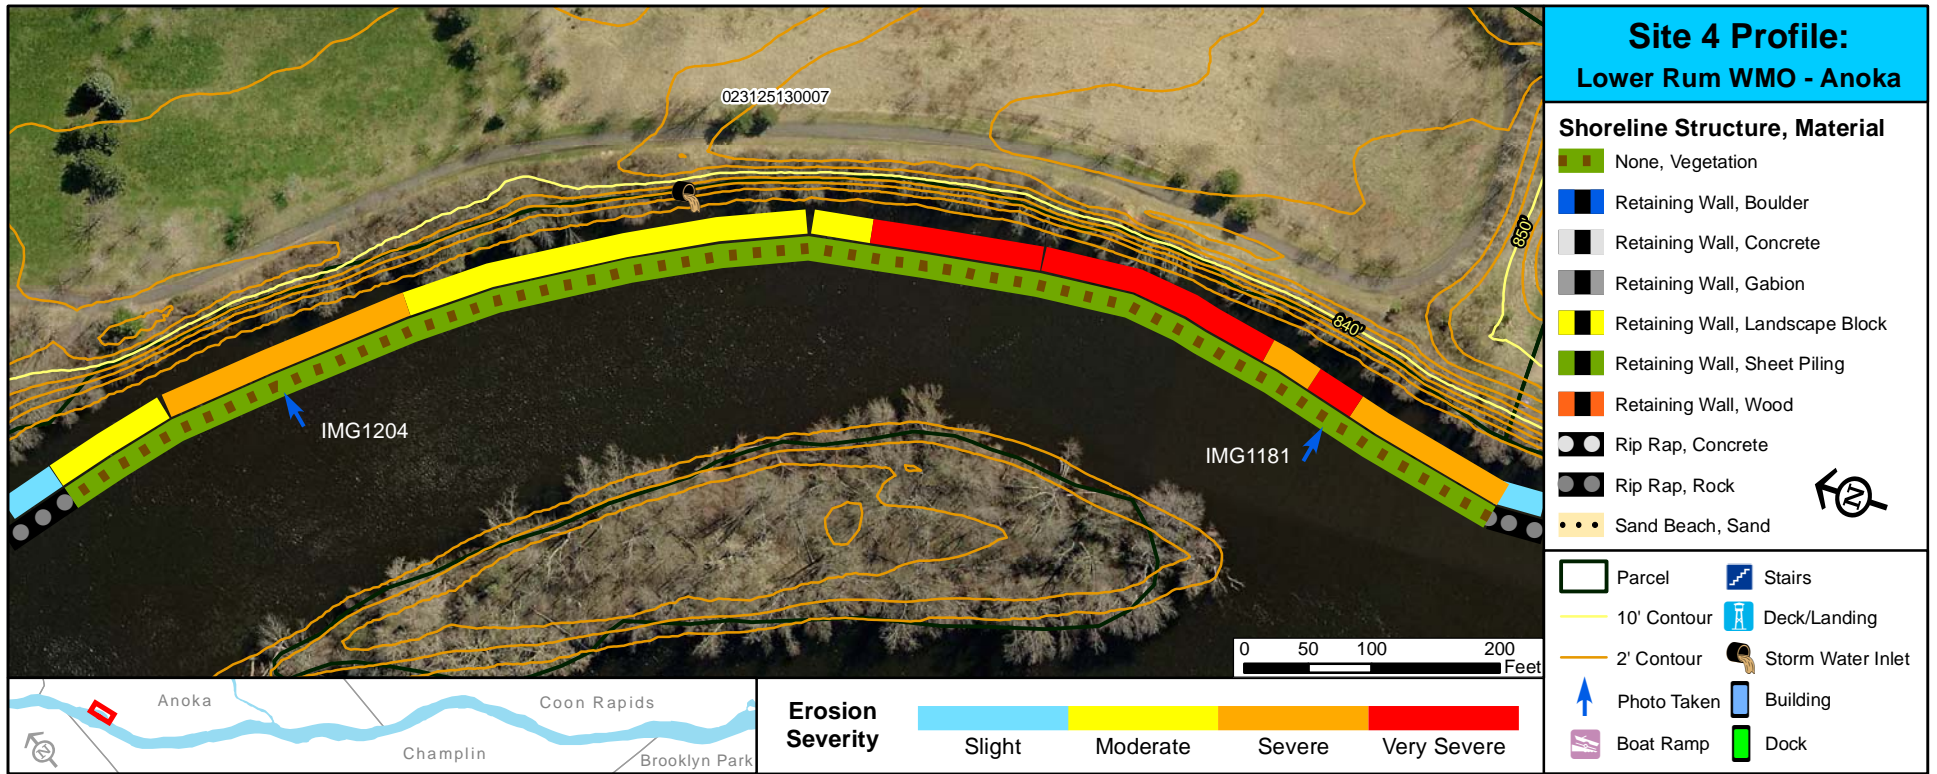
**Additional Info:** Located on a cut-bank, this area is likely to be hit by large sheets of ice in the spring. Many slumping and recently fallen trees show the fast pace of soil loss here. Root overhangs of several feet are widespread in the areas marked severe and very severe. A paved City of Anoka bike trail runs along the top of the bank, between 10 and 15 feet away from the steep bank. Within a few years erosion could threaten the integrity of the trail.

**Potential Solution:** Protect the toe of this bank from ice damage by armoring it with large rip rap or boulders several feet above the waterline. Use native plants to cover and stabilize the upper slopes. A turf stabilization material may also be needed for the steepest sections of the bank.

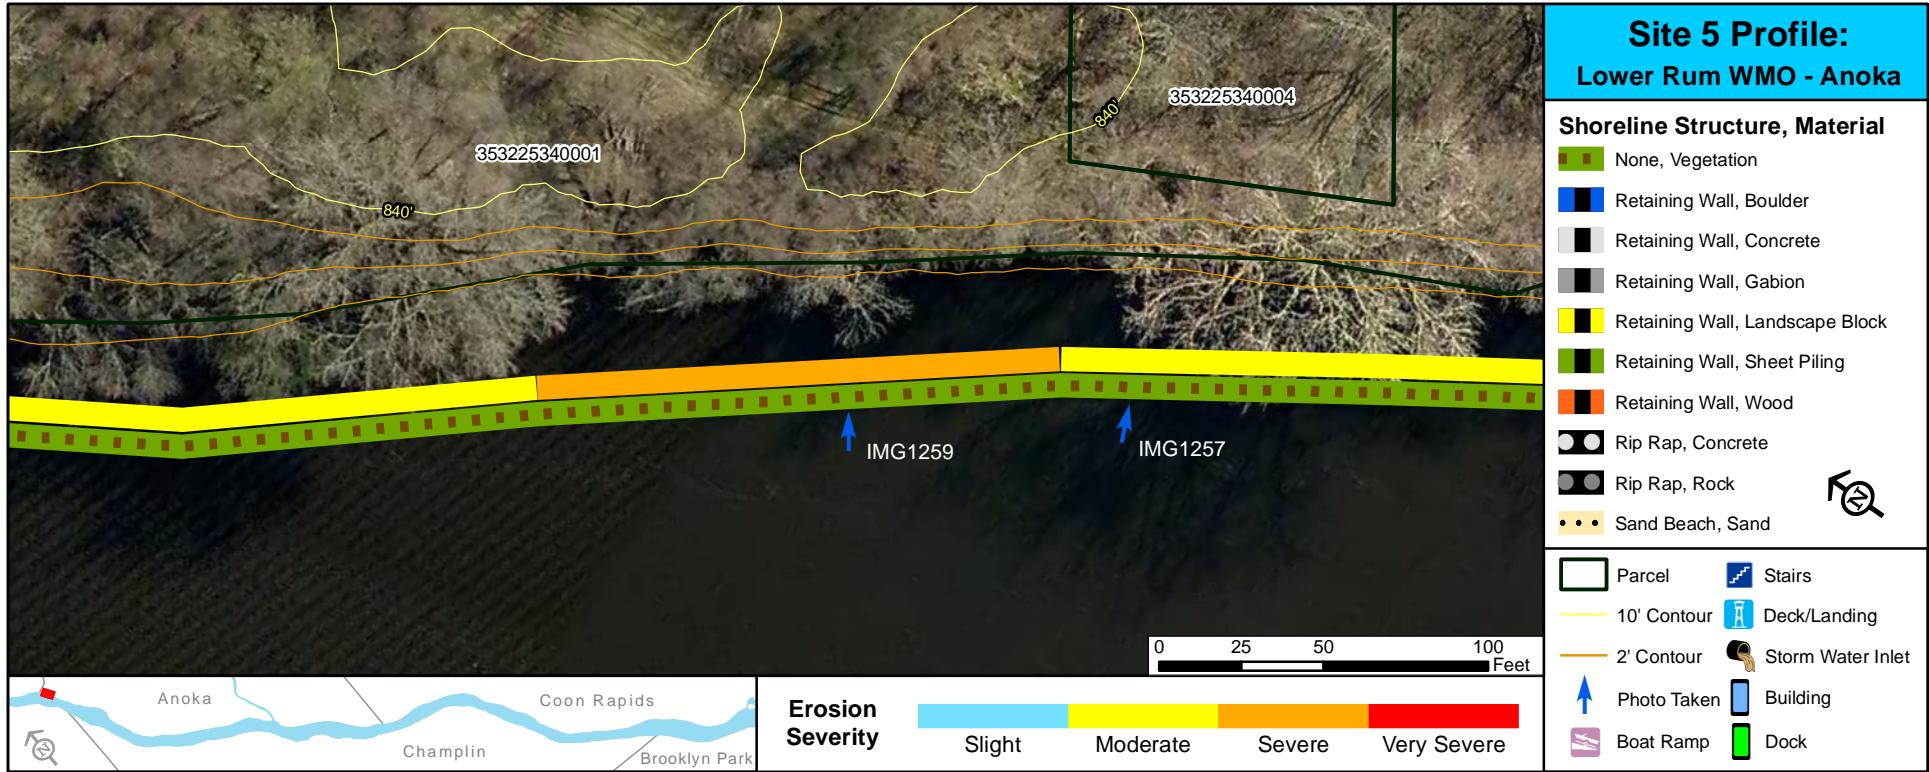
**Additional Info:** This site is located on the northern end of King’s Island in Anoka. It is located on a cut-bank, which likely means it is hit by large ice sheets in the spring. All of the trees along the shoreline have heavily exposed roots and a few are beginning to slump. The bank is only a few feet tall, so the total amount of soil loss here is not as great.

**Potential Solution:** Protecting the bank from ice using rip rap or boulders will help the bank rebuild itself over time. Native plants will help hold the soil in place.

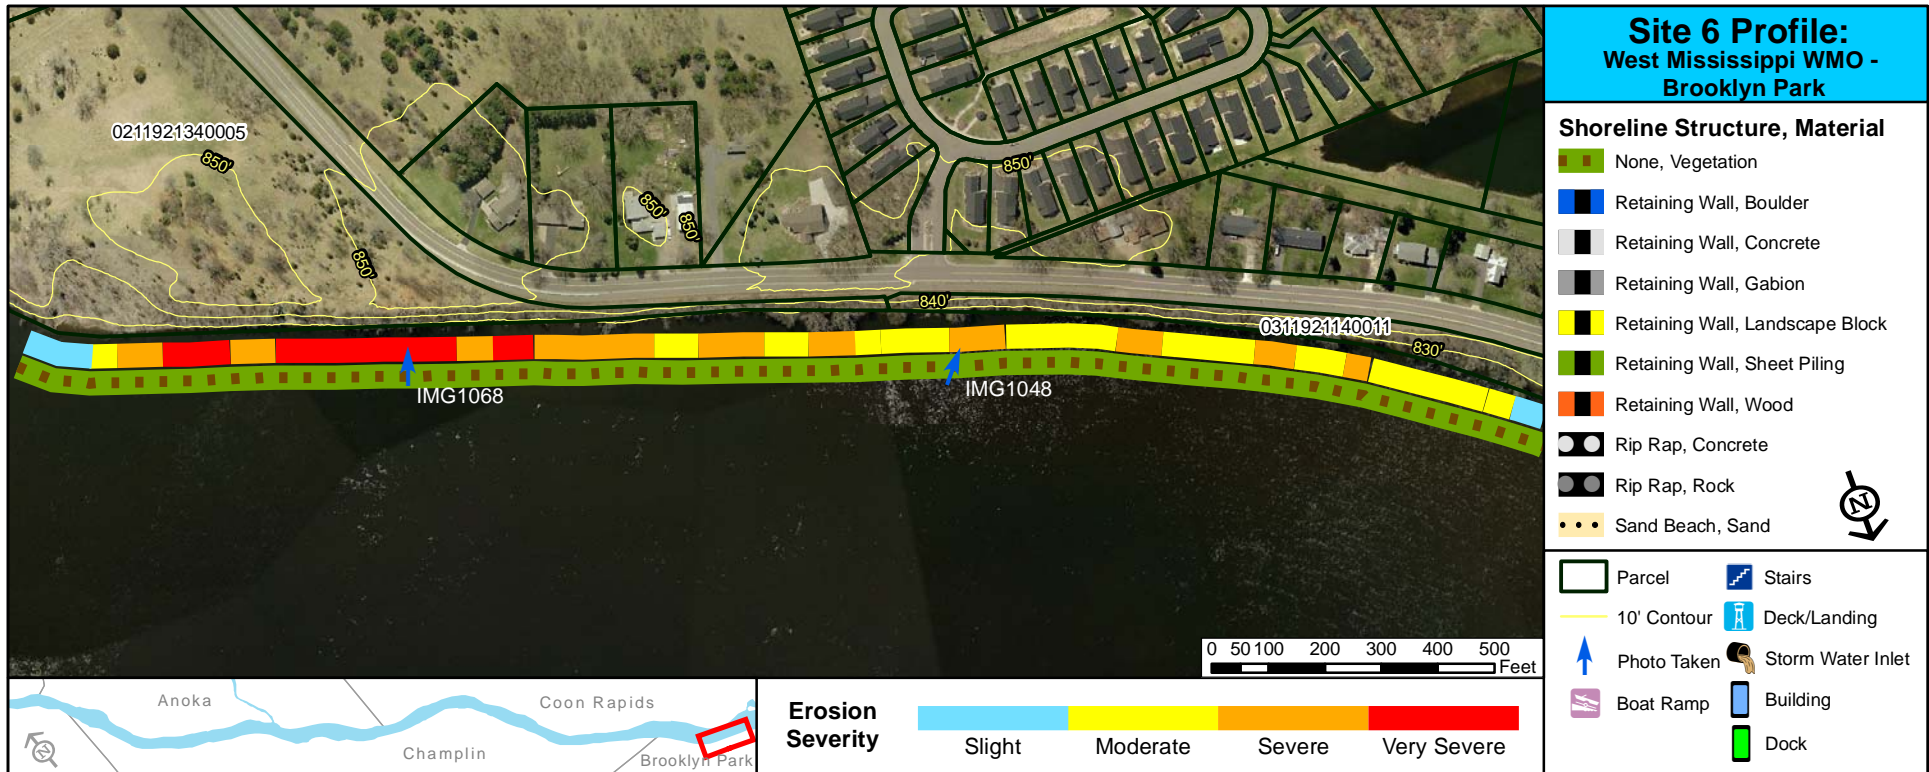
**Additional Info:** Located on a cut-bank, this area is likely hit by large sheets of ice and moving water in the spring. The downstream portion of this site, where erosion is worst, is part of the Coon Rapids Dam Regional Park. Root overhangs of several feet are widespread and the bank is mostly bare. The upstream portion is owned by a local HOA. The erosion is less concentrated here, but a paved bike trail and West River Road are only a few feet from the top of the steep bank.

**Potential Solution:** Protect the toe of this bank from ice damage by armoring it with large rip rap or boulders several feet above the waterline. Use native plants to cover and stabilize the upper slopes. The bank is very steep in some areas, so a turf stabilization material may also be needed.

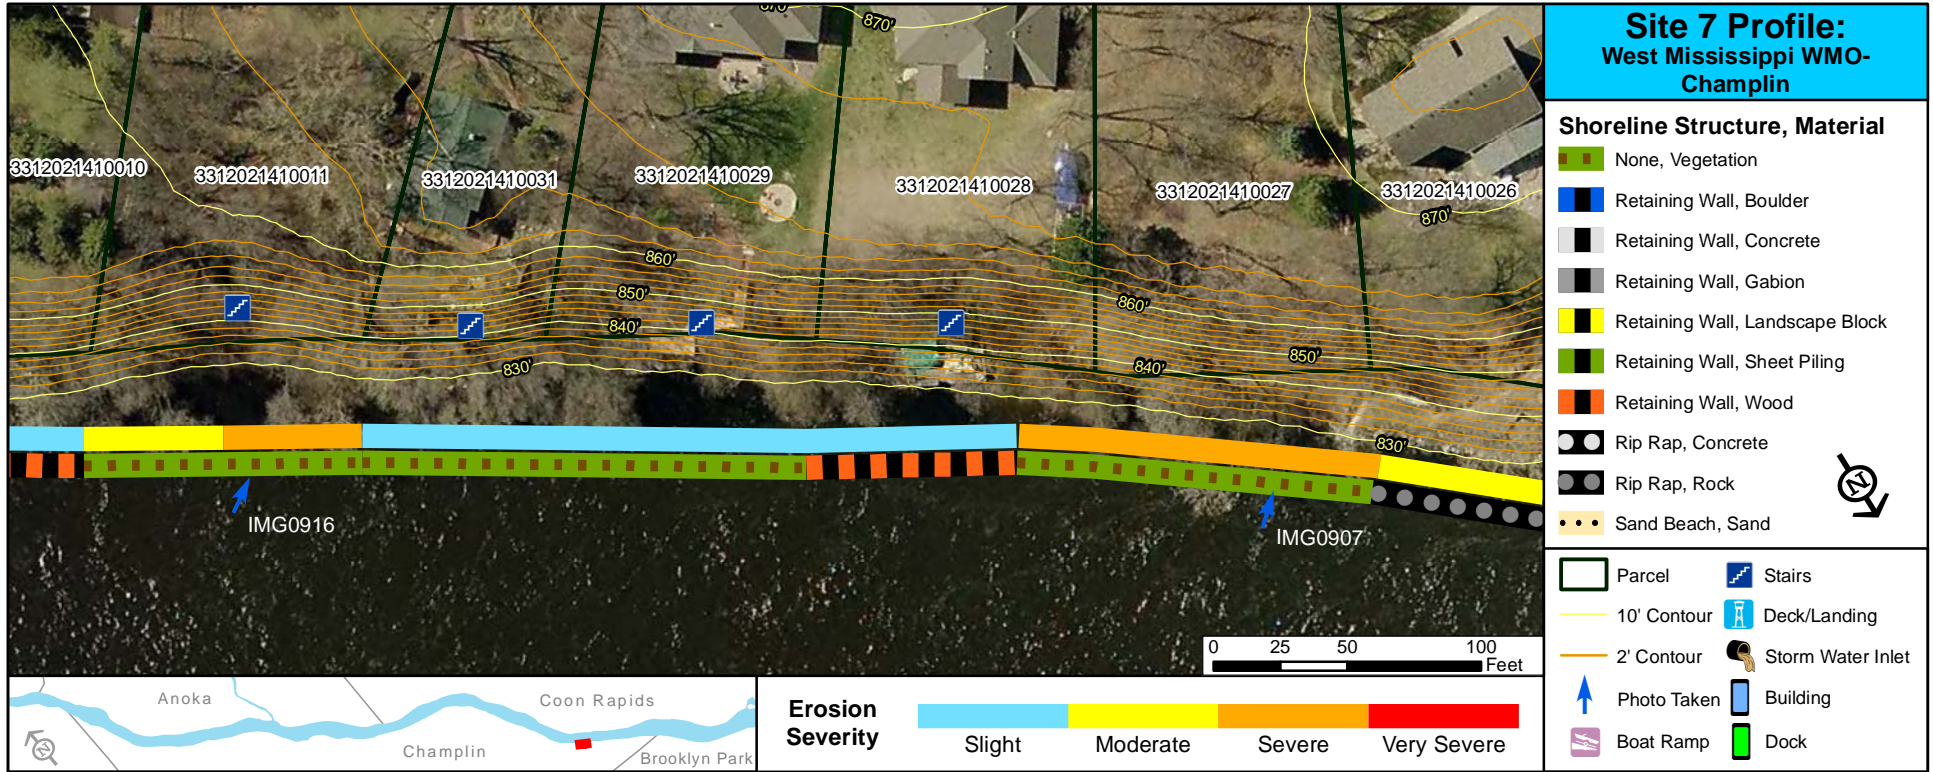
**Additional Info:** Located on a cut-bank, this area is likely to be hit by large sheets of ice and moving water in the spring. Most of the erosion at this site is currently happening above water level. The bank in this location is tall (30+ feet) and very steep. Much of the bank is bare with many exposed tree roots indicating a fast pace of erosion.

**Potential Solution:** Protect the toe of this bank from ice damage by armoring it with large rip rap or boulders several feet above the waterline. Use native plants to cover and stabilize the upper slopes. A turf stabilization material may be needed for the steepest sections of the bank. Some thinning of the tree canopy would allow more sunlight to reach the bank and promote plant growth.

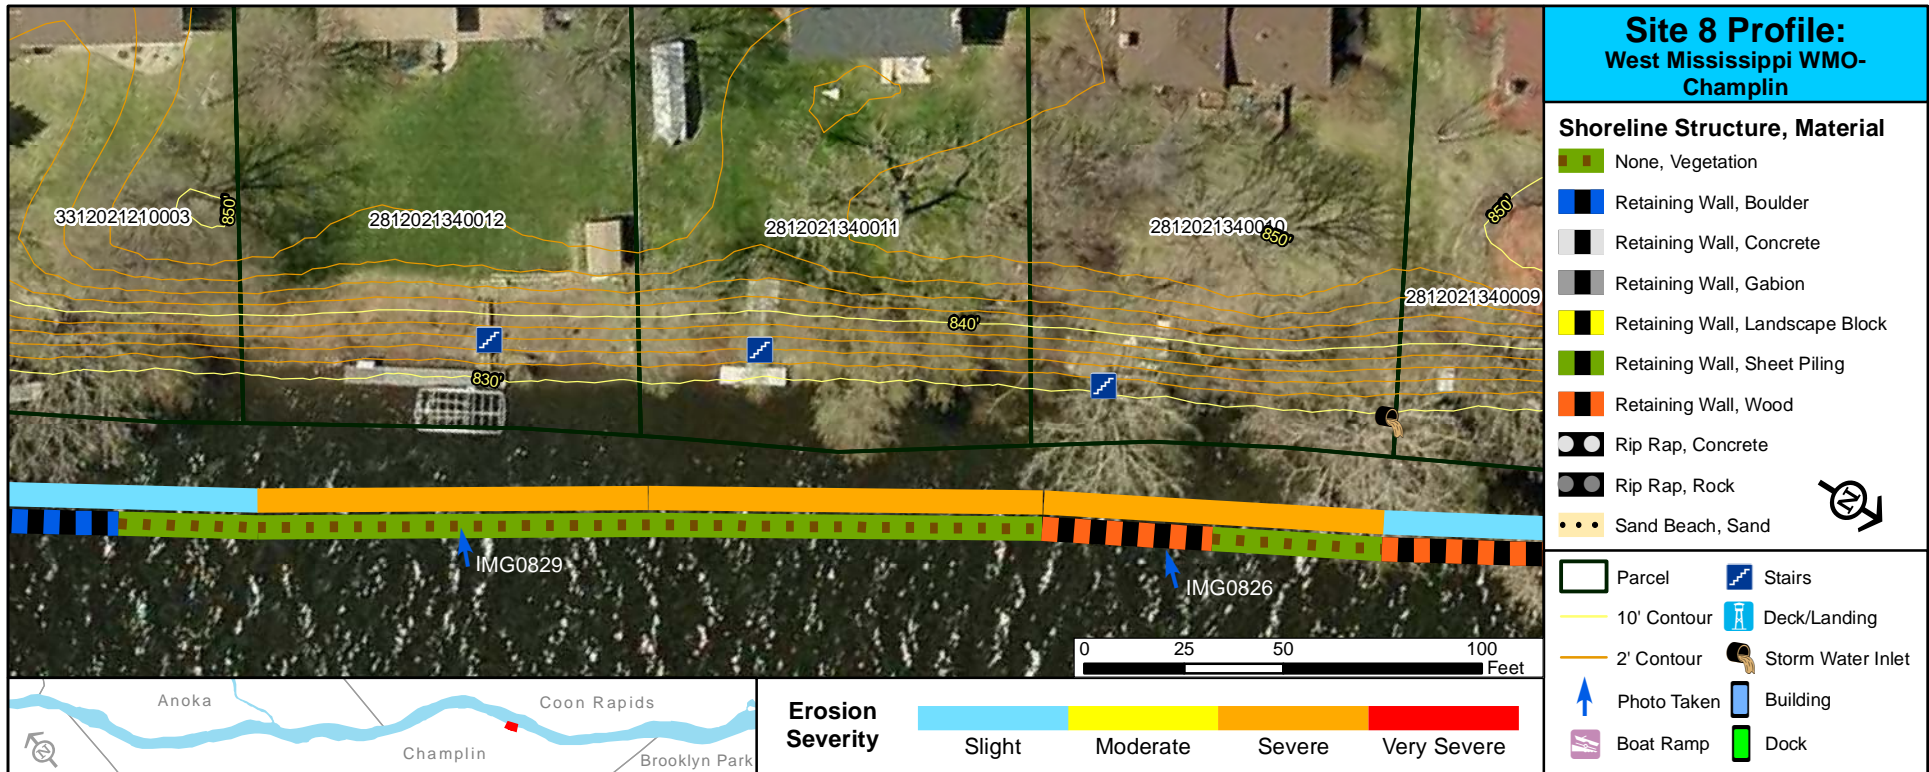
**Additional Info:** The bank here is not particularly high, but it is quite steep. Very few trees are growing on part of the southern end of the bank. This may be the result of or a contributing factor to the erosion. The erosion here seems aggravated by yard waste dumping which smothers vegetation.

**Potential Solution:** Promote plant growth here by disposing of yard waste properly and thinning the tree canopy in some places to allow in more sunlight. Some turf stabilization material may also be necessary to stabilize the steepest sections of the bank.

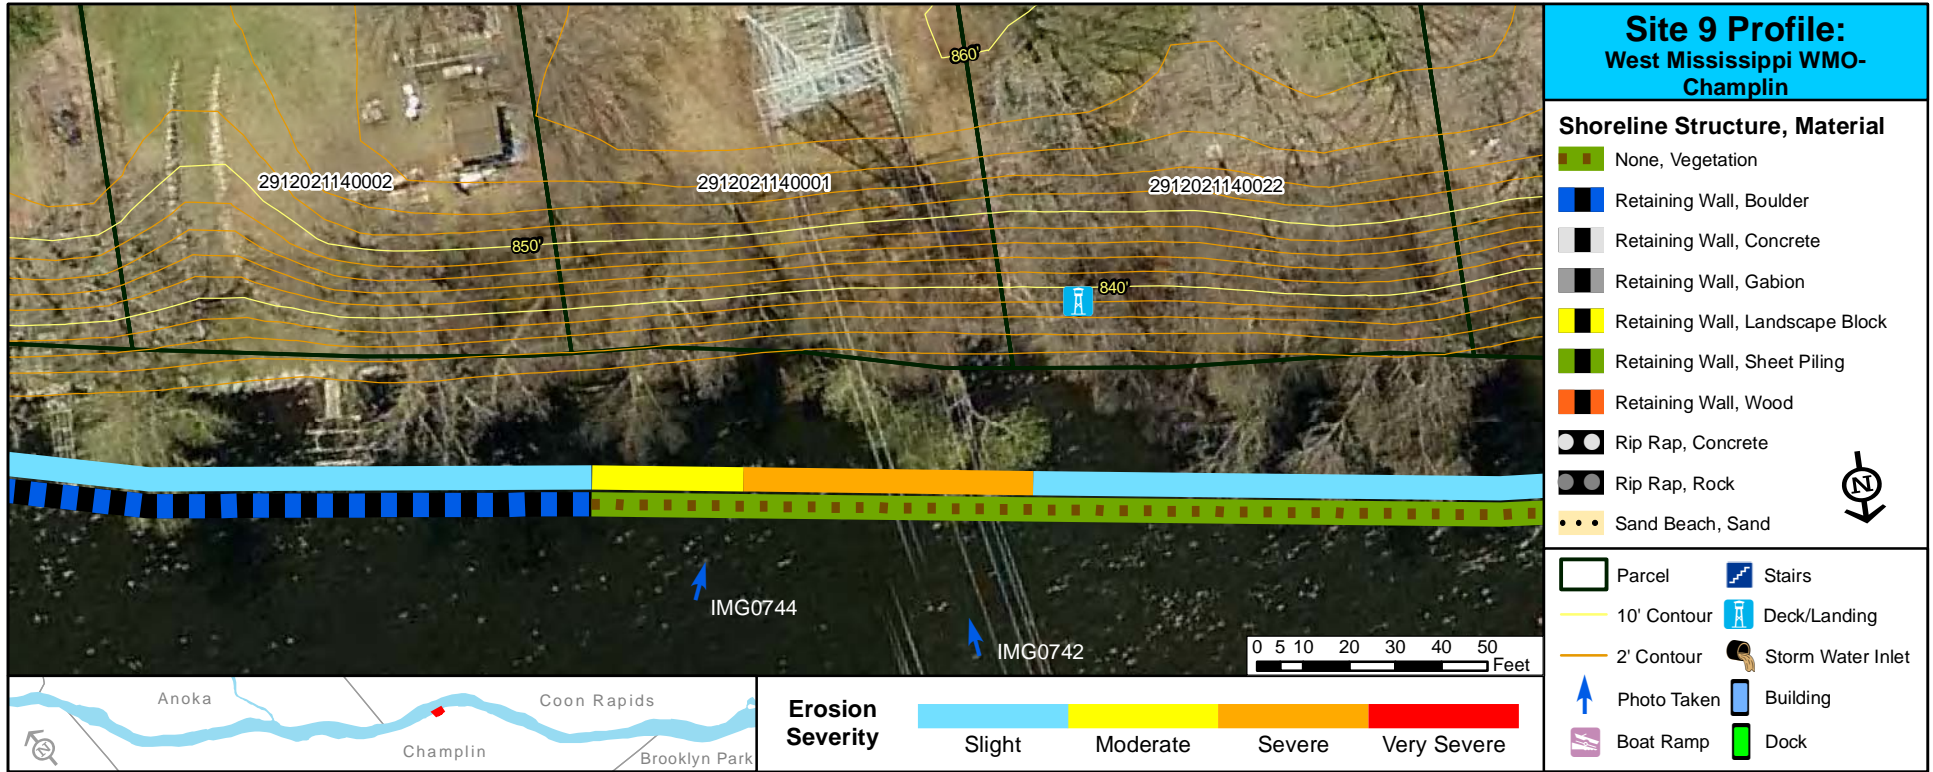
**Additional Info:** The erosion here is located directly below a transmission line. Repeated cutting of trees below the line might be contributing to the erosion here. The base of the tower is approximately 15 feet back from the top of the steep bank.

**Potential Solution:** Protect this bank by armoring the toe with rip rap or boulders. Consider removing trees and planting grass cover to stop repeated cutting of trees. Some turf stabilization material may also be needed on the steepest part of the slope.

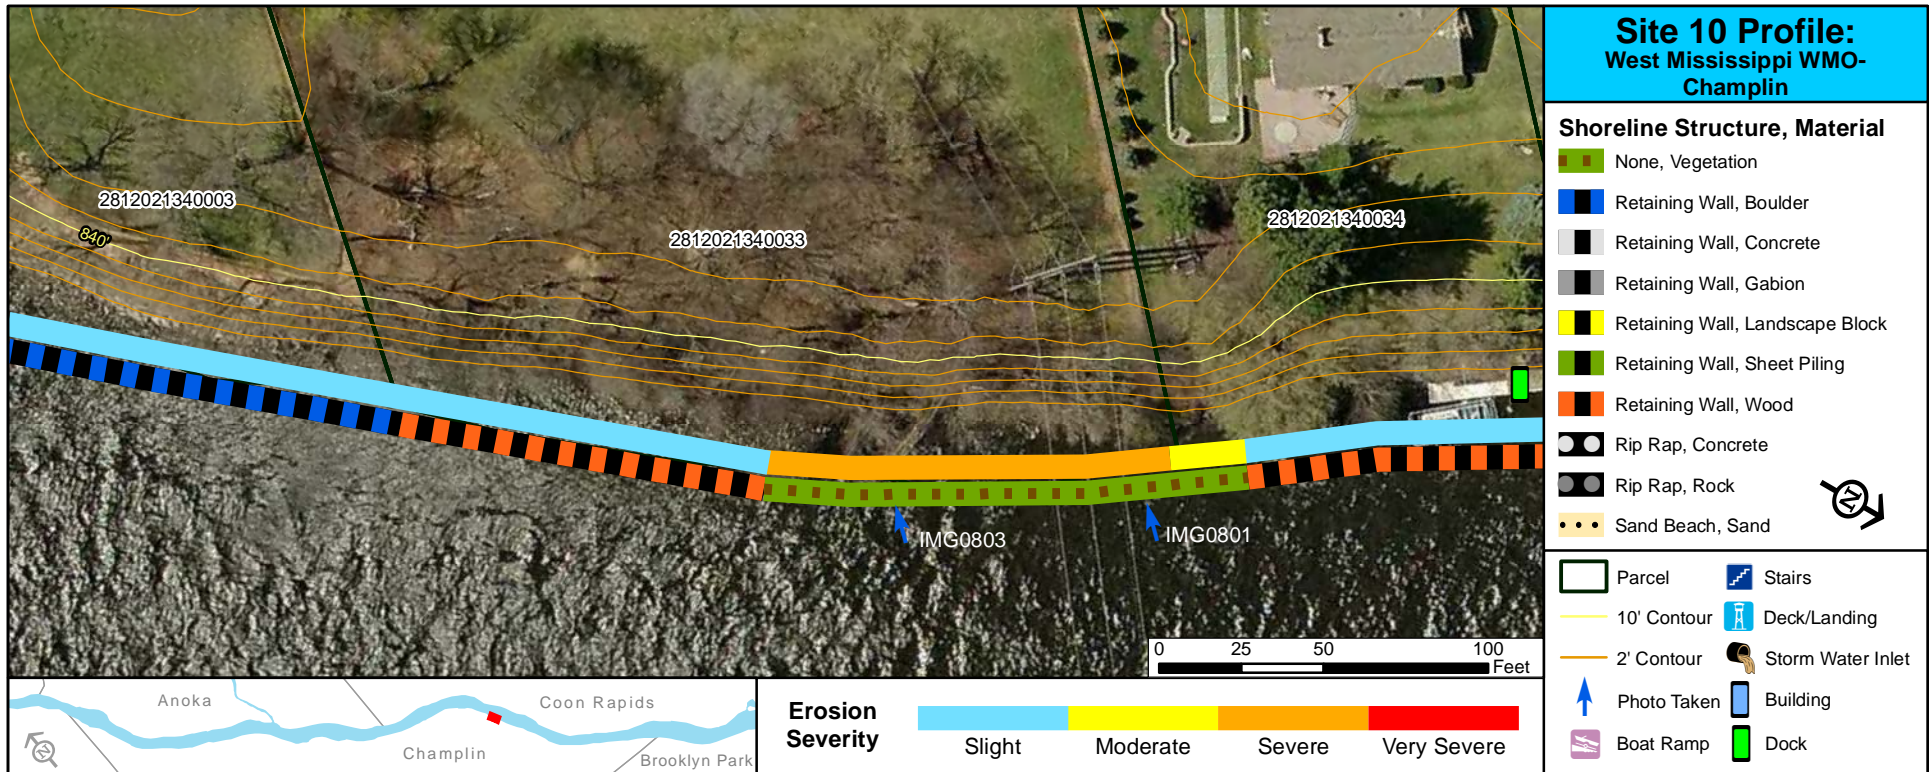
**Additional Info:** The erosion here is located mostly below a power line crossing the river. Repeated cutting of trees away from the line may contribute to the erosion problem here. Yard waste dumping was also apparent here.

**Potential Solution:** Avoid the repeated cutting of trees by replacing them with grass cover. Also, promote more robust vegetation growth by disposing of yard waste properly and potentially thinning the tree canopy to allow more sunlight to reach the plants.

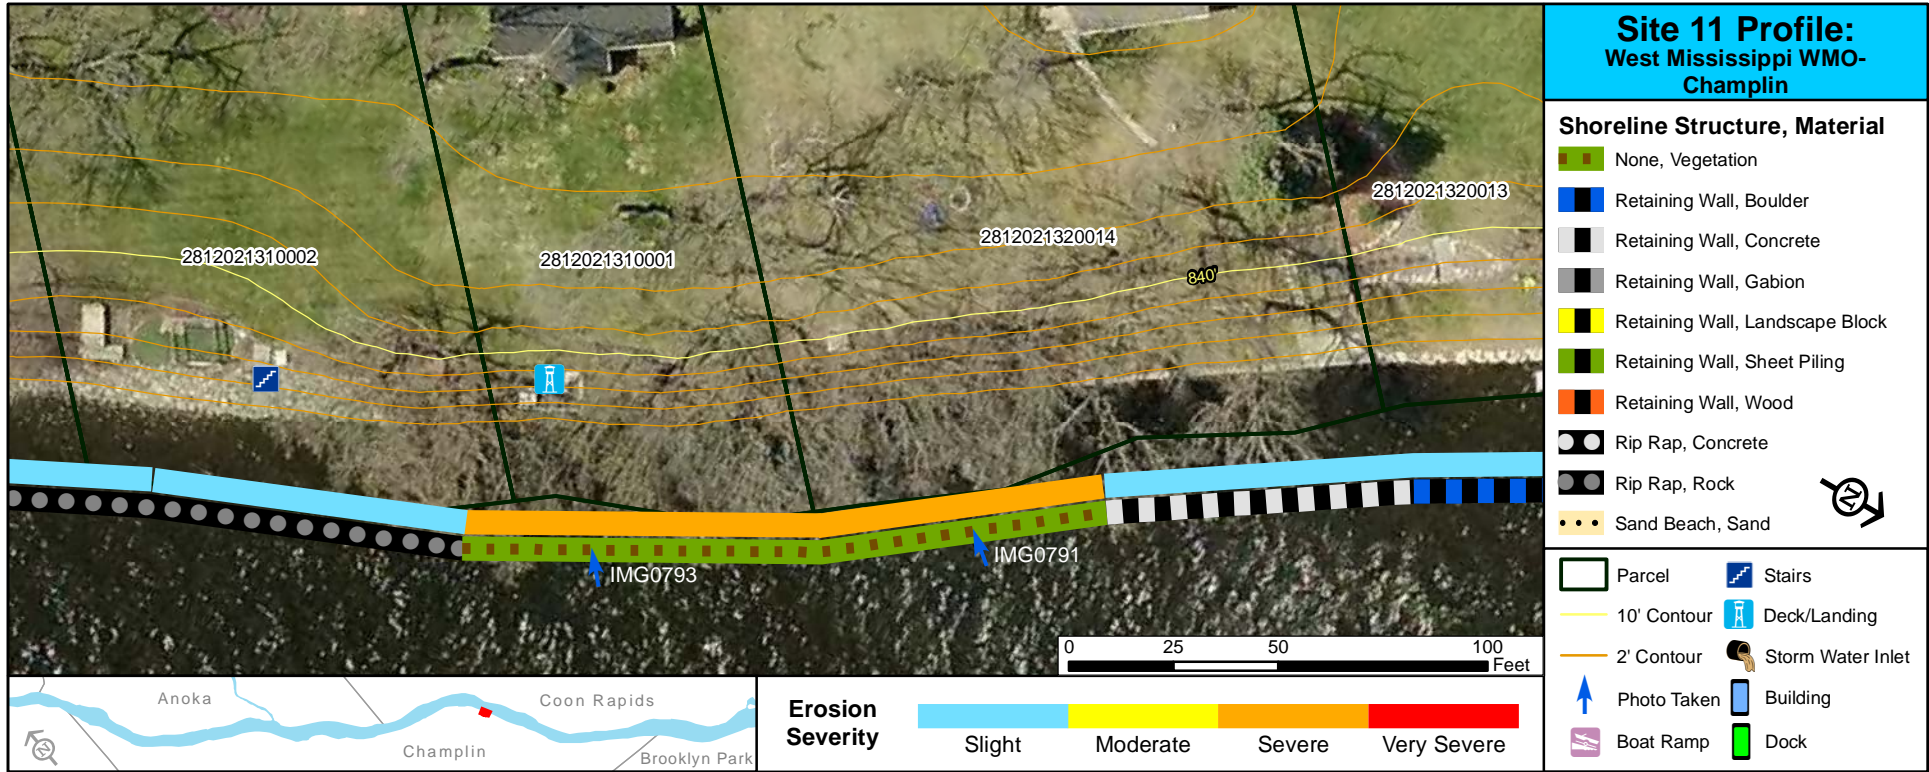
**Additional Info:** Many roots of the large trees along the top of the bank are exposed. These trees could be threatened if the erosion here continues. It appears the grass is mowed all the way to the edge of the bank, which often leads to erosion.

**Potential Solution:** Allow a buffer of un-mowed vegetation to grow along the top of the bank. Some armoring of the toe would also help stabilize the bank.

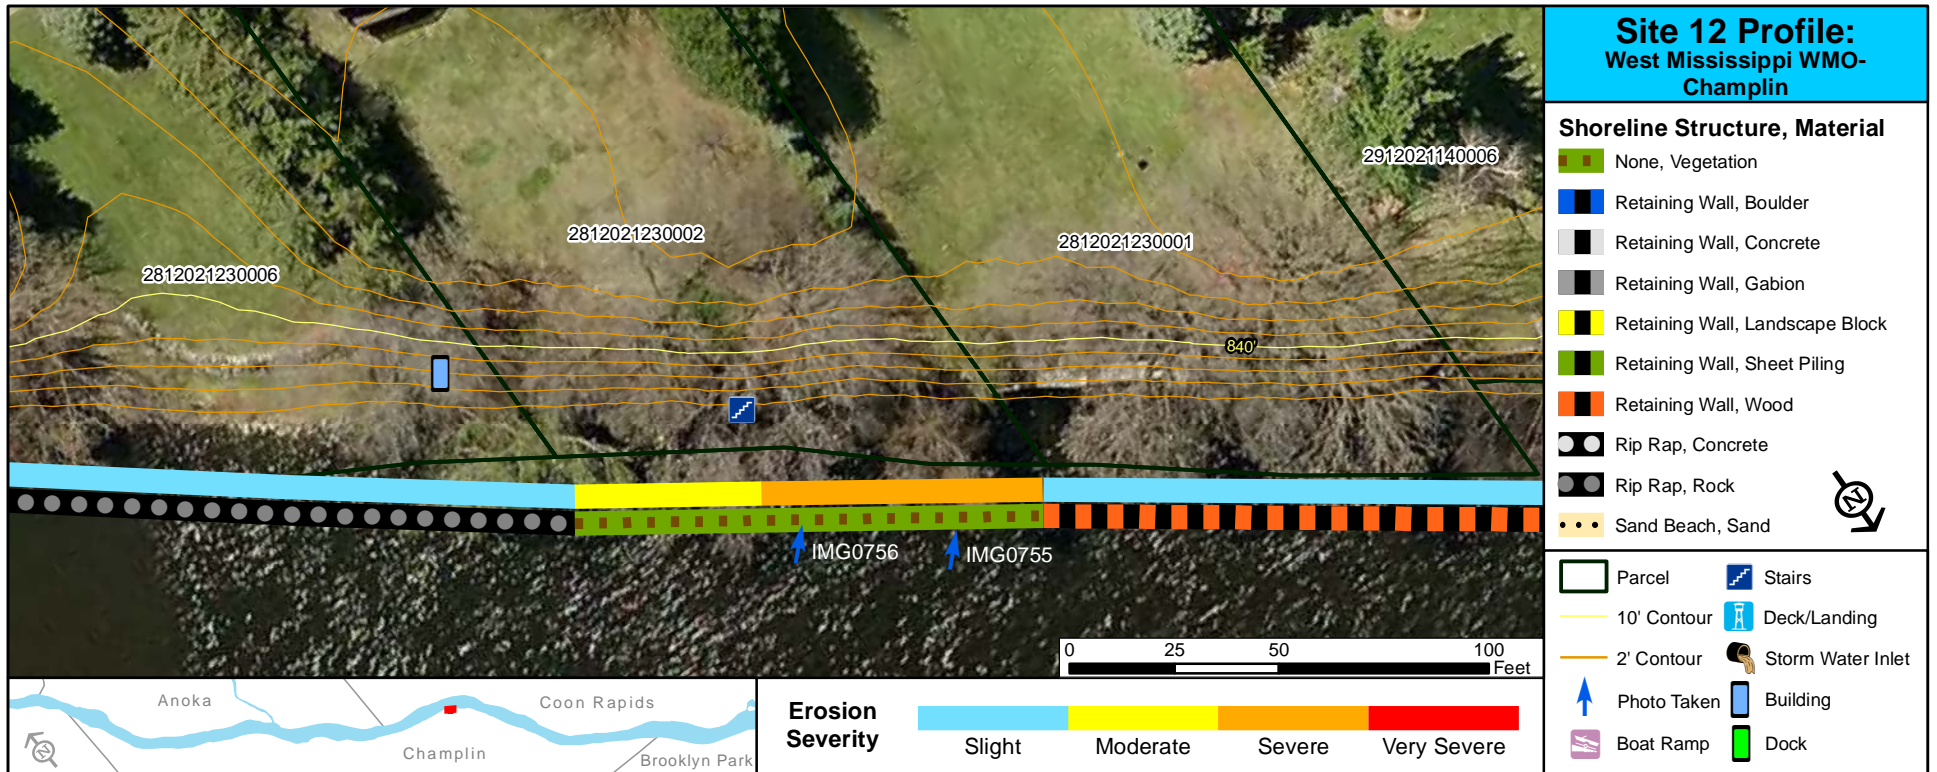
**Additional Info:** This site is marked by several slumping trees and a lot of exposed soil. These trees could be lost in a few years if the erosion continues. It appears the grass is mowed all the way to the edge of the bank, which often leads to erosion.

**Potential Solution:** Promote vegetation growth by thinning the tree canopy to allow more sunlight to reach the ground. Also allow a buffer of un-mowed vegetation to grow along the top of the bank.
