# Coon Rapids Dam Pool Shoreline Inventory

*The Minnesota Department of Natural Resources*

December 2012

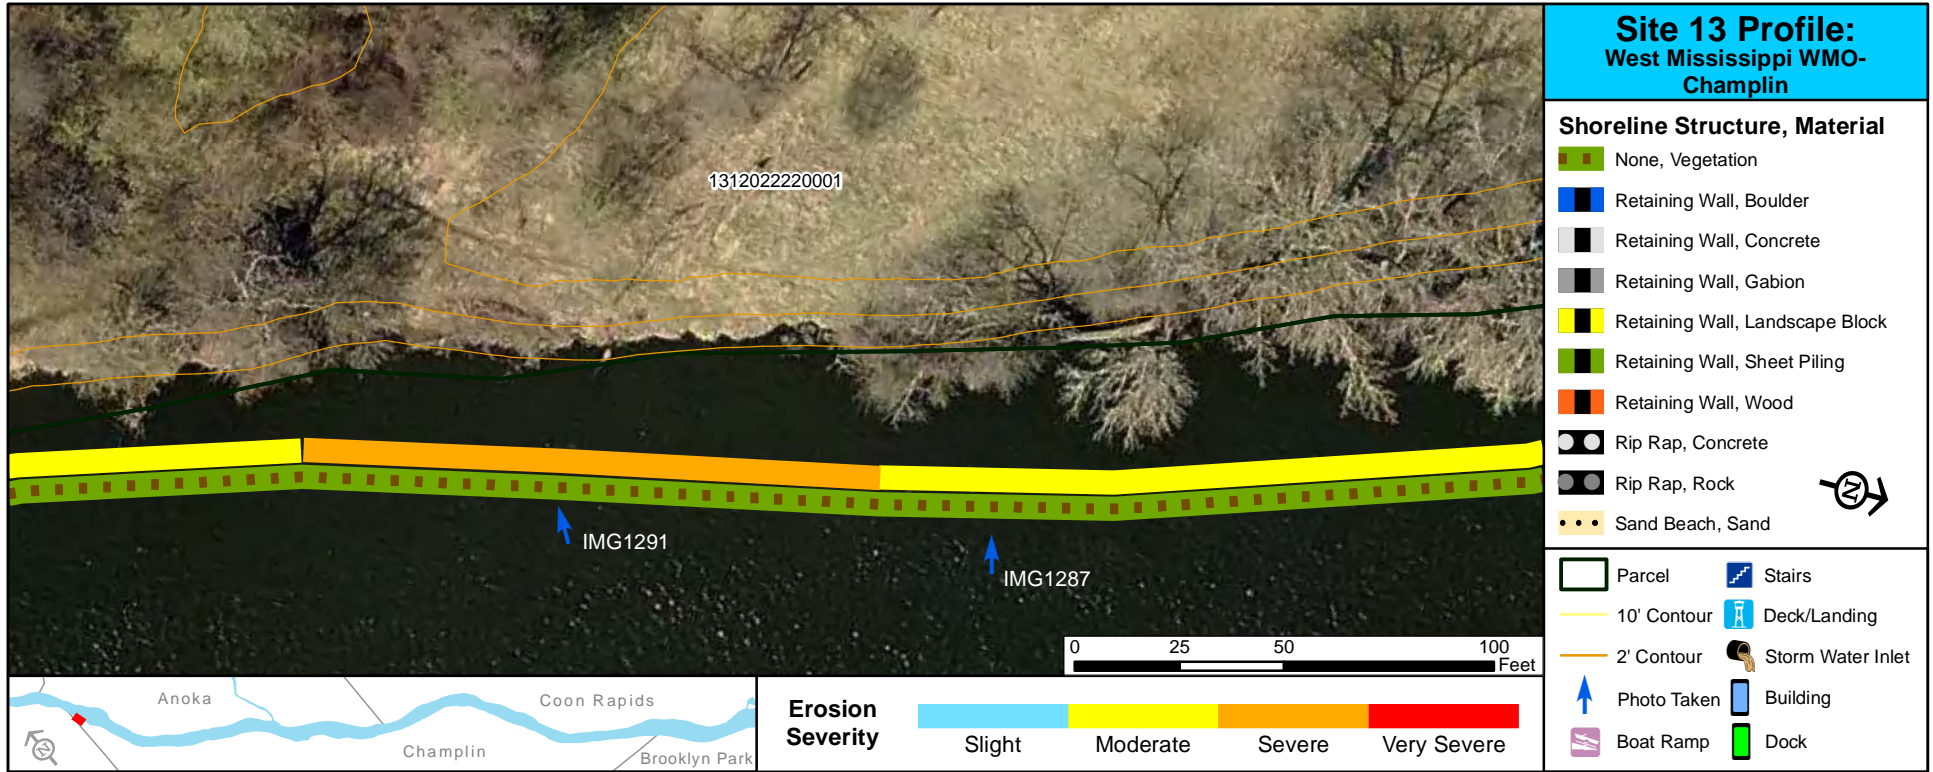
**Additional Info:** This site is part of Donnie Galloway Park in Champlin. Most of the shoreline in this park is unprotected and eroding at least moderately. One large tree has fallen recently here and vegetative overhang is widespread. The bank is only a few feet tall, so the total soil loss here is not great.

**Potential Solution:** Because the site is not on a cut-bank, hard armoring may not be necessary. Instead, lining the bank with cut cedar trees might allow sediment to rebuild the bank. Planting native shrubs such as dogwood along the shore would help to hold the soil long-term.
