# Historic Ramsey Town Hall: Ramsey, MN

Corinne Deger, Morgan Kuehn, Kate Stanger, and  
Vanessa Walton

Students in ARCH 5672: Historic Building Conservation  
Instructor: Todd Grover  
College of Design

Prepared in Collaboration with  
Kurt Ulrich  
City Administrator, City of Ramsey

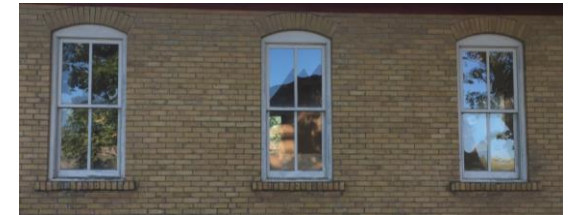
Figure 25 – Side Elevation Window

The painting around the frame is patchy, and there is caulk missing around the window frames.

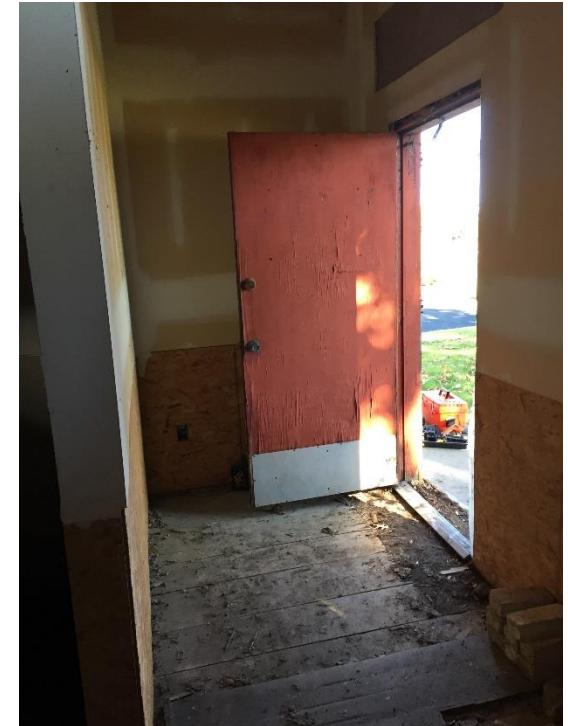
Figure 31 – Entry Hall

The original walls were removed and replaced with fiber boards during a previous renovation. The fiber boards have since been replaced with modern gypsum board on the top two thirds of the wall and particle board on the bottom third, presumably to recreate the original wainscoting. There is also a large rectangular hole cut in the gypsum board above the front door. On the interior, the walls appear structurally sound and have no apparent water damage. The gypsum board has been tapped and mudded, but not been treated with a primer.

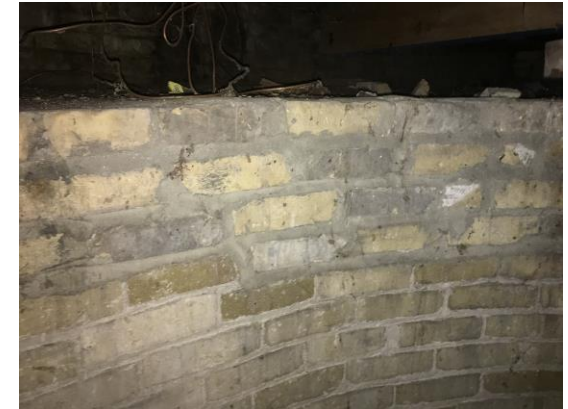
Figure 40 – Clay Masonry Wall

The clay masonry portion of the wall is in good condition. The units should be examined with better lighting conditions; however, no major issues were initially discovered that require remediation.

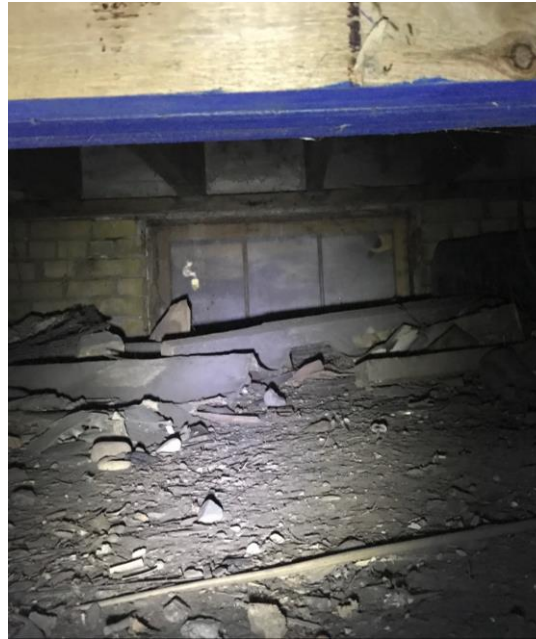
Figure 42 – Exterior Basement Window

The brick and lath system, which appears to be original, is performing well. There does not appear to be holes or cracks to the exterior elements.

Standard 5 states property characterizing elements should be preserved, making the original window is of interest. Even if reinstallation is not desired, the window should be inspected and removed intact if possible. The hole after window removal can be filled with brick to match the historic.

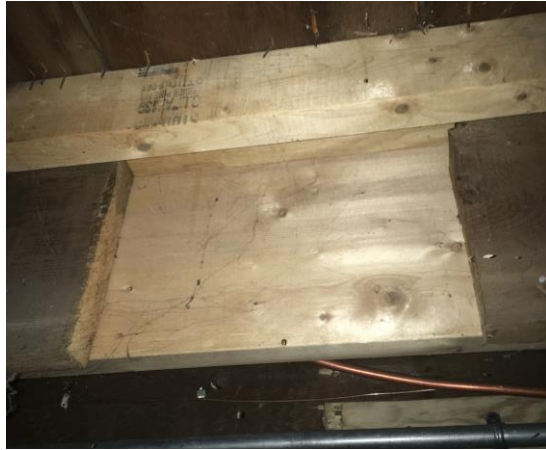
Figure 44 – Replacement Floor Joist

A few of the floor joists appear to not rest on the intermediate beam. Their natural lower elevation is about one centimeter above the beam. The joists may need to be realigned to provide the intended load path.

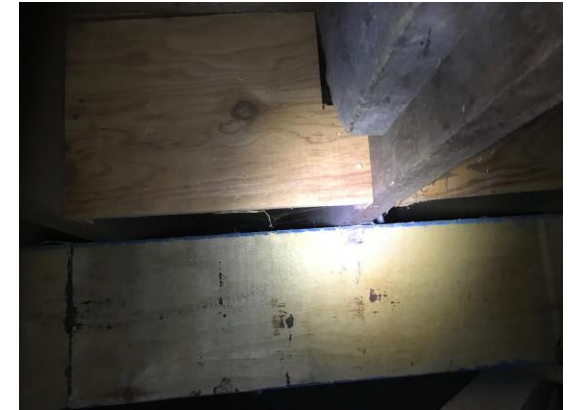
Figure 46 – Intermediate Beam

The structural supports of the beam are extremely unsafe. They are not code compliant, and they offer very little stability. Large posts should be used for all of the supports. Additionally, the beam should be securely connected to the support, and the support should be securely connected to the soil or masonry base.

Shoring will be needed to provide temporary support during reinforcement or installation. An engineer should be consulted to create a safe plan.
