2024 CACHE CREEK ANNUAL STATUS REPORT
(BOARD OF SUPERVISORS DRAFT)

2024 Cache Creek Annual Status Report

Prepared by the Cache Creek Technical Advisory Committee

for the 2024 Water Year
(October 1, 2023 – September 30, 2024)

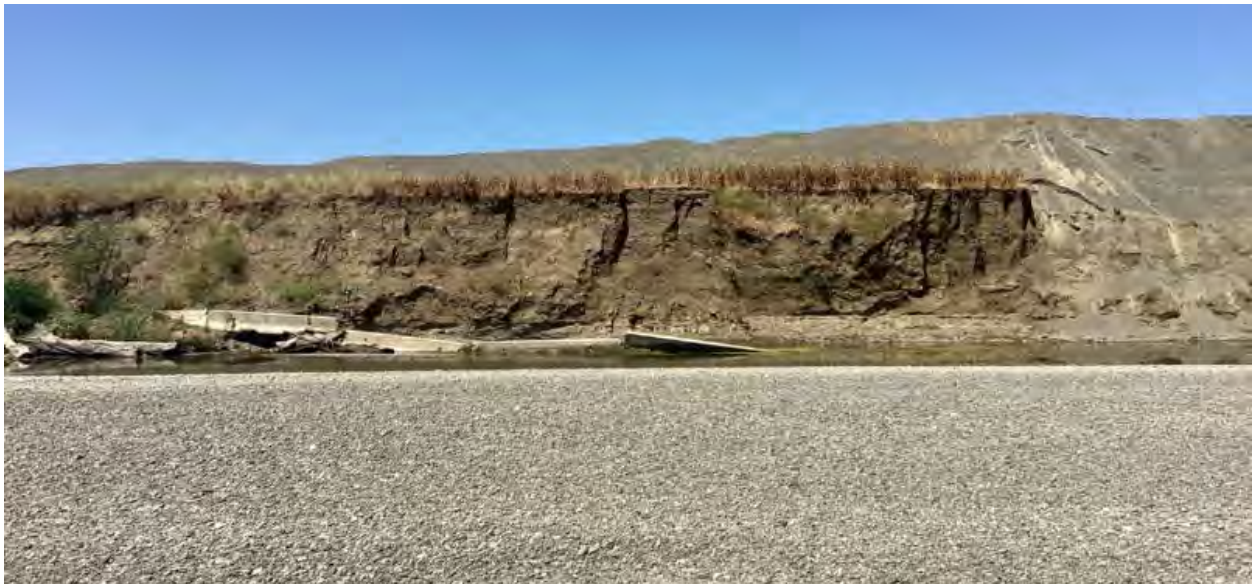
Teichert Gravel Pile at River Mile 22.9

Bank erosion over several years has occurred near River Mile 22.9 at the Teichert Esparto plant. As the bank has retreated northwards, it has resulted in a large pile of gravel being perched immediately above the creek with potential for it to slump into the creek. Furthermore, K-rails have been placed at the toe of the slope to protect the bank (Fig. 2-20). These K-rails have shifted and are not performing any stabilization function. In 2023 and 2024, it appeared as though some sloughing of gravel material into the creek is occurring. This pile should be regraded to prevent discharge of gravel material into the creek.

Figure 2-20. Teichert gravel pile on the north (left) bank. (2024)

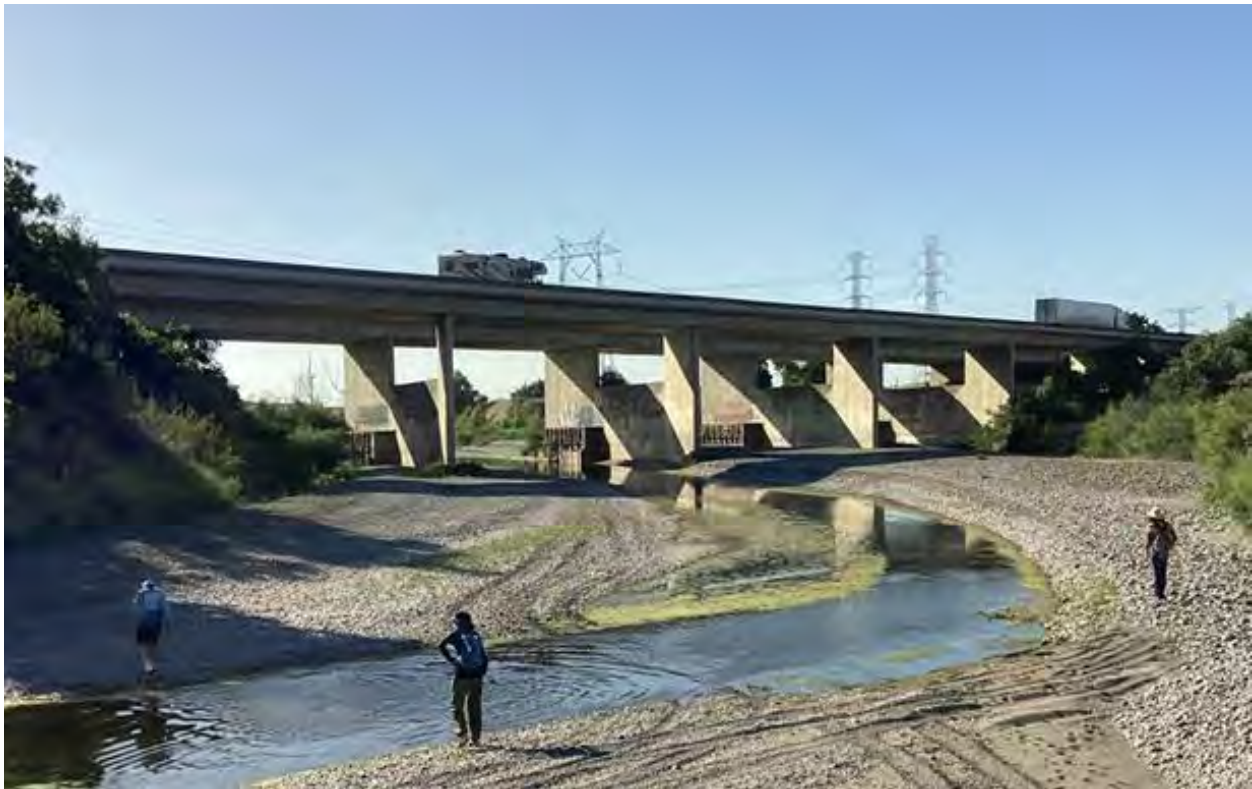
In 2024, little change was observed at the I-505 Bridge itself – the winter of 2023-2024 had scoured the bed of the channel clean of vegetation but no deleterious scour was noted (Fig. 2-23).

Figure 2-23. Looking upstream at I-505 Bridge. (2024)

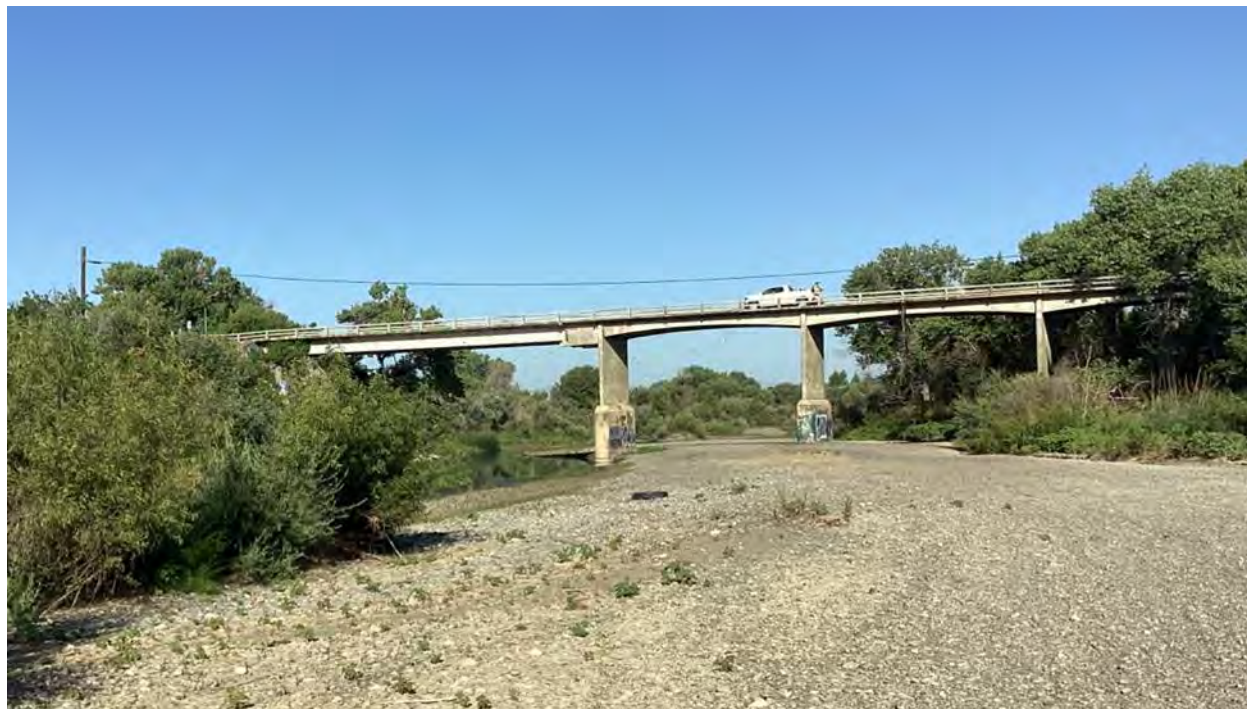
Stephen's Bridge (County Road 94B)

Similar to other bridges, no significant changes occurred at Stephen's Bridge in 2024. The fairly heavy flows of 2024 scoured vegetation clean, but no deleterious scour was observed (Fig. 2-24).

Figure 2-24. Looking upstream at the Stephen's Bridge (County Road 94B). (2024)

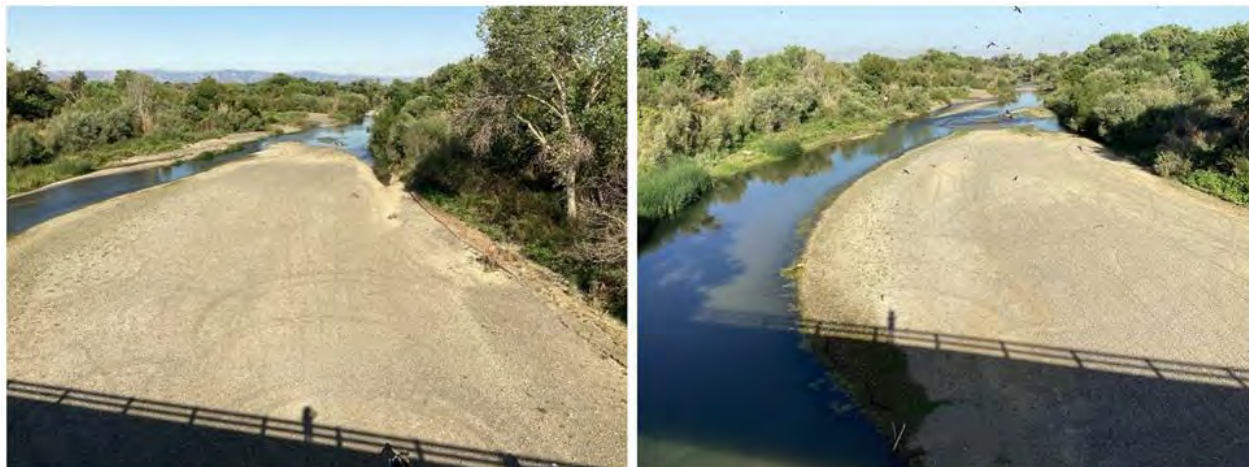
Figure 3-2 shows a typical reach of Cache Creek in 2022 and 2023 with significant changes in sediment patterns and geomorphic features typical throughout Cache Creek after Water Year 2023 winter flows. Changes included removal of in-channel vegetation, migration of the active channel, erosion of channel banks, and deposition of gravel bars.

Figure 3-2. Looking upstream of CR 94B in Water Year 2023 (left) and 2024 (right) showing typical changes in geomorphic conditions and riparian vegetation adjacent to and in the active channel.

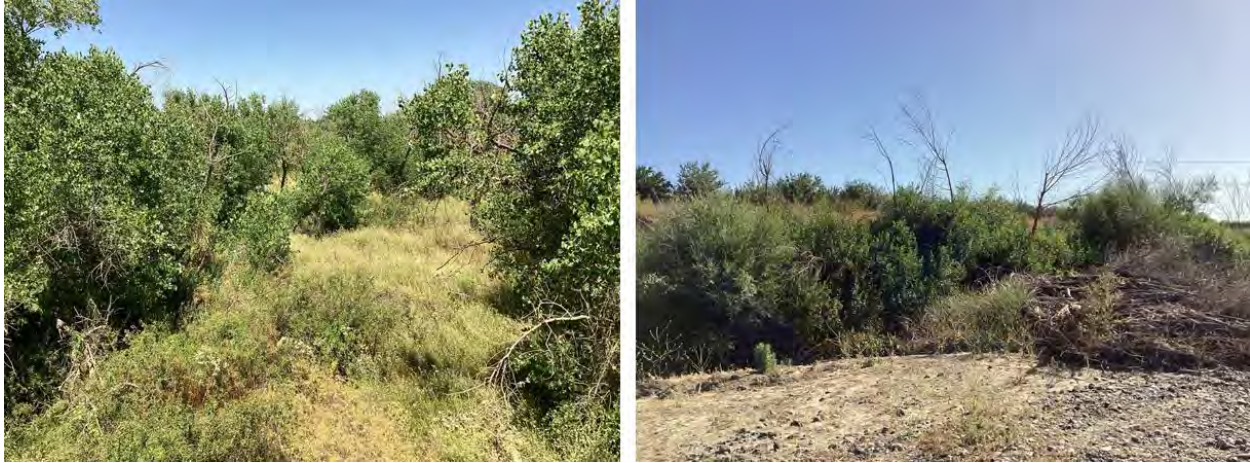
Second, woody vegetation was observed to be recovering from drought stress in many locations, including at RM 20.5 in the Guesisosi Reach and at RM 16.5 in the Dunnigan Hills Reach (Fig. 4-3). From 2021-2023, observations of drought-stressed and dying woody vegetation were frequently made during annual Creek Walks in all but the Dunnigan Hills and Rio Jesus Maria Reaches, although some limited recovery was observed in 2023 at locations within the Madison, Guesisosi, and Hoppin Reaches. Cycles of drought, dieback, and regrowth are inherent features of resilient semi-arid and arid riparian ecosystems, and native riparian plant species such as willows and cottonwoods have a remarkable ability to resprout after drought or fire. In 2024, native woody vegetation, including Valley oaks (*Quercus lobata*) and black walnuts (*Juglans californica*), was also observed to be continuing to slowly recover from a 2023 fire on the north bank from RM 28.2–28.3 in the Capay Reach. While fire is a natural, albeit generally infrequent, process in California riparian ecosystems, fires along Lower Cache Creek are often the result of

Figure 4-3. Native woody vegetation was observed in 2024 to be recovering from drought stress observed in 2023 in many locations. Photos from RM 16.5 in the Dunnigan Hills Reach (left), and RM 20.5 in the Guesisosi Reach (right).

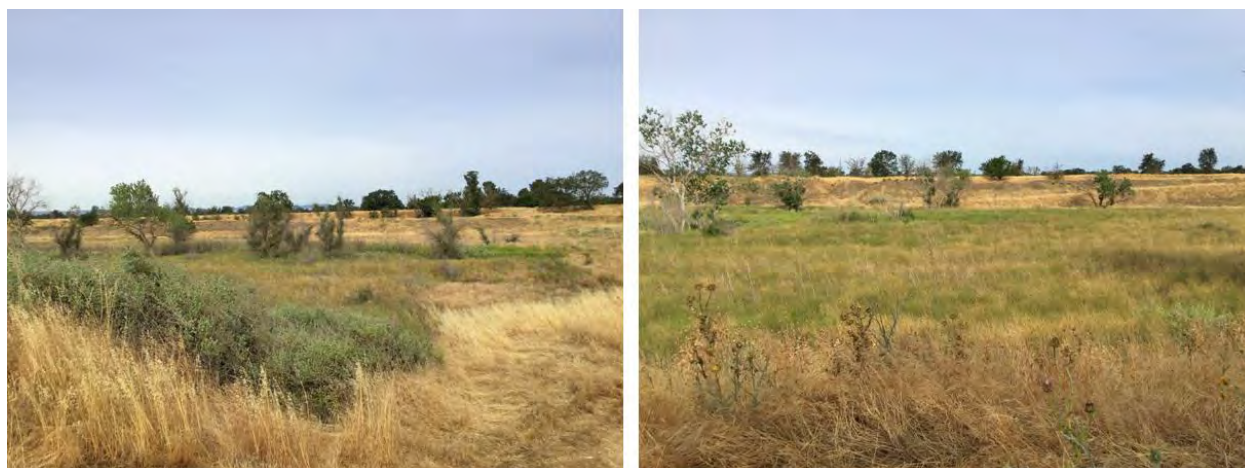
One of the locations with the most potential for active habitat restoration continues to be a series of off-channel former mining pits on the north bank from approximately RM 15.0–15.4 in the Dunnigan Hills and Hoppin reaches (Fig. 4-8). Some native woody vegetation has established in

some these areas, although the understory is dominated by arundo, tamarisk, perennial pepperweed, and other invasive species. Restoration would include invasive species removal, and the planting of a native understory in addition to shrubs and trees. During high flow years, these areas are hydraulically connected to Cache Creek leading to significant inundation that should favor riparian habitat establishment. A portion of this area, described below, has been in the process of being restored by Teichert for the past five years (see Section 4.2.2) and could serve as a model for further restoration of the surrounding upstream and downstream areas.

Figure 4-8. Potential restoration sites at off-channel mining pits on the north bank from RM 15.0–15.4 in the Hoppin Reach. Photos are from 2022 and show view upstream (left) and downstream (right). Conditions were essentially unchanged in 2024.

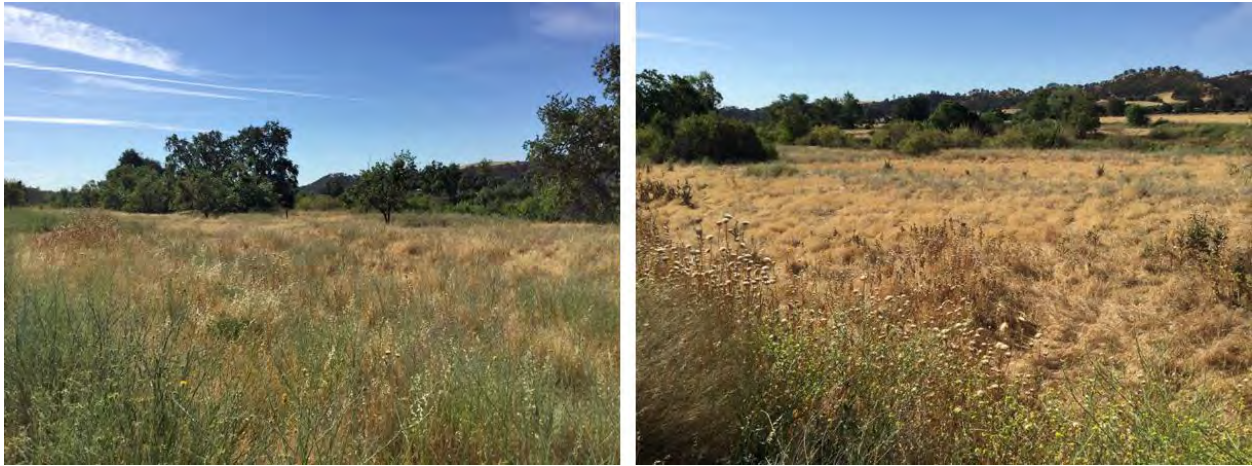
Other high-priority sites for habitat enhancement and restoration include upland areas on the north bank in the Capay Reach from RM 26.8–27.8 (Fig. 4-9), the Hayes “Bow-Tie” property on the north bank at RM 20.0 in the Guesisosi Reach, the Wild Wings Open Space Park on the south bank at RM 17.0 in the Dunnigan Hills Reach, the primary slough running through the Cache Creek Nature Preserve property at RM 16.1 in the Dunnigan Hills Reach, and the Correll-Rodgers pits on the south bank at RM 13.9 in the Hoppin Reach that could potentially be hydraulically reconnected to the main river channel, at least to degree to facilitate habitat restoration (Fig. 4-10). In addition, a private landowner (Capay Organic, a third-generation family-owned organic farm on the banks of Lower Cache Creek) expressed a desire in 2019 to Cache Creek Conservancy

Figure 4-9. Potential restoration sites on upland portions of the north bank at RM 27.5 (left) and RM 27.8 (right) in the Capay Reach. Photos are from 2022, and conditions were essentially unchanged in 2024.

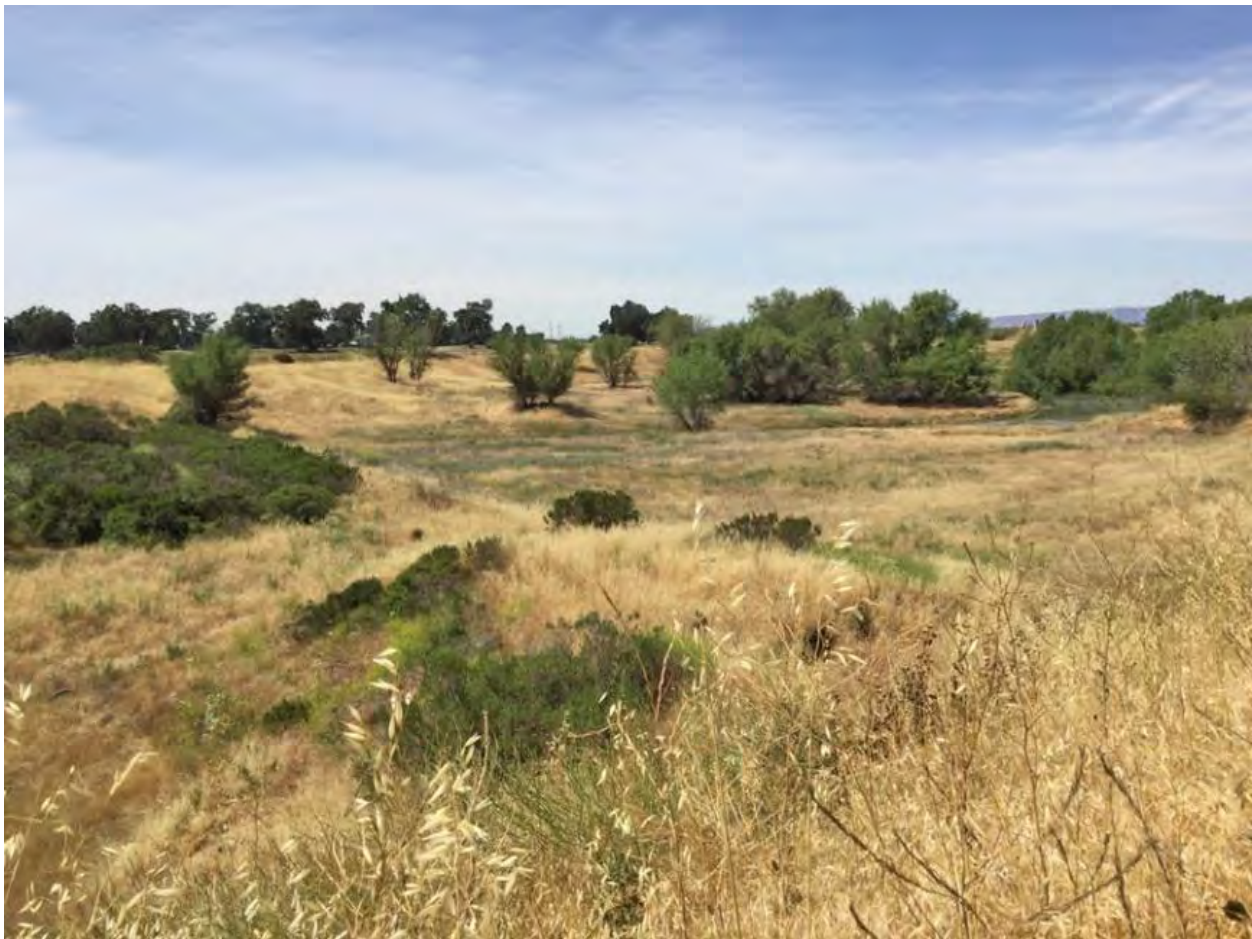
Figure 4-10. Potential restoration site at the Correll-Rodgers pit on the south bank at RM 13.9 in the Hoppin Reach. Photo is from 2022, and conditions were essentially unchanged in 2024 with exception of increased soil moisture and more robust understory vegetation.

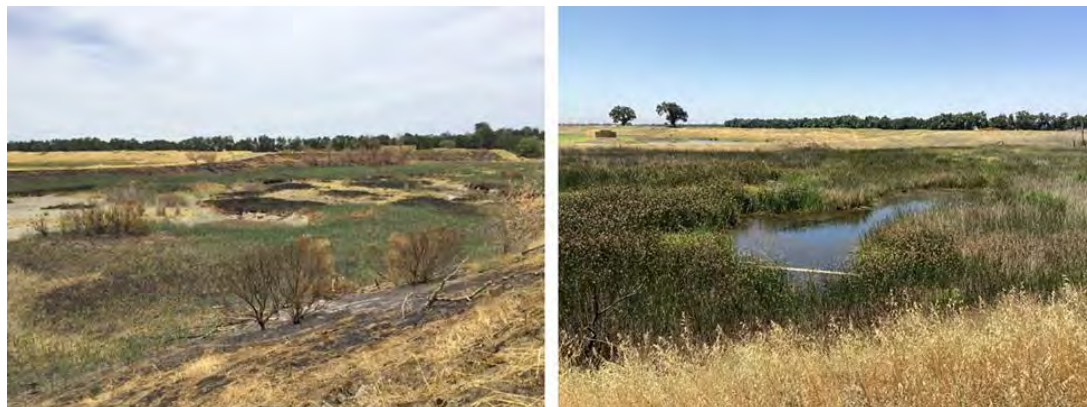
Native grasses were planted in October 2020 on a large bank stabilization site adjacent to Granite's operations on the north bank at RM 24.5, and these grasses still appear to be persisting to some degree even under drought conditions. Previously, a 2010 planting of native grasses and shrubs on the south bank at RM 20.7 in the Guesisosi Reach was lost due to scouring high flows in winter 2016–2017. In 2019, a substantial construction project was initiated to repair the irrigation infrastructure of the Moore Siphon at RM 18.0–18.1 in the Dunnigan Hills Reach. Construction is complete, but the site has yet to be revegetated as of June 2024, although both native and non-native vegetation has continued to establish on the project site. The Cache Creek TAC also observed the wetland portion of the Cache Creek Nature Preserve on the north bank at RM 16.5 in the Dunnigan Hills Reach a year after a prescribed burn that was conducted in April 2022. In 2023, the resulting removal of thatch appears to have stimulated new wetland vegetation growth and reintroduced a degree of habitat heterogeneity that should benefit birds and other wildlife. Conditions were similar in 2024, with the wetland vegetation appearing to be thriving (Fig. 4-11).

Figure 4-11. The results of a prescribed burn of wetlands at the Cache Creek Nature Preserve at RM 16.5 in the Dunnigan Hills Reach in 2022 (left) and two years later in 2024 (right).

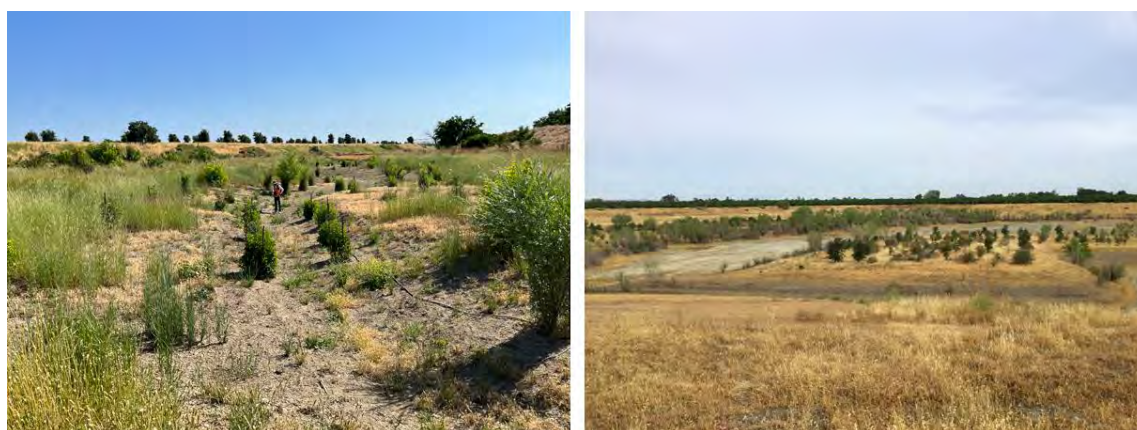
As mentioned above, an off-channel mining pit on the north bank at RM 15.1 is in year five of restoration by Teichert (Fig. 4-12; see also Yolo County 2018), and the *Haller/Muller Habitat Enhancement Project* has the potential to be a model for restoration of similar areas in the future (e.g., the Correll and Rodgers properties at RM 13.7). A former aggregate mine, the 3.8-acre site was reclaimed in 1998 and remains within the active floodplain of Lower Cache Creek. The relatively flat basin dominated by non-native and invasive species was regraded to create a series of terraces that were planted with diverse native overstory and understory species. A seasonal wetland should develop at the lowest grade, with native vegetation transitioning from mesic (e.g., cottonwood, willow, California blackberry) to xeric (e.g., Valley oak, blue elderberry, coyote brush) up the slope. The site will fill with at least some water during high-flow events, but will otherwise remain relatively dry for most of the year. Long-term monitoring will ensure that native vegetation successfully establishes, and that non-native and invasive species are adequately controlled. This restoration site is just to the southeast of an older Teichert reclamation site – Teichert Muller “90” – that was last observed during the 2022 Creek Walk, on which native vegetation seemed to be persisting in the face of drought conditions (Fig. 4-12).

Figure 4-12. Teichert-led restoration projects in the Hoppin Reach: the five-year old Haller/Muller Habitat Enhancement Project at RM 15.1 (2023 photo; left), and the Teichert “Muller 90” site just to the northwest (photo from 2022; right). Planted native vegetation on both project sites is persisting through sustained drought conditions.

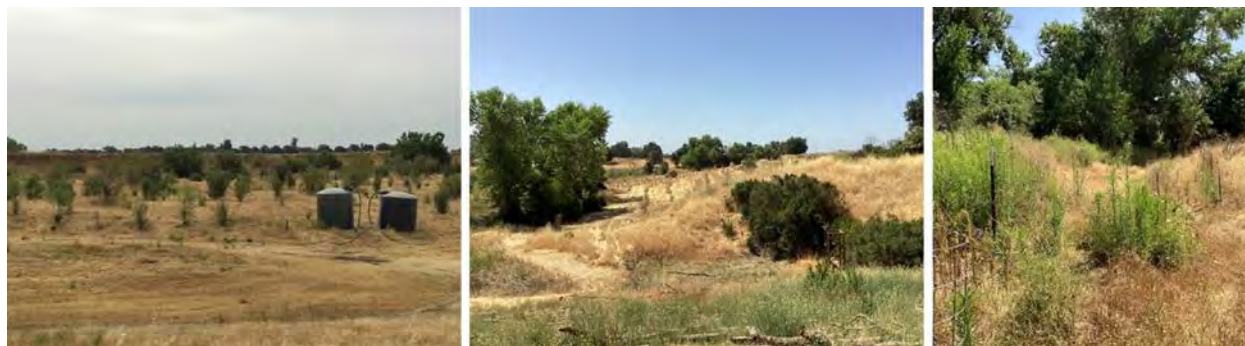
The status of three blue elderberry mitigation sites in the Hoppin Reach was also evaluated during the 2024 Creek Walk (Fig. 4-13). As described in Section 4.4 below, blue elderberry is a special-status plant since it serves as the sole host for the federally-threatened Valley elderberry longhorn beetle (VELB). When elderberry shrubs are impacted by channel stabilization and other types of priority projects on Lower Cache Creek, mitigation is required, and new patches of elderberry shrubs are established (along with other associated native plant species) to provide suitable habitat for VELB. The first elderberry mitigation site is on the Granite Woodland Reiff property on the north bank at RM 14.5 and appeared in 2022 to be in good condition overall after being planted in 2020; conditions were assumed to be similar in 2024. A second, more recent Yolo Habitat Conservancy elderberry mitigation site was planted in late 2021 and is on the Correll property, on the south bank at RM 13.7. The condition of elderberry shrubs has been challenging to assess in past years given their seedling form and the abundance of non-native vegetation covering the site, as well as impacts from high flows in winter 2022-2023. Additional plantings have recently been conducted in higher-elevation areas, and the site seems to be in overall good condition. Increased control of non-native vegetation continues to be recommended for this site, and it is also recommended that future VELB mitigation sites be located in areas less likely to be impacted during high flow years. A third Yolo Habitat Conservancy elderberry mitigation site at RM 13.8 in the Hoppin Reach was also assessed in 2024, and the site also appears to be in overall good condition.

Figure 4-13. Elderberry mitigation sites at RM 14.5 (left; planted in 2020 and photo from 2022), RM 13.7 (center), and RM 13.8 (right).

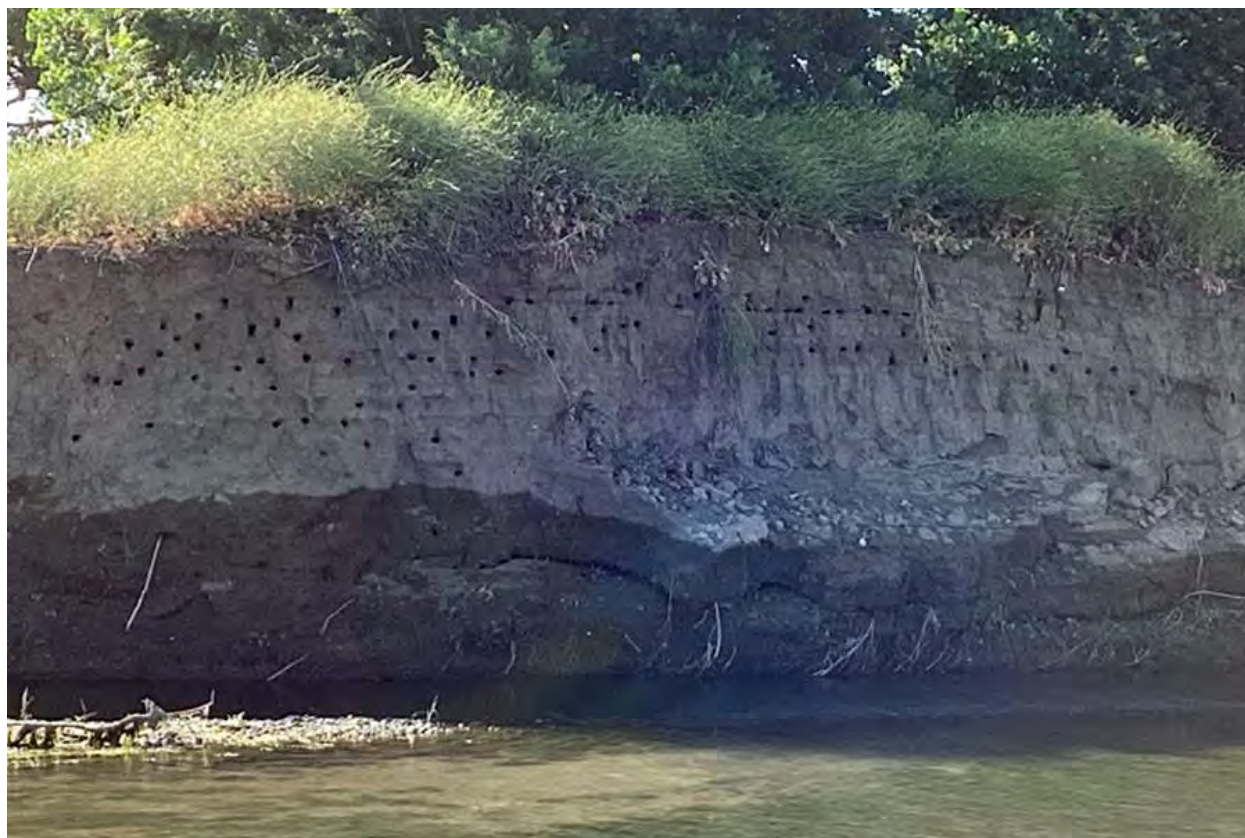
Notably, at least five active riparian bank swallow (*Riparia riparia*; ST) colonies were observed during the 2024 Creek Walk, which represented the greatest number of colonies and holes observed on Lower Cache Creek for at least the last 10 years. A large colony (approx. 190 holes) was observed on the south bank at RM 15.6 in the Hoppin Reach, with a smaller (approx. 25 holes) colony just downstream that could have been an extension of the former. Likewise, an additional large colony (approx. 100 holes) was observed several hundred feet further downstream on the south bank at RM 15.5 (Fig. 4-18), and all three locations may have been part of a single colony. An additional colony (approx. 40 holes) was observed on the south bank at RM 14.6 in the Hoppin Reach, and lastly a very large (approx. 250 holes) colony was observed on the south bank at RM 14.2 in the Hoppin Reach. Other potential bank swallow nesting locations were observed and evaluated beginning at the south bank at RM 26.4 in the Hungry Hollow Reach and downstream at numerous locations including north and south banks from RM 22.8–23.4 in the Madison Reach, the north bank at RM 20.5 in the Guesisosi Reach, the south bank at RM 19.2 in the Guesisosi Reach, north and south banks from RM 18.2–18.7 in the Dunnigan Hills Reach, north and south banks from RM 15.4–15.7 in the Hoppin Reach, and north and south banks from RM 15.1–15.3 in the Hoppin Reach. Biologists from the Cache Creek Conservancy once again assisted with assessing potential bank swallow colony locations, verifying bank swallow presence, and estimating the number of burrows, which was greatly appreciated.

In terms of factors potentially having negative impacts on bank swallows along Lower Cache Creek, significant OHV activity was observed to have specifically occurred adjacent to multiple occupied bank swallow colonies at RMs 14.2, 15.4, and 15.7 in the Hoppin Reach, as well as adjacent to potential bank swallow habitat (suitable but unoccupied) at RM 14.7 in the Hoppin Reach. This level of OHV activity adjacent to the breeding habitat of a sensitive, State threatened bird is concerning and could be having adverse effects on bank swallow reproduction. Also, new bank modifications and hardening actions were once again observed on the south bank from RM 25.3–23.5 in the Hungry Hollow Reach that would likely prevent bank swallows from establishing an active colony, although the habitat was generally suitable otherwise.

Figure 4-18. A large, active bank swallow (*Riparia riparia*) colony on the south bank at RM 15.4 in the Hoppin Reach observed during the 2024 Creek Walk.

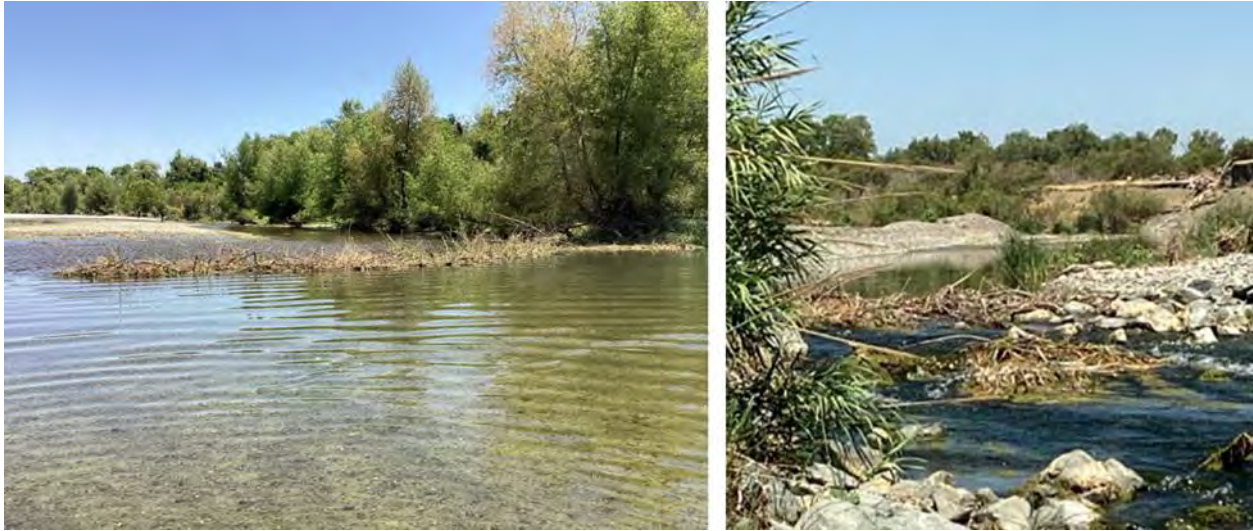
furthest upstream observations of beaver dams for at least 10 years. Beaver dams were confidentially observed in the Dunnigan Hills Reach at RM 17.9 and at RM 17.3, where a complex of dams and pools was observed (Fig. 4-20). As in 2023, none of these beaver dams were observed to be creating adverse flow conditions, nor were beaver impacts on woody vegetation overly harmful. Pools resulting from beaver dams were again observed to be frequently used by native wildlife, and pools seemed to be having a positive impact on surrounding native vegetation. No OHV damage to beaver dams was observed, nor was any reported by Cache Creek Conservancy staff.

Figure 4-20. Beaver dams and resulting pools observed during the 2024 Creek Walk at RM 17.3 (left) and, RM 17.9 (right) in the Dunnigan Hills Reach.

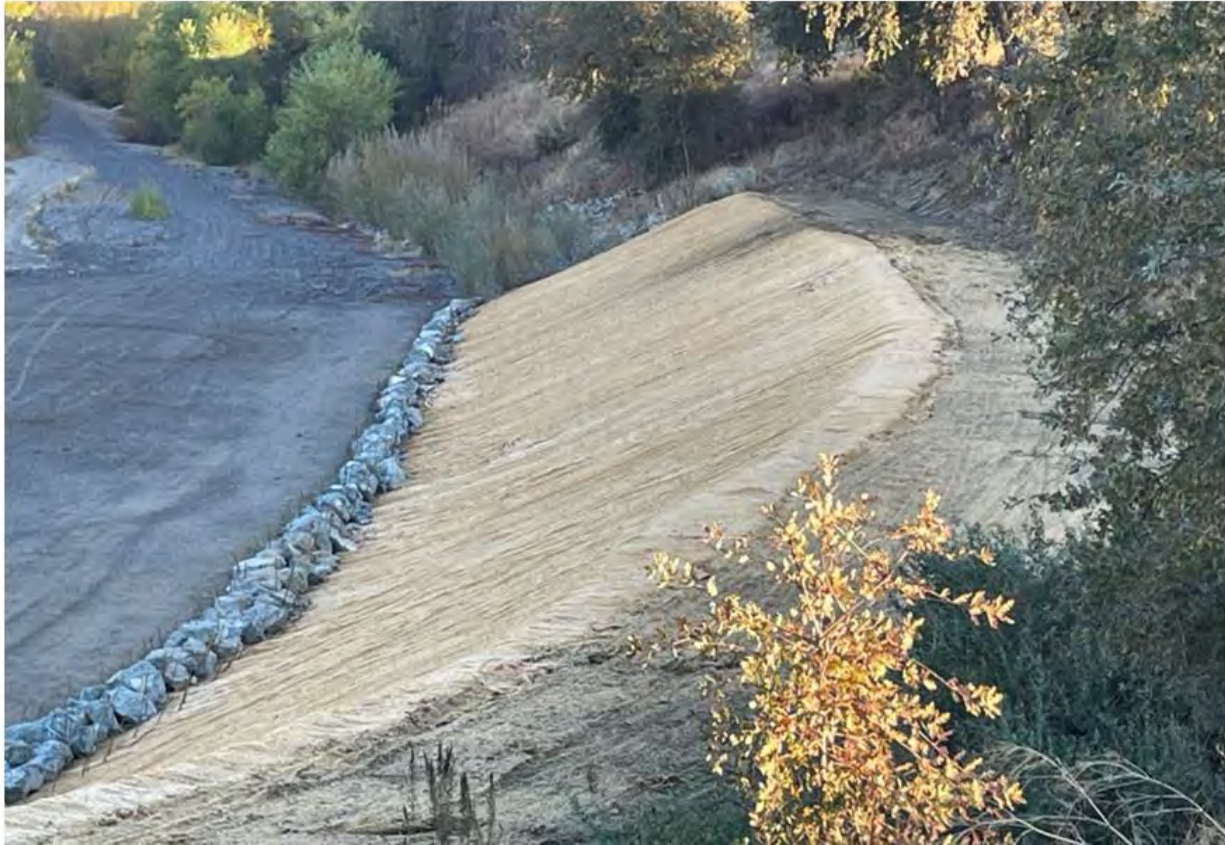
As of the drafting of this update, the “In-Channel Repairs Project” and the “Levee Maintenance Project” were substantially completed by Martin Brothers Construction and Nordic Industries, respectfully. Some representative project photos are provided below (Figs. 4 and 5).

Figure 4. A portion of the completed Huff's Corner In-Channel Repairs Project. Photo taken November 18, 2024.

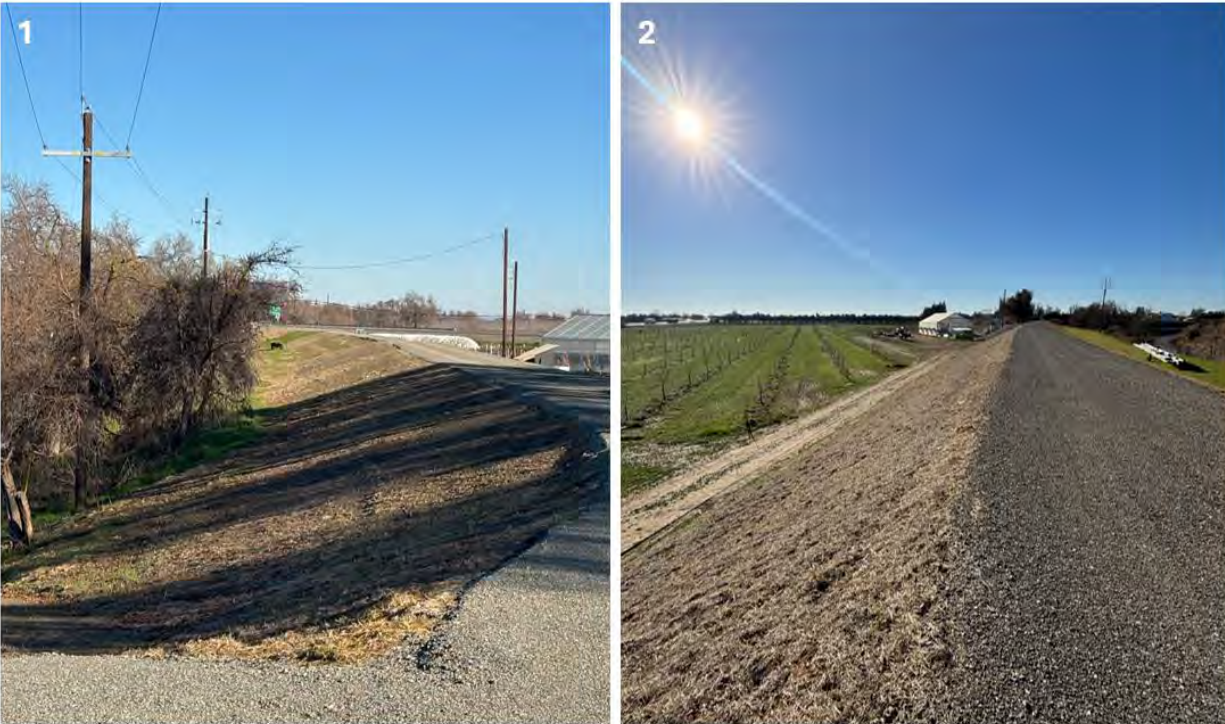
Figure 5. Representative photos showing the completed Huff's Corner Levee Maintenance Project. Photo 1 depicts the waterside slope looking upstream towards I-5. Photo 2 depicts the landslide slope looking downstream. Photos taken January 22, 2025.
