Housing Rehab Program

ENTITY: City of Weslaco

PROJECT: Reconstruction of a single family housing unit located at: 305 S Nevada Ave., Weslaco, Texas

FUNDING YEAR: HOME 2020

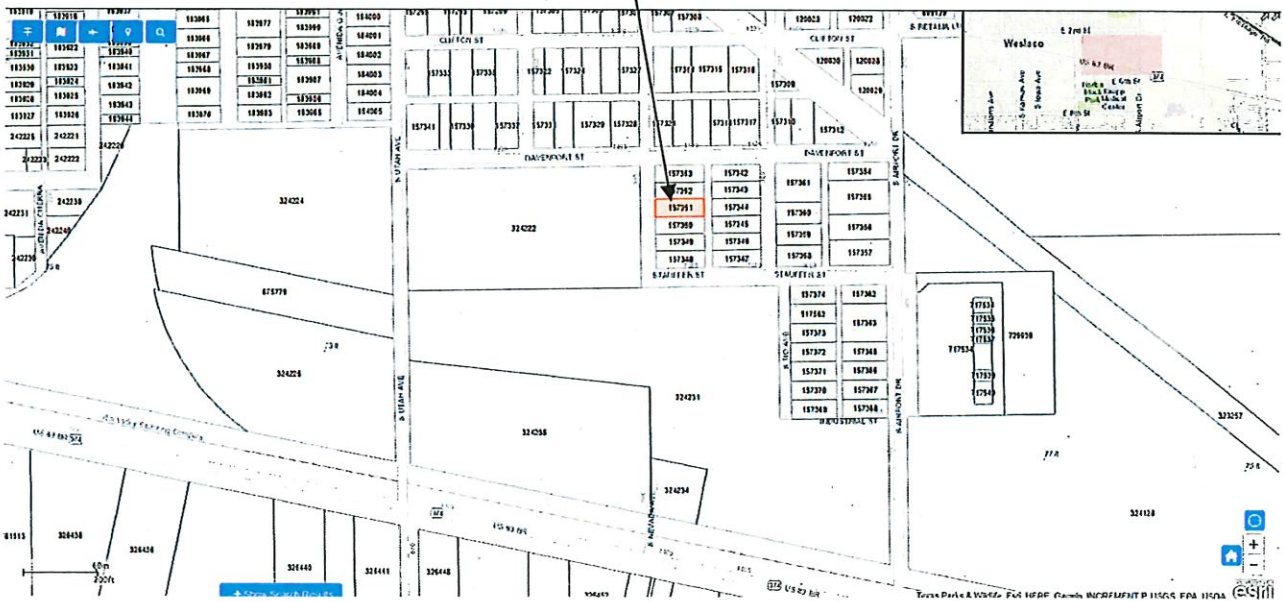
Subject Property

305 S. Nevada Ave. / C Davenport No.2 Blk 1 Lot 10, Weslaco TX
