Housing Rehab Program

PROJECT: Reconstruction of a single family housing unit located at: 2507 S. Border Ave. Weslaco, Texas

INITIAL HOME INSPECTION

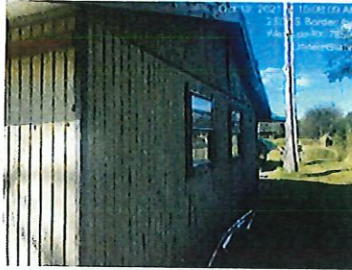
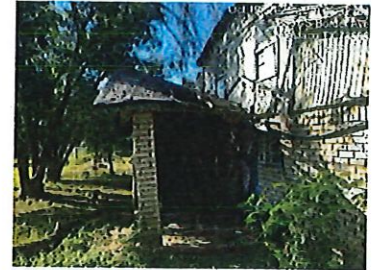
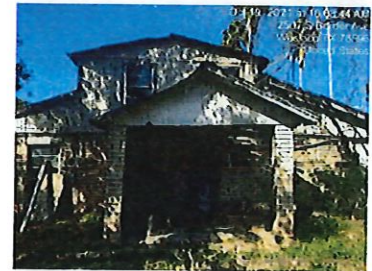
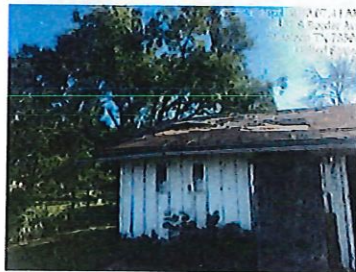
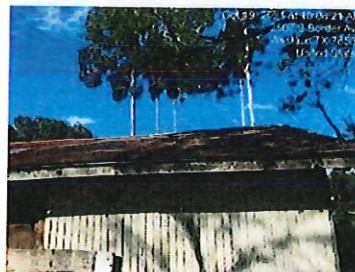
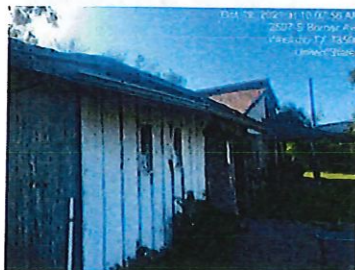
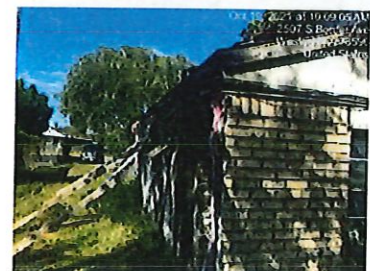
EXTERIOR PICTURES

2507 S. BORDER AVE.
WESLACO, TX-10/19/21
INITIAL INSPECTION PICS

Notes: Foundation cracked in most areas of home
