Housing Rehab Program

PROJECT: Reconstruction of a single family housing unit located at: 1917 Fresnos St. Mercedes, Texas

INITIAL HOME INSPECTION

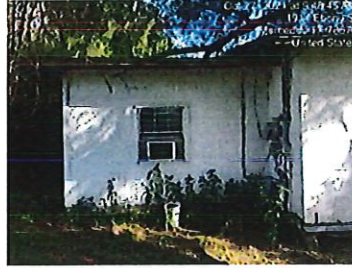
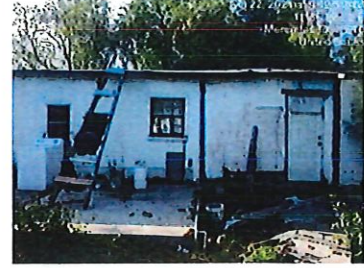
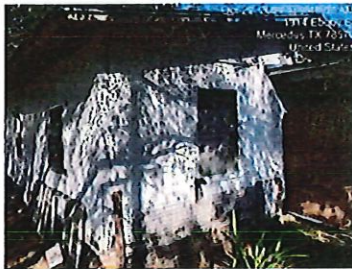
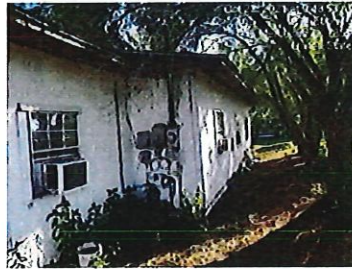
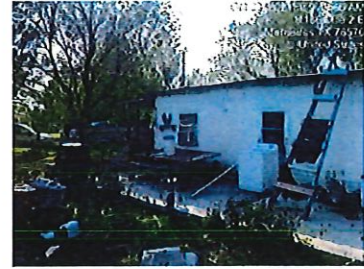
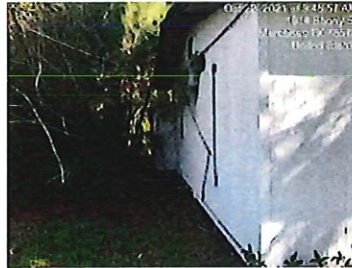
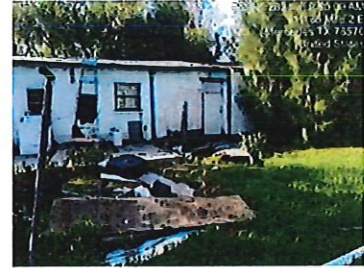
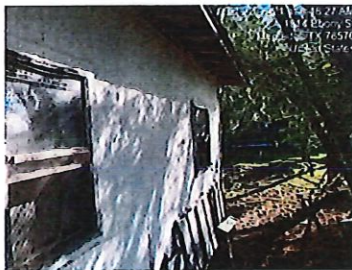
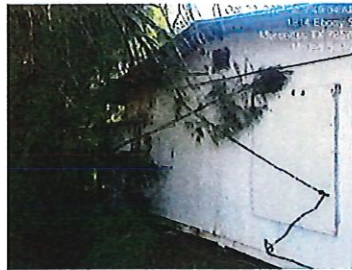
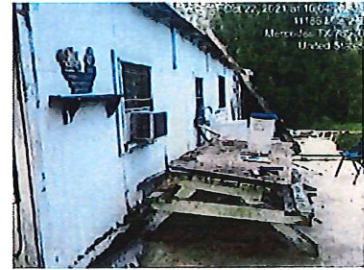
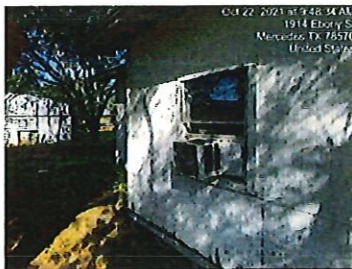
EXTERIOR PICTURES

1917 FRESNO ST.
MERCEDES, TX-10/22/21
INITIAL INSPECTION PICS
