**RE: Contract # C-22-0728-01-01 - Work Authorization #2 ~ Hidalgo County Jail West
Parking Facility**

TASK	% Complete
Geotechnical Drilling, Testing & Eng. Services	
<u>UPDATED:</u> B2Z secured a sample of Limed Flexbase material for testing on the following item: <ul style="list-style-type: none">• Moisture/Density Standard Proctor• Atterberg Limits of Soil Reports: HCWP-5S & HCWP-6S	20%
B2Z performed field testing with the use of the nuclear density gauge to measure compaction of Lime Treated Subgrade Material for Roadways. Reports: HCWP -3S, HCWP-4S & HCWP -7S

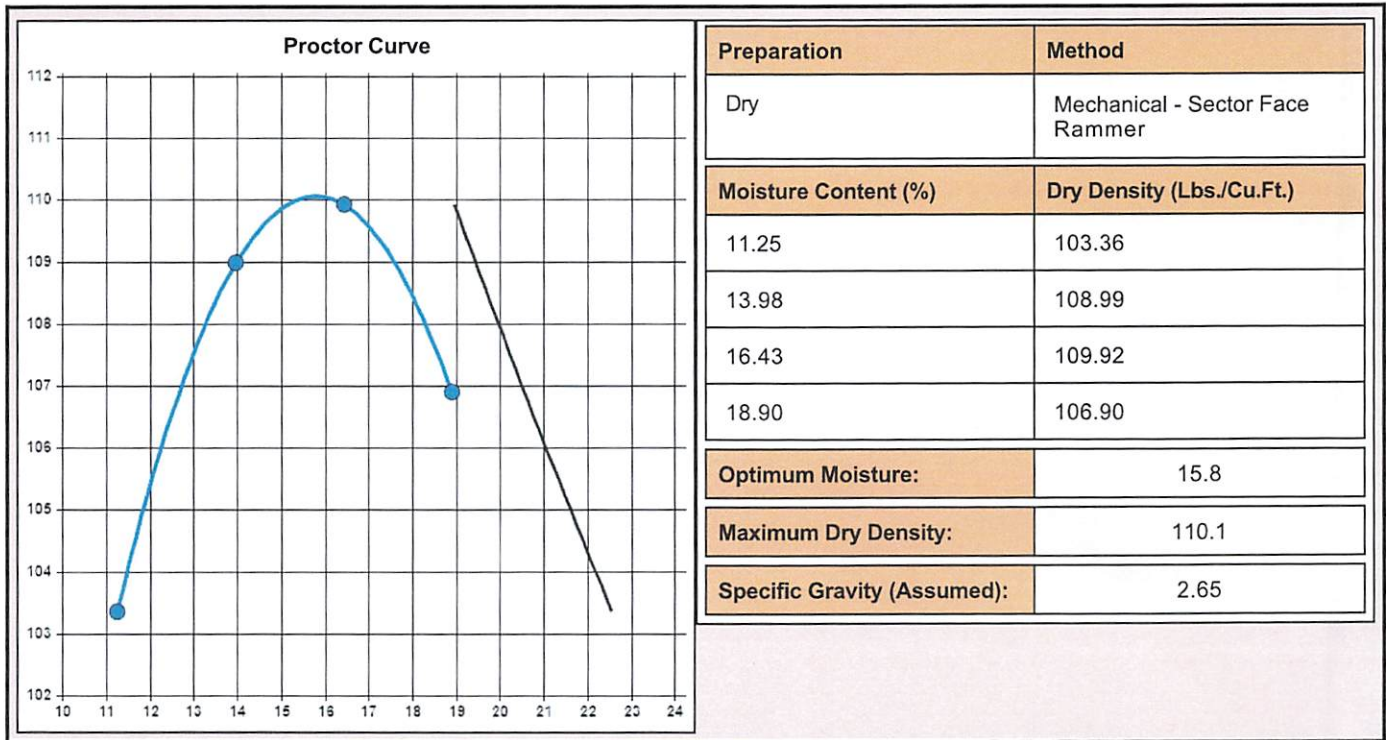
Test Results

Sample Date:	12/01/2023	MF Sample Number:	4900
Sample From:	Stockpile	Material Description:	Limed Flexbase
Sampled By:	Jacob Chavez	Location Details:	South West Quadrant/ North West Quadrant On site. From Martin Marietta Pit

Test Completed Date:	12/05/2023	Test Completed By:	Jorge Solis
-----------------------------	------------	---------------------------	-------------

Test Results: The test is for informational purposes.
