**RE: C-24-0211-07-09 (ARPA-24-121-358)
WA# 2 ~ Wellness, Activity and Community Center (WACC) – CMT**

Project Info:
Contract #C-24-0211-07-09 WA#2
Wellness Activity Community Center
(WACC) - CMT

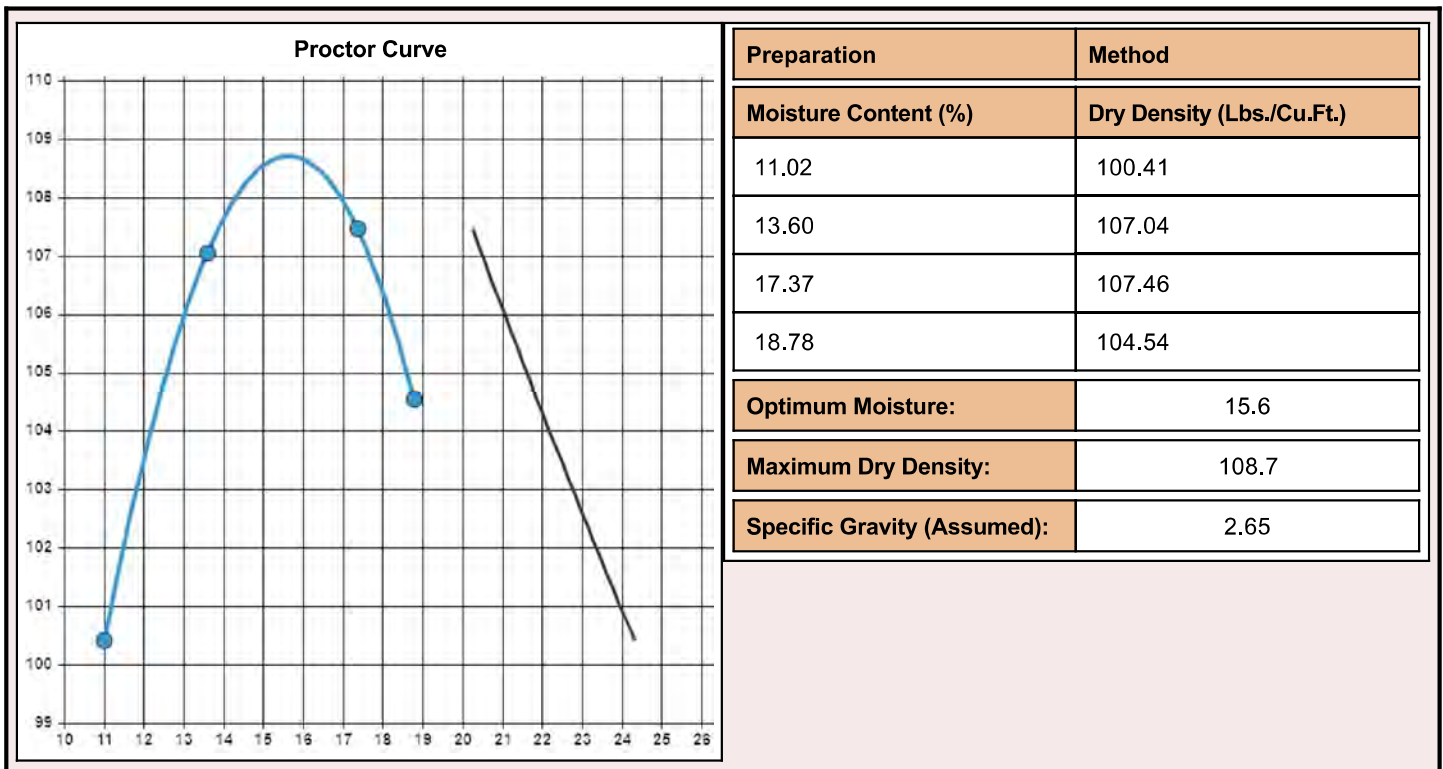
Test Results

Sample Date:	12/06/2024	MF Sample Number:	7572
Sample From:	Windrow	Material Type:	Select Fill
Sampled By:	Manuel De Santiago	Location Details:	NE of building Stockpile at jobsite

Test Completed Date:	12/12/2024	Test Completed By:	Jorge Solis
-----------------------------	------------	---------------------------	-------------

Test Results: The test is for informational purposes.
