Housing Rehab Program

PROJECT: Reconstruction of a single-family housing unit located at: 613 Church St. San Juan, Texas

FUNDING YEAR: Texas Department of Housing & Community Affairs Colonia Self-Help Program (TDHCA) #CSH24-0165

Initial Inspection Checklist for Housing Rehabilitation (When compliance with TMCS is required)

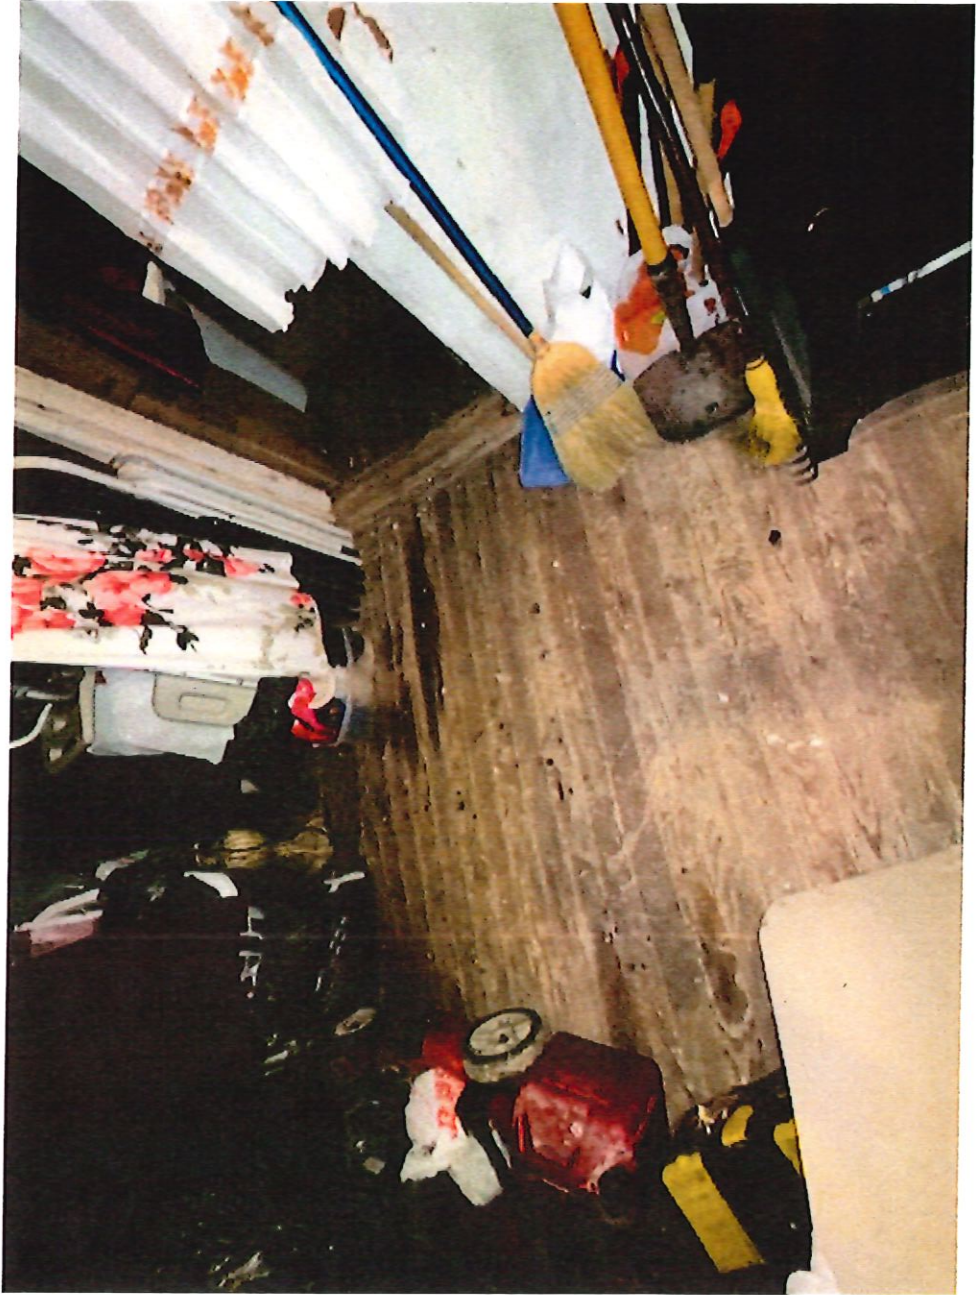
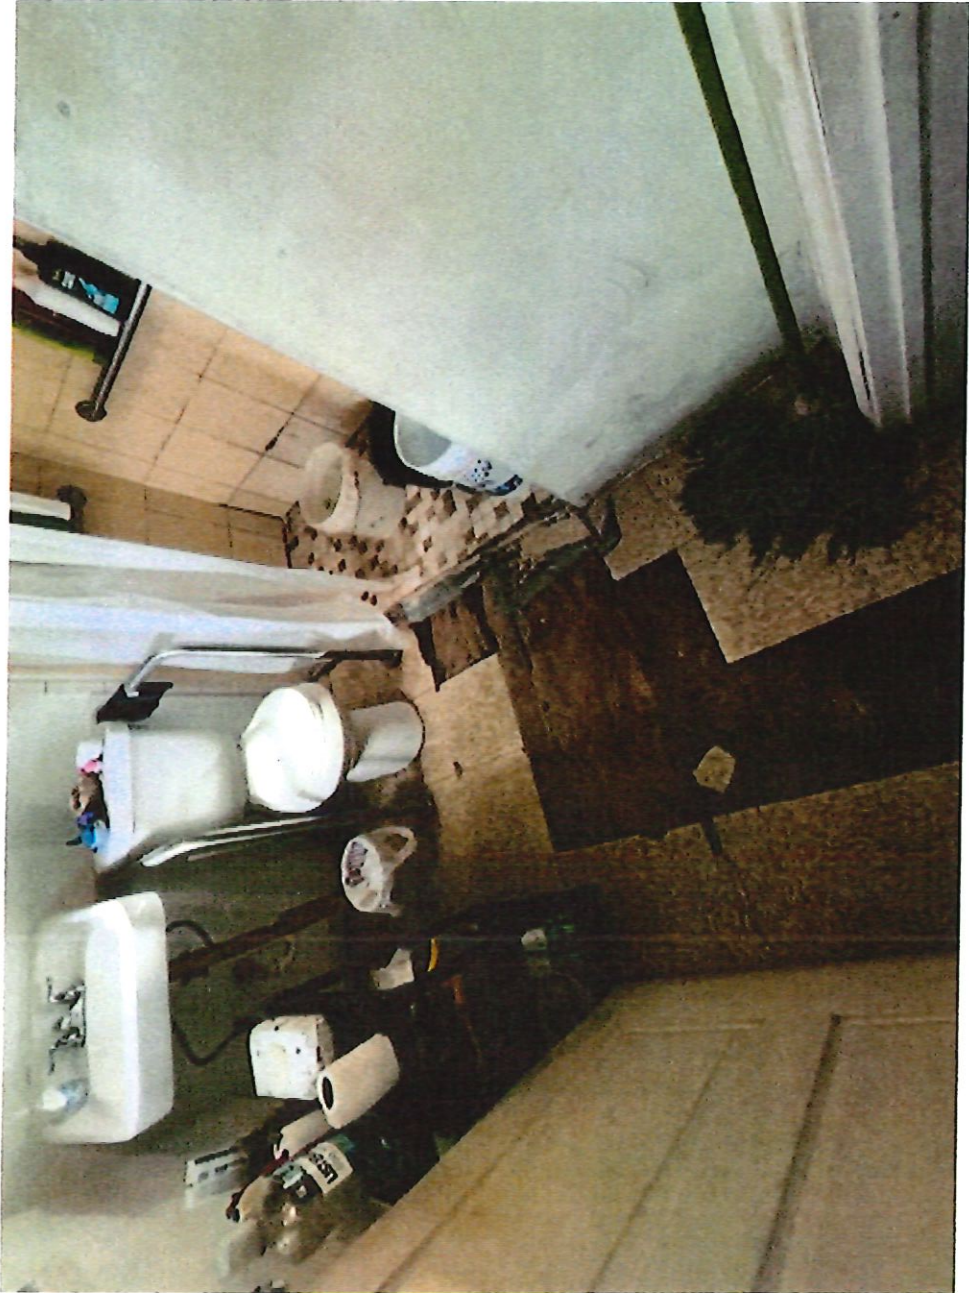
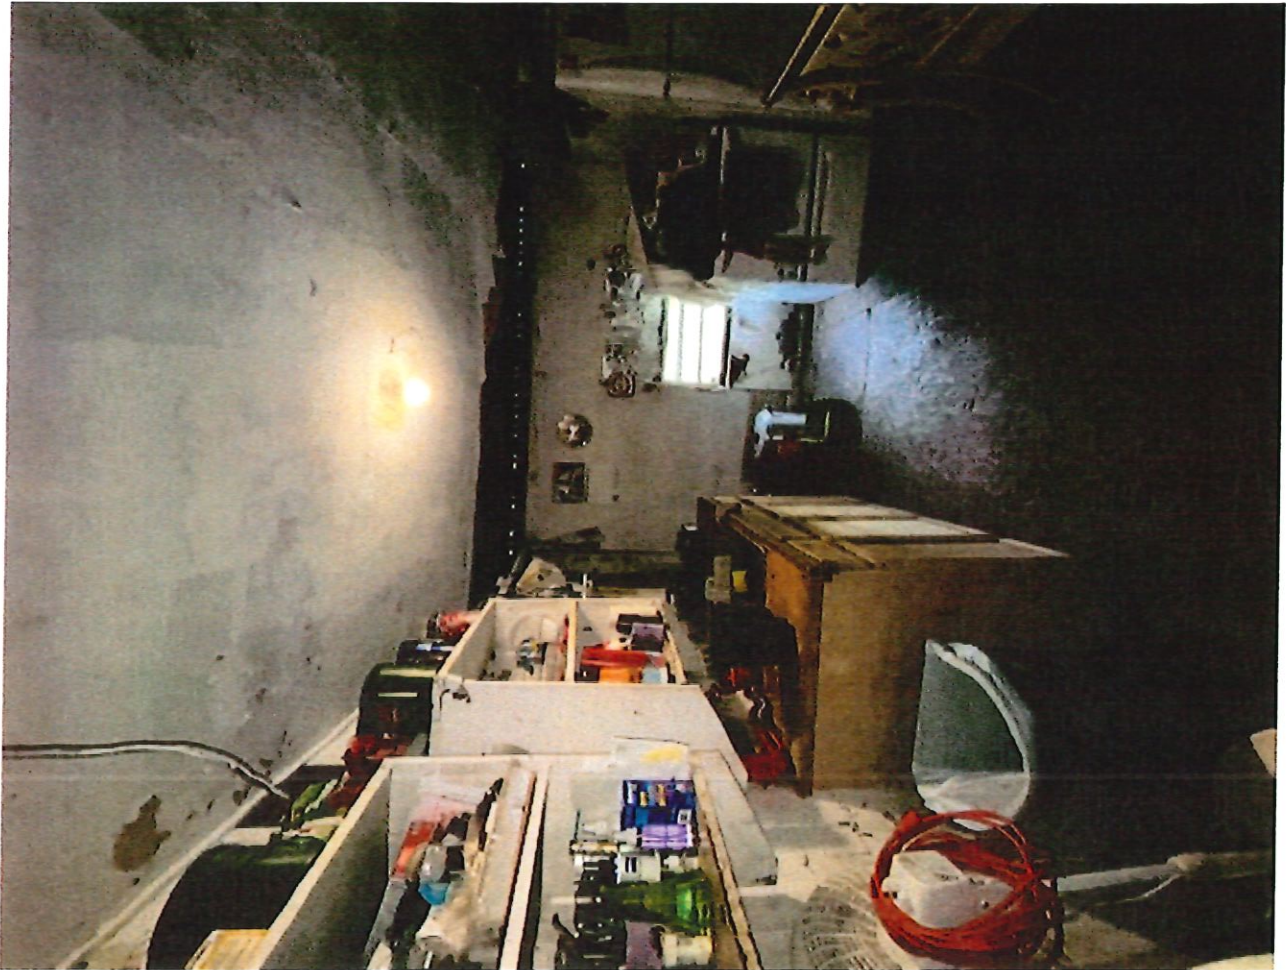
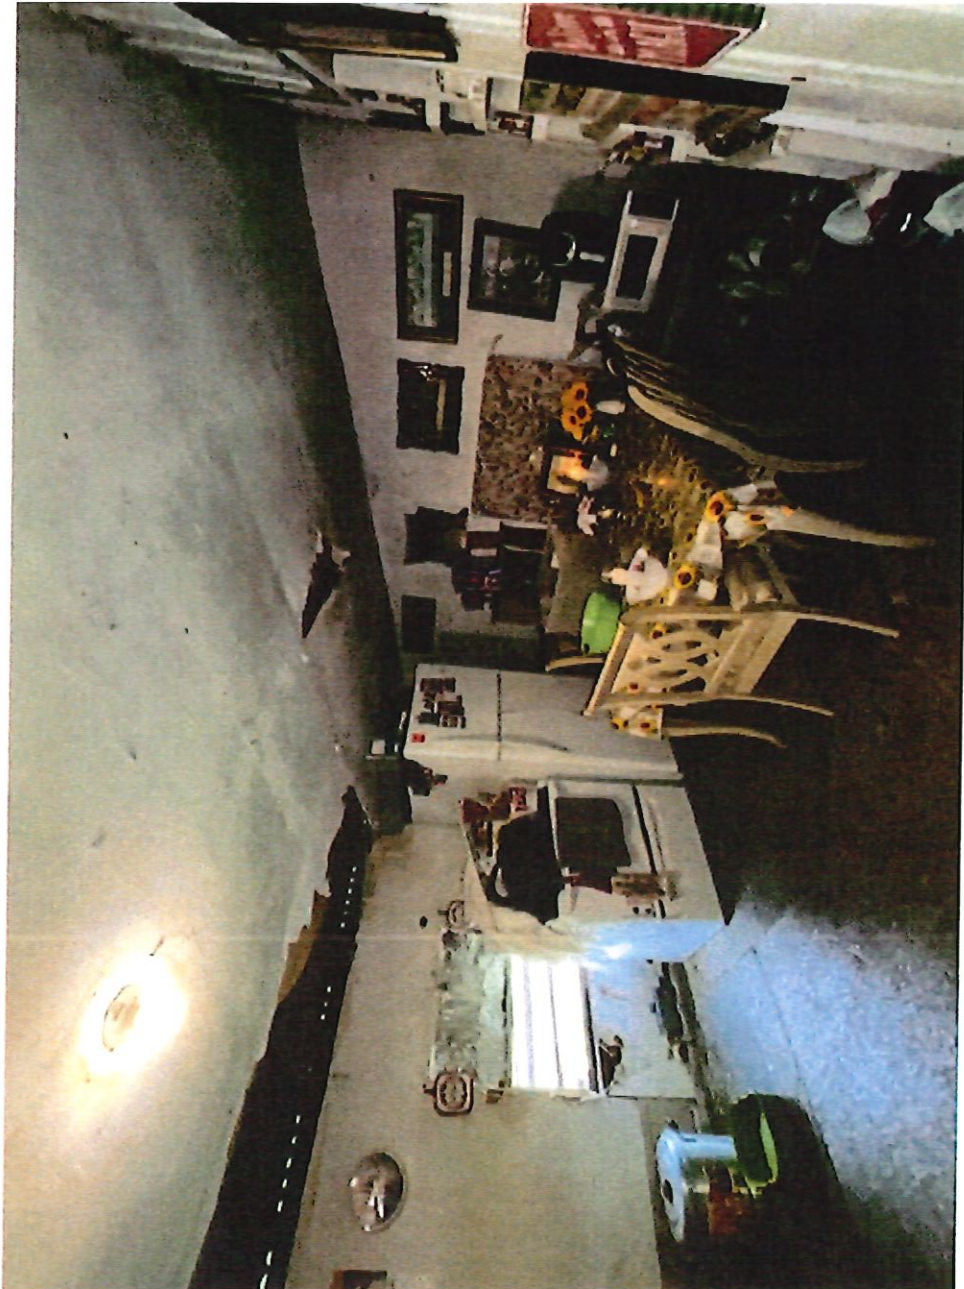
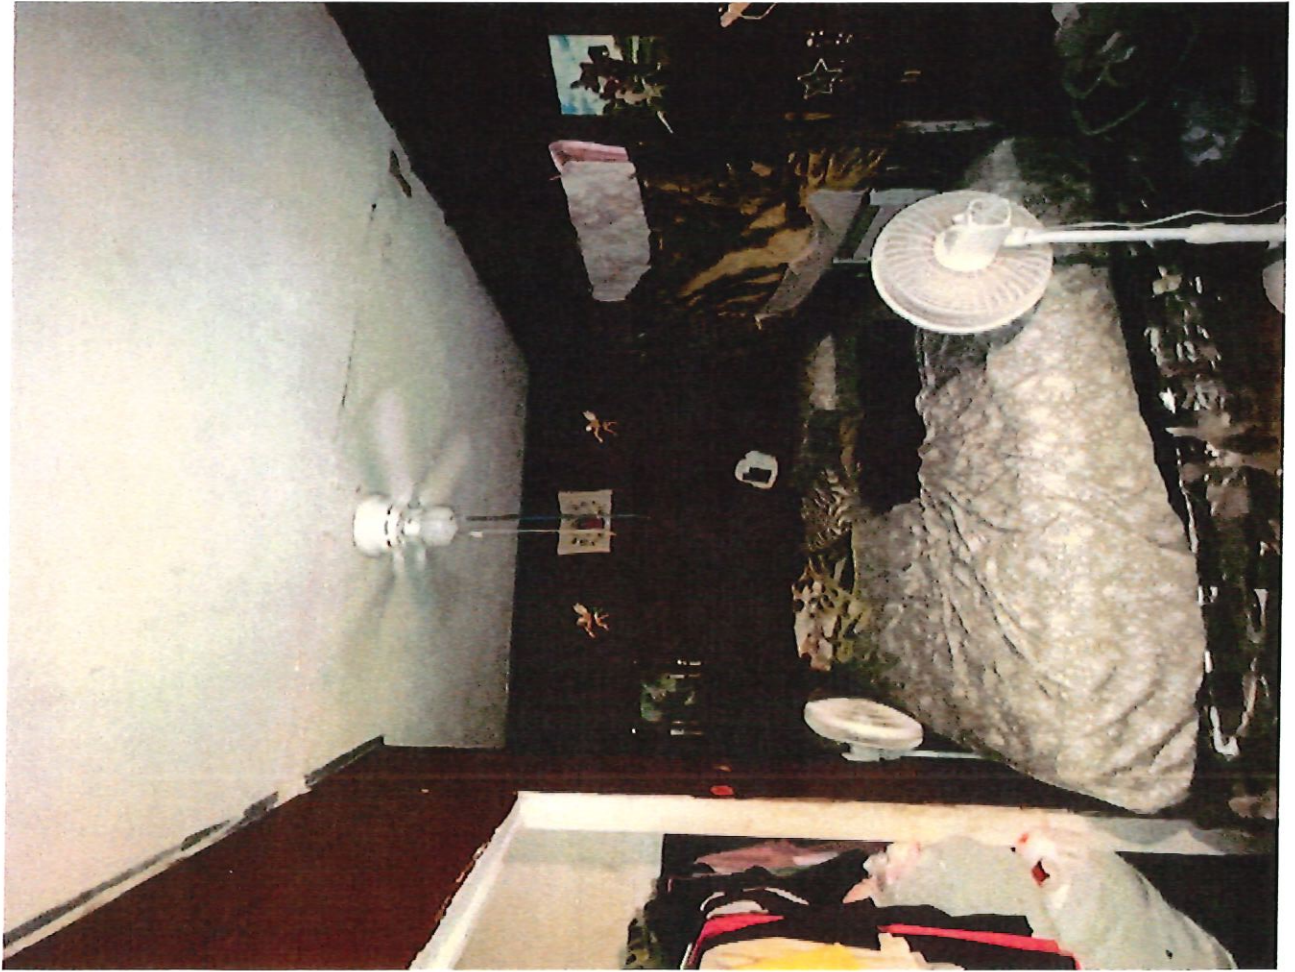
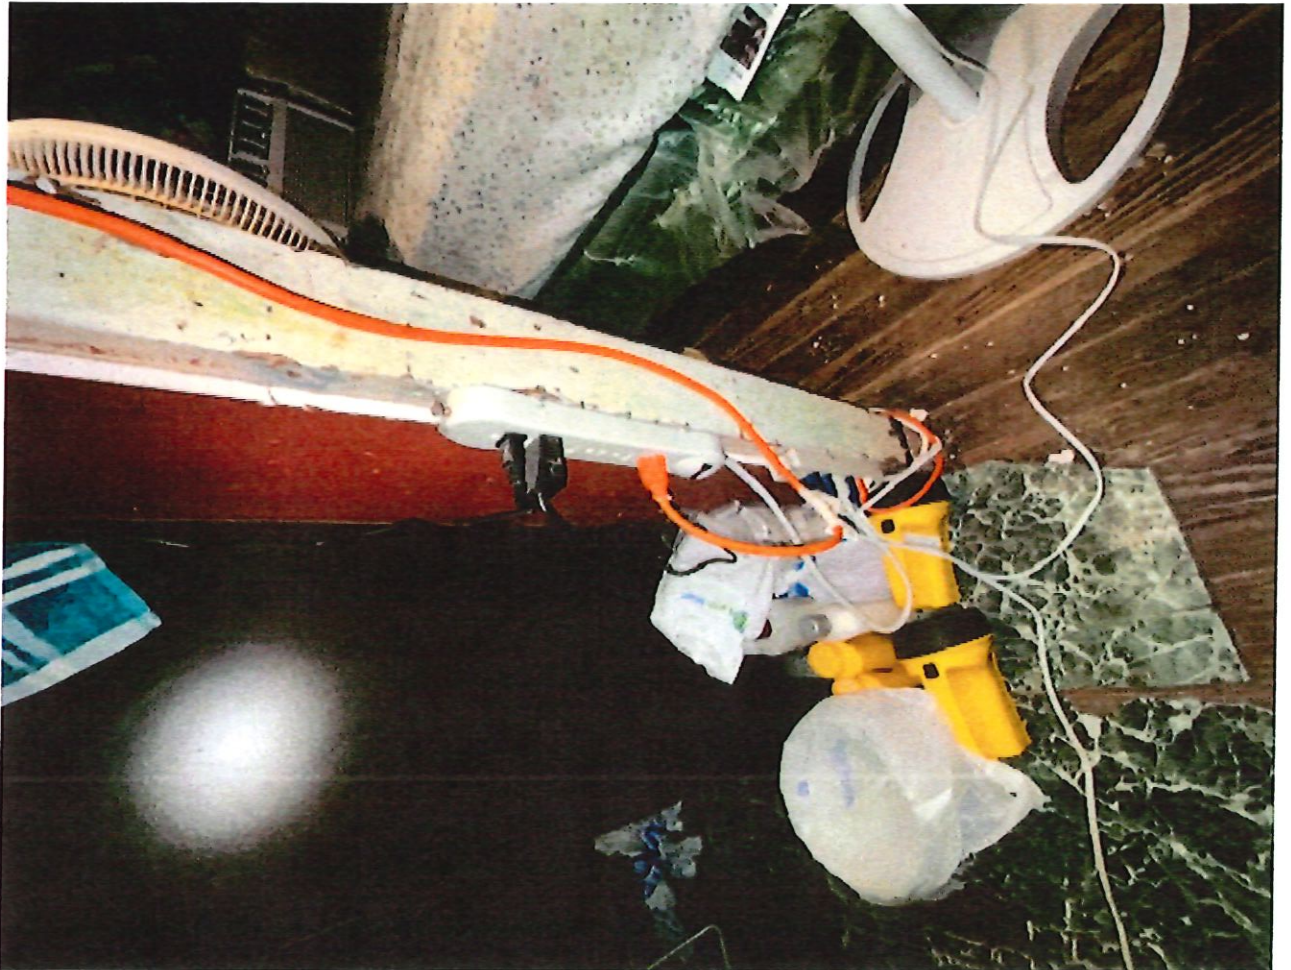
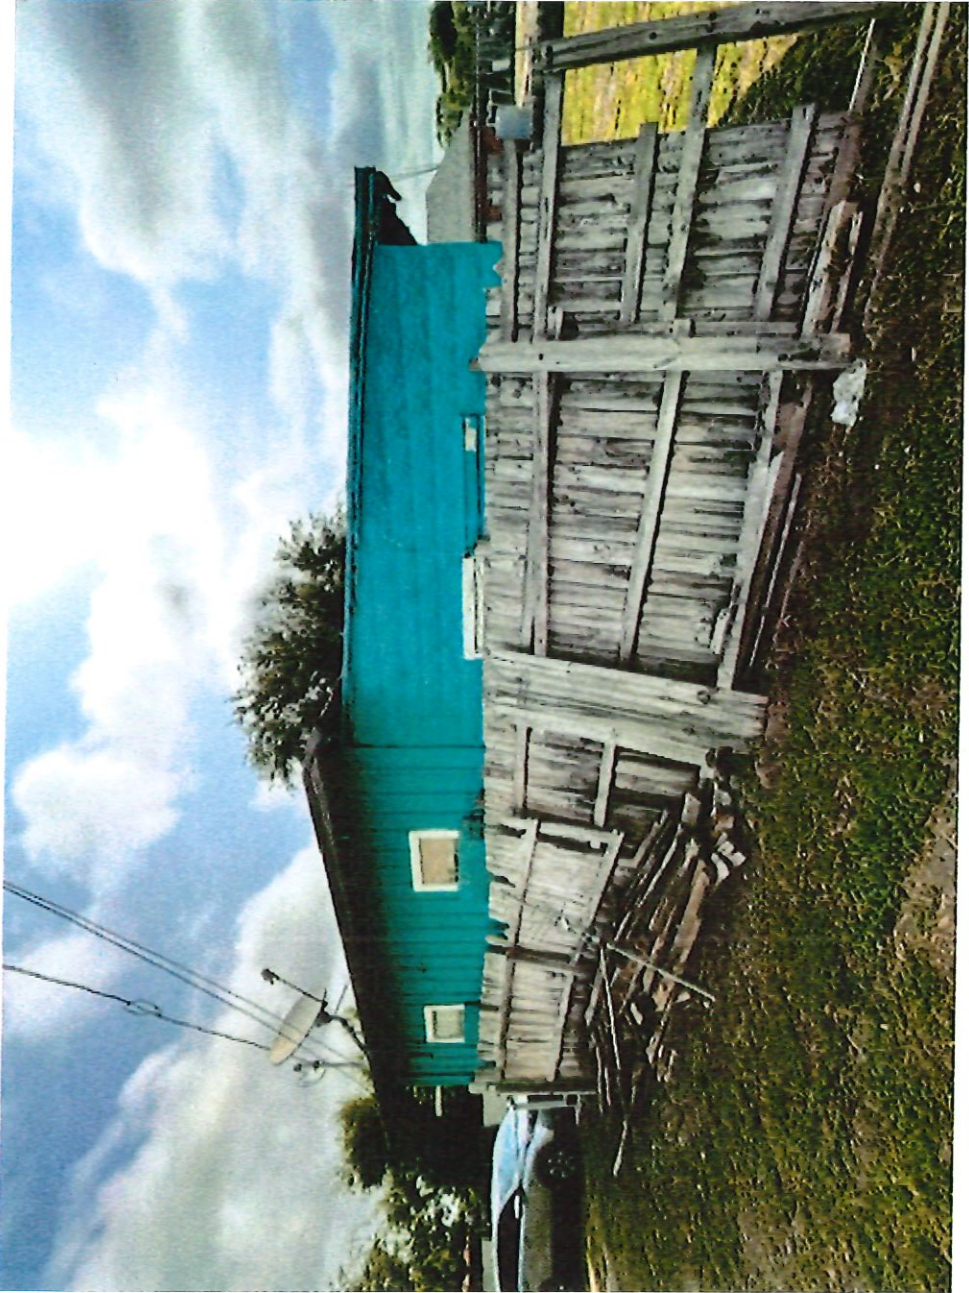
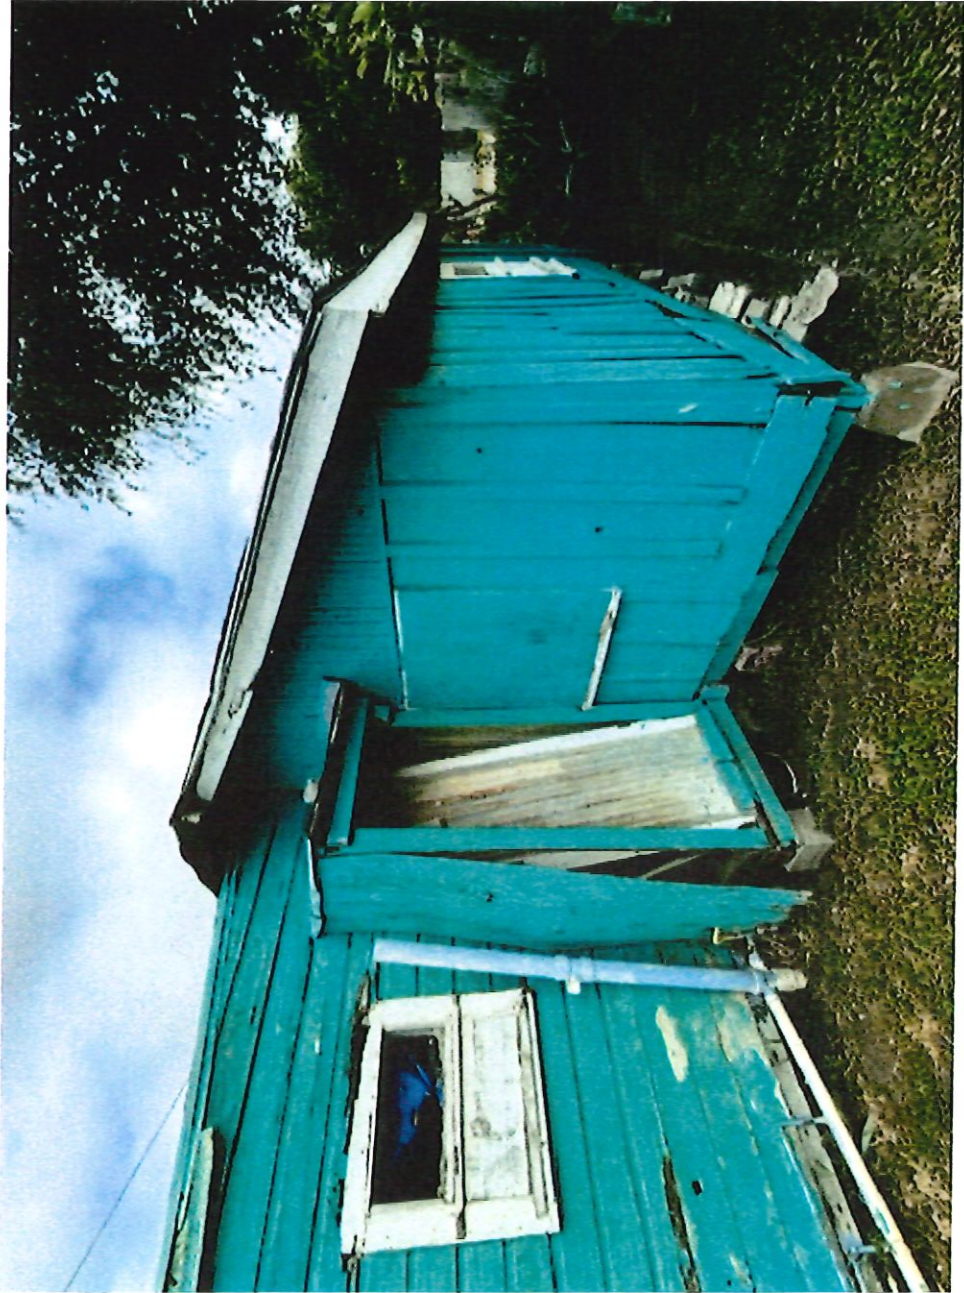
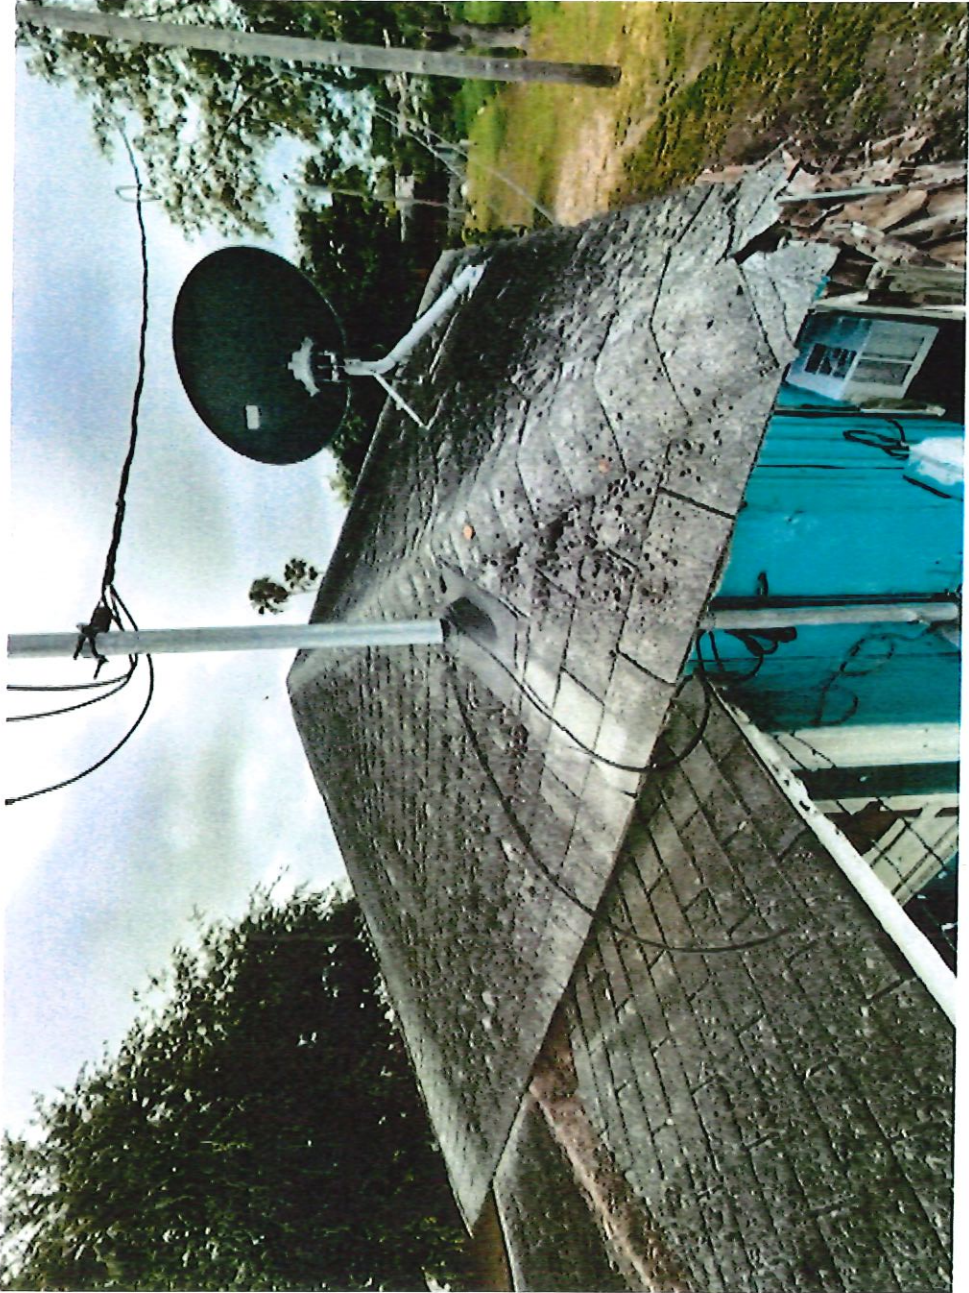
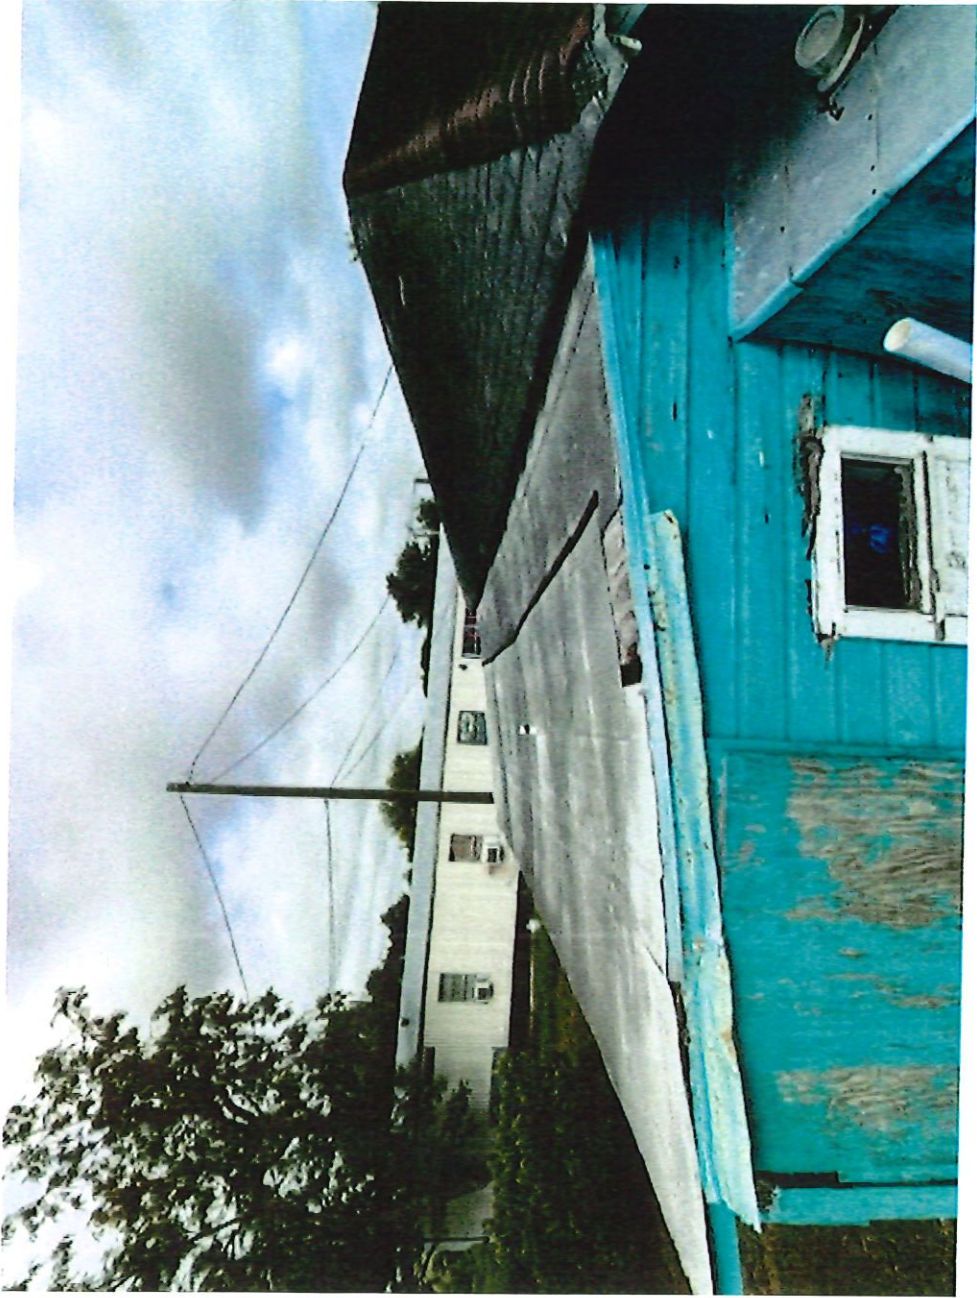
- Color photos to support each major system deficiency listed below are required.
- If site built home, plans must be submitted for review.

Exterior walls look to be poorly constructed, and the exterior finish of the home (the siding) is very poorly done (poor workmanship) with damaged and missing siding in some areas of the home. Plumbing and electrical penetrations do not look to have been sealed properly. All of these are contributing factors to the structural failure of the home.

The roof of the home is found to be in poor condition. Shingles are worn out and missing in some areas, the roof decking is rotted in some areas, the Facia is damaged and missing on some areas of the home and there is no soffit though out the home.

The electrical work on the home is noted as deficiency. There are several electrical wires hanging outside the walls and ceiling. Some outlets are being overloaded with the use of extension cords to power adjacent living areas. Lack of GFI outlets near water fixtures pose an electrical hazard.

This home looks to be in very poor conditions and any attempt to repair this home to make it a safe, structurally sound home would likely result in spending an excessive amount of money. I would highly recommend this home be demolished and reconstructed.
