## Housing Rehab Program

**PROJECT:** Reconstruction of a single-family housing unit located at: 807 Water St., San Juan, Texas

**FUNDING YEAR:** Texas Department of Housing & Community Affairs Colonia Self-Help Program (TDHCA) #CSH24-0165 & HOME Owner-Occupied Rehabilitation Program

**RE: Reconstruction Recommendation – 807 Water Street San Juan, TX 78589 - Veronica Macias**

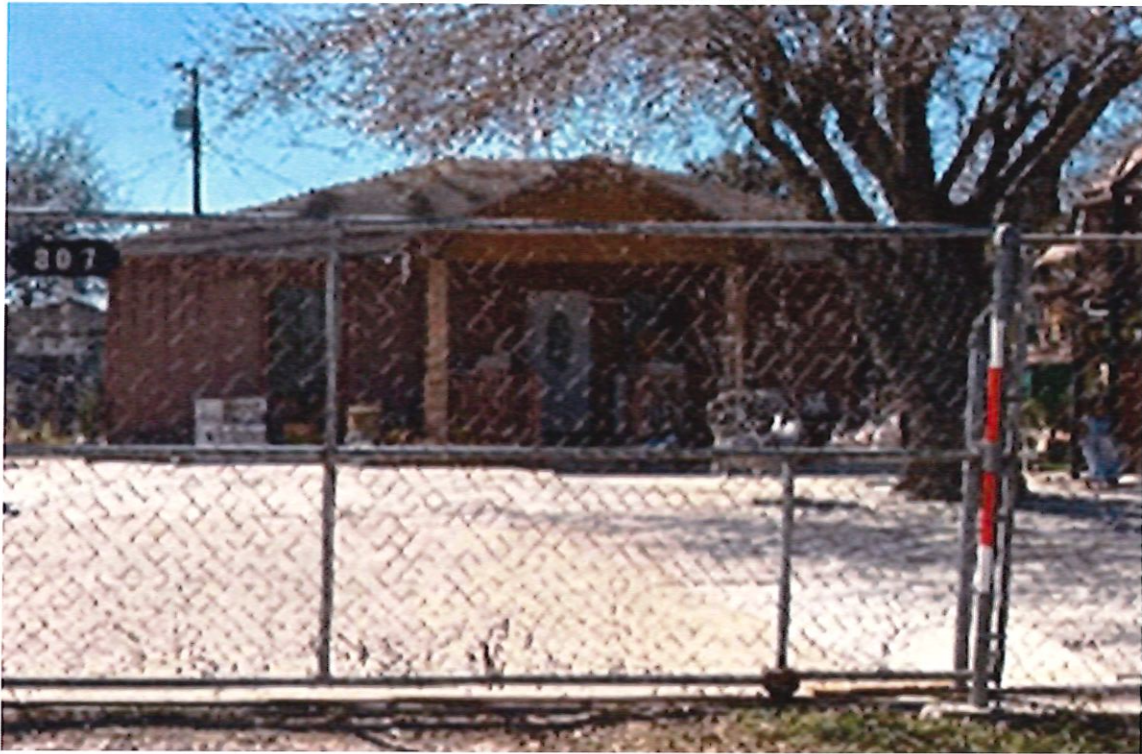
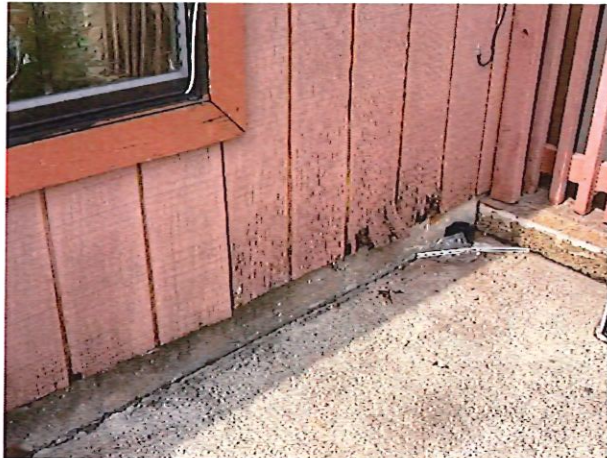
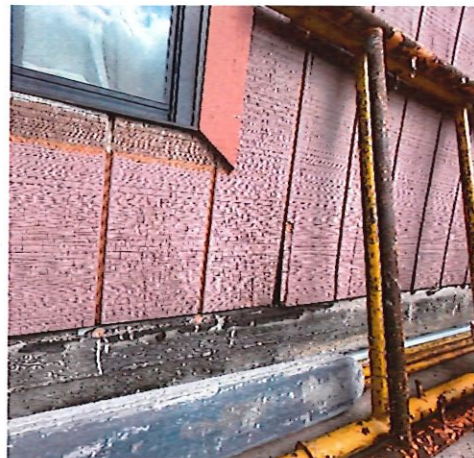
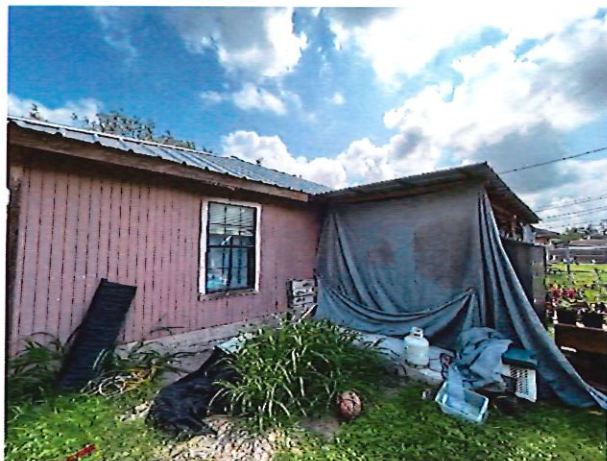
807 Water St. San Juan TX. 78589

The home in in need of repairs to the exterior of the home (siding) and the interior of the home (drywall). The roof needs replacement. The home needs a complete installation of a water heater closet, including water heater and all supply line (both electrical and plumbing).

On May 28, 2026, Proyecto Azteca Construction Director Raul Cervantes conducted an inspection of the home to assess its current condition and determine whether reconstruction assistance is warranted. The inspection identified deficiencies affecting several major components of the residence, including a roof in poor condition with worn and missing shingles, deteriorated soffit and fascia, exterior siding repairs, interior drywall repairs, plumbing fixture deficiencies, electrical corrections associated with the water heater installation, and water damage in bathroom areas. The homeowner also reported a history of significant wall cracking throughout the home prior to recent cosmetic improvements.

| Cost Estimate | Please check ALL applicable items |
|---|---|
| House has extensive damage to roofing, cost estimate for this repair: \$ . | <input checked="" type="checkbox"/> |
