- Water Distribution System
Integrity Study – Burgess
& Niple

Huber Heights, Ohio

Public Water System OH5703612

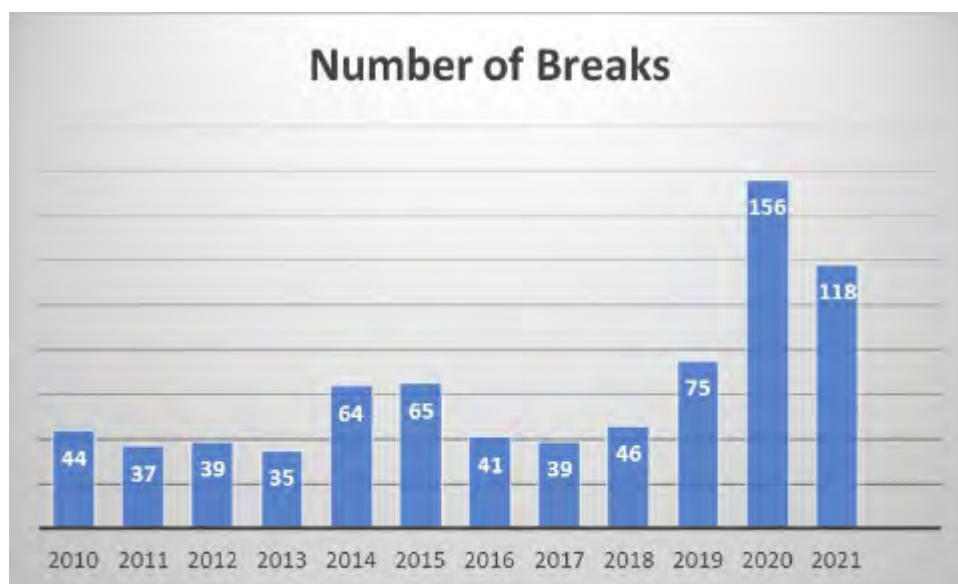
Figure 1-1. Distribution System Break Rate by Year

The City of Huber Heights water distribution system experienced a sudden increase in its watermain break rate beginning in 2019 (see **Figure 1-1**). For the 9 years prior, the average number of breaks per year was just over 45. The 156 breaks in 2020 was nearly 3.5 times that average, and the 118 breaks in 2021 was 2.6 times that average. The purpose of this study was to determine the causes of the spike in breaks; determine if the cause(s) will persist; and evaluate alternatives to control the future break rate to acceptable levels.

Prior to the spike in breaks, the average annual break rate was approximately 22 breaks per 100 miles per year. Many major cities in the US experience a break rate of less than 20 breaks per 100 miles per year, and the AWWA Partnership for Safe Water Distribution System Program's 2018 goal for a fully optimized distribution system is 15 breaks per 100 miles per year. Even before the spike in breaks, the City was in a position to potentially benefit from targeted, proactive watermain replacements, and did some proactive replacements in 2019 and 2020. This study will analyze alternative investment levels to control the break rate to varying degrees.

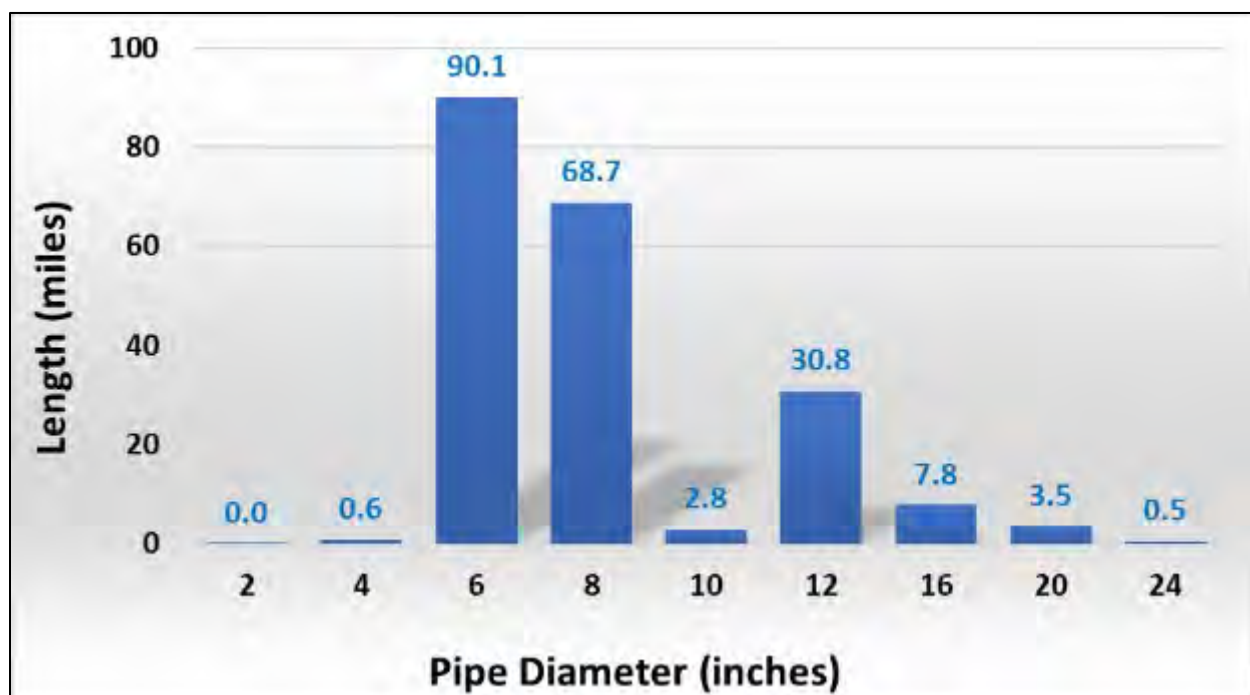
Figure 2-3. Length of Water Main by Size

Pipe size was also populated in the initial GIS data set for every pipe. Pipe size ranges from 2-inches to 24-inches, as shown in **Figure 2-3**.

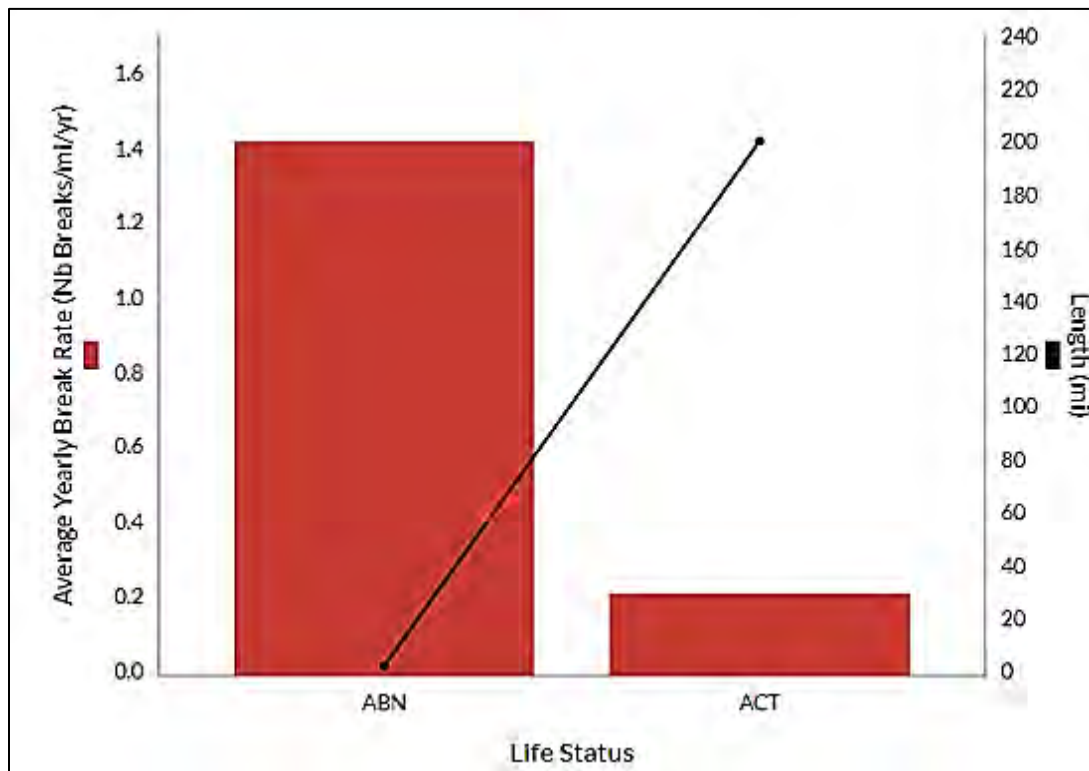
Figure 2-5. Average Annual Break Rate of Abandoned (ABN) Pipe and Active (ACT) Pipe

Figure 2-5 shows the average annual break rate of abandoned (ABN) pipes at the time they were abandoned (1.43 breaks per mile per year) versus the current average annual break rate of active (ACT) pipes (0.22 breaks per miles per year). This data indicates that at the time of abandonment, the abandoned pipes had an average annual break rate 6.5-times higher than the current average annual break rate of active pipe, and that Huber Heights has historically selected the right pipes to replace.

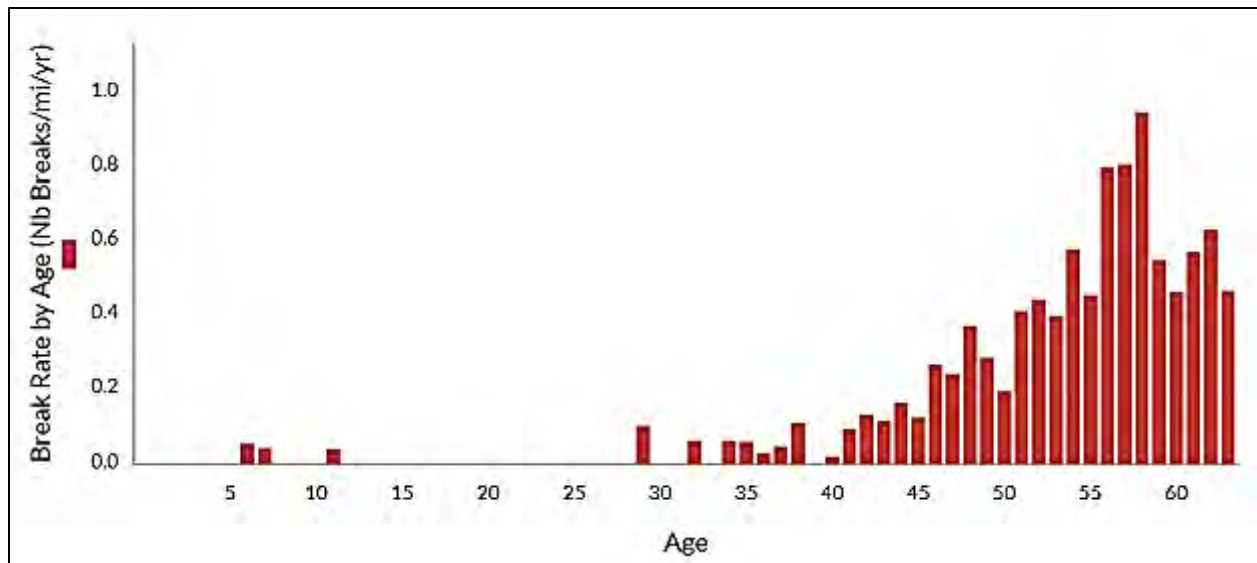
Figure 3-3. Systemwide Break Rate versus Age (Nb=number; mi=miles; yr=year)

Overall Break Rate versus Age (all materials). The data in **Figure 3-3** shows how the break rate of distribution system pipes increases with age, as expected. While watermain in the system experience a very low break rate through about 40 years of age, the break rate rises significantly after age 40.

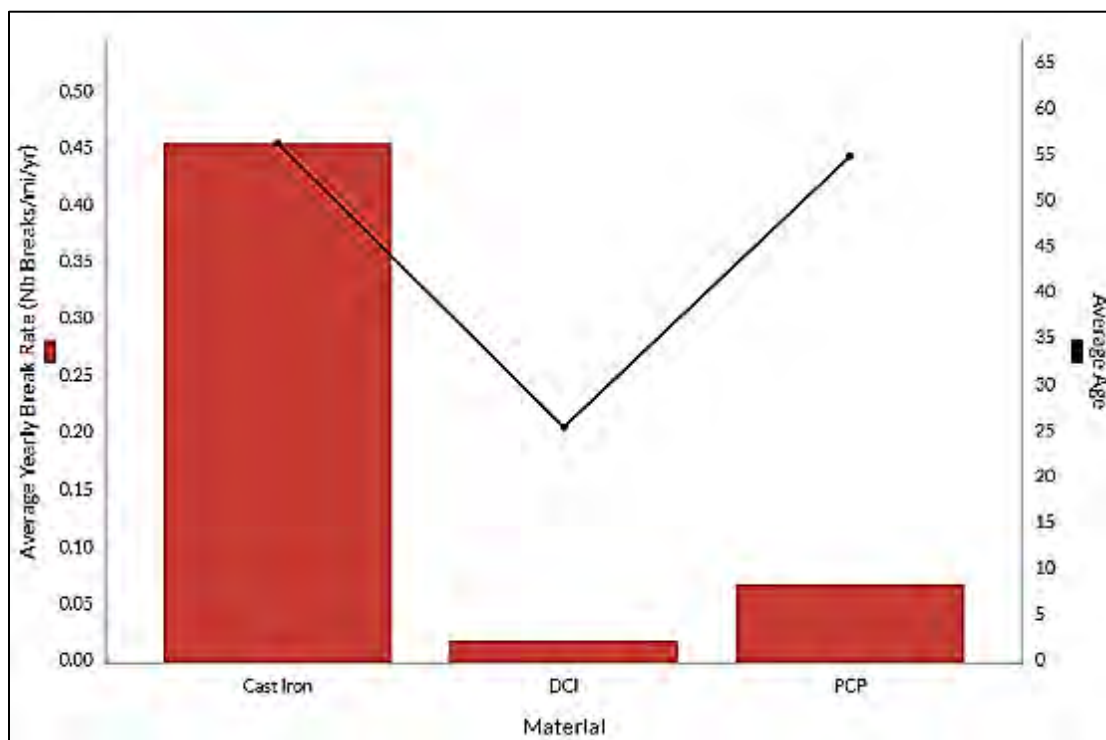
Figure 3-5. Average Annual Break Rate and Average Age of CI, DI, and PCCP

Watermain break rate is dependent on more than age. Two other primary factors include material and diameter. **Figure 3-5** shows the relationship between break rate (red bars) and material, with cast iron showing a very high break rate (0.46 breaks per mile per year) and average age (black points on the figure) of 56 years. Ductile iron has a very low break rate (0.02 breaks per mile per year with an average age of 26 years). Despite its average age of 55 years, PCCP pipe has a relatively low break rate (0.07 breaks per mile per year), which is in line with longevity predictions of PCCP pipe in the Midwest (105 years), as published in the American Water Works Association (AWWA) Buried No Longer report.

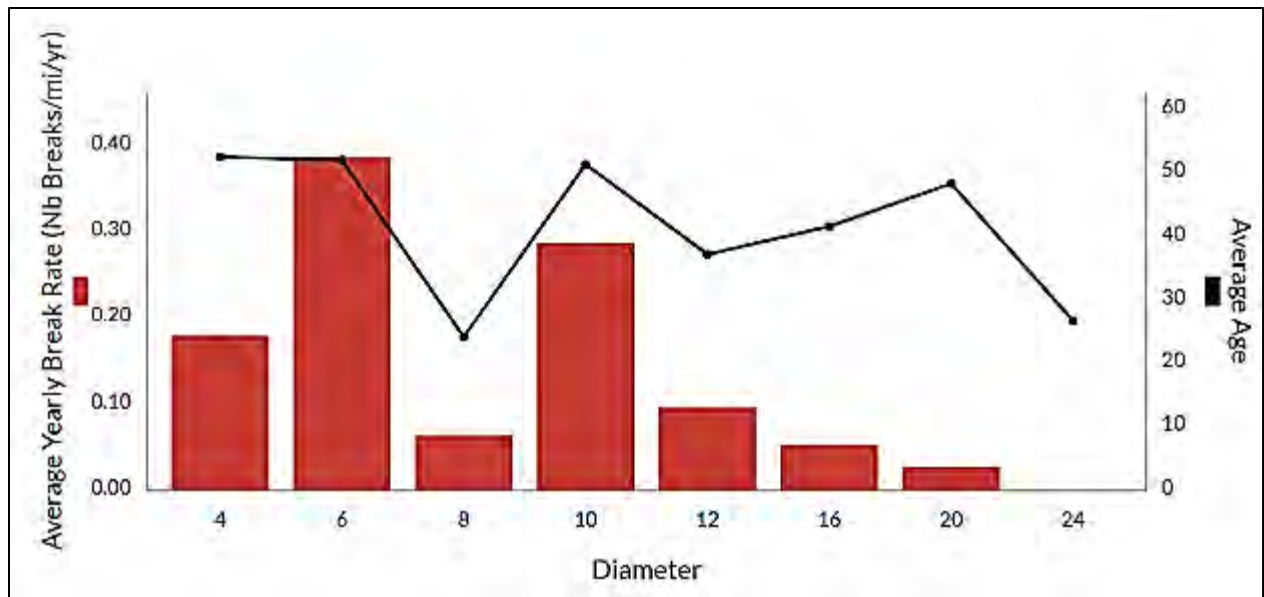
Figure 3-6. Systemwide Break Rate versus Diameter

Figure 3-6 illustrates the relationship between break rate and pipe diameter. As expected, the break rate decreases as the diameter increases. This is generally because larger diameter pipes have greater wall thickness and take longer for deterioration to cause breaks. The two anomalous values in the chart can be largely explained: The lower than expected break rate for 8-inch pipes is due to the fact that most 8-inch pipe is (a) younger pipe (the average age of 8-inch pipe is 24 years old, as shown by the black points in the figure, compared to 52 years old for 6-inch pipe and 51 years old for 10-inch pipe; and (b) 87-percent of 8-inch pipe is ductile iron pipe, which is performing far better than cast iron – see Figure 3-5 above). The lower-than-expected break rate for 4-inch pipe has a different explanation related to statistical significance: only 1 break has occurred on 4-inch pipe; there are only 0.6 miles of 4-inch pipe in GIS. One additional break on 4-inch pipe would double its break rate to a more expected value. It is possible not all breaks on 4-inch pipe are recorded as they may be private service connections.

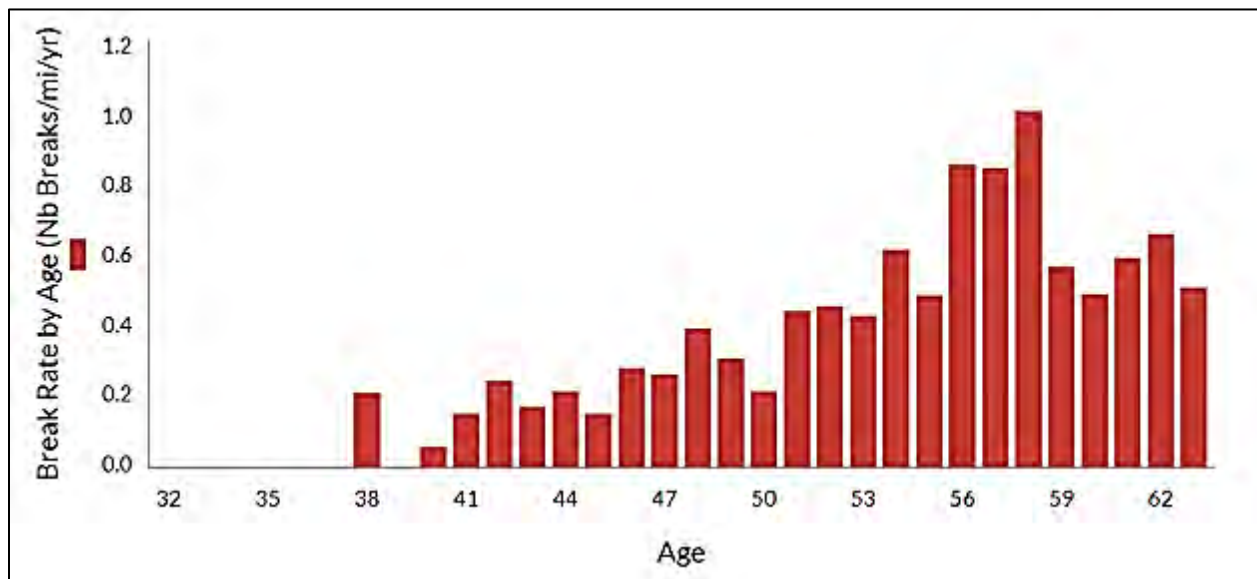
Figure 3-7. Average Yearly Break Rate and Length by Age of CI Pipe

Figure 3-7 shows the relationship between the break rate for CI versus age. For CI pipe older than 50 years old, the break rate is significantly higher than the systemwide average break rate of 0.22 breaks per mile per year.

(Note: because the break database goes only as far back as 2010, and because there is no cast iron present in the system with an installation data after 1978, all cast iron pipe was at least 32 years old when break data begins, hence why the age in Figure 3-7 starts at 32 years.)

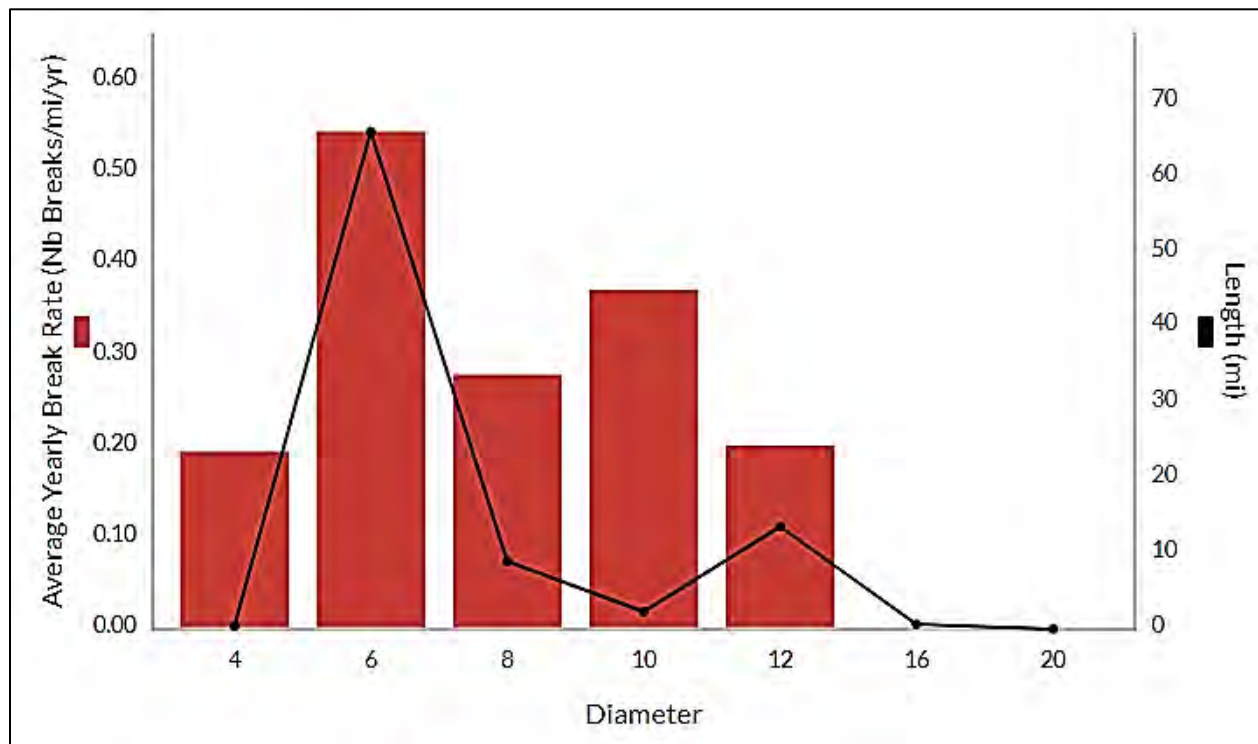
Figure 3-8. CI Break Rate by Diameter

Figure 3-8 shows the relationship between the break rate for CI versus diameter. The general trend in break rate is downward as diameter increases, which is the expectation. The low break rate for 4-inch diameter is based on having only 1 break and a relatively small relative length (0.5 miles).

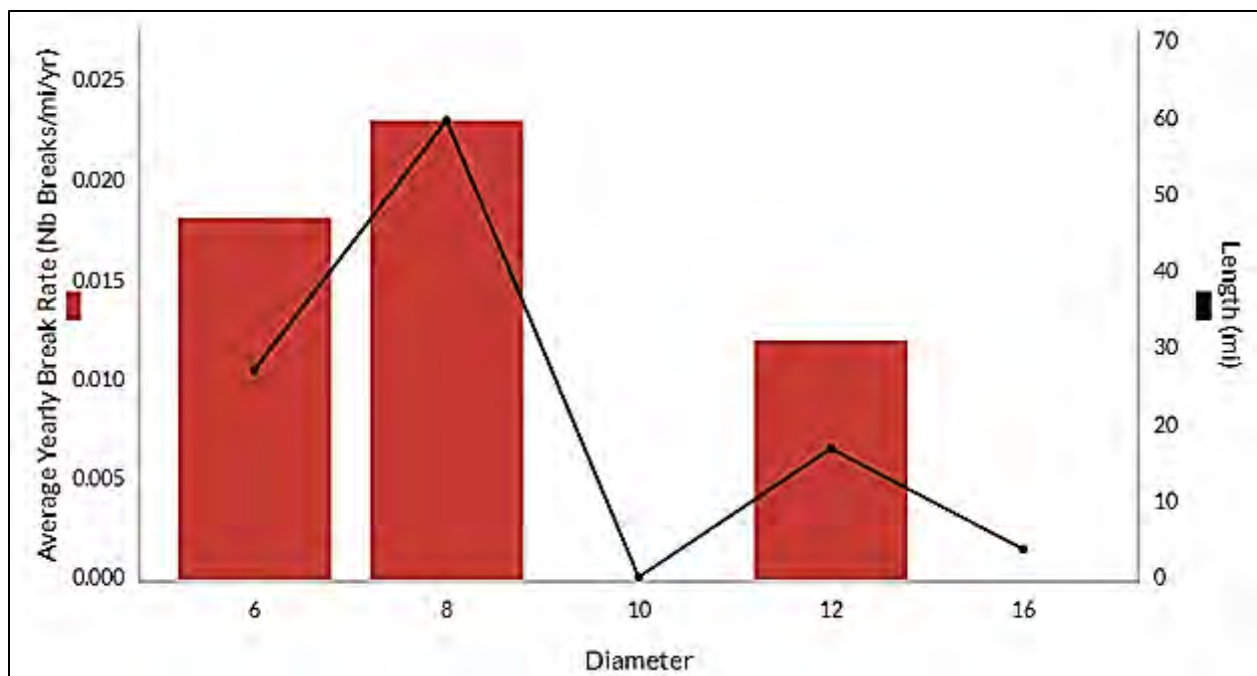
Figure 3-10. DI Break Rate by Diameter

Figure 3-10 shows the relationship between the break rate for DI versus diameter. The general trend downward is expected, and the lack of a break rate for 10-inch pipe is related to the very small amount of 10-inch DI in the system (0.6 miles).

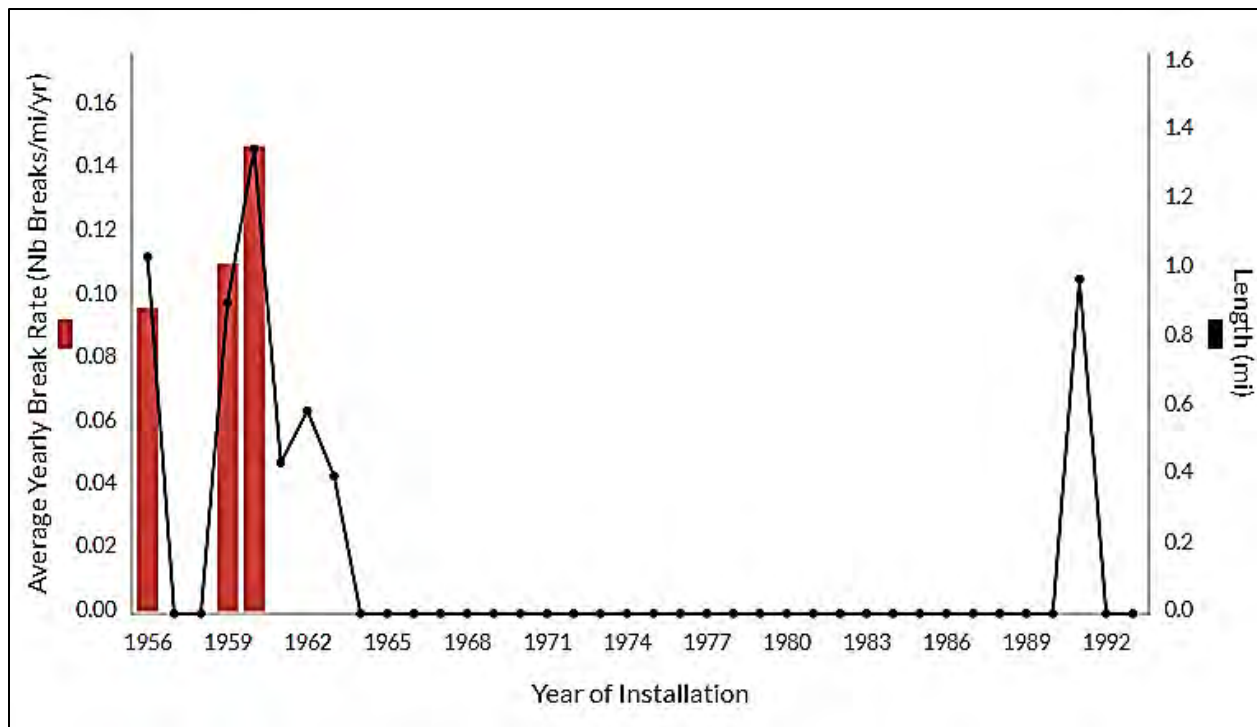
Figure 3-11. Average Yearly Break Rate and Length by the Year of Installation of PCCP Pipe

Only 4 breaks have been recorded on PCCP pipe, all of which occurred on older, 16-inch PCCP (See **Figure 3-12**). **Figure 3-11** shows that the break rate for each vintage of pipe is below the system average break rate of 0.22 breaks per mile per year.

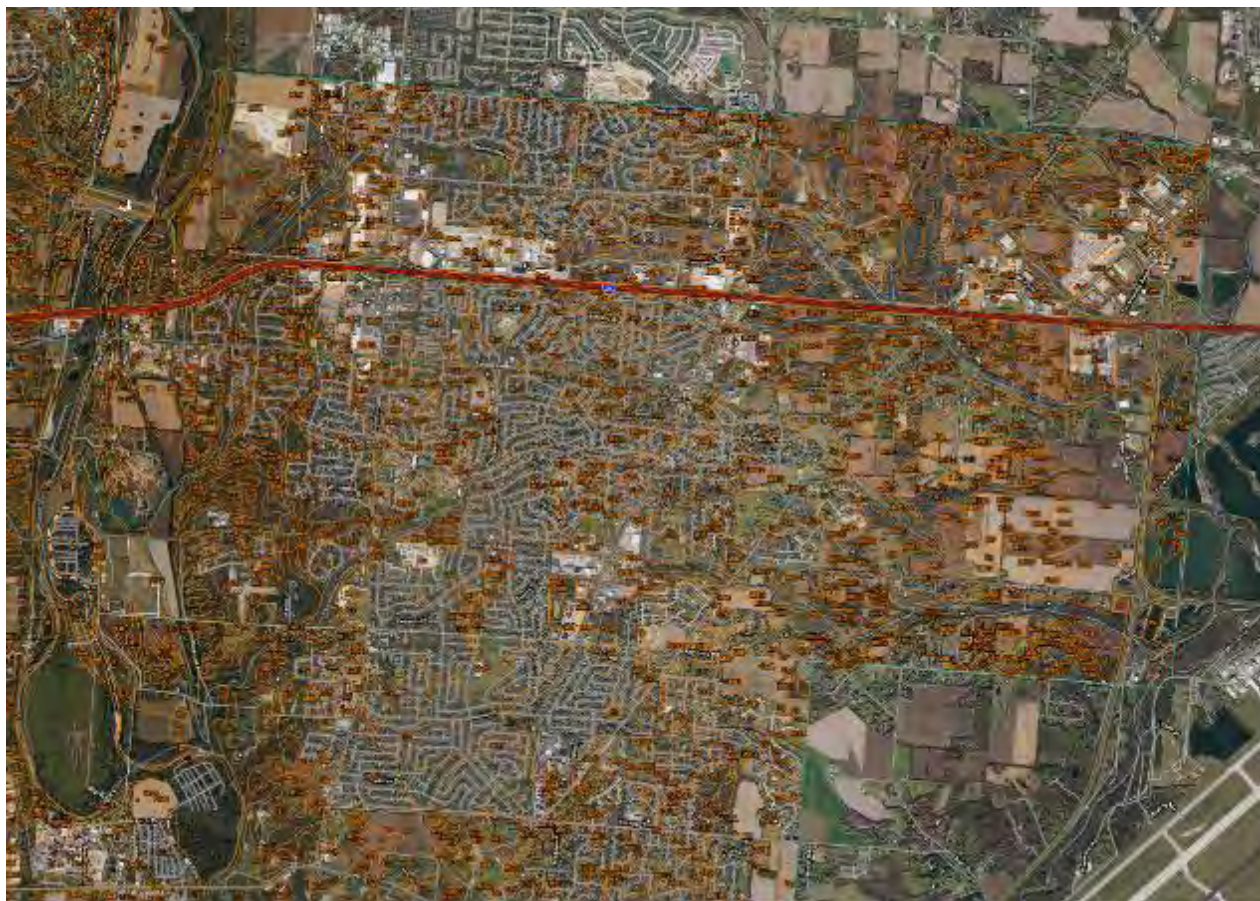
Figure 3-13. Soil Type Map for Northeast Montgomery County

B&N utilized the US Department of Agriculture - Natural Resources Conservation Service soil survey database to access information about the corrosiveness of native soils in Huber Heights. This database was updated in September 2022. An example of the soil type data for Huber Heights within Montgomery County is shown in **Figure 3-13**. While the soil types shown in this figure are not legible as shown, it is the subsequent maps that illustrate the properties of those soils that are relevant to this study.

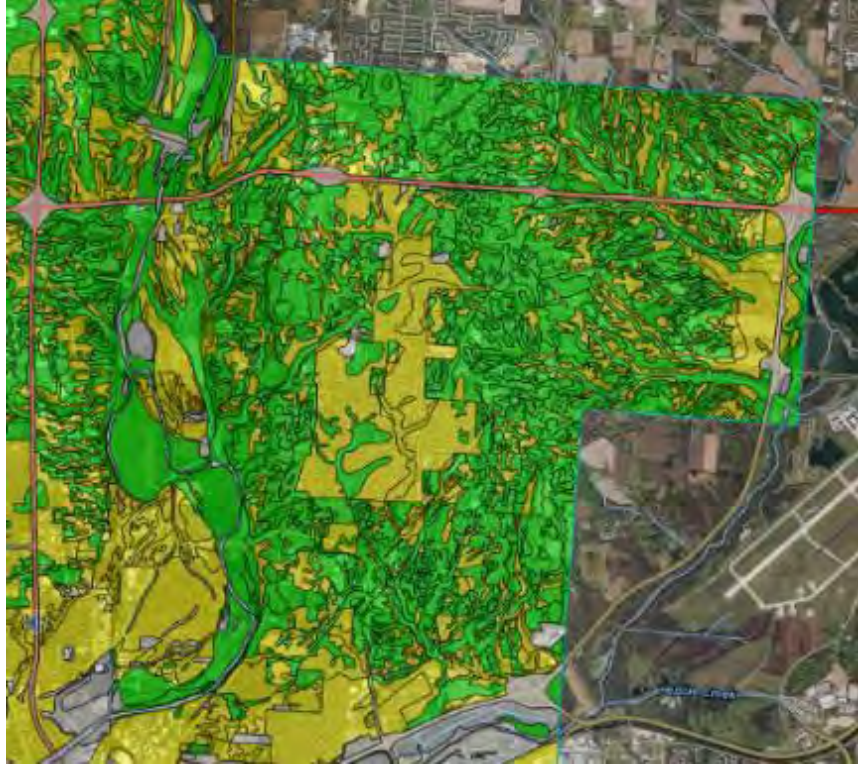
The soil database assesses the “risk of corrosion to concrete” in a single parameter that pertains to potential soil-induced electrochemical or chemical action that corrodes or weakens concrete. The rate of corrosion of concrete is based mainly on the sulfate and sodium content, texture, moisture content, and acidity of the soil. The risk of corrosion is expressed as "low," "moderate," or "high" in the database. There are no areas that are highly corrosive to PCCP in Huber Heights (see **Figure 3-14**).

Figure 3-14. Risk of Soil Corrosion for Concrete (Montgomery County only)
(Green = Low Corrosivity for Concrete; Yellow = Moderate Corrosivity for Concrete)

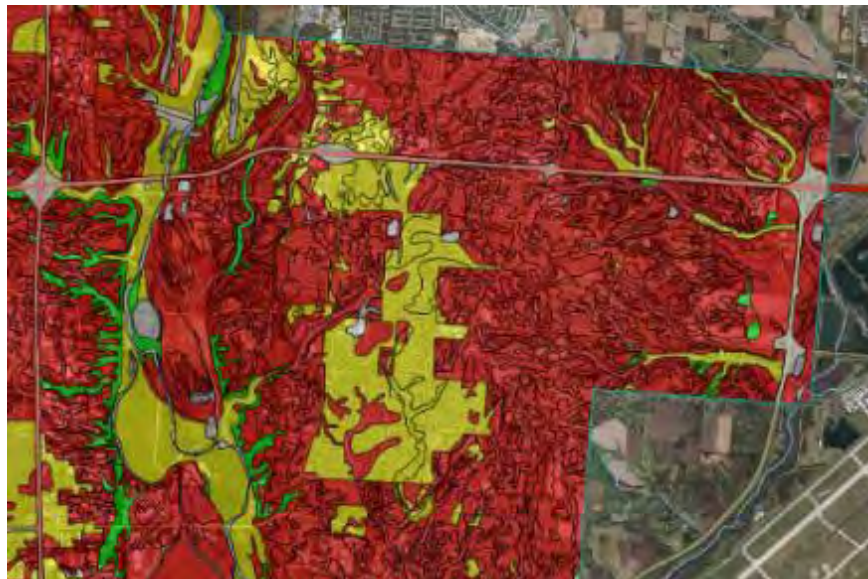
The soil database also assesses the “risk of corrosion to steel” in a single parameter that pertains to potential soil-induced electrochemical or chemical action that corrodes or weakens uncoated steel. The rate of corrosion of uncoated steel is related to such factors as soil moisture, particle-size distribution, acidity, and electrical conductivity of the soil. The risk of corrosion is expressed as "low," "moderate," or "high". While iron can develop a patina to inhibit corrosion of the metal's integrity, potentially giving it better corrosion resistance than steel, the failure morphology for steel and iron watermain is similar (“Control of External Corrosion of Iron and Steel Watermain”, R.A. Gummow, 2004). This parameter is, therefore, applicable to iron pipes. For Huber Heights, soils are either highly or moderately corrosive to metal (See **Figure 3-15**). There are not soils in Huber Heights that have low corrosion for steel.

Figure 3-15. Risk of Soil Corrosion for Steel (Montgomery County only)
(Yellow = Moderate Corrosivity for Steel; Red = High Corrosivity for Steel)

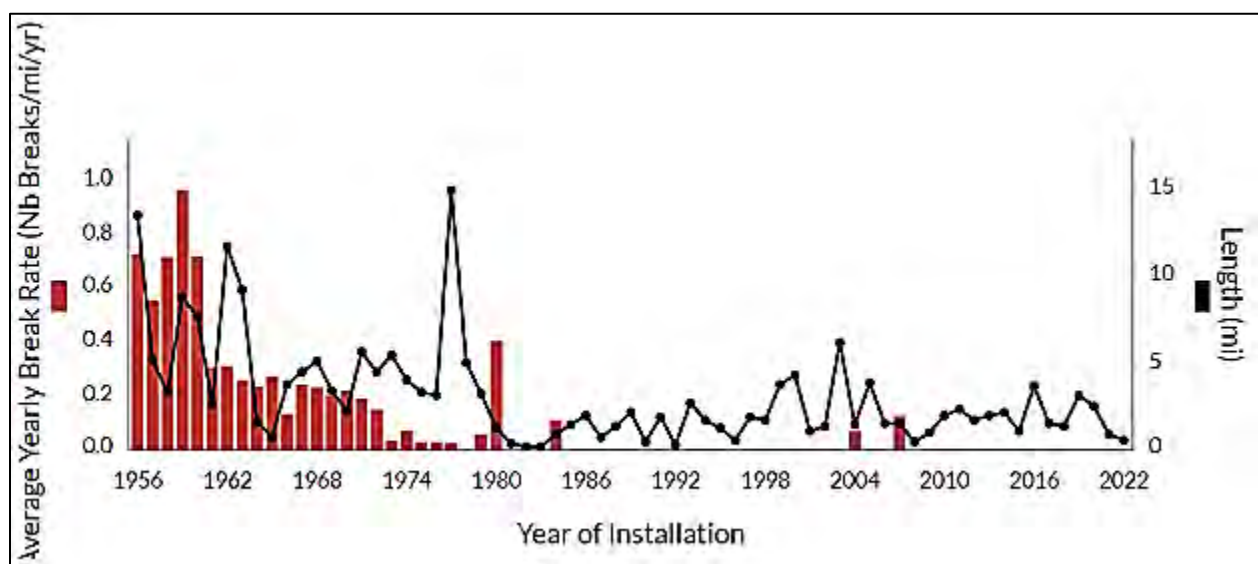
Figure 4-1. Average Annual Break Rate of DI Pipe Based on Year of Installation

Examining DI pipe only, **Figure 4-1** shows that the break rate of DI pipe installed after 1985 is extremely low. This supports the potential conclusion that pipe bedding changes have had beneficial results. However, (a) pipe installed after 1985 is relatively young and breaks are not expected in significant quantities, and (b) even DI pipe installed between 1975 and 1985 exhibited a relatively low break rate.

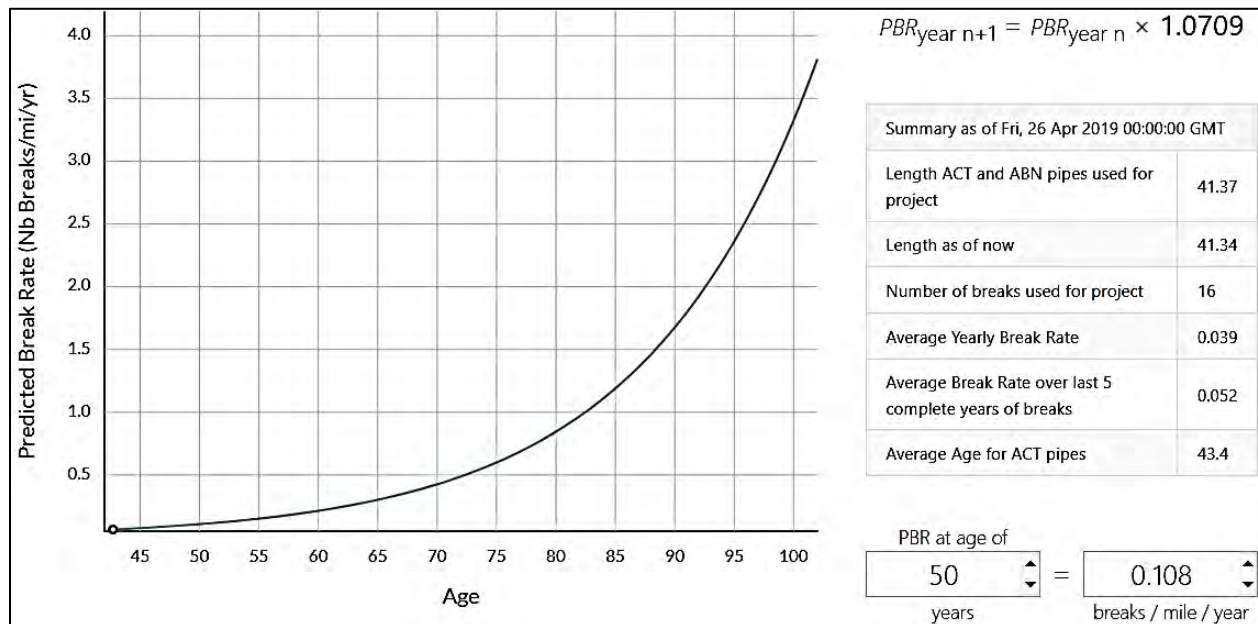
Figure 4-2. Aging Curve for DI Pipe Built Through 1985

DI Pipe was separated into two cohorts: DI installed through 1985 and DI installed in 1986 and after. Their aging curves (which shows break rate versus age) for each cohort are shown below in **Figures 4-2 and 4-3**. The two most significant number to examine in each aging curve figure are the annual rate of increase of breaks in the top right corner (1.0709 and 1.0743) and the break rate at age 50 for each cohort in the bottom left corner (0.108 and 0.107). These number are nearly identical and suggest the break rate between cohorts (and therefore the impacts of new backfill procedures in 1985) are indeterminate with the data currently available.

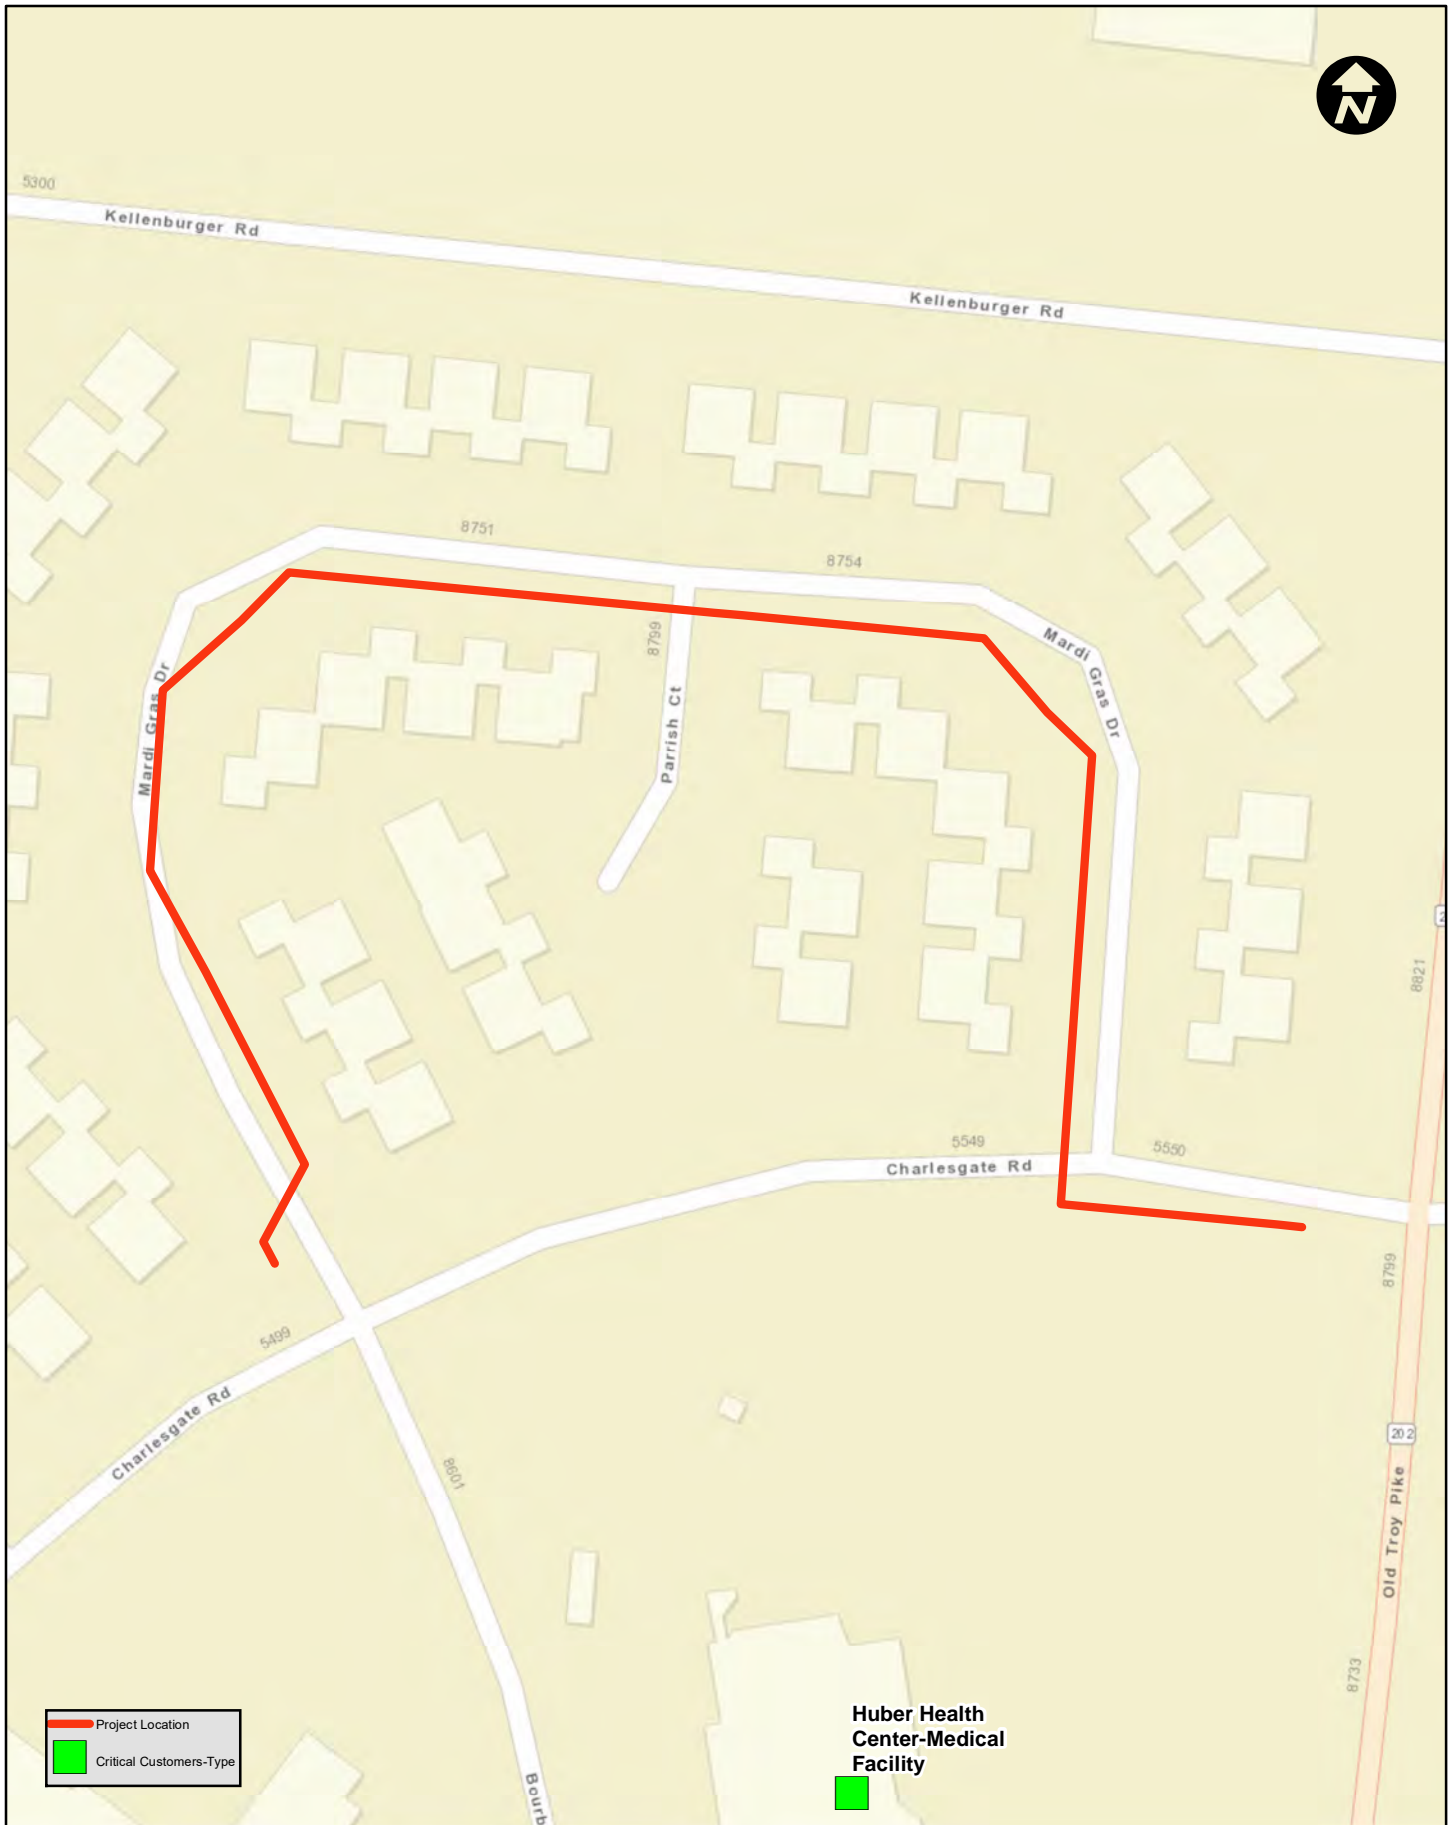
Project 16

Replacement Cost (\$):

2,485,560

Project BCR Ratio: 0.11
BURGESS & NIPLE

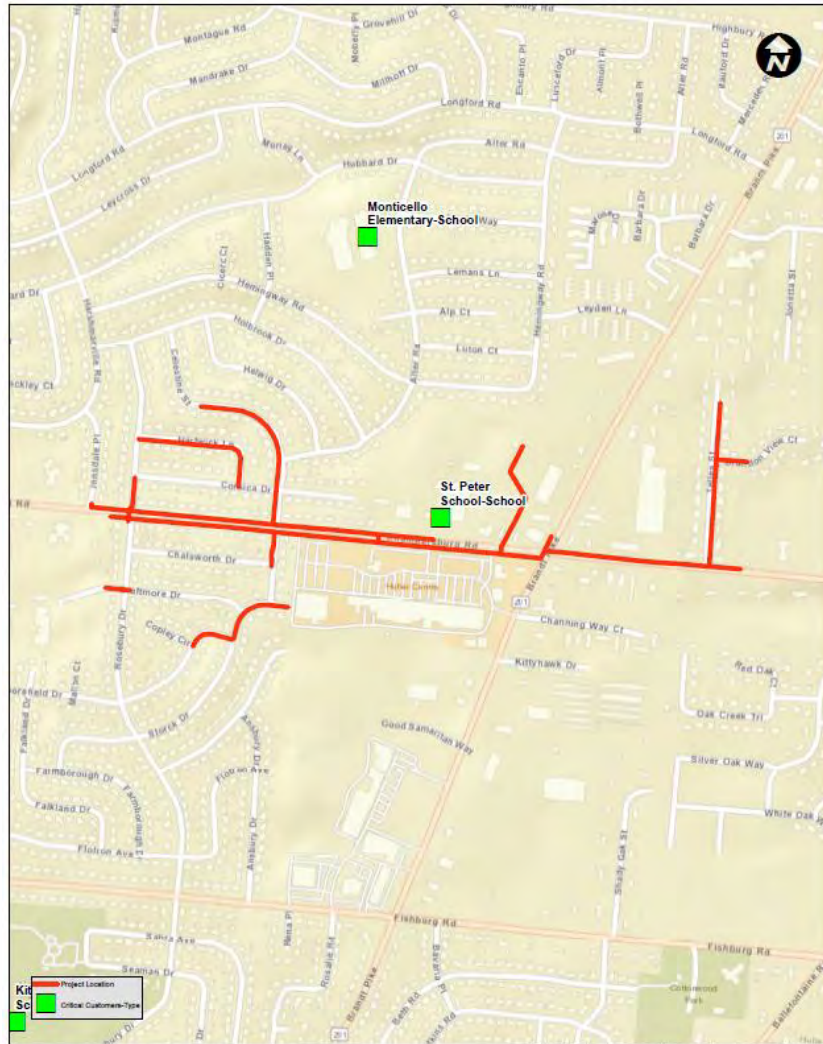
Potential CIP Projects

Project 3
 Project BCR Ratio: 1.55
BURGESS & NIPLE
 BCR & 50-Year Risk Scores
