Yellowstone Historic Preservation Board
A Certified Local Government (CLG)
Program representing four governing bodies:

MEETING MINUTES
September 13, 2022
1st Floor Conference Room
Planning Division – Miller Building

a. Certificate of Appropriateness: 2910 Minnesota Avenue

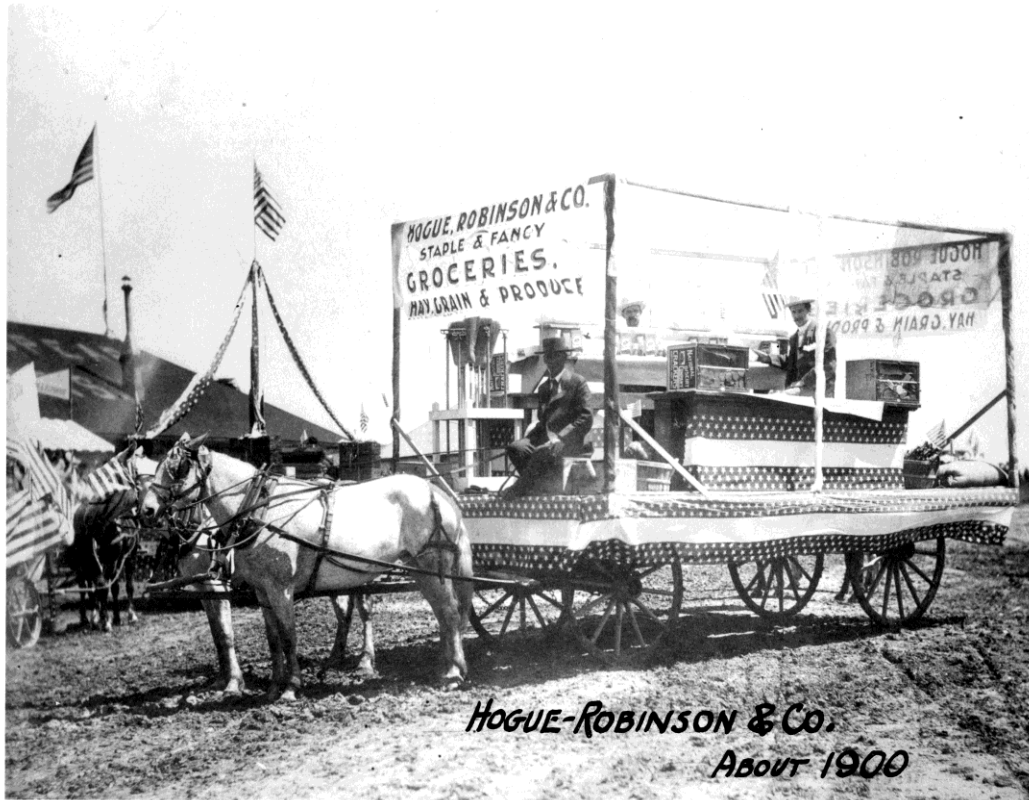
*HOGUE-ROBINSON & CO.
ABOUT 1900*

Only historic reference found for this property, no photos.

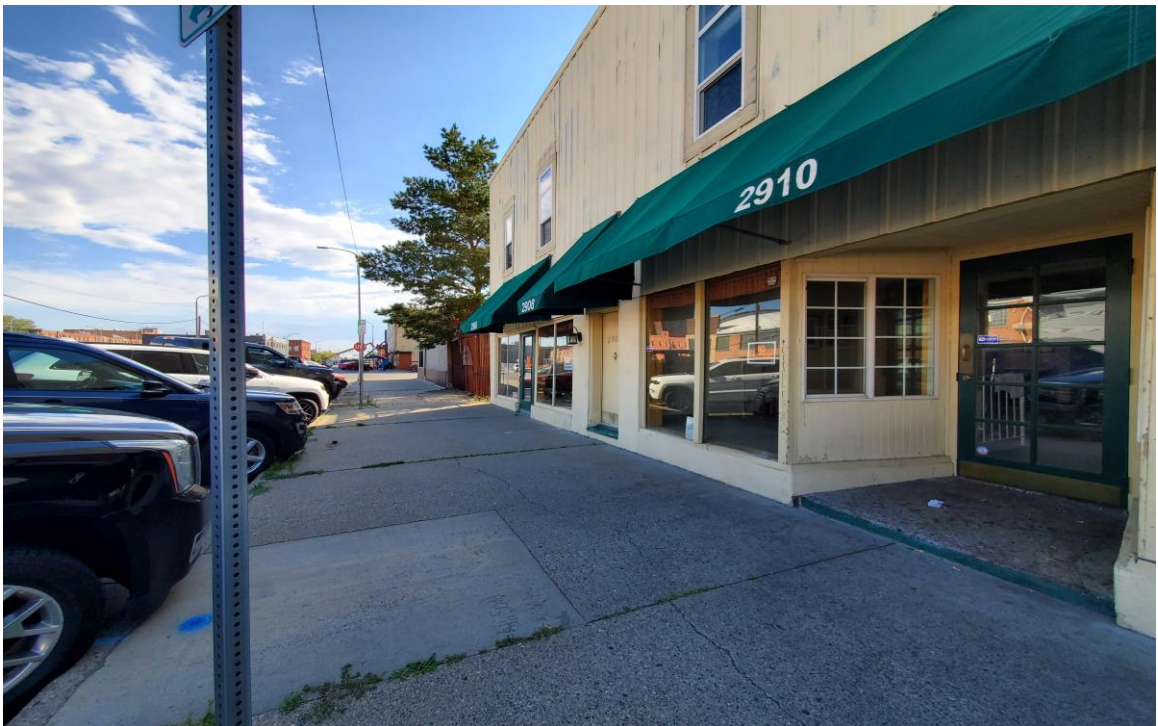
View southeast from Minnesota
