Build Arizona Award

INNER BASIN WATERLINE

Public | \$10 Million - \$50 Million | Utilities

Project Name: Inner Basin Waterline

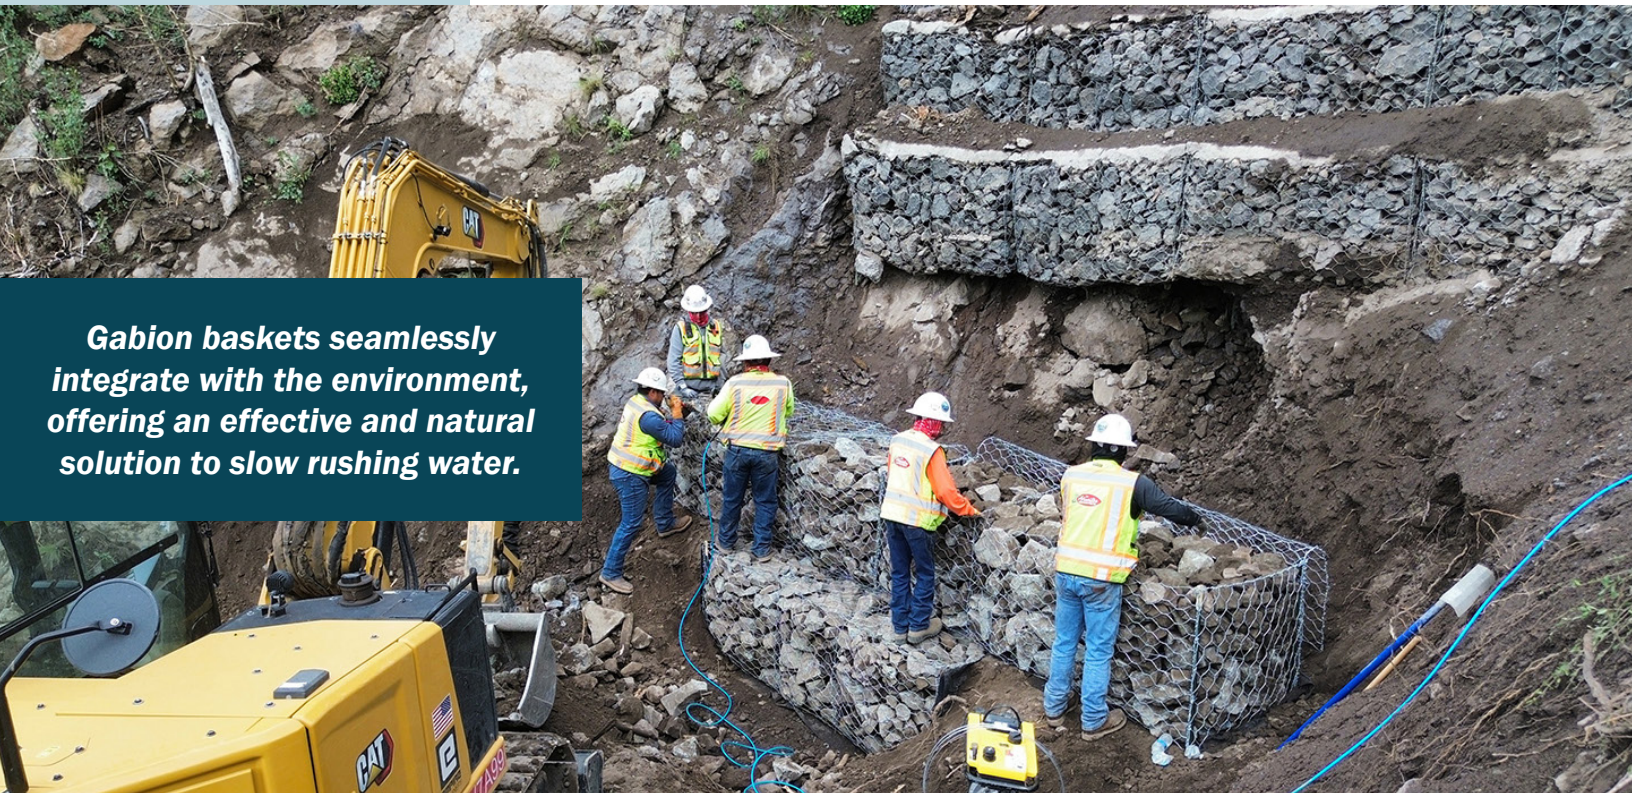
Gabion baskets seamlessly integrate with the environment, offering an effective and natural solution to slow rushing water.

- 2. Tailored Engineering Solutions**
 - **Slope Stabilization:** The use of gabion baskets, concrete retaining walls, and rock mattresses was integral to mitigating erosion and supporting slopes. Structures were designed to blend naturally with the environment, using locally sourced materials wherever possible.

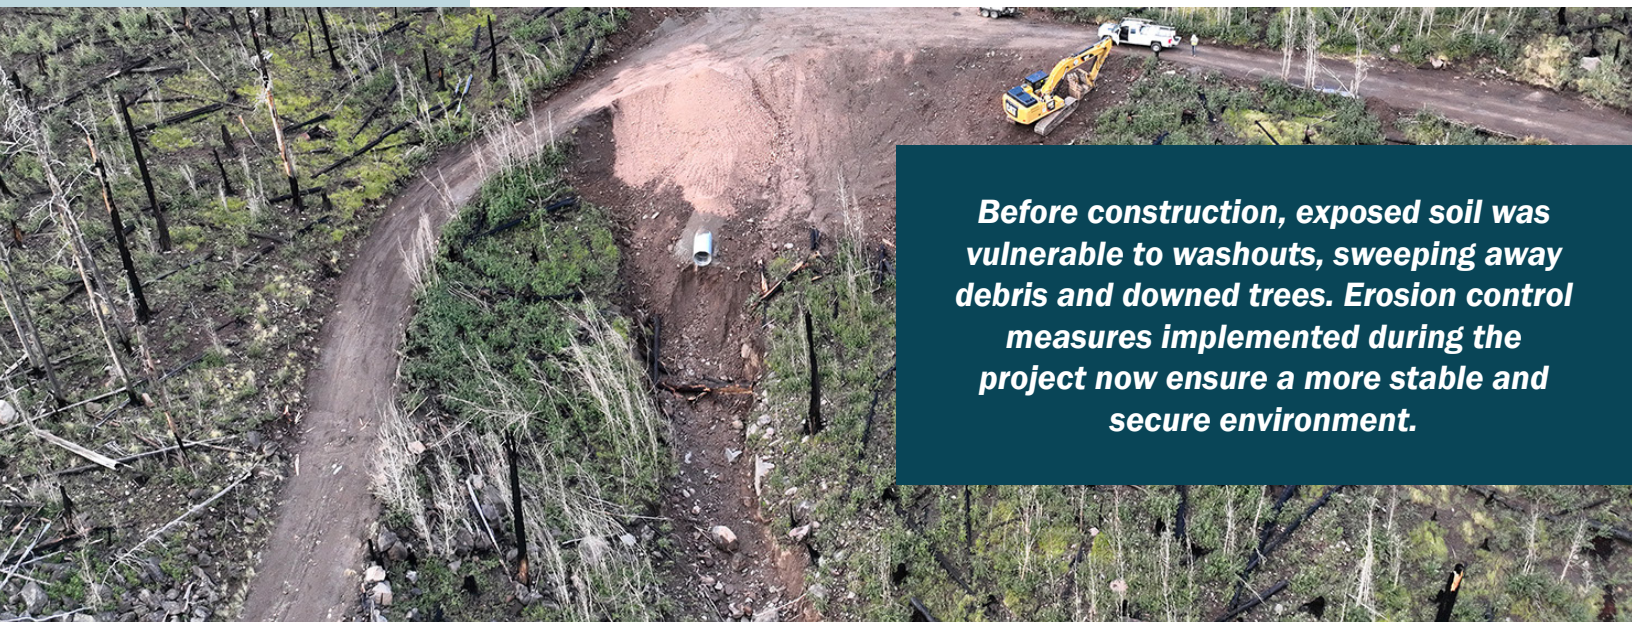
Before construction, exposed soil was vulnerable to washouts, sweeping away debris and downed trees. Erosion control measures implemented during the project now ensure a more stable and secure environment.

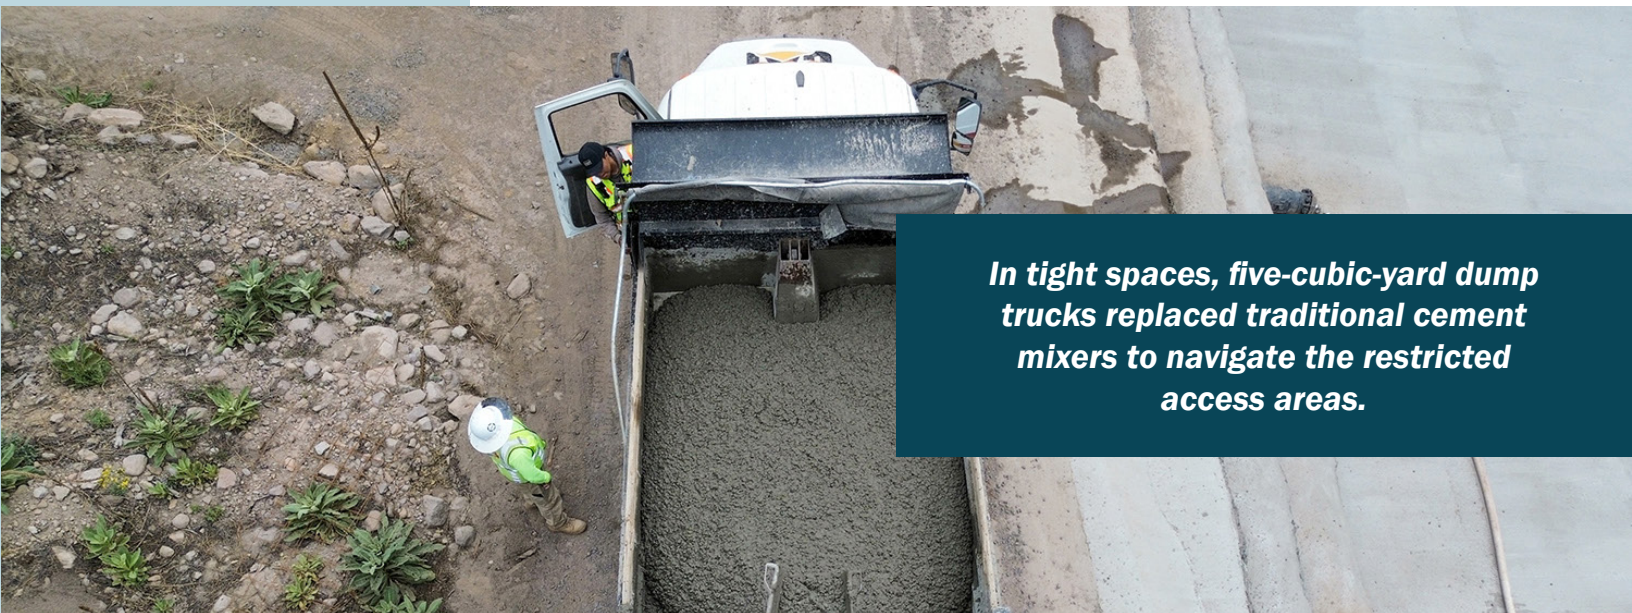
In tight spaces, five-cubic-yard dump trucks replaced traditional cement mixers to navigate the restricted access areas.

- 1. Tailoring Equipment to the Environment** | Given the restricted access and tight workspaces, the team opted for mid-size excavators instead of standard large excavators and used five-cubic-yard dump trucks instead of traditional cement mixers. These smaller vehicles allowed for easier navigation of narrow roads and staging areas but introduced challenges such as faster-drying concrete.

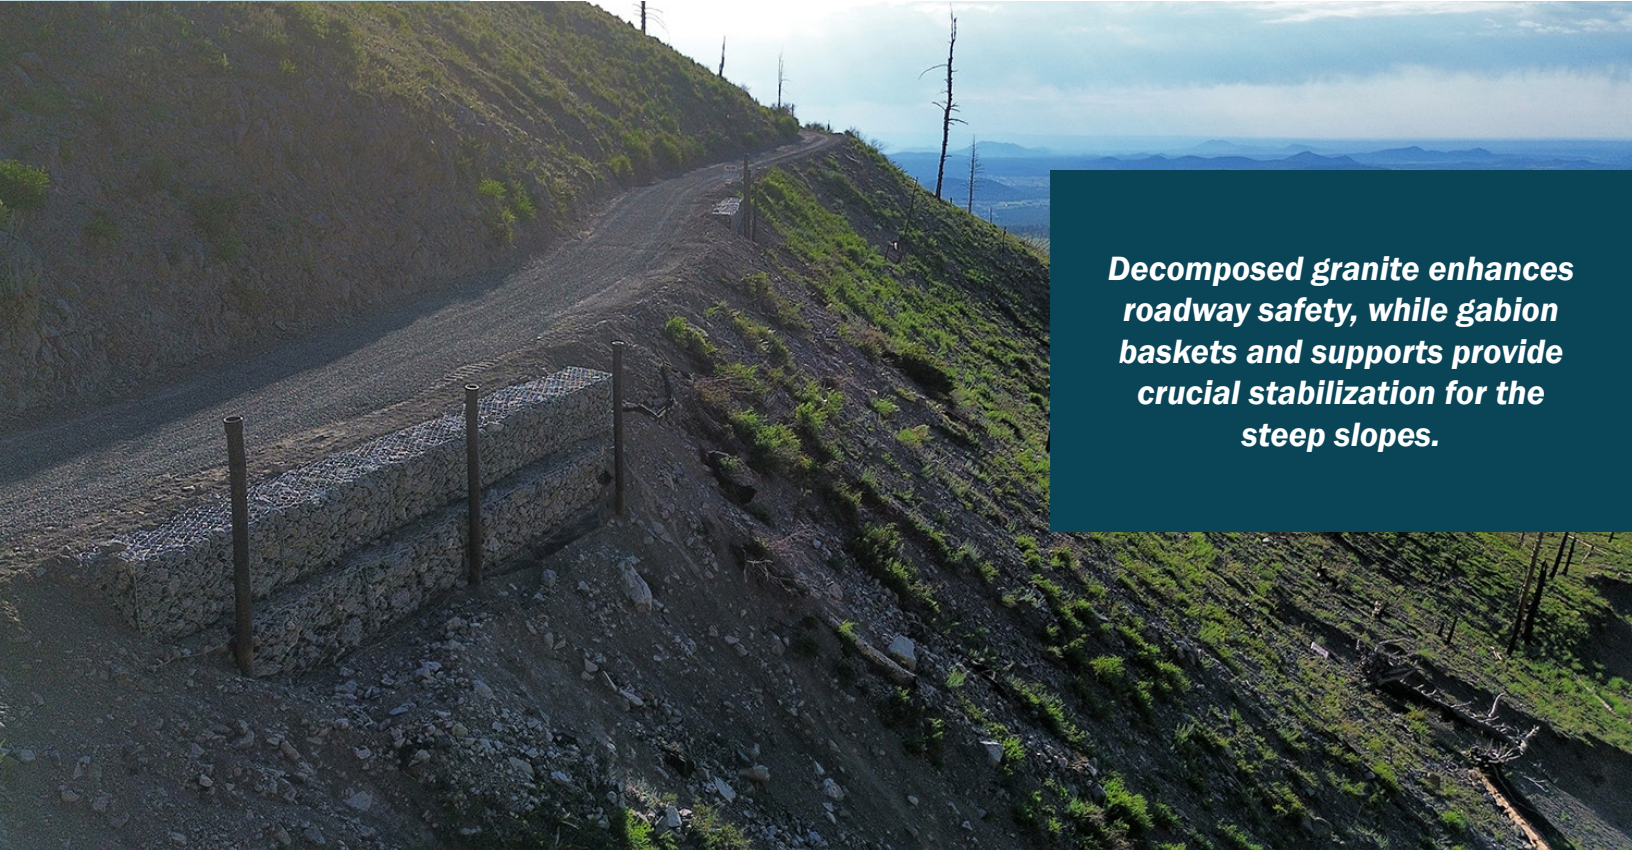
Decomposed granite enhances roadway safety, while gabion baskets and supports provide crucial stabilization for the steep slopes.

- Over 5,326 linear feet of gabion baskets—equivalent to approximately one mile—were installed. These cost-effective and eco-friendly structures stabilize steep slopes while promoting the growth of native vegetation around and through their wire mesh and rock fill. Some gabion baskets, towering 20 to 40 feet high, were thoughtfully designed to resemble waterfalls, blending seamlessly into the natural landscape.
- Concrete Ford Crossings were constructed in low wash areas to further prevent erosion, enhancing roadway durability against the region's severe weather conditions.
