EnviroSystems Management Inc. (ESM) conducted a Cultural Resource Study for Studio LP4 to support the planned subdivision of the existing office building into (2) distinct Business (B-Group) Commercial Occupancies as permitted under Flagstaff Zoning Code and the removal of an abandoned underground diesel fuel tank (*Figure 1*). This letter report complies with Flagstaff Zoning Code 10-30.30.050. The property lies within the Flagstaff North End Historic Residential District (Woodward and Stein 1985). Since the property was not yet 50 years old during the 1985 study, no official National Register of Historic Places (NRHP) nomination occurred. The property currently serves as a commercial business. The proposed subdivision of the existing business occupancy triggers mandatory accessibility upgrades. These upgrades will require minor alteration to existing site elements to provide an accessible path of travel throughout the site which may be visible from the public way. Additionally, the diesel fuel tank poses a safety and environmental hazard, and its removal will prevent future remediation work. The property is located at parcel 101-09-010 (Block 64, Lots 10-12). It previously had th

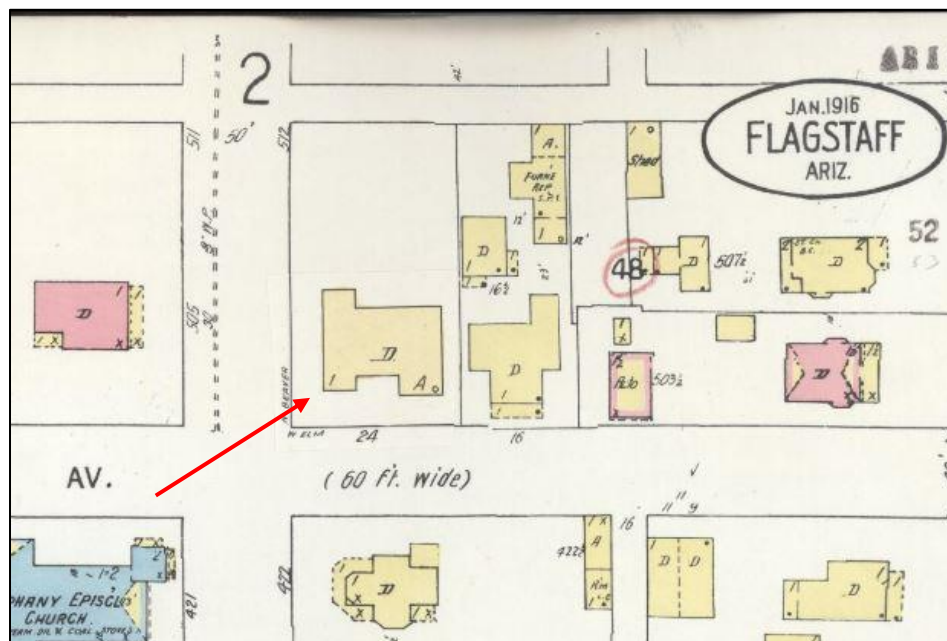
On March 12, 2025, ESM reviewed archival documents and visited the Coconino County Recorder's Office to examine property records, which are also accessible online. According to land deed records, Clyde P. Wing (1899–1967) and his wife, Mildred (née Dickson, 1898–1987), purchased lots 10–12 in Block 64 on August 6, 1947, from Maurice B. Tribby. However, a newspaper article from the Arizona Daily Sun dated December 26, 1946, places the couple at the property in "their lovely new home." The family appears in the 1947 Flagstaff Telephone Directory at 22 West Elm Avenue. The 1948 Sanborn Fire Insurance map confirms that this building was constructed during this period (*Figure 2*). Newspaper articles indicate that Clyde Wing operated Acme Dry Cleaning in Flagstaff. Dr. Harry and his wife, Inis Barnes, purchased the property in 1957 and continued under Inis' ownership from 1978, following her husband's death, until 1980. Telephone records indicate the Barnes family rented the property to various tenants throughout the years.

Figure 2: 1948 Sanborn of Flagstaff

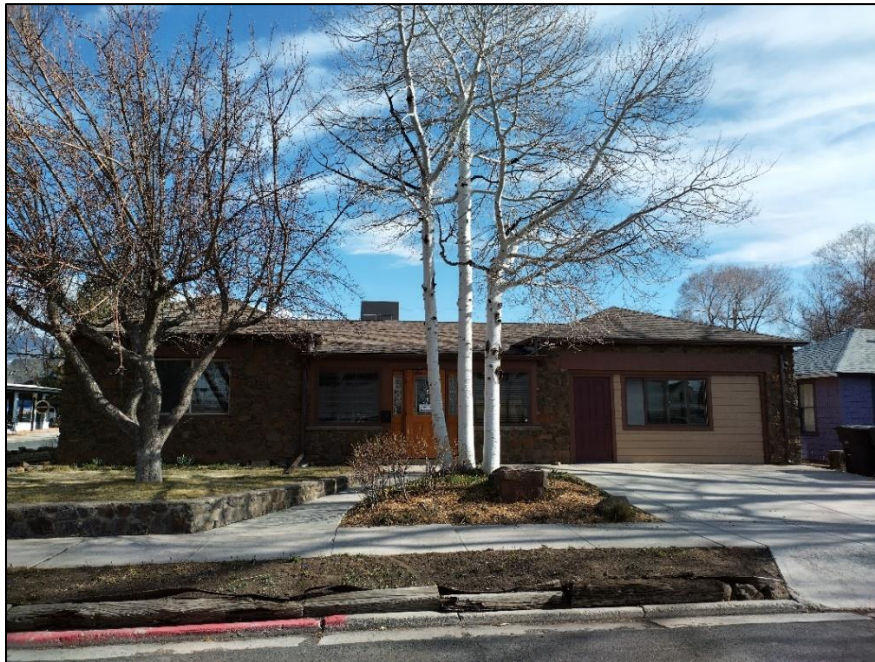
A field visit was conducted on March 26, 2025, with Architect Lloyd Paul in order to collect detailed information on the architectural elements and modifications made to the property. The property located at 500 North Beaver Street (Formerly 22 West Elm Avenue) was likely constructed sometime in 1946 (see discussion above). Similar to contemporary constructions, the property exhibits a mix of Ranch Style and mid-20th century modernist architectural elements (*Photograph 1*). Ranch Style elements include a single story L-shaped floor plan, orientation to maximize width along Elm Avenue, and a low sloped hip roof framing. The structure utilizes load bearing malpais stone masonry exterior walls in conjunction with a conventionally framed wood rafter roof above. The façade includes unique concrete lentils above all entryways and windows. The original entryway was originally located at the south elevation on West Elm Street.

Photograph 1: South Elevation of Property showing original entryway from West Elm

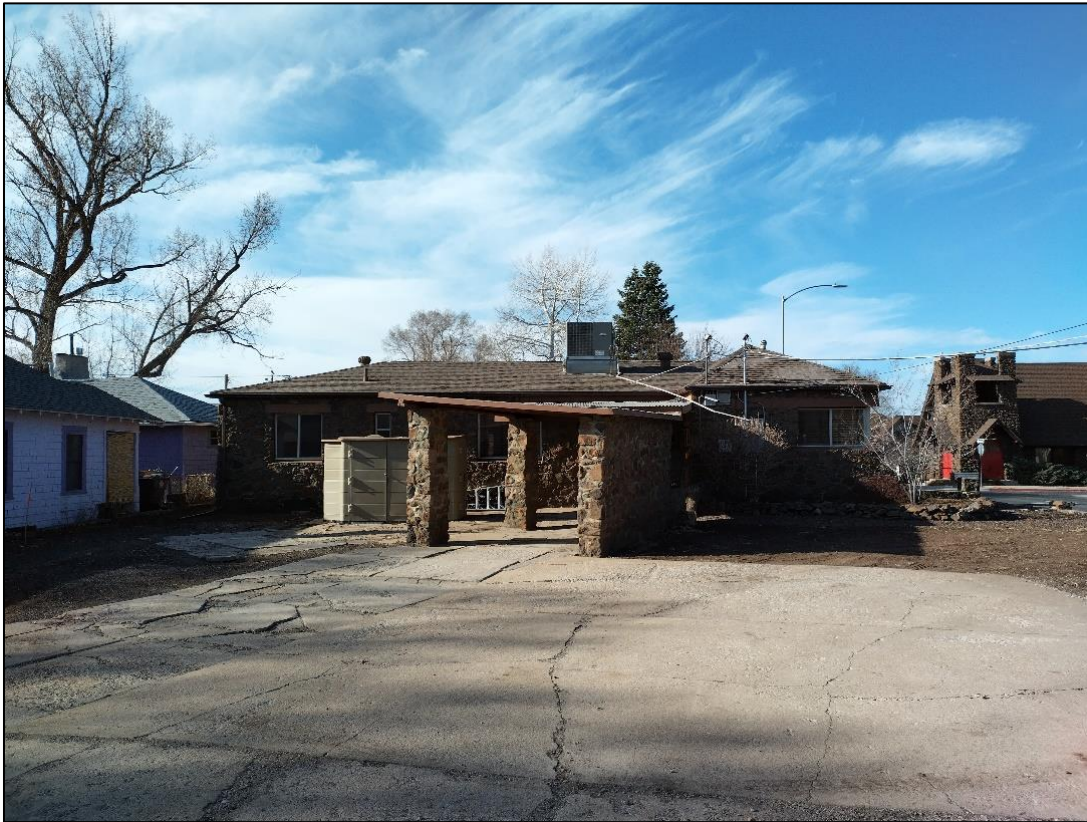
The property has undergone significant modifications, diminishing its integrity. Modern, historically non-conforming replacements have replaced all windows and doors. Vinyl sliding windows now occupy all window openings. The eastern projection at the south elevation features modern horizontal vinyl siding (see Photograph 1), significantly departing from the original malpais stonework. This projection of the structure was originally a garage as indicated by the 1948 Sanborn Fire Insurance Map (Figure2). Extensive alterations on the north elevation include incorporating an outbuilding (not depicted in the 1948 Sanborn Map) or courtyard into the main building with a connecting roof (*Photograph 2*). This open-air northern structure appears to have been modified extensively and currently serves as a covered walkway from the on-site parking area and the building's existing north entrance. A stone hardscape floor/hardscape exists

at this area, covered above by non-original corrugated metal roofing installed over on modern dimensional lumber and modern framing connection hardware. The filling inlet for the previously mentioned underground fuel tank is located adjacent to the westernmost stone wall, with the tank assumed be located below, possibly explaining it's unusual placement. Finally, a severely degraded exterior wall extending from the west elevation of the building to the to the Beaver Street public sidewalk does not appear original, as indicated by the observed joint between the wall and the main structure (*Photograph 3*). It seems the wall once extended westward but was dismantled at some point in the past.

Photograph 2: North Elevation of Property showing modified outbuilding attachment

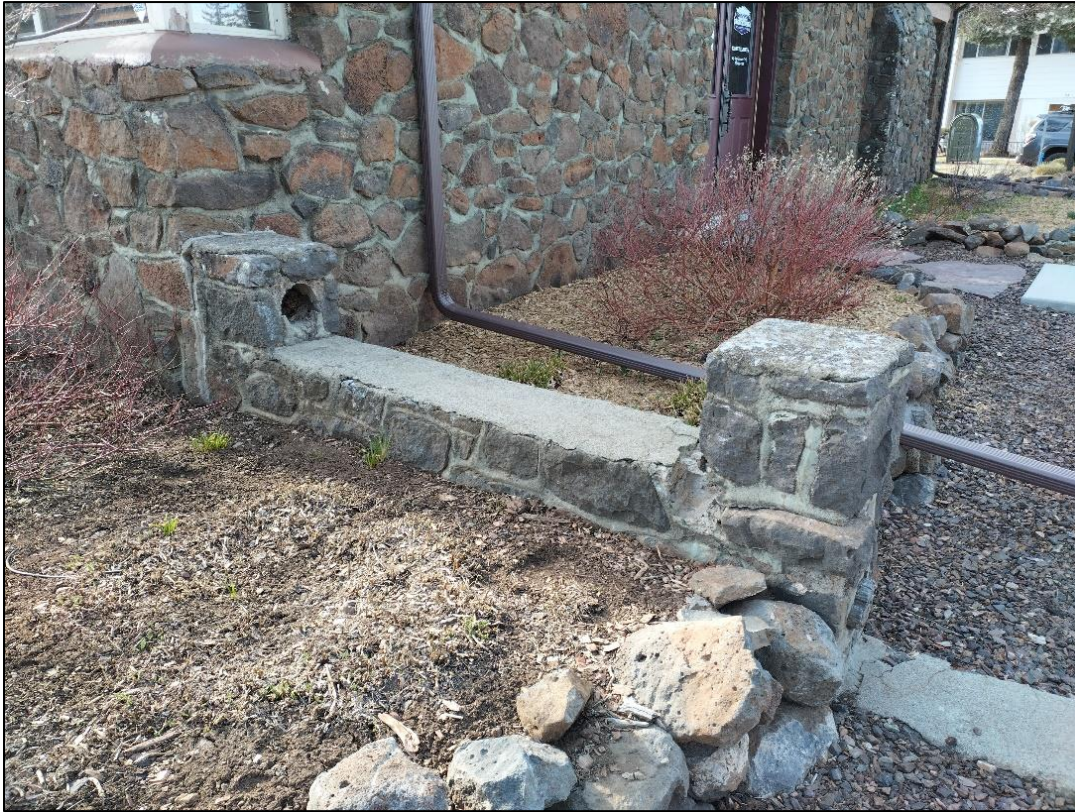
Photograph 3: West elevation extending wall
