**PHASE 1 CULTURAL RESOURCE STUDY for PARCEL 101-16-001 at 418
EAST BIRCH AVENUE, FLAGSTAFF, COCONINO COUNTY, ARIZONA**

Lynn A. Neal, RPA / M.A.
Historic Preservation Specialist

City of Flagstaff Community Development Division Project No. PZ-25-00102
LA Neal Consulting Project and Report No. 1103-25

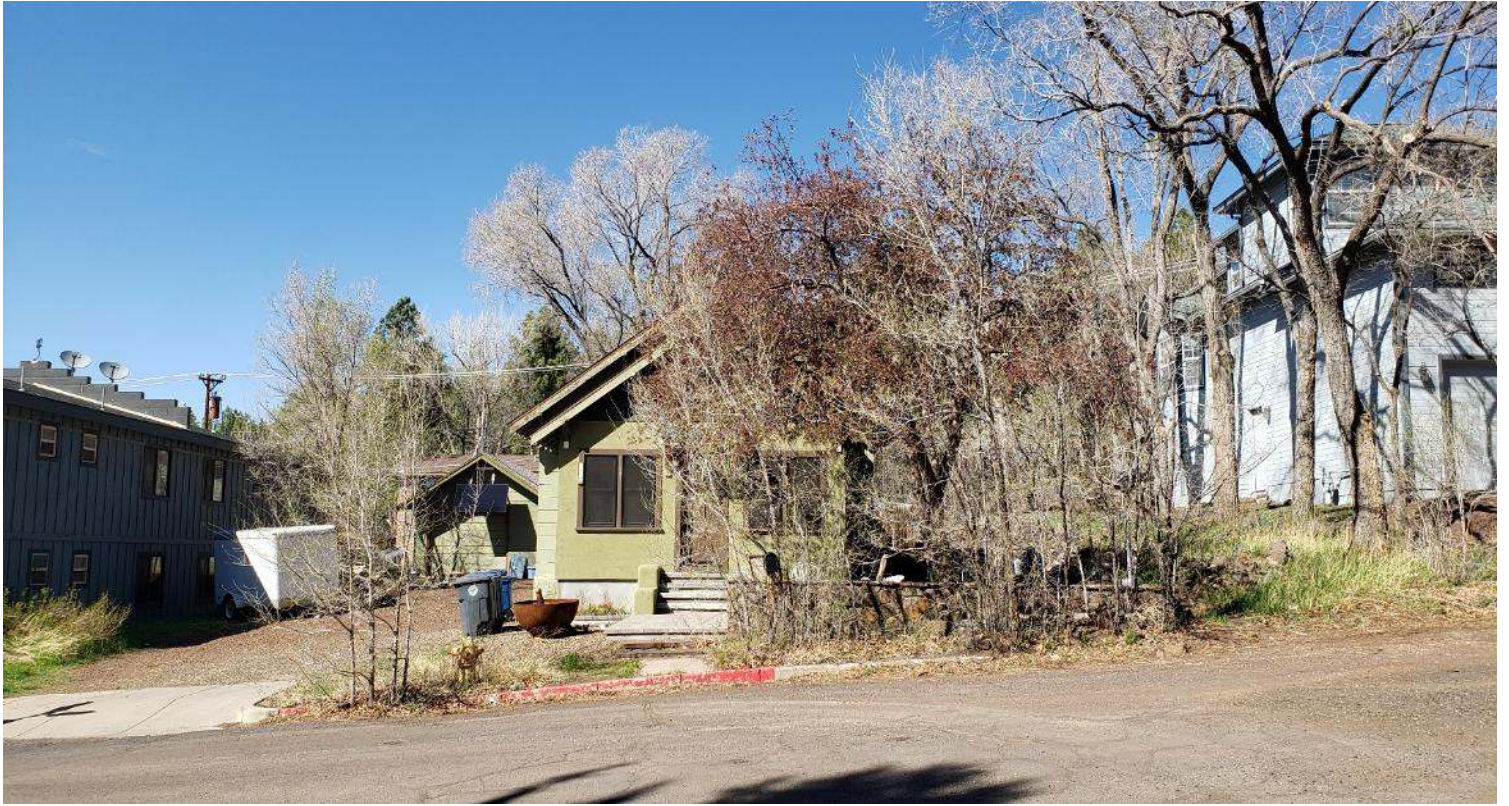
Photos 1–2. 418 E Birch Ave overview from S side of Birch to NNE (top, apartments to W at 408 E Birch & larger newer residence at 422 E Birch) and to N (bottom, apartments at 408 & 406 E Birch).

The property at **418 East Birch Avenue** (Block 29, Parcel 101-16-001, Lots 11–13) is a 1½-story, modest Bungalow-style, nine-room house (eight on the first floor plus the open attic room) fronting Birch Avenue to the south (*Appendix B, Photos 1, 2, 4*). The 1,907-square foot (1,233 first floor, 674 second floor) structure is rectangular in plan with the long axis oriented NNE-SSW perpendicular to Birch Avenue. The main house measures 42.5 feet N-S × 25.4 feet E-W (1,080 square feet) and the enclosed front porch 19.4 feet E-W × 8 feet N-S; the house sits on a 0.23-acre lot (*Appendix A, Figure 3, property site plan*). The garage is set back in the lot's northwest corner and measures 610 square feet (see Photo 1). *Photos 1–12* provide views of the surrounding properties, largely a mix of newer commercial and residential rentals, office buildings, and post-1955 residences. The property types and construction dates are also identified on Figure 1.

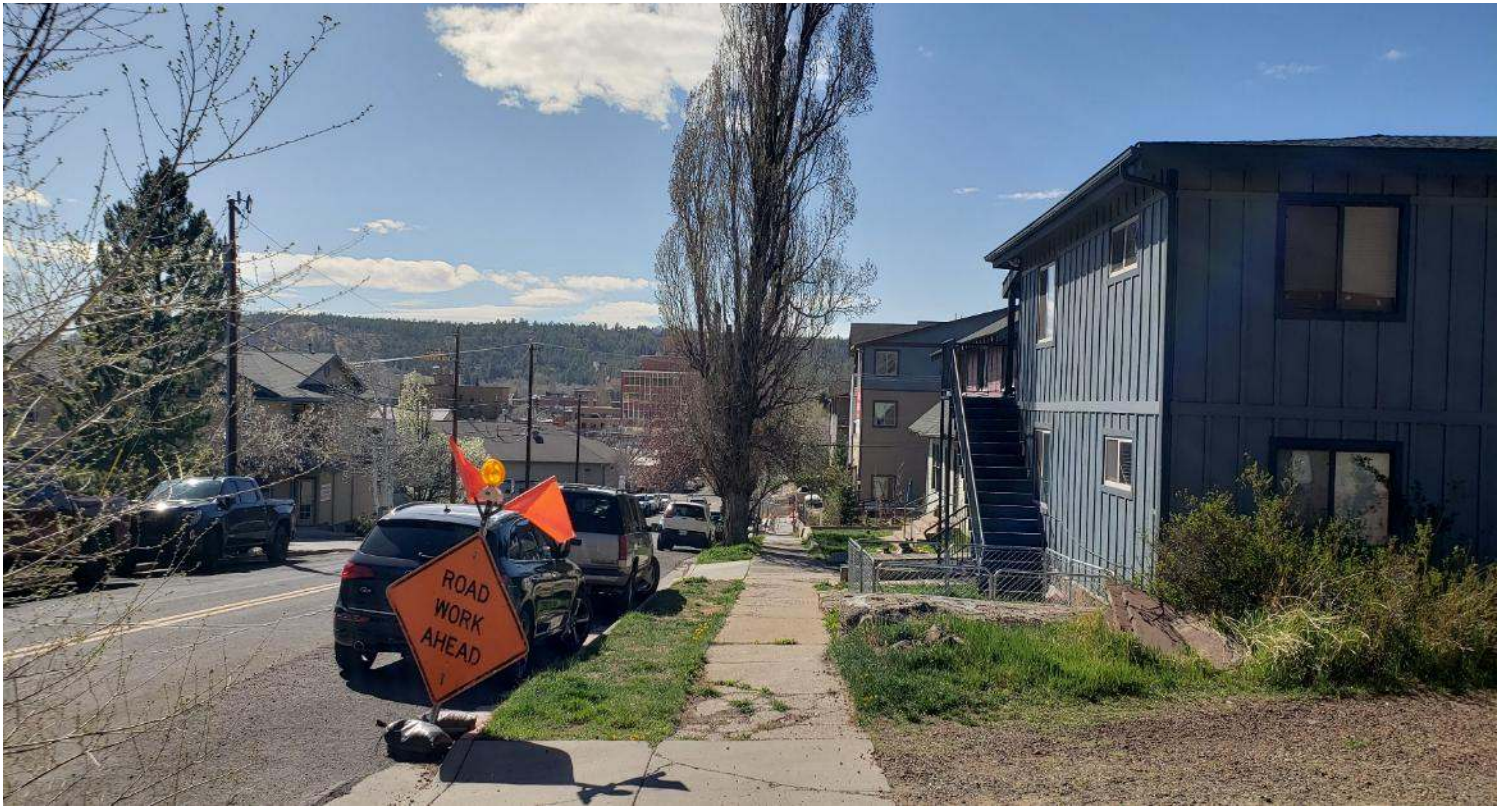
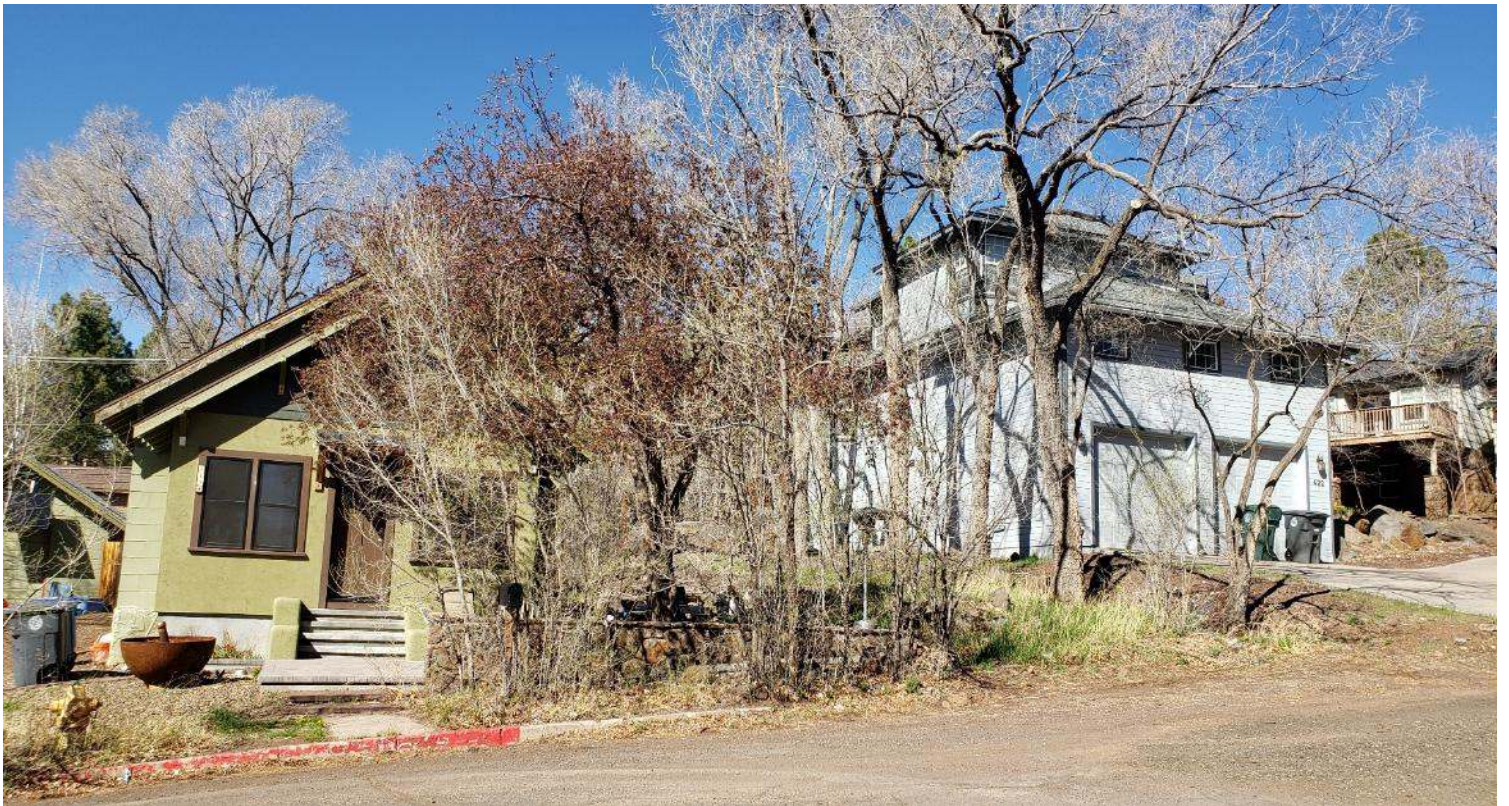
Photos 3–4. 418 E Birch Ave overview from front of house to WNW down Birch (top, 310 Downtown Condominiums in right background) and from street to NE (bottom, large house to right at 422 E Birch).

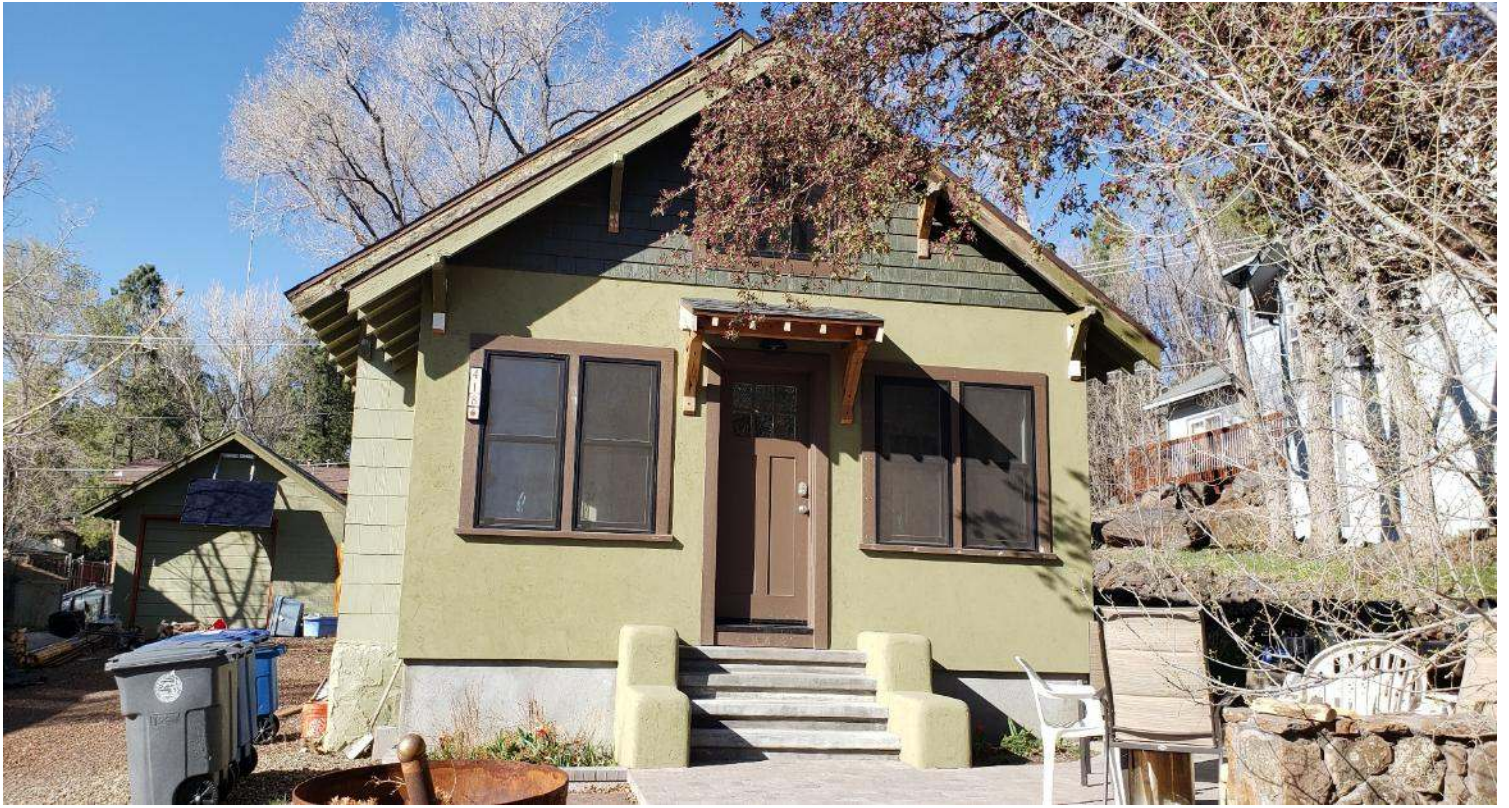
Photos 13–14. 418 E Birch Ave front/SSW façade and garage facing NNE (top) and facing NE (bottom).

The house façades/elevations are shown in *Appendix A, Figure 4* and *Appendix B, Photos 13–19*. The main house and enclosed front porch have an 8:12-pitch gable roof (see Photo 14), and this pitch will be retained on the front façade in the proposed remodel (see Figure 4). The low pitch roof on the rear extension of the house (see Photo 15) would be removed and replaced by extending the 8:12-pitch roof of the main house portion (see Figure 4). The house's distinctive but simple bracketed corbels (*Photo 20*) on the front façade would remain on both roof lines (see Photos 13–14), as well as on the rear main roof line (see Photo 15). The corbels project beyond the roof line from under the enclosed eaves present around the perimeter of the house, whereas the exposed rafters are flush with the roof line on the east and west façades (see Photo 18). The only gutter on the house is on the rear/north façade over the door (*Photo 21*). Asphalt shingles over 1 × 12-inch wood planking make up the roof. The roof planking and 2 × 4-inch rafters appear to have been replaced likely post 1940, with the exterior materials replaced more recently than the interior. As part of the remodel, the entire roof would be replaced to meet current building requirements, but the owner would make every effort to recycle the planking for other purposes. The floor of the attic remains the same and would not be elevated (*Figure 5*). The house foundation wall is basalt rubble sealed with cement (*Photo 22*). It would be replaced with concrete similar to how it was done on the front enclosed porch foundation wall. The primary exterior wall finish is Transite (asbestos/cement fiber) shingle siding over **original**

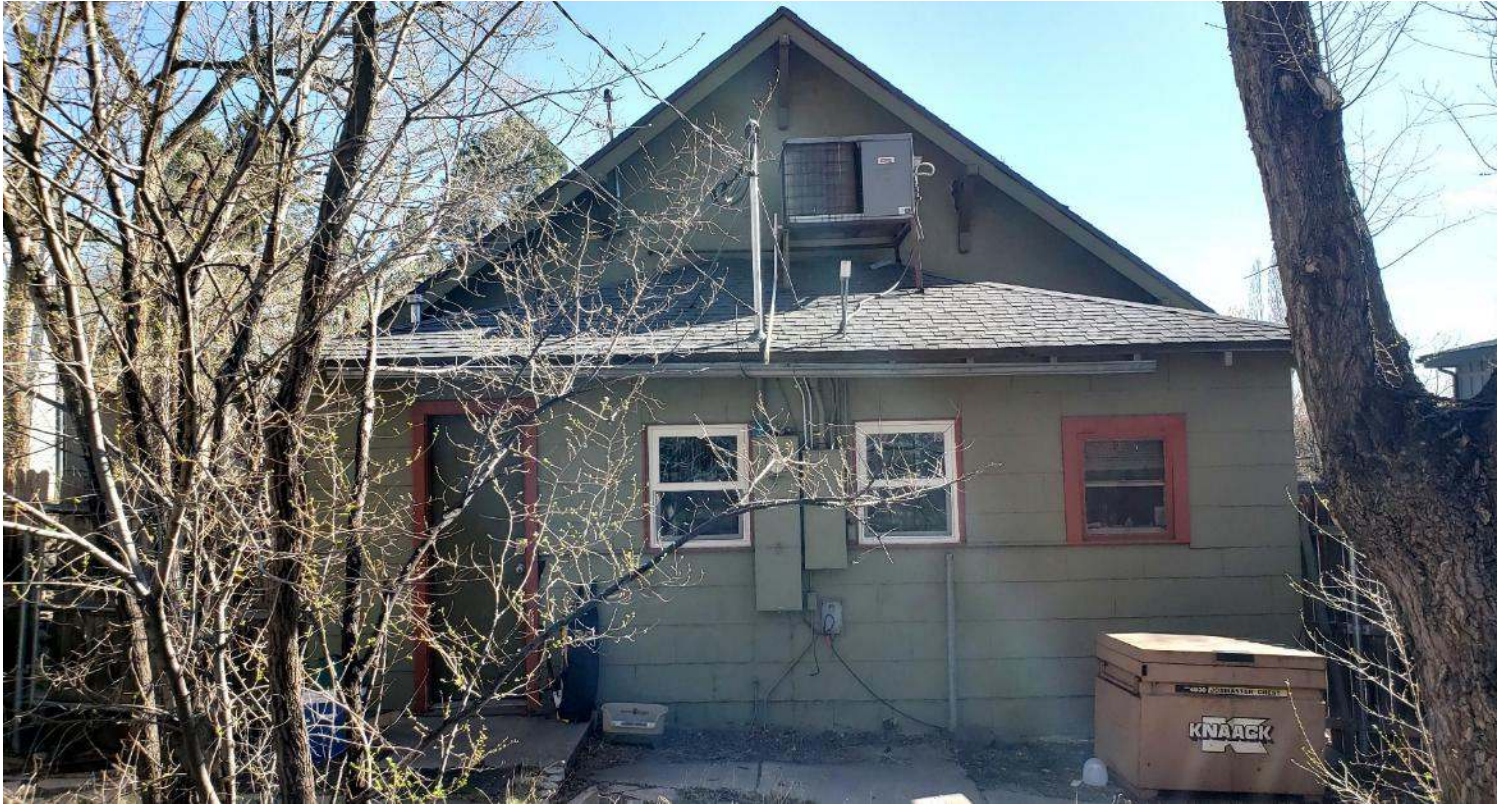
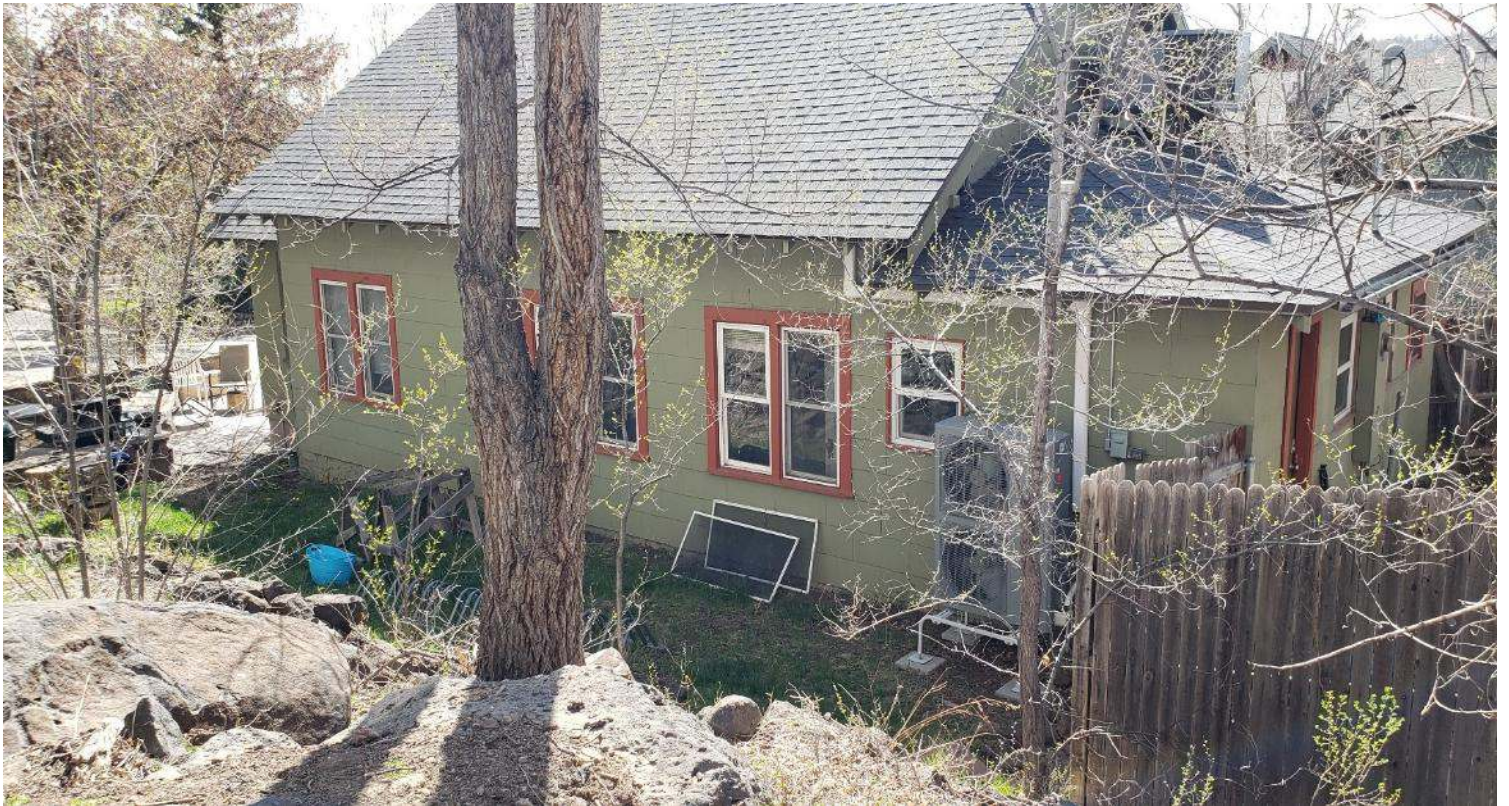
Photos 15–16. 418 E Birch Ave rear/NNE façade facing SSW (top) and E façade & rear facing W (bottom).

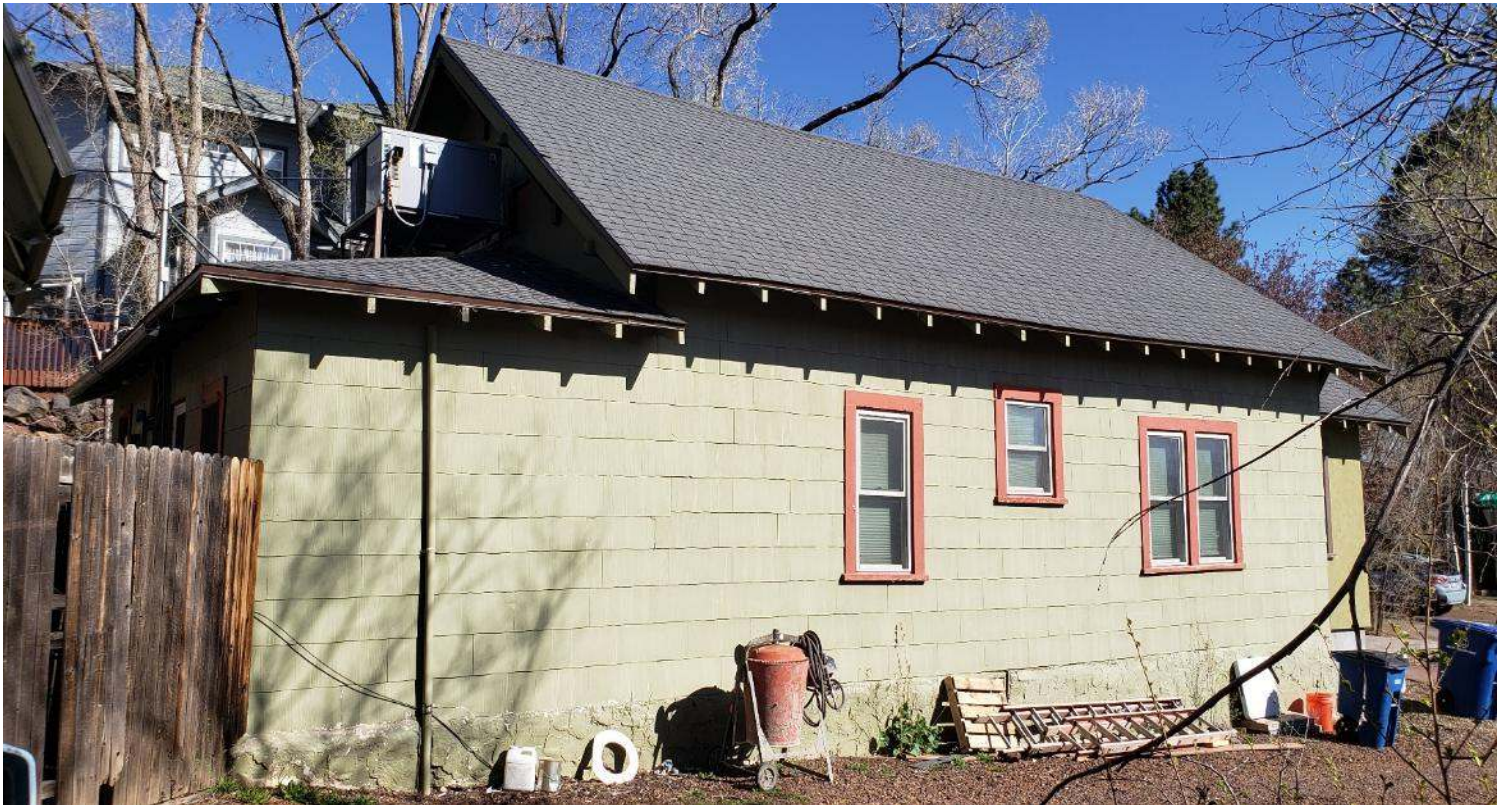
Photos 17–18. 418 E Birch Ave rear/NNE façade facing SSW (top) and E façade & rear facing W (bottom).

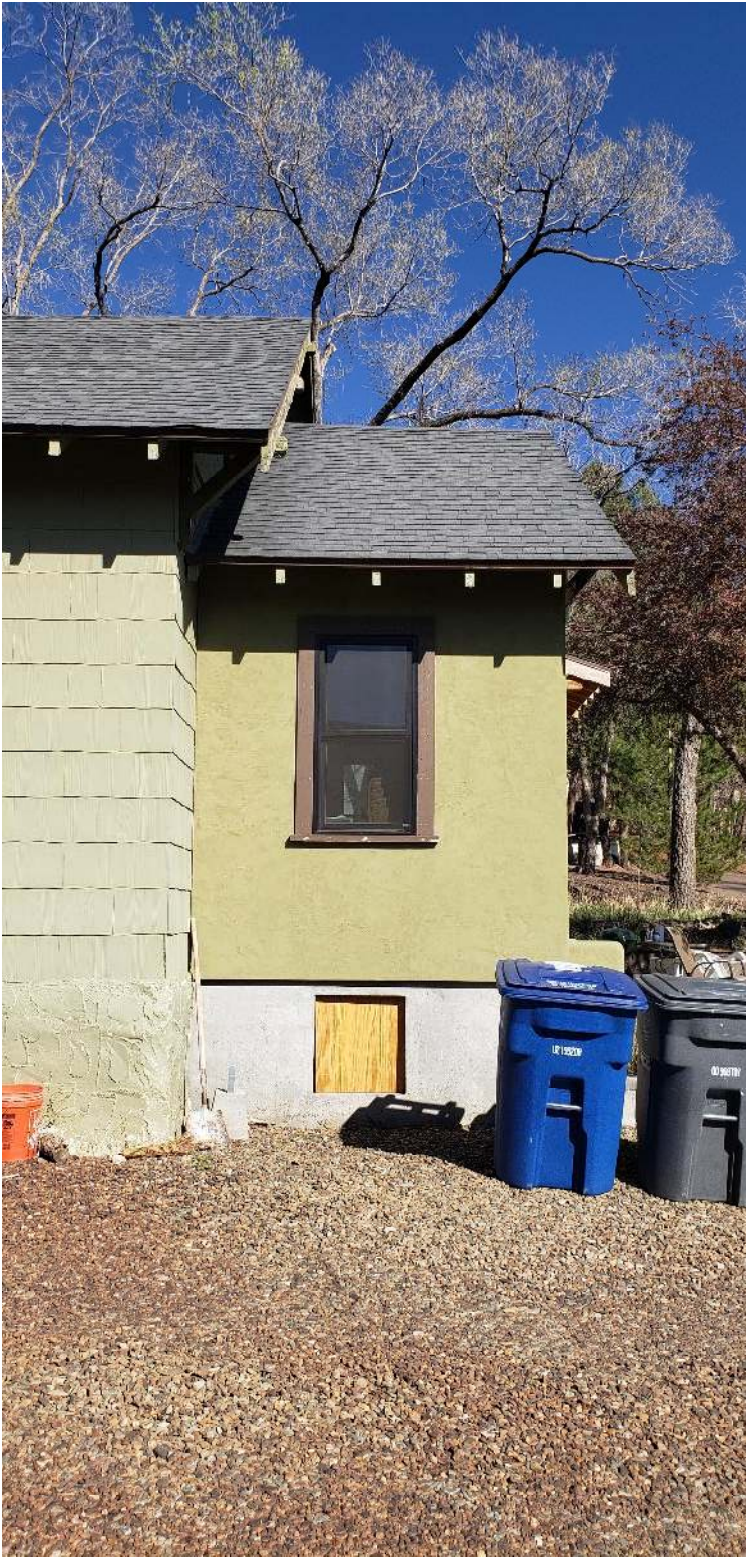
Photos 19–20. 418 E Birch Ave W façade focused on enclosed front porch facing ESE (left) and enclosed front porch/main house junction facing ESE/up (right).

clapboard siding over wood framing (see Photos 22, 23–24). The enclosed front porch recently had the Transite siding removed and replaced with stucco and shingled smart siding in the gable (see Photo 19). The upper portion of the rear of the house also has a stucco finish. All the exterior doors are post-1950 replacements as are all but one of the windows. The one pre-1950 window, a wood-frame single-hung with wood screen, is in the rear addition to the house (*Photo 25*). The window openings, however, are thought to be original.

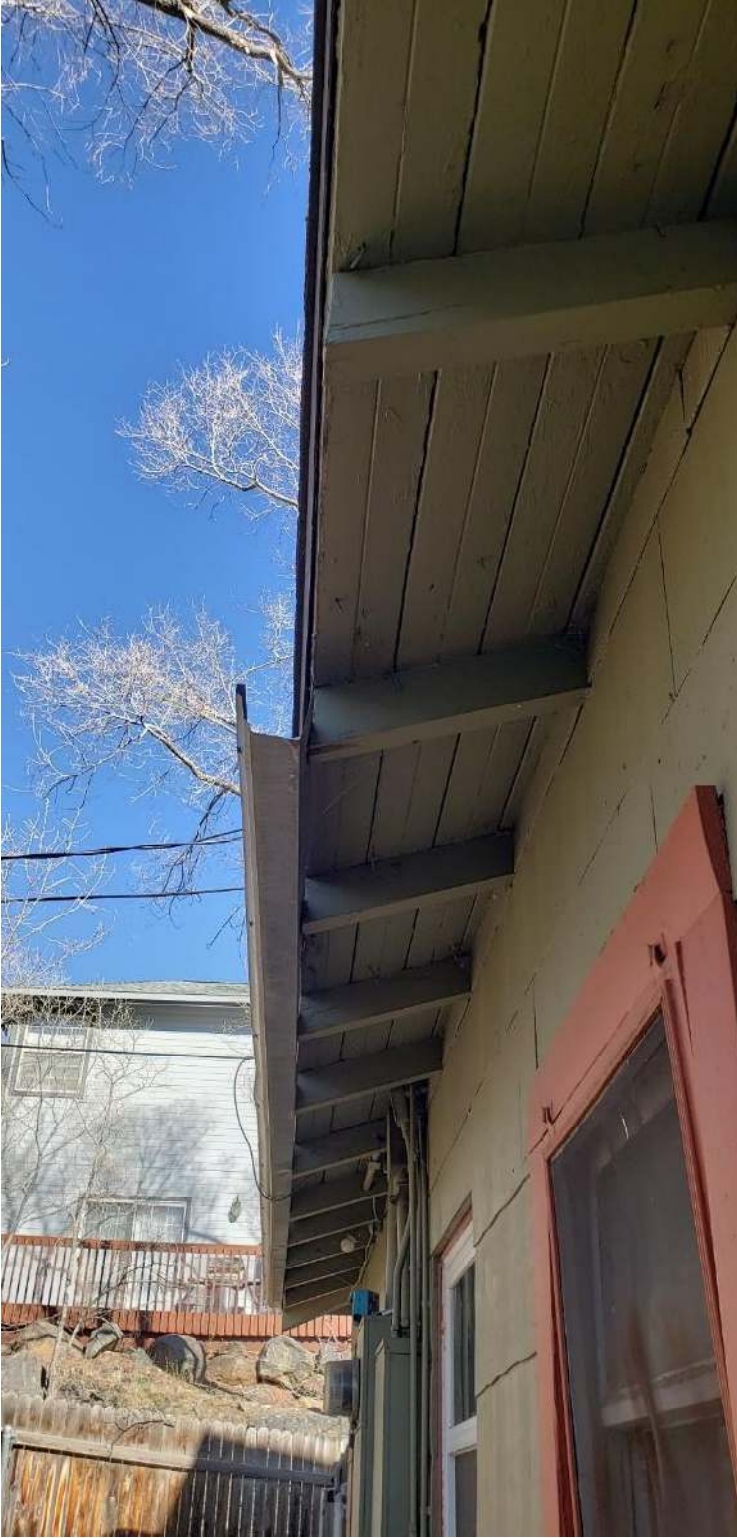
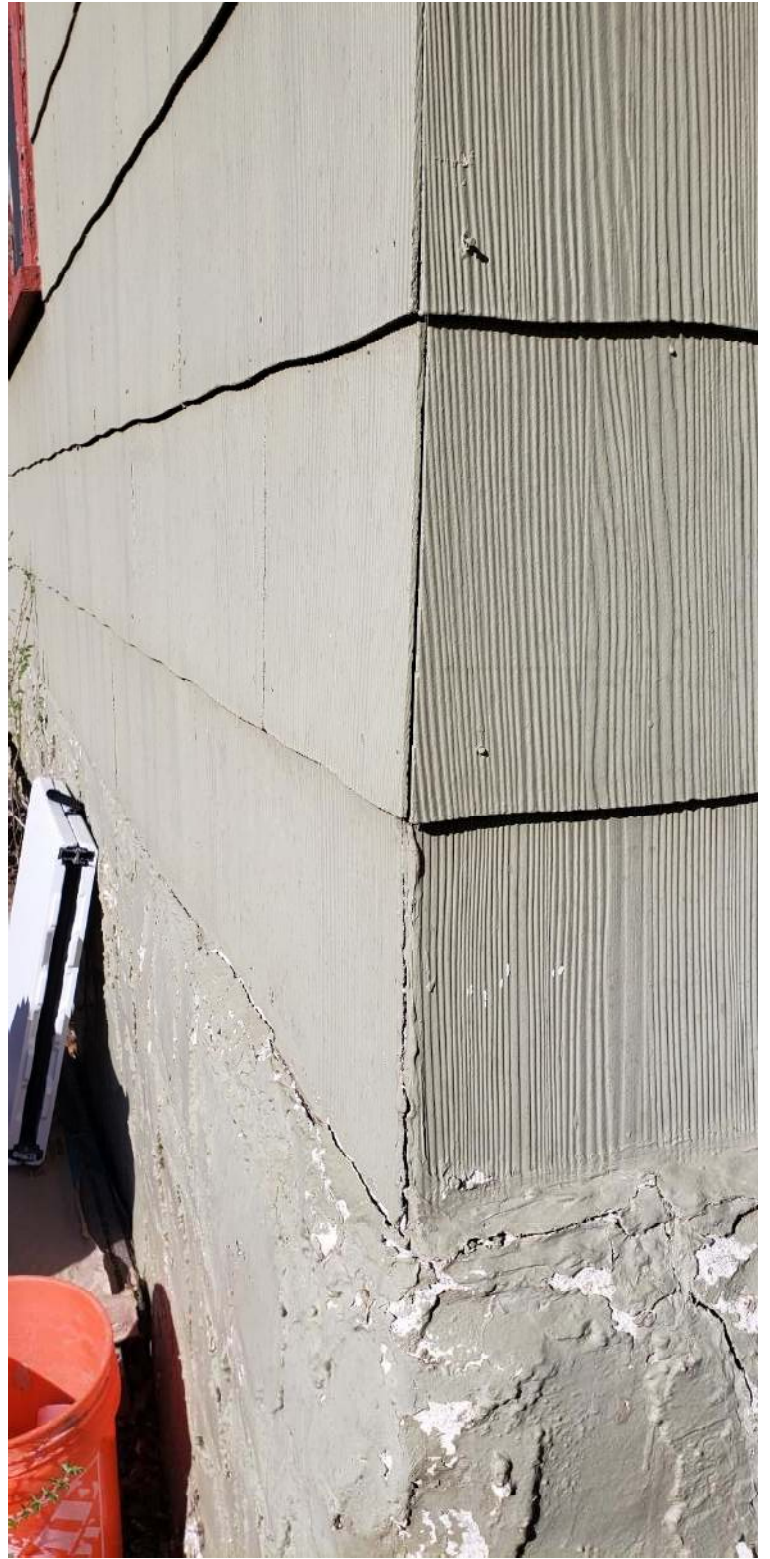
Photos 21–22. 418 E Birch Ave N façade focused on eave facing ESE (left) and SE corner detail at house/ enclosed front porch junction facing NE (right).

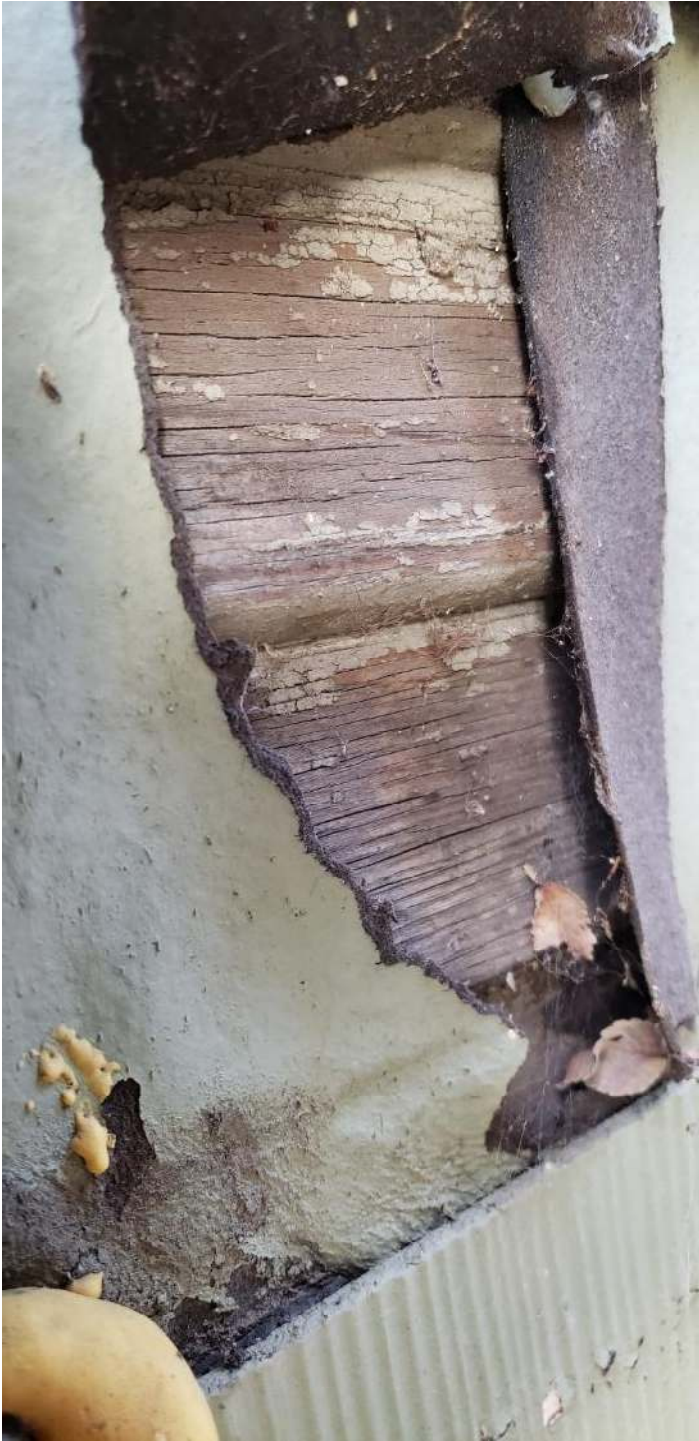
Photos 23–24. 418 E Birch Ave E façade detail of likely original clapboard siding under later Transite shingles facing NW (left), and detail of the clapboard siding on house's interior (what was the original N façade) facing SW (right).

clapboard that once covered the house exterior largely remains beneath the cement fiber shingles. The property owner would like to recycle as much of this material as possible and/or replace it with like material where necessary, ultimately getting rid of the current shingle siding. The newly stuccoed and smart-sided enclosed front porch will remain as is. Therefore, those materials used in constructing the subject building which contribute to the neighborhood's historic period of significance could in part be reinstated or compatibly replaced.

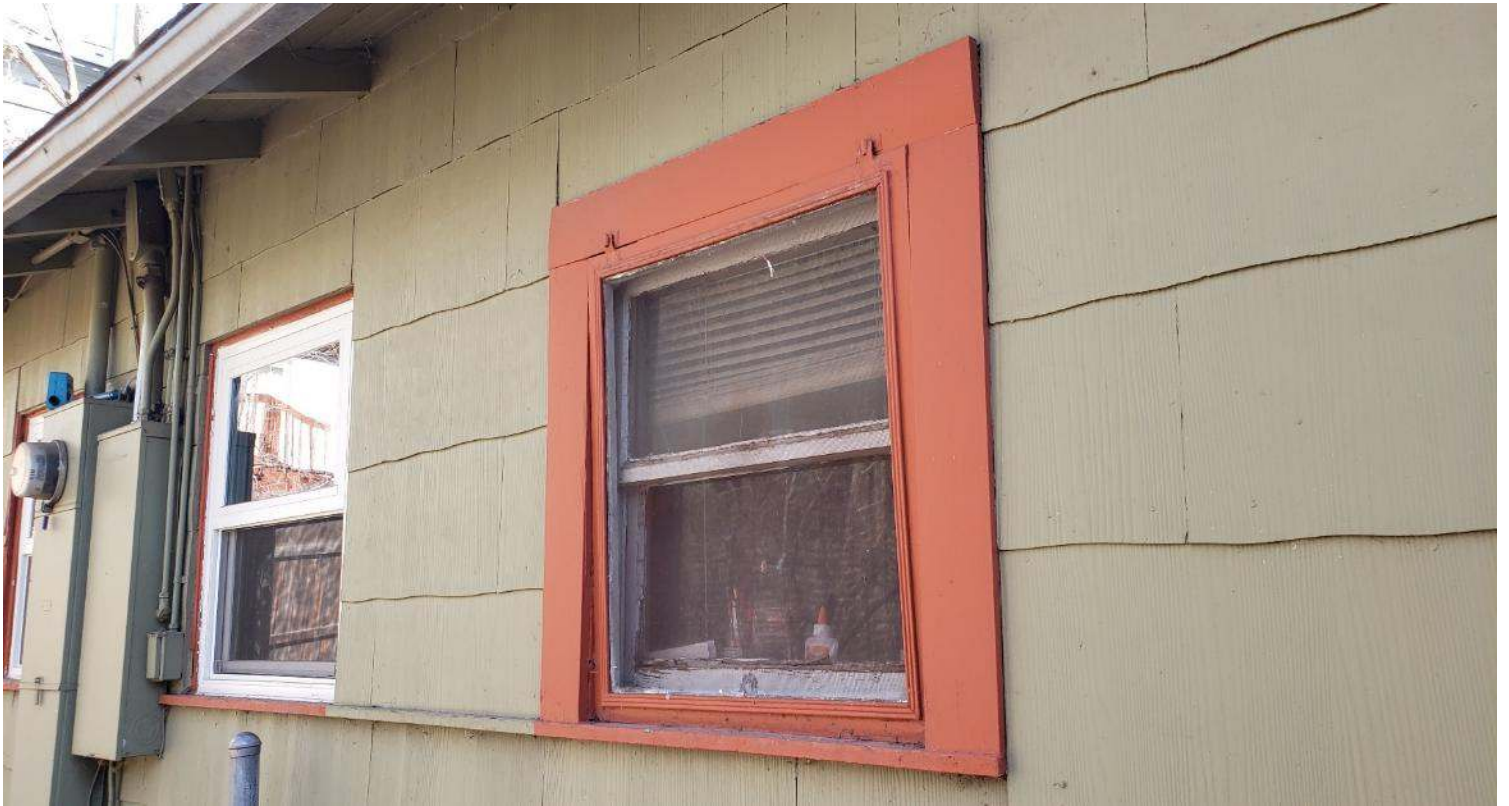
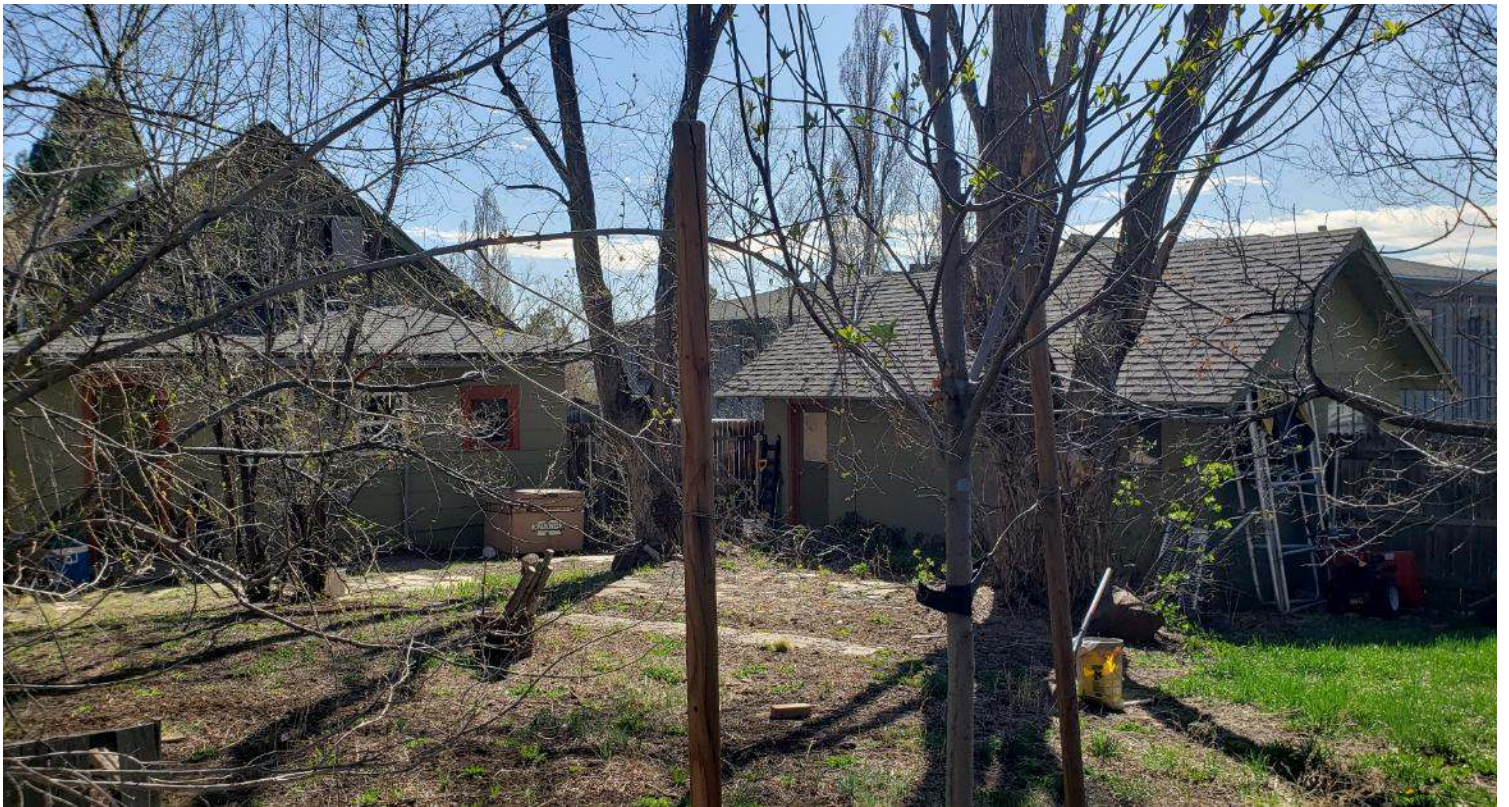
Photos 25–26. 418 E Birch Ave N façade showing only non-replaced window facing SE (top), and view of garage relative to the house from parcel's NE corner facing SW (bottom).

The only other building on the property is a single-car garage in the parcel's northwest corner (*Photo 26*). Its walls are constructed of concrete block with metal-frame fixed windows on three façades, a paneled wood door in the east façade, wood-framed roof and cement fiber-sided gables, and a rolling steel garage door on the front/south façade (*Photos 27–30*). It was likely constructed in the early 1960s, probably around the same time the Transite siding was added to the house and placed on the garage gables.

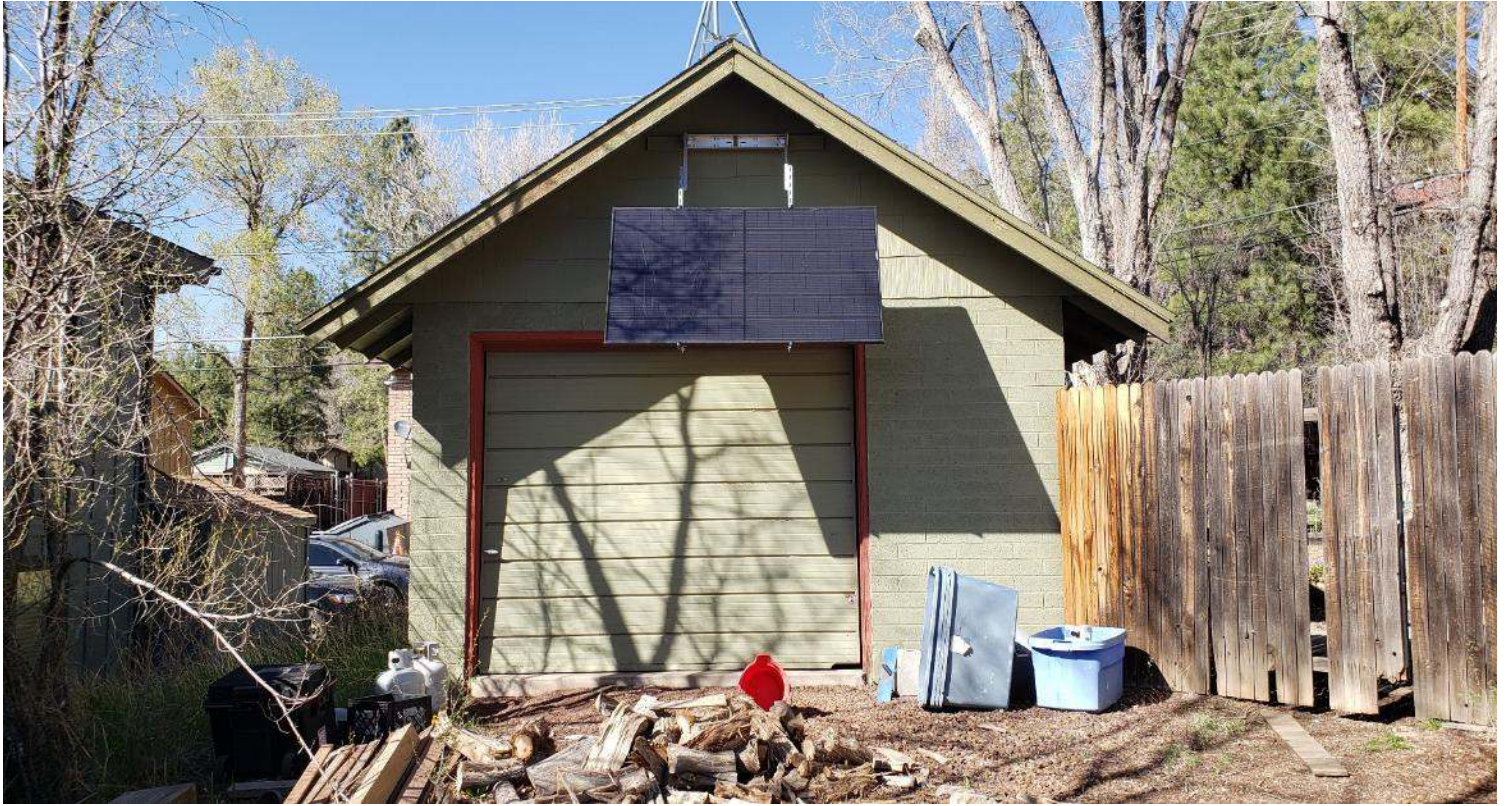
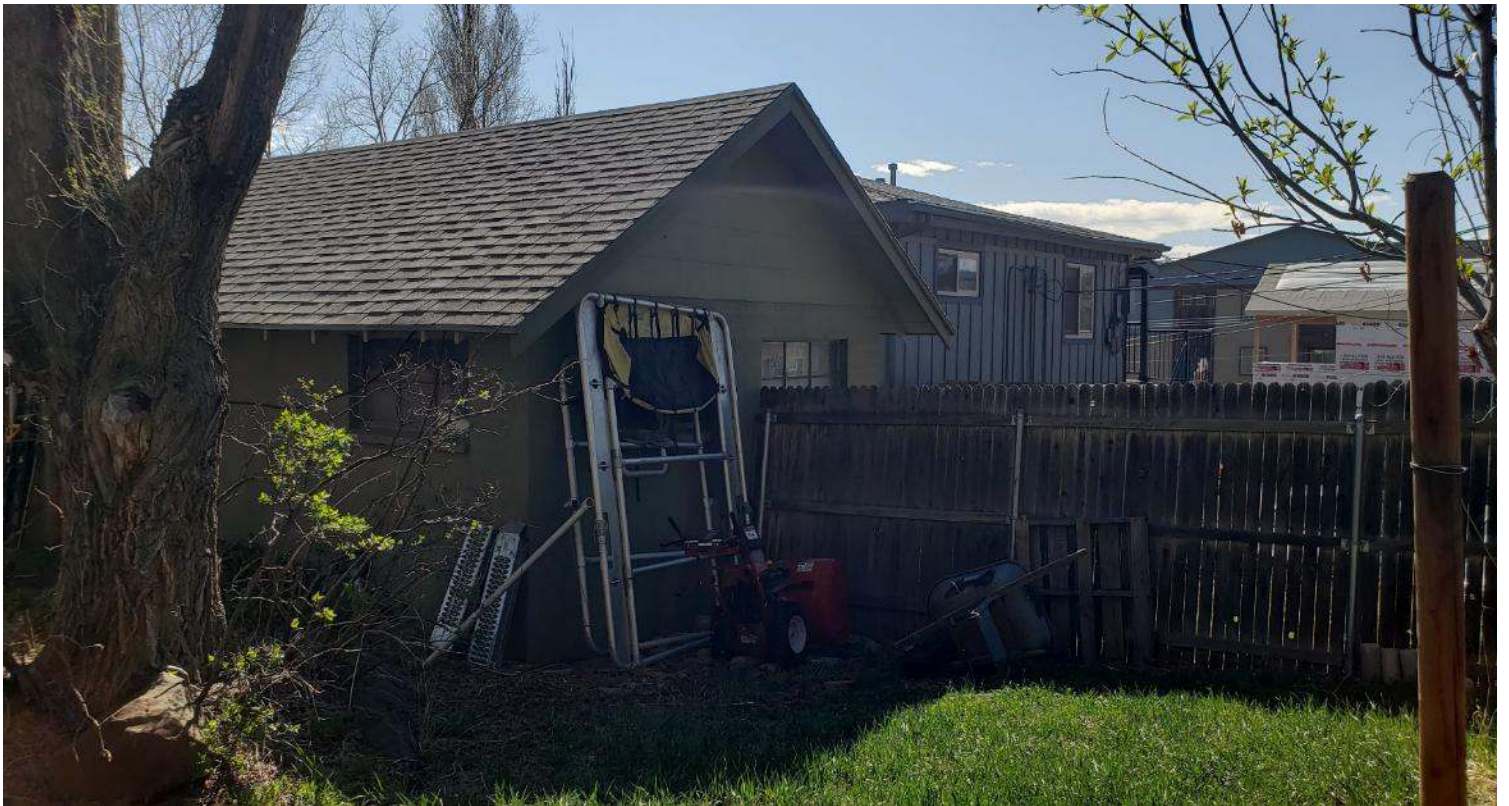
Photos 27–28. 418 E Birch Ave garage front/S façade facing NNE (top) and rear/N facade facing SW (bottom).

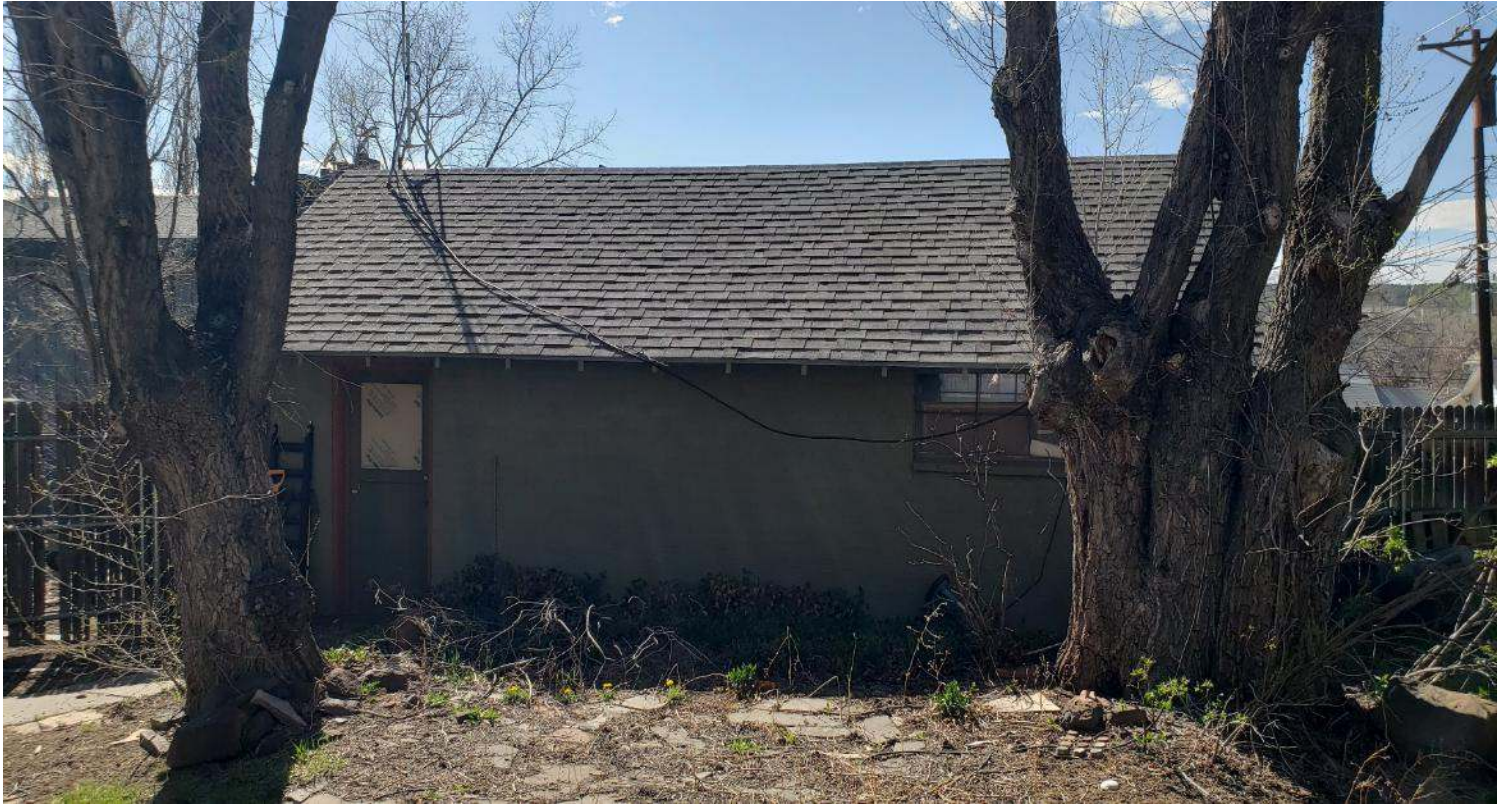
Photos 29–30. 418 E Birch Ave garage E façade facing W (top) and W façade facing NE (bottom).
