Hurricane Irma

Damage Assessments

Related Account: 0195 - City of Fort Pierce
Project Name: Fort Pierce: City Hall Irma Damages
Project Address: 100 North US 1, Fort Pierce, FL,
Report Date: 9/16/2017
Report Time: 9:00 AM

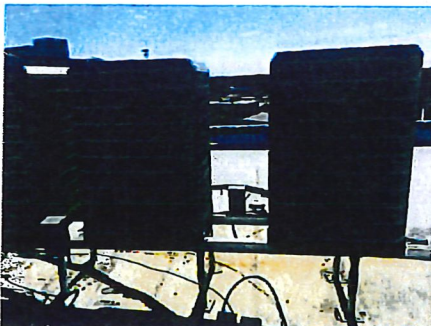
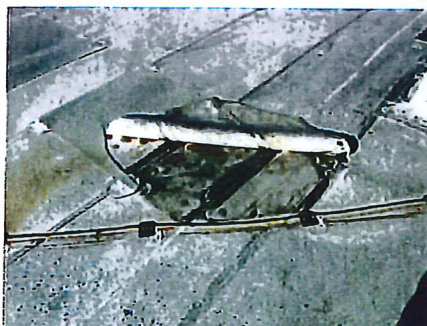
Estimated Damage Amount: \$25,000 - \$50,000
Damage Notes: HVAC units on roof broke a loose from brackets. Repairs have already been done and units are back in place. A small roof lap has blown up and needs to be repaired. There is extensive carpet and baseboard damage on the third floor of the building. The contractors have already begun remediation with dehumidifiers and air scrubbers set up on the floor. The Industrial hygienist did not recommend wall demolition.
Wind Damage %: 0
Flood Damage %: 20
Other Damage %: 0

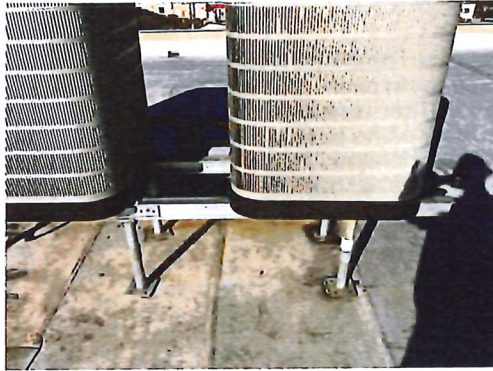
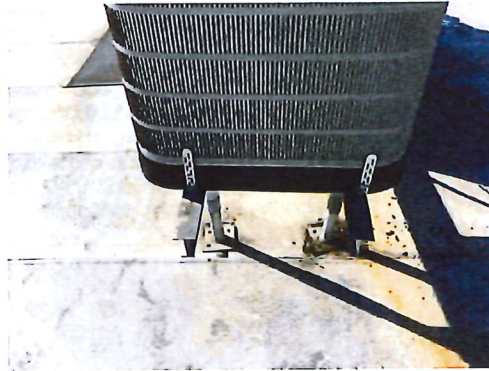
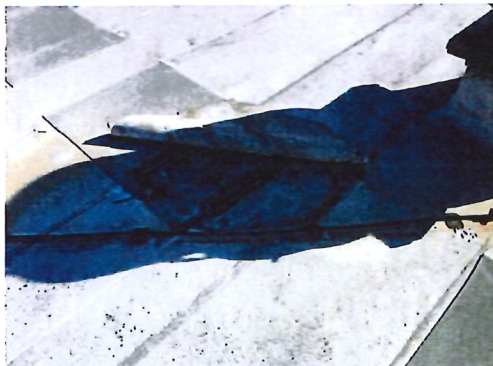
Company/Subcontractor: Industrial Safety Solutions, Inc.
Subcontractor Rep: Vance Cochran
Phone Number: 228-217-9629
Email: vancecochran@gmail.com
Recommendation(s): The HVAC units on the roof apparently dislodged during the event. The units have been uprighted and attached to the brackets that were broken. The units are back in place and seem to be functioning properly. There is a flap of the vinyl roof that is torn and needs to be replaced or repaired.

Next Action: Repair roof flap
Action Assigned To: Unknown
Action Due Date: 9/16/2017

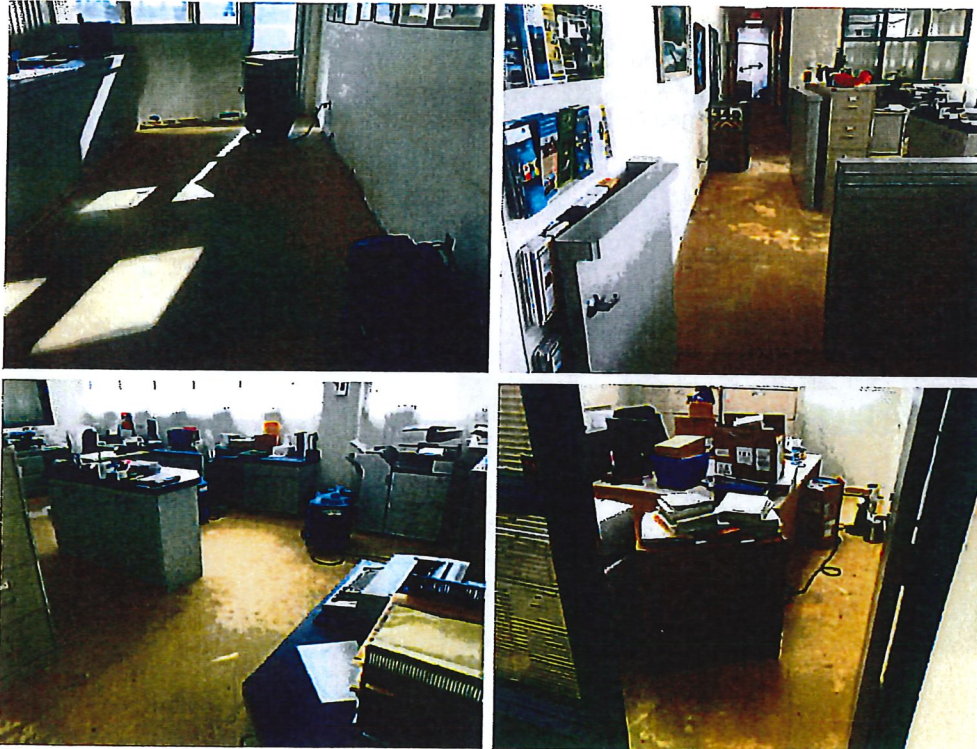
Company/Subcontractor: Industrial Safety Solutions, Inc.
 Subcontractor Rep: Vance Cochran
 Phone Number: 228-217-9629
 Email: vancecochran@gmail.com
 Recommendation(s): Demolition has already taken place. It seems as though the flooring has been removed as well as the base molding. Drying is taking place with fans and dehumidifiers.

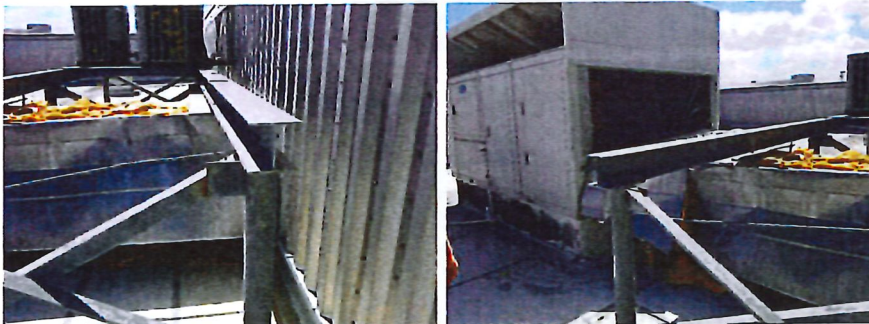
Estimated Damage Amount: \$25,000 - \$50,000
Damage Notes: HVAC system damaged on roof of garage above retail area
Lights damaged on top deck of garage
Wind Damage %: 20
Flood Damage %: 0
Other Damage %: 0

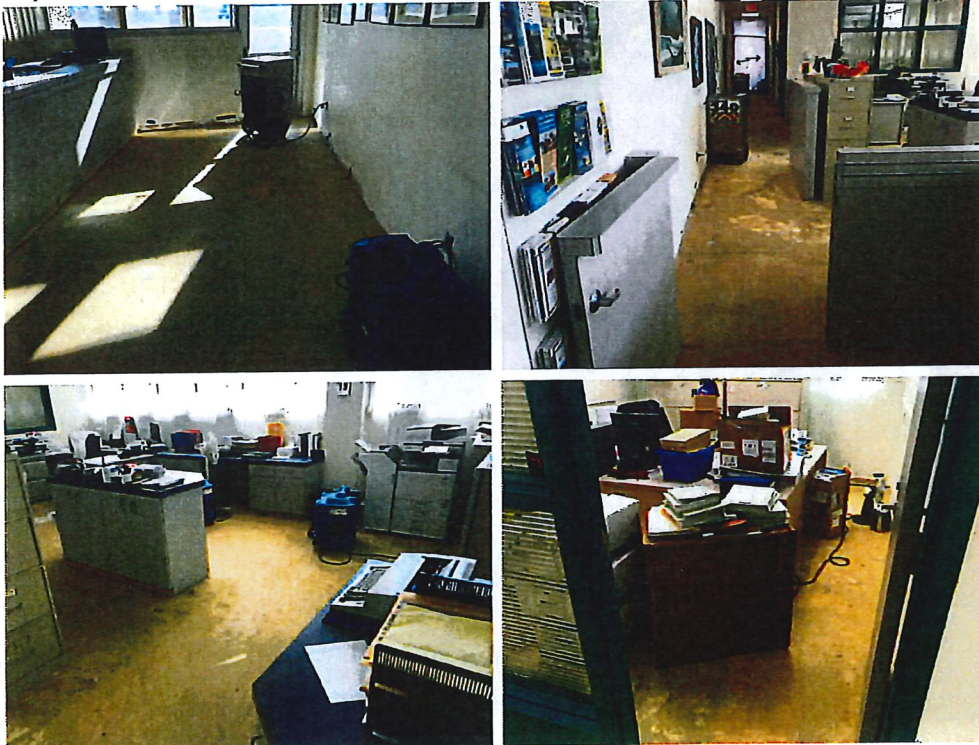
Company/Subcontractor: Industrial Safety Solutions, Inc.
Subcontractor Rep: Vance Cochran
Phone Number: 228-217-9629
Email: vancecochran@gmail.com
Recommendation(s): Demolition has already taken place. It seems as though the flooring has been removed as well as the base molding. Drying is taking place with fans and dehumidifiers.

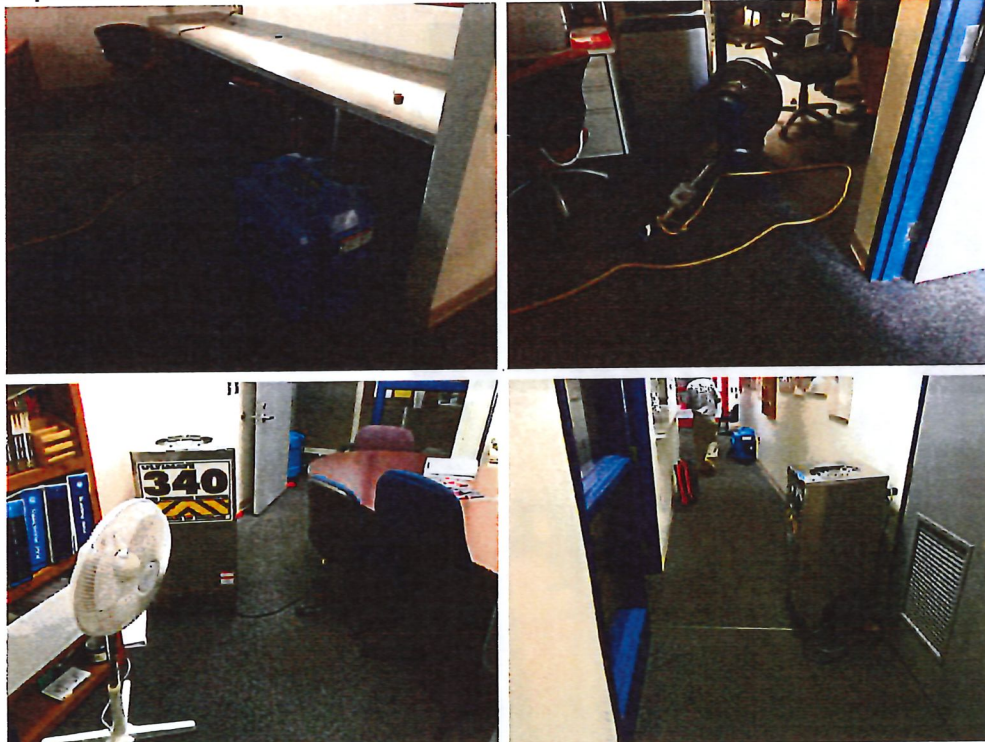
Company/Subcontractor: Industrial Safety Solutions, Inc.
Subcontractor Rep: Vance Cochran
Phone Number: 228-217-9629
Email: vancecochran@gmail.com
Recommendation(s): Contractors have fans and dehumidifiers in place. Custom Carpet Cleaners is cleaning the carpet and recommends not changing it out.

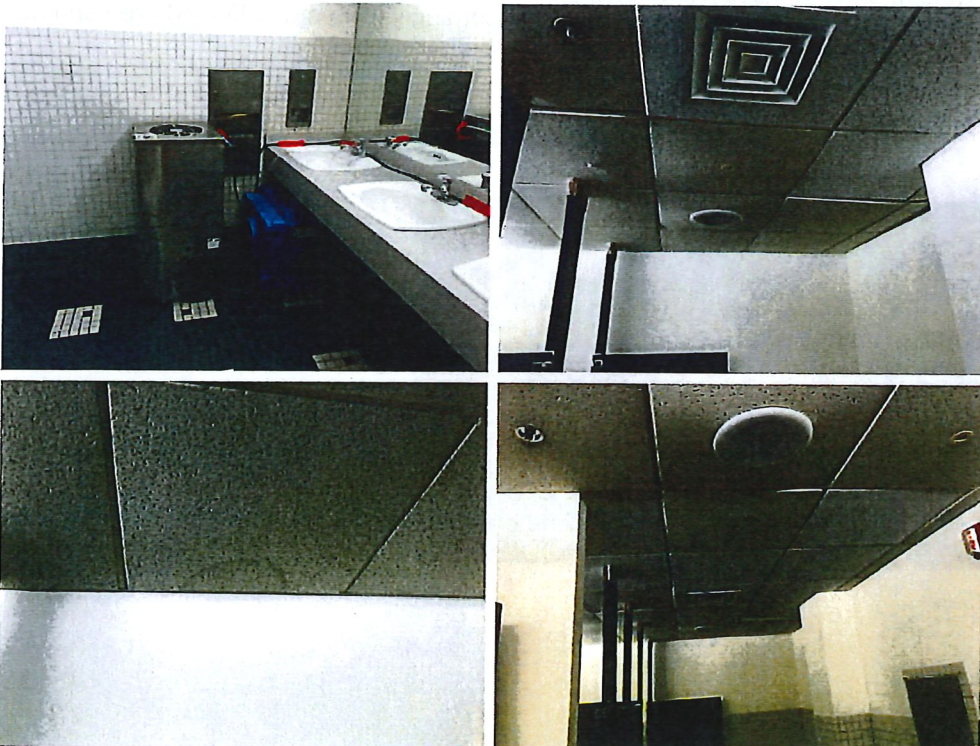
Company/Subcontractor: Industrial Safety Solutions, Inc.
Subcontractor Rep: Vance Cochran
Phone Number: 228-217-9629
Email: vancecochran@gmail.com
Recommendation(s): Contractors have fans and dehumidifiers in place. Ceiling tiles have been replaced.
Project Notes:

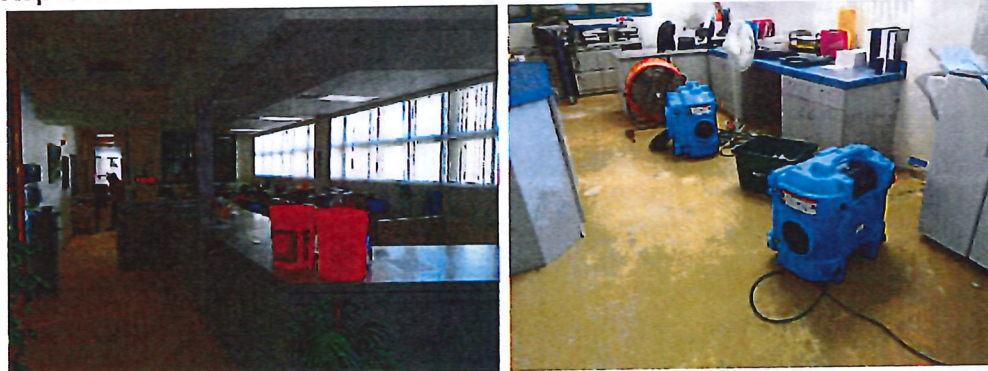
Company/Subcontractor: Synergy NDS, Inc.
Project Manager/Specialist: Mike Matheny
Phone Number: 954.732.7594
Email: mmatheny@synergyid.com
Recommendation(s): Refer to Photos sent in by City regarding rooftop AC Units blown off anchors. Vertical water damage affected multiple office areas. Migration through duct system seems to have contributed to the affected areas. Carpet in selective areas has been removed due to heavy odor and saturation. DKI has done a good job stabilizing areas with minimal tear outs, etc. Dry in place methods to continue with IH review.

Next Action: Continue dry in place. Remove bulk of air scrubbers doubling as air blowers. Change out with Airmovers or charge accordingly. IH tested affected area and no environmental conditions are present to support.

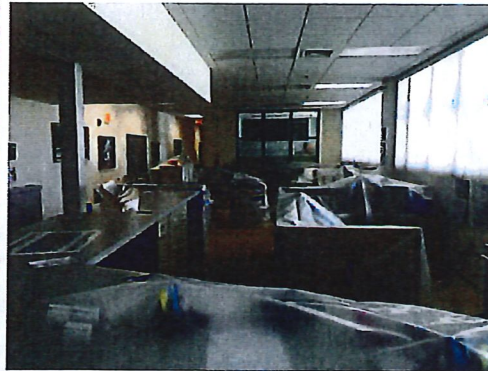
Company/Subcontractor: Industrial Safety Solutions, Inc.
Subcontractor Rep: Vance Cochran
Phone Number: 228-217-9629
Email: Vancecochran@gmail.com
Recommendation(s): Continue with remediation.
Project Notes: Contractors have covered all flat surfaces with polyethylene plastic. There are also holes drilled in the walls on 6 inch centers about 4 inches up from the floor. The dryers and dehumidifiers continue to run in order to remove moisture from the building.

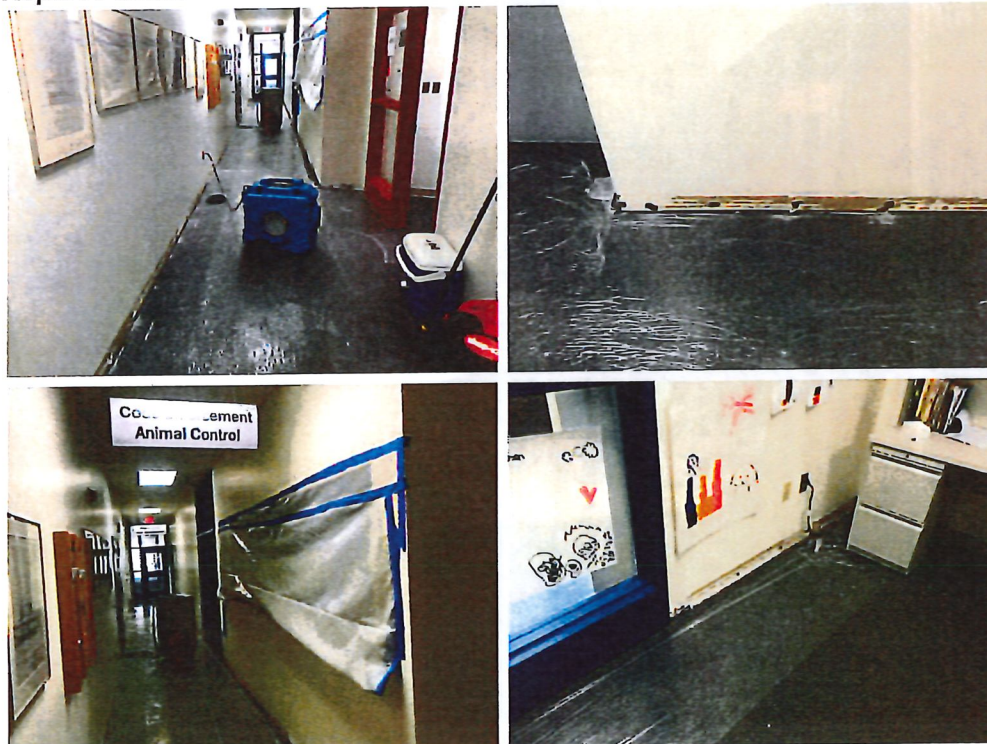
Company/Subcontractor: Industrial Safety Solutions, Inc.
 Subcontractor Rep: Vance Cochran
 Phone Number: 228-217-9629
 Email: Vancecochran@gmail.com
 Recommendation(s): Contractors should continue with remediation.
 Project Notes: Contractor has put plastic down over carpet to protect from dust. Holes are drilled in wallboard at the bottom of the wall on 1 foot centers about 3 inches up from the floor. The dryers and dehumidifiers continue to extract moisture from the area. There is also plastic covering a reception area window into code enforcement and animal control.

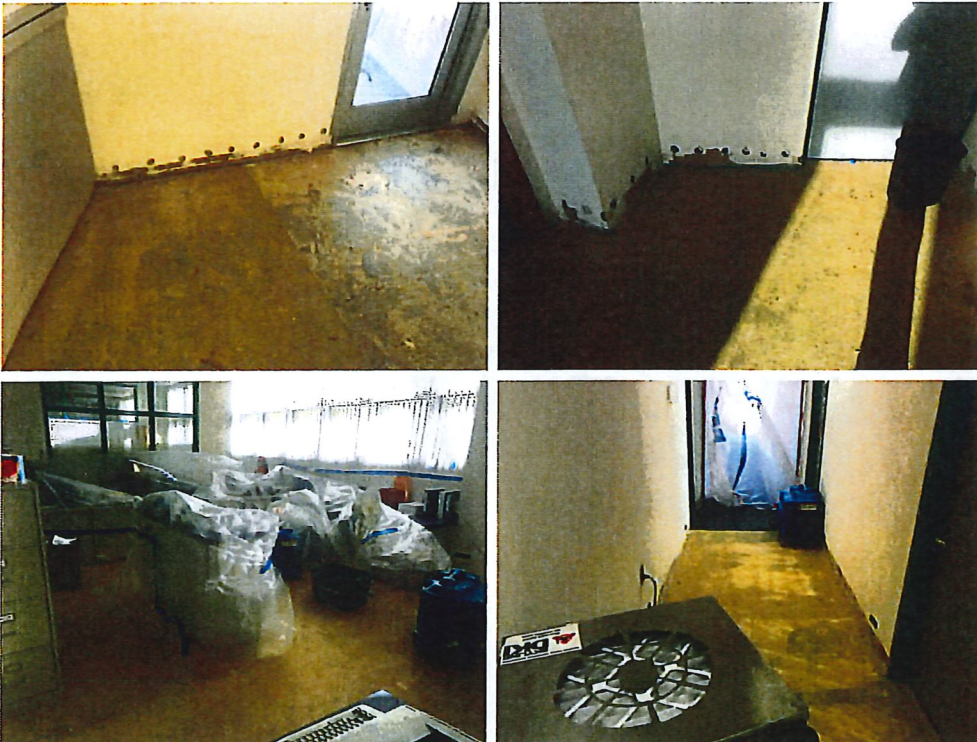
Company/Subcontractor: Industrial Safety Solutions, Inc.
Subcontractor Rep: Vance Cochran
Phone Number: 328-217-9629
Email: Vancecochran@gmail.com
Recommendation(s): Contractors should continue with mediation.
Project Notes: Some of the contract workers state that the and walls are dry and repair should be able to begin shortly.

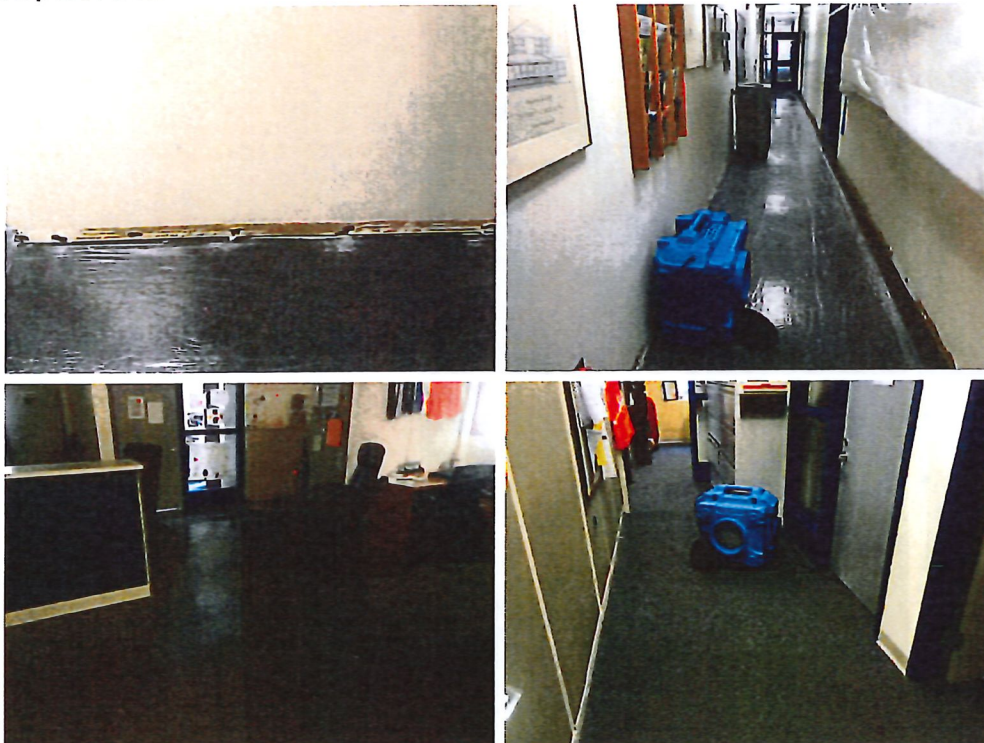
Company/Subcontractor: Industrial Safety Solutions, Inc.
Subcontractor Rep: Vance Cochran
Phone Number: 328-217-9629
Email: Vancecochran@gmail.com
Recommendation(s): Contractor should continue with remediation.
Project Notes: Contract workers state the second floor seems to have more moisture in it then the third. Drying continues with dehumidifiers and blowers.

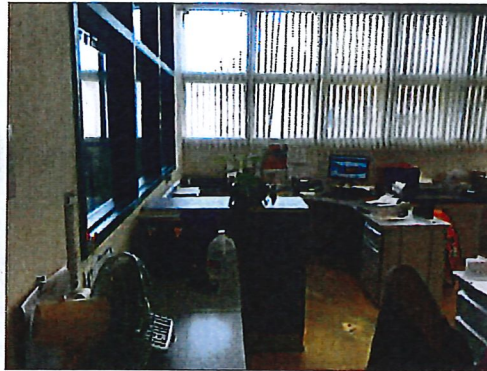
Company/Subcontractor: Industrial Safety Solutions, Inc.
Subcontractor Rep: Vance
Phone Number: 228-217-9629
Email: Vancecochran@gmail.com
Recommendation(s): Continue with mediation.
Project Notes: Contractor states all dehumidifiers and blowers except for one or off the third floor. All drying and dehumidification will be complete by tomorrow morning. All plastic has been removed except for small area in an office where a dryer and fan is located.

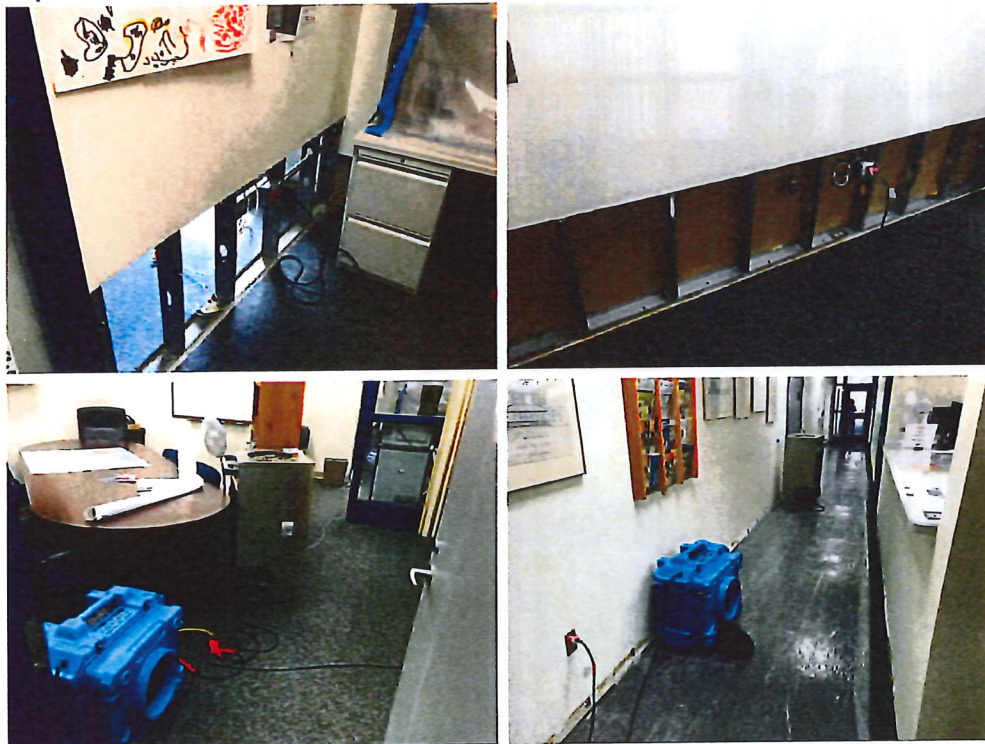
Company/Subcontractor: Industrial Safety Solutions, Inc.
Subcontractor Rep: Vance Cochran
Phone Number: 228-217-9629
Email: Vancecochran@gmail.com
Recommendation(s): Continue with remediation.
Project Notes: Drying and dehumidification continues. Two dryers, two air scrubbers, and two dehumidifiers are still in use. Drywall has been removed in several places 2 feet up from floor. Contractor states drying and dehumidification should be complete tomorrow.

Next Action: Install dry wall to replace cut outs.
Action Assigned To: Dry wall
Action Due Date: 9/18/2017

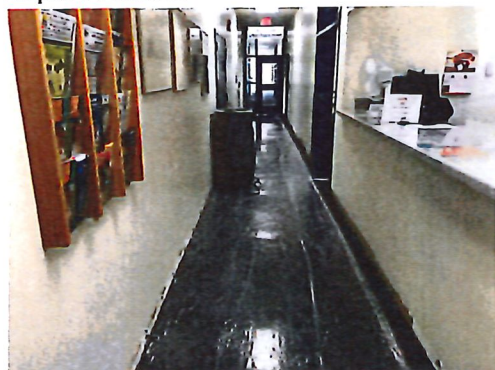
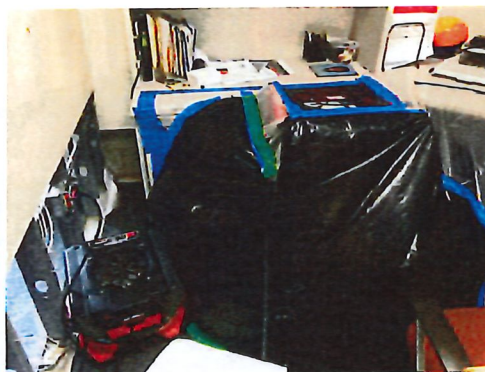
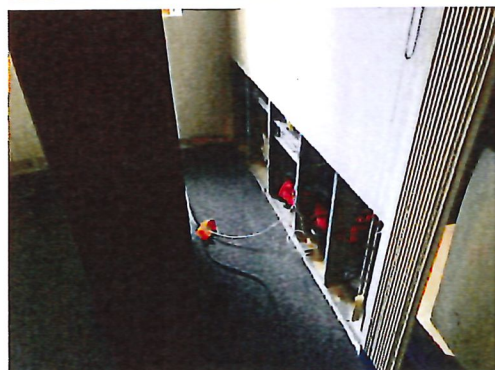
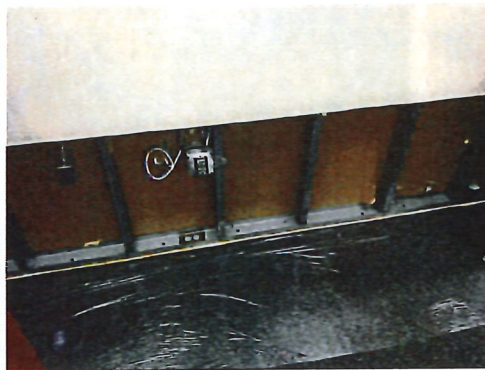
Company/Subcontractor: Industrial Safety Solutions, Inc.
Subcontractor Rep: Vance Cochran
Phone Number: 228-217-9629
Email: Vancecochran@gmail.com
Recommendation(s): Continue with remediation
Project Notes: Dryers and humidifiers continue to remove moisture.

Next Action: Installation of drywall
Action Assigned To: Drywall
Action Due Date: 9/18/2017

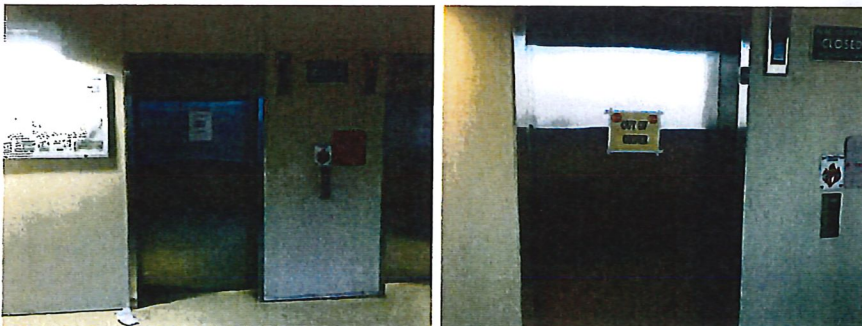
Estimated Damage Amount: \$25,000 - \$50,000
Damage Notes: 2 of the 3 elevators in the building are out of service. This is an addition to a previous assessment. Assessor was not aware of the damage being storm related.
Wind Damage %: 0
Flood Damage %: 0
Other Damage %: 0

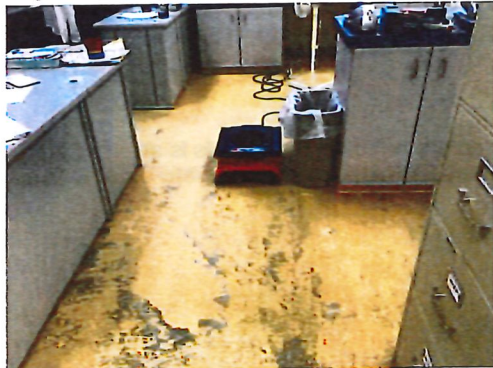
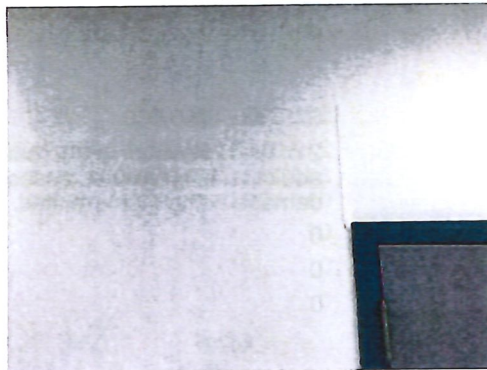
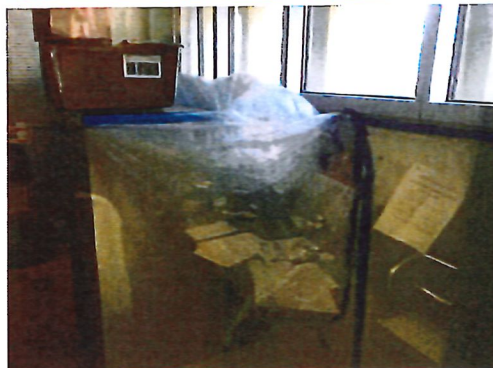
Company/Subcontractor: Industrial Safety Solutions, Inc.
Subcontractor Rep: Vance Cochran
Phone Number: 228-217-9629
Email: Vancecochran@gmail.com
Recommendation(s): Continue with remediation, find source of leak, and repair.
Project Notes: Most of the moisture removal is completed. The only source left is the HVAC unit.

Next Action: Ascertain source of leak and repair.
Action Assigned To: HVAC
Action Due Date: 9/19/2017

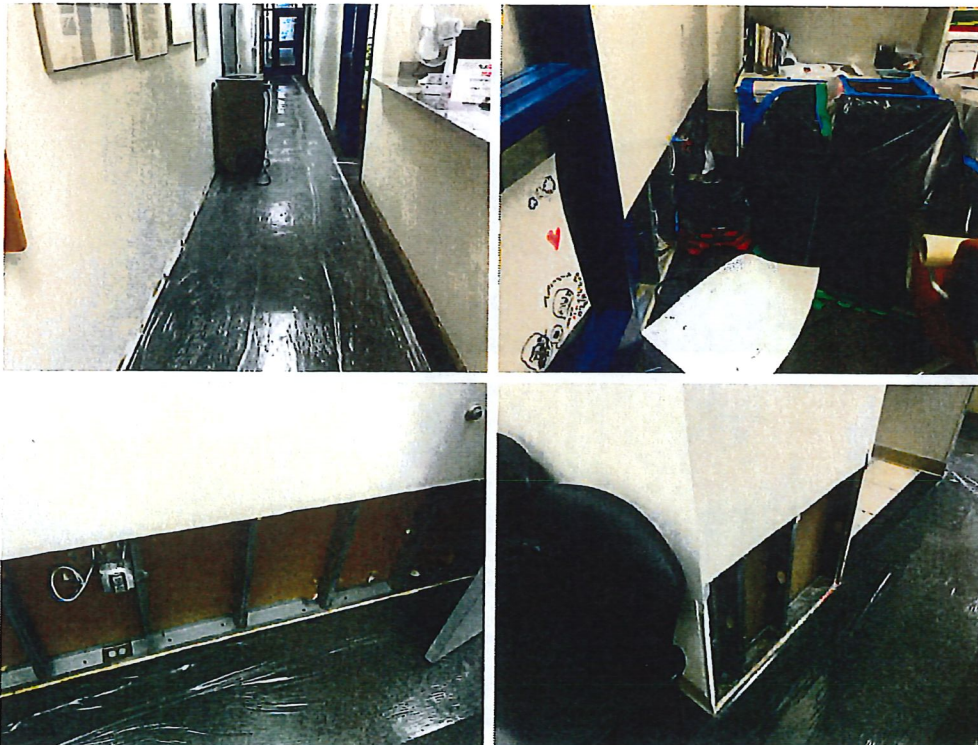
Company/Subcontractor: Industrial Safety Solutions, Inc.
Subcontractor Rep: Vance Cochran
Phone Number: 228-217-9629
Email: Vancecochran@gmail.com
Recommendation(s): Continue with remediation
Project Notes: Drying is still occurring in a couple of areas. Dehumidifiers and fans are in operation.

Next Action: Replace drywall
Action Assigned To: Drywall
Action Due Date: 9/19/2017

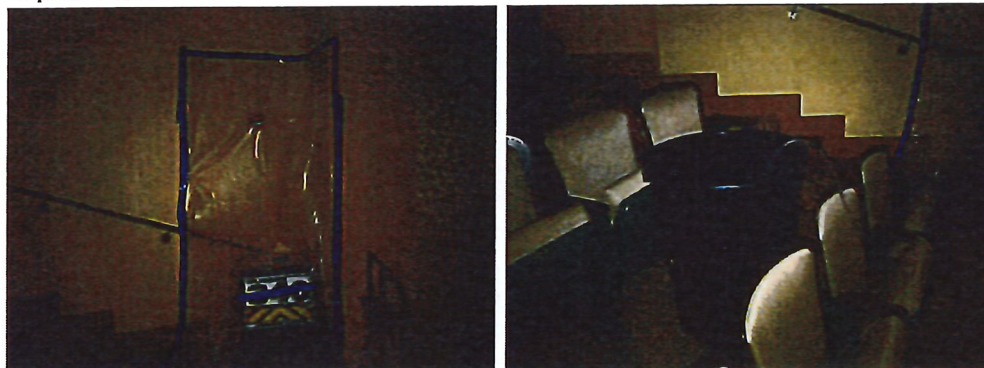
Company/Subcontractor: Industrial Safety Solutions, Inc.
Subcontractor Rep: Vance Cochran
Phone Number: 228-217-9629
Email: Vancecochran@gmail.com
Recommendation(s): Continue with remediation
Project Notes: The balcony wall at the bottom of the stairs is chambered with a dehumidifier installed to remove moisture from the drywall.

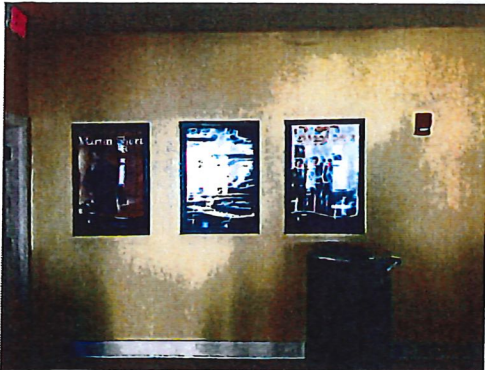
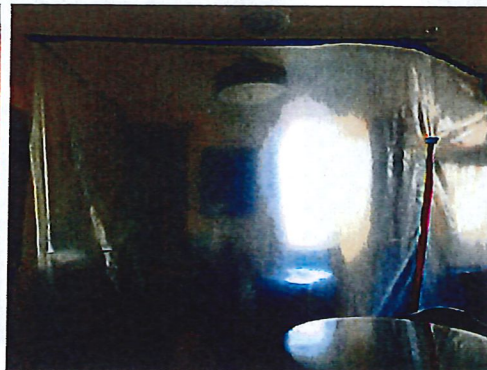
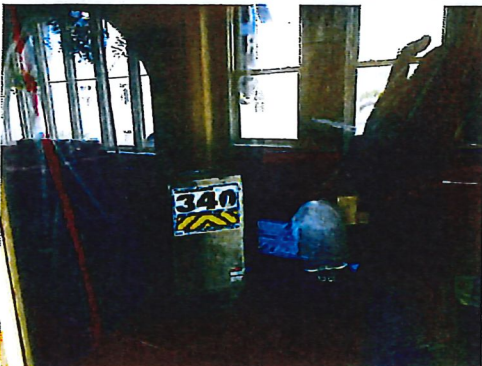
Company/Subcontractor: Industrial Safety Solutions, Inc.
Subcontractor Rep: Vance Cochran
Phone Number: 228-217-9629
Email: Vancecochran@gmail.com
Recommendation(s): Continue with mediation
Project Notes: The area above the bar is chambered with a dehumidifier and dryer installed to remove moisture from the drywall. There's also a dehumidifier on the west wall of the lounge.

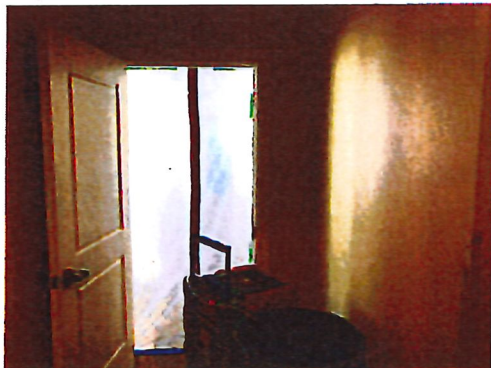
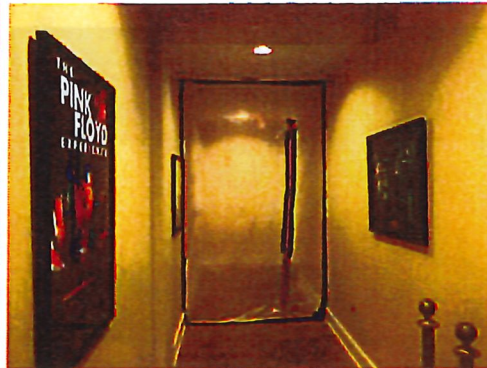
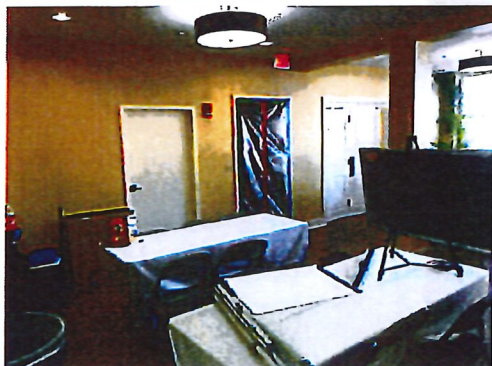
Company/Subcontractor: Industrial Safety Solutions, Inc.
Subcontractor Rep: Vance Cochran
Phone Number: 228-217-9629
Email: Vancecochran@gmail.com
Recommendation(s): Continue with remediation
Project Notes: A chamber is constructed from the catering door into the elevator hall 10 feet from the elevator shaft. A dehumidifier is removing moisture from the drywall.

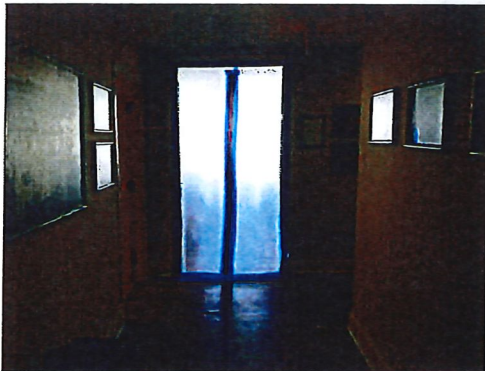
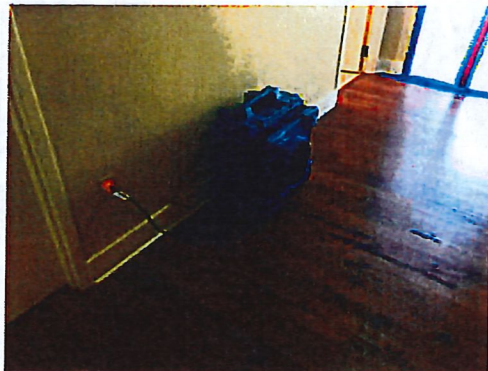
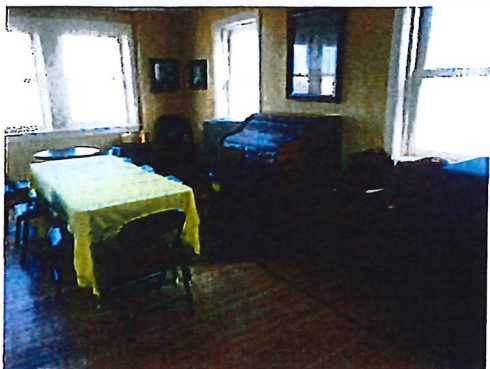
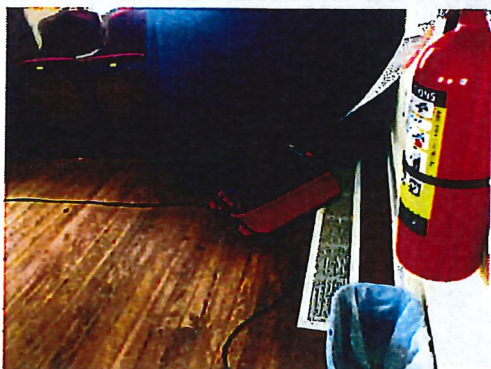
Company/Subcontractor: Industrial Safety Solutions, Inc.
 Subcontractor Rep: Vance Cochran
 Phone Number: 228-217-9629
 Email: Vancecochran@gmail.com
 Recommendation(s): Continue with remediation
 Project Notes: Apartment is chambered with dryers and dehumidifiers removing moisture from the wood floors and drywall.

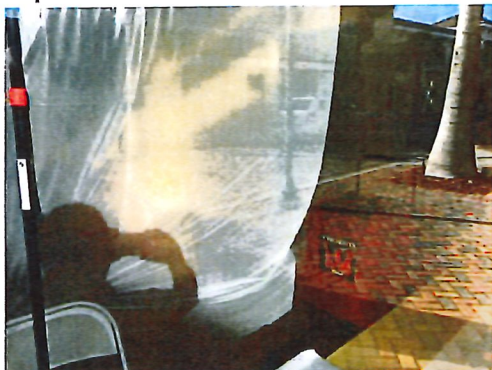
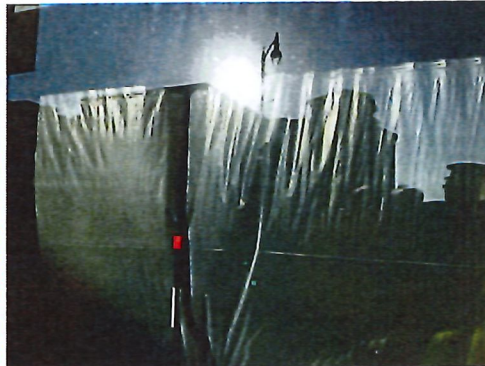
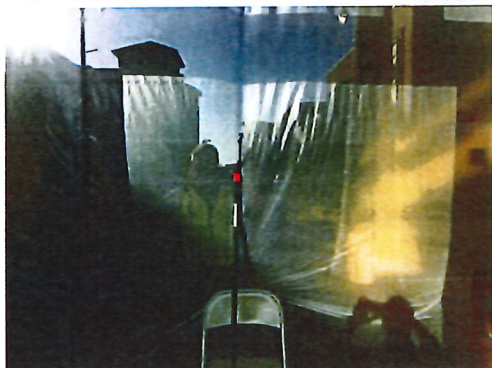
Company/Subcontractor: Industrial Safety Solutions, Inc.
Subcontractor Rep: Vance Cochran
Phone Number: 228-217-9629
Email: Vancecochran@gmail.com
Recommendation(s): Continue with remediation
Project Notes: Dehumidifier continues to remove moisture from the affected area within the chamber.

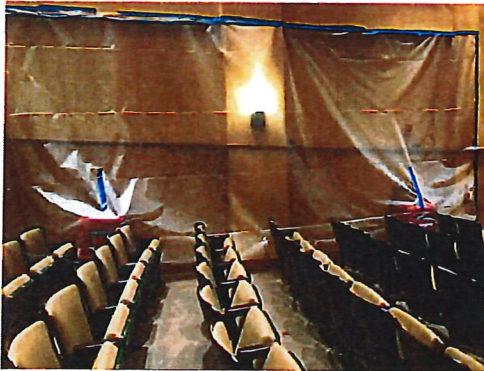
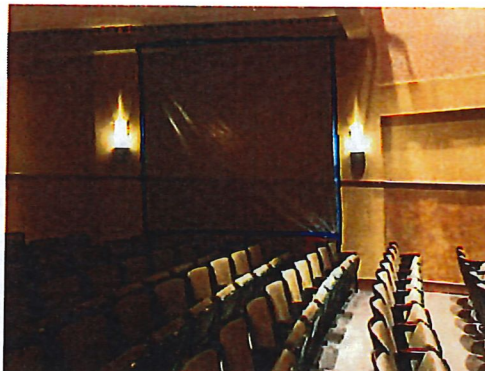
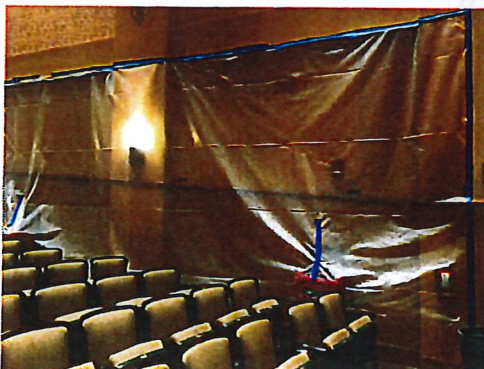
Company/Subcontractor: Industrial Safety Solutions, Inc.
Subcontractor Rep: Vance Cochran
Phone Number: 228-217-9629
Email: Vancecochran@gmail.com
Recommendation(s): Continue with remediation
Project Notes: Dryers and dehumidifiers continue to remove moisture from the affected areas.

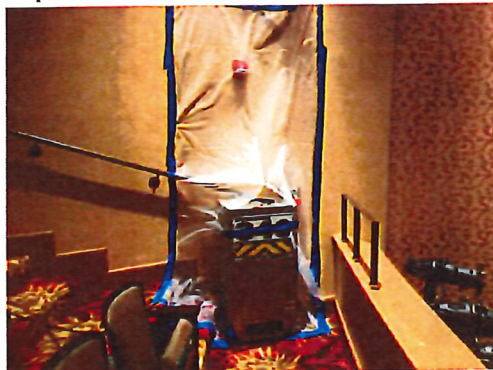
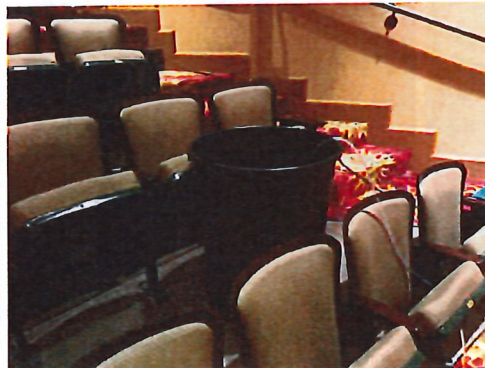
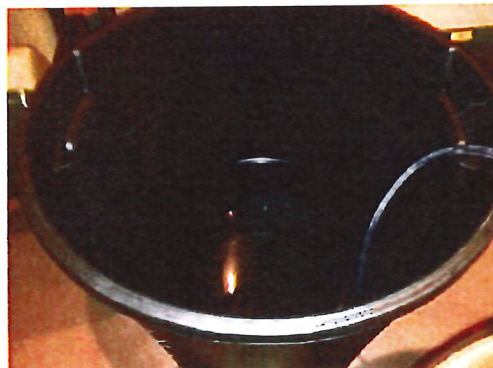
Company/Subcontractor: Industrial Safety Solutions, Inc.
Subcontractor Rep: Vance Cochran
Phone Number: 228-217-9629
Email: Vancecochran@gmail.com
Recommendation(s): Continue with remediation
Project Notes: Dehumidifier continues to run inside the chamber. Moisture is being removed from the drywall

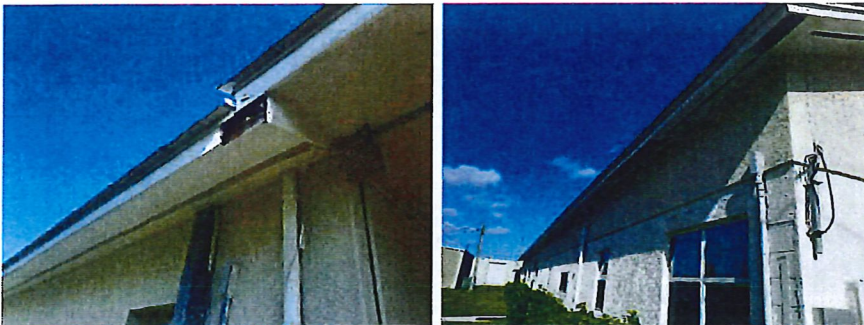
Estimated Damage Amount: Under \$25,000
Damage Notes: Soffit damage
Wind Damage %: 1
Flood Damage %: 0
Other Damage %: 0

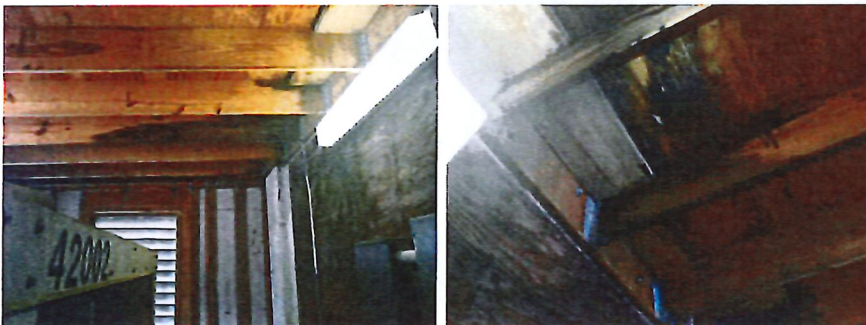
Estimated Damage Amount:
Damage Notes: Screening damage on patio
Emergency Generation room - roof leaking
Wind Damage %: 5
Flood Damage %: 0
Other Damage %: 0

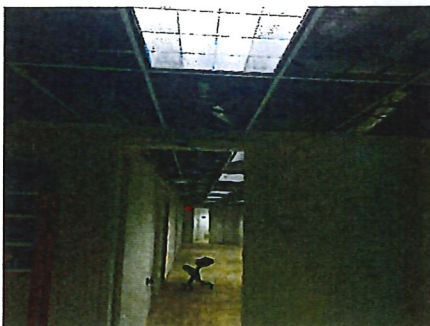
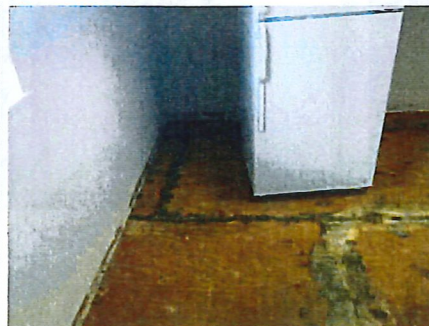
Estimated Damage Amount: \$25,000 - \$50,000
Damage Notes: Total loss of carpet on 1 floor
Total loss of carpet on 2 floor
Total loss of drop ceiling on 2 floor
Drywall damage
Possible electronics damage
Possible wood floor damage
Wind Damage %: 0
Flood Damage %: 60
Other Damage %: 0

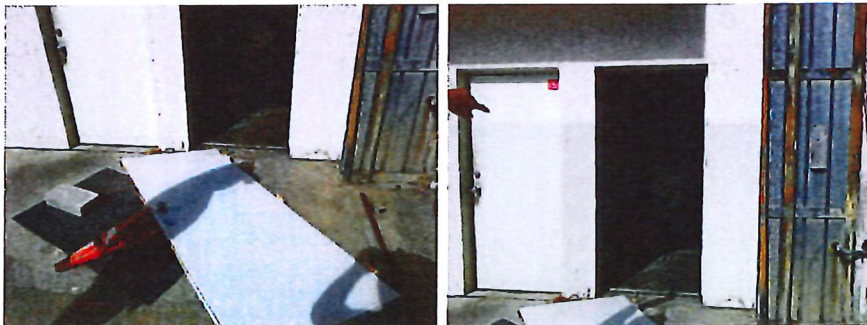
Estimated Damage Amount: Under \$25,000
Damage Notes: Air compressor room door damaged
Wind Damage %: 1
Flood Damage %: 0
Other Damage %: 0

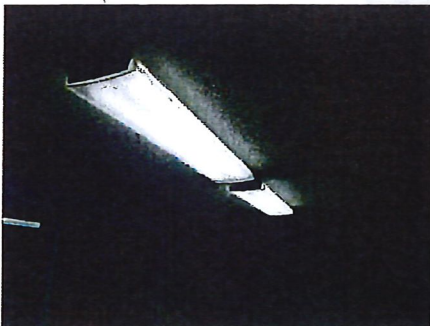
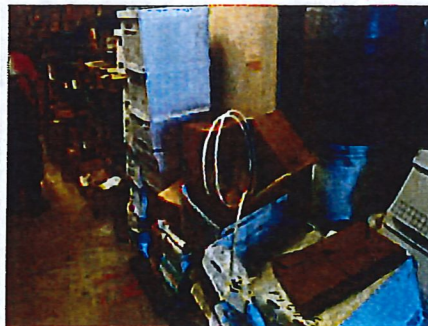
Estimated Damage Amount: Under \$25,000
Damage Notes: Break room lights damaged by water
Store room roof leelaking on record files
Wind Damage %: 5
Flood Damage %: 0
Other Damage %: 0

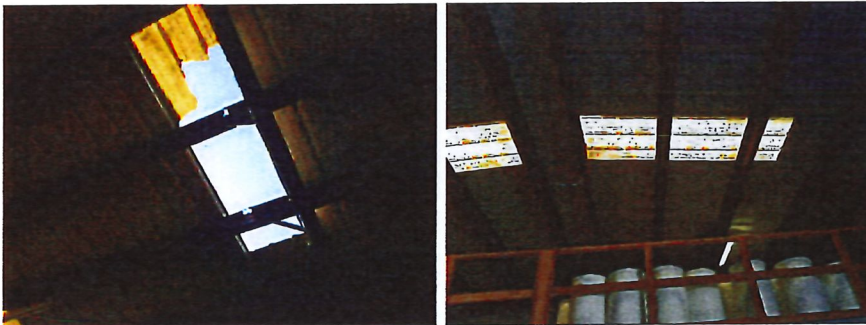
Estimated Damage Amount: Under \$25,000
Damage Notes: Sky lights damage
Water intrusion in storage room from damaged ceiling. Tool room
Wind Damage %: 5
Flood Damage %: 0
Other Damage %: 0

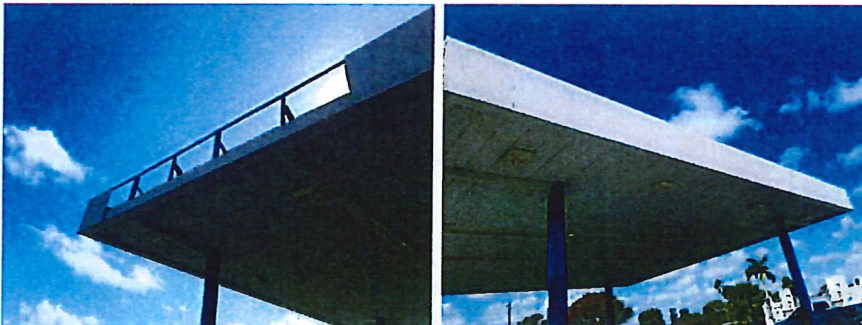
Estimated Damage Amount: Under \$25,000
Damage Notes: Sheet metal damage from wind
Wind Damage %: 5
Flood Damage %: 0
Other Damage %: 0

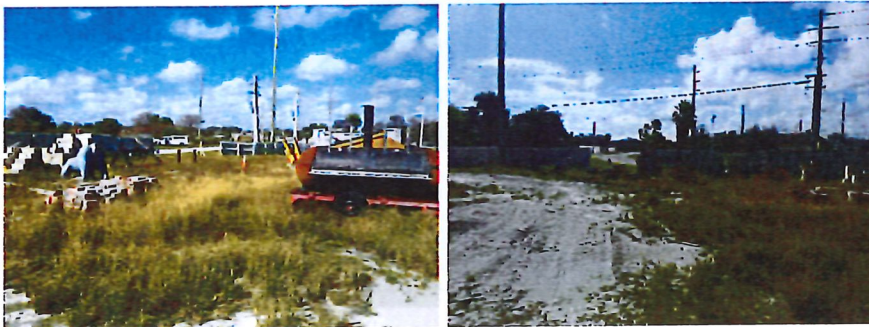
Estimated Damage Amount: \$25,000 - \$50,000
Damage Notes: Fencing damage
Fencing impacted by semi trailer
Wind Damage %: 25
Flood Damage %: 0
Other Damage %: 0

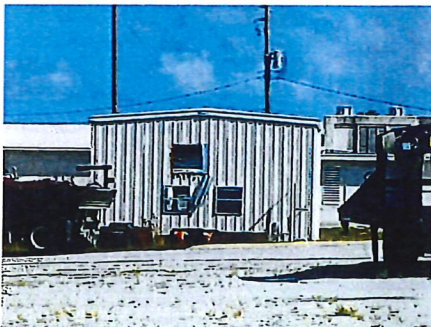
Estimated Damage Amount: Under \$25,000
Damage Notes: Exhaust fan damaged
Wind Damage %: 5
Flood Damage %: 0
Other Damage %: 0

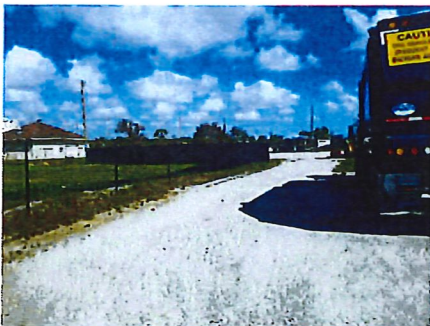
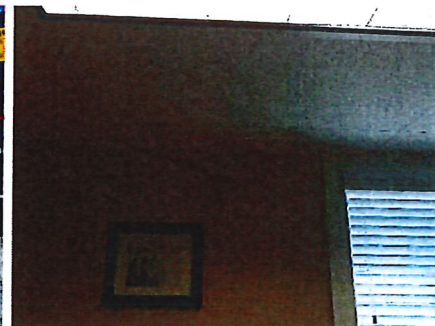
Estimated Damage Amount: Under \$25,000
Damage Notes: 100 yrd of vinyl fencing
Water damage. - on wall near window
Soffit damage
Wind Damage %: 5
Flood Damage %: 0
Other Damage %: 0
