COA 17-38

1313 Delaware Ave

Consideration of an approval for the replacement of the metal shingle roof with 5V Crimp metal roof (up to half of the main roof, east side only).

HISTORIC PRESERVATION BOARD : PUBLIC HEARING

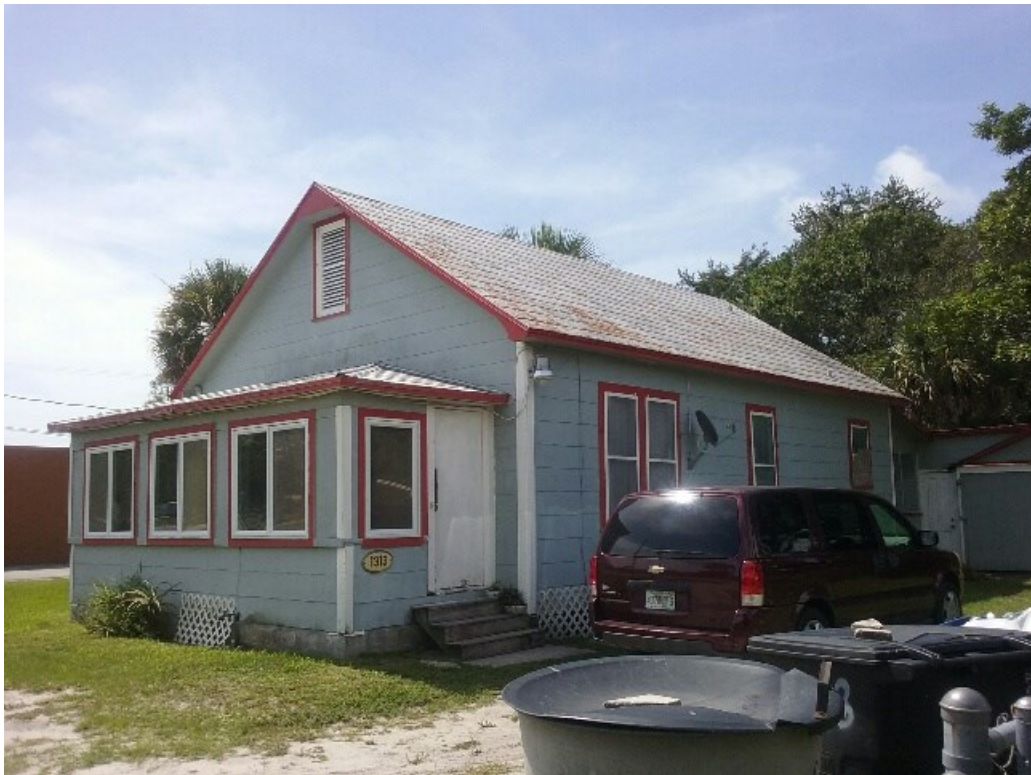
West Façade

This Frame Vernacular structure retains the form, massing and most of the original architectural features. This wood frame structure sits on concrete piers. The wood 1/1 windows are original. Original wood clapboard siding is underneath the asbestos siding. Metal awnings were added later. The front gable end porch with hip roof has been enclosed with 1-light casement style windows. This building is a good example of historic styles built during the 1920's in Fort Pierce.

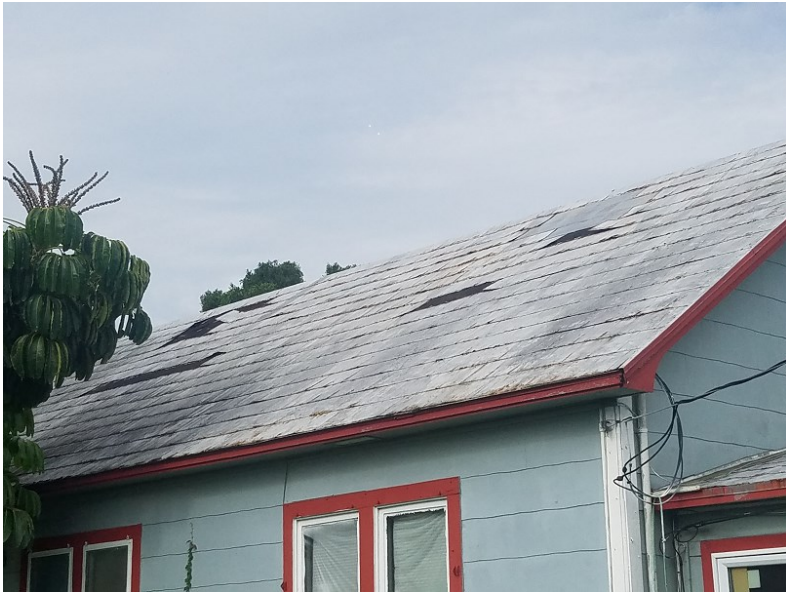
East side roof to be replaced

Identifying, retaining, and preserving roof materials is extremely important in defining a building's overall historic character especially for individually designated structures. The submitted request conflicts with Secretary of Interior Standards 2, 5, & 6 as it seeks to remove distinct features and materials from the historic structure and replace with different design, texture, and material. However, if the board decides that existing tiles are damaged or deteriorated to a point which necessitates replacement, staff recommends that the Board approve replacement of the roof with the condition that the replacement match the existing in design, texture, color, and material.

If the Board decides to approve 5-V metal panels as proposed replacement material, staff recommends it will be installed on the entire roof, not just on the east side of the structure.
