Certificate of Substantial Completion

PROJECT: Construction of Parking Lot at San Carlos CRC and Sunflower Park

**Re: Construction Punch List for:
C-16-115-04-05 / Construction of Parking Lot at San Carlos CRC and Sunflower Park
Hidalgo County Precinct No. 4
LEMC No. P-159**

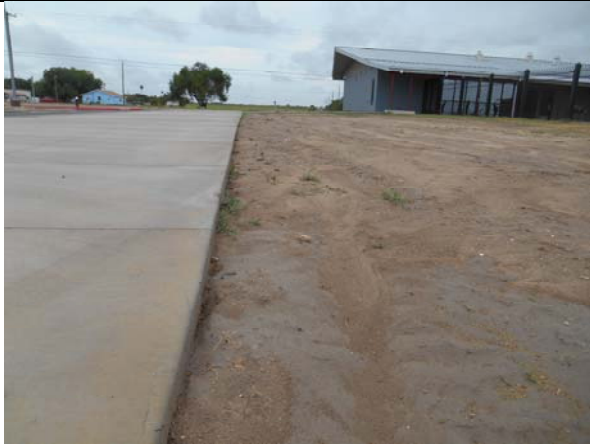
Photo 1

- Backfill on west side of concrete sidewalk (see photo 1).
- Fix concrete cracks at dumpster pad (see photo 2).
- The steel columns at the dumpster pad do not have concrete all around (see photo 3).

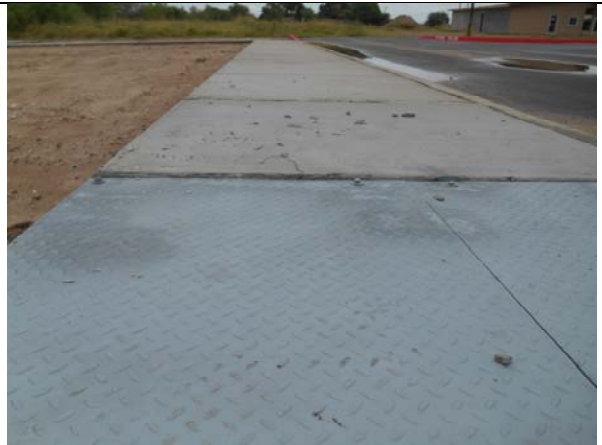
Photo 4

- The concrete sidewalk flume steel plate has a tripping hazard. The wrong bolts were installed as well as the steel plate not being flush with the sidewalk. This needs to be revised (see photo 4) as per Detail 16 on Sheet 2.11.

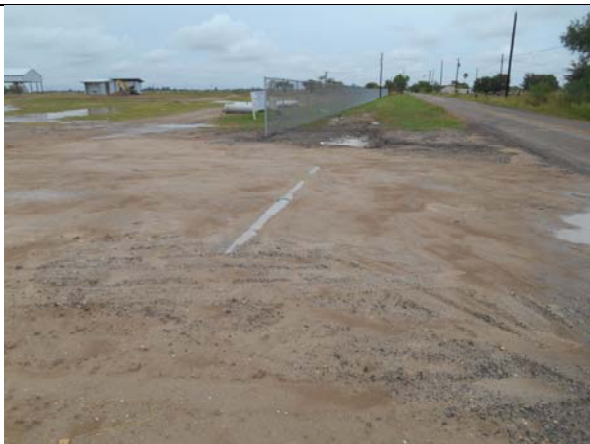
Photo 5

- The concrete culvert is exposed, and needs to be backfilled properly to avoid it from being damaged (see photo 5).
- The Light Pole wrapping needs to be removed (see photo 6)

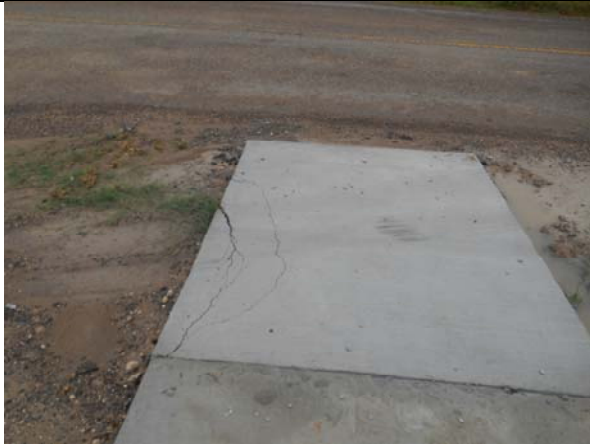
Photo 7

- There is a concrete sidewalk and curb that are damaged, and these cracks need to be repaired.
- The northern portion of the parking lot has excessive ponding, and a remedy is necessary to avoid ponding that may cause failure to the parking lot in the future (see photo 7 & 8). Perhaps a second concrete sidewalk flume can be installed to get the water into the green area.
