# **DRAFT FEASIBILITY REPORT**

## **ALPINE DRIVE RECONSTRUCTION**

### **CITY IMPROVEMENT PROJECT NO. 17-01**

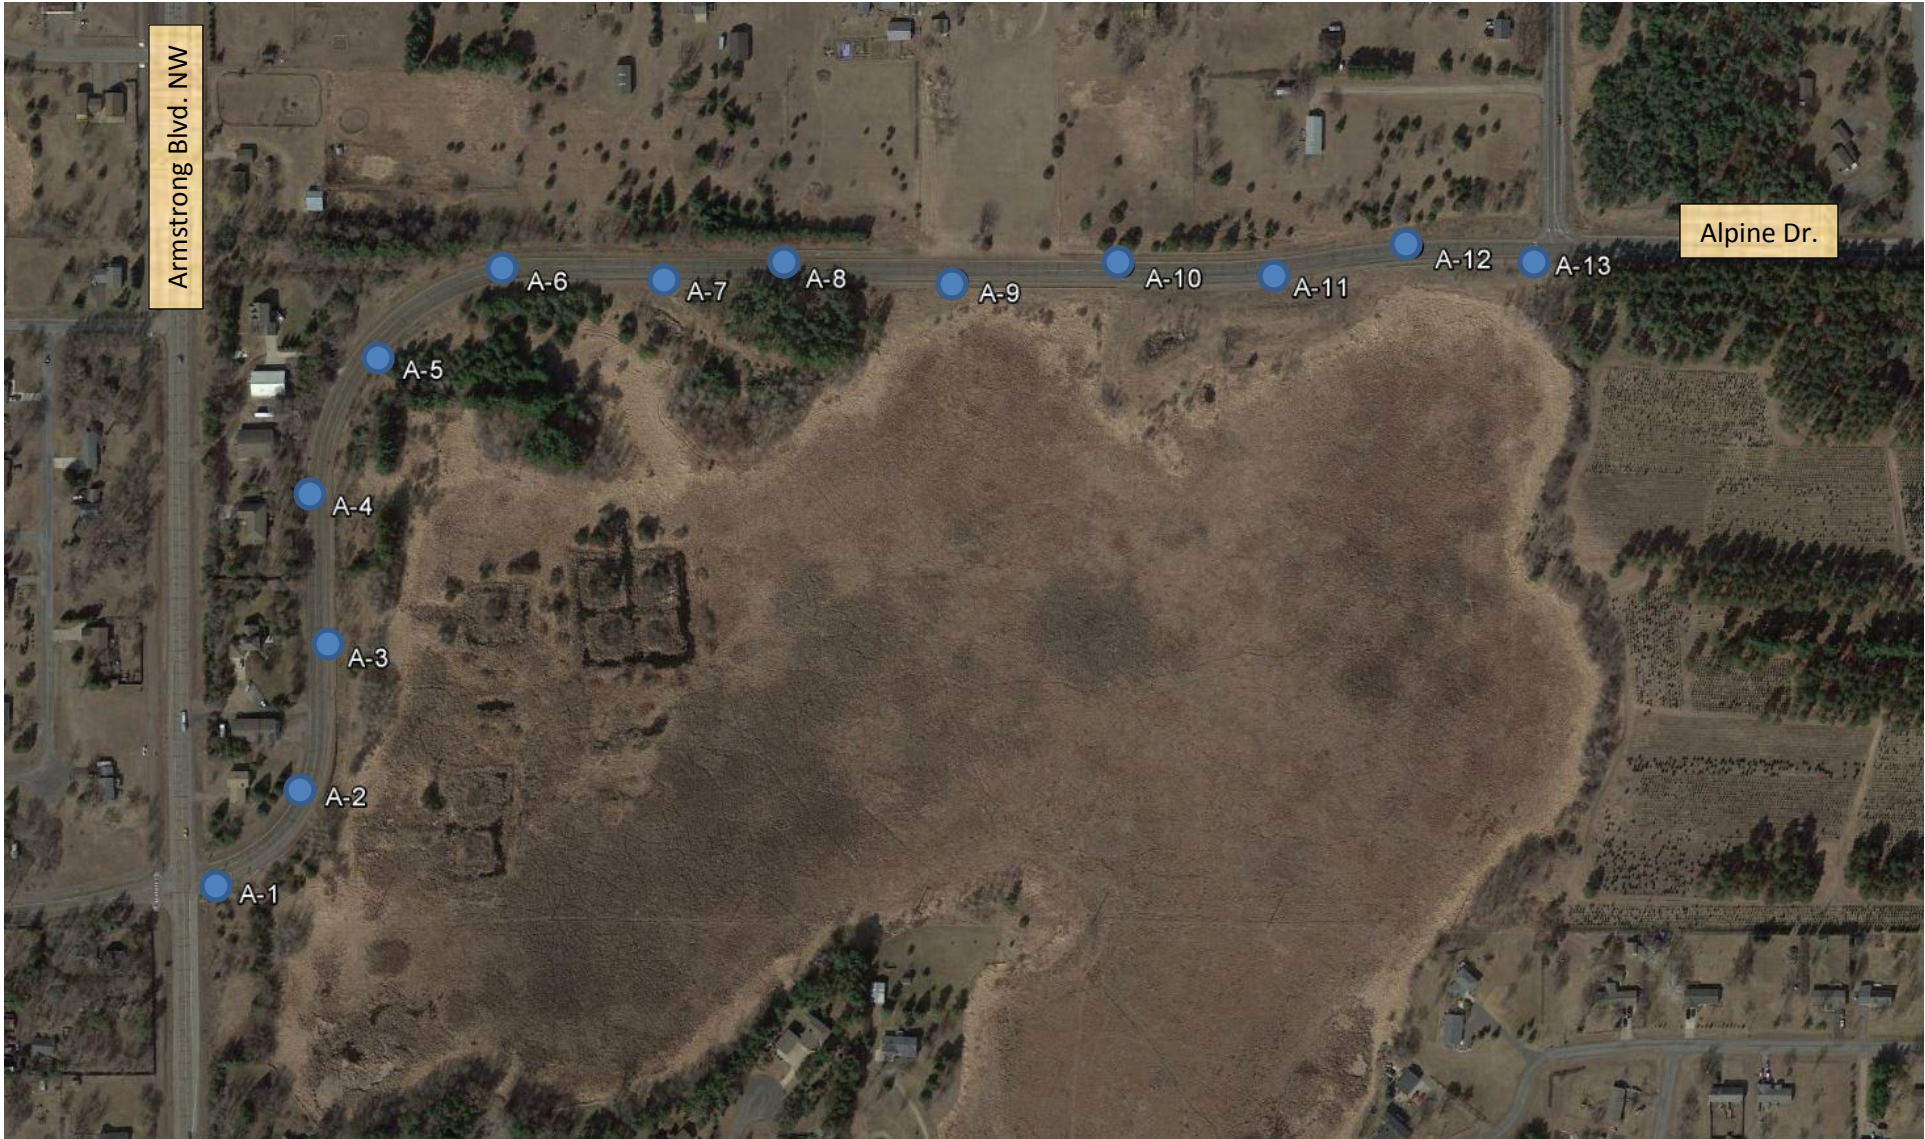
Boring Location Diagram  
Alpine and Sunwood Drive – Street Improvements – Alpine Drive  
Ramsey, Minnesota  
NTI Project #: 16.61770.100

Completed Soil Borings: ●

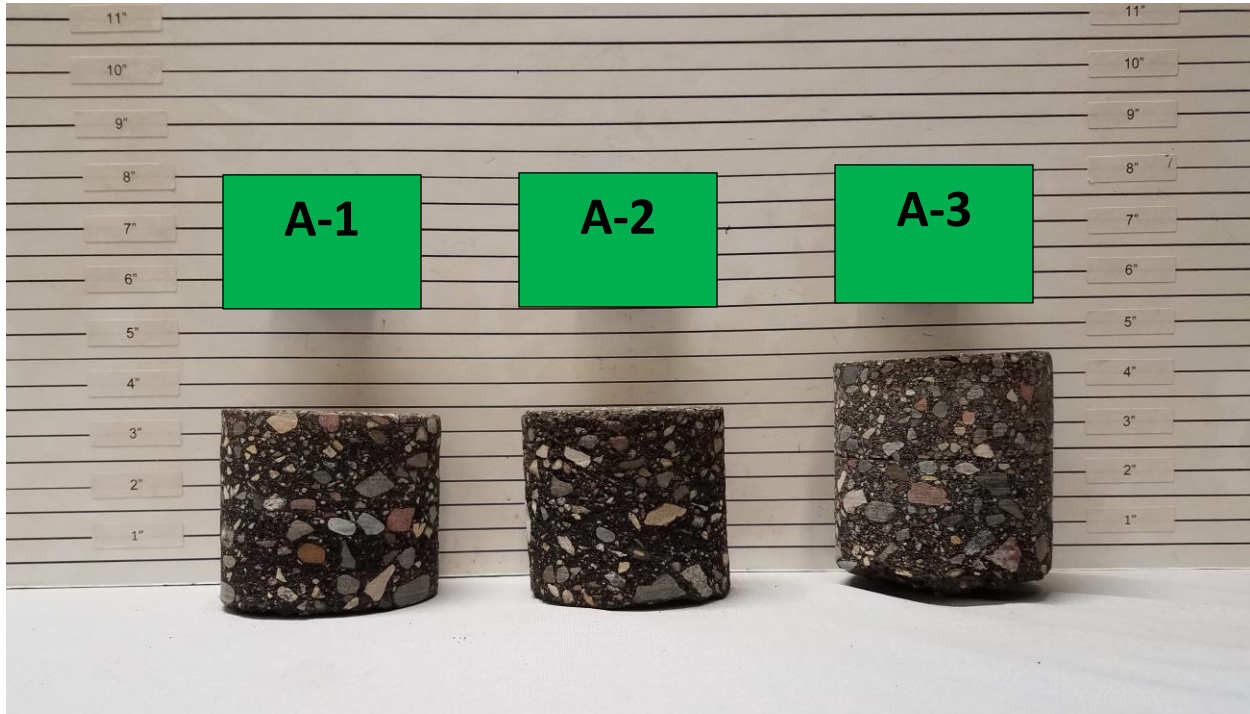
Bituminous Pavement Cores, A-1: 3 ½ Inches, A-2: 3 ½ Inches, A-3: 4 ½ Inches.

Bituminous pavement thickness within this roadway area ranged from approximately 3.5 to 5.0 inches at the boring locations. Apparent aggregate base was not observed at the majority of the borings. As exceptions, apparent aggregate base was observed at Boring A-2, A-4, A-5, A-7, and A-10 locations and varied in thickness from approximately 2.5 to 24.0 inches. Occasional cobbles and hard drilling conditions were encountered at Boring A-6, A-7, A-9, A-10, A-12 and A-13 locations.

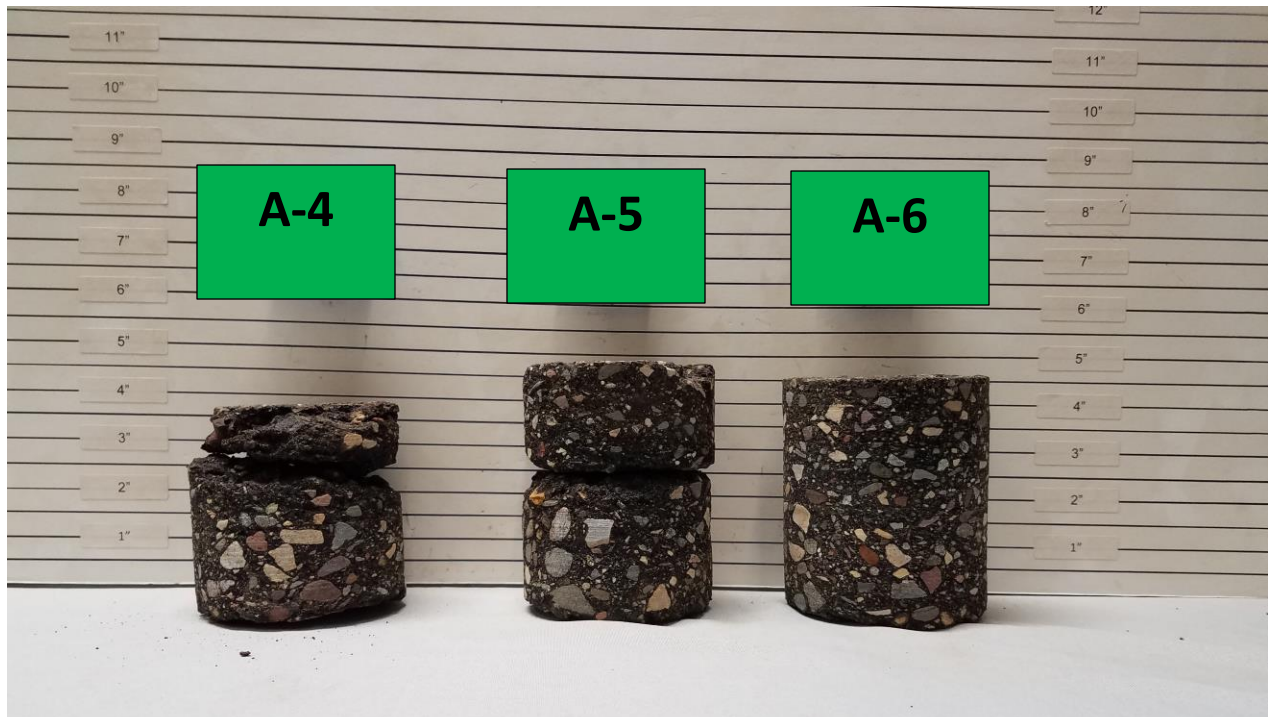
Bituminous Pavement Cores, A-4: 3 ¾ Inches\*, A-5: 4 ¾ Inches\*, A-6: 4 ½ Inches.

\*Core height not representative due to crumbling during coring process.

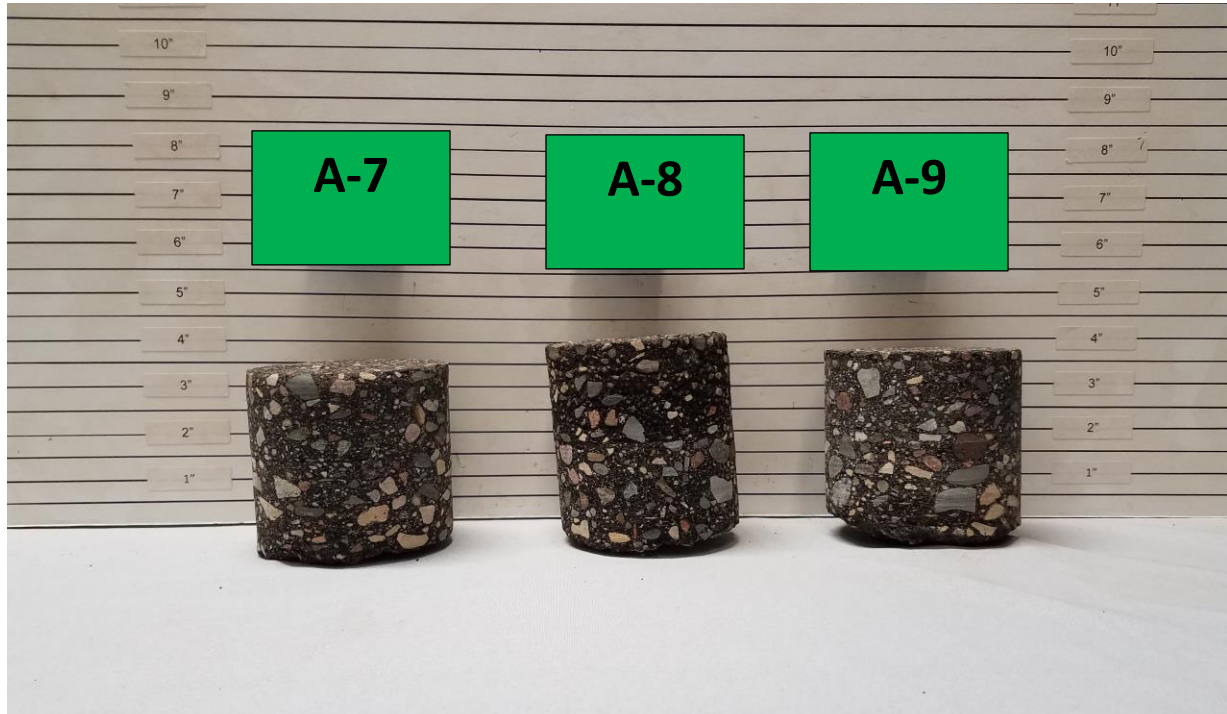
Bituminous Pavement Cores, A-7: 3 ¾ Inches, A-8: 4 Inches, A-9: 3 ¾ Inches.

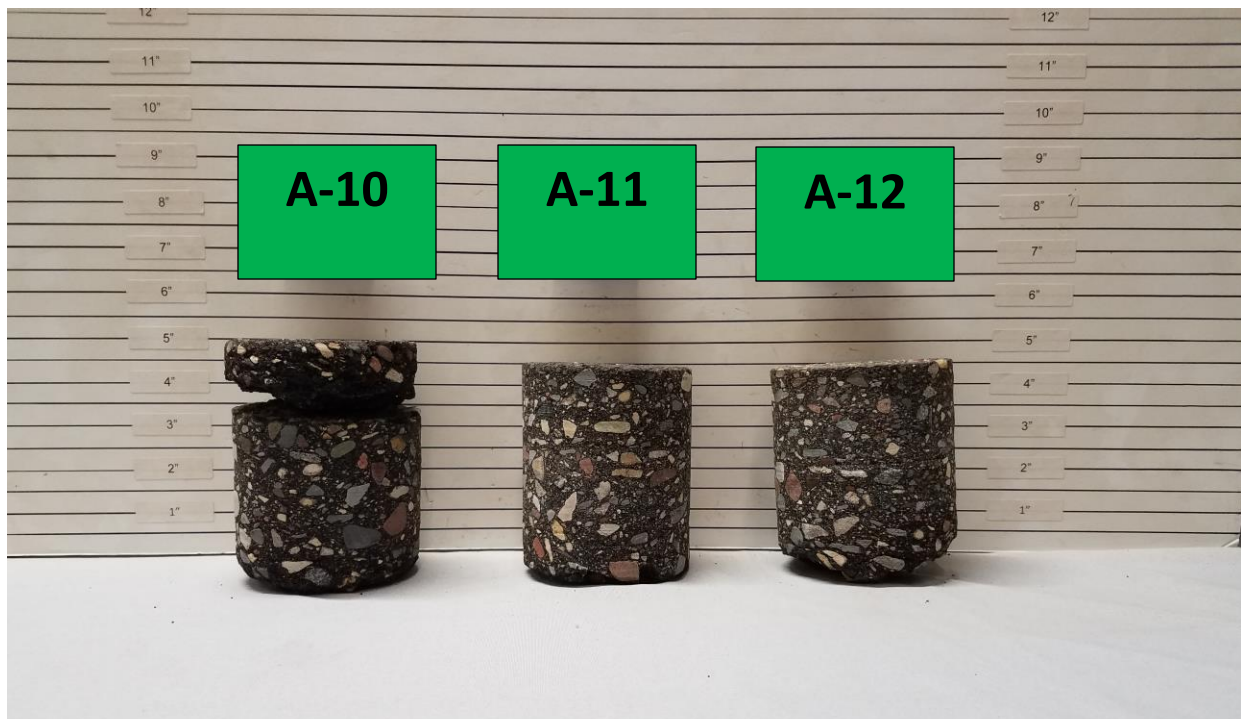
Bituminous Pavement Cores, A-10: 5 Inches\*, A-11: 4 ½ Inches, A-12: 4 ½ Inches.

\*Core height not representative due to crumbling during coring process.

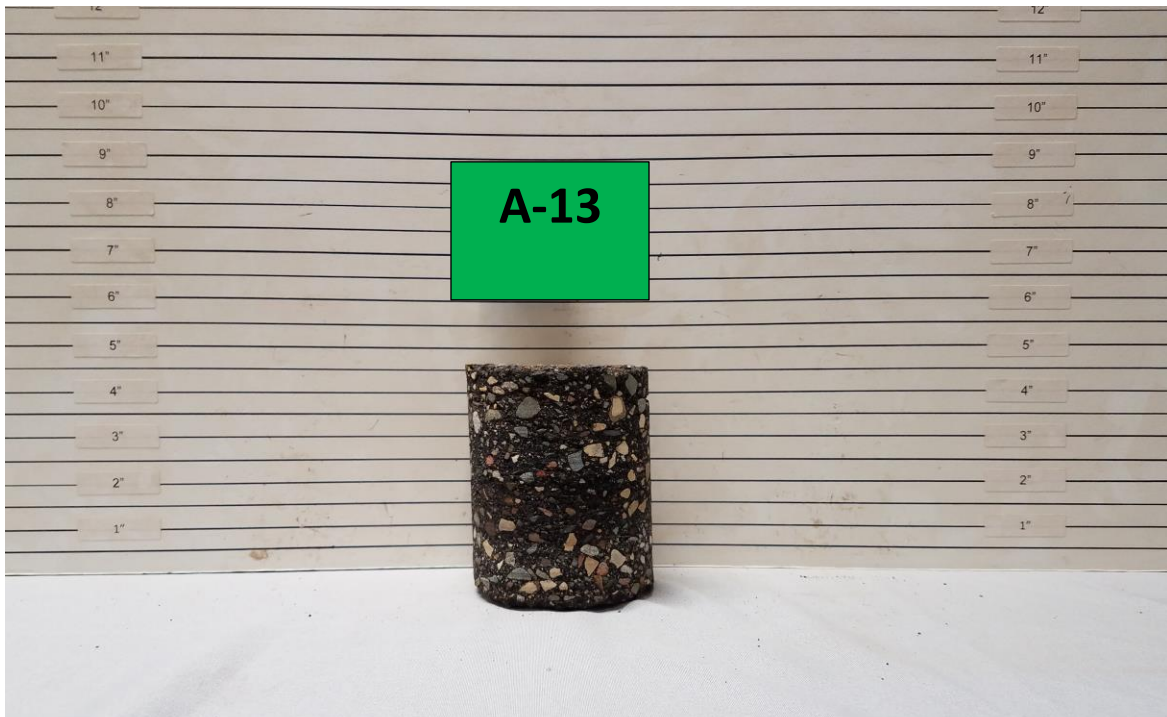
Bituminous Pavement Cores, A-13: 4 ¾ Inches.
