***Interim* Playground Replacement Policy**

City of Ramsey, Minnesota

Adopted: x/x/2021

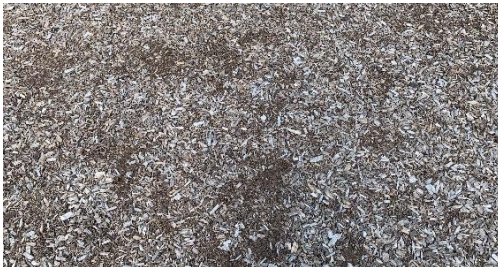
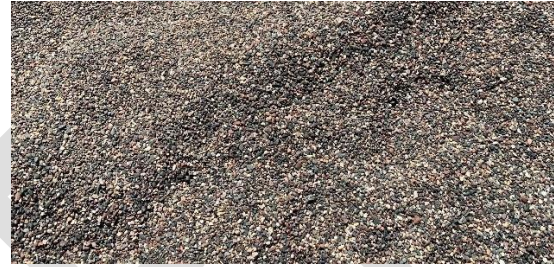
The city of Ramsey primarily uses two different types of surfaces for its playgrounds—engineered wood fiber (known colloquially as wood chips) and pea gravel (reused seal coating rock). Both surfaces are considered safe as long as kept at a depth of at least twelve inches, though pea gravel may have concerns due to its shape, making it desirable for children to put in their mouth or take home with them. Additionally, the surfaces—as well as rubber mulch—are desirable due to low upfront installation costs (with pea gravel being the cheapest), but require regular maintenance (raking and levelling to maintain a proper depth for cushioning falls but still remaining accessible) and need to be replaced roughly every five years. Funding for surface replacement could be from the Lawful Gambling Fund, instead of the General Fund as has been the case.

Figures 3-4: (left to right) engineered wood fiber (EWP); pea gravel

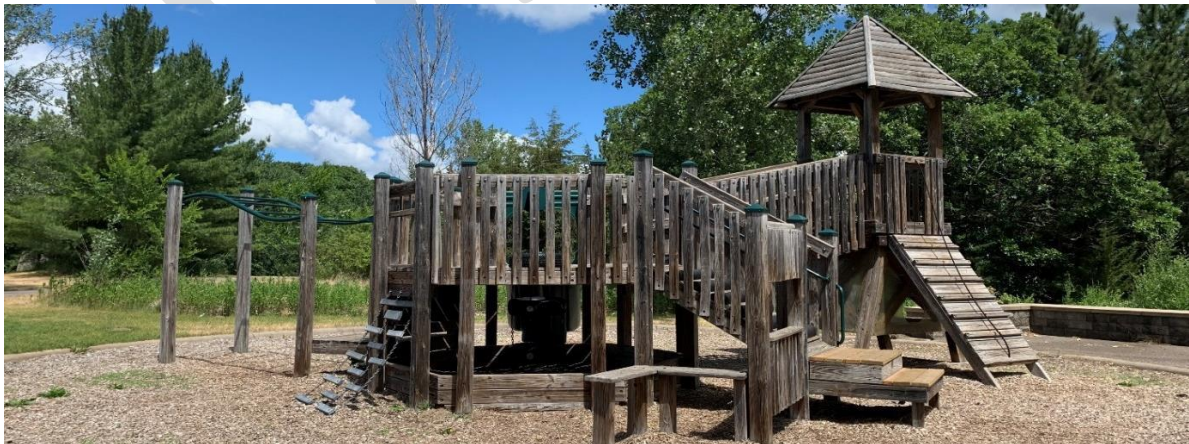
Figure 20: Alpine Park Playground

There are five means of entry—the aforementioned transfer surface and ladder, a wooden staircase, a chain link ladder (with four parallel chains) with metal footings, a chain link ladder on the interior of the structure which three rubber tires serving as steps, and a wooden climbing wall (sloped roughly 60 degrees with the ground) with six wooden steps and a rope for balance. The bottom of the climbing wall is worn, likely due to use as an additional step. The protective covering on the rope is worn and the metal inside of the rope is exposed in places. The rope has also been stretched considerably.

The entire surface of the structure is wooden with the exception of a bridge, which has a rubber mat for a surface. The bridge is sloped slightly (less than 15 degrees) from one end to the other, however there are four peaks on the rubber surface with thin wooden planks on top. The rubber surface is somewhat worn and there are cross slopes in some places that are unrelated to the design. The chains for both ladders are in fairly good condition. The wood throughout the structure ranges from okay to poor condition visually. The wood on the supports for the tallest portion of the structure (i.e. the area with the wooden climbing wall) is in the poorest condition with several of the planks making up horizontal and diagonal supports being splintered. The playground also has talk tubes (metal megaphone toys through which children may communicate with one another through opposite ends), which are both in good working condition.

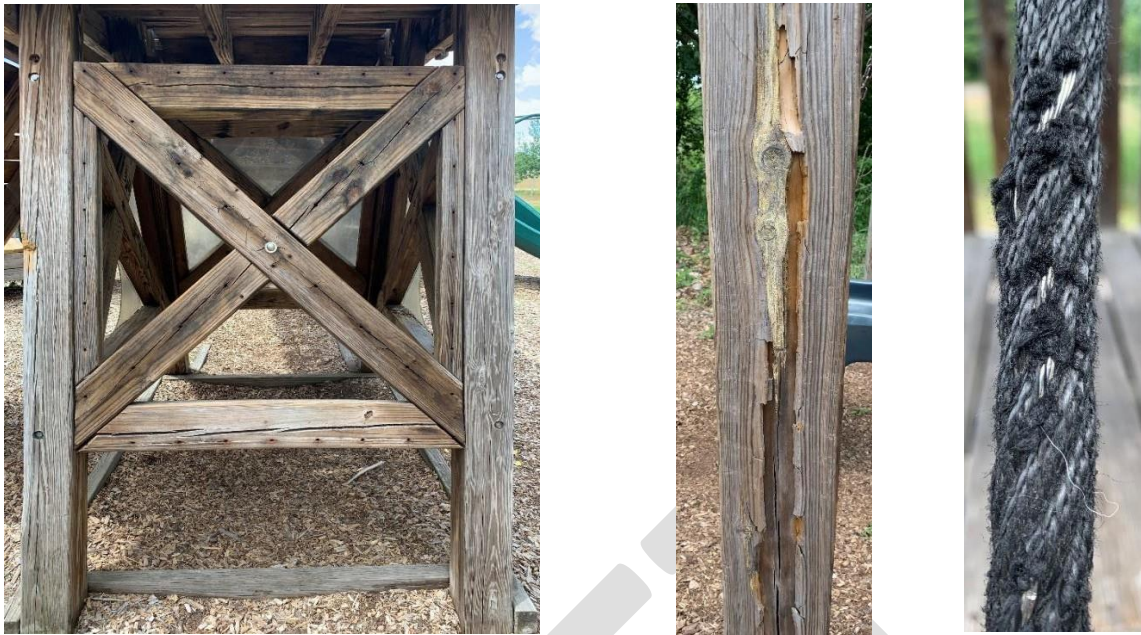
Figures 21-23: (from left to right) Splintered wood on horizontal and diagonal supports; Splintered wood on support for swing set; Worn rope on climbing wall

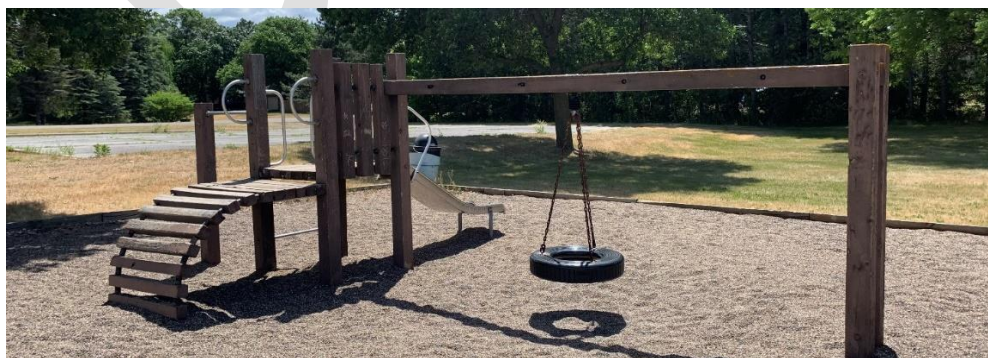
Figure 24: Autumn Heights Park Playground

The playground consists of a single wooden play structure with a tire swing and a metal pull-up bar. The tire itself is in good condition, but the chain it is attached to is fairly rusted and worn. The top surface of the play structure consists of five parallel wooden planks, all of which are fairly loose (with the exception of the second-to-rightmost plank). There are two means of entry, neither of which are ADA-compliant. One is a ladder with two metal bars serving as steps. The other is a curved surface with narrow gaps for footholds, comprised of eight wooden planks, all of which are fully attached. The flat surface between this surface and the top surface (which is three inches above this surface) is comprised of six wooden planks (none of which are fully secured) perpendicular to those on the top surface and parallel to those on the curved surface. There is a single straight metal slide, which is in fair condition, (however it is South facing, which is not desirable).

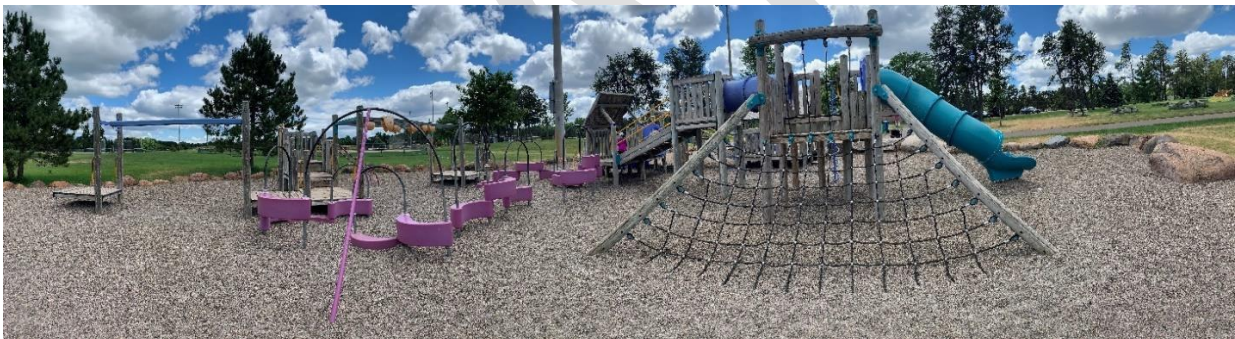
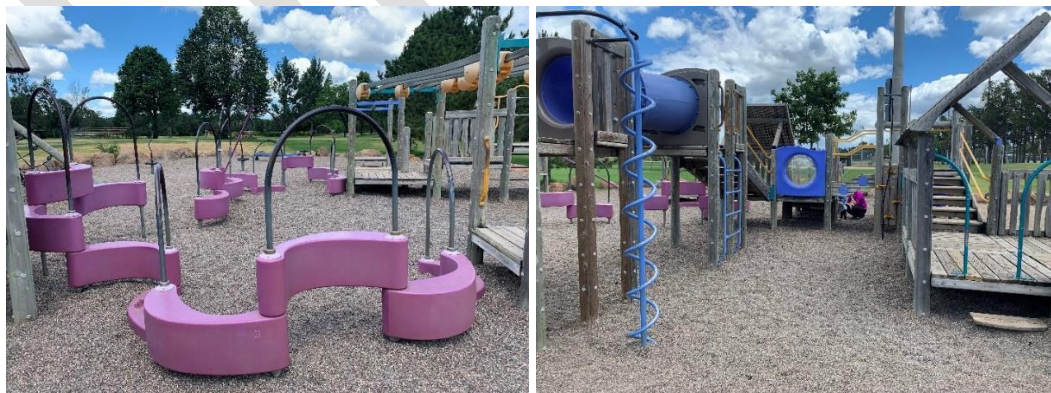
The structure is largely wooden, but there are multiple plastic and metal components as well, such as two plastic slides—one enclosed and one open with three parallel tracks—and a plastic tunnel. The wood is in fair condition, but is exhibiting some wear and tear. There are two track-rides, one straight with a single track and one curved with five parallel tracks. The grip for the first track-ride is metal, with chipped paint, and the grips for the latter are plastic and are in good condition, albeit with slightly faded paint.

Linking the two track-rides is a series of four wooden transfer platforms. The topmost platform is accessible via a metal chain-link ladder as well as two parallel metal bars for climbing. Linking the track-rides and transfer platform between them with the rest of the playground structure is a series of seventeen arched plastic platforms. Additional means of entry include a rope climbing wall, metal ladder, a wooden climbing wall with a rope, a step with handrails for accessing a transfer platform, a corkscrew climber, and a wooden ramp.

Additional playground features include two playground excavator toys, two spinners, and a balance beam. Overall, the playground is in fair condition, but the wooden components are worth monitoring.

Figure 25: Central Park Playground wide shot; **Figures 26-27:** (left to right) seventeen curved platforms; several means of entry, including a metal ladder, a wooden climbing wall with a rope, a corkscrew climber, and a step with handrails

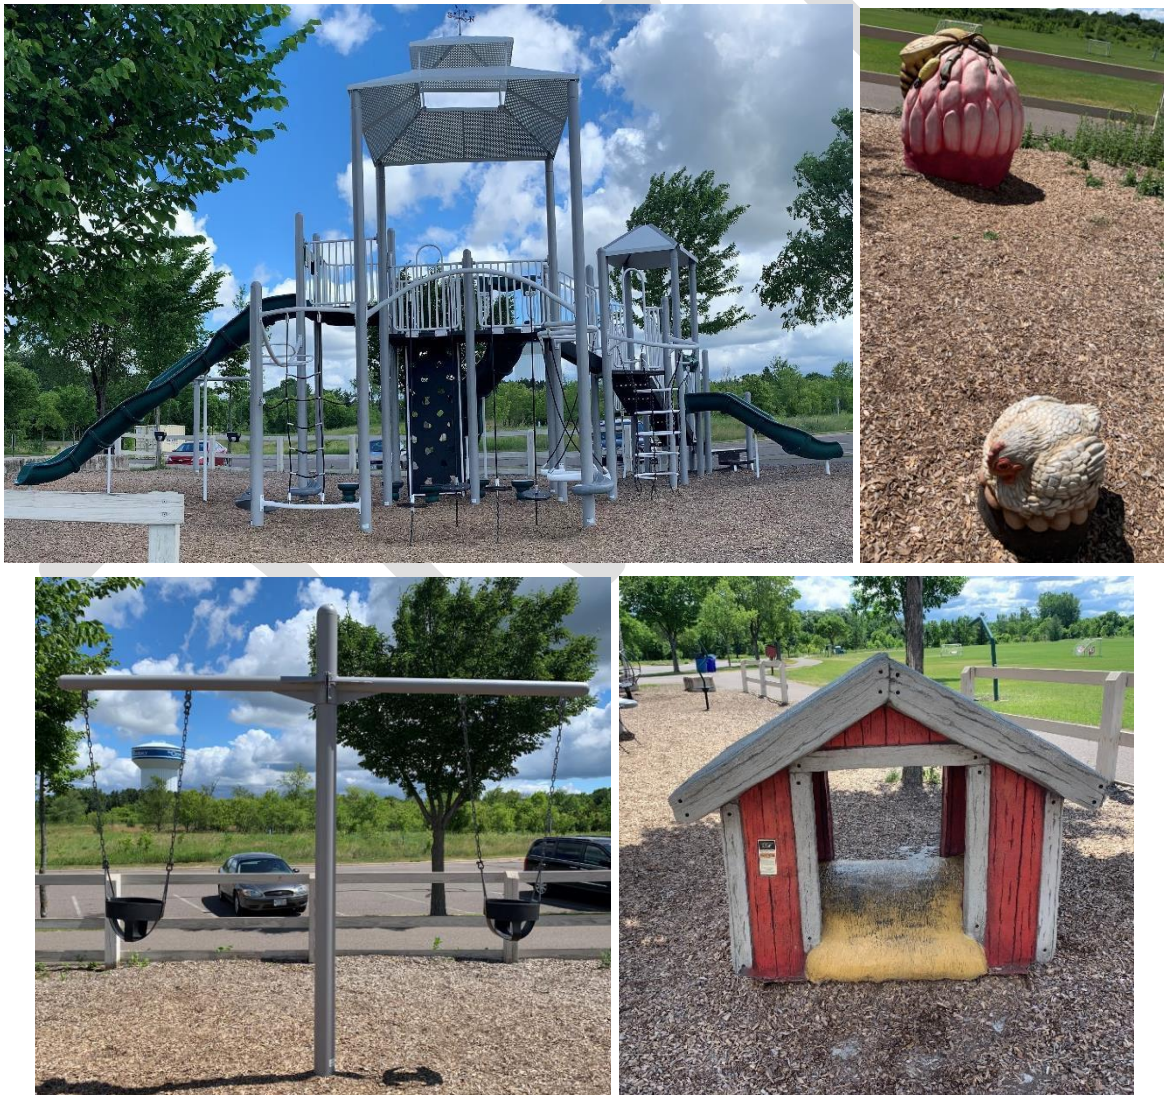
The farm-themed playground features a main playground structure, a swing set with two bucket swings, a play barn, two spinners (one globe spinner), two chicken sculptures and one bee sculpture for climbing. The main play structure contains an obstacle course with a rope ladder, four angled platforms secured into the ground by a chain, a curved metal bar with four ropes crossing one another for balancing, a set of inclined monkey bars comprised of three rings forming six handholds, and five stepping pods. Additionally, the playground has three zigzagging slides and five means of entry—one transfer surface, two platforms forming a quasi-staircase, a ladder consisting of three platforms, an enclosed chain-link ladder with five metal semicircular footholds, and a climbing wall with slots cut out for footholds. All components of the playground are in excellent condition.

Figures 28-31: (clockwise from the top left) main play structure; chicken sculpture, bee and fruit sculpture; swing set with bucket swings; play barn

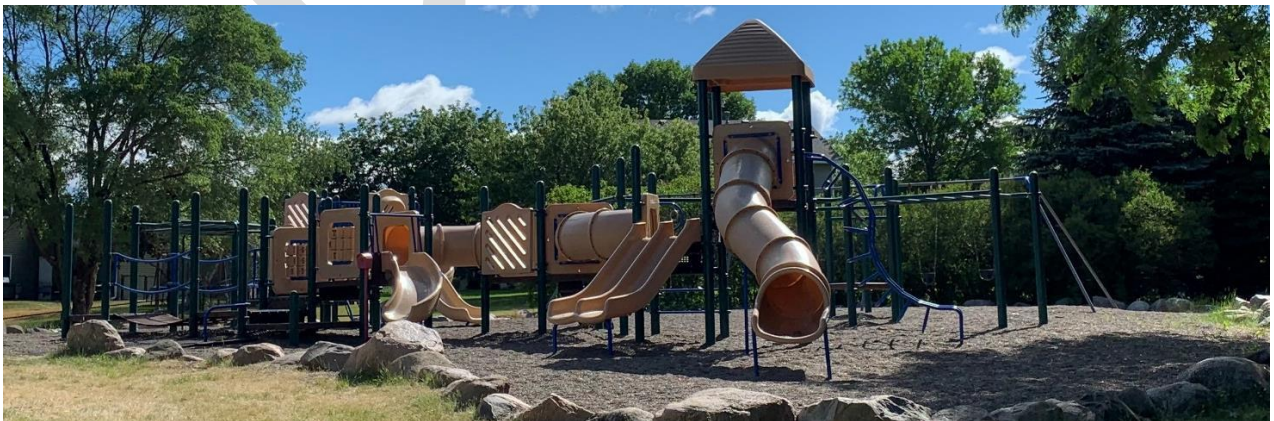
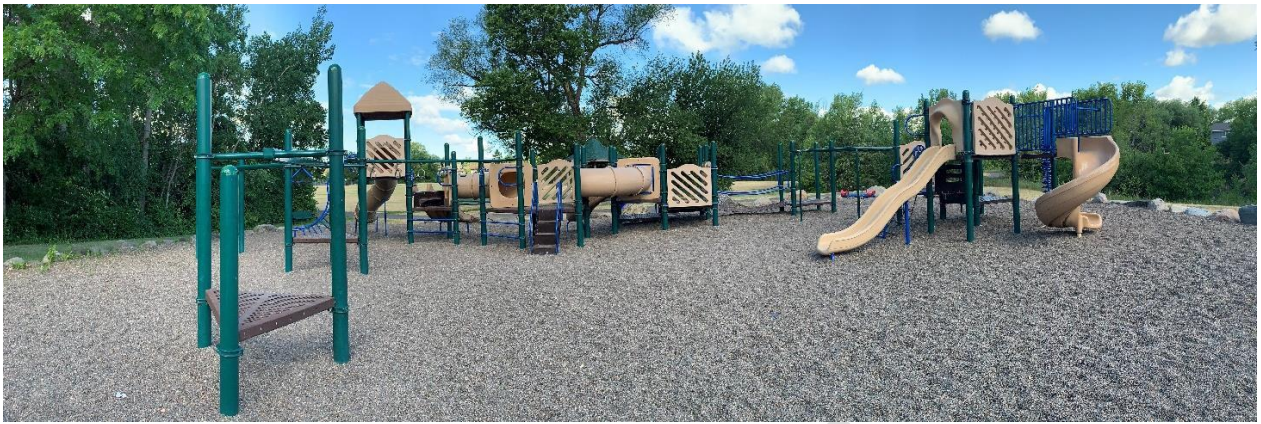
Emerald Pond Park consists of three components—a seesaw spring rider, a swing set, and a large composite play structure. The seesaw is fairly worn, with paint chipped and metal beginning to rust in some places, but it is still functional. The swing set is mostly in good condition, albeit with some of the chains exhibiting rust. The swing set consists of three bays, two with two belt swings each, and the third with two bucket swings.

Additionally, it features five slides—one short straight slide with two parallel tracks, one straight slide with a single hump in the middle, one short curved slide rotating 90 degrees, one curved slide rotating 360 degrees, and one enclosed zig-zagging slide. The enclosed slide has drainage issues, with water occasionally pooling at the bottom, but this does not pose a safety issue. All of the slides are in good condition otherwise. The other plastic components—two tunnels, two interactive sensory components with 3 x 3 rotatable blocks with letters on them, most of the guardrails, and a roof—are in good condition.

Figure 32: Emerald Pond Park Playground (looking northeast)

Figure 33: Emerald Pond Park Playground (looking west)

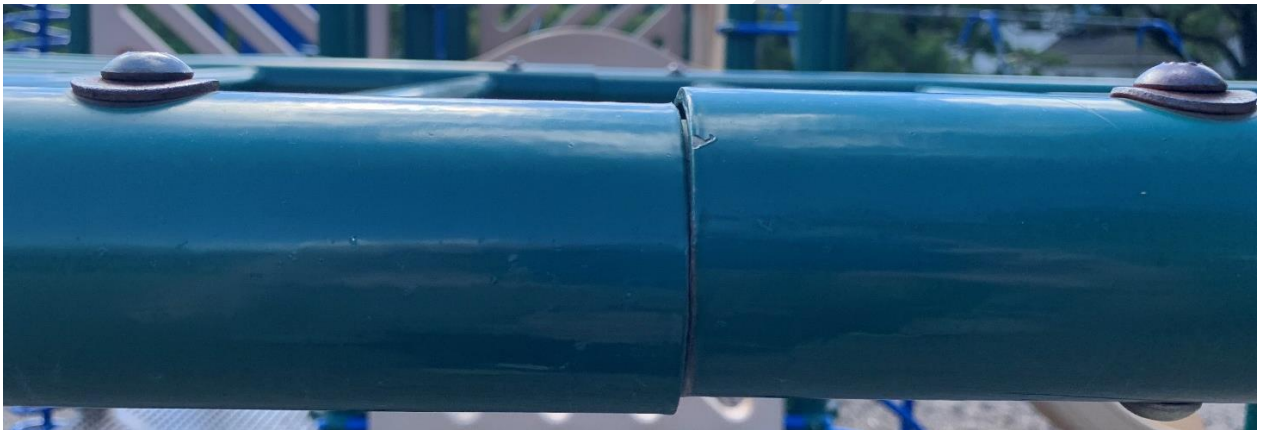
Adjacent to the clatter bridge is a set of flat monkey bars with a curved path. Two of the metal shafts in adjacent sections of the monkey bar structure are not completely flush, which is not a safety issue in and of itself, but should be repaired outside of a full playground replacement. On the opposite side of the playground structure, there are two sets of monkey bars as well as a track-ride, linked together by a triangular transfer platform. One of the sets has flat bars while the other has six rings suspended by short chains, the latter linking the former as well as the track-ride with the rest of the play structure.

Figure 34: Section of monkey bars misaligned

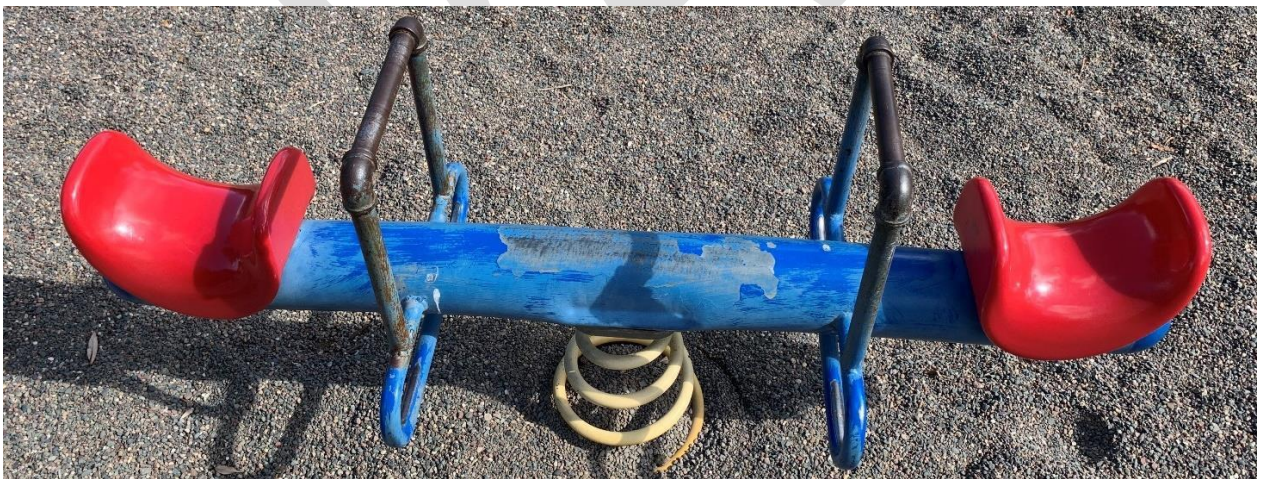
Figure 35: Seesaw spring-rider

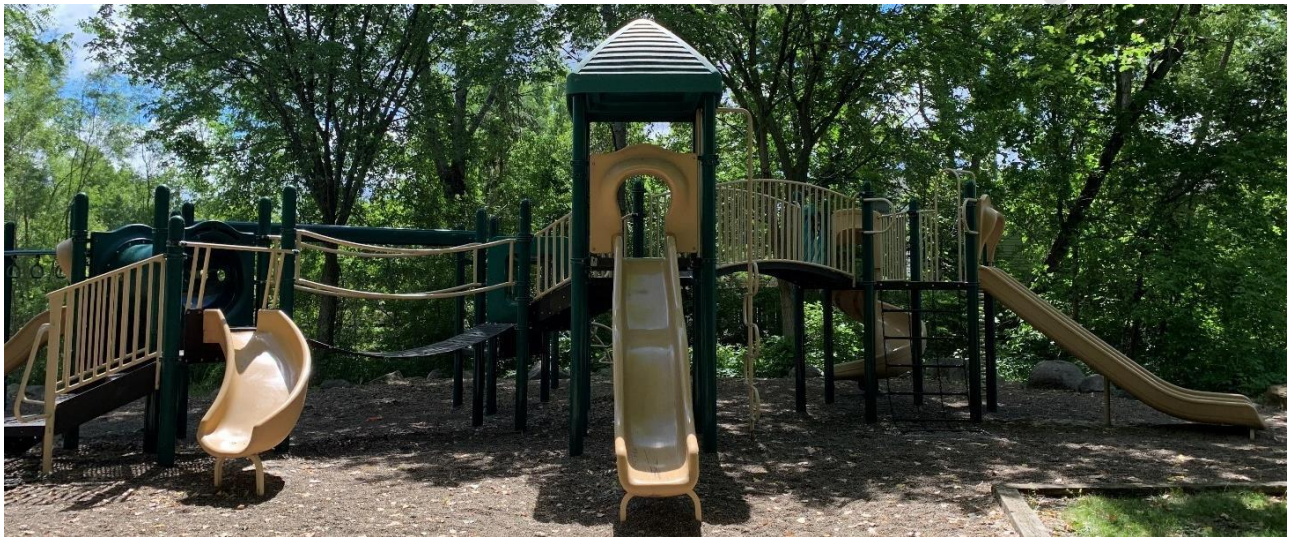
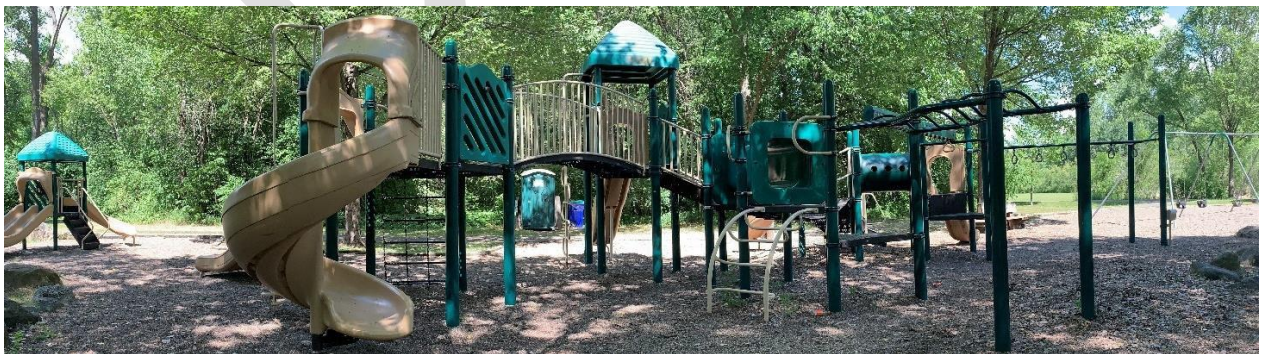
Figures 36-37: Flintwood Terrace Park Playground (looking east and west, respectively)

The playground consists of three components—a swing set, a small play set, and a large play set. The swing set has three bays—two with two belt swings each, and one with two bucket swings. The small play set has two slides—one straight with two parallel tracks and one curved 90 degrees—as well as a staircase and two opposing handrails for entering the structure.

There are five different ways one can enter the main structure—a staircase, a metal ladder with five alternating semicircular rungs forming ten footholds, a curved metal ladder with four semi-rectangular rungs, a chain-link ladder with six rungs, and a corkscrew climber. The main play set has five slides—a straight slide, a straight slide with a hump, a straight slide with two parallel tracks, a curved slide rotating 90 degrees and a curved slide rotating 360 degrees. Linking the different elements of the structure are two bridges—a clatter bridge and a belt bridge—and a plastic tunnel. Additionally, there is a track-ride and two sets of monkey bars. One set of monkey bars has seven upwardly curving bars, while the other has seven rings suspended by chains. Overall, the playground is in great condition.

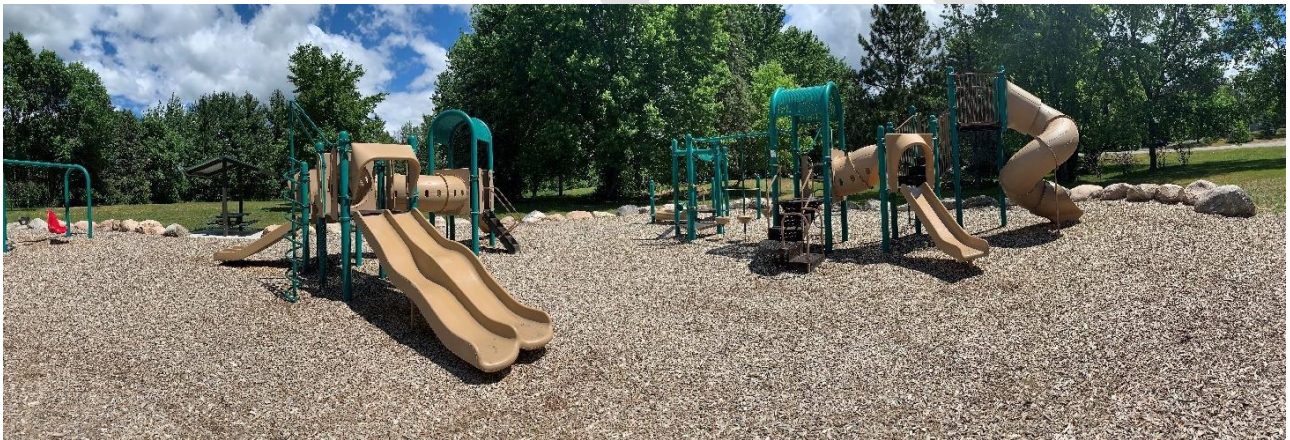
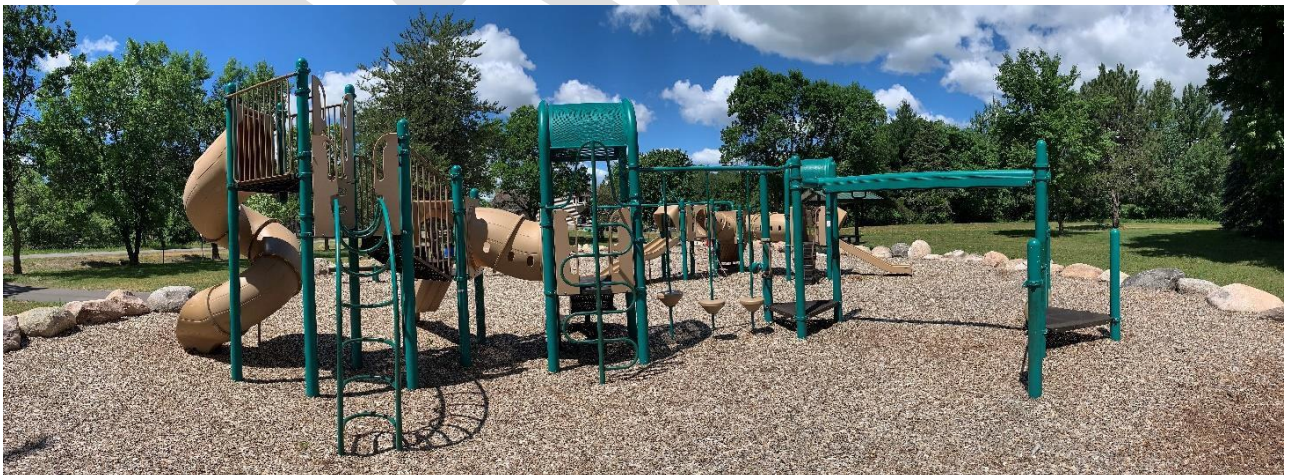
Figures 38-39: Ford Brook Park Playground, facing southeast and southwest, respectively

The other playset has three main means of entry—a staircase and two metal ladders—and two slides—one straight, the other enclosed and rotating 360 degrees. It also features an obstacle course consisting of three platforms connected to metal poles, a track-ride, a pull-up bar, and a log roll.

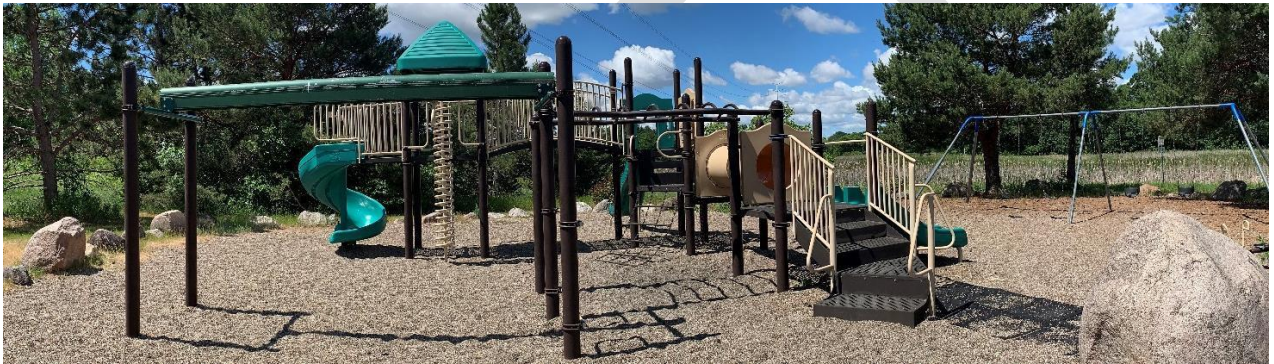
Figure 40: Fox Park Playground

The playground is composed of two components, a swing set and the main playground structure. The swing set is divided into two sections, one with two tot swings and one with two normal sbelt wings.

The main playground has three means of entry—one transfer surface, one chain link ladder with metal steps, and one corkscrew climber—and three slides—one straight slide with two parallel tracks, one straight slide with a hump, and one curved slide that turns 180 degrees. Different components of the structure are connected by one plastic tunnel and one upwardly curving belt bridge. Lastly there is a set of monkey bars with seven bars that curl upwards, as well as a track-ride. All playground components are in good condition.

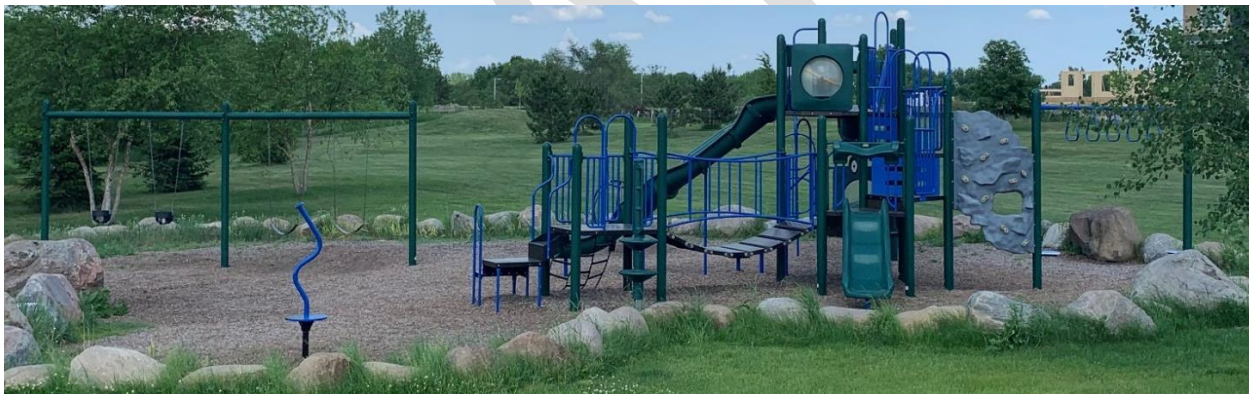
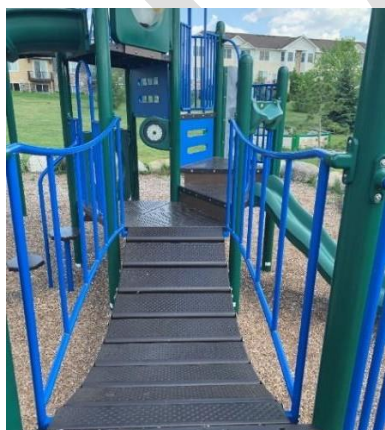
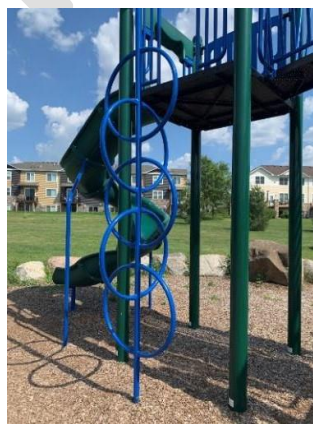
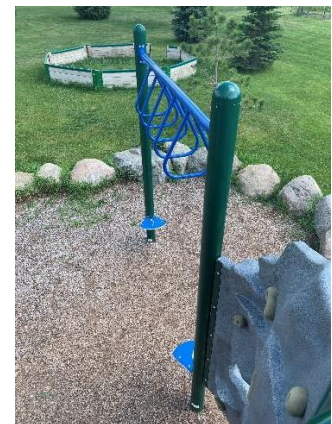
The monkey bars consist of five triangular bars. The climbing wall is plastic with nine holds on the front side and seven holds on the back side and a hole near the bottom of the wall (on the right side when viewed from the front) that can serve as a hand hold or foot hold. The top portion of the structure is accessible via two separate ladders made from walls with two slots cut out for foot holds. The bottommost of these ladders may have accessibility concerns—although one can use the guardrails as handholds, there is not a lot of room to maneuver through the opening.

Figure 41: North Commons Park Playground wipe shot; Figures 42-44: (left to right) bridge connecting to upper portion of the playground structure, ladder with accessibility concerns in the background; ladder with five orthogonal rings; monkey bars and climbing wall

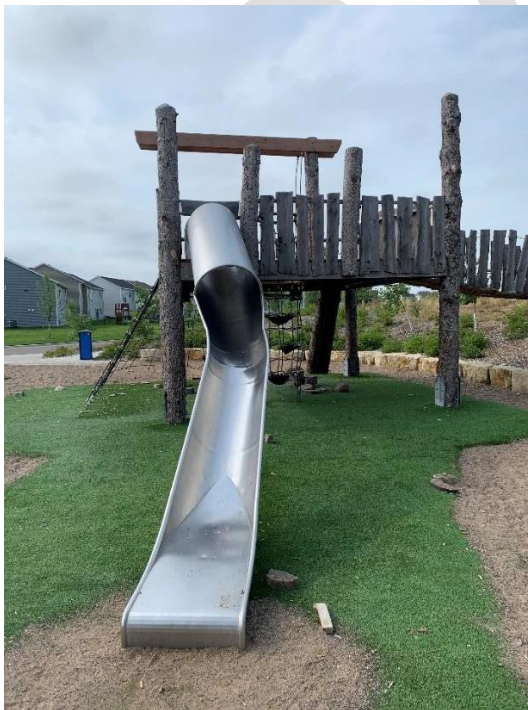
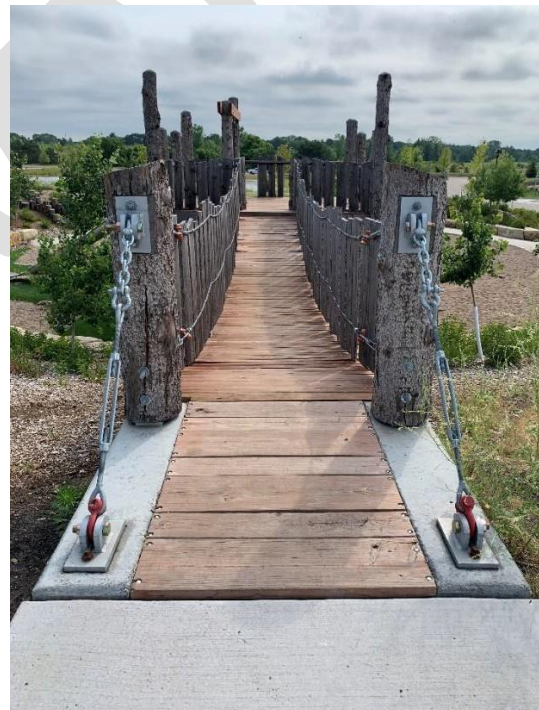
The playground includes a \$35,000 long stainless steel slide (enclosed near the top, but open near the bottom) that bends slightly near the middle. The main point of entry is a wooden bridge accessible via a concrete sidewalk. The other three means of entry are a thin wooden climbing wall (background of *Figure 15*) and two rope climbing structures. The larger one lines the southeast corner of the playground structure, while the smaller rope structure is located in the center. An octagonal opening in the wooden deck of the playground structure allows one to enter via the smaller rope structure. The smaller rope structure is enclosed and also has large curved footholds for ease of use. All playground components are in near-new condition.

Figures 45-46: (left) Pearson Park Playground (not pictured: bridge); (right) Bridge

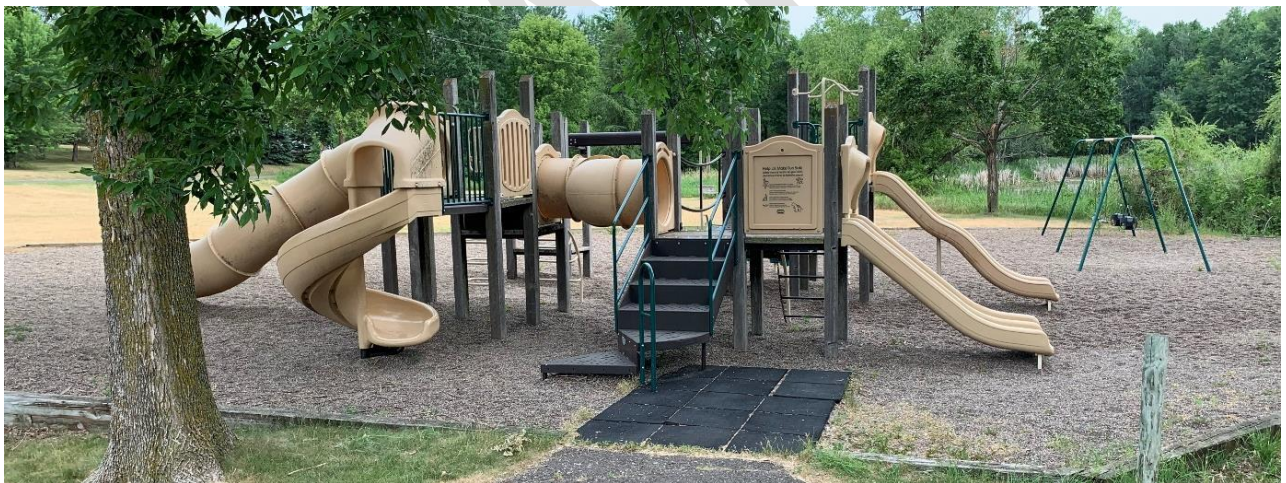
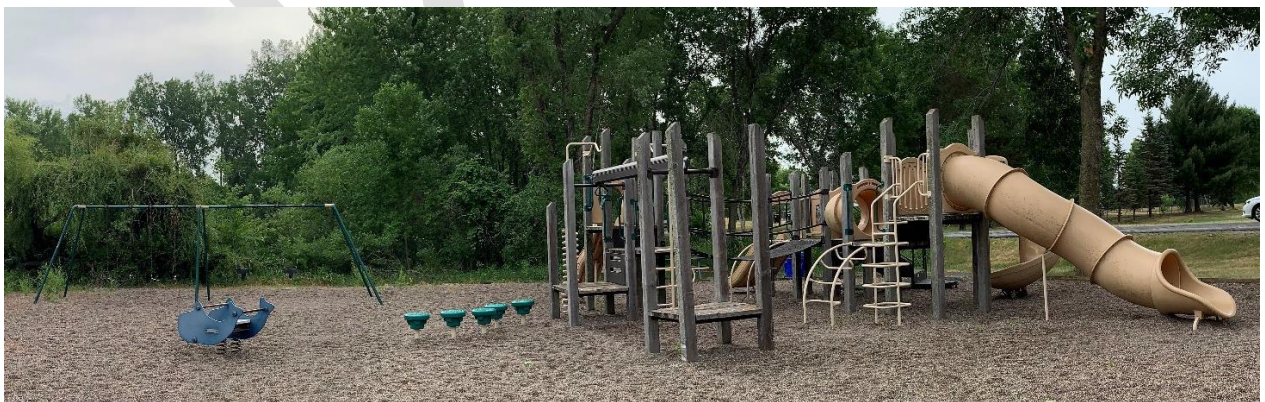
Figure 47-48: Peltzer Park Playground (facing North and Southeast, respectively)

The spring rider is in fair condition, though its paint is faded and some of the metal is in the initial stages of rust formation. The swing set consists of two bays with two swings each; one bay contains belt swings and the other contains bucket swings. The swings are all in good condition.

Overall, the playground is in fair condition. The paint on the plastic components has faded and the wood on the decks and supports is slightly worn but the playground is structurally in working condition.

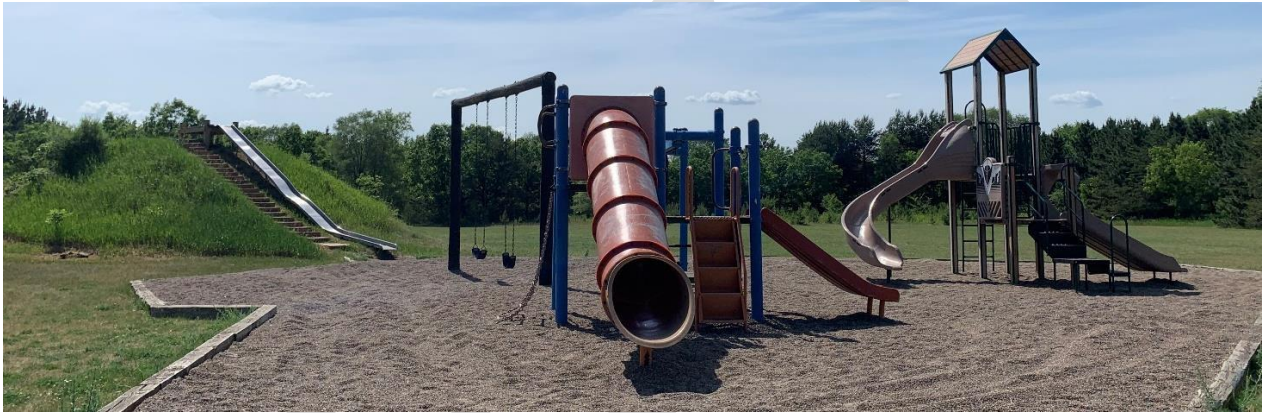
Figure 49: Rabbit Park Playground

The other play structure has two slides (one enclosed), three means of entry—one transfer surface, one chain-link ladder, and one-metal ladder—and a track-ride. The transfer surface steps are very narrow and steep, and are not ADA compliant. The chains for both swings are also worn and/or surface rusted. The playground is not accessible via an ADA trail.

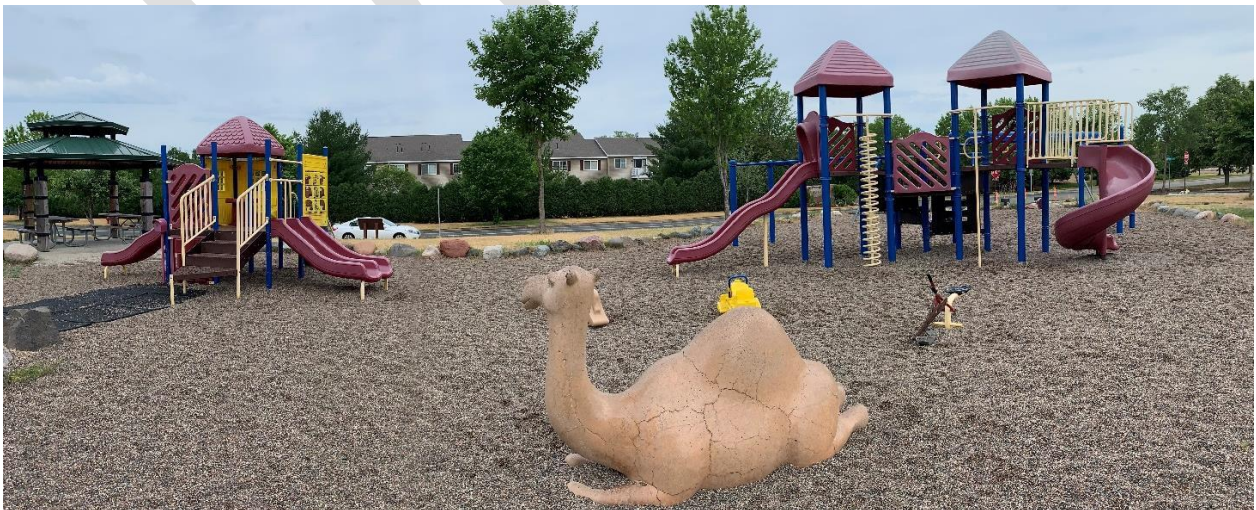
Figure 50: Riverdale Park Playground

The playground consists of three main components—two distinct play structures and one swing set—as well as four other components—a concrete camel sculpture, an excavator toy, and two spring-riders (one in the shape of a horse, the other in the shape of a bulldozer). The four components are in fair condition (however the concrete sculpture does have small cracks). The swing set has two bays with two swings each (two bucket swings and two belt swings in separate bays). The two talk tubes linking the two main play structures are deteriorating.

The larger play structure has a corkscrew climber and two slides—one straight with a single hump and one curved 360 degrees. Additionally, there is a set of monkey bars with eleven straight bars and a track-ride. Both are in good condition, though there is a small area on the grip for the track-ride with chipped paint. The transfer surfaces are in good condition but there are some accessibility concerns. The play set is not accessible via a flat surface and the transfer platforms are spaced vertically from one another by 18 to 24 inches. The six transfer surfaces are triangular and arranged together in a hexagonal shape with the last three being level with one another, forming a trapezoid. This top platform is alternatively accessible via a ladder formed by three slots cut into a wall, which is supplemented by two handholds. Even with the handholds, there are still accessibility concerns.

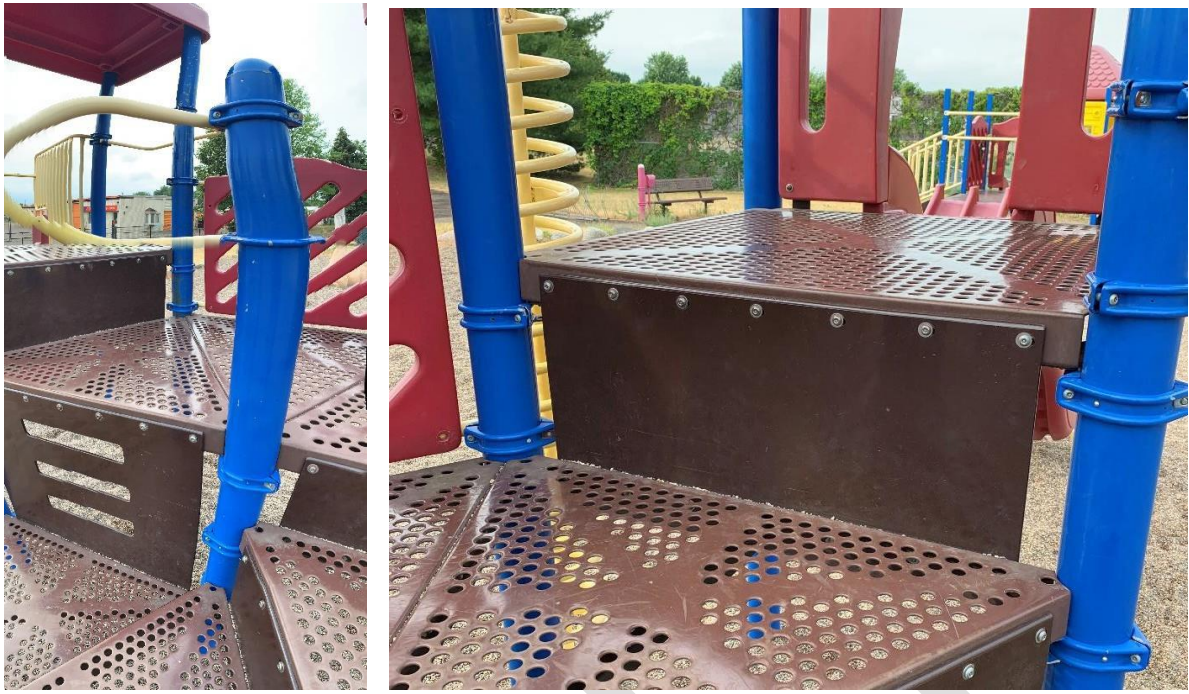
Figures 51-52: Transfer Surfaces on the Larger Playground at Riverdale Park (note that the picture on the left is a vertical panorama and is compressed vertically and angularly distorted)

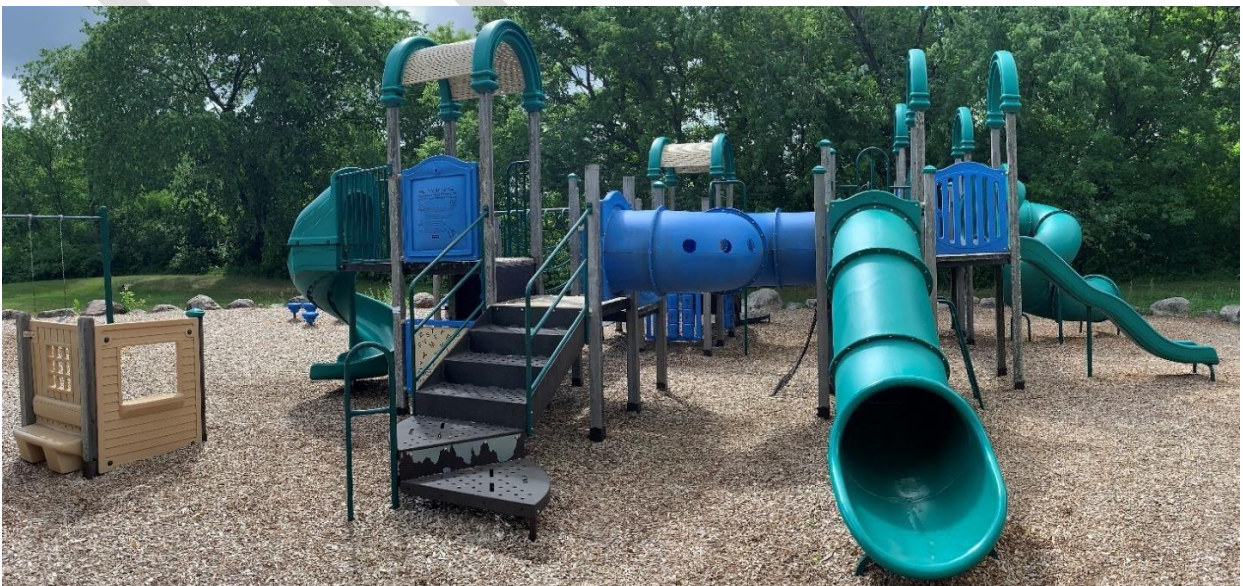
Figure 53: Rivers Bend Park Playground

The two play houses are mirror-images of one another, each consisting of two plastic walls held together by three wooden posts. The walls facing each other both have a small window with a 3 x 3 pattern as well as a bench below the window. The other two corners of each of the houses are open. The houses are both in good condition. The swing set has two bays, one with two bucket swings and one with two belt swings. The entire structure is in good condition. The paint on the dolphin spring-rider is chipped and the concrete base is worn, but it is otherwise in good condition.

The main play structure is a mix of plastic (slides, tunnels, roofs, and sensory components), metal (transfer platforms, some guardrails and supports), and wood (most platforms and supports). Visually the playground is in great condition, besides some faded paint and mud on the side of some of the plastic components. The main play structure has six entrances—two transfer surfaces, one chain-link ladder, one metal ladder with four alternating semicircular rings forming eight footholds, one metal ladder with four flat rungs, and one corkscrew climber. The main play structure also consists of five slides—one straight enclosed slide, one curved enclosed slide rotating 360-degrees, one straight slide with two parallel tracks, one straight slide with a hump, and another curved slide rotating 360-degrees. Additionally, there is a set of monkey bars with seven round rings. Tying the structure together are a clatter bridge, a belt bridge, and two tunnels each with two 90-degree turns.

The play structure also has four interactive sensory components—a board with letters on it, an abacus, a tic-tac-toe board (similar to the one outside of the main play structure), and a toy similar to the tic-tac-toe boards but with numbers painted on them.

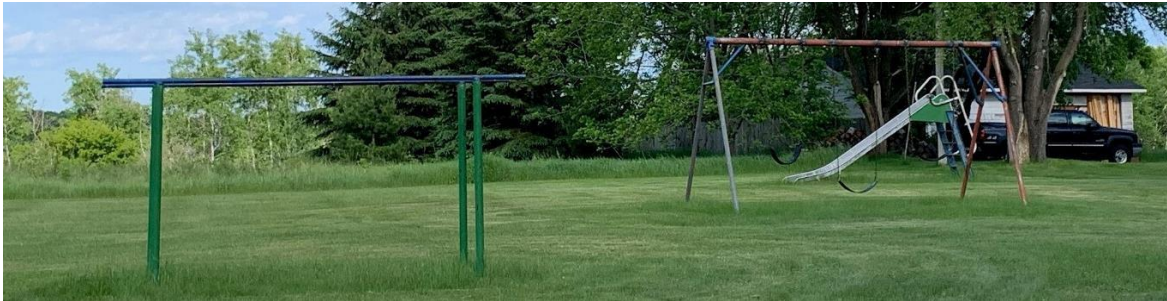
Figure 54: Shawn Acres Park Playground

Shawn Acres Park is a neighborhood park located in a low-density area in northern Ramsey along Chameleon Street, 1/5 mile north of 173rd Avenue, and west of Thorn Lake. Its playground was placed there before 1980, and it is believed that it was used components at that time. The playground consists of three separate small element: a rusted metal-pole swing set with three swings, a stand-alone metal slide, and a parallel set of metal bars akin to monkey bars without bars. The paint on each of three components is rusted. Two of the three swings are inaccessible to younger children and those with mobility limitations without the help of an adult. The slide is also inaccessible to those with mobility impairments. The playground is not ADA compliant, nor does it have resilient surfacing, and has low ‘play value’.

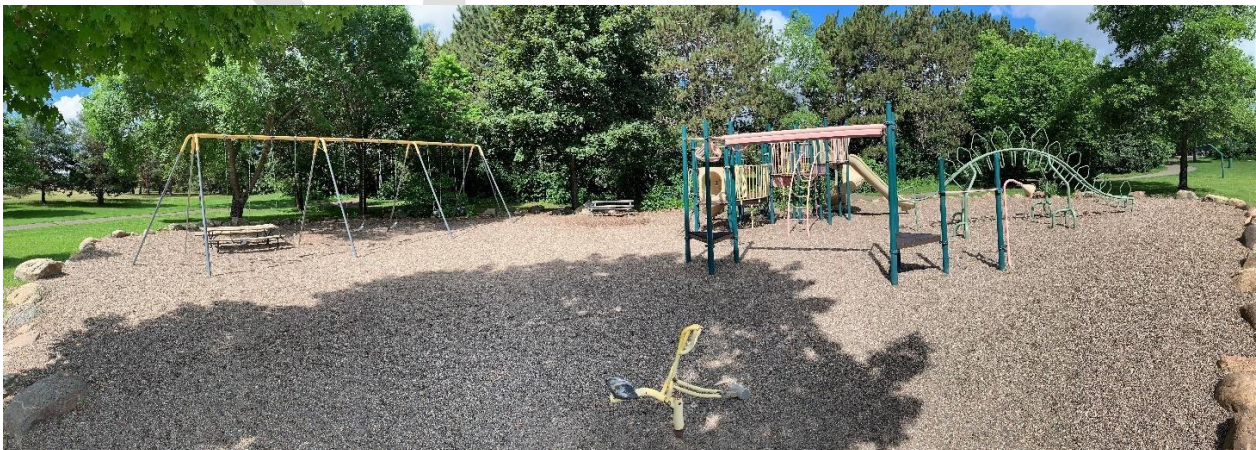
Figure 55: Solstice Park Playground

There are two curved slides, the shorter one turning 90 degrees and the longer one turning 360 degrees. There is a third straight slide. All of the slides are in good condition, however there are scratch marks in several places.

There are three main points of entry for the main composite playground structure—one transfer surface / staircase, one metal ladder curving upwards then horizontally, and one chain link ladder. Additionally, a corkscrew climber can be used for entry. Transfer platforms serving the monkey bars can also serve as a means of entry. There is a tunnel linking different parts of the structure that is in fair condition.

The sandbox excavator like many, due to their popularity, is in poor condition with paint chipped and metal rusted in several places. The swing set has three sections, divided by supports with two legs each, with two swings per section. One of the sections has two tot, bucket swings. All of the swings are in good condition. The monkey bars, comprised of nine triangular metal rings, are in good condition, as is the track-ride, though there is chipped paint in one place. There are two miscellaneous interactive sensory components, a tic-tic-toe board and a steering wheel, both of which are in good condition. Finally, there is a pull-up bar and talk tubes, both of which are in fair condition.

The dinosaur-shaped climbing structure has a spine of parallel metal bars with 17 rectangular ‘ribs’ on the underside for climbing linking the two bars. On the top there are 12 pentagonal scales on alternating sides of the spine for climbing. The structure is held up by four legs. All components of this structure are in good condition.

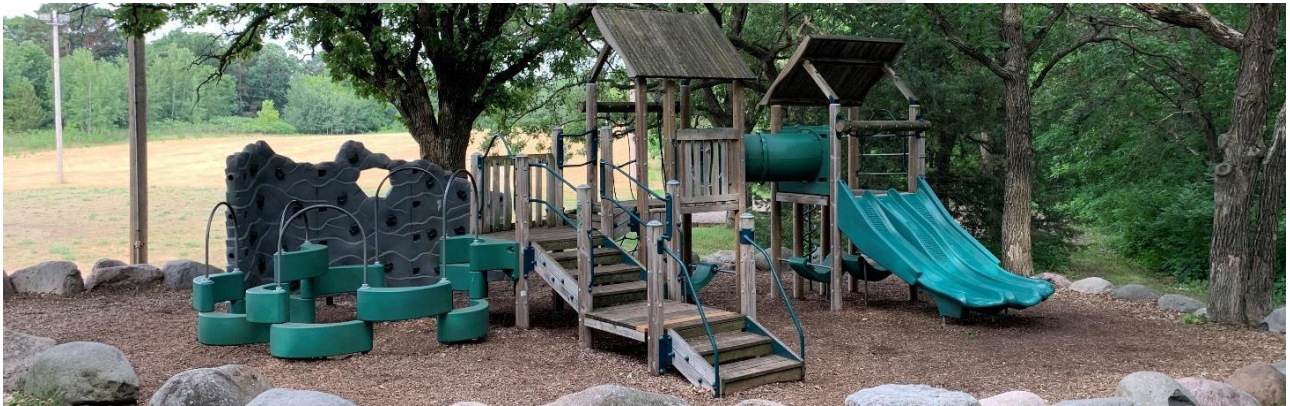
Figure 56: Titterud Park Main Play Area

The swing set is made of wooden posts and a metal crossbar, and has two belt swings. The main structure is largely wooden, but with metal guardrails and a single plastic slide with three parallel tracks and a plastic tunnel. The main means of entry is a transfer platform and staircase. Another entrance is via a gray plastic rock climbing wall attached to a series of twelve green arched climbing platforms arranged in circular patterns. Adjacent to this is a rope climbing ladder with four parallel ropes at the top for handholds. On the opposite end of the playground structure is another means of entry—a ladder consisting of seven rungs and another ladder connected at a 135-degree angle with four rungs. The fifth and sixth means of entry are a narrow ladder with a rope for balancing, and a corkscrew climber. One of the boards on the transfer surface was recently replaced, so the structure is overall in good condition.

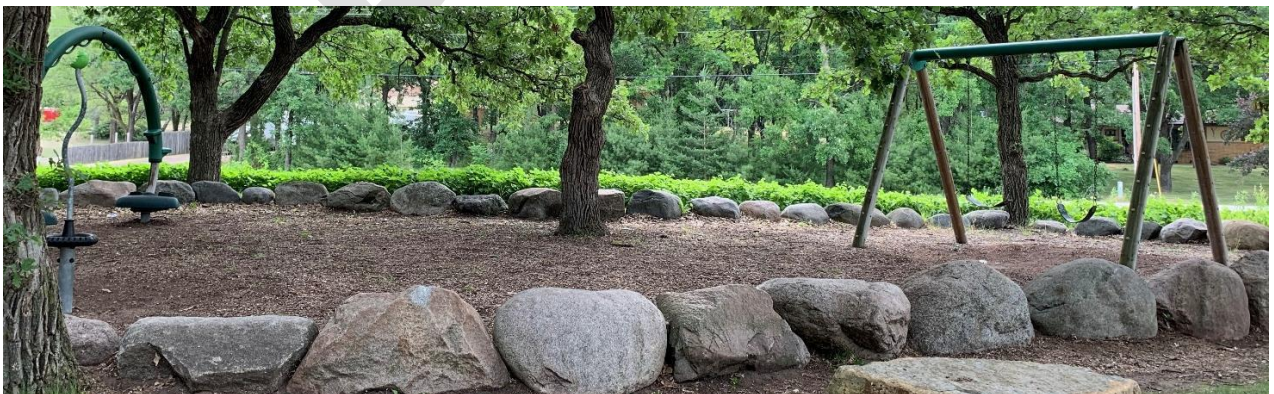
Figure 57: Titterud Park Secondary Play Area

There are three areas for playing—one with the main play set, one with a swing set and two pieces of equipment for bouncing, and an empty sandbox (with pea gravel for surfacing). The bouncing equipment is in good condition. One consists of a spiral pole with a singular platform from bouncing and the other is in the shape of a ring, allowing for two children to take turns jumping and launching the other upward.
