***Interim* Playground Replacement Policy**

City of Ramsey, Minnesota

Adopted: x/x/2021

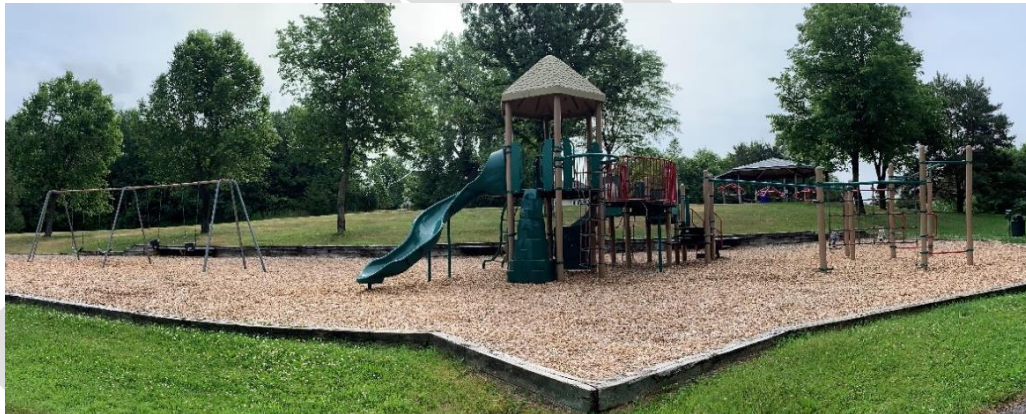
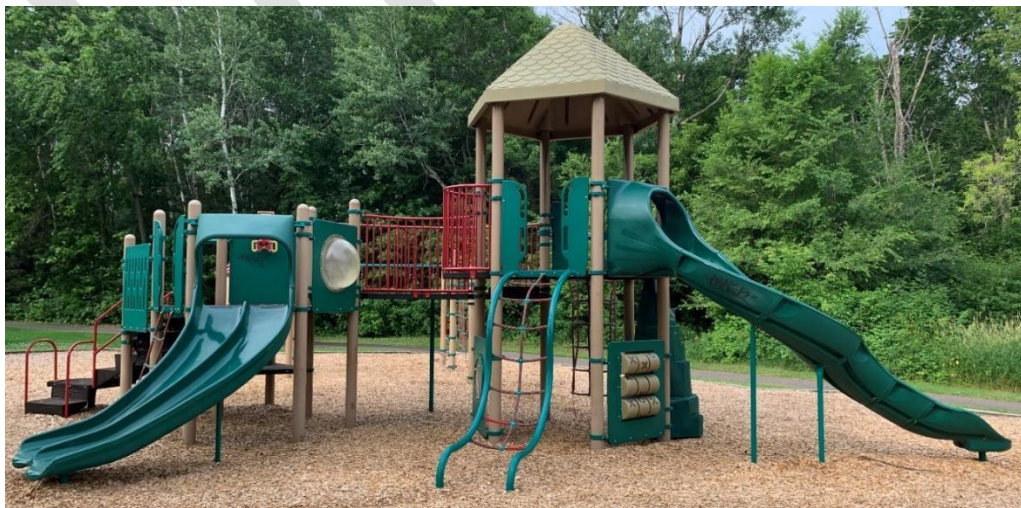
Figures 58-59: (top to bottom) Woodland Green Park Playground (looking east and west, respectively)

The playground features four components—the main structure with an attached jungle gym, a swing set, and two spring riders (both of which are in good condition). The swing set, consisting of two bays with two belt swings and two bucket swings in the respective bays, is in fair condition, though the crossbar is beginning to rust.

The main play structure has two curved slides, one with parallel tracks and curving roughly 45 degrees and another slide (longer than the first) zigzagging, but curving roughly 45 degrees as well. There are six means of entry, the main one being a transfer surface and staircase. There are three metal rope-like ladders—one enclosed with a metal ring on top, one with two parallel metal bars on the sides, and one with a single climbing track. A fifth means of entry is a green plastic climbing structure adjacent to the longer slide. A sixth possible method of entry is the jungle gym attached to the main structure. It also consists of a rope climbing wall, a set of monkey bars made up of five rings each attached to the end of a chain, a pull-up bar, and a set of monkey bars with three tilted, rotating, circular handholds. The second set of monkey bars is slanted. The jungle gym and main playground structure are both in good condition.
