Review Updated Estimated Costs for Sunfish Lake Sedimentation Basin Improvements

Bergevin Swale Removal Request

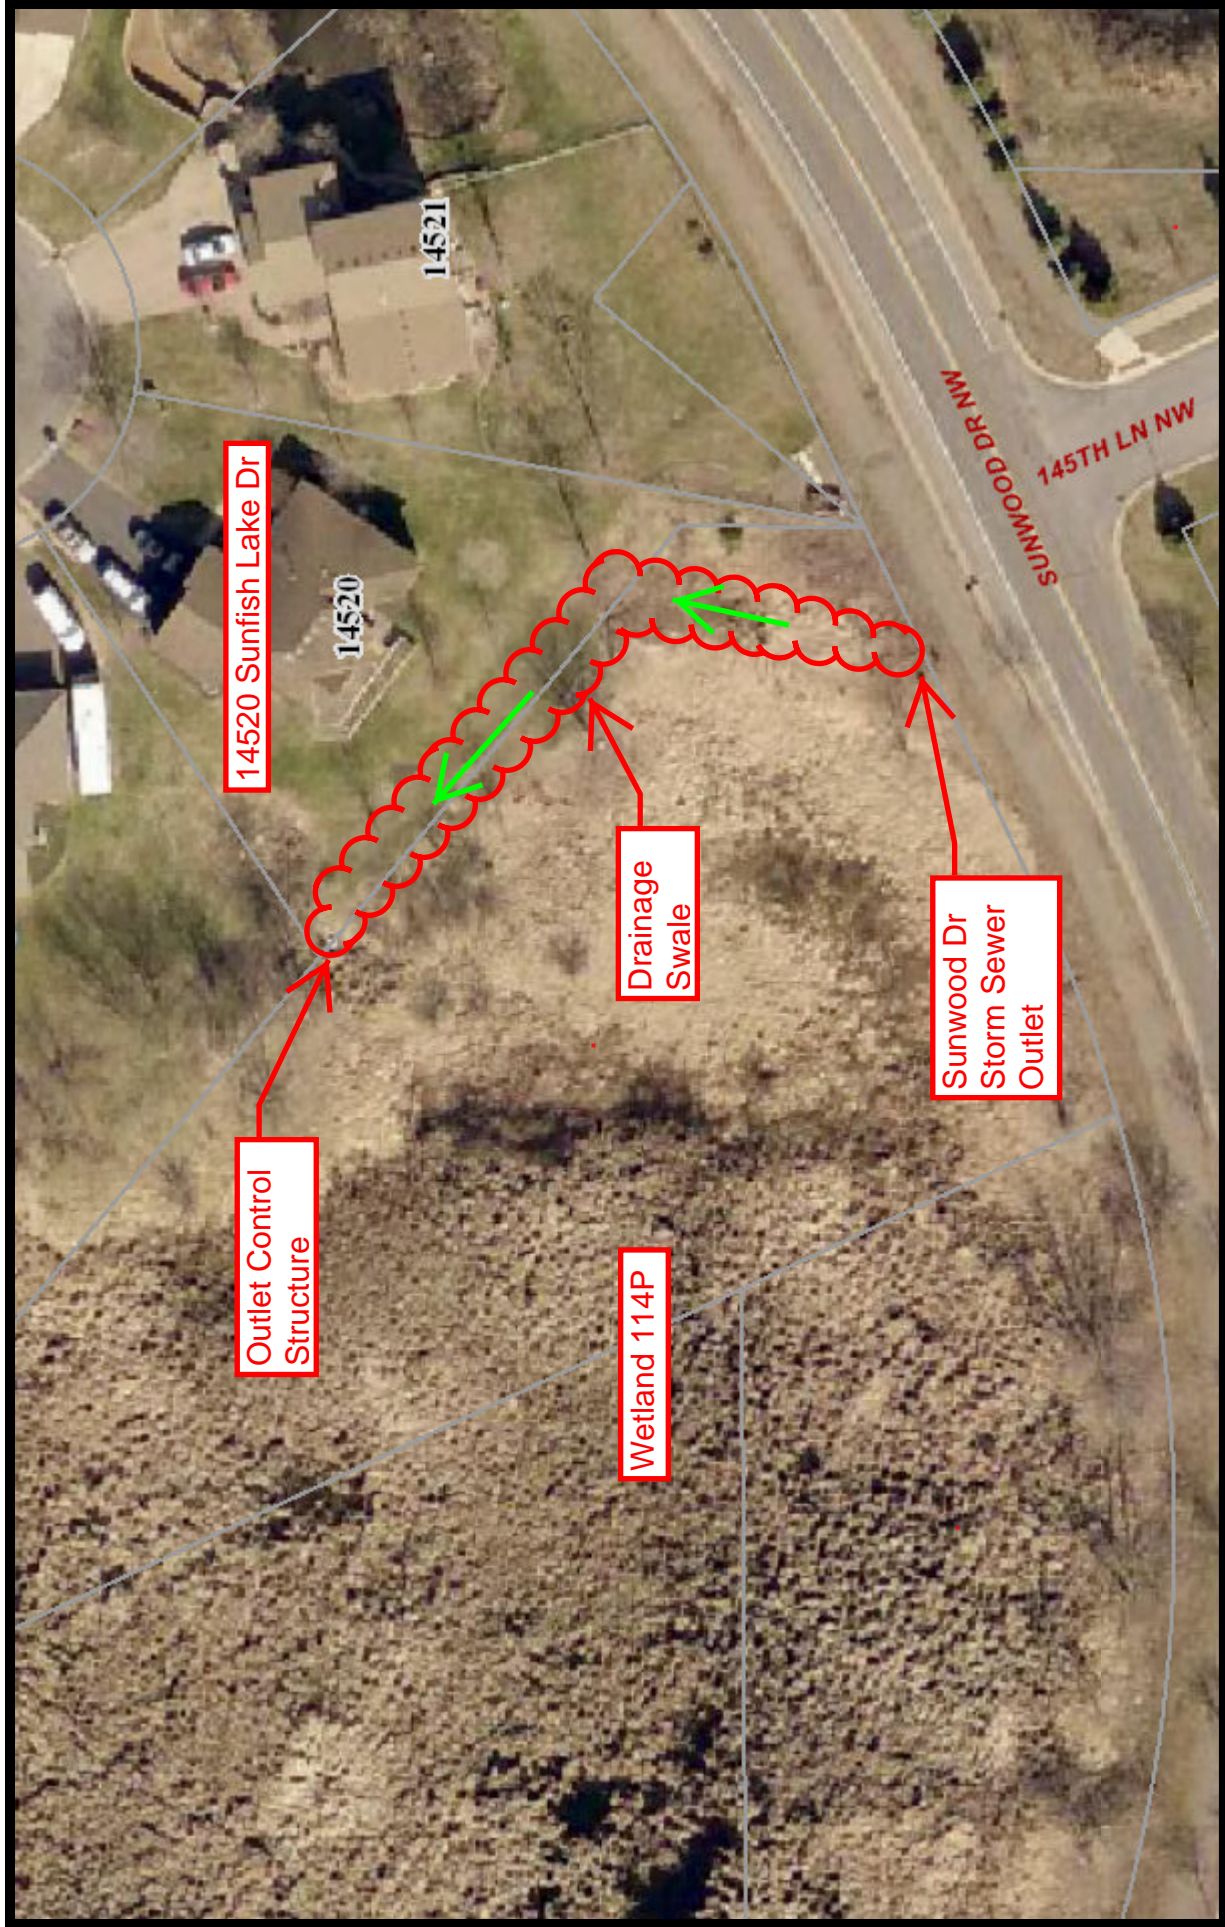
FIGURE 1

This property is located in the Sunfish Lake Estates subdivision which was platted in 1996. The plat dedicated the 20-foot drainage and utility easement parallel to the rear lot line to accommodate a drainage swale that connects the storm sewer outlet from Sunwood Drive to an outlet control structure located near the southwest corner of the lot. Attached is a certificate of survey that shows the lot boundaries and locations of the rear lot drainage easement and berm along the back side of the swale.

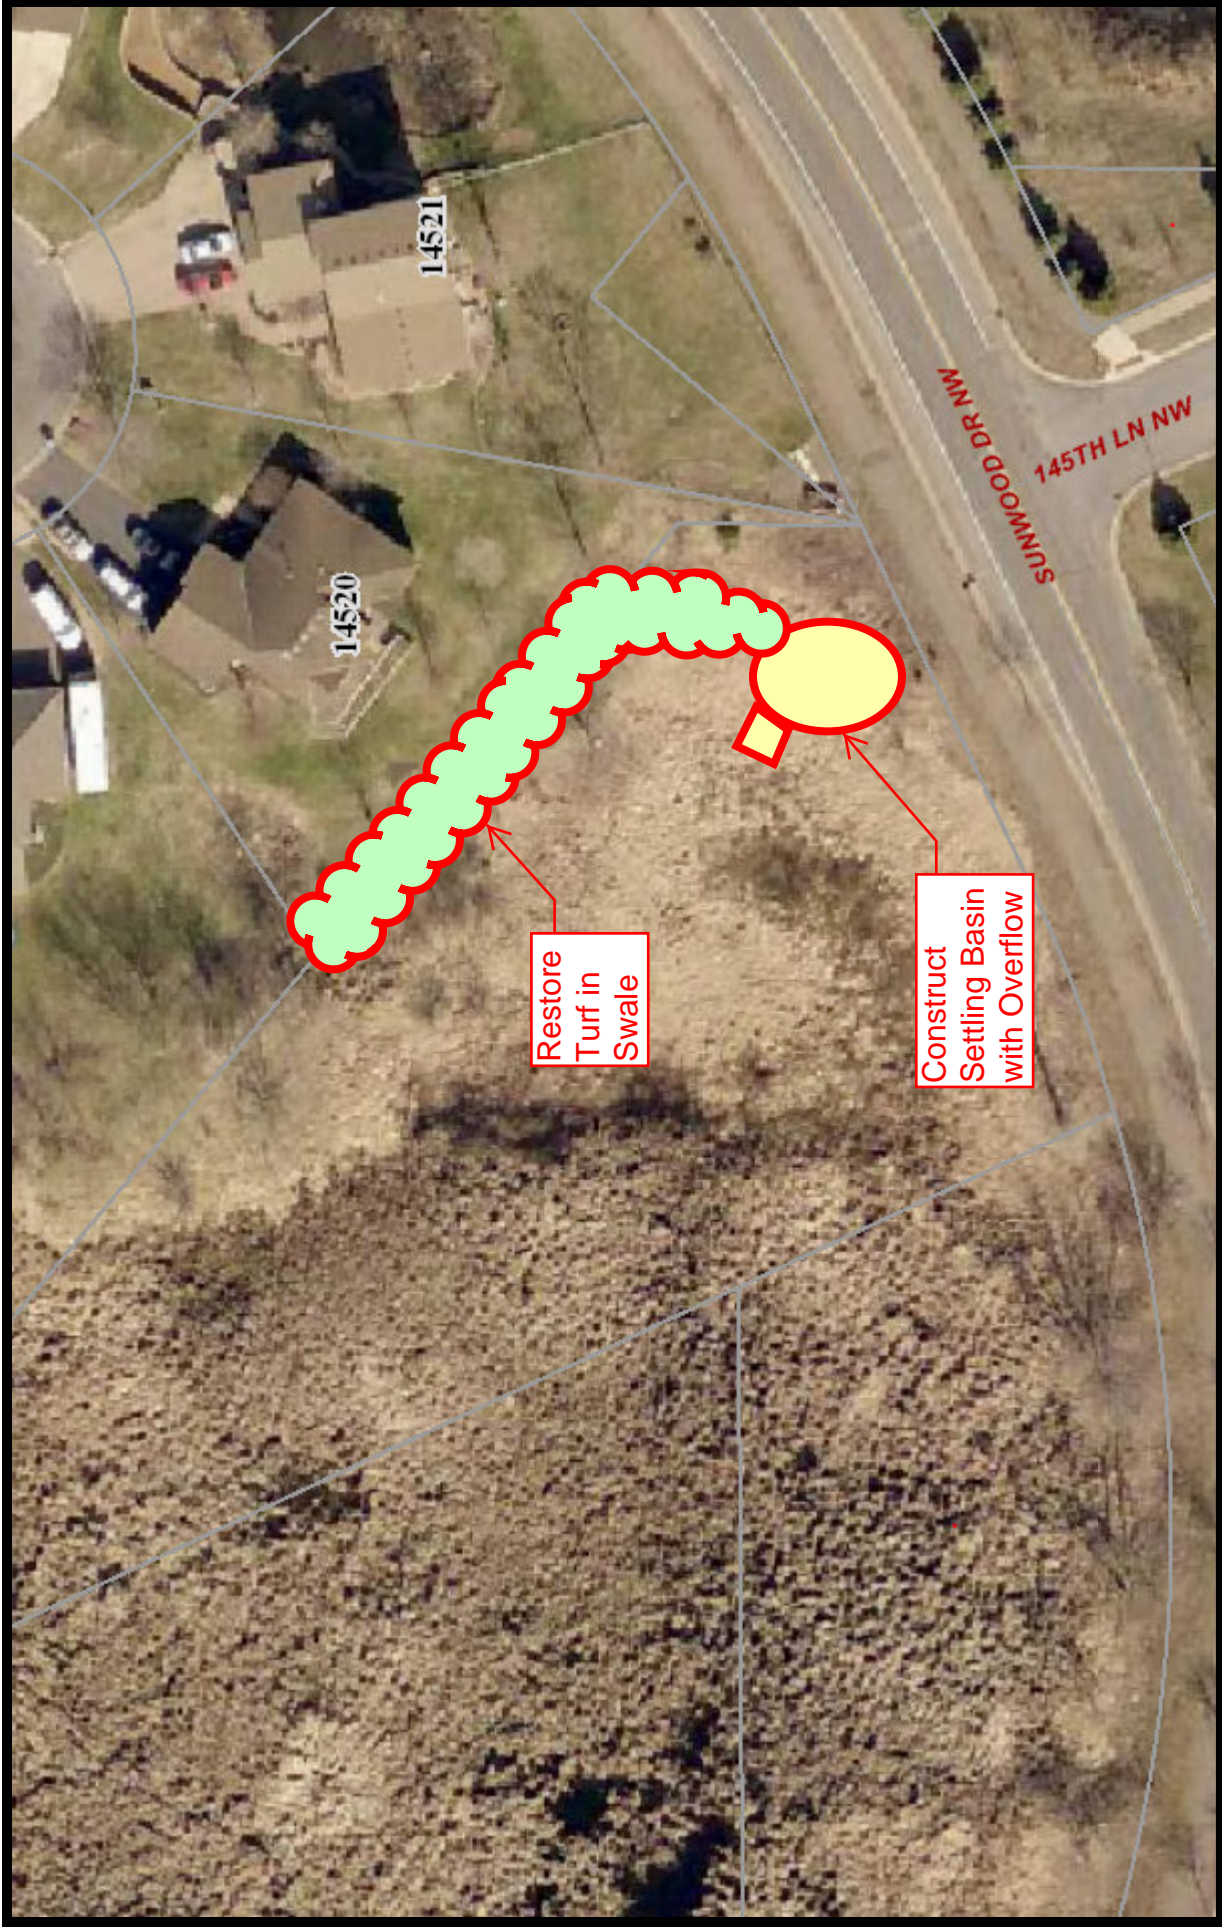
FIGURE 2

The property owner at 14520 Sunfish Lake Drive NW is requesting that the City reconstruct specific stormwater treatment improvements impacting a portion of their back yard. The requested work includes constructing a settling basin at the end of the storm sewer outlet from Sunwood Drive where it intersects 145th Lane NW for the purpose of reducing the frequency and volume of stormwater runoff running through the existing drainage swale along their rear lot line, and removing the existing cattails and other types of vegetation commonly found in wetlands from the swale and restoring the swale to a lawn type condition using sod, though seeding could be acceptable if done correctly. Attached *Figure 1* shows 2014 aerial photography of the property and the surrounding area including parcel lines, property addresses, and street names, and identifies the locations of the swale and various storm sewer outlets in relation to the property. Attached *Figure 2* shows the concept design for the requested improvements.

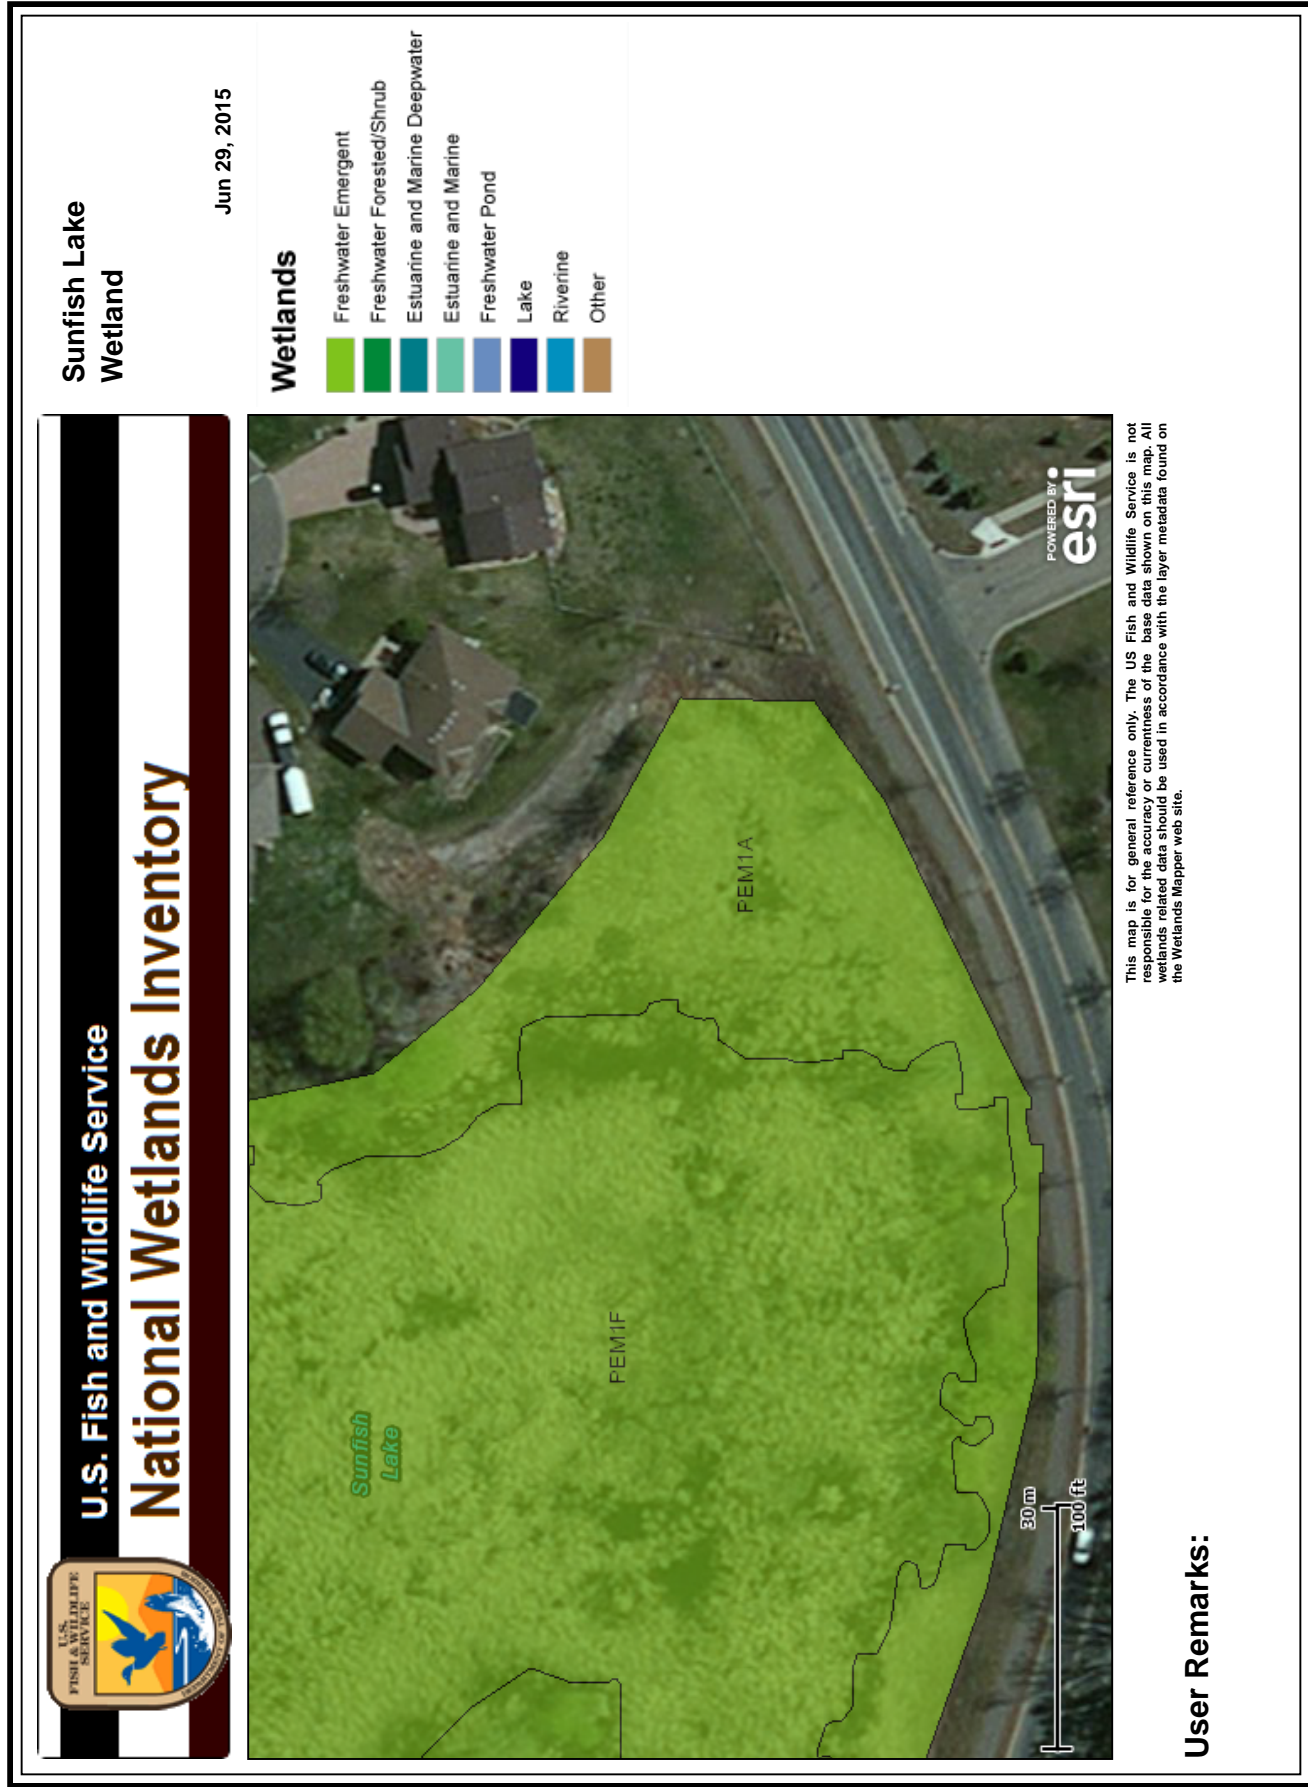
FIGURE 3

Permits from both the DNR and the Lower Rum River Watershed Management Organization would be required to complete the requested improvements as the settling basin and overflow would be located within wetland 114P (see attached *Figure 3*) which requires a WMO permit, and the work would be occurring below the Ordinary High Water Level which requires a permit from the DNR. In addition, wetland mitigation credits would need to be purchased at a 2:1 ratio to replace the impacted wetland due to construction of the settling basin. This is reflected in the attached estimated costs.

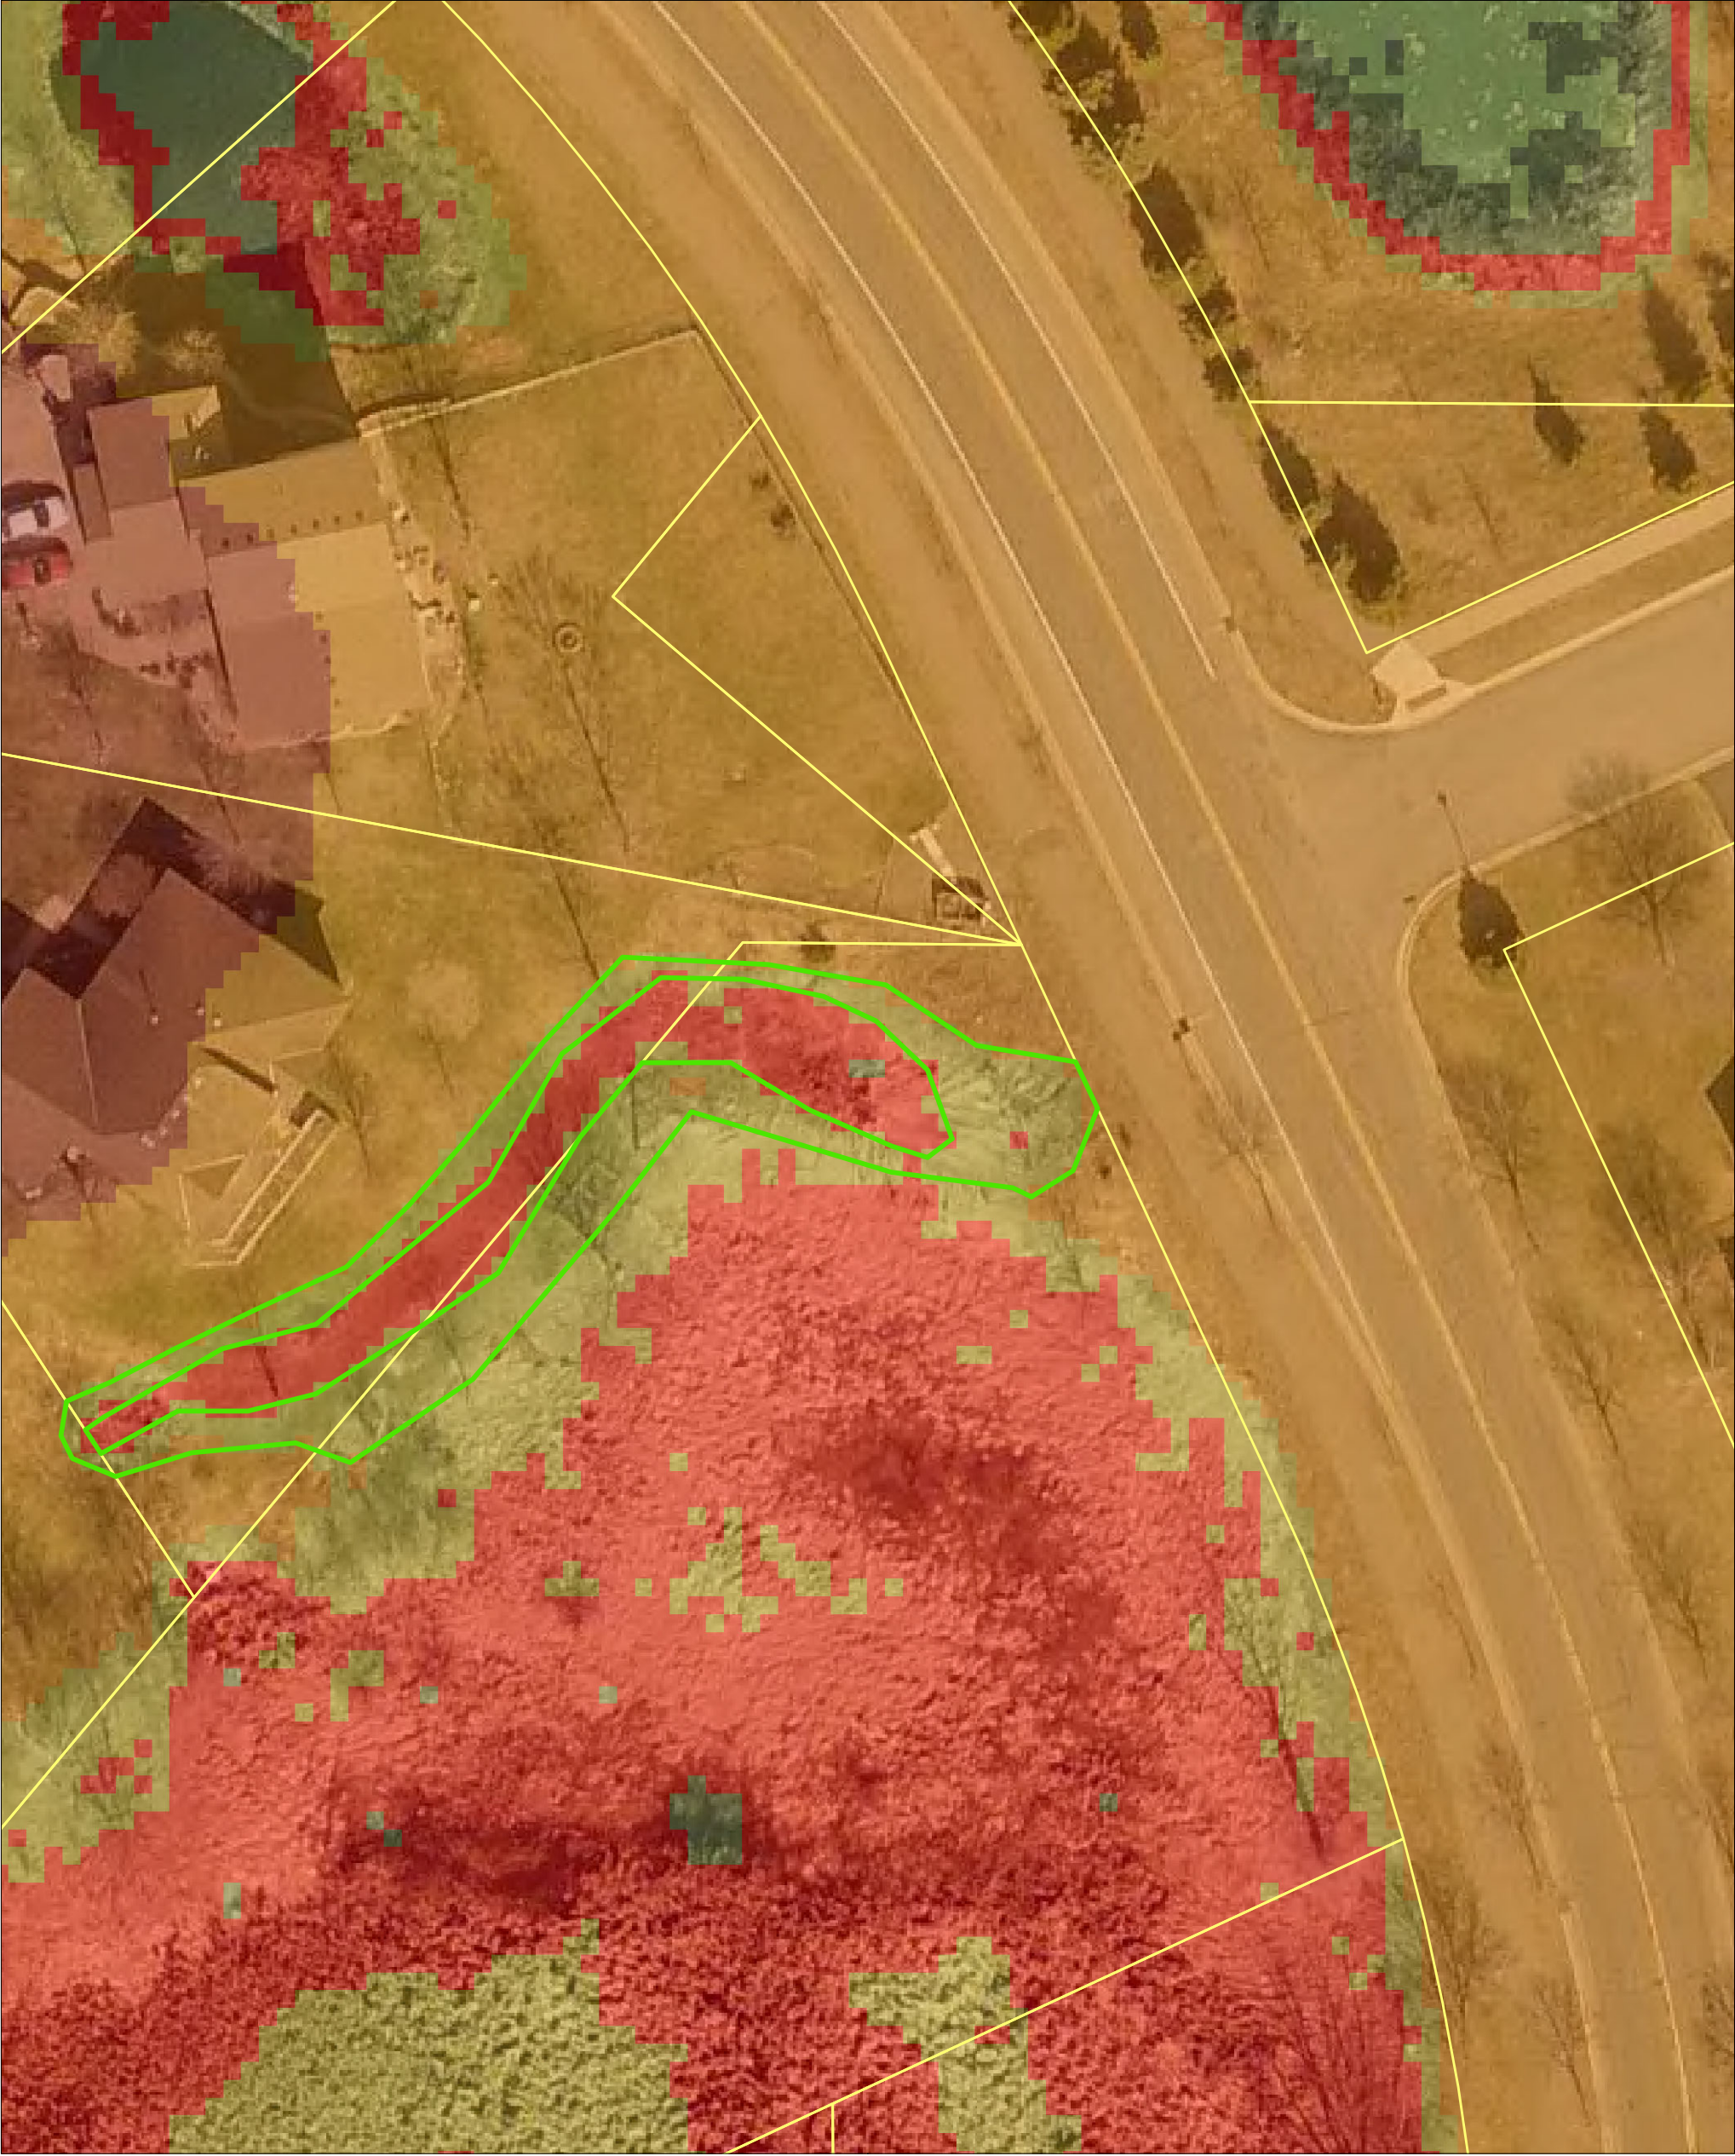
- Proposed
- Identified Properties

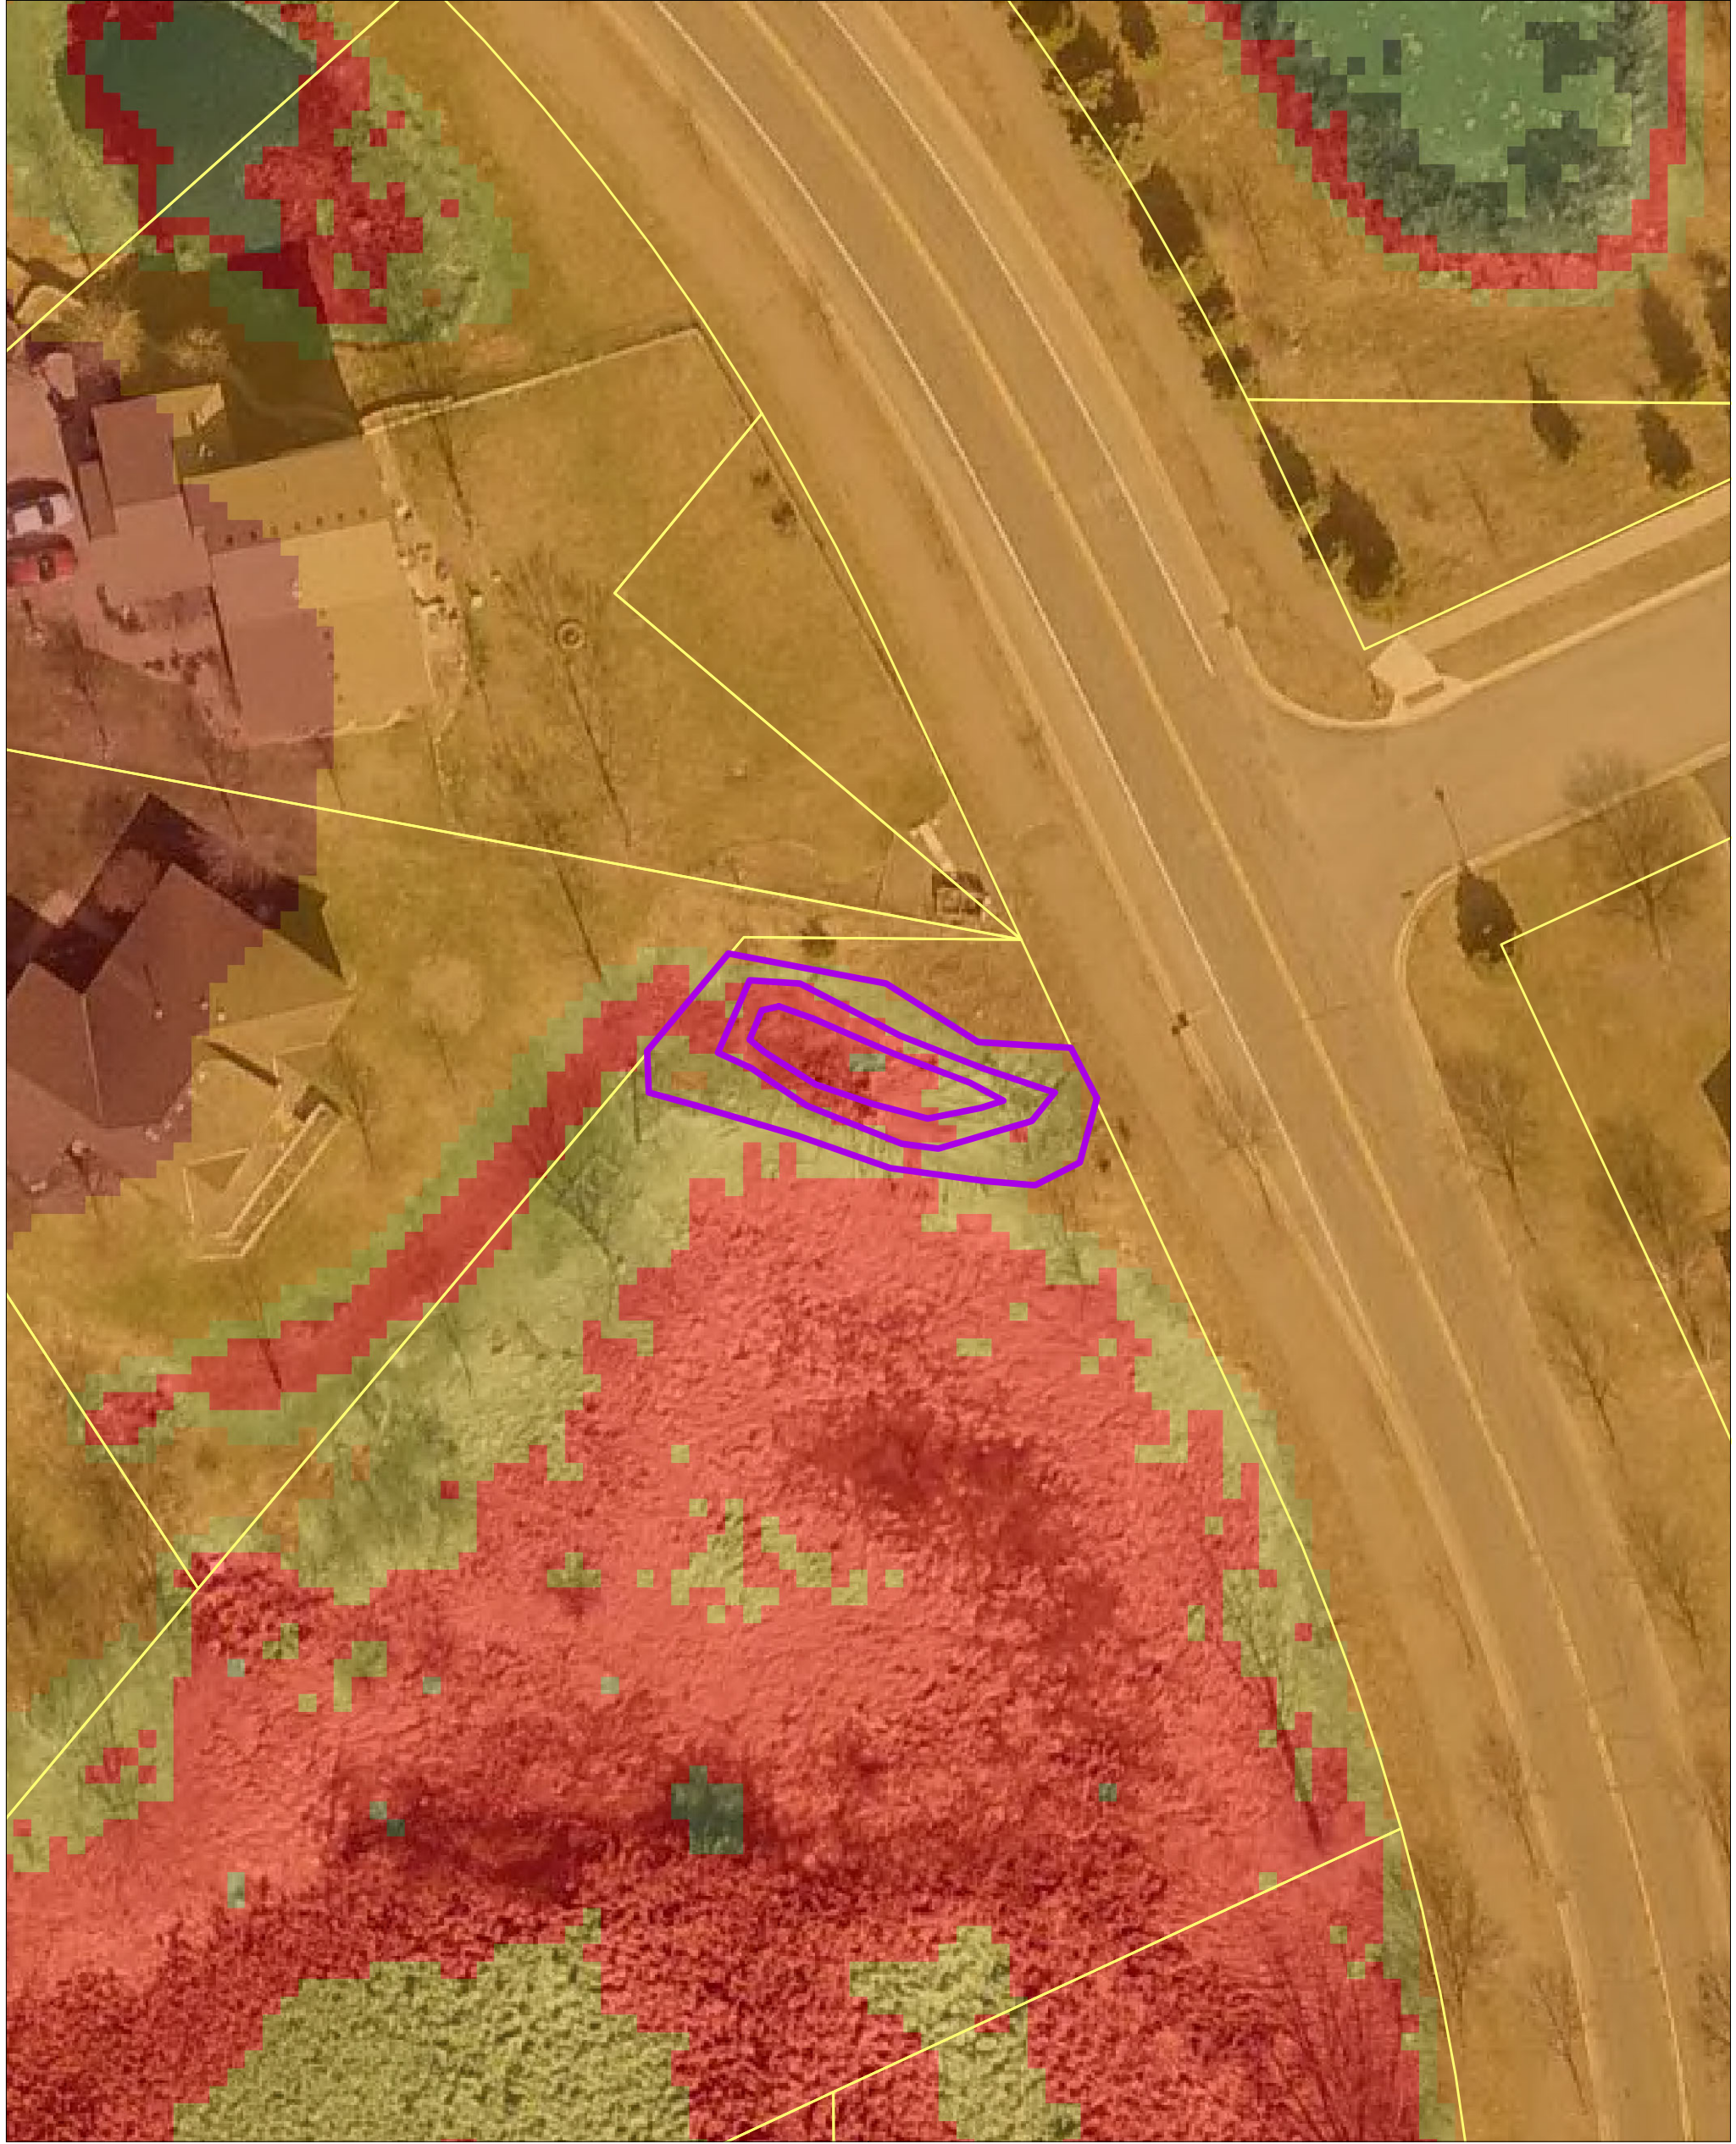
- Existing
- Identified Properties
