Evaluation and Proposal

Roswell City Hall - Renovation

March 23, 2026

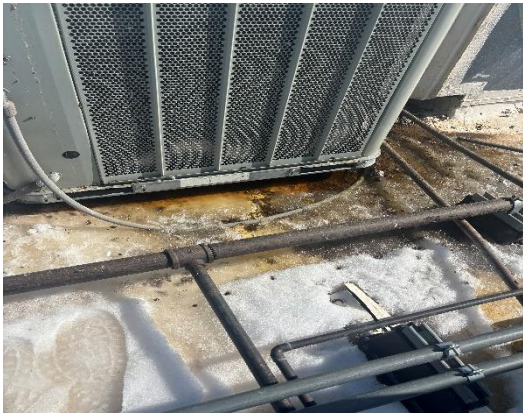
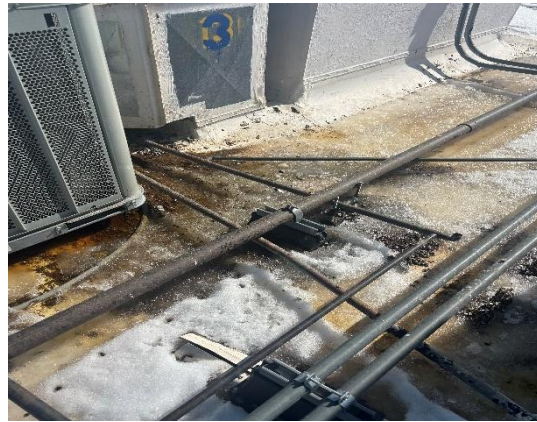
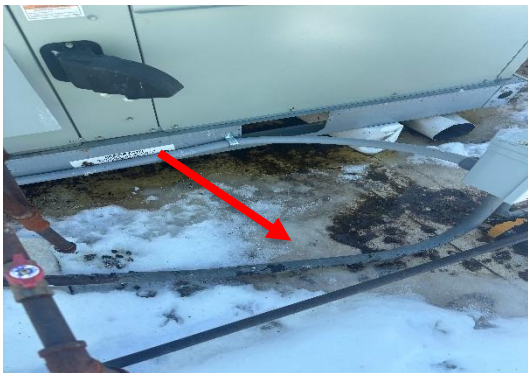
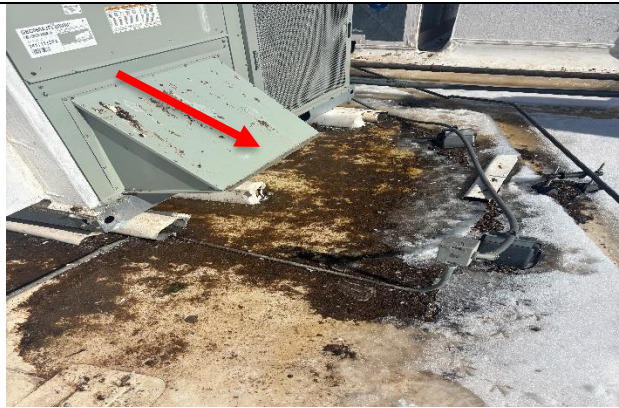
## Photo Documentation:

- **Roof Type:** TPO
- **Square Foot:** Approx 5,623 sq. ft. including walls
- **Roof Age:** Unknown
- **Overall Roof Condition:** Failing
- **Active Leaks:** Yes

The existing TPO roofing system exhibits advanced signs of aging and weathering, including membrane brittleness, surface cracking, and seam separation. Prolonged UV exposure and loss of flexibility have compromised the integrity of the membrane, resulting in active water infiltration. Ponding water is also present in the central roof area where HVAC units are located, further accelerating membrane deterioration. Based on these conditions, the roofing system has reached the end of its service life and requires repair or full replacement to prevent continued water intrusion and associated damage.

- Set up OSHA-compliant fall protection and safety equipment prior to the start of work.
  - Verify all work areas are secure and accessible for personnel and equipment.
  - Lift existing HVAC units to allow for proper surface preparation, before coating application, correct ponding water conditions by improving drainage
-

- Perform **3-course penetration detail** in accordance with **Metacrylics® Penetration Detail Instructions**.
  - Ensure all roof penetrations, seams, and transitions are properly reinforced.
-
