A RESOLUTION OF THE SAN LUIS CITY COUNCIL RELATING TO COMMUNITY REDEVELOPMENT IN SAN LUIS; DEFINING THE REDEVELOPMENT AREA; FINDING THE EXISTENCE OF A SLUM AND/OR BLIGHTED AREA IN THE CITY OF SAN LUIS AND DECLARING THE NECESSITY FOR, AND THE CREATION OF, THE DOWNTOWN SAN LUIS REDEVELOPMENT AREA.

FINDINGS OF NECESSITY REPORT

CITY OF
SAN LUIS
ARIZONA

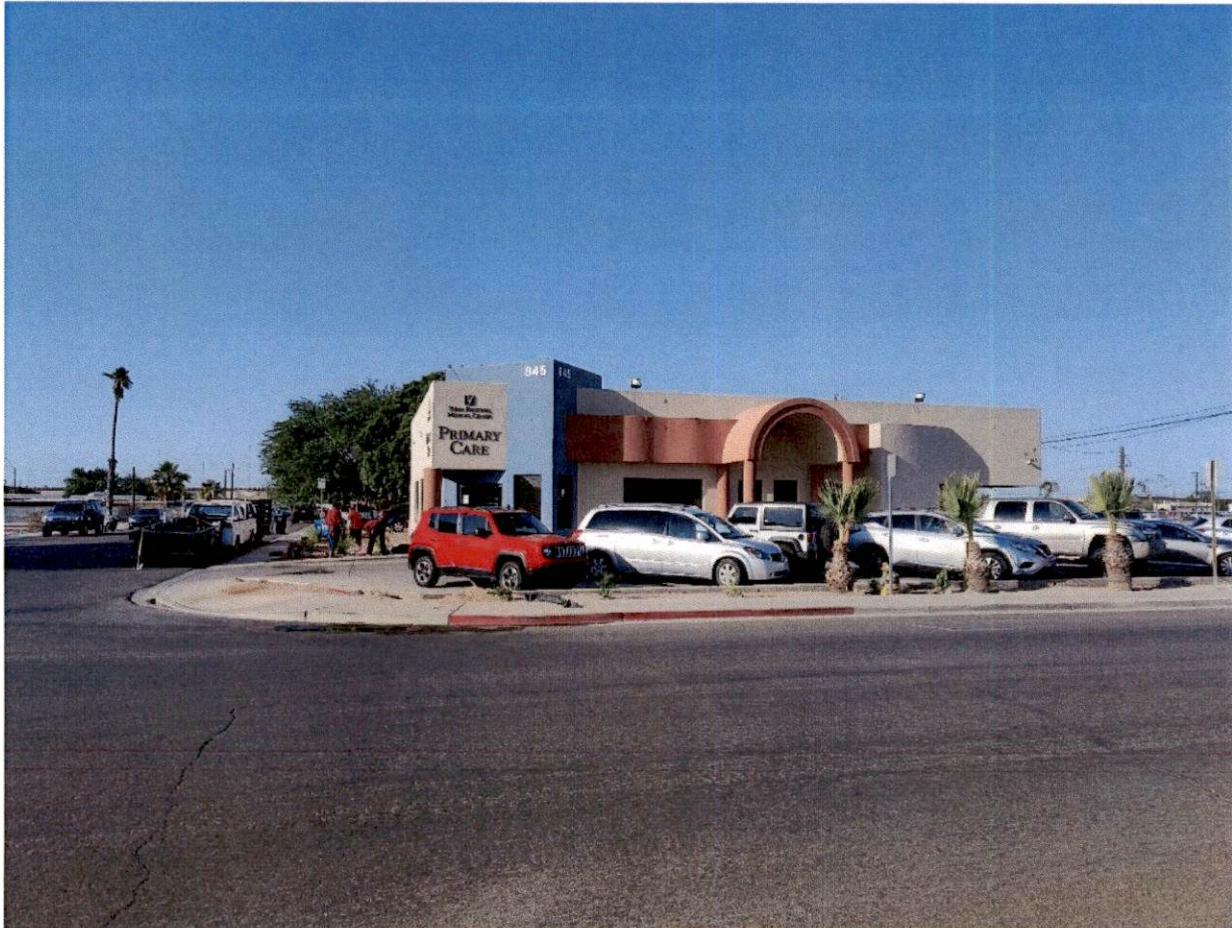
Inadequate or Incomplete Connection to the Street includes properties lacking an improved connection to the public roadway. Properties in this category are deficient with the City’s requirements for curb, gutter, sidewalk, and paved surface connecting parking areas to the adjacent rights-of-way. This condition contributes to blight with unsafe and uncontrolled vehicular access to the public street from parking areas on residential or commercial properties within the RDA.

As shown in **Table 3-3**, 3.5% of the total parcels in the RDA is determined to be blighted due to an inadequate connection to the street. **Figure 3-3** displays the location of these properties.

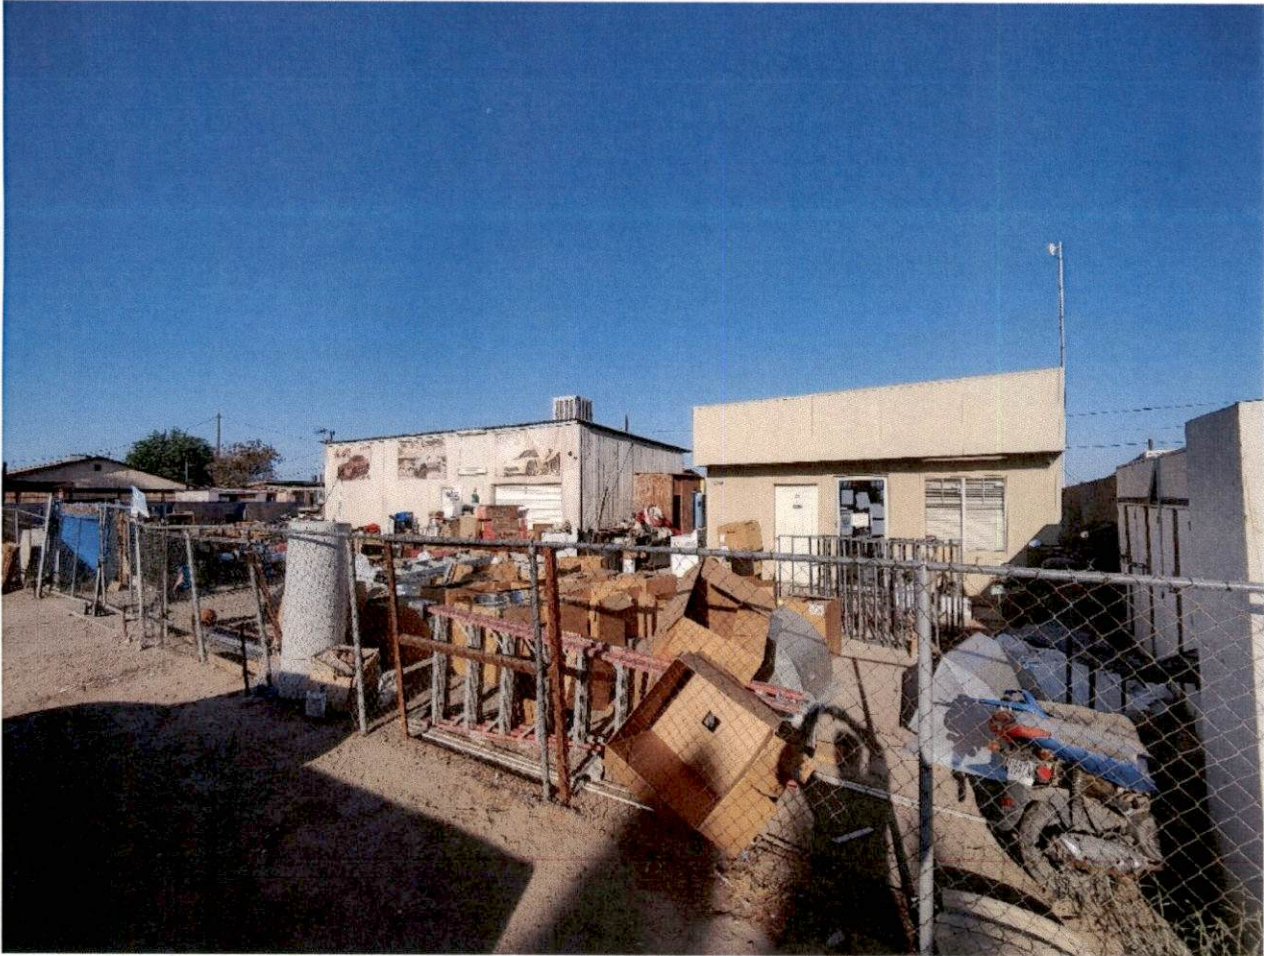
This blight factor involves the presence of refuse and debris on the residential property or premises of the business. In some cases, vacant land with refuse was counted separately under each category. Refuse and junk could have been counted as Unsanitary and Unsafe, or a Deterioration of Site dependent on the actual field conditions present as recorded by the field analyst. This condition was present on a total of 64 parcels or 31.8% of the parcels in the RDA boundary.

Table 3-5 21.8% the total number of parcels in the RDA is determined to be blighted due to Refuse/Debris/Junk.

Figure 3-5 displays the location of these properties.

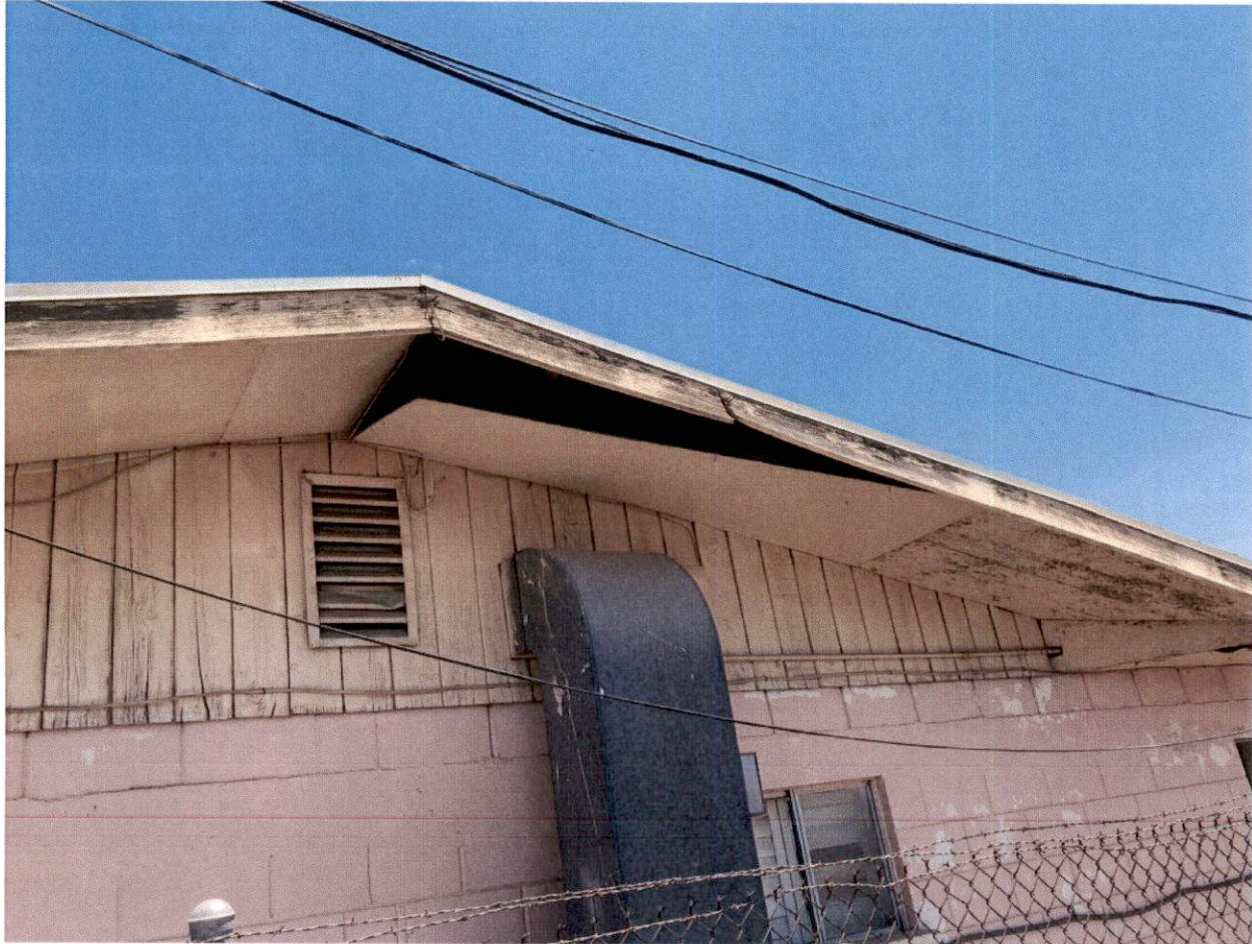
4. Deteriorating or Damaged Building and/or Structure

This blight factor involves the presence of a Deteriorating or Damaged Building and/or Structure which could include wall damage, roof damage, or other elements of the building or structure including supporting elements, awnings, and other attached elements of construction. This blight condition was counted as Unsanitary and Unsafe, or a Deterioration of Site dependent on the actual field conditions present as recorded by the field analyst. This condition was present on a total of 36 parcels or 17.9% of the parcels in the RDA boundary.

Table 3-6 27.5% of the total number of parcels in the RDA is determined to be blighted due to Deteriorating or Damaged Building and/or Structure.

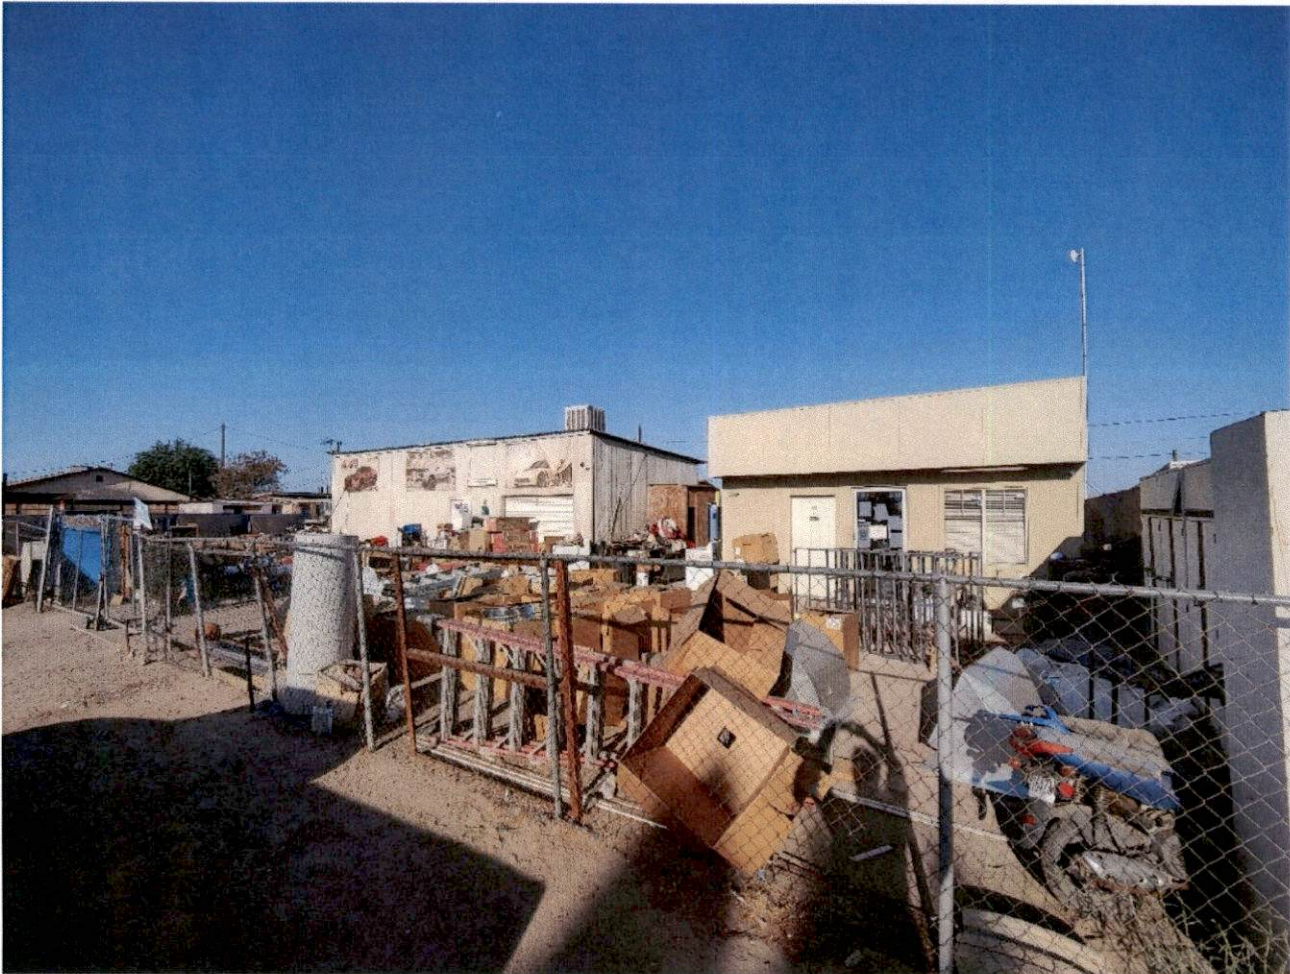
5. Excessive Outdoor Storage

This blight factor involves the presence of excessive outdoor storage that could include boxed or unboxed

storage of items normally kept within the confines of a building or enclosed area and outside of public view from the public rights-of-way. This blight condition was counted as Unsanitary and Unsafe, or a Deterioration of Site dependent on the actual field conditions present as recorded by the field analyst. This condition was present on a total of 18 parcels or 9% of the parcels in the RDA boundary.

Table 3-7 9% the total number of parcels in the RDA is determined to be blighted due to Excessive Outdoor Storage.

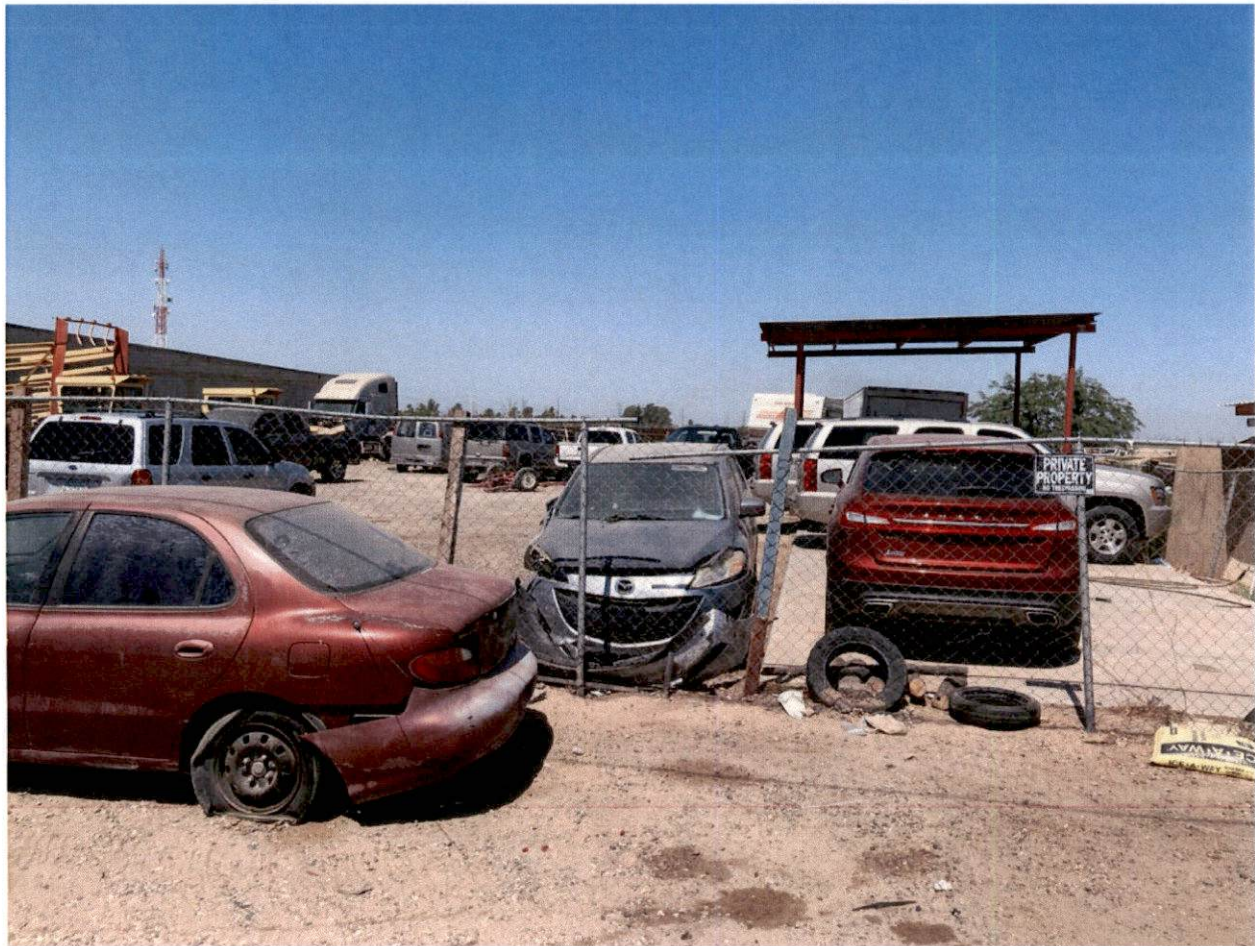
6. Junk / Abandoned Vehicles

This blight factor involves the presence of junk and/or abandoned vehicles, which may include operable and inoperable vehicles with or without proper and up-to-date registration. This blight condition was counted as Unsanitary and Unsafe, or a Deterioration of Site dependent on the actual field conditions present as recorded by the field analyst. This condition was present on a total of 14 parcels or 4.8% of the parcels in the RDA boundary.

Table 3-8 7% the total number of parcels in the RDA is determined to be blighted due to Junk/Abandoned Vehicles.

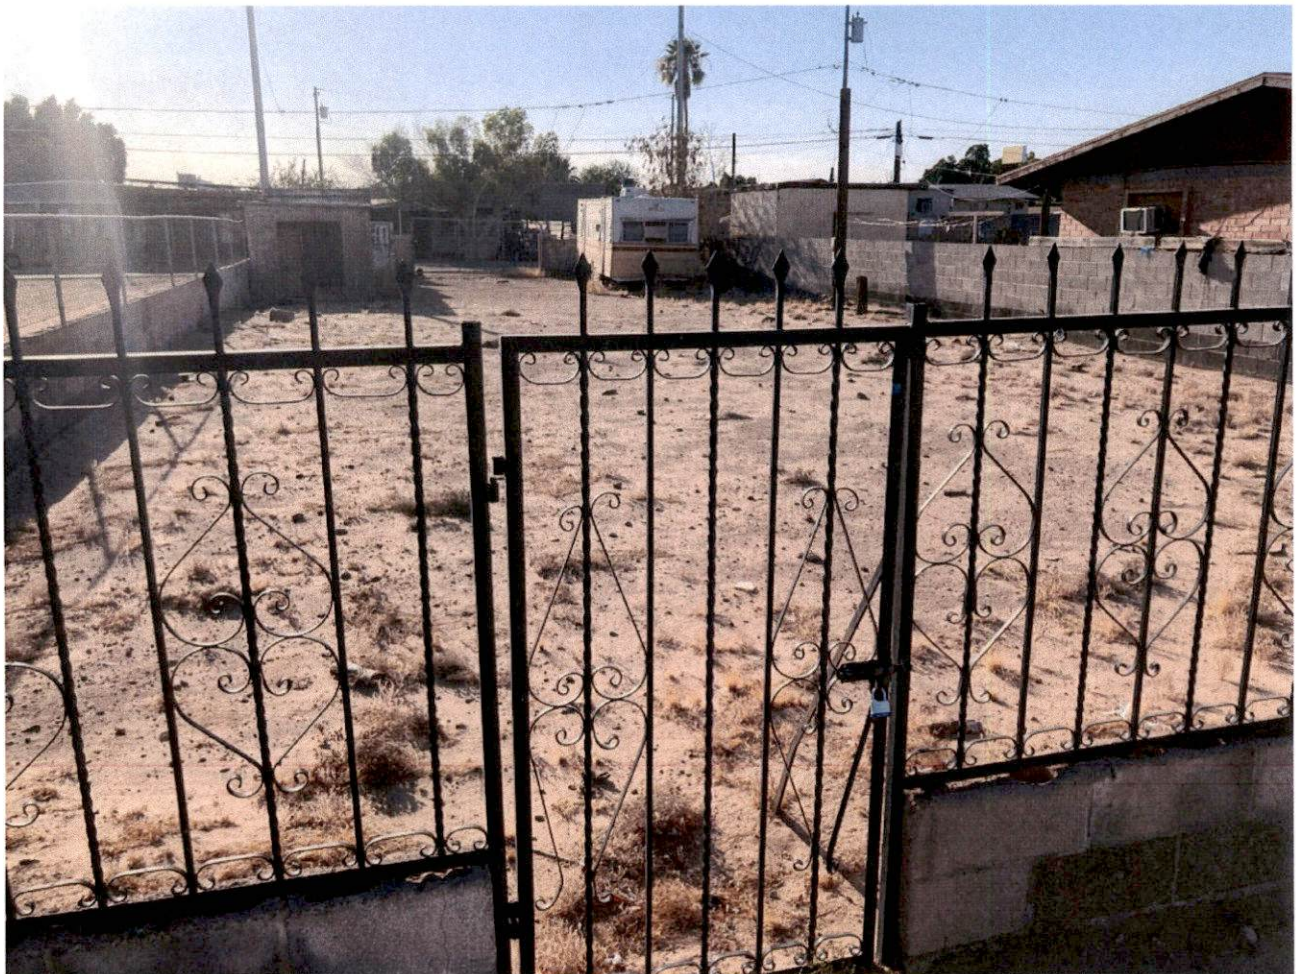
7. Overgrown Weeds / Unkept Landscaping

This blight factor involves the presence of overgrown weeds and/or unkempt landscaping in public view from the public rights-of-way. This blight condition was counted as Unsanitary and Unsafe, or a Deterioration of Site dependent on the actual field conditions present as recorded by the field analyst. This condition was present on a total of 12 parcels or 4.1% of the parcels in the RDA boundary.

Table 3-9 4.1% the total number of parcels in the RDA is determined to be blighted due to Overgrown Weeds / Unkept Landscaping.

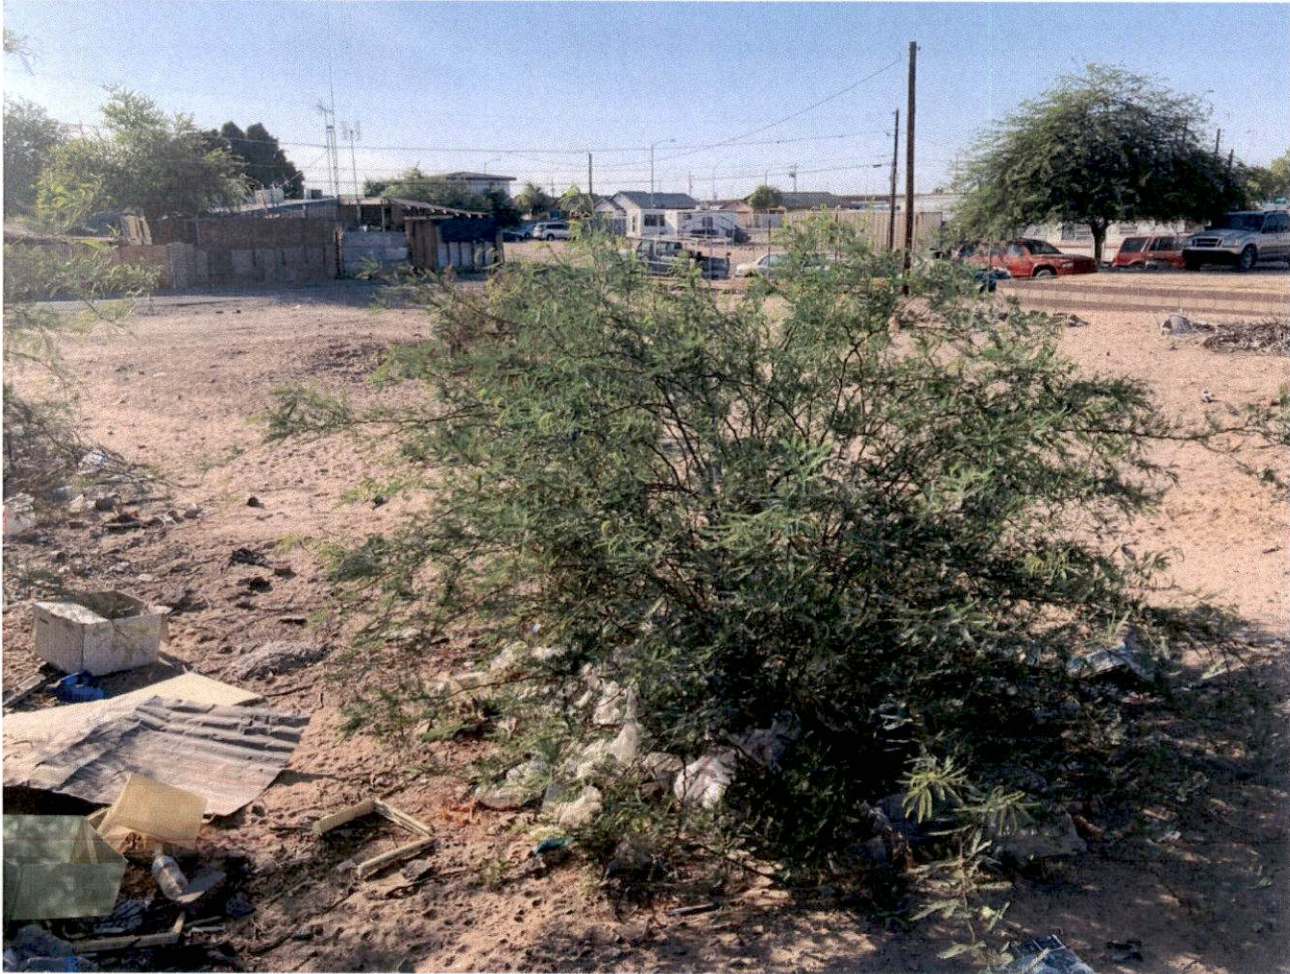
Deterioration of site or other improvements includes physical property conditions that detract from the overall appearance. Parcels were determined to be blighted if they contained the following indicators:

- Deteriorating roof
- Poor pavement conditions
- Excessive weeds
- Broken windows
- Peeling paint

As shown in **Table 3-11**, 37.2% in the research area is determined to be blighted due to deterioration of site or other improvements.
