OHV Impacts in Lower Cache Creek

Cache Creek Technical Advisory Committee

Yolo County Board of Supervisors

October 26, 2021

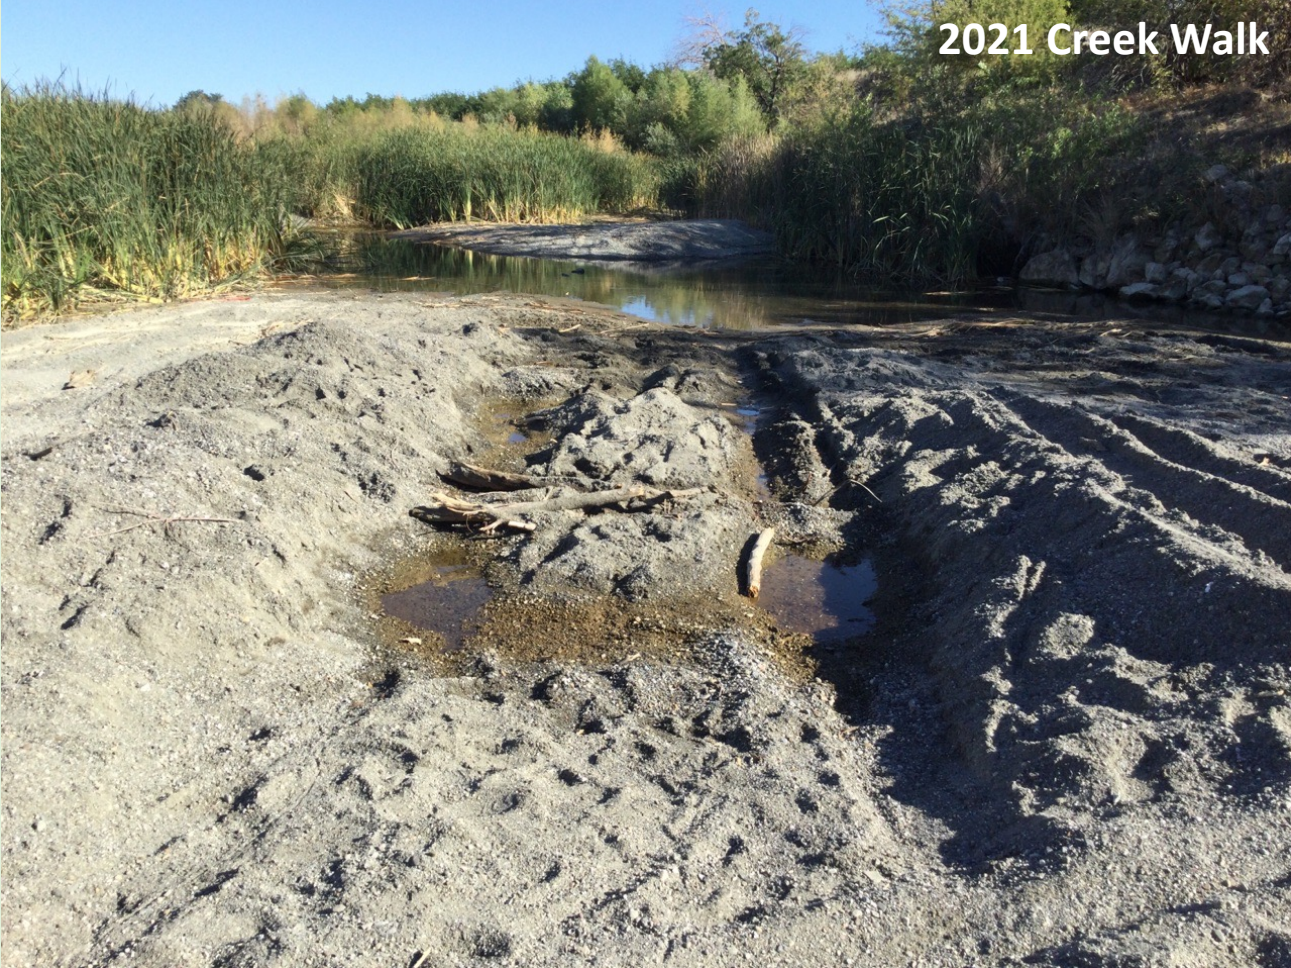
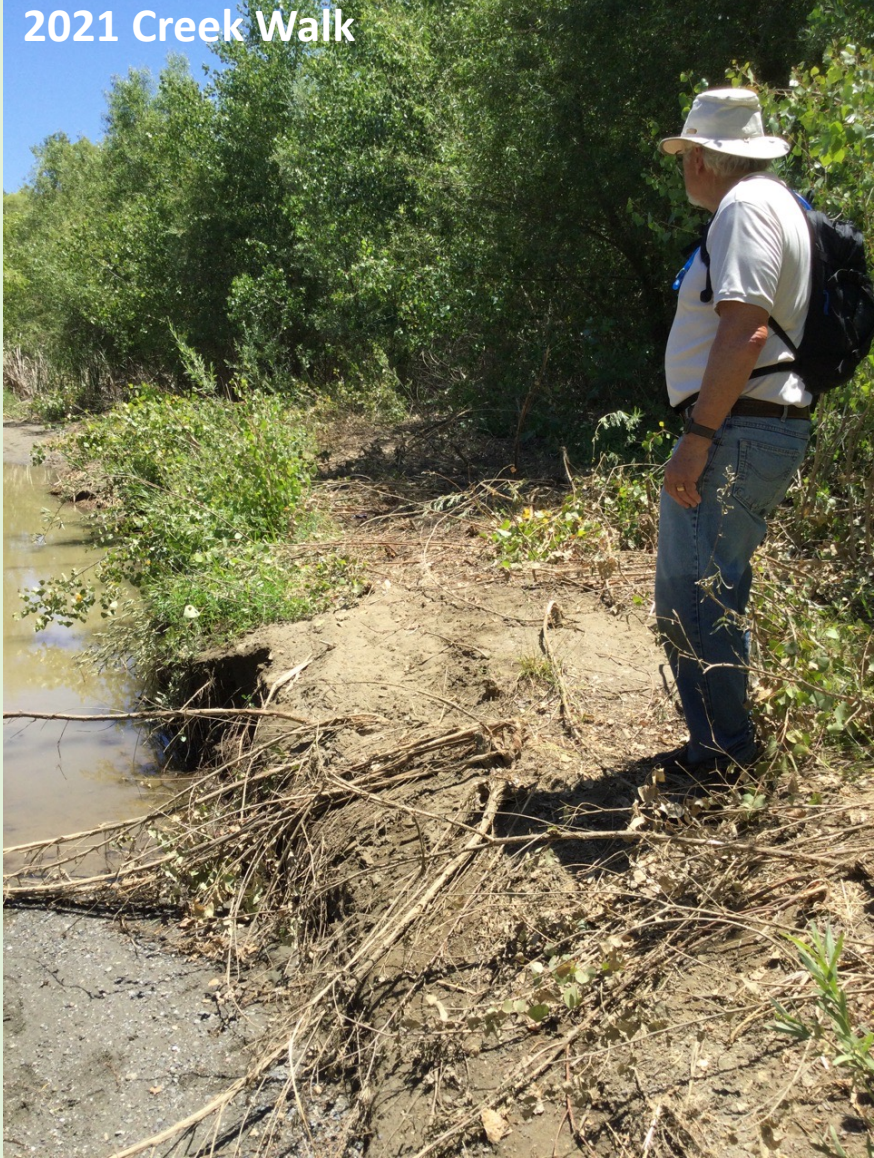
Damage to natural habitat

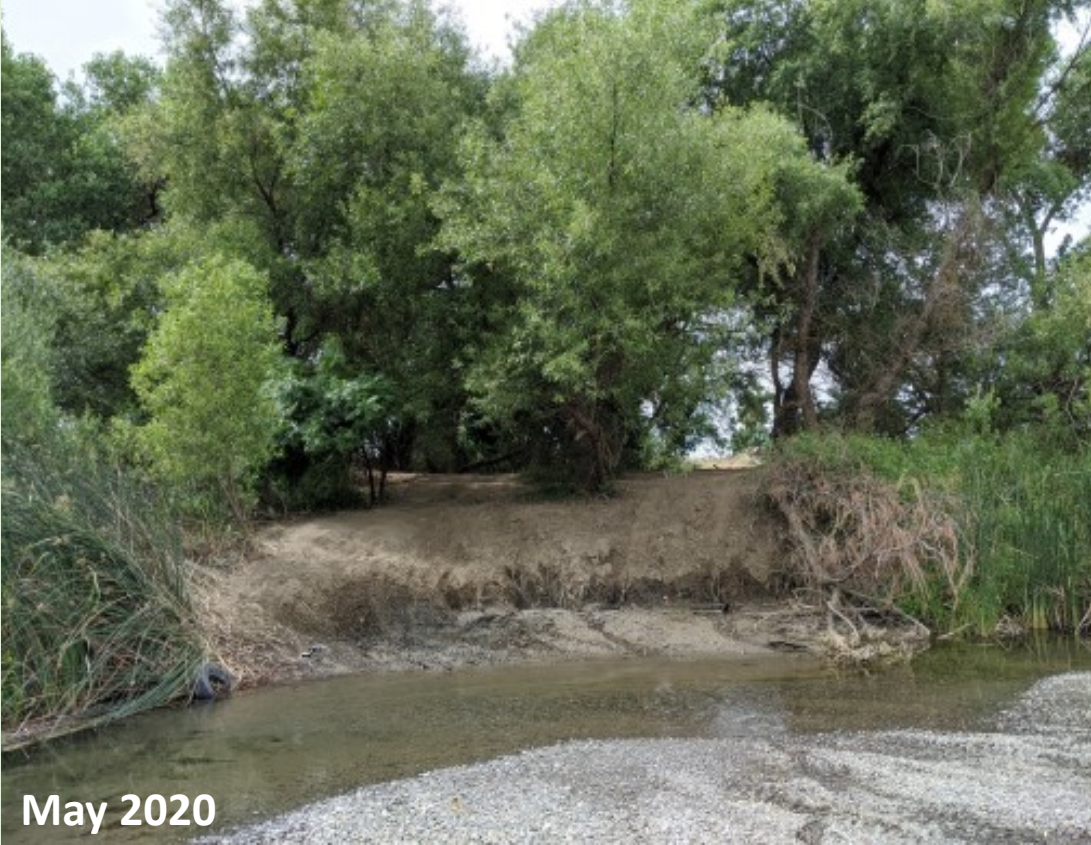
Relatively new OHV road crossing on to creek bank. All the native vegetation on the creek bank has been destroyed.

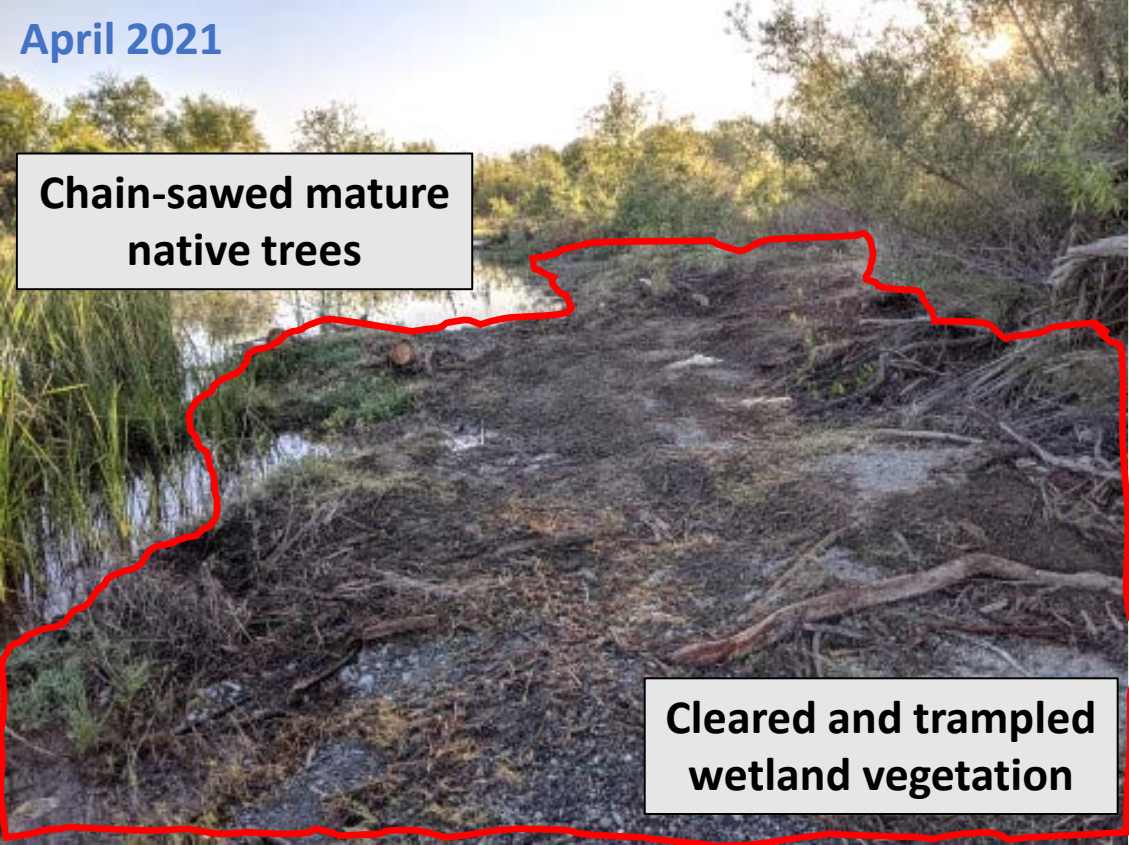
Across the creek from the Cache Creek Nature Preserve. When the primary OHV road was flooded by a beaver pond, OHV users cleared a path through native vegetation.

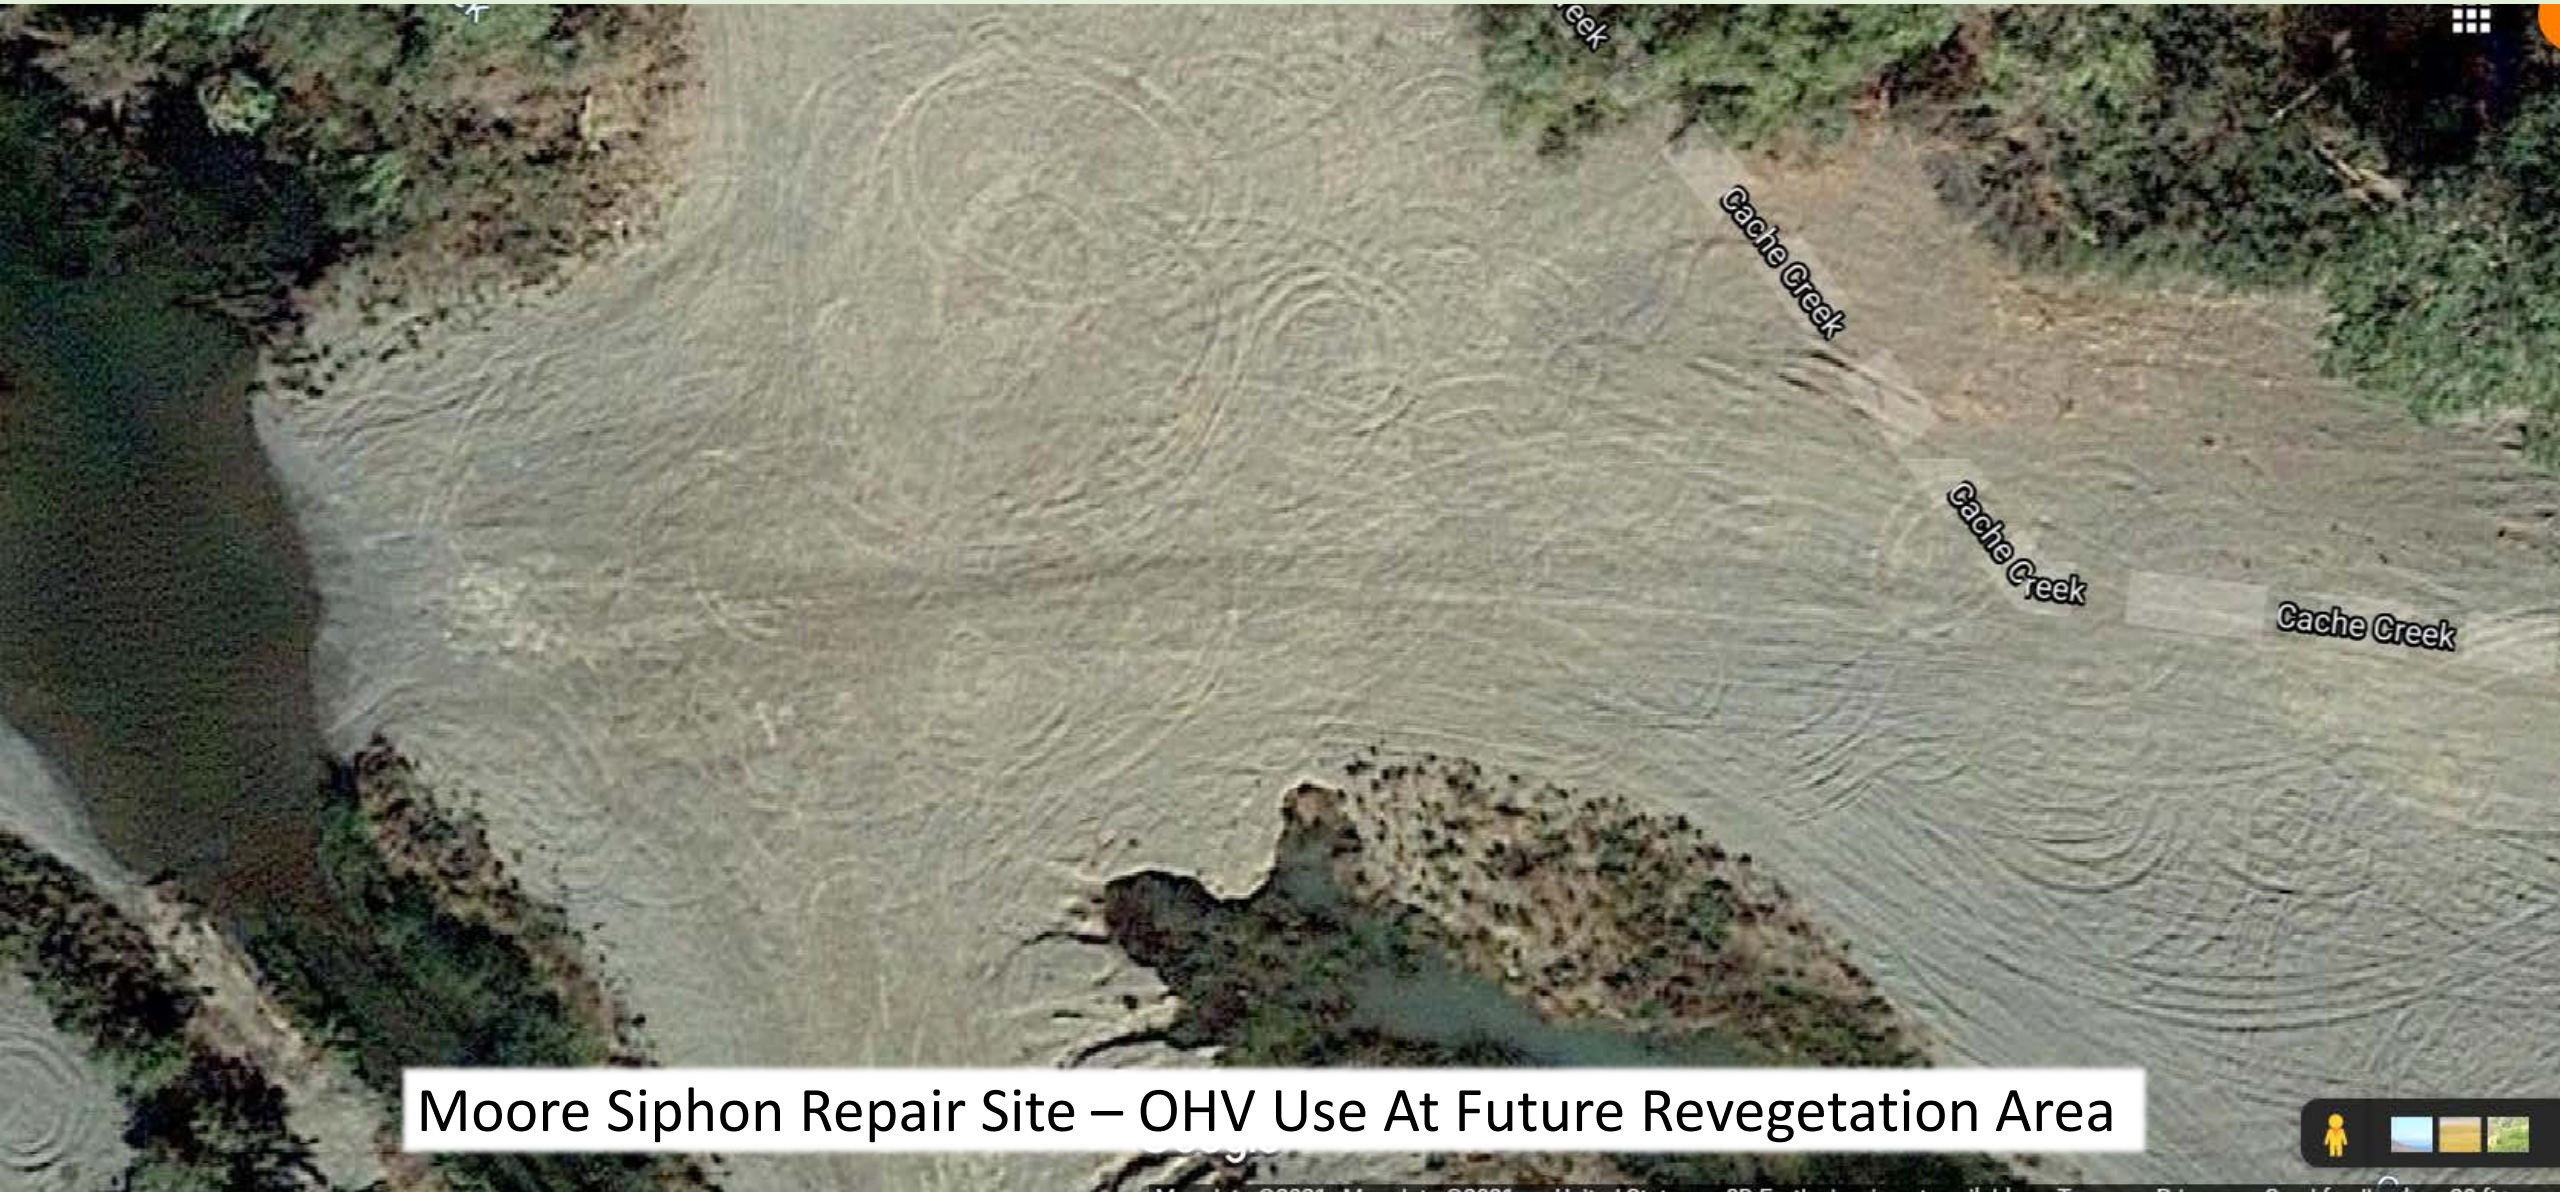
Moore Siphon Repair Site – OHV Use At Future Revegetation Area

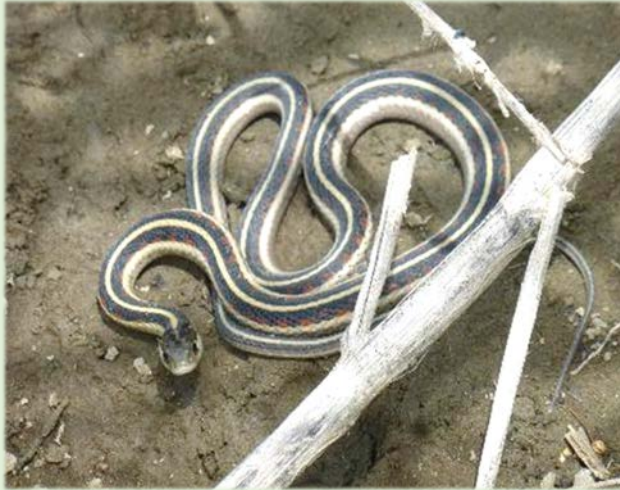
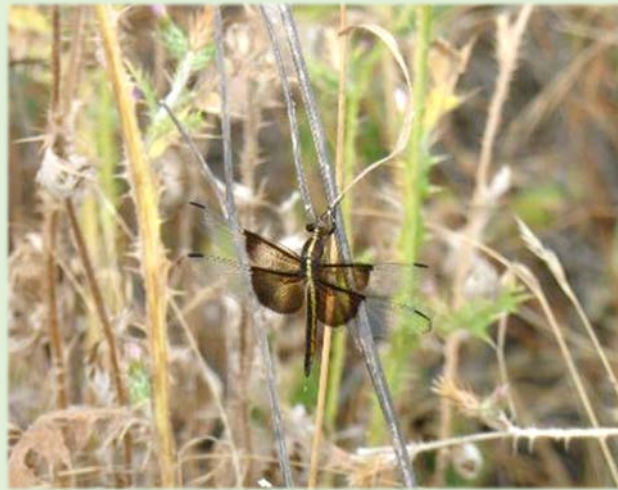
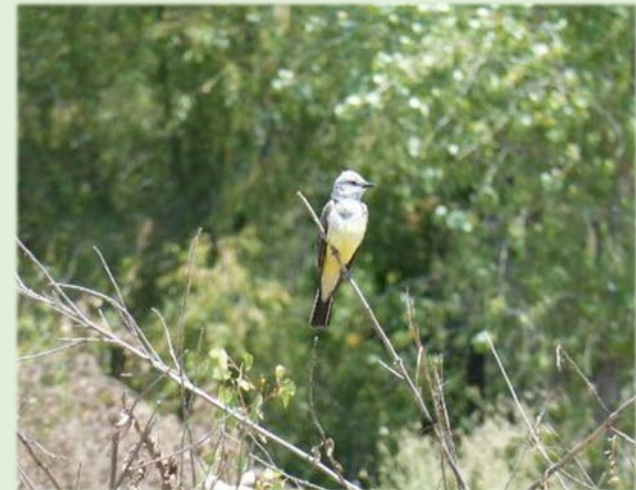
Wildlife disturbance and injury

- Wildlife disturbance from OHVs has been directly observed, including during nesting / breeding season, which can reduce survival.
- Strong potential of injury or death of wildlife unable to avoid fast-moving OHVs.
 - Ground-nesting birds, small mammals, Western pond turtles, amphibians, snakes, fish, insects.

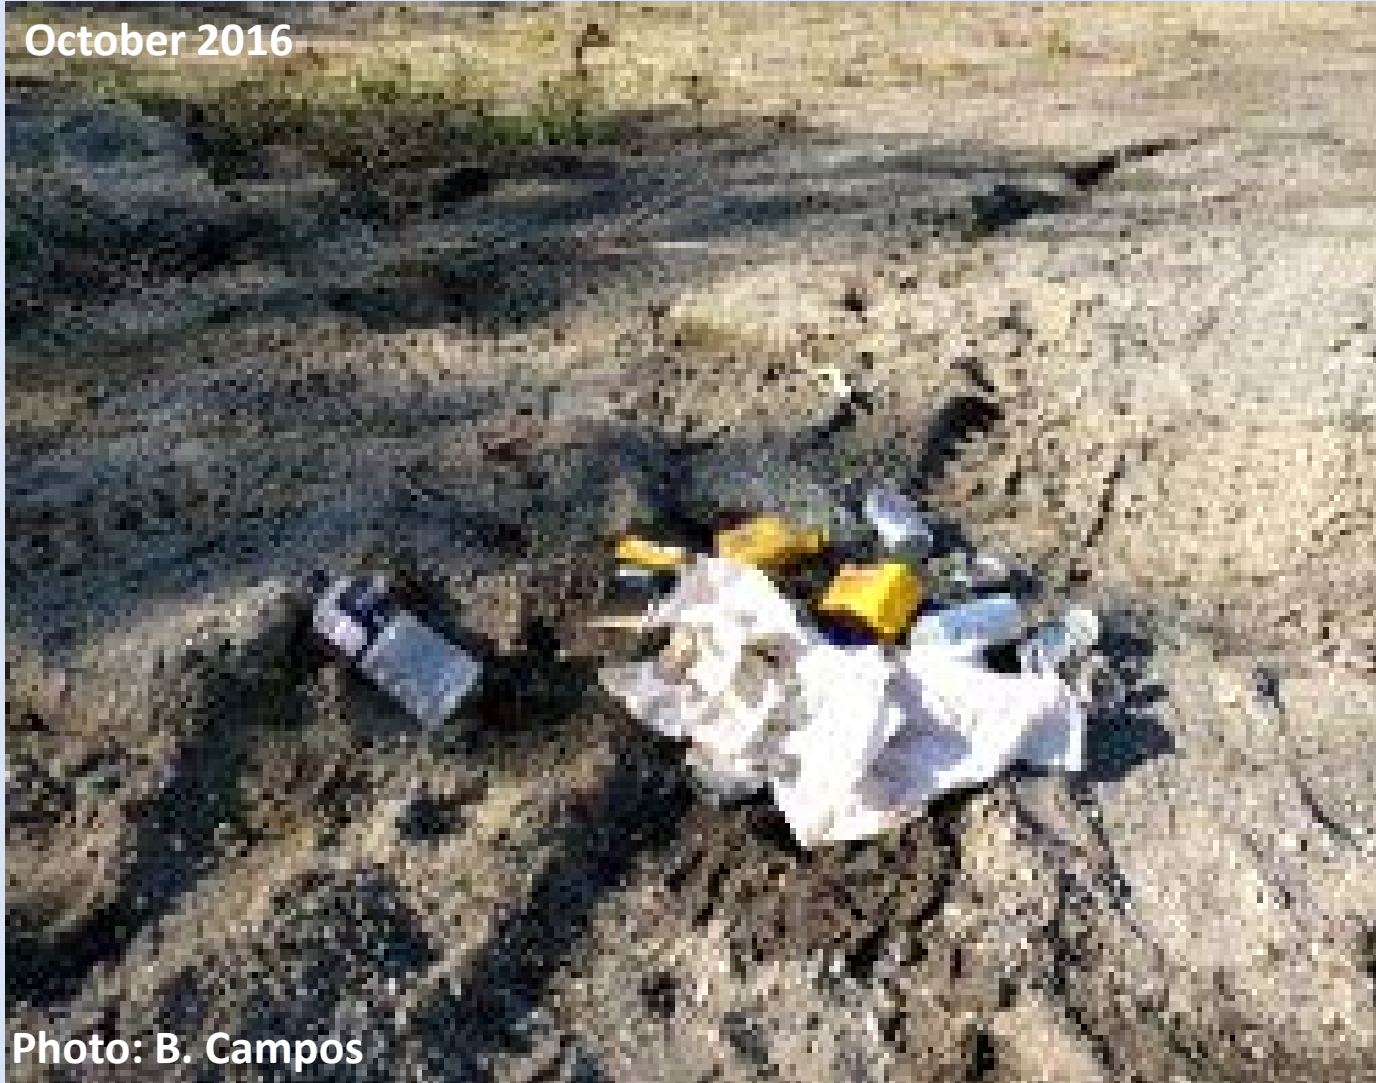
October 2016

An OHV user added oil or changed the oil in their vehicle and discarded the oil containers at the edge of the creek. The soil was saturated with oil.

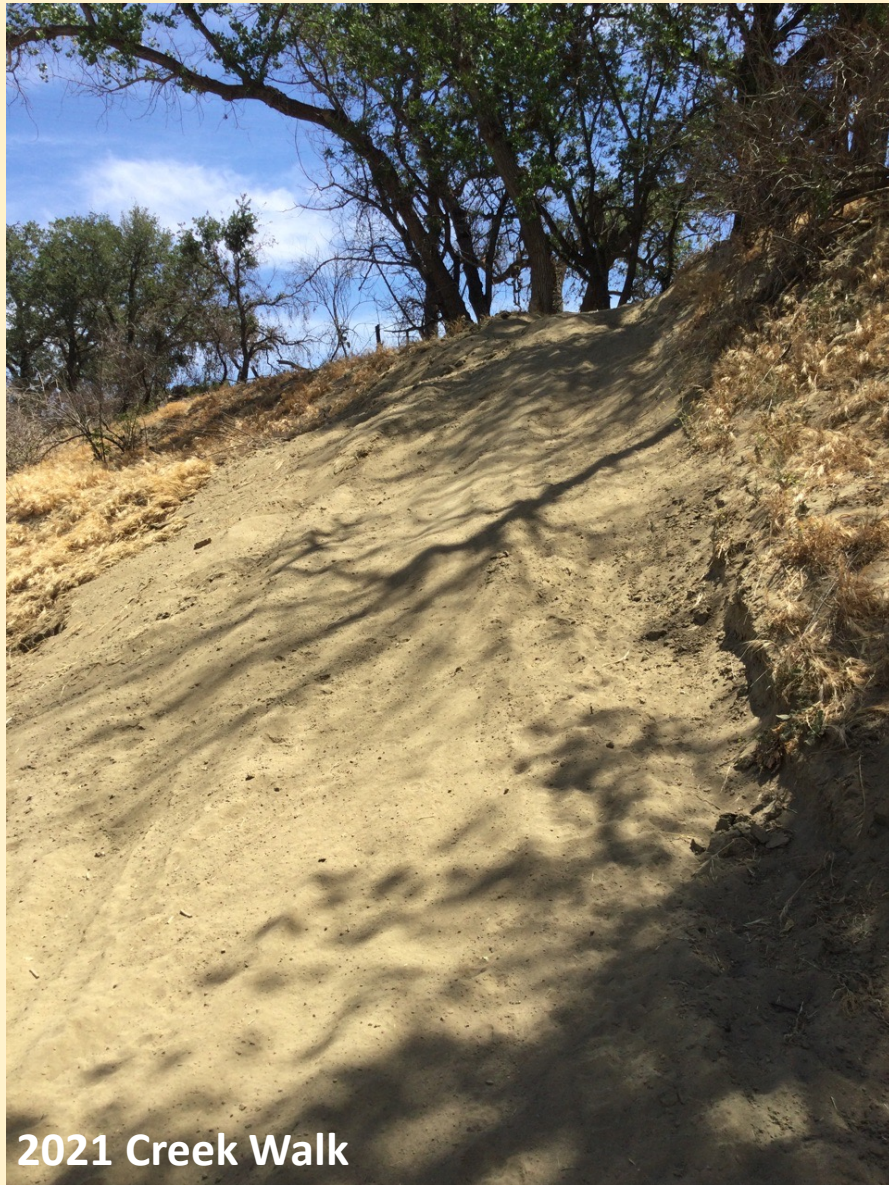
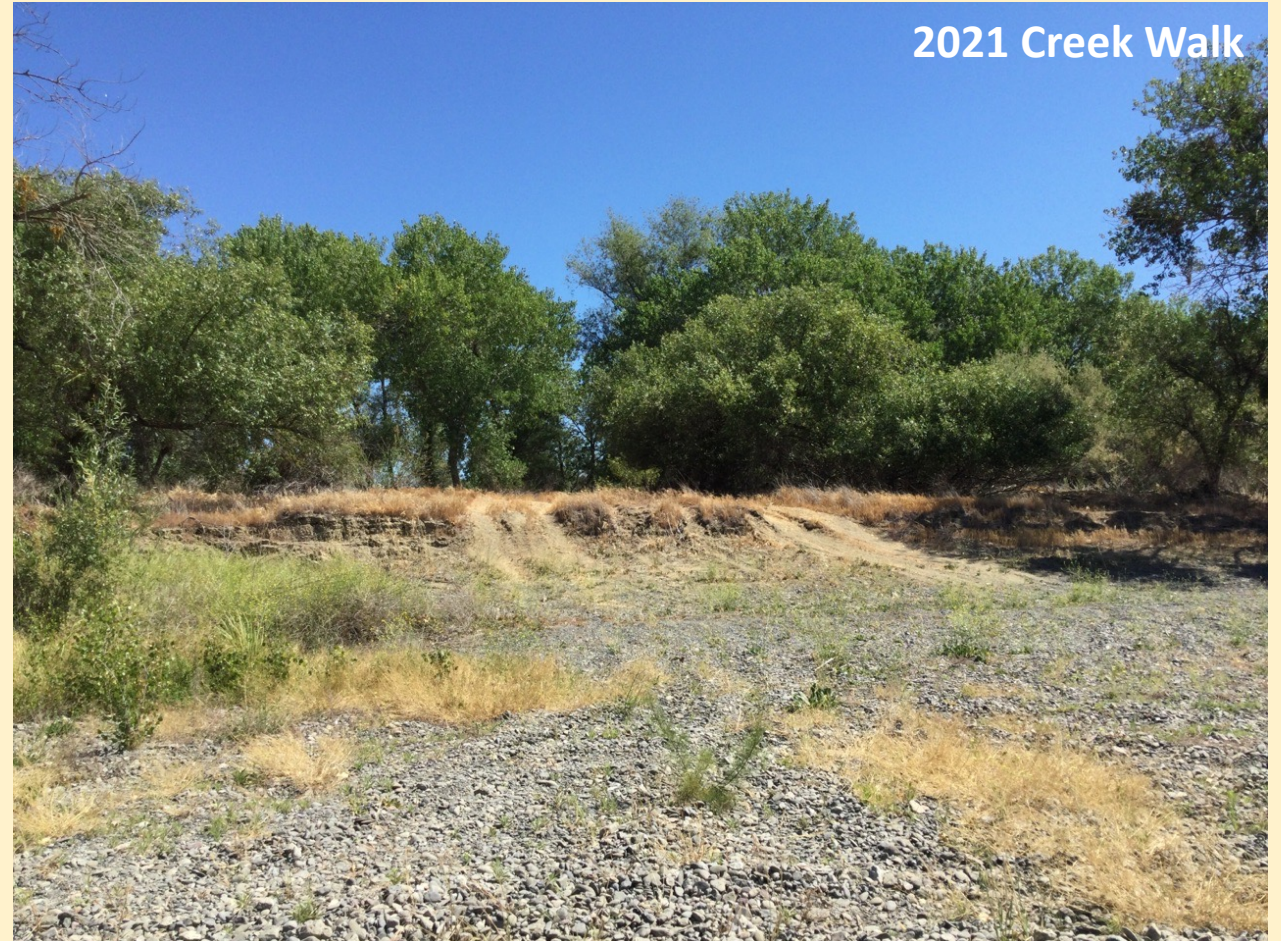
1. Vegetation contributes to natural geomorphic processes - disturbed or destroyed vegetation can increase channel instability and degrade habitat.
2. Direct disturbance of channel bank and bed sediments results in more frequent and more extensive channel instability.
3. Individual site impacts may appear minor, but may cumulatively result in significant loss of channel stability and habitat occurring more frequently than without OHV use.
