# Stillwater Building Inspection Summary

Prepared by the City of Billings – Facilities Division

8/11/2021

# **Structural Condition Assessment Report**

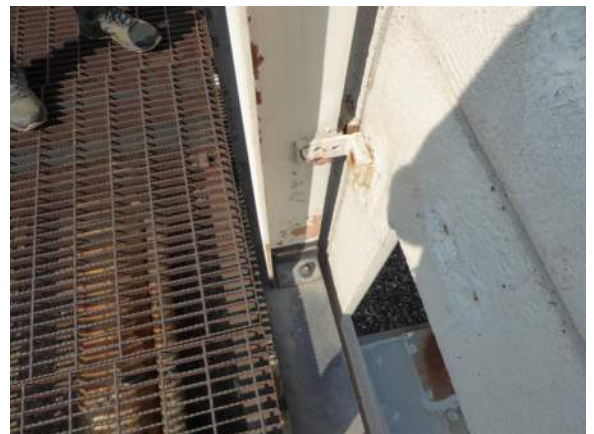
P44: Roof top mech equipment enclosure; precast concrete panels and steel frame; panel joint connection to column

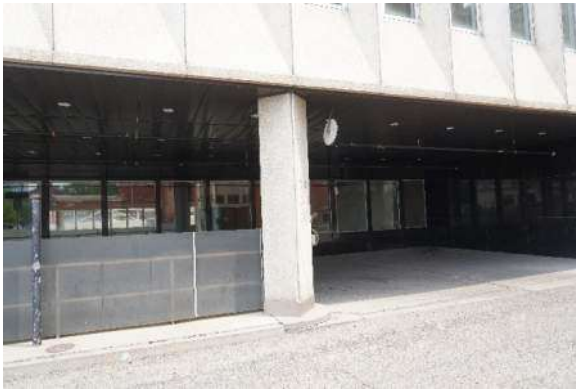
entry and ramp to the basement level parking garage are located on the west elevation. Two additional, overhead doors are located at grade, near the west end of the south elevation and the south end of the west elevation. **(Photos #3 and #4)** A pedestrian bridge was constructed across North 26th Street to a neighboring parking garage. Two precast wall panels were removed during the bridge construction and were available for our examination. **(Photo #5)** The removed window units were also stored but were wrapped and not readily accessible for our examination.

**Photo #3** West elevation entry to the vehicular ramp to the basement garage.

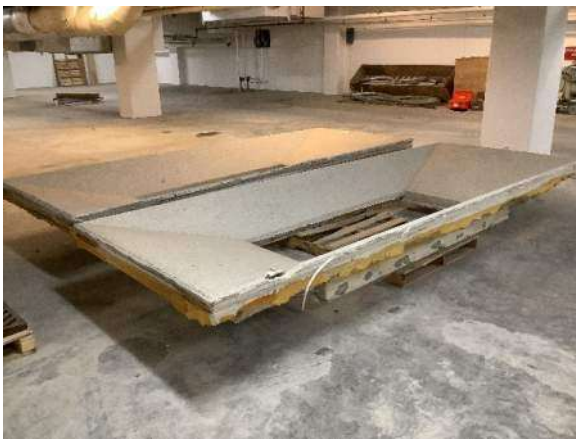
**Photo #5** Precast panels removed as part of the pedestrian bridge construction.

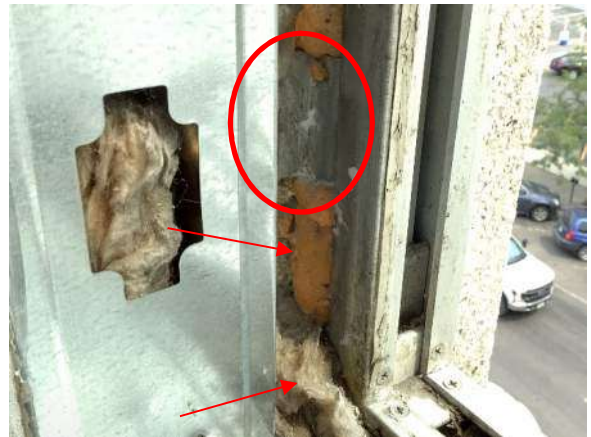
**Photo #34** Batt & SPF insulation indicated by red arrows. Window anchor indicated by red oval.

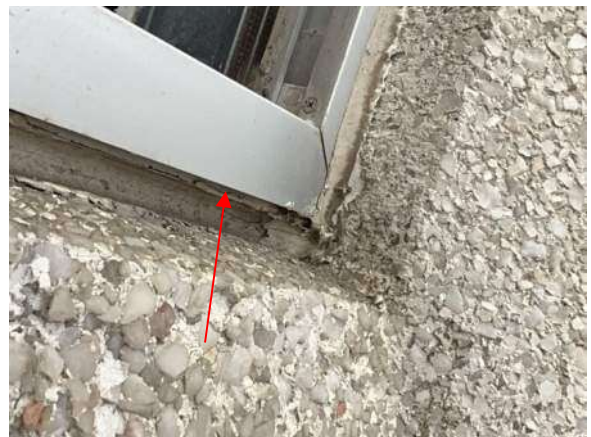
**Photo #36** Approximate location of the weep hole is indicated by red arrow.

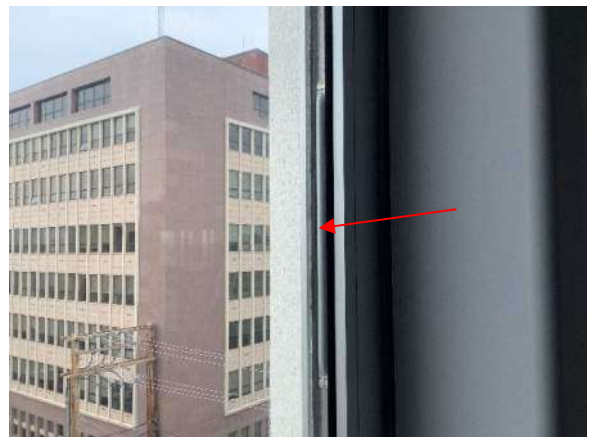
as three distinct types of IG units were observed. The original IG units have an aluminum channel spacer with a desiccant-filled tube mounted to the jamb spacer. **(Photo #48)** The original exterior glazing material appeared to be compound glazing and, as noted above, was observed to typically be in very poor condition. The original interior glazing material was a continuous gasket, and the original IG units have "Thermopane" etched in the lower right corner. **(Photo #49)**

**Photo #48** Desiccant-filled tube (red arrow) typical of original IG units.

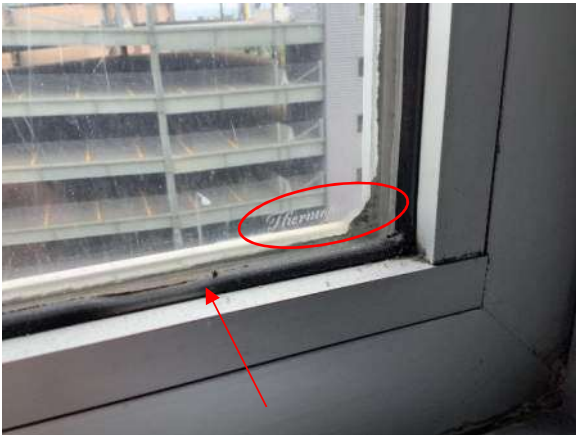
**Photo #49** Original IG units have “Thermopane” etched in the lower right corner (red oval) and interior glazing gaskets (red arrow).

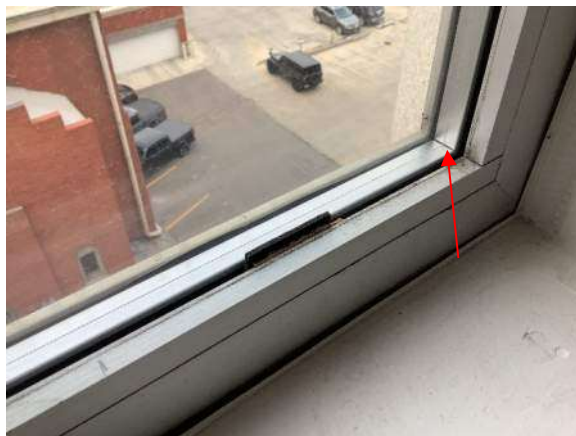
**Photo #51** Recently replaced IG units typically have no spacer stamp and the spacers have cut corners (red arrow).
