## WORK SESSION AGENDA

August 16, 2021

# **Structural Condition Assessment Report**

Subject: Stillwater Building Preliminary Condition Assessment

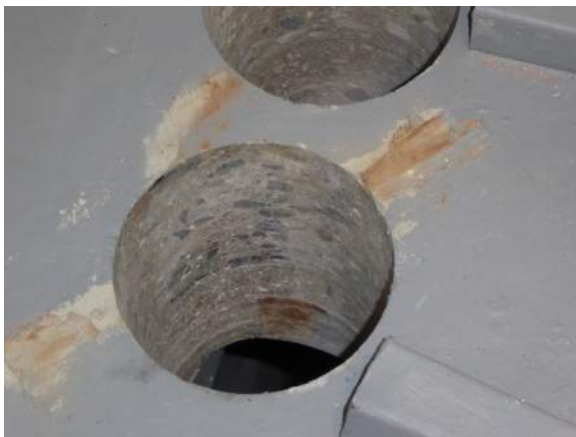
P11: slab on metal deck core holes

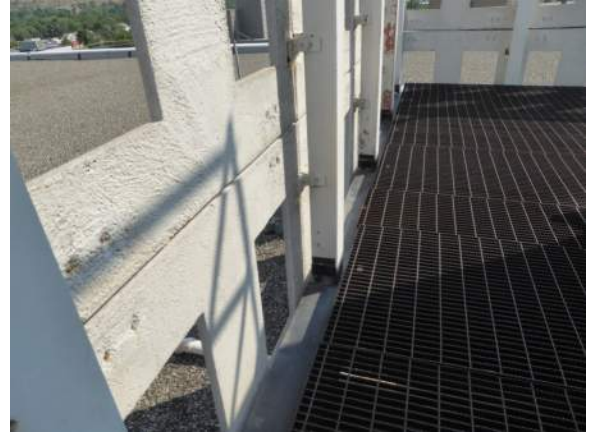
P40: Roof top mech equipment enclosure; precast concrete panels and steel frame

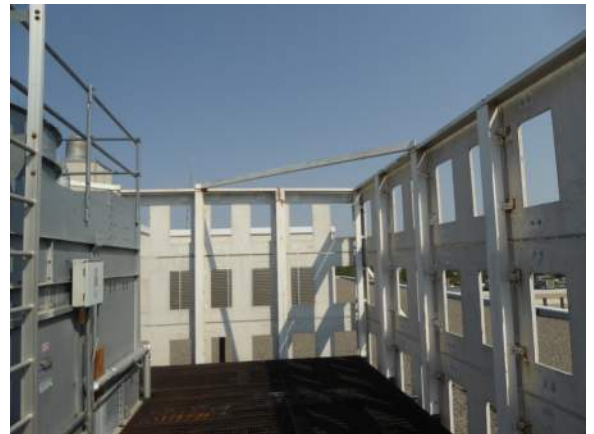
P42: Roof top mech equipment enclosure; precast concrete panels and steel frame

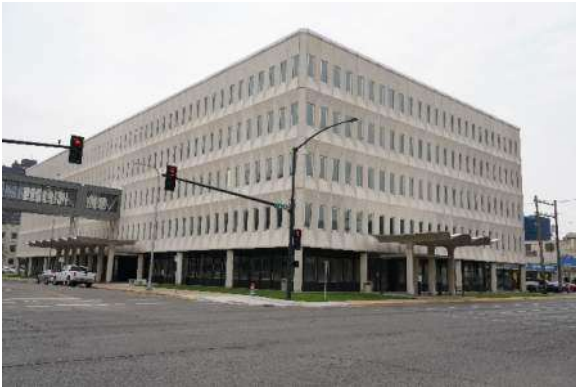
**Photo #1** Overall view of the Stillwater Building looking southwest.

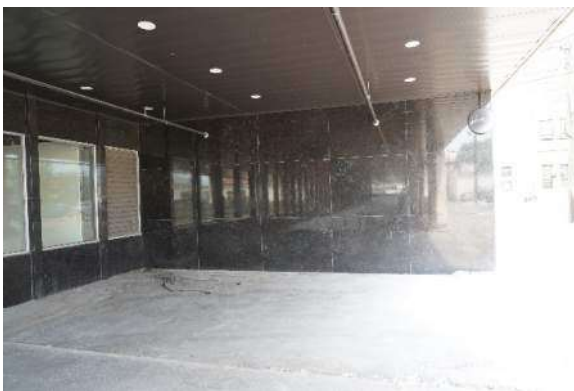
The granite cladding at the first floor was observed to be in generally good and serviceable condition. **(Photos #22 and #23)** Evidence of deterioration or distress was not observed within the areas of granite cladding during our assessment. Other than the wall areas adjacent to the overhead doors, the exterior walls at the first floor are protected from the weather by the overhanging the upper floors. Granite is an extremely durable material and unlikely to require maintenance over the life of the building.

**Photo #22** Typical view of the granite cladding installed at the first floor.

**Photo #23** View showing the granite cladding at the top of the vehicular ramp.

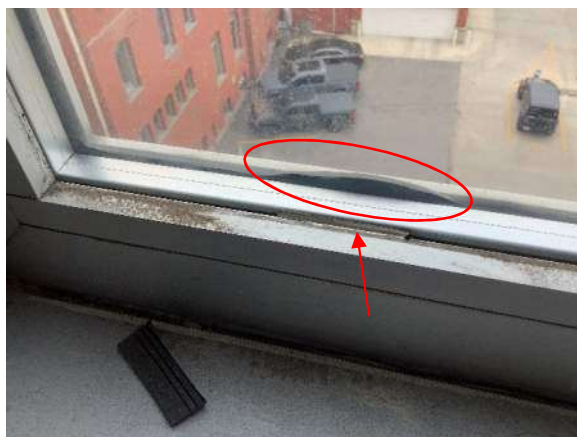
The first replacement program is believed to have occurred around 1991 as the Insulating Glass Certification Council (IGCC) spacer stamp is dated from 1991. **(refer to Photo #31)** The 1991 replacement IG units were "wet" glazed at the exterior, and the original interior gaskets were typically reinstalled but were often damaged. **(refer to Photo #31)** It was reported that as many as 80 additional IG units were recently replaced, and stickers were present on the interior of a few recently replaced units. **(Photo #50)** These recent replacements do not have IGCC spacer stamps, and the spacer is cut at the corners. **(Photo #51)** The recent replacements used butyl tape as the exterior glazing material, but rubber shims were used in lieu of continuous gaskets at the interior of the units. The shims were typically installed at two locations along the head and sill and at three locations along each jamb. At many locations, the head shims had fallen out. At the sill, we observed the butyl glazing materials pushing out of the glazing joint at the shim locations indicating a high level of IG unit edge pressure at the shim locations. **(Photos #52 and #53)**

**Photo #53** Butyl glazing tape bulging from the exterior glazing joint (red oval) at the shim (red arrow).

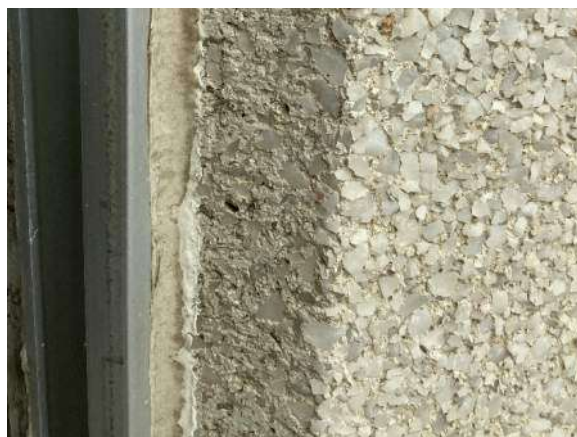
**Photo #54** Window perimeter sealant at the fourth floor. Two colors of sealant indicate that the sealant has been overcaulked.

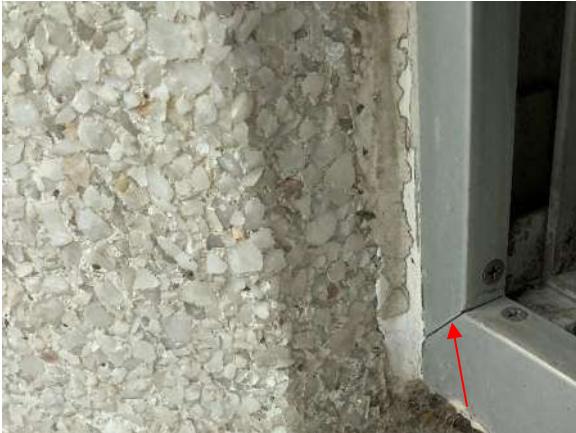
**Photo #55** Overcaulked window perimeter sealant at the fourth floor. Note that the frame corner joint is open (red arrow).

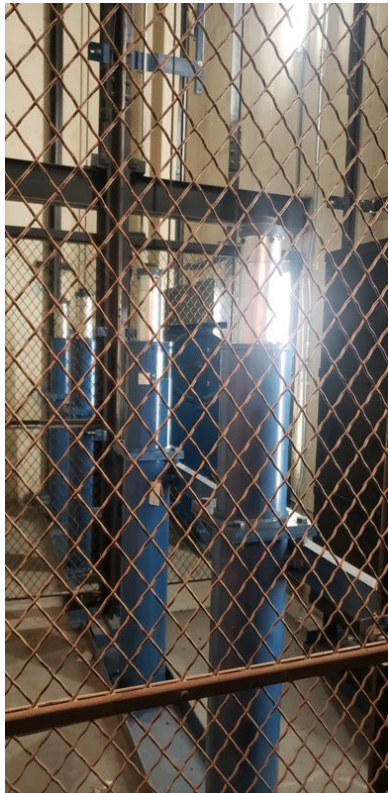
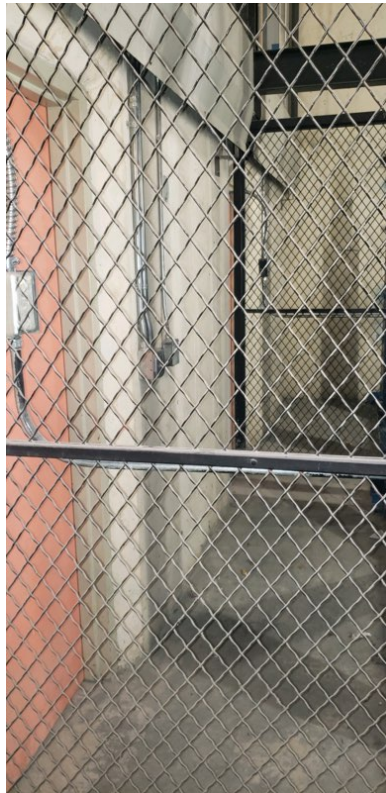
Oil buffers are code compliant

lighting, properly barricaded and door entrances are code compliant

Elevator pits are clean, have adequate
