Housing Rehab Program

PROJECT: Reconstruction of a single family housing unit located at: 1000 Dove St., Alamo, Texas

PROJECT: Reconstruction of a single family housing unit located at: 8015 Buckles Blvd., Edinburg, Texas

INITIAL INSPECTION

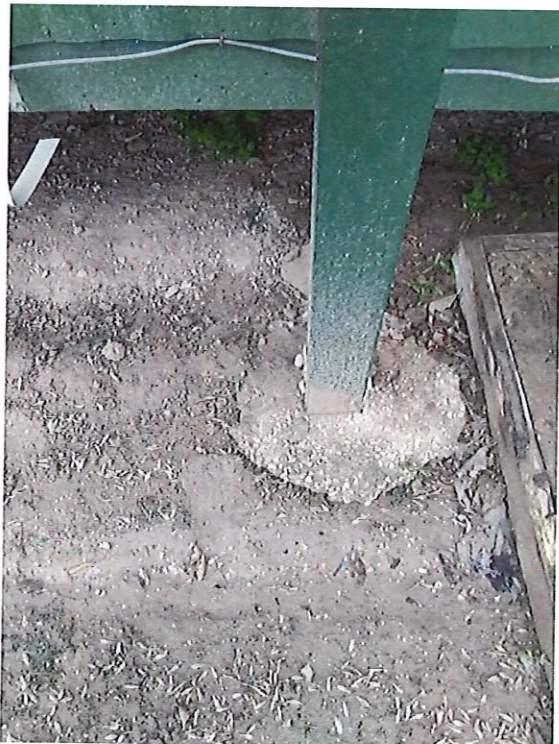
Footing for free standing roof

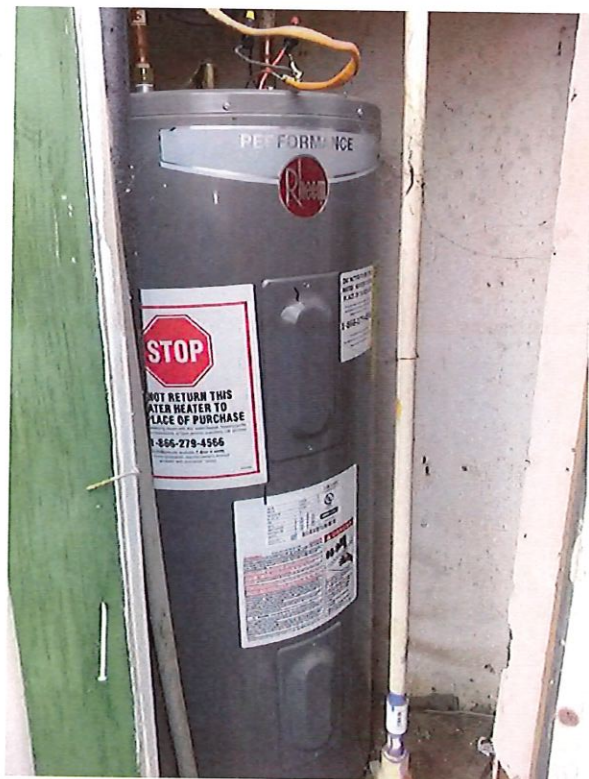
Electric water heater

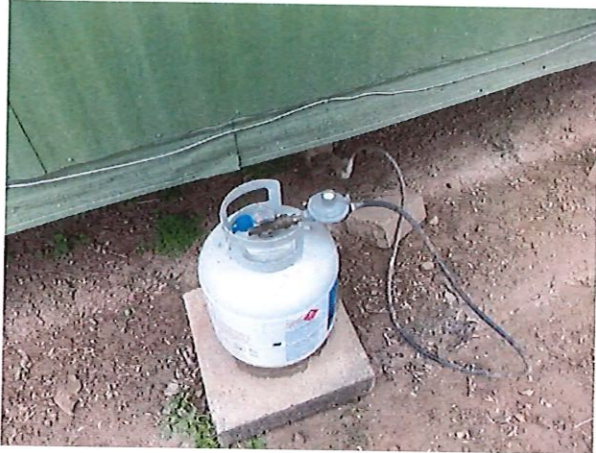
Propane tank

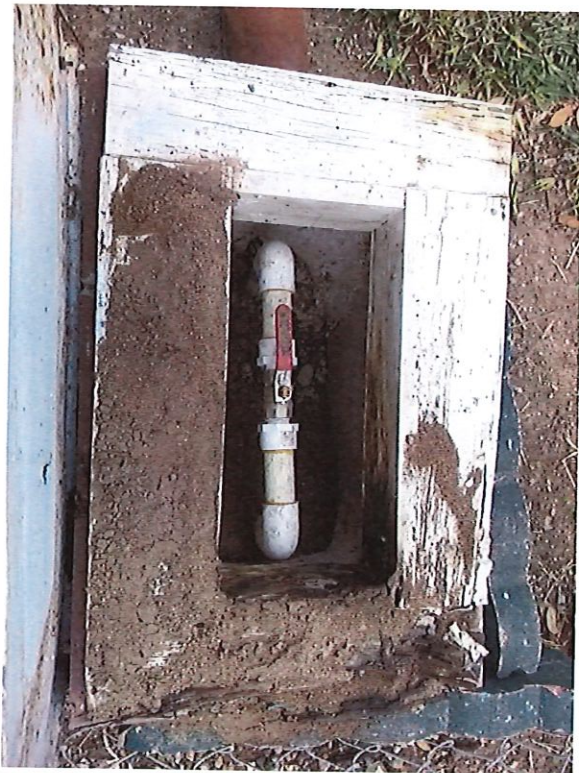
Water connection

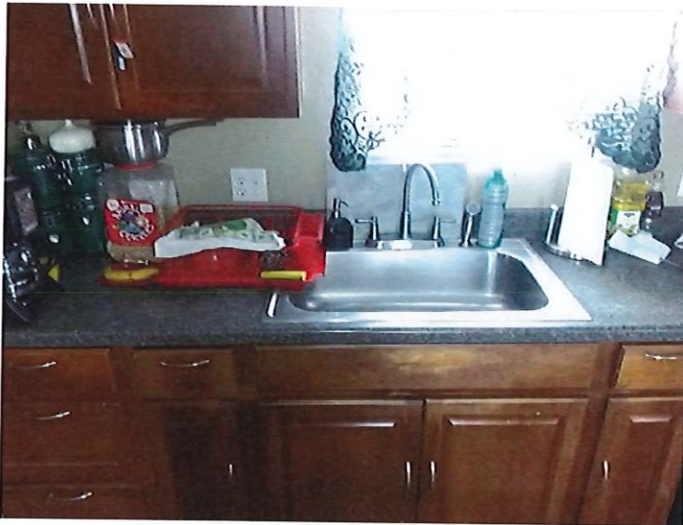
Kitchen sink

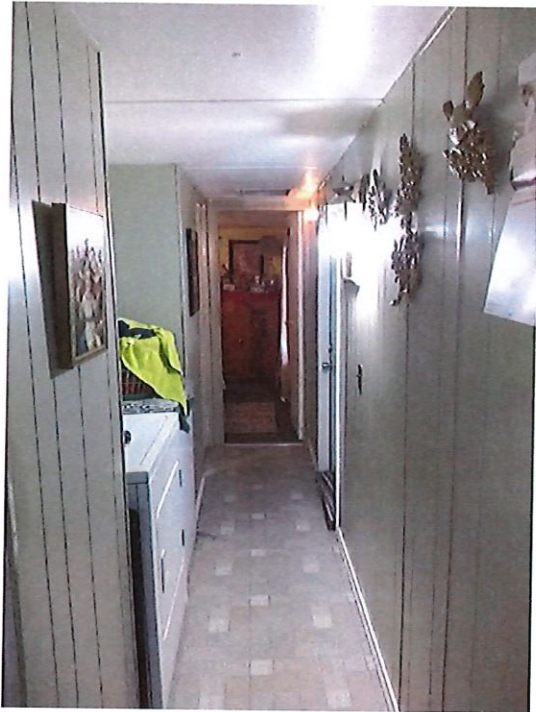
Hall way

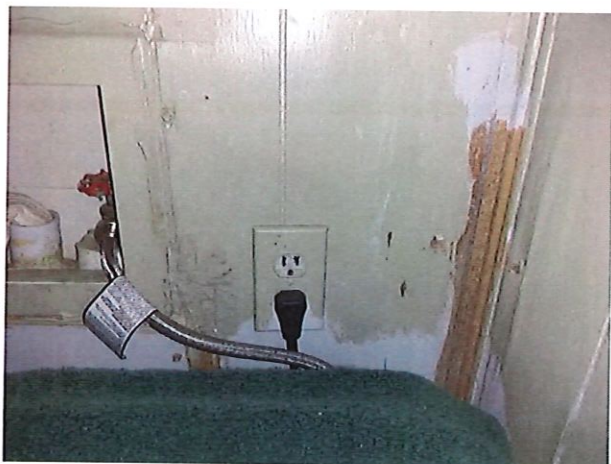
Behind washer
