**NOTICE OF MEETING
TOURISM ADVISORY BOARD
August 17, 2021
11:00 AM
Council Chambers
504 N. Queen Street
Palestine, TX**

MT. VERNON AME
913 E. Calhoun Street
Palestine, Texas

Preservation Master Plan – Phase 1
February 10, 2021

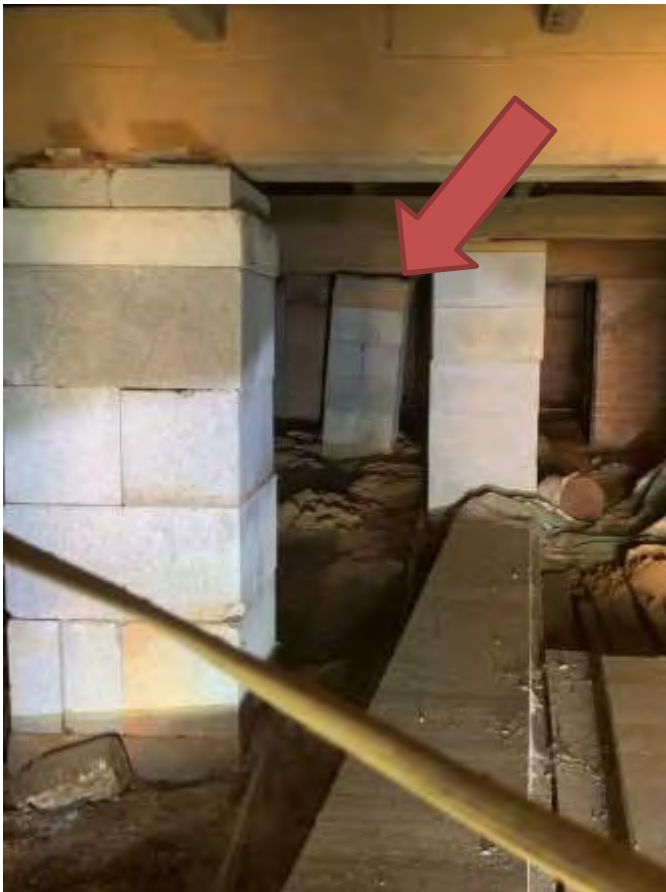
Crawl space, View to west. Several piers have settled and/ or rotated.

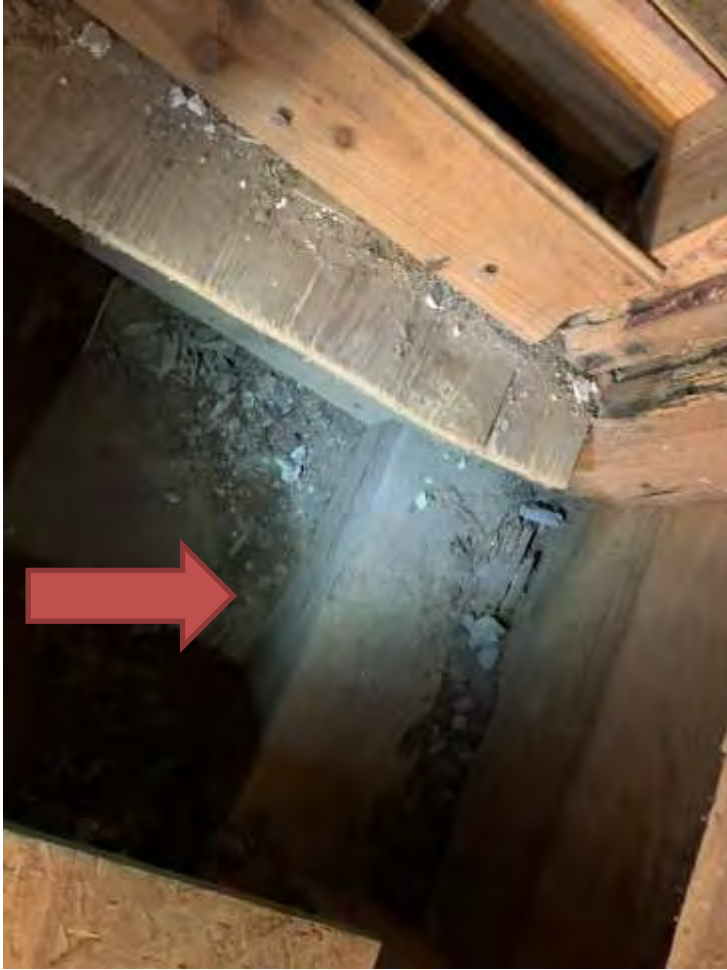
Near northeast corner at Women's restroom. Wood sill in contact with grade.

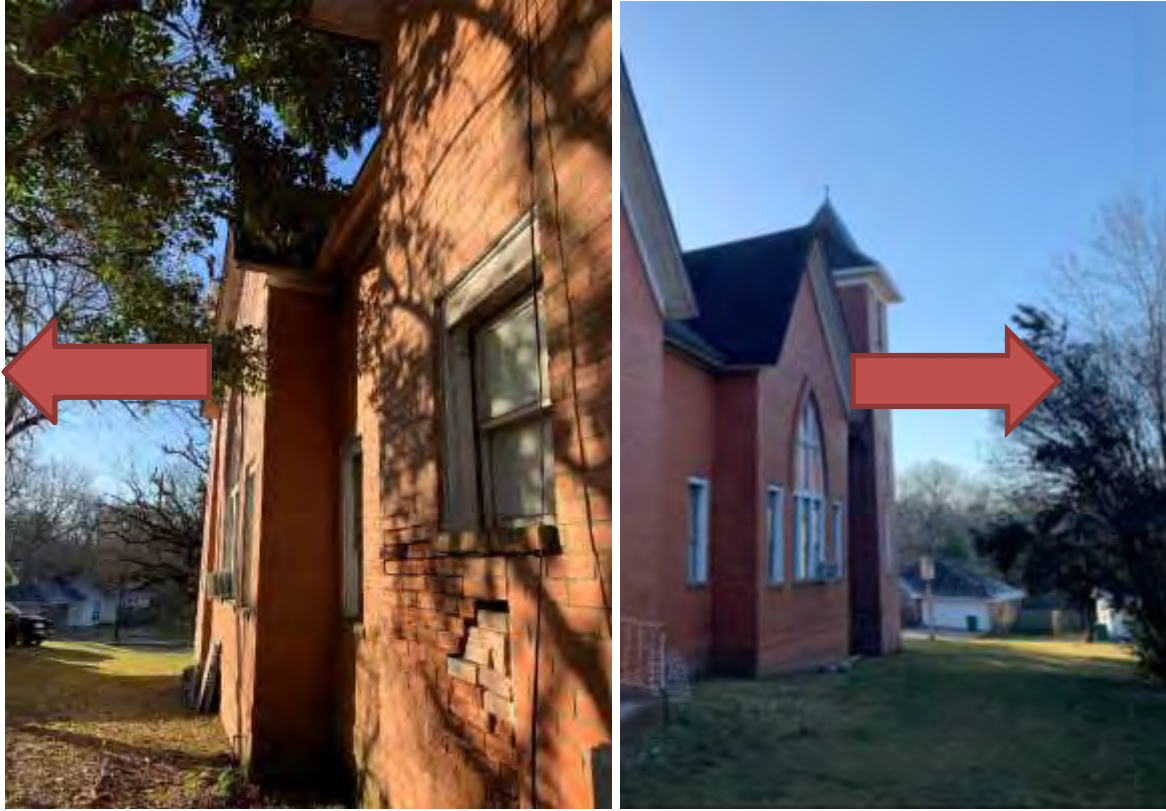
Exterior walls are of the initial brick veneer construction; ca 1921 was the era of transition from the bonded wall systems to the common brick veneer systems where a single wythe of brick are installed and secured laterally to wood framing. Exterior masonry is included in this section because it is an integral part of the exterior wall system. Note that this early veneer system did not incorporate a moisture barrier between the wood sheathing and back of brick.

Outward movement of Sanctuary east and west gables.

1. Remove brick from the west and east Sanctuary gables. Phase II.
2. Reinforce walls and add additional framing for cable bracing. Phase II.
3. Install cable bracing in exterior west and east walls to restrain further outward movement. Phase II.
4. Reinstall brick masonry. Phase II.
5. Secure connections and install additional reinforcement in attic. Phase II.
6. Repair and restore interior finishes in Sanctuary. Phase III.
7. Replace deteriorated roof decking and replace the roof system. Phase II.
8. Repoint all exterior masonry on remainder of building. This work can take place under any phase after cable bracing has been installed. Phase III.

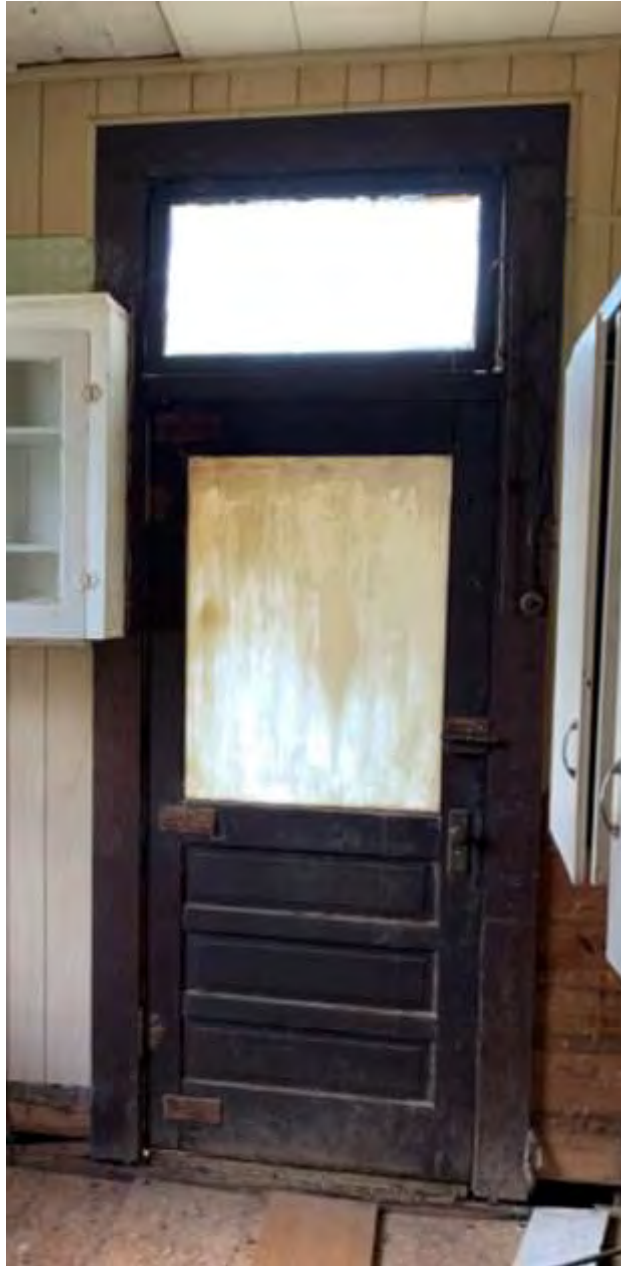
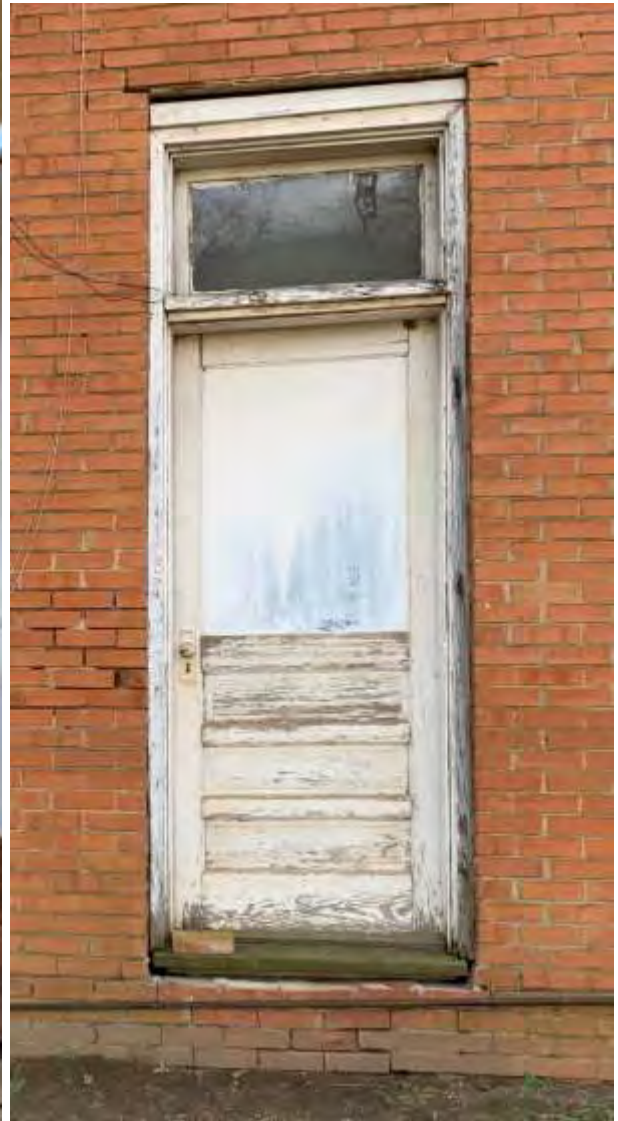
All exterior doors are modern except the one located at near the southeast building corner. The original wood exterior door is a half glass over three panel door with original hardware. This door also contains a transom window with its original hardware. The door has had some reinforcements added to the surface. The interior side of the door was originally natural wood finish and the exterior door and frame were painted white. The door and transom are restorable.

Exterior door near southeast building corner. Interior and exterior view.

1. Repair doors so they will function properly. Conduct minor repairs on hardware. Phase IV.
2. Restore original Multipurpose room door and hardware. Phase V.
3. Replace all hollow metal doors with replica wood doors. Phase V.

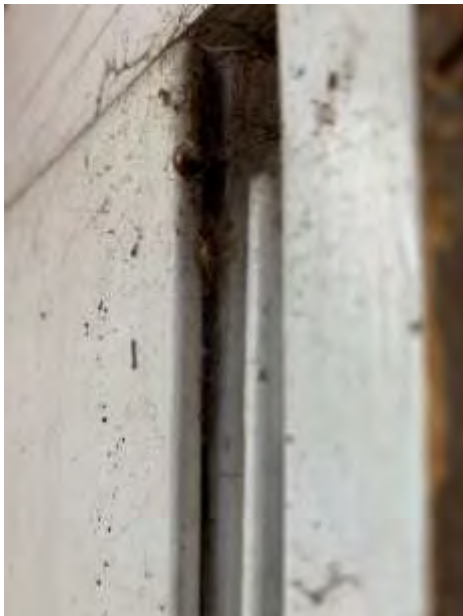
Modern exterior doors consist of laminated doors with metal surface panels. They are currently exhibiting signs of corrosion and will have a limited life. The oldest doors (ca. 1950's) are located as door pairs for the two towers facing Calhoun Street. The exterior door into the Multipurpose room near the northwest corner is ca. 1970 to present era. These two door pair and the single door should be replaced during Phase V.

Face sheet separation of door edge.

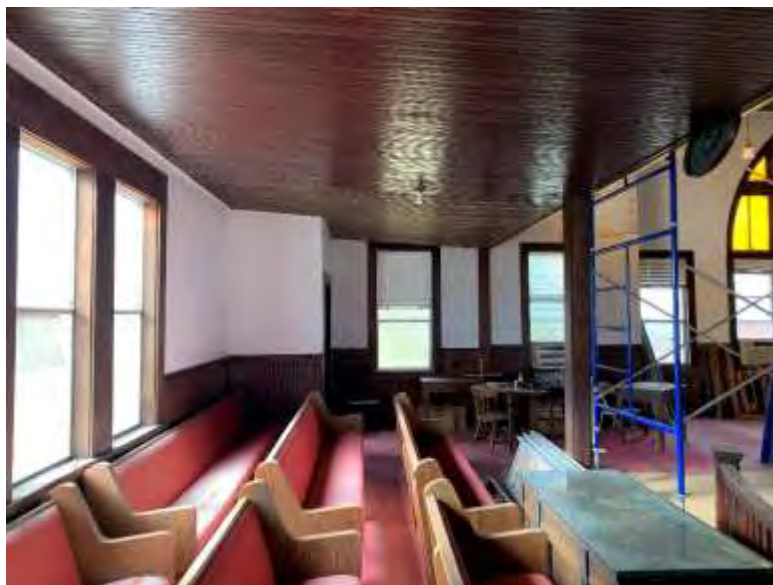
All lower, rectangular, windows of the Sanctuary are non-original aluminum frame.

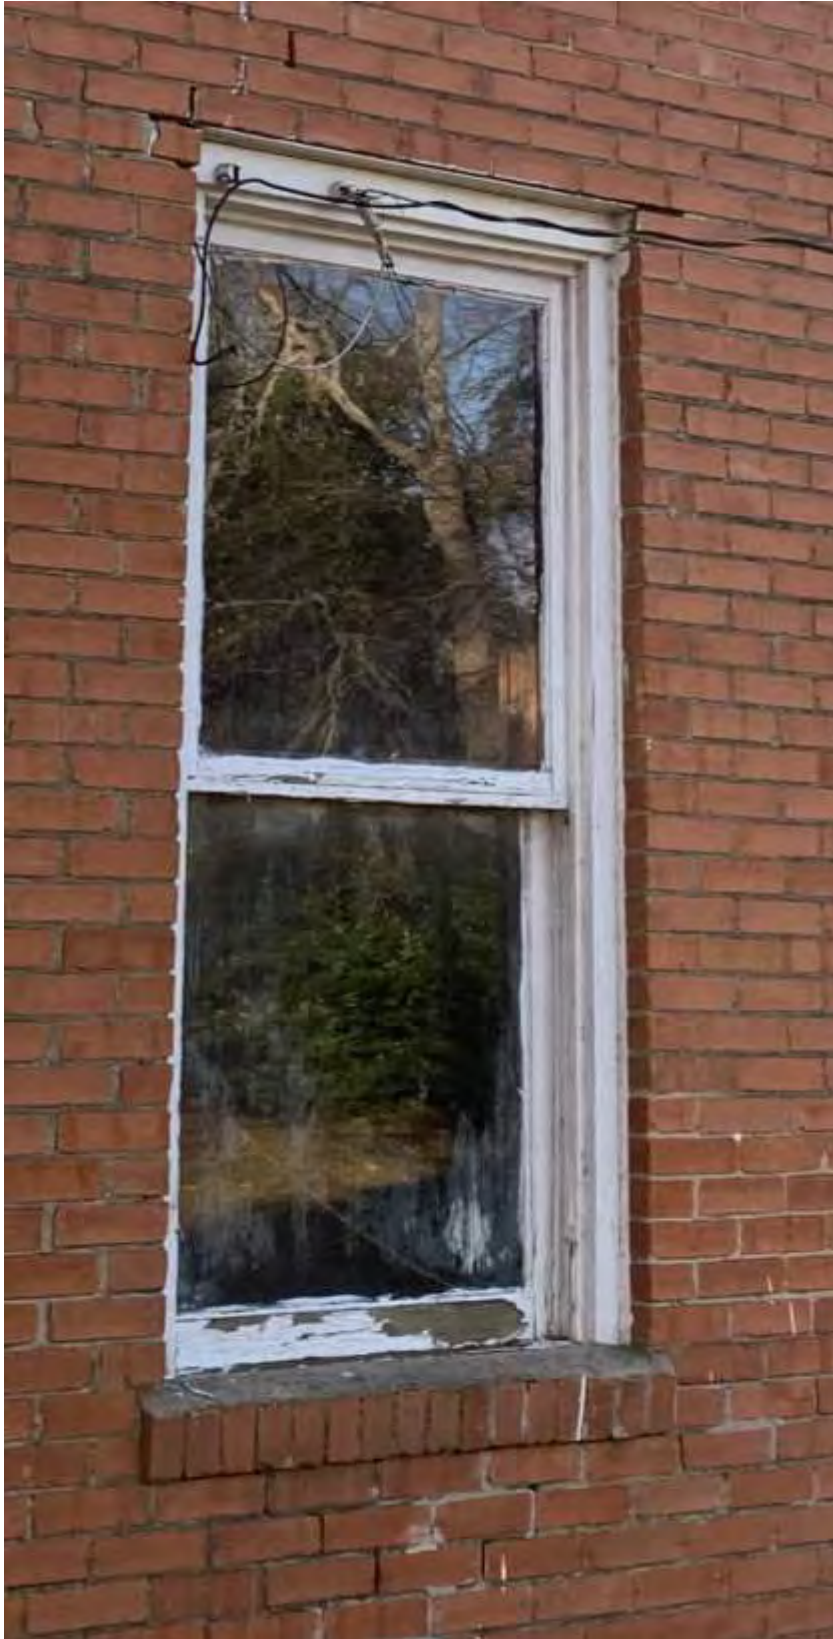
Original wood windows are in poor but restorable condition, most retain the original glazing. The glazing puddy is in need of replacement on almost all. Due to cost and other needed repairs of higher priority, restoration of the original wood windows has been placed under Phase IV. It would be beneficial if the original wood windows could be simply painted with a white primer to cover exposed bare wood in an effort to temporarily preserve the frames and sashes.

Example of original wood framed window with original glazing.

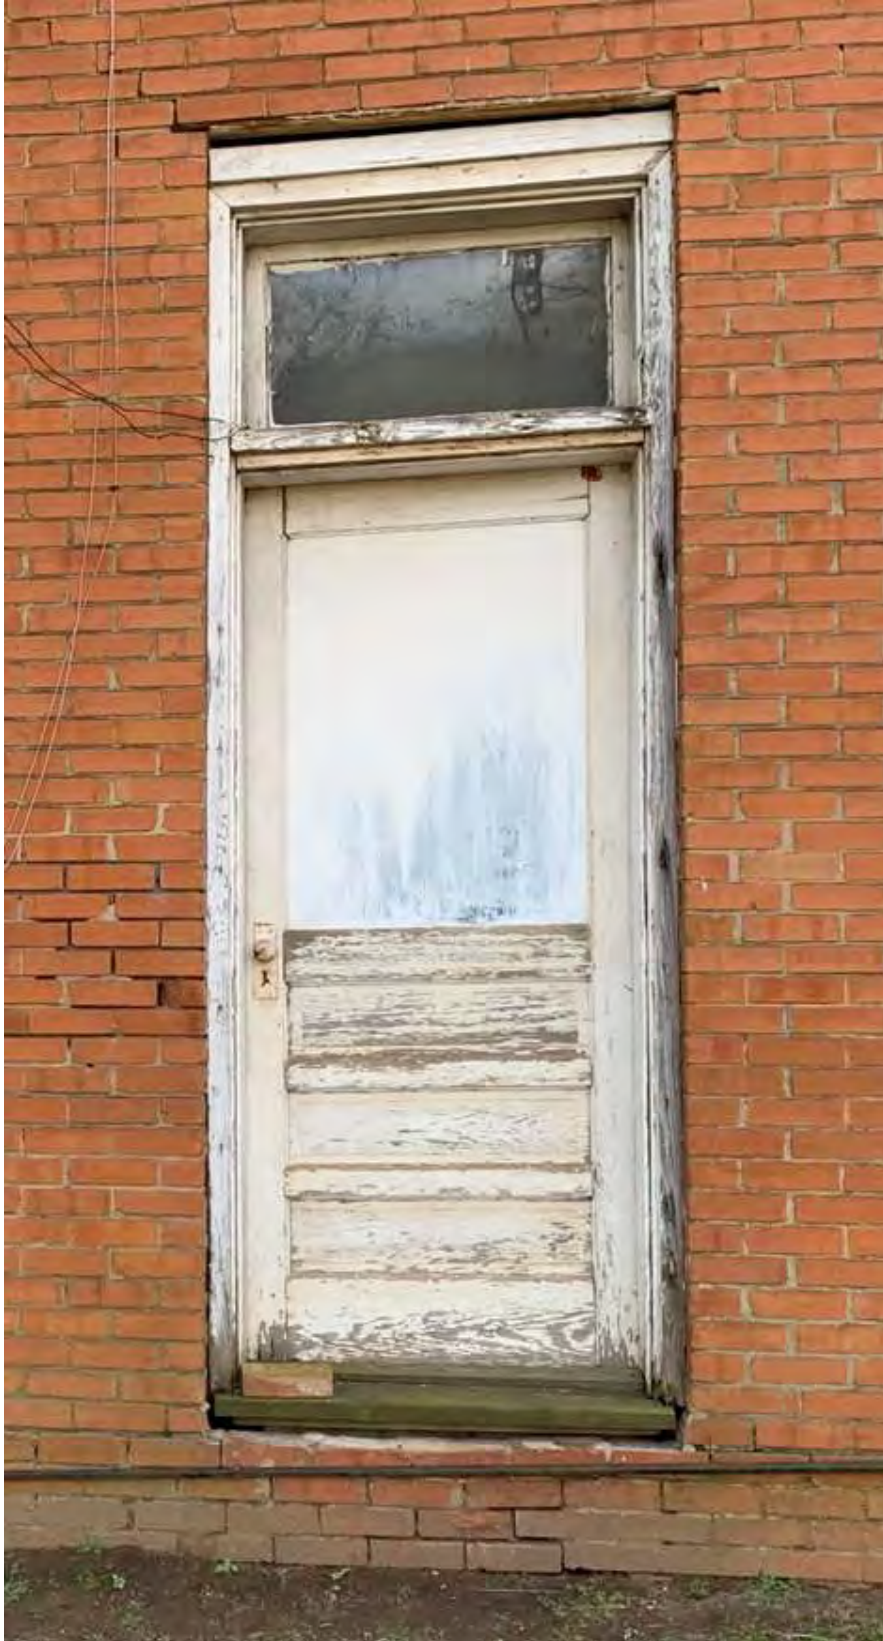
Northeast door. A wood stair probably was at this location.

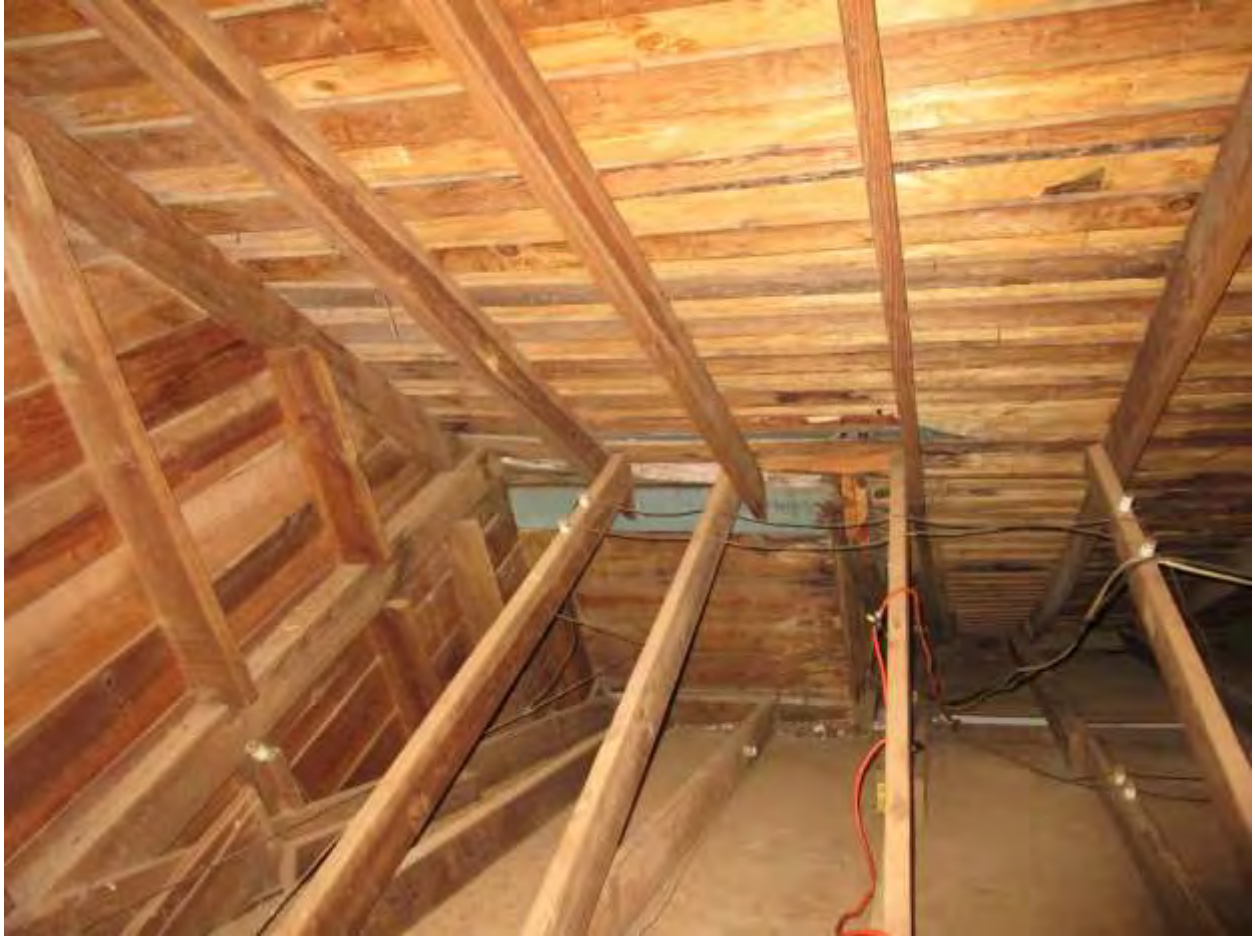
Attic, near southwest tower. Custom built scissor trusses.

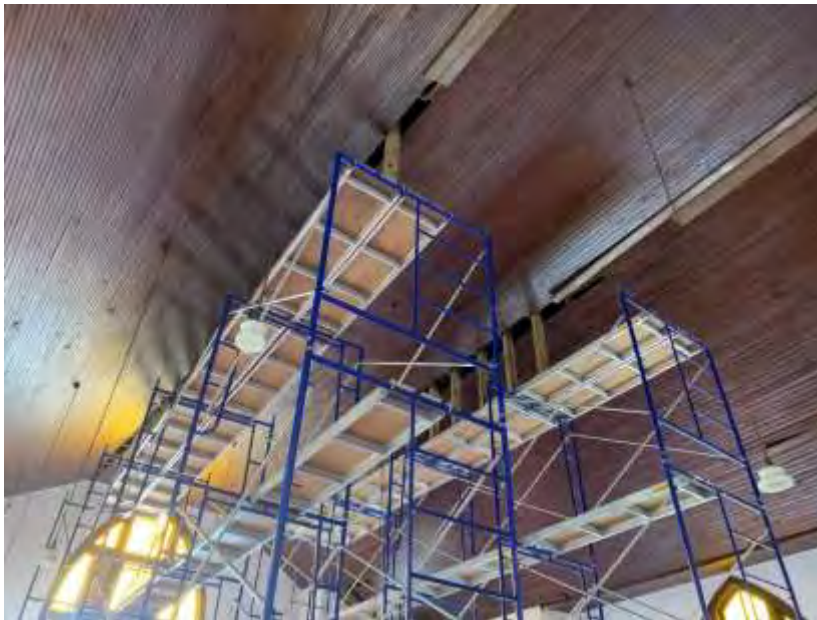
Sanctuary. Scaffolding erected to partially transfer roof loading.

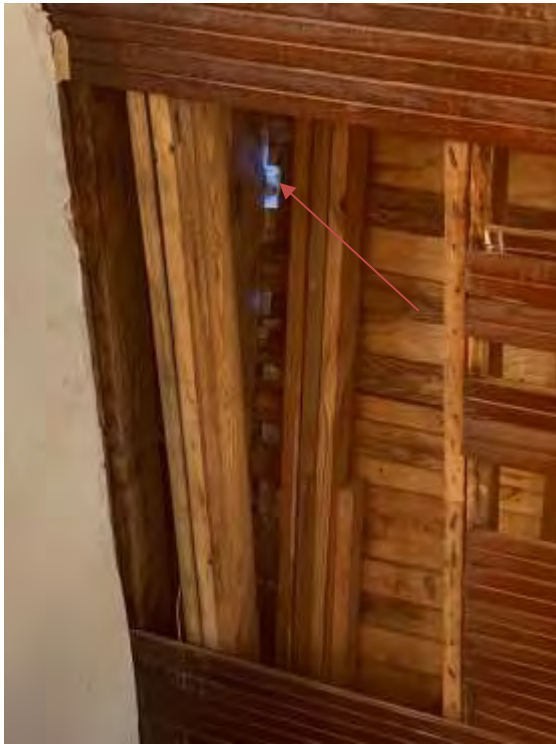
Example of roof opening where day light is visible from below.

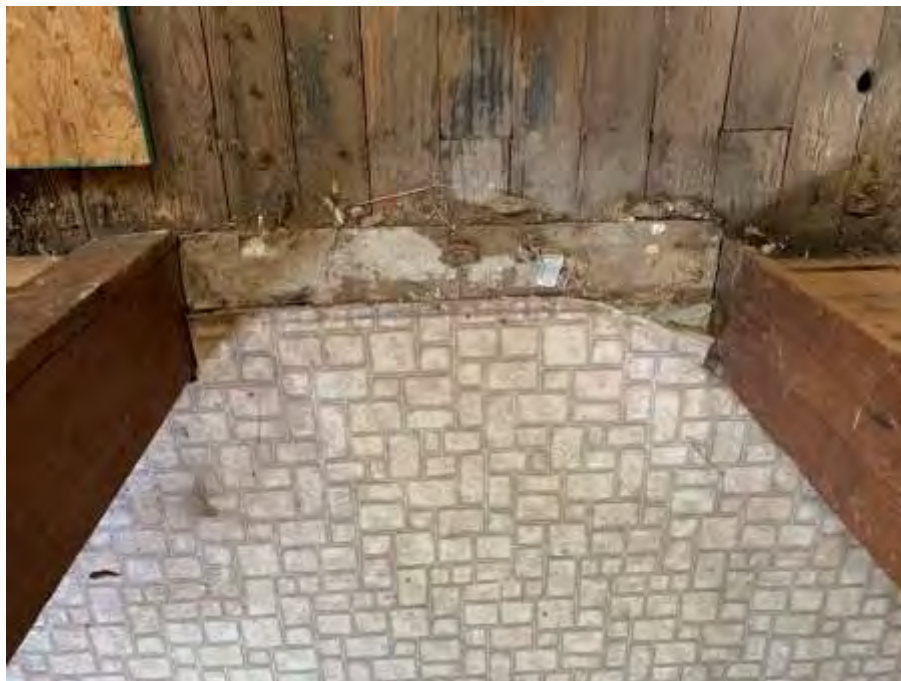
Non-historic sheet vinyl, over plywood (bottom of photo), over original wood flooring (top of photo).

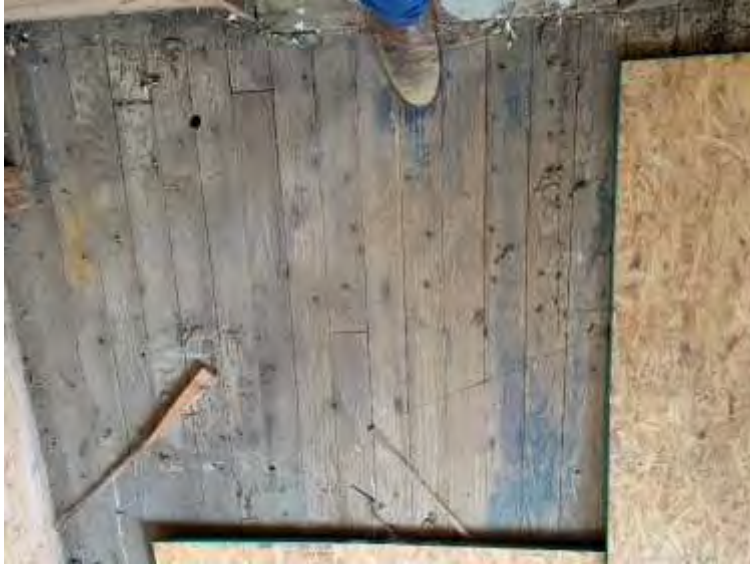
Area where later overlays have been removed and original wood flooring is exposed.

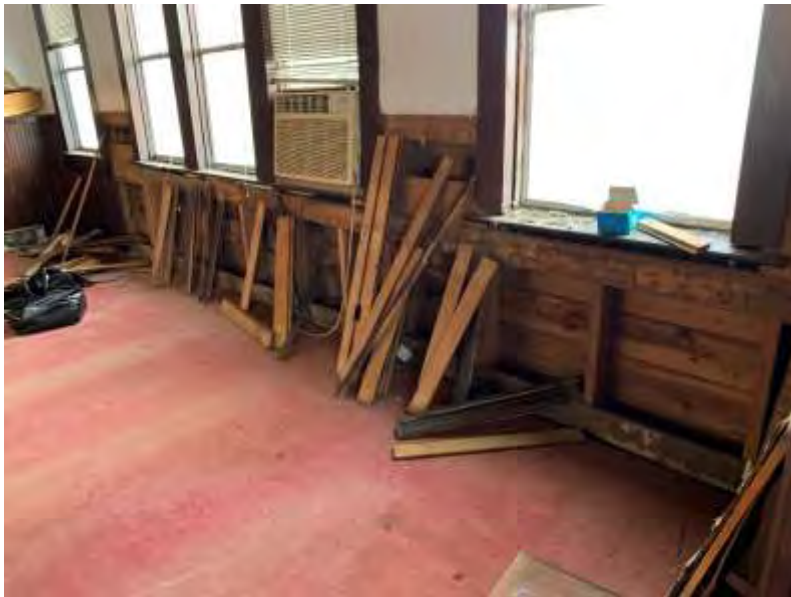
Sanctuary, west wall. Wainscot numbered and removed.

1. Remove all gypsum board material (pending environmental report). Phase I.
2. Remove all wall paneling. Phase I.

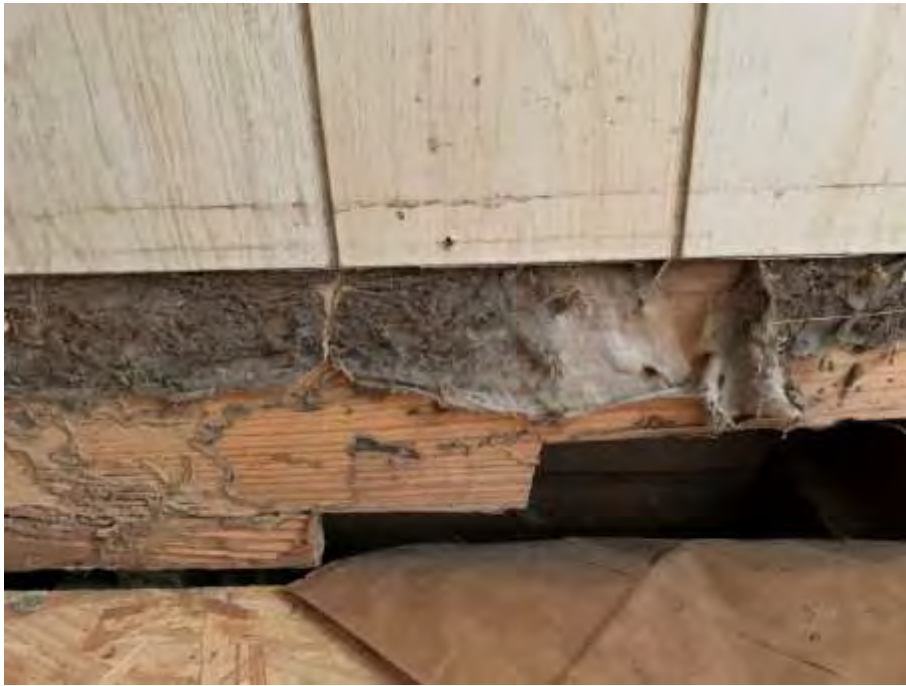
Remains of original wall papers backing under paneling.

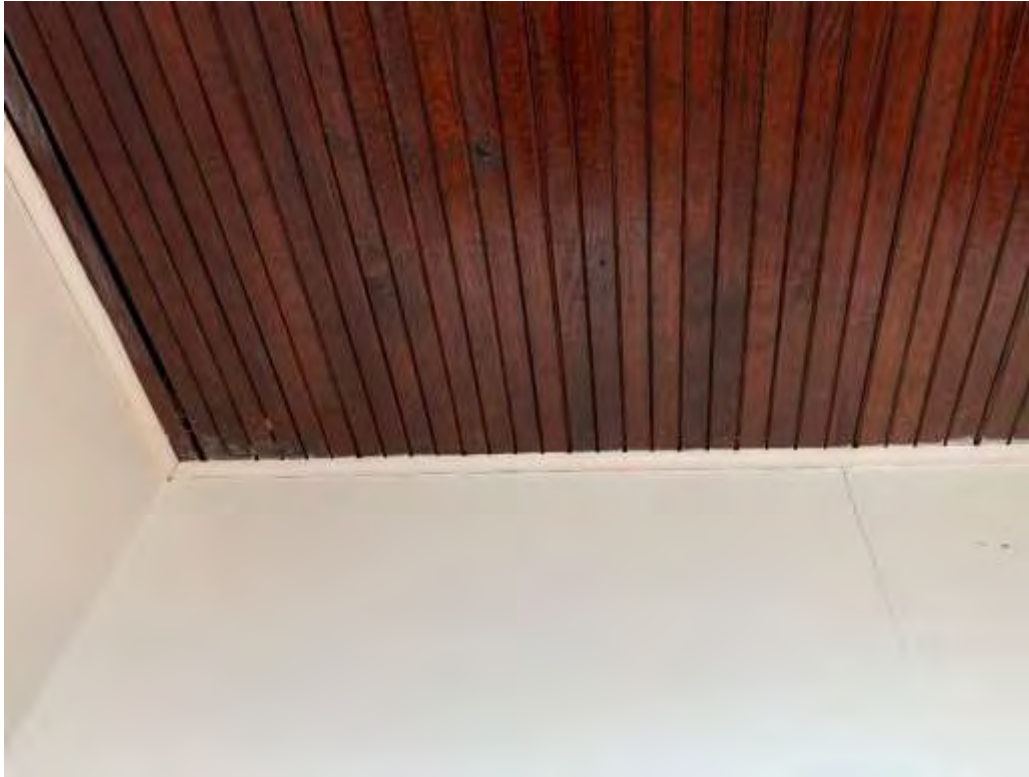
Beadboard ceiling with one generation of finish. Original moulding has been painted.

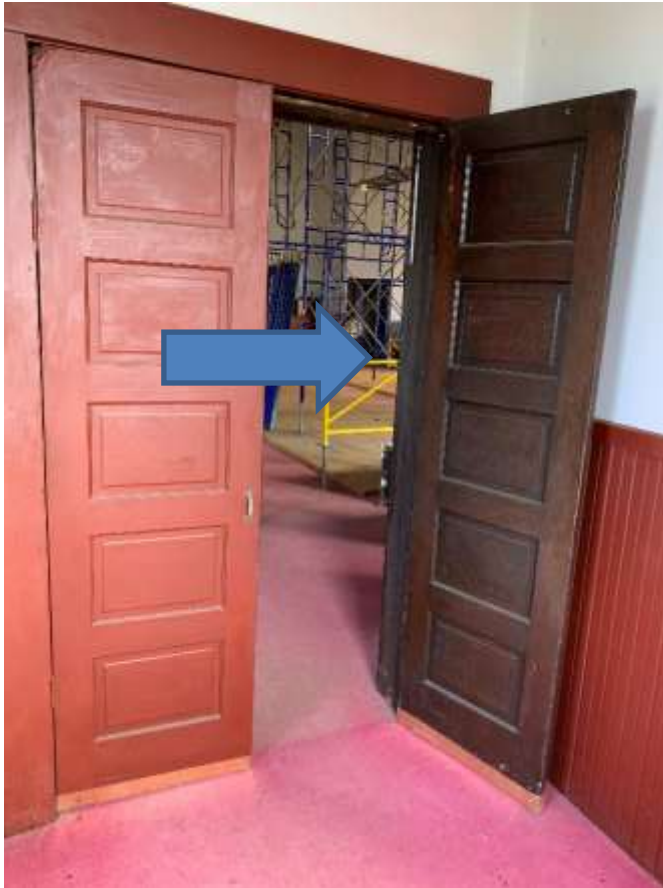
Original doors are 5 panel and had a natural wood finish (arrow).

1. Repair doors so they will function properly. Conduct minor repairs on hardware. Phase IV.
2. Restore all original doors and hardware. Phase V.

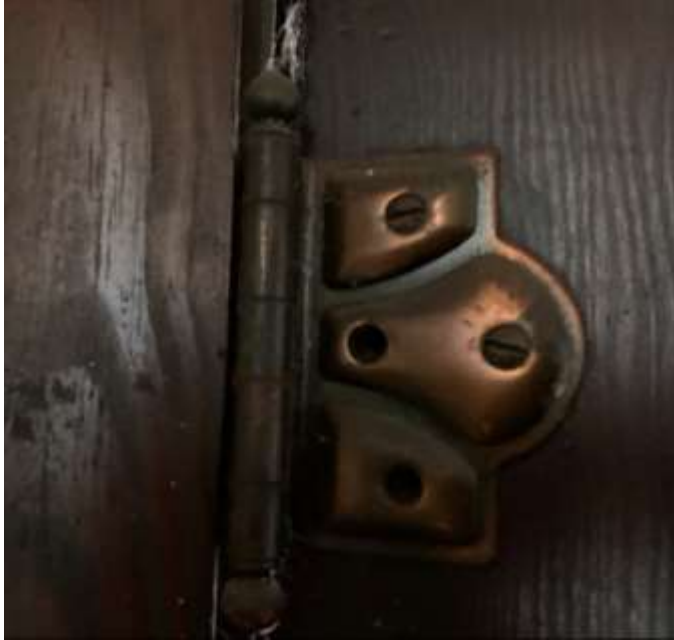
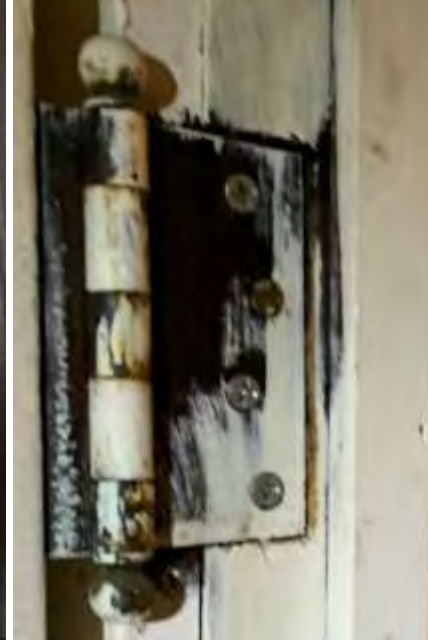
Original interior door hinge with remaining original finish. Modern replacement hinge.

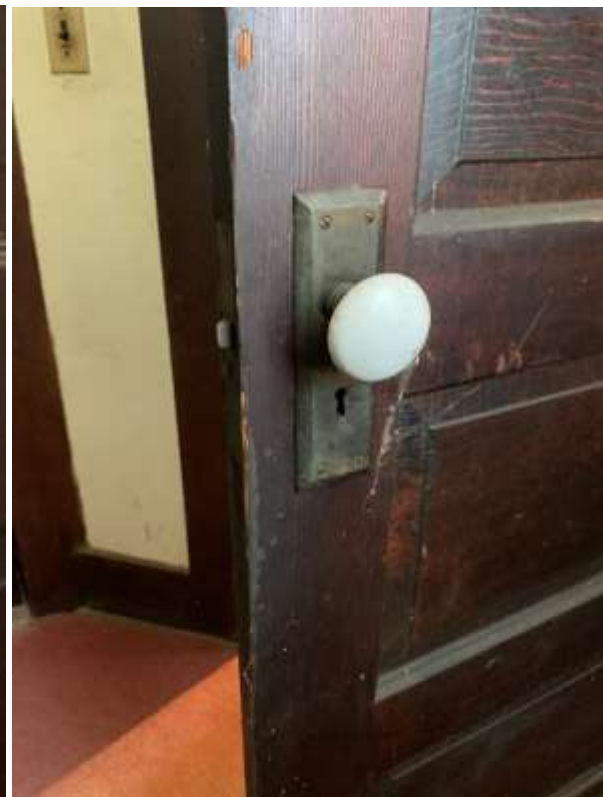
Probable white ceramic replacement knob.

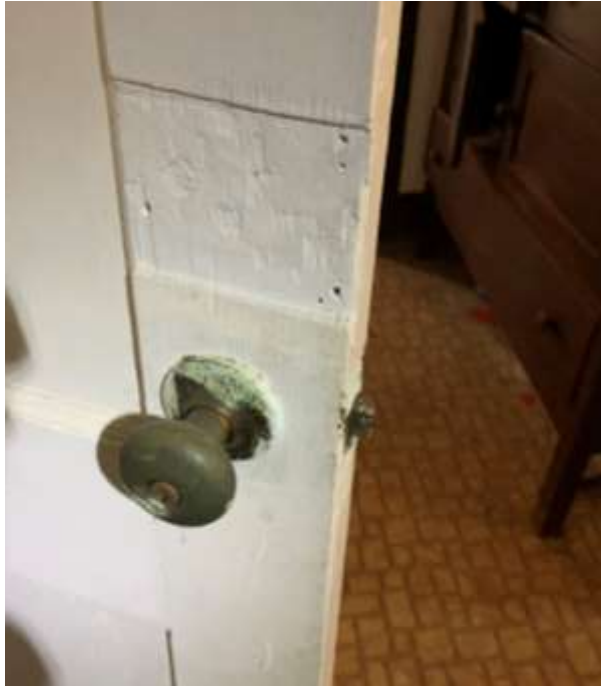
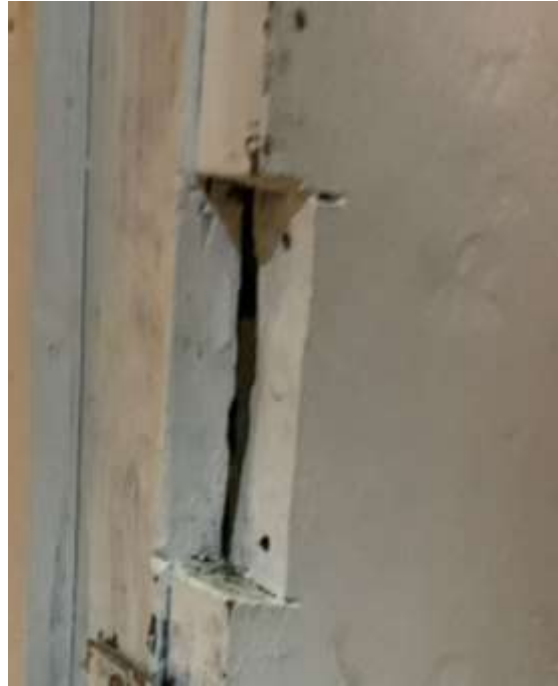
Ca. 1950's latchset. Evidence of removed rim latchset. Chiseled out casing for rim latch receiver.

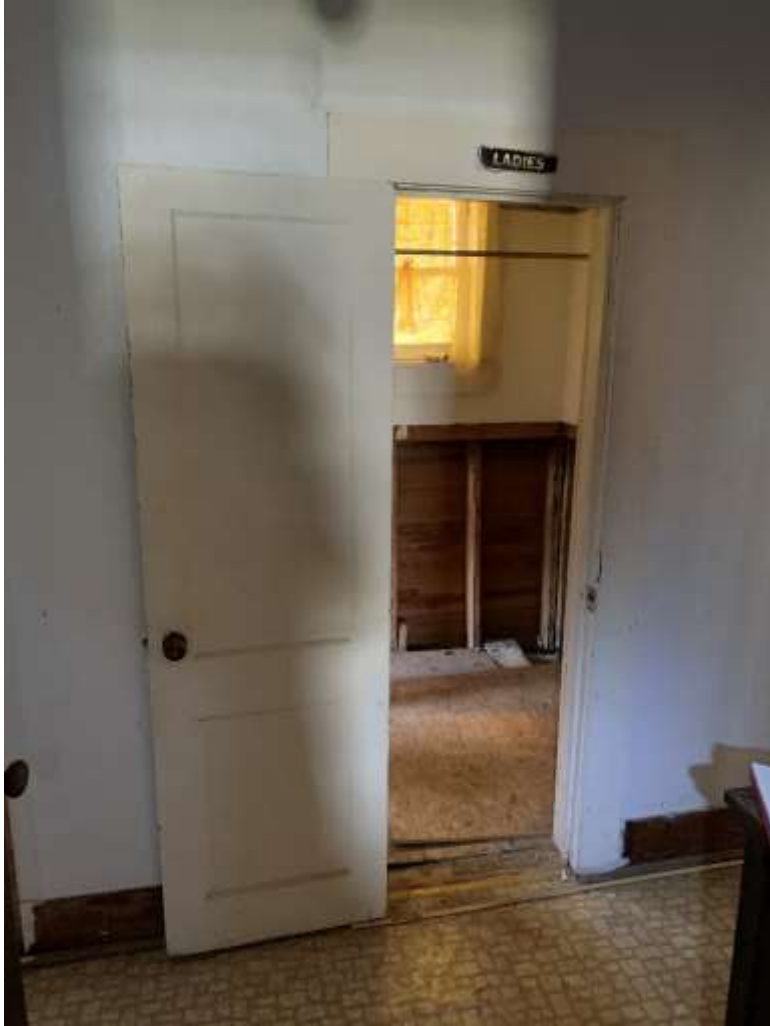
Narrow width, two panel door (24 inch Restroom door). Door and casings have been painted.

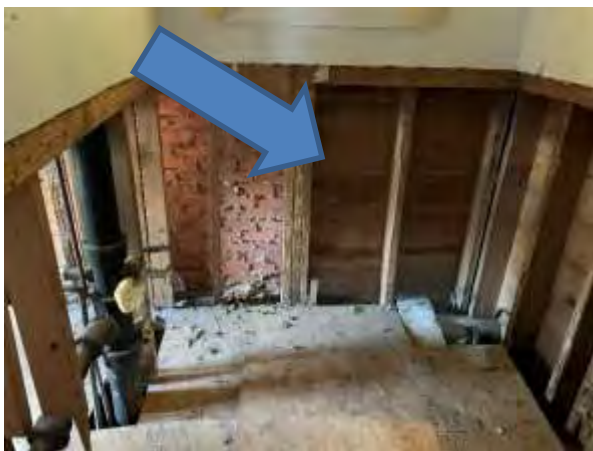
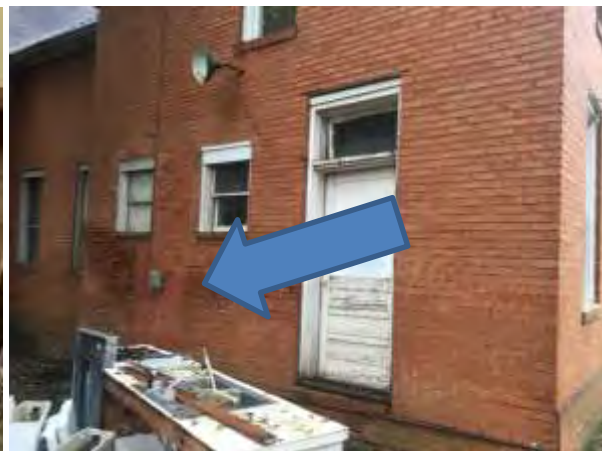
Former door location. Undetermined reasoning for previous configuration. Needs additional investigation. It is possible the original floor plans did not include indoor plumbing and the restrooms were added later.

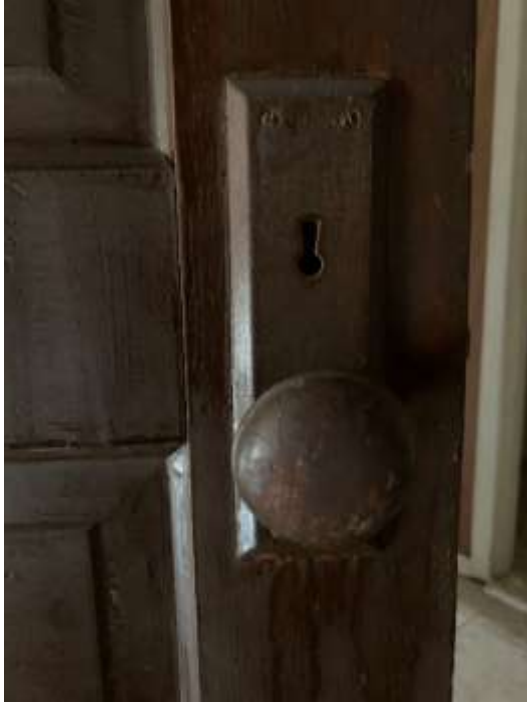
Original door hardware later reinstalled upside down.

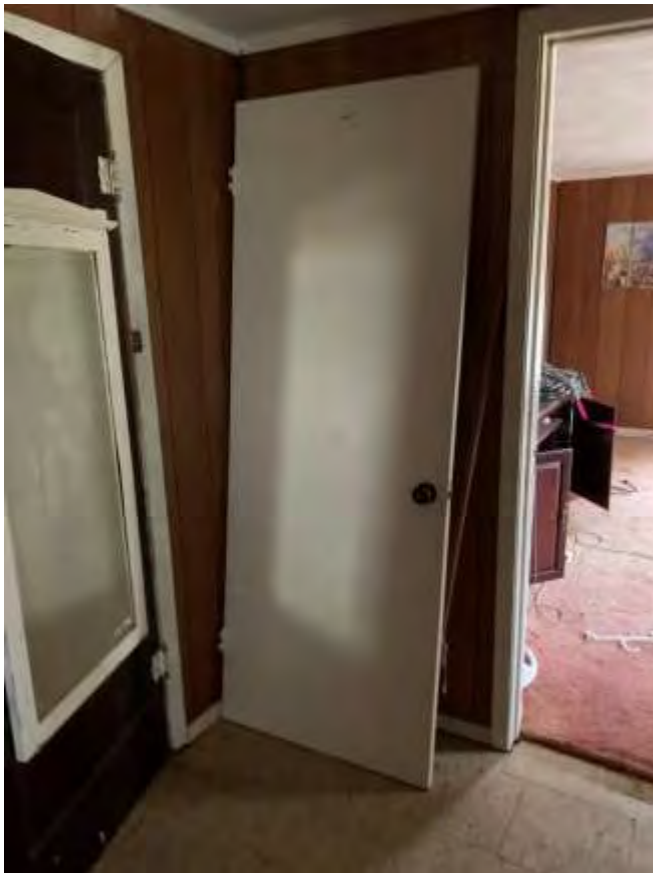
Second level. Plain wood doors are possibly ca. 1950's.

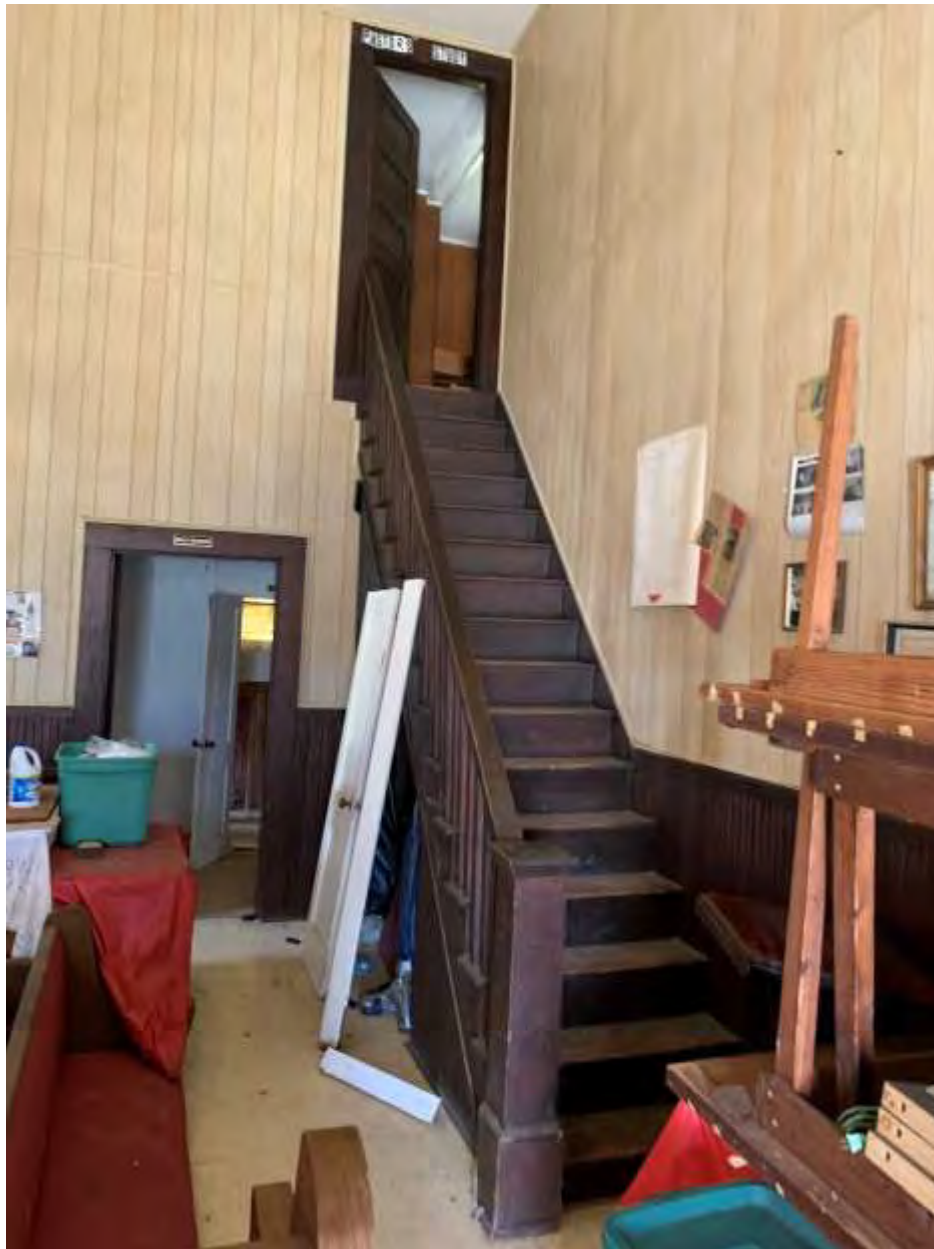
Multipurpose. Original stair.

1. Protect the stair from damage during work of all phases.
2. Clean and touch up finish. Phase V.

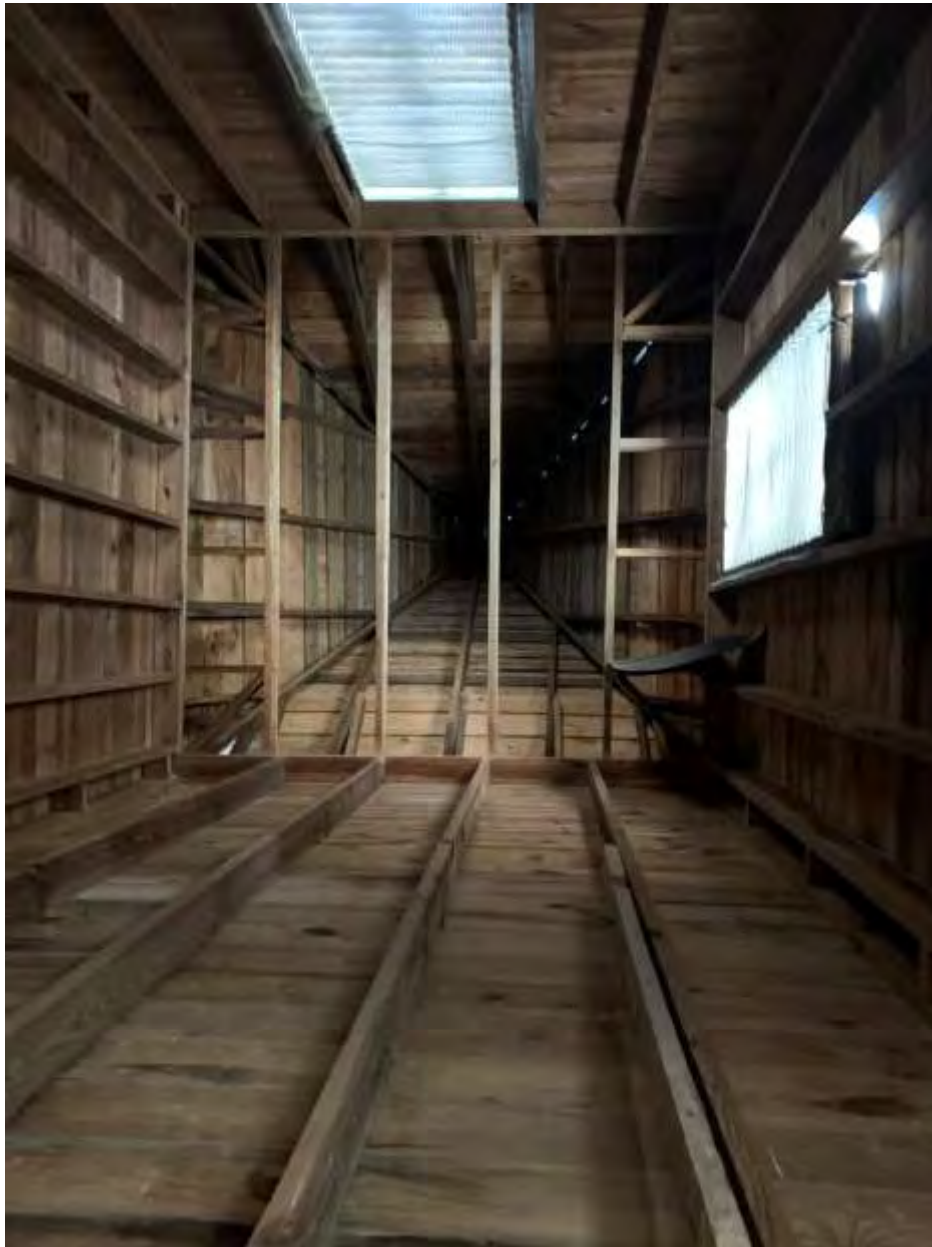
There are various locations where the 1x6 tongue and groove sheathing is deteriorated, especially at the corners. Since it is not practical to remove masonry to replace the sheathing, plywood panes could be added to the interior face of wood studs. During this procedure, additional brick ties could be added to restore the restraint system which currently includes deteriorated corrugated brick ties.

View upward in southwest tower.

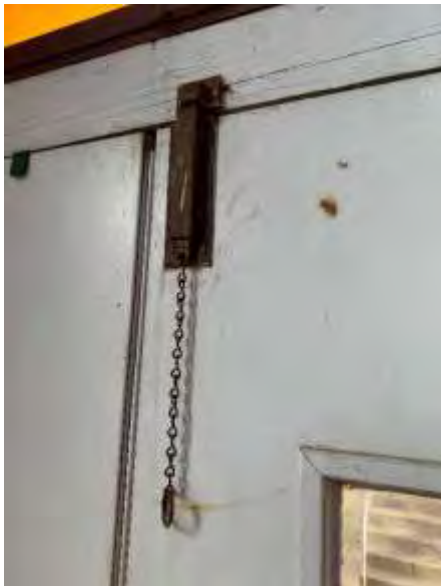
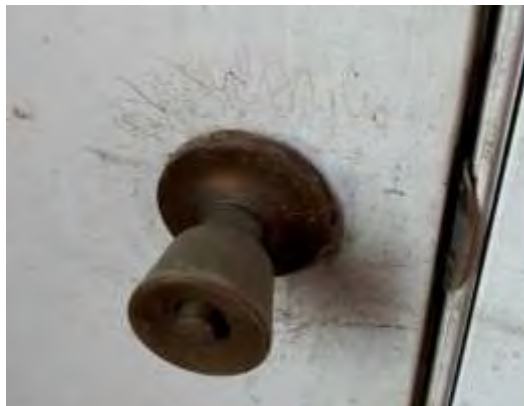
Probably a reinstalled original spring bolt (left) and modern knob on 1950's exterior door (right).

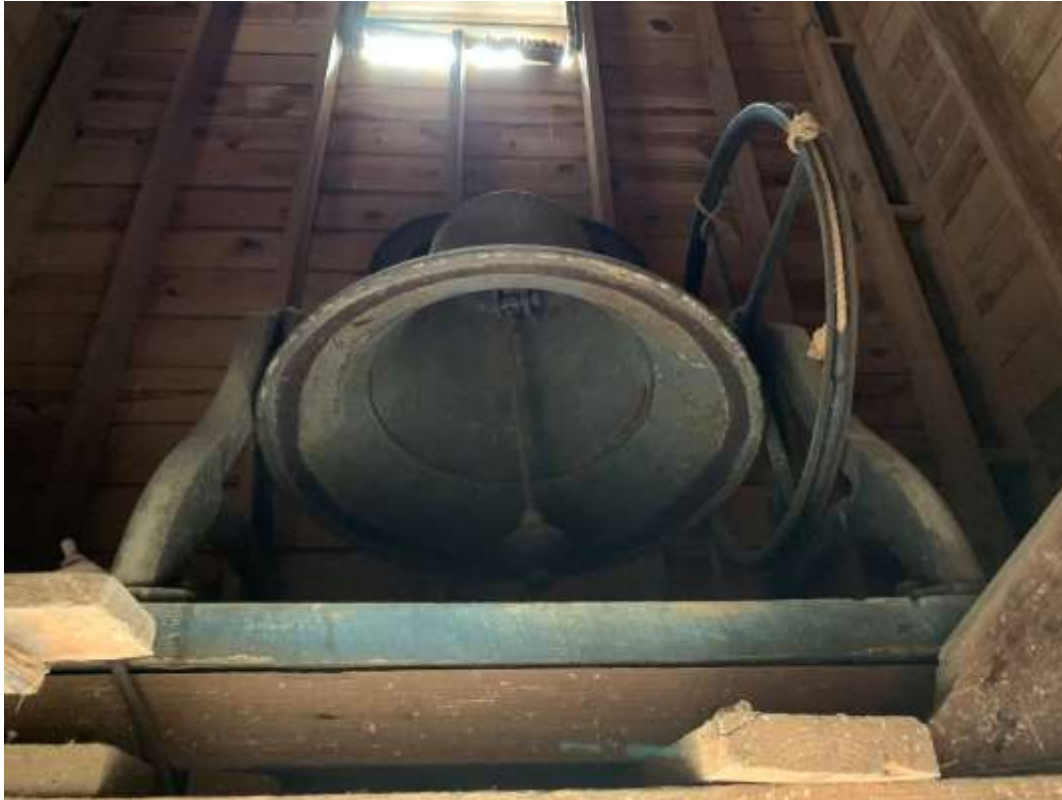
Steel bell system. Blue-gray color plank is unique and may have been shipped with the bell.

1. Clean and lubricate bell and moving parts. Phase IV.
2. Restore finishes in the room. Phase V.

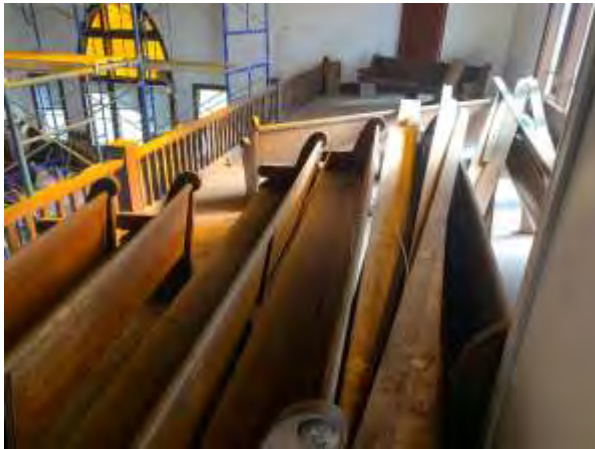
There are approximately seven original wood pews located on the Balcony. The original pews should be restored and used in the Sanctuary as a part of Phase IV. Replicas could be constructed to complete seating under Phase V.

Original pews.

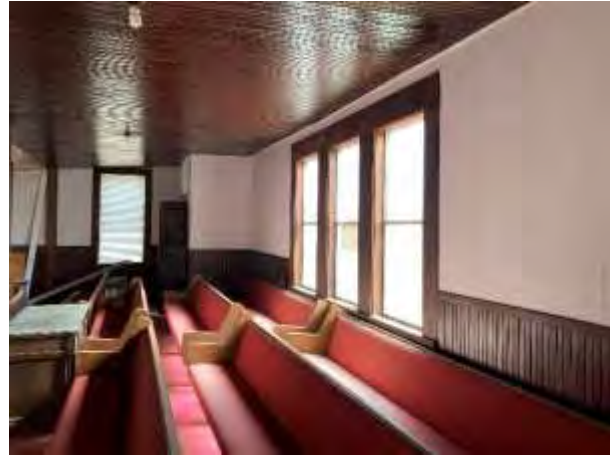
Non-original pews.
