**NOTICE OF MEETING
TOURISM ADVISORY BOARD
August 17, 2021
11:00 AM
Council Chambers
504 N. Queen Street
Palestine, TX**

MT. VERNON AME
913 E. Calhoun Street
Palestine, Texas

Preservation Master Plan – Phase 1
February 10, 2021

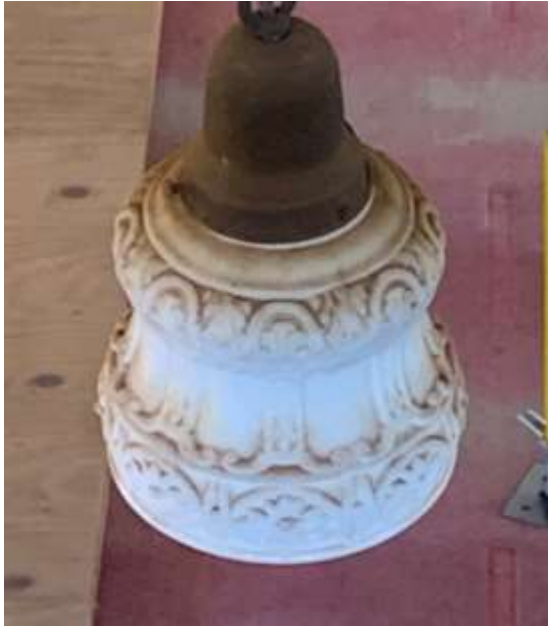
Original light fixture and globe.

1. Replace electrical infrastructure from meter to a new main panel board and disconnect. Phase III.
2. Replace selected areas of electrical components to provide limited HVAC, lighting and power. Phase III.
3. Completely replace all electrical components. Phase IV.
4. Install a smoke alarm system. Phase III.
5. Install emergency egress lighting. Phase IV.
6. Install wireless internet service. Phase V.
7. Install supplemental can light fixtures. Phase IV.
8. Rewire and reinstall original light fixtures. Phase V.

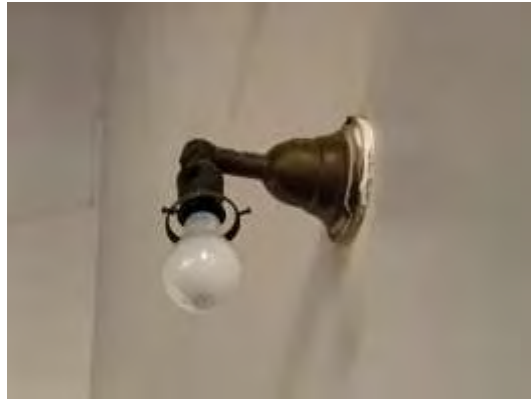
Original wall fixture base.

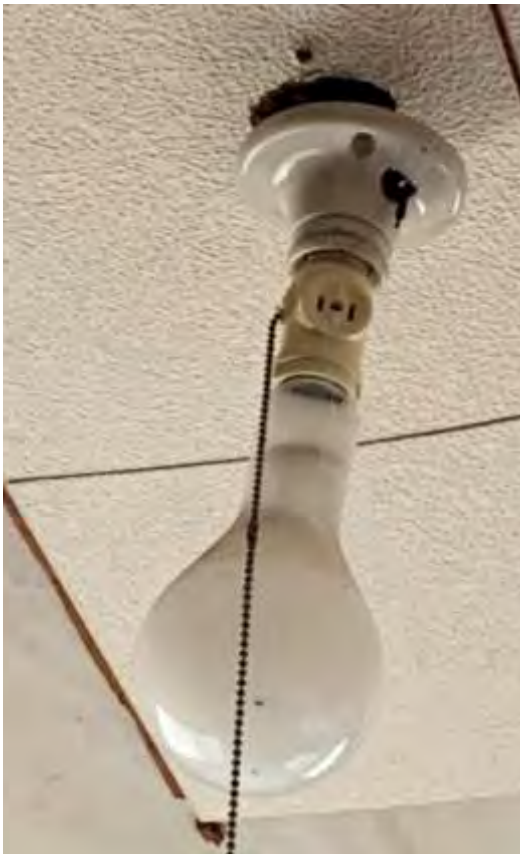
Ceramic base with bare bulb fixture.

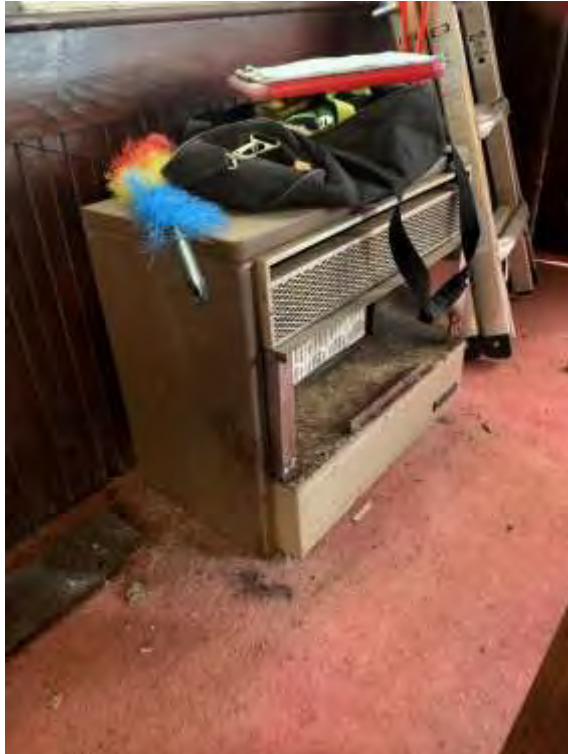
Gas space heaters and gas water heaters have been installed post WWII. The galvanized and black pipe system has deteriorated to the point it should be completely removed. Abandoned gas jets present a trip hazard and should all be removed. It is recommended to remove all gas infrastructure, remaining heaters, and water heaters under Phase I. It is recommended the Church consider an all-electric system for heating in a future restoration.

Non-original gas space heater.

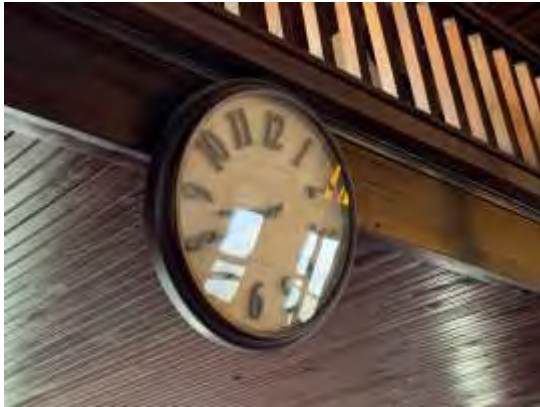
It appears there were an early generation of wall clocks, one in the Sanctuary and one in the Multipurpose room. The remaining clock located on the balcony fascia is a modern plastic clock. It is recommended to install new clocks, representative of the 1920's, and with a wood enclosure.

Modern clock.

1. Install replica clocks. Phase V.

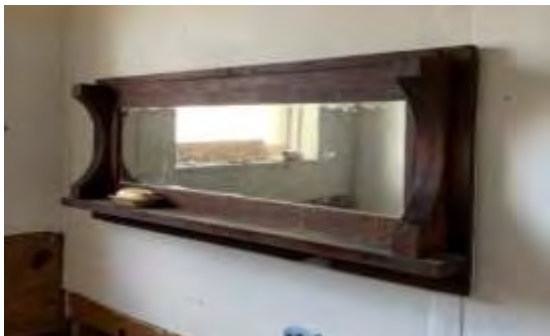
Original mirrored shelf in Men's restroom.

1. Preserve items. Reinstall at same locations after replica wall paper is installed on walls.
Phase V.

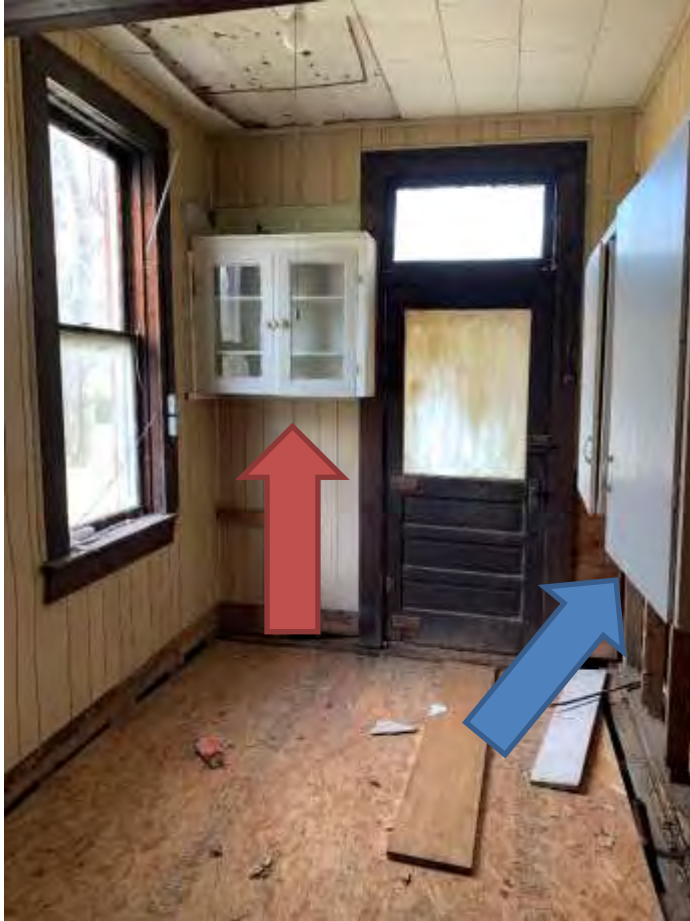
Northeast corner of Vestibule. Historic cabinet (red arrow) and non-historic cabinet (blue arrow).

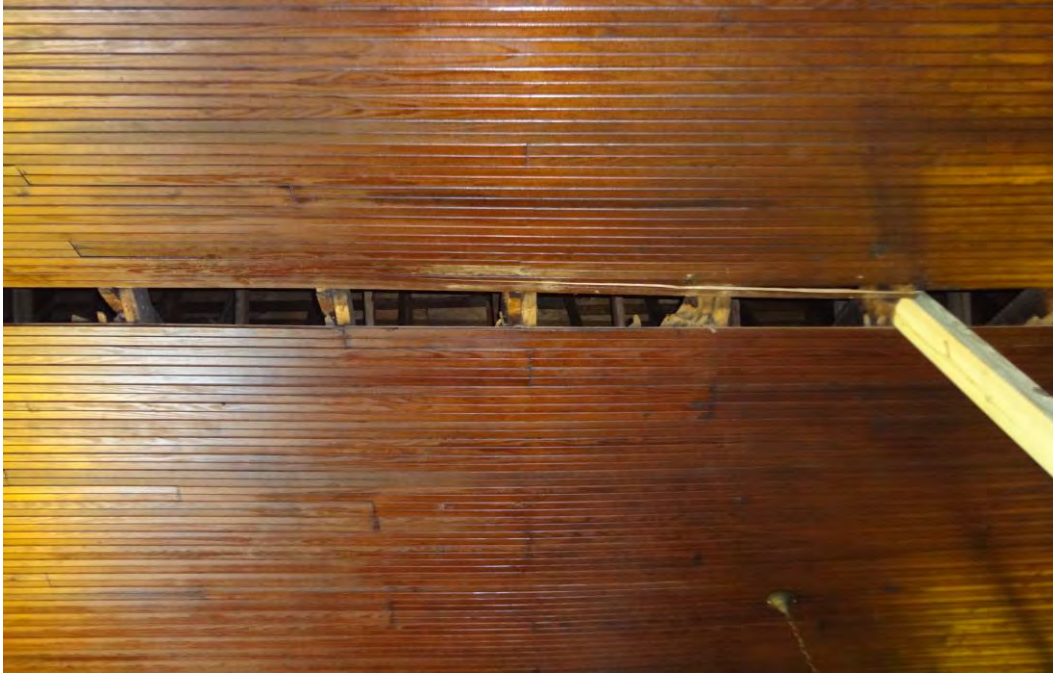
Photograph 3 – Typical Horizontal Bottom Chord to Sloped Bottom Chord Transition.
